HIGH PRECISION METAL FORMING

Mr. Jerry Dickson, US Army AMCOM

Mr. Bill Baschnagel, Creare, Inc.

Mr. Albert Tatka, US Army TACOM-ARDEC

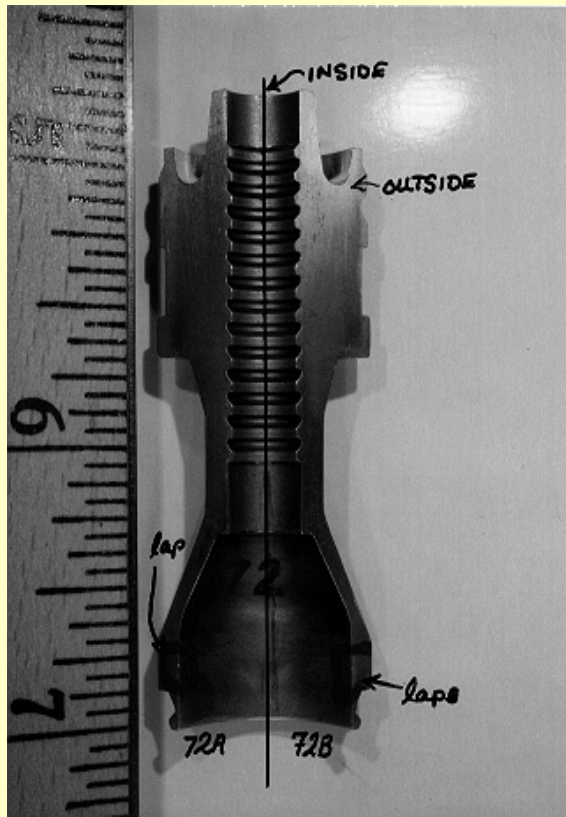
Figure 1a. Sabot No. 72 in the "as-received" condition, teeth facing up.

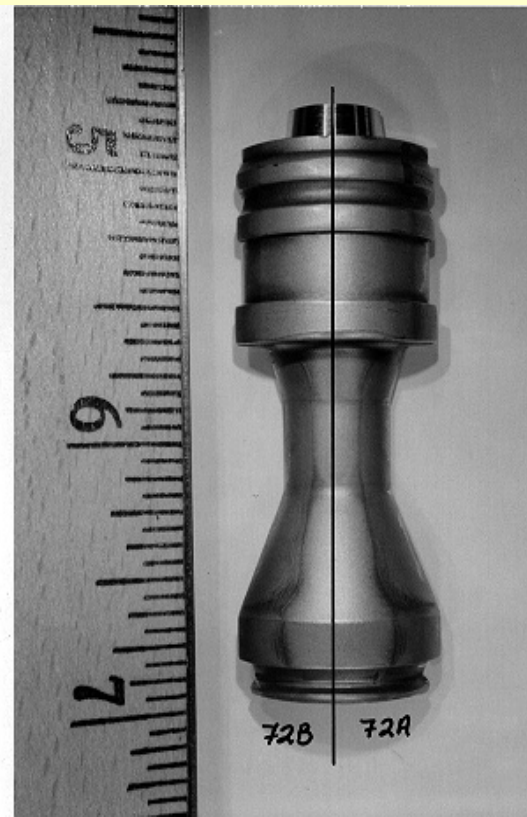
Figure 1b. Sabot No. 72 in the "as-received" condition, outer surface.

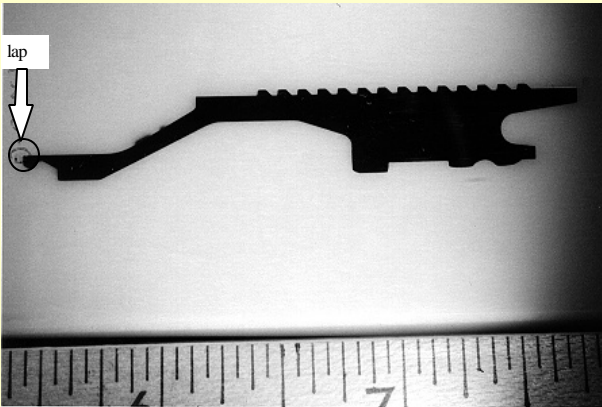
Figure 2a. Cross-section of Sabot No. 72A inside. The circled area is a lap that corresponds to Figure 2b.

- ARDEC WECAC sectioned formed sabots to observe grain structure and flaws
- Laps found in non-critical
- Difficult to move metal thru cap groove

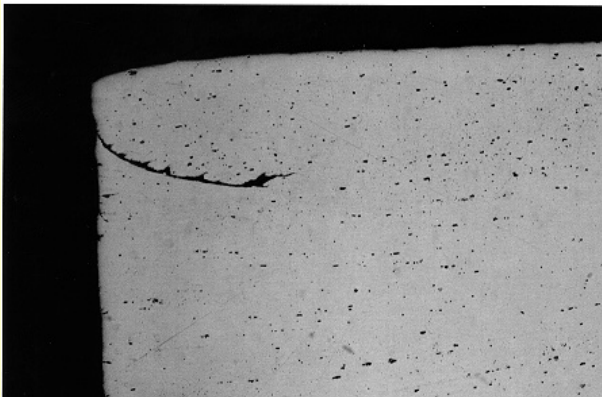
Figure 2b. Lap noted in Sabot No. 72A inside, mag. 100x.

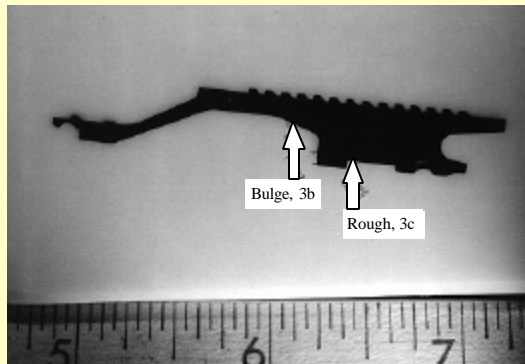
Figure 3a. Cross-section of Sabot No. 72B outside wall. Arrows point to anomalies in the structure and correspond to Figures 3b & 3c below.

- Additional flaws identified
- Bulges found in saddle area
- Rough sections found in band seat

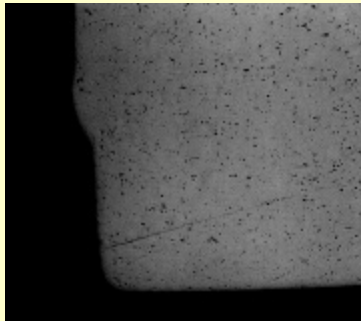
Figure 3b. Bulge found in Sabot No. 72B outside wall, 40x.

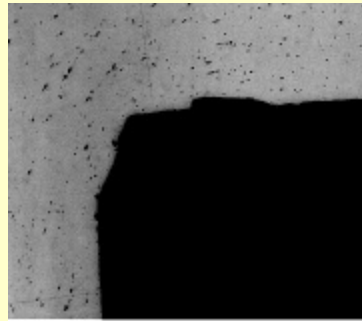
Figure 3c. Rough area found in Sabot No. 72B outside wall, 75x

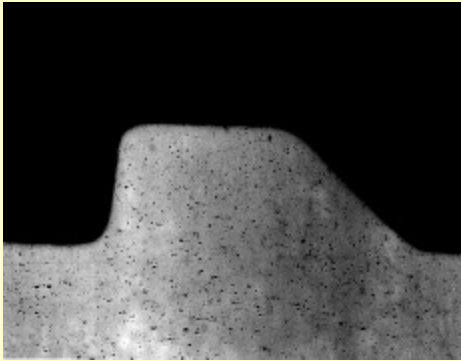
Figure 9. Tooth from Sabot No. 72A inside, 50x.

- Teeth fully formed, no laps or other flaws noted in teeth area that would result in weakened structure
- Go ahead given to produce ballistic test hardware

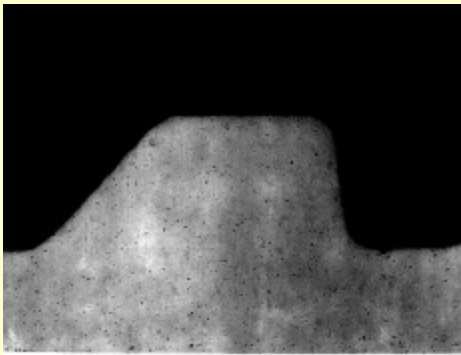
Figure 10. Tooth from Sabot No. 73B inside, 50x.
