Marmet Lock & Dam

Automated Instrumentation Assessment

Summer / Fall 2004

2005 Tri-Service Infrastructure Conference
August 4, 2005

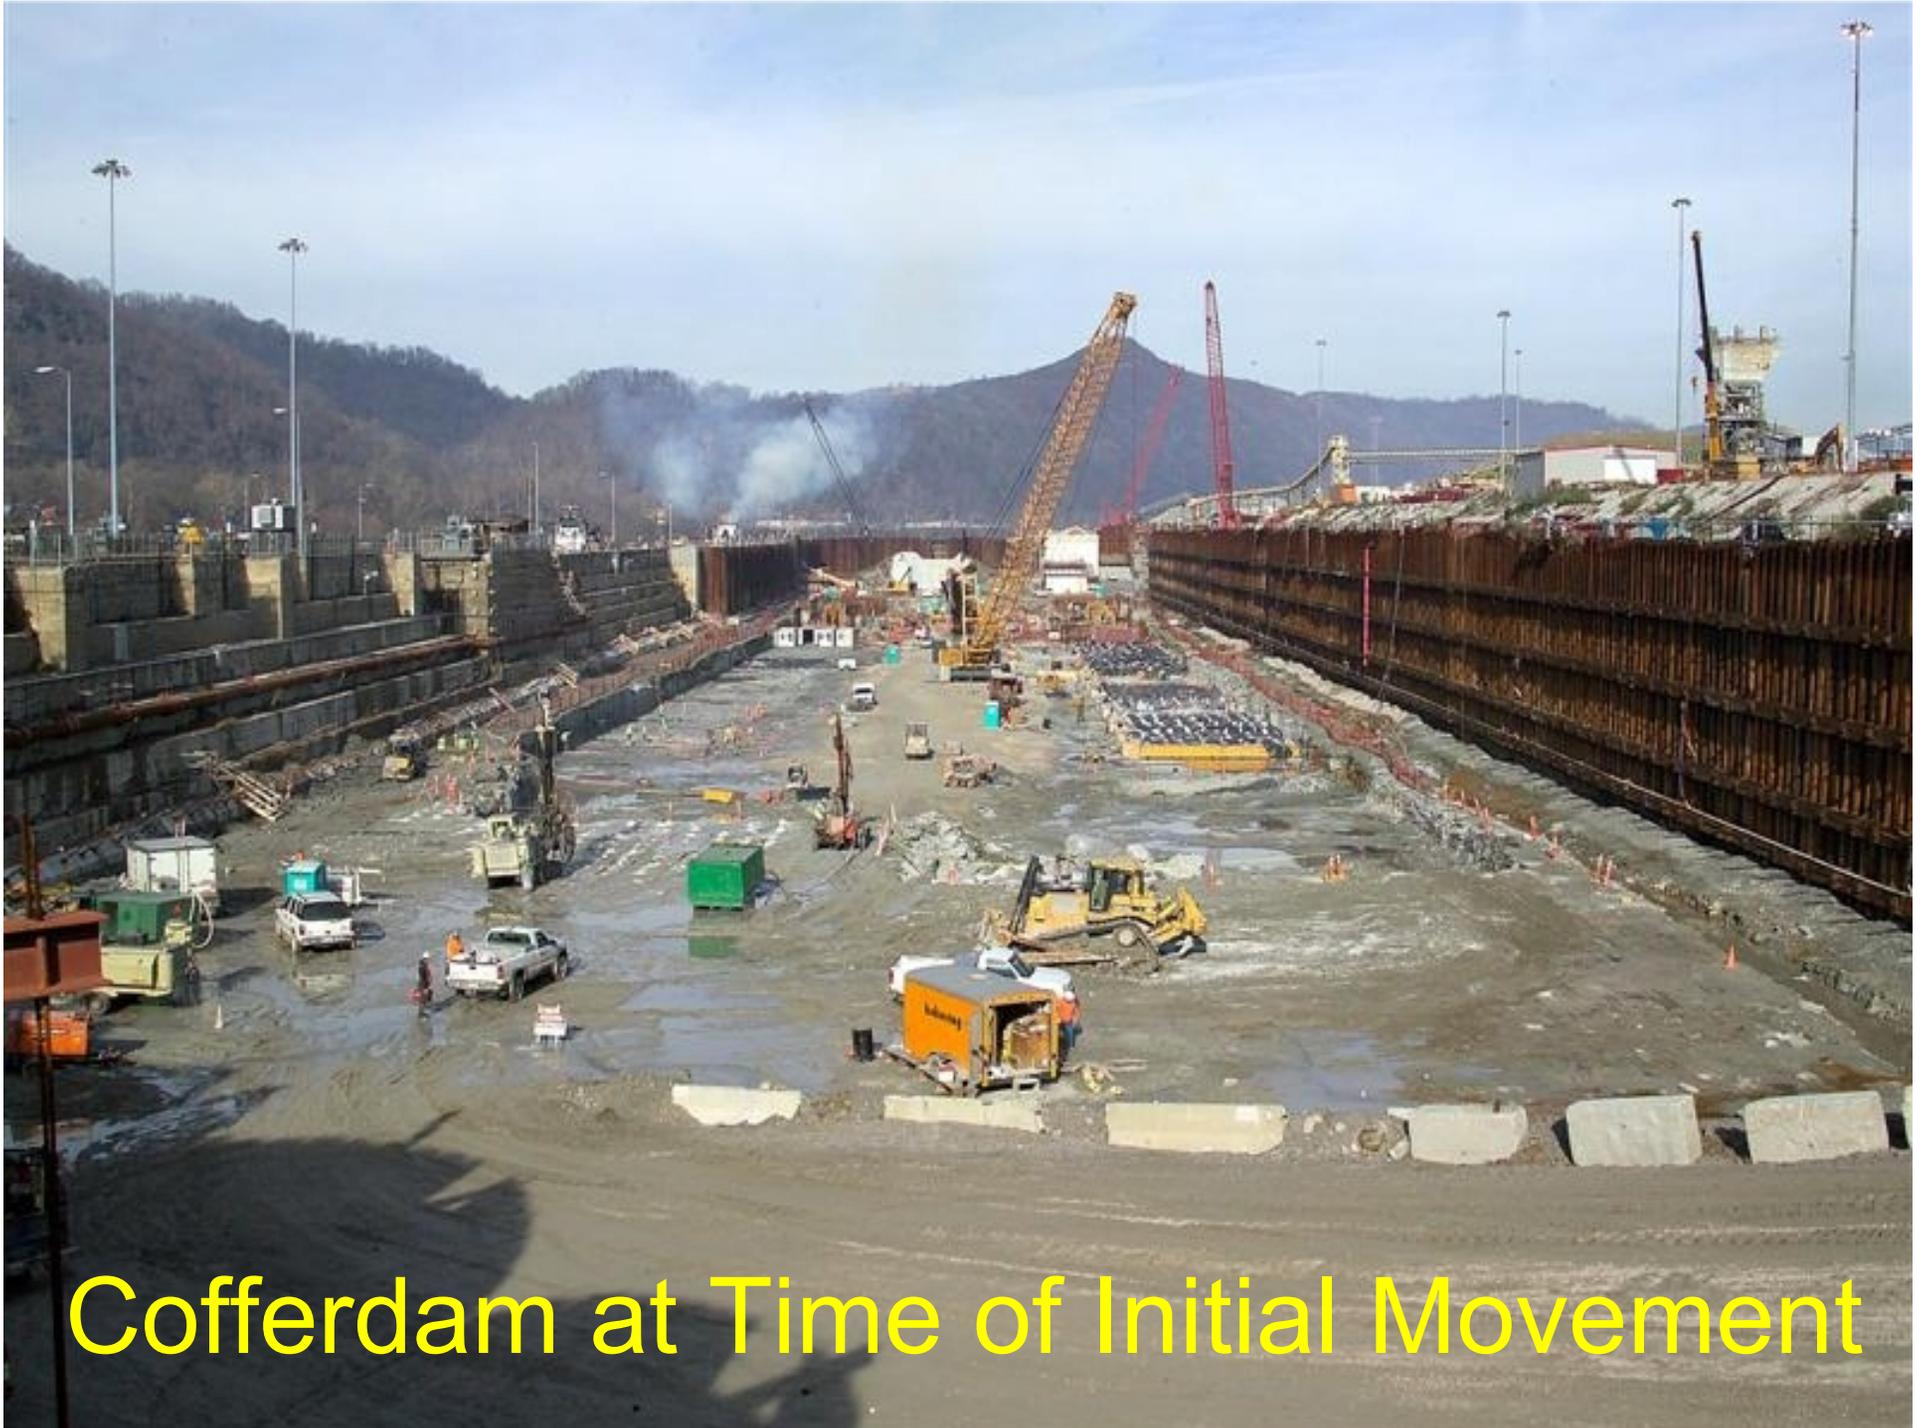
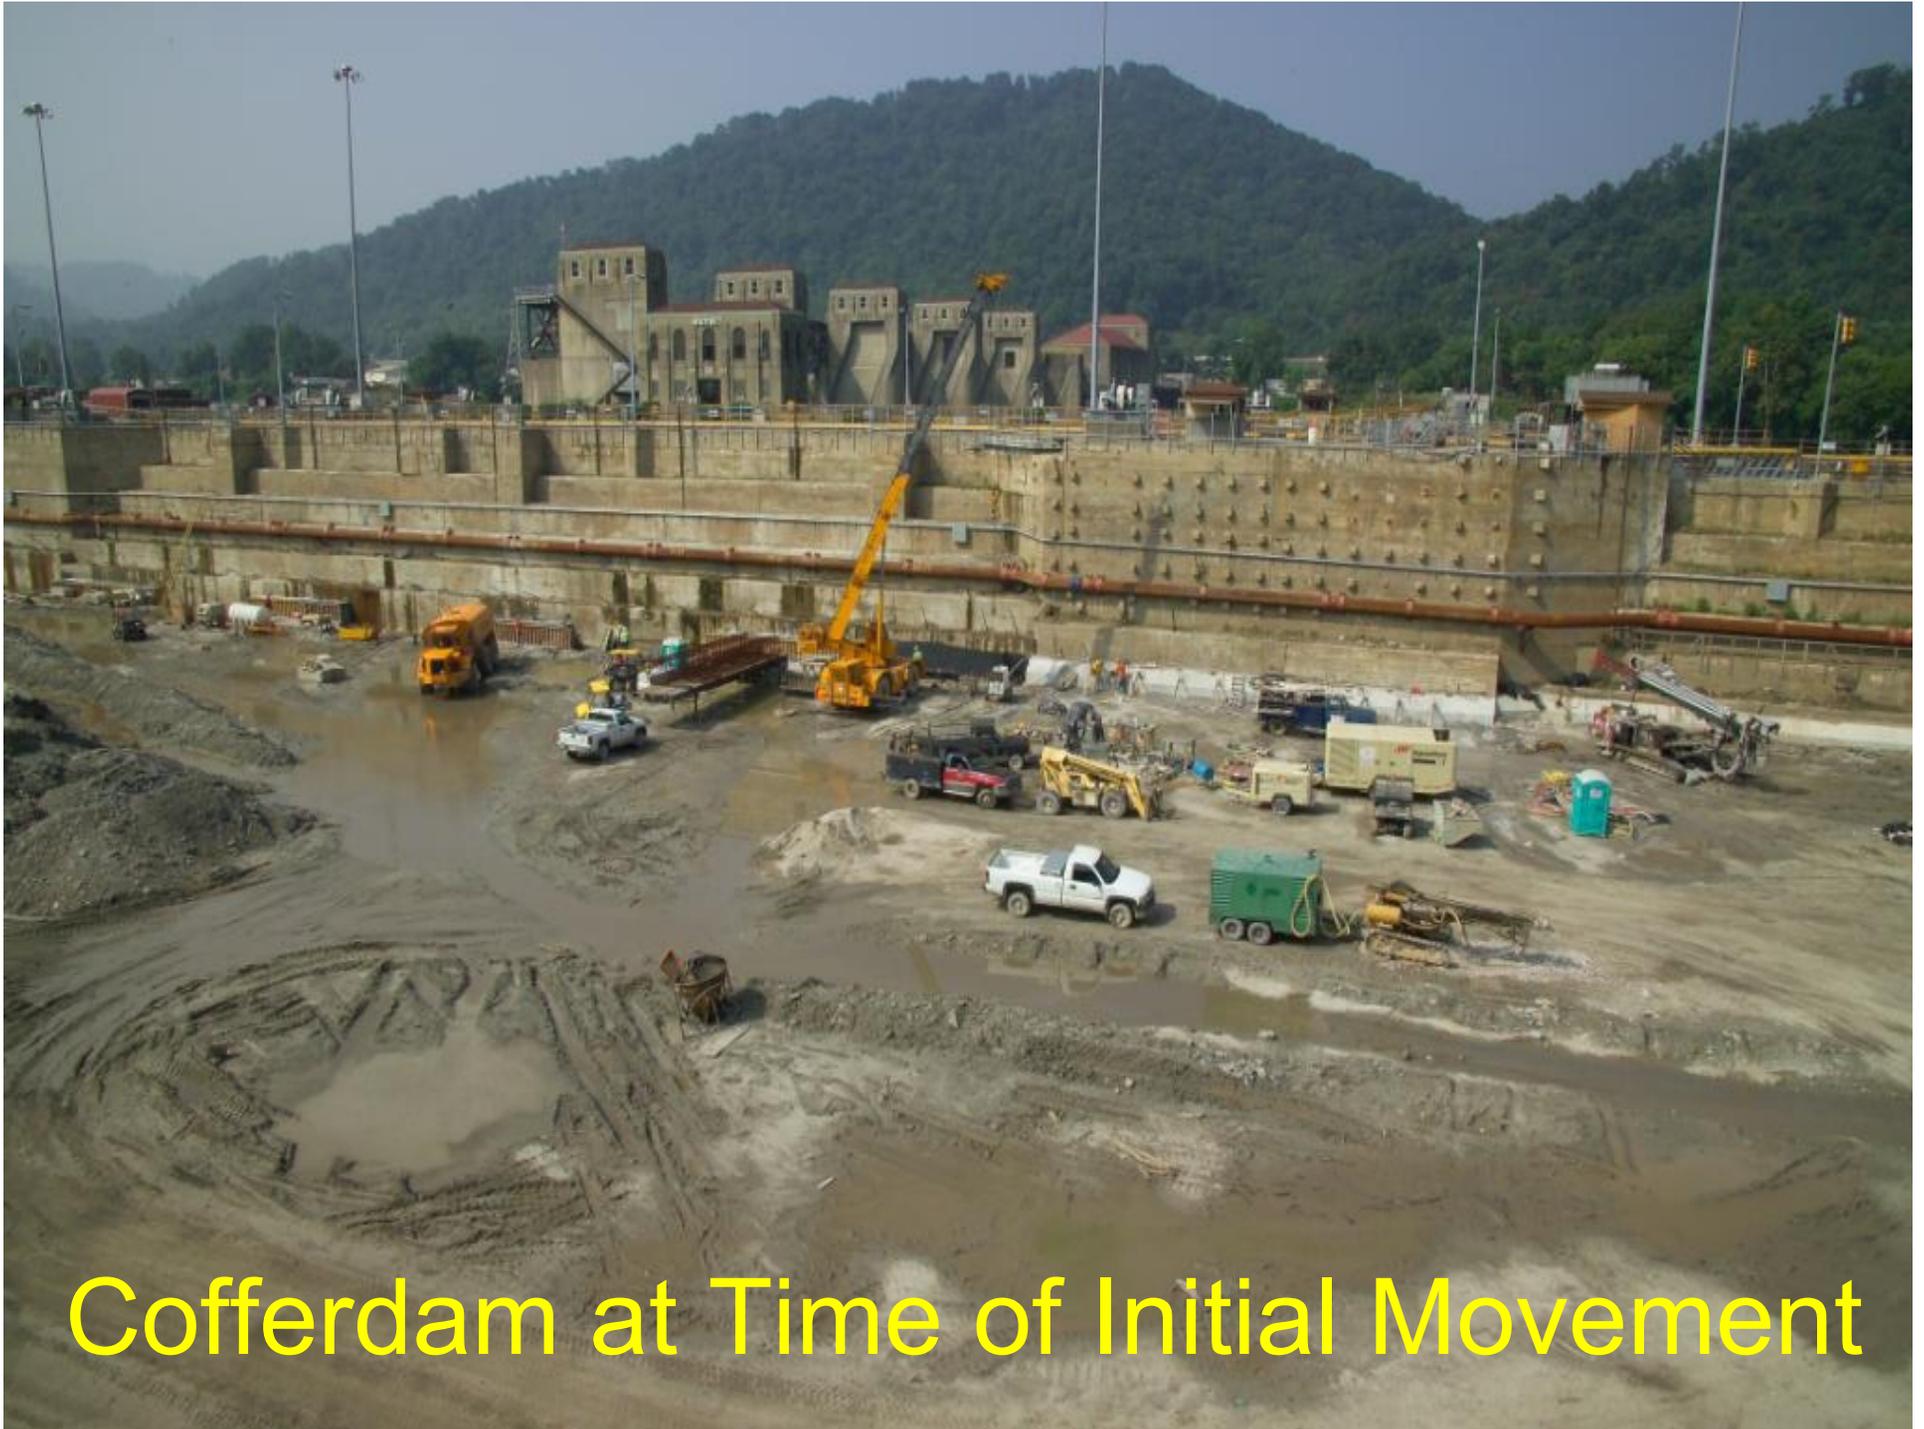
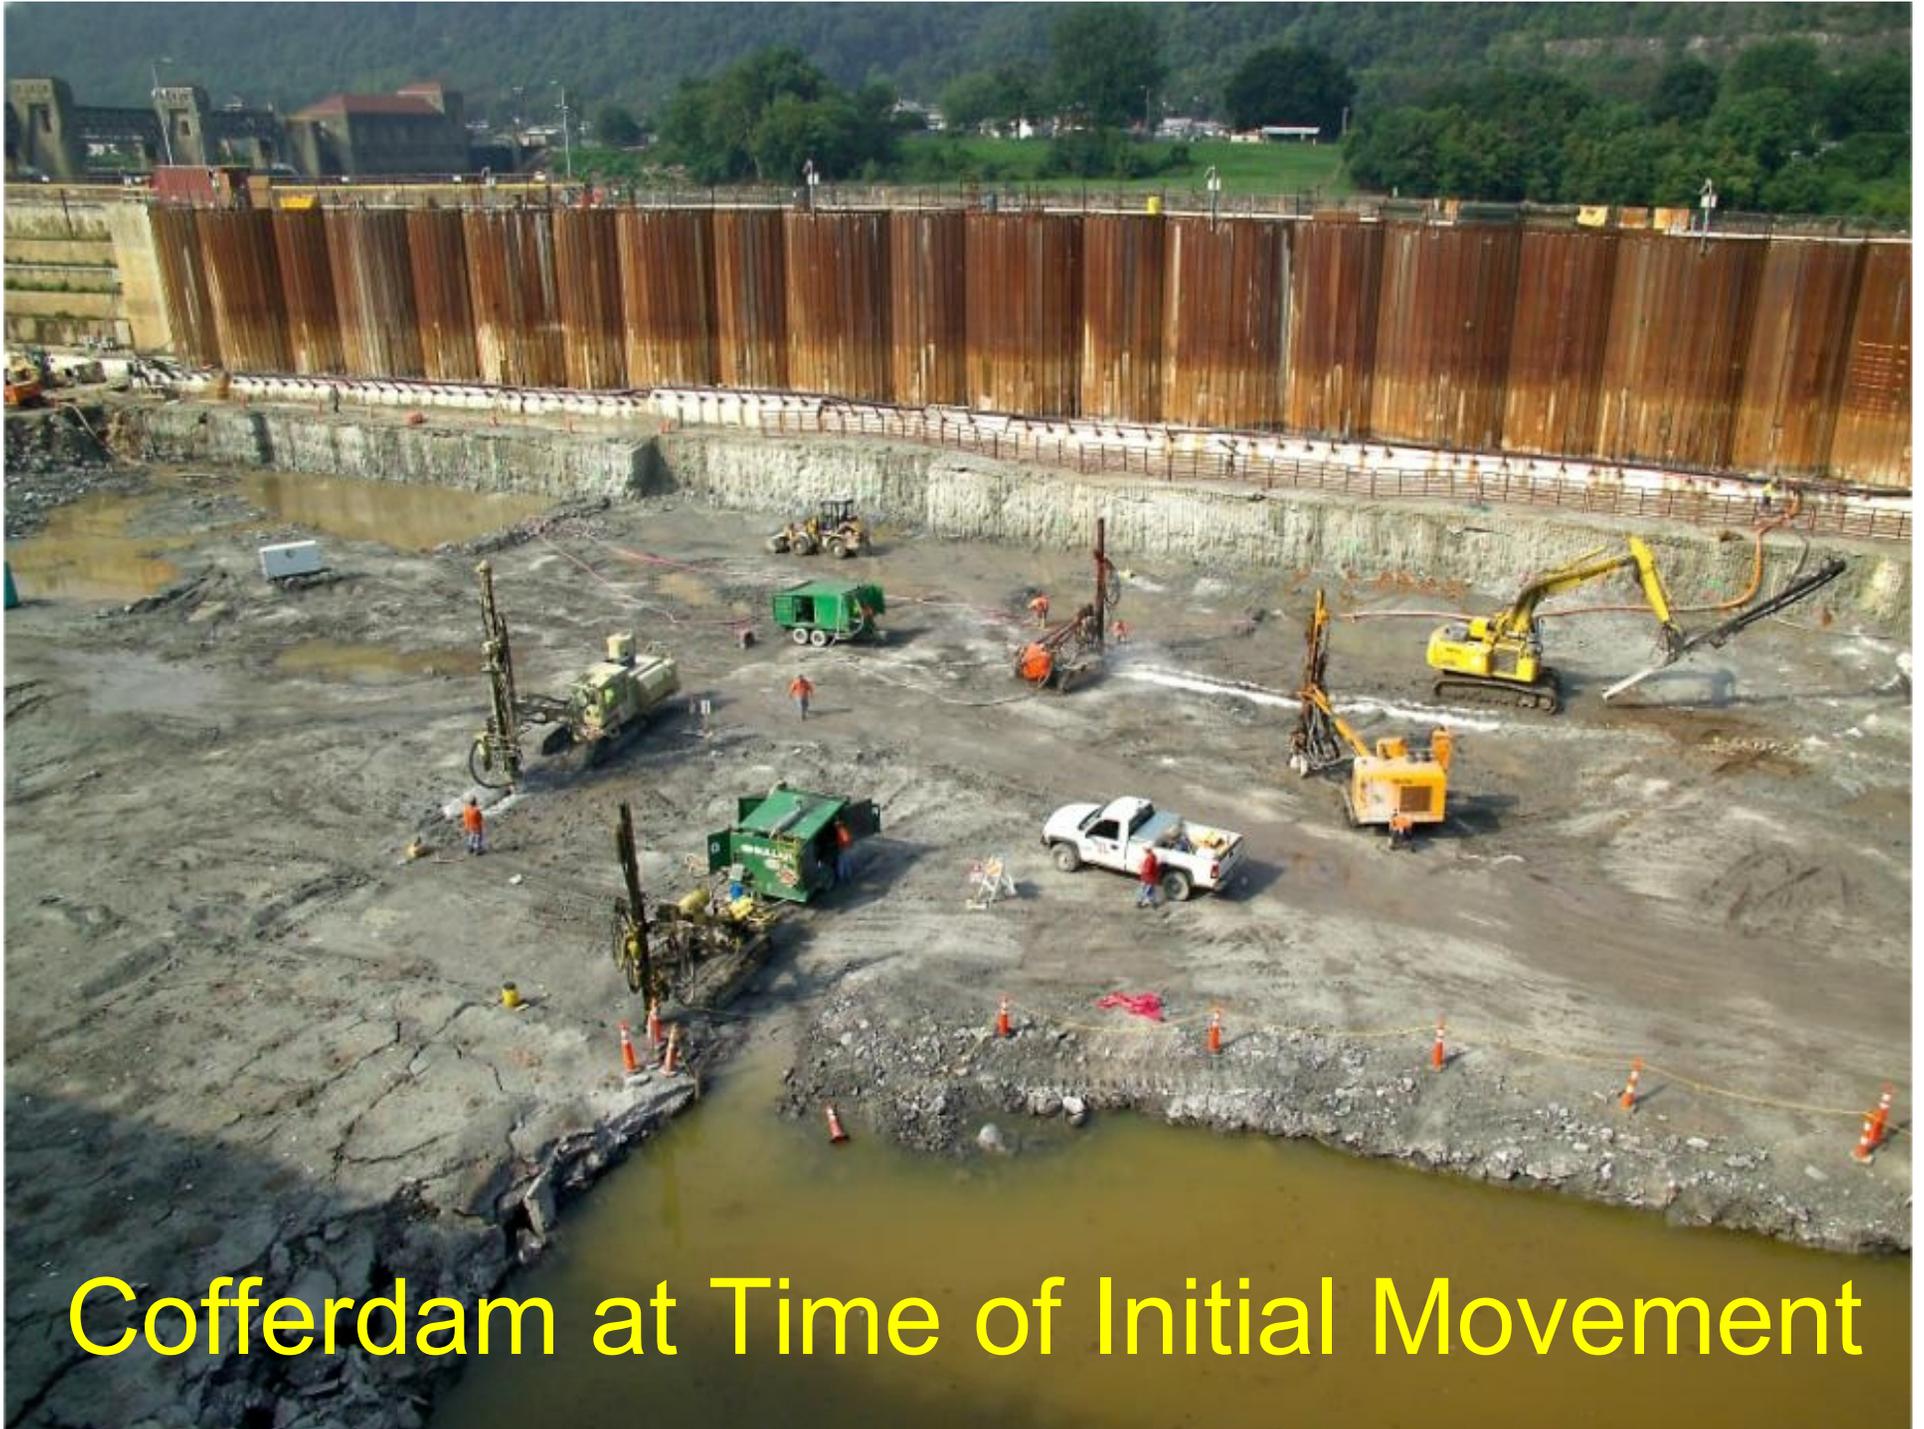
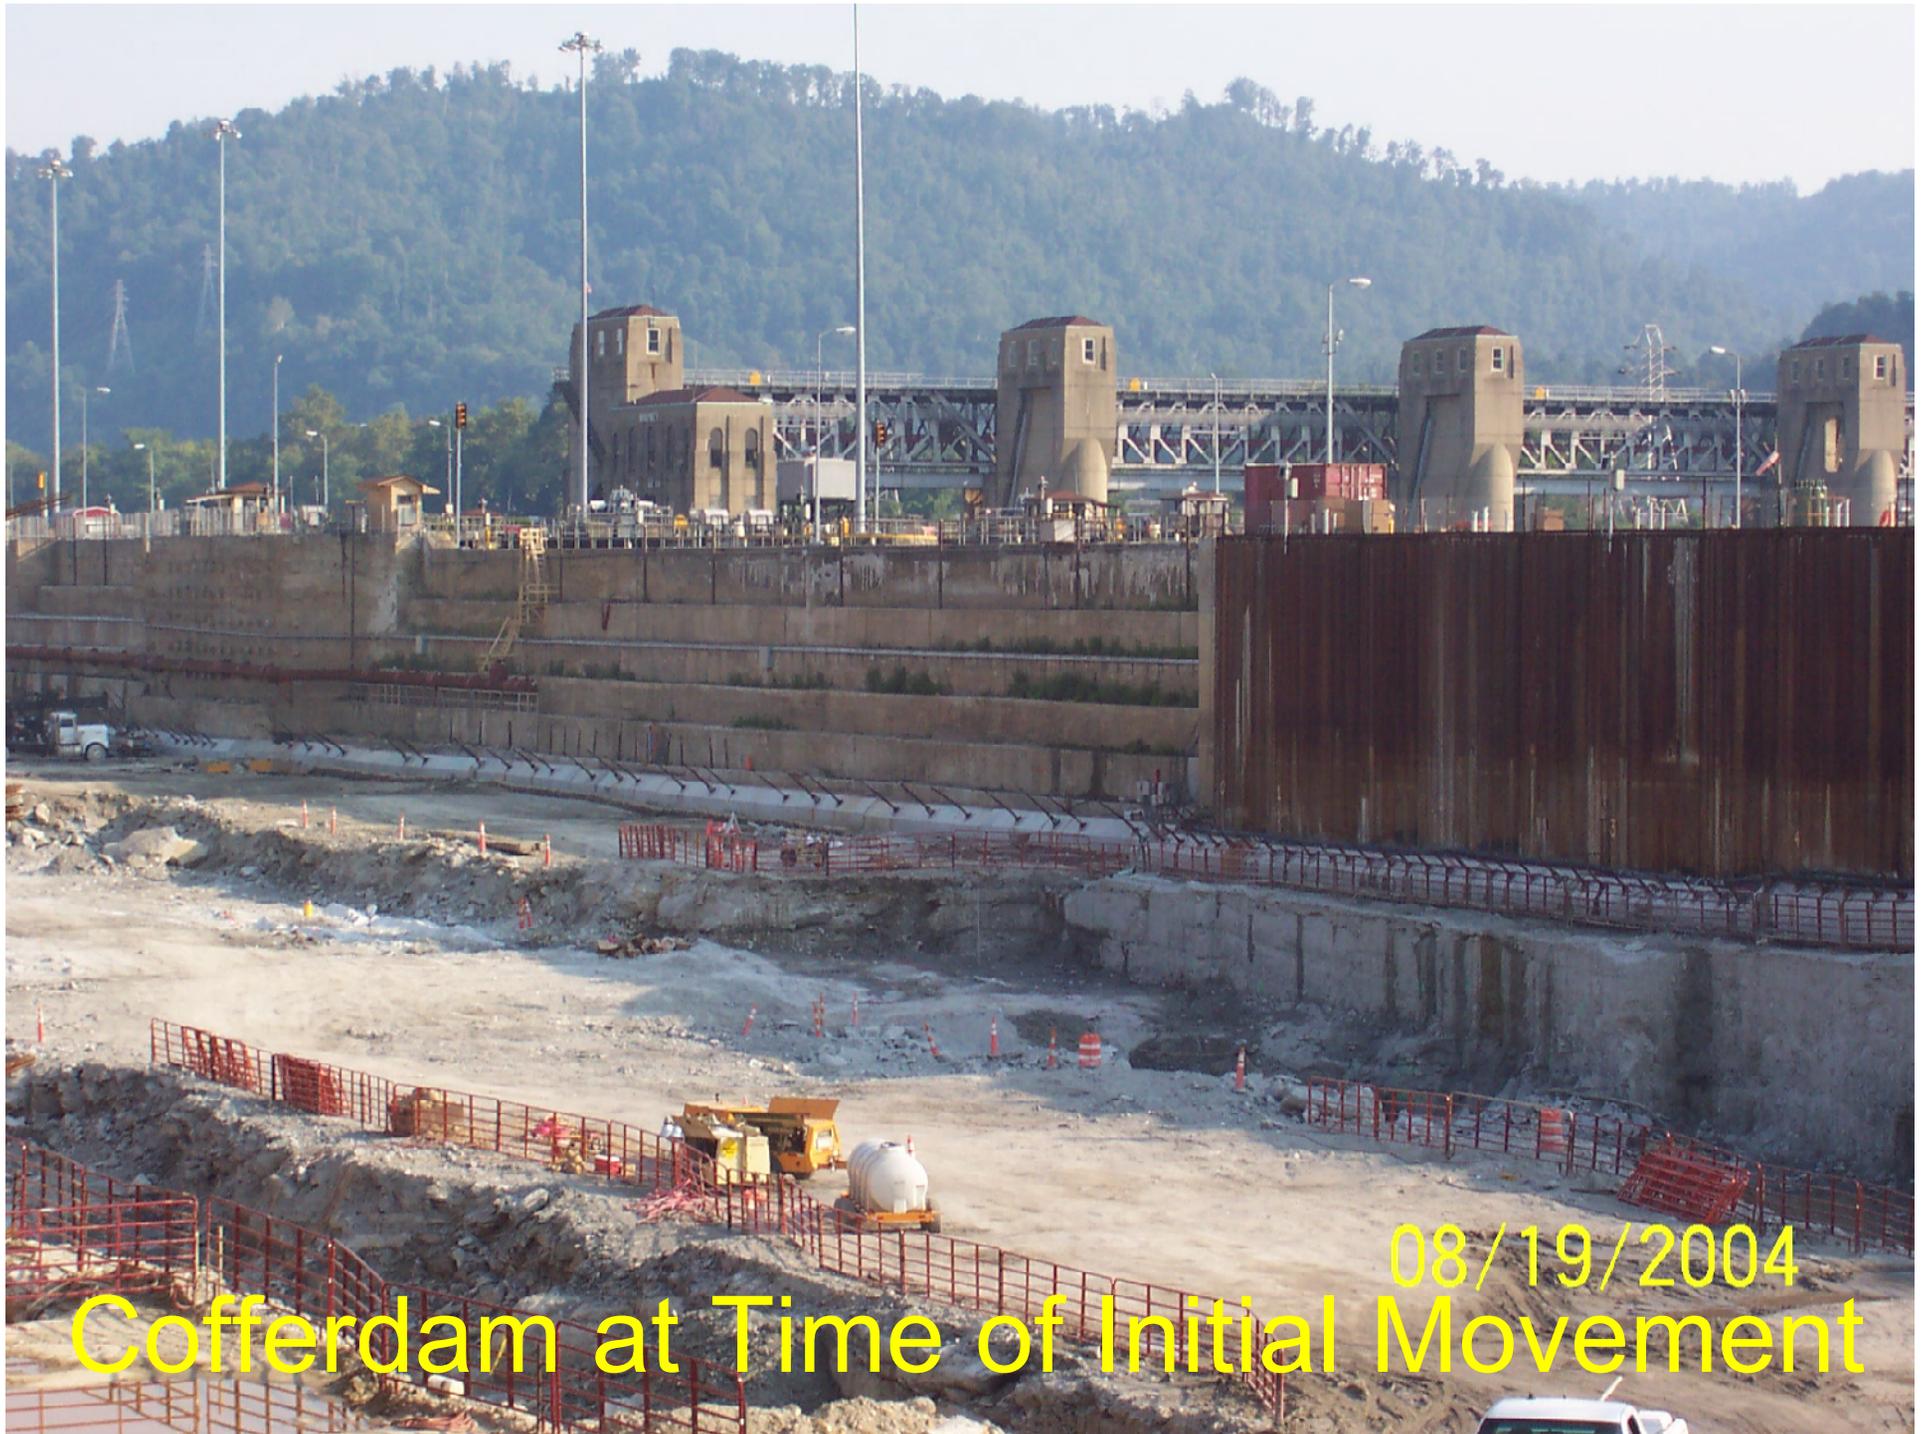
Cofferdam at Time of Initial Movement

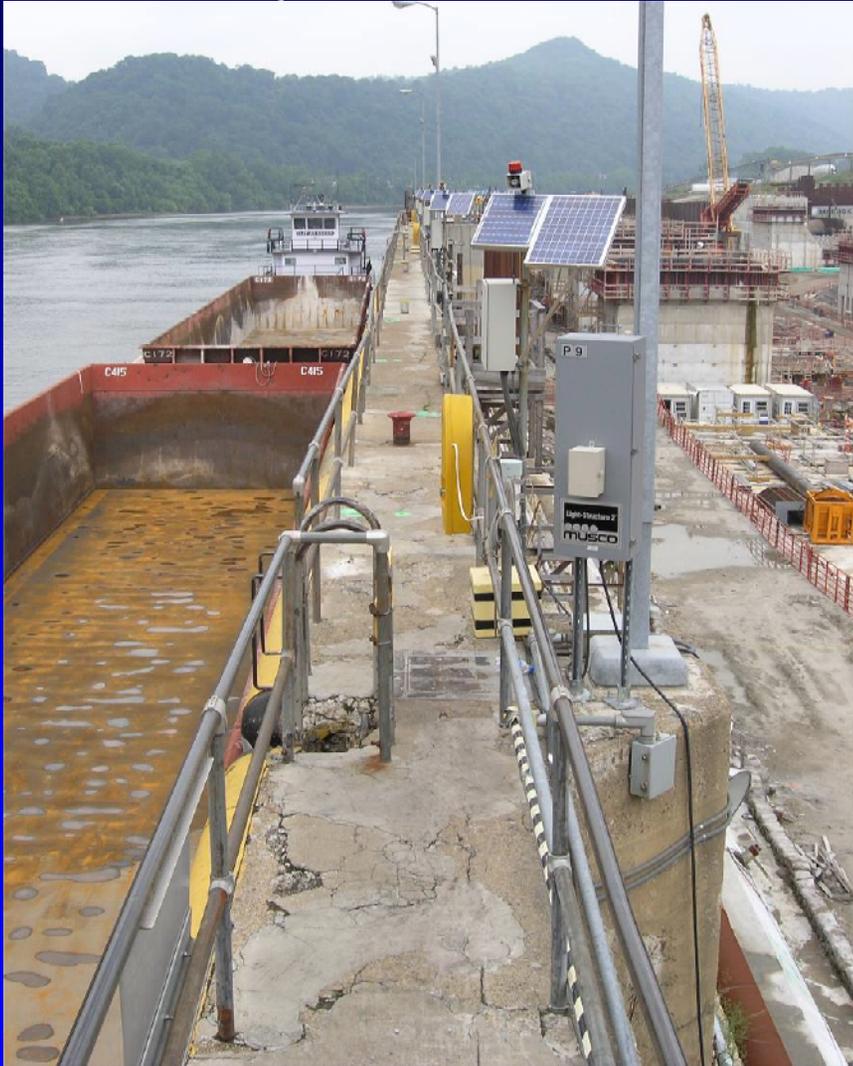
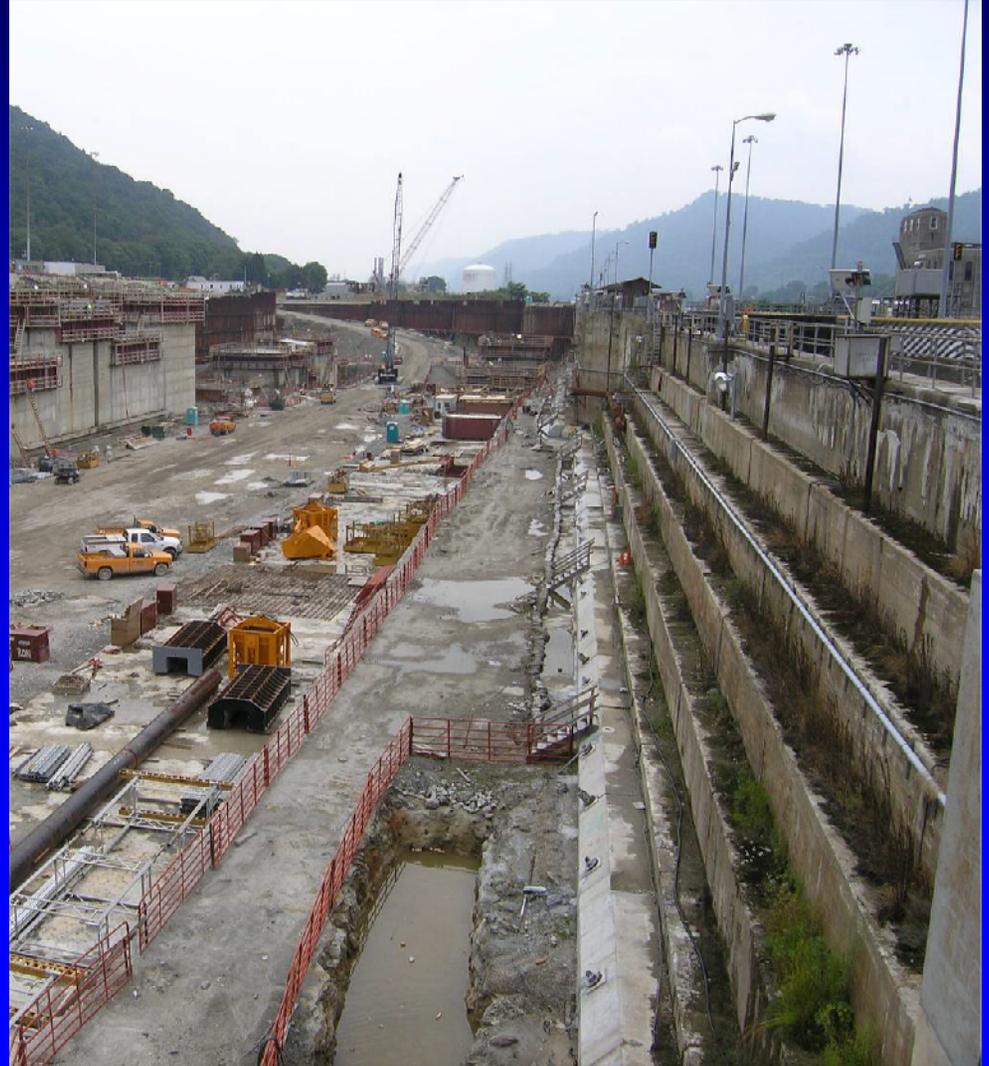
ADAS Challenges Grounding / Physical Location

- MCUs Located On Cells And Existing Lock Wall
 - Kanawha River On West Side
 - Excavated Walls / Construction On East Side
 - No Good Location For Individual Grounds
 - Bare Copper Ground Wire Runs From Upstream Cell To Downstream Cell, Exposed Above Ground
 - Copper Ground Wire Fastened To Safety Fence
 - All Lock Wall MCUs Grounded To Same Copper Ground Wire

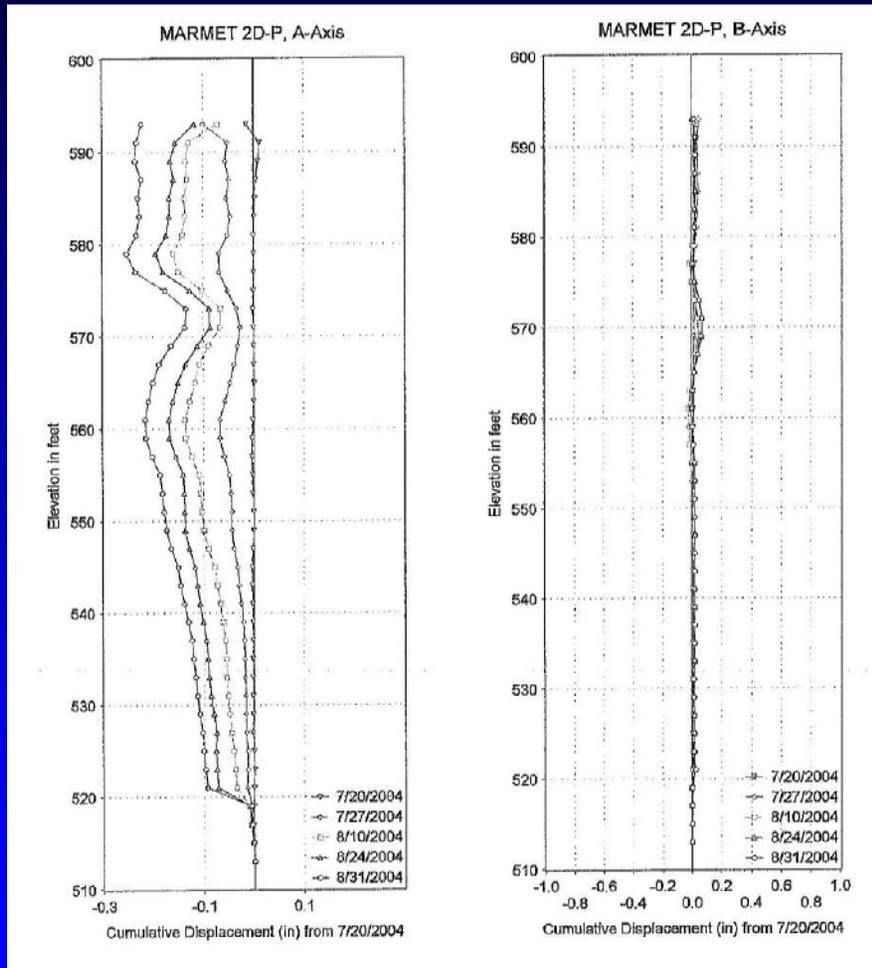
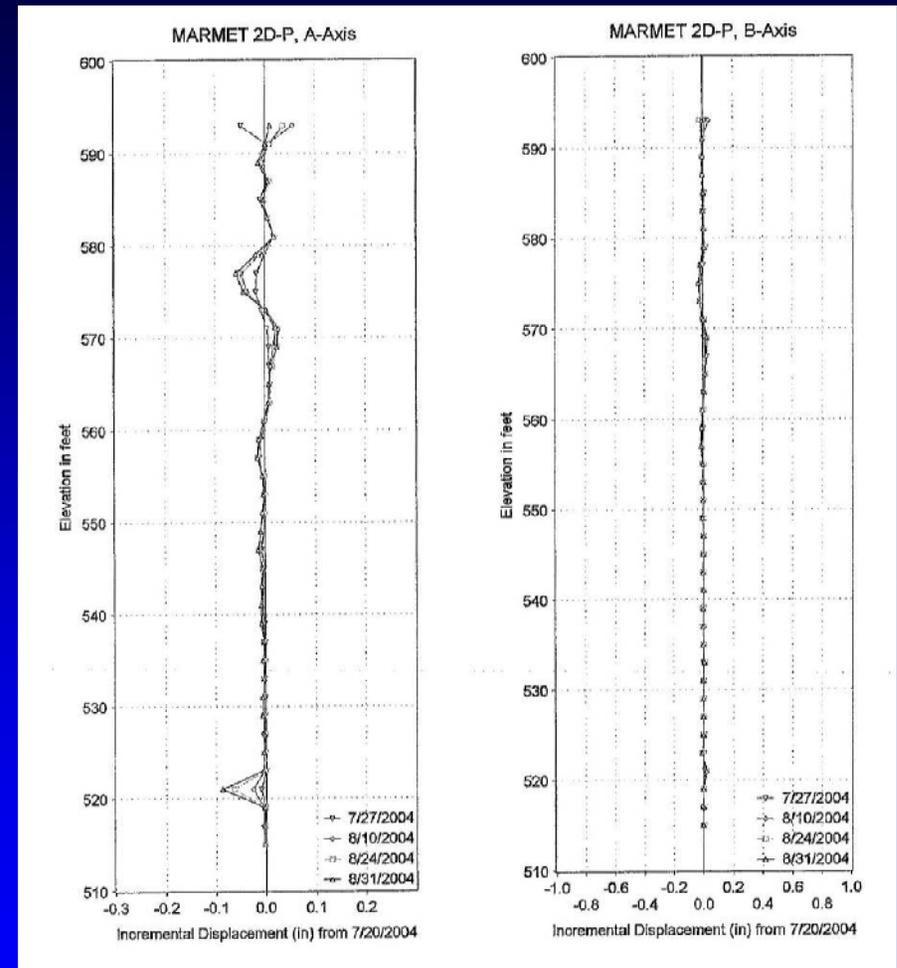
Initial Movement – Cell 2D
August 2004

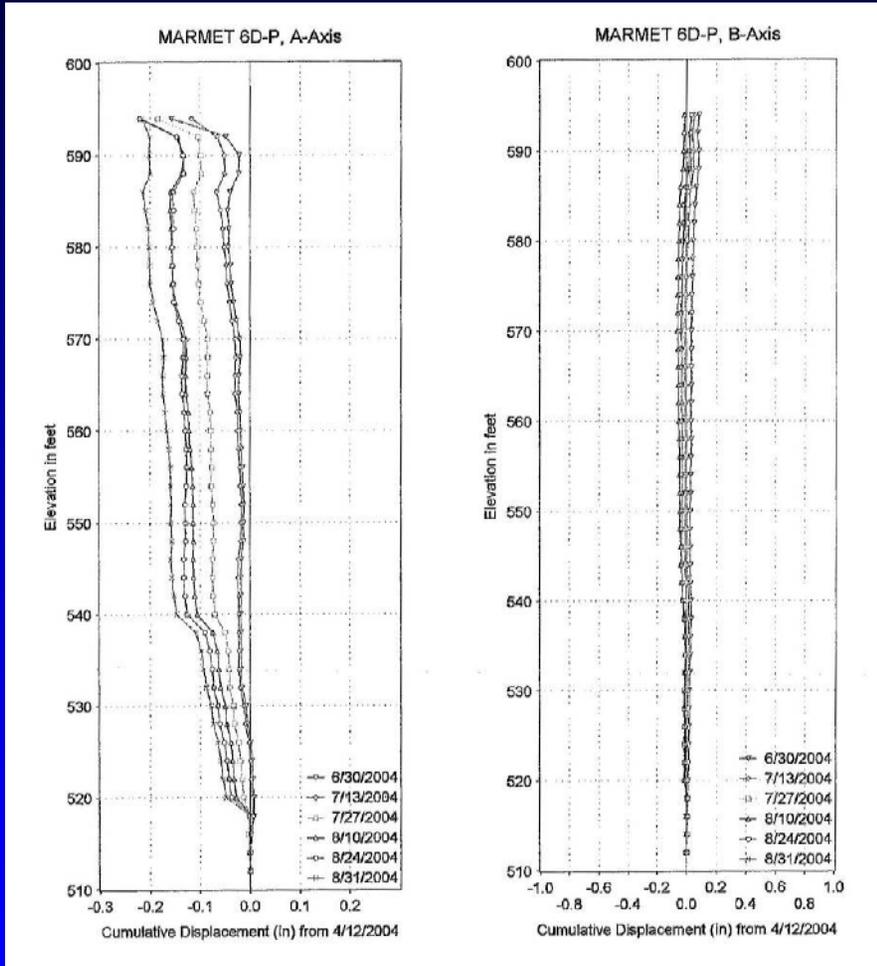
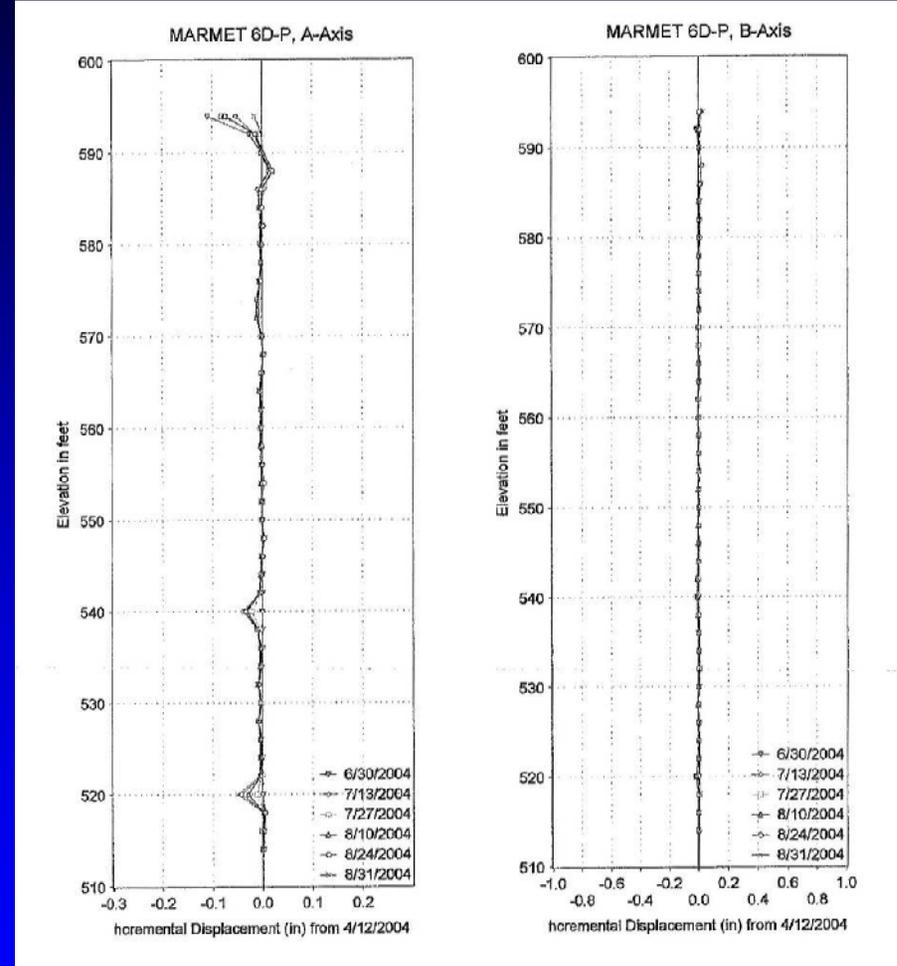
Initial Movement – Cell 6D

August 2004
