Design, Construction and Seepage at Prado Dam

**Douglas E. Chitwood, P.E., G.E.
Embankment Engineer, Prado Dam**

Prado Dam

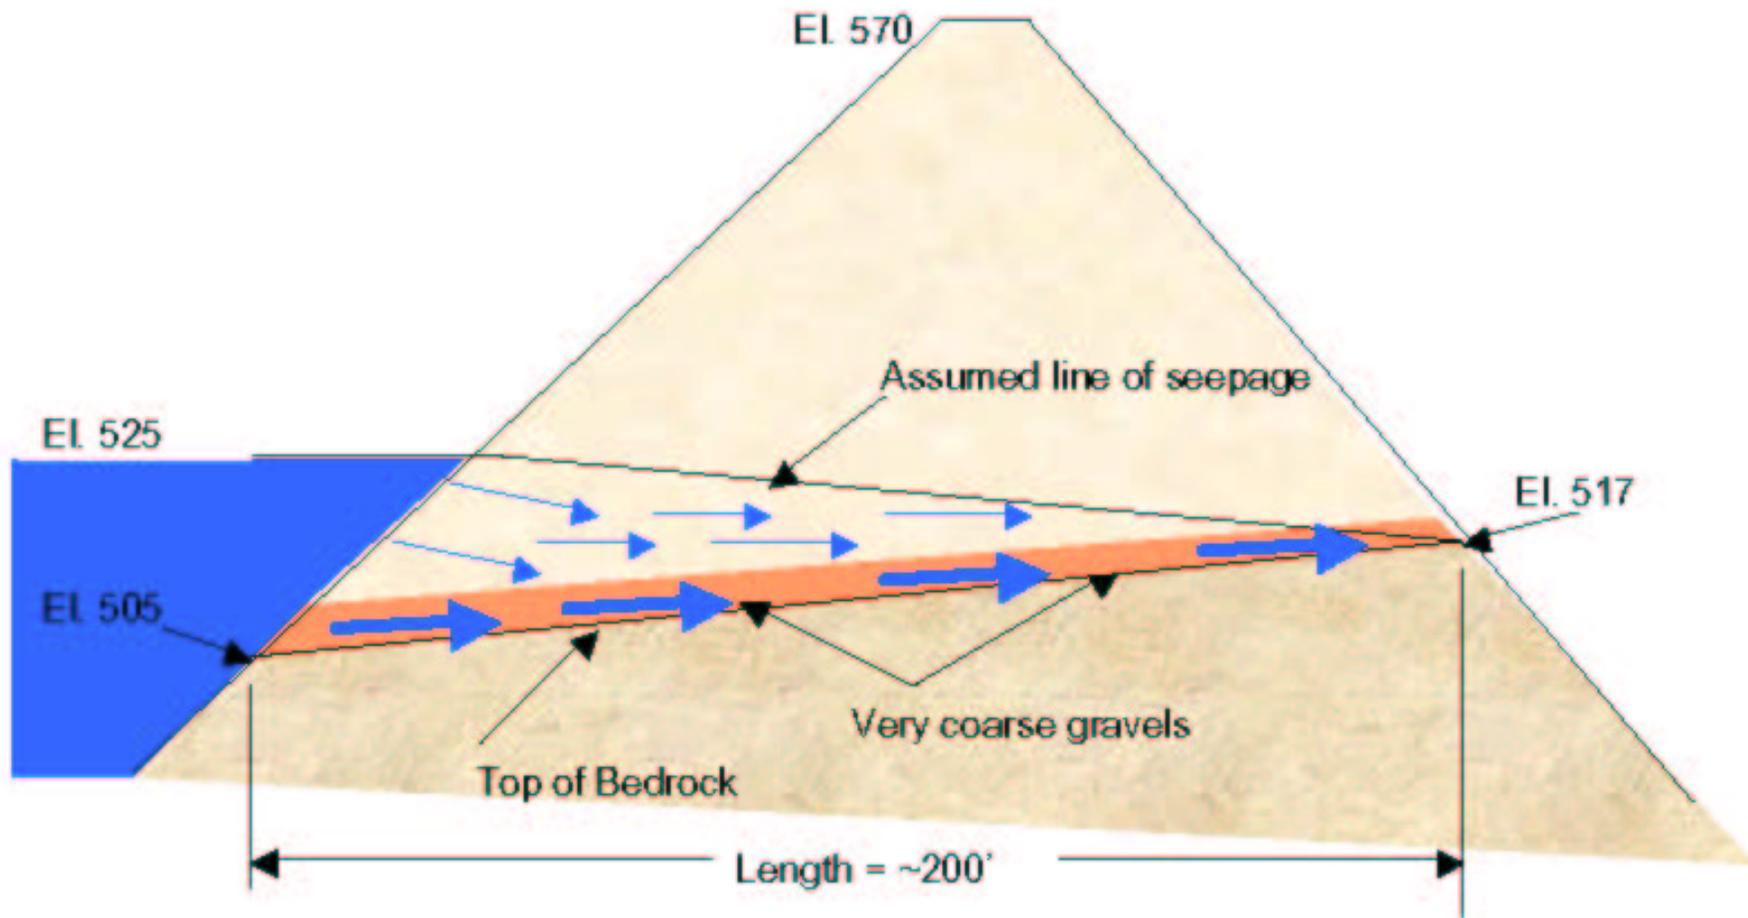
Cross-Section through Thinnest Section of Left Abutment

A stability analysis was conducted by the Los Angeles District Geotechnical Group on the “Thin Section” in December 2003. Among other things, the reported concluded:

“Catastrophic failure due to seepage will not occur as gradient would be much less than critical”

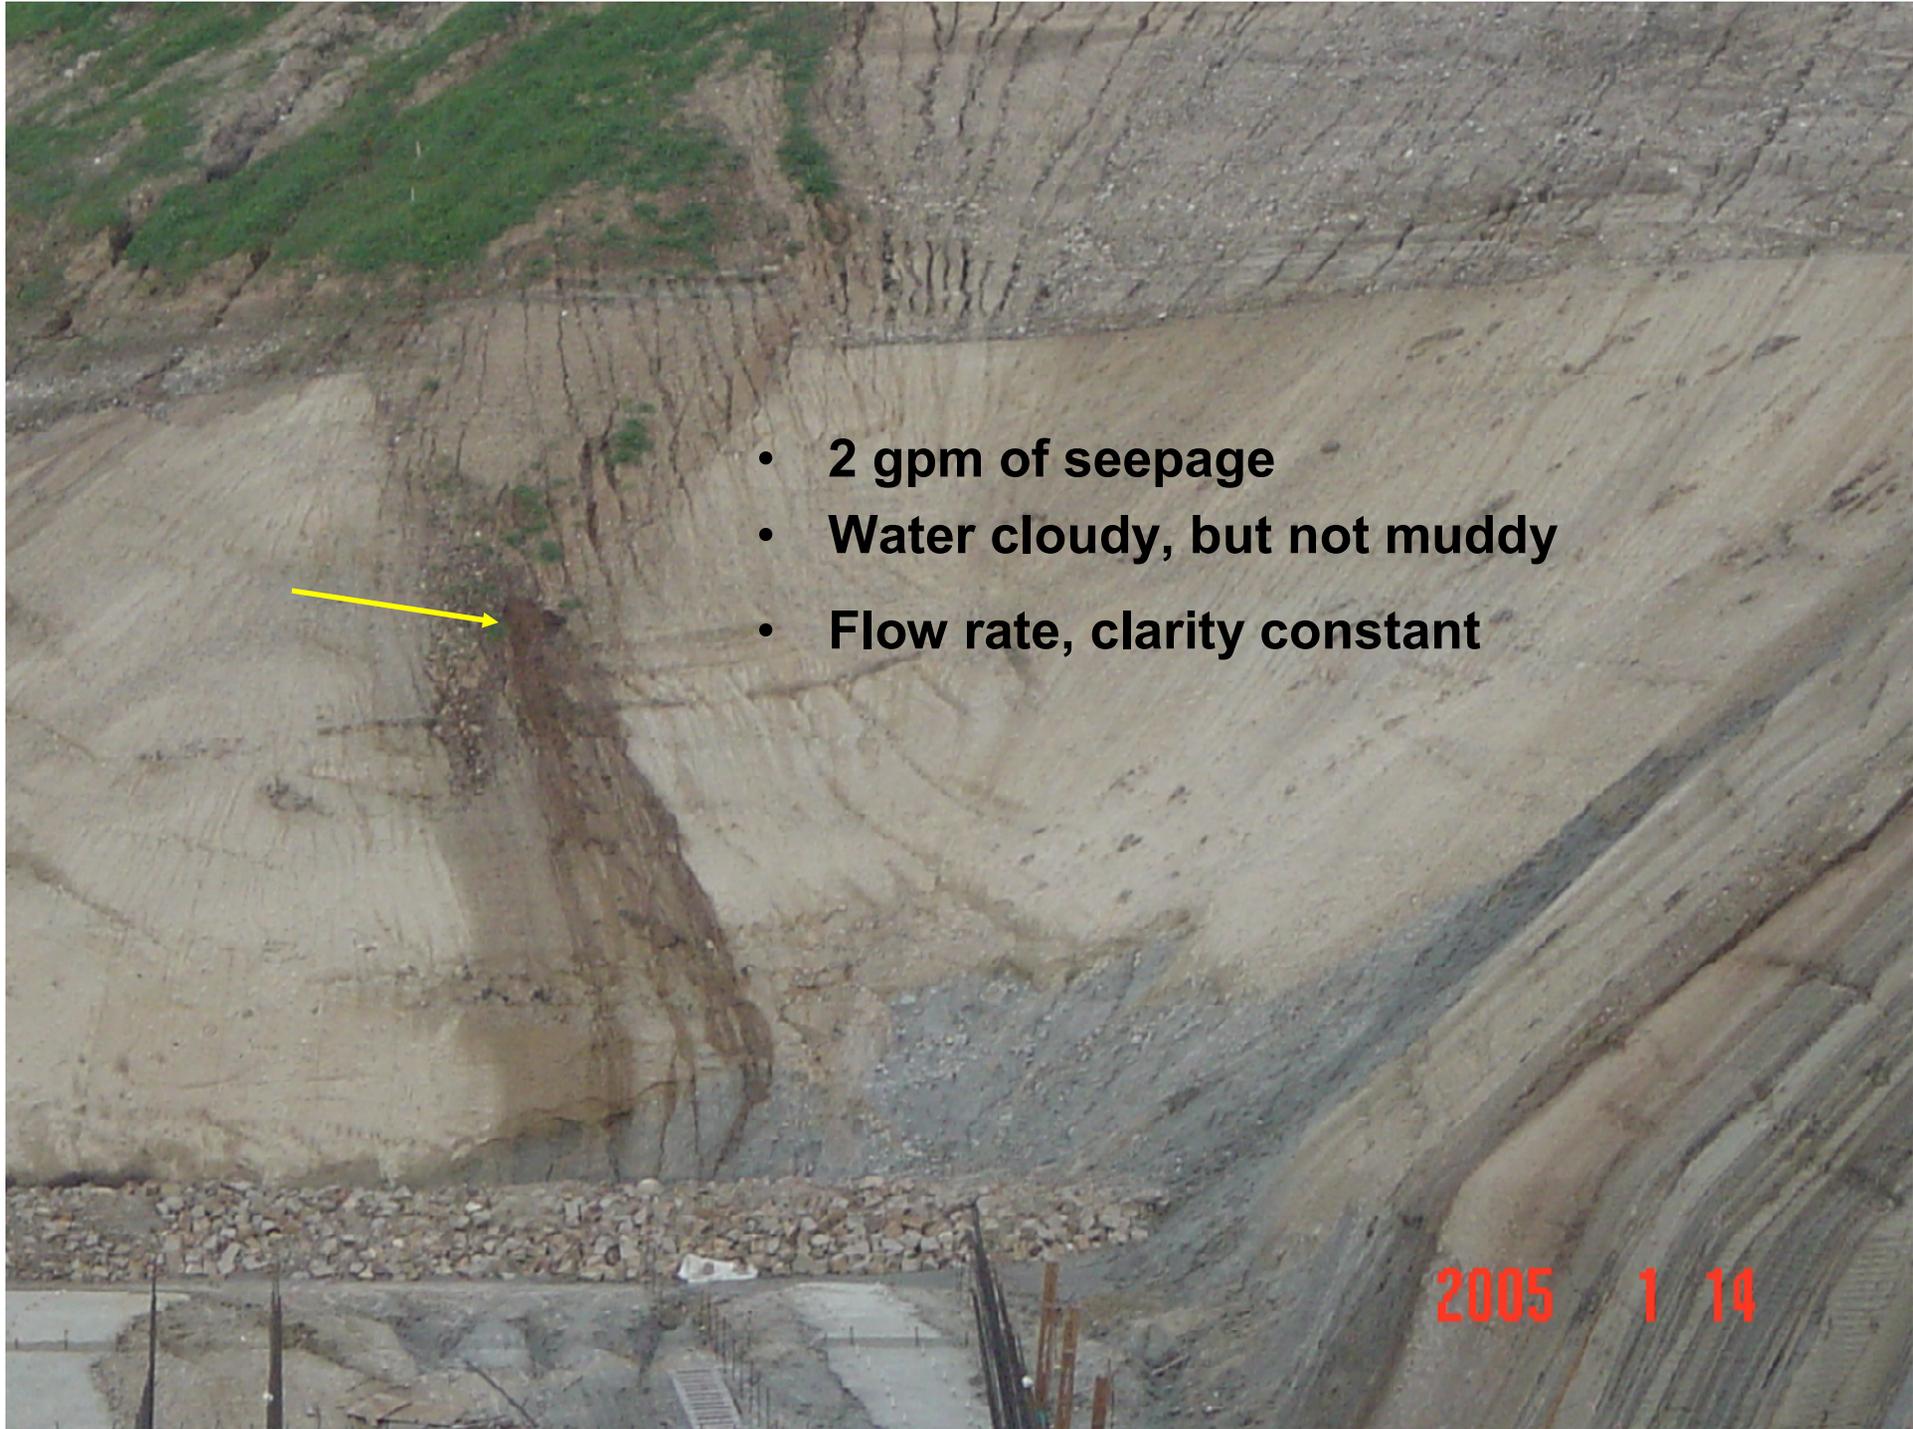
- **2 gpm of seepage**
- **Water cloudy, but not muddy**
- **Flow rate, clarity constant**

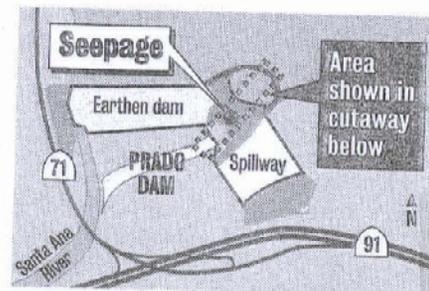
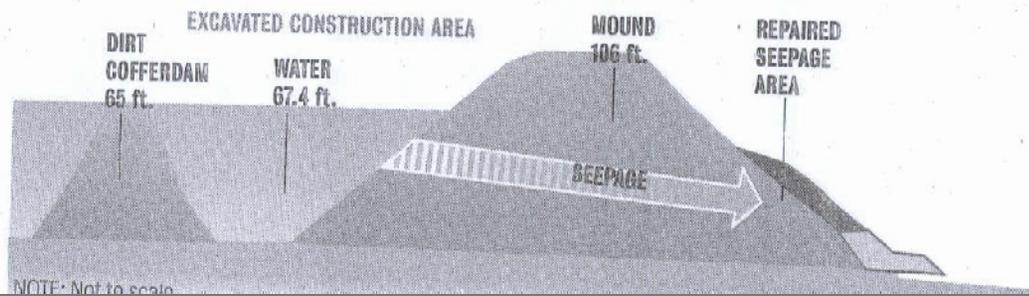
STOPPING A LEAK: Seepage was discovered Thursday on the downstream face of Prado Dam where construction was being done on the new intake gate and outlet works. The Army Corps of Engineers took immediate steps to correct and repair the problem.

The problem:

- The temporary dirt cofferdam was built 65 feet high to keep water out of an area excavated for construction.
- Recent heavy rains caused Prado Reservoir to rise to 67.4 feet, which flooded the area.
- Water seeped through the hill that is part of the earthen dam.

The solution:

- Water being released from the dam has been increased from 5,000 to 10,000 cubic feet per second to drop the reservoir level and relieve pressure on the dam.
- The face of the dam where seepage has been found is being shored up with additional dirt.
- The seepage area is being reinforced with a fine mesh called geotextile to keep it stabilized.
