**US Army Corps
of Engineers**

SEVEN OAKS DAM

Outlet Tunnel Invert Damage

Santa Ana River Mainstem Project

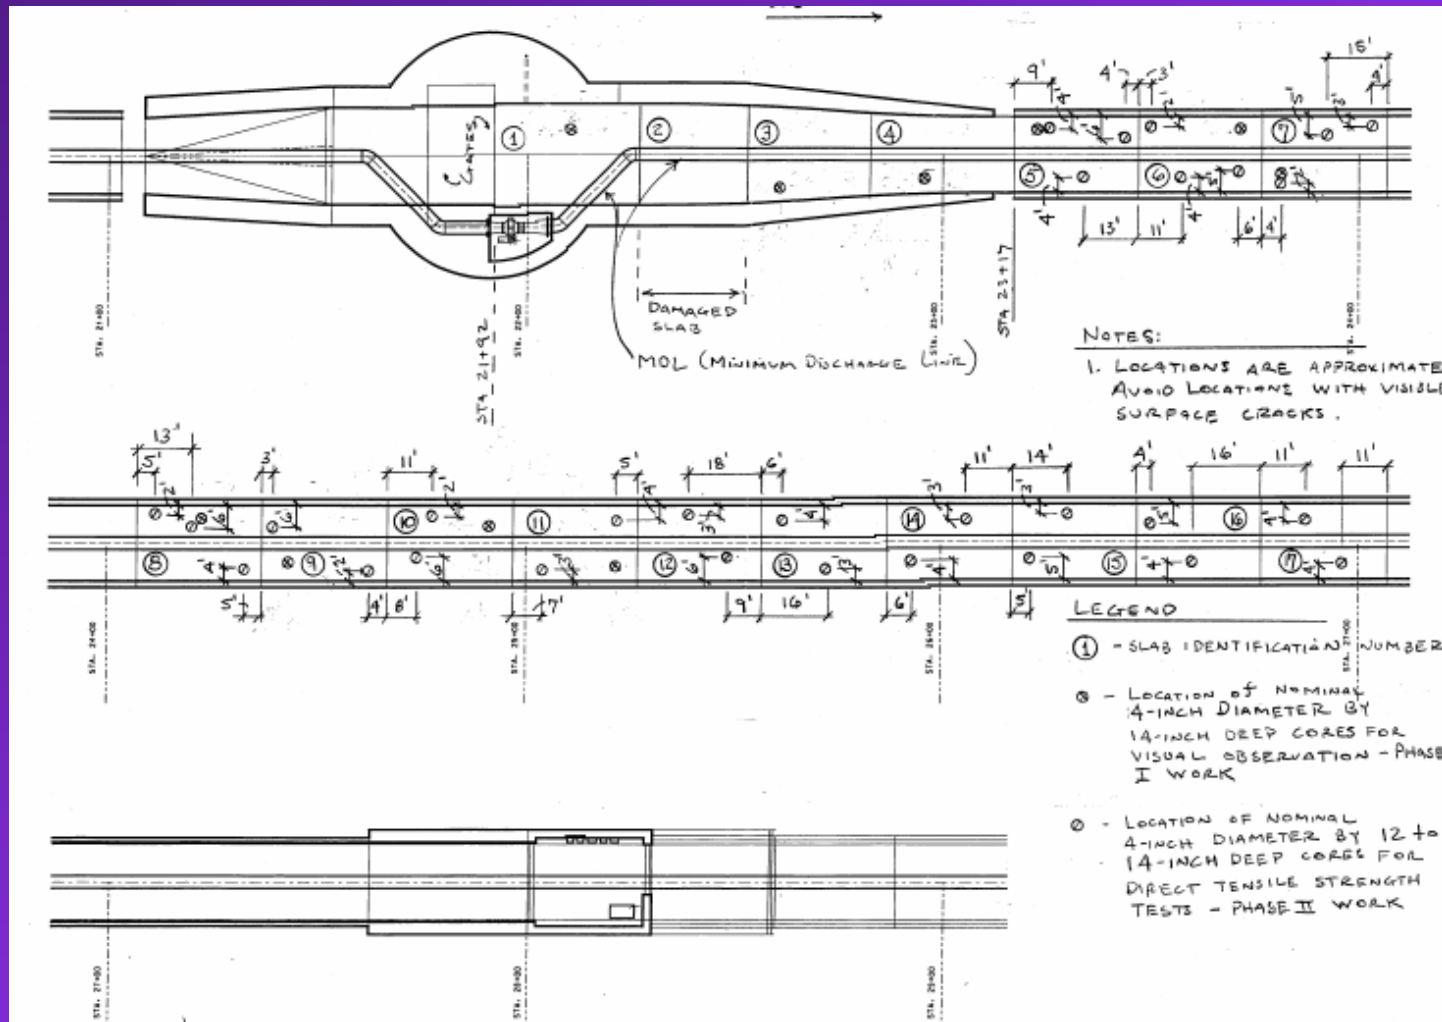
67% Cores Debonded

- Phase 1- Concrete Core Testing
 - > Completed – 27 Apr 05
 - > 67 % cores debonded
 - > Compressive strength tests pending
 - > Cursory petrography suggests tensile failure from incomplete bond development due to improper surface preparation or cold joint formation;
 - > Veneer of carbonate deposit

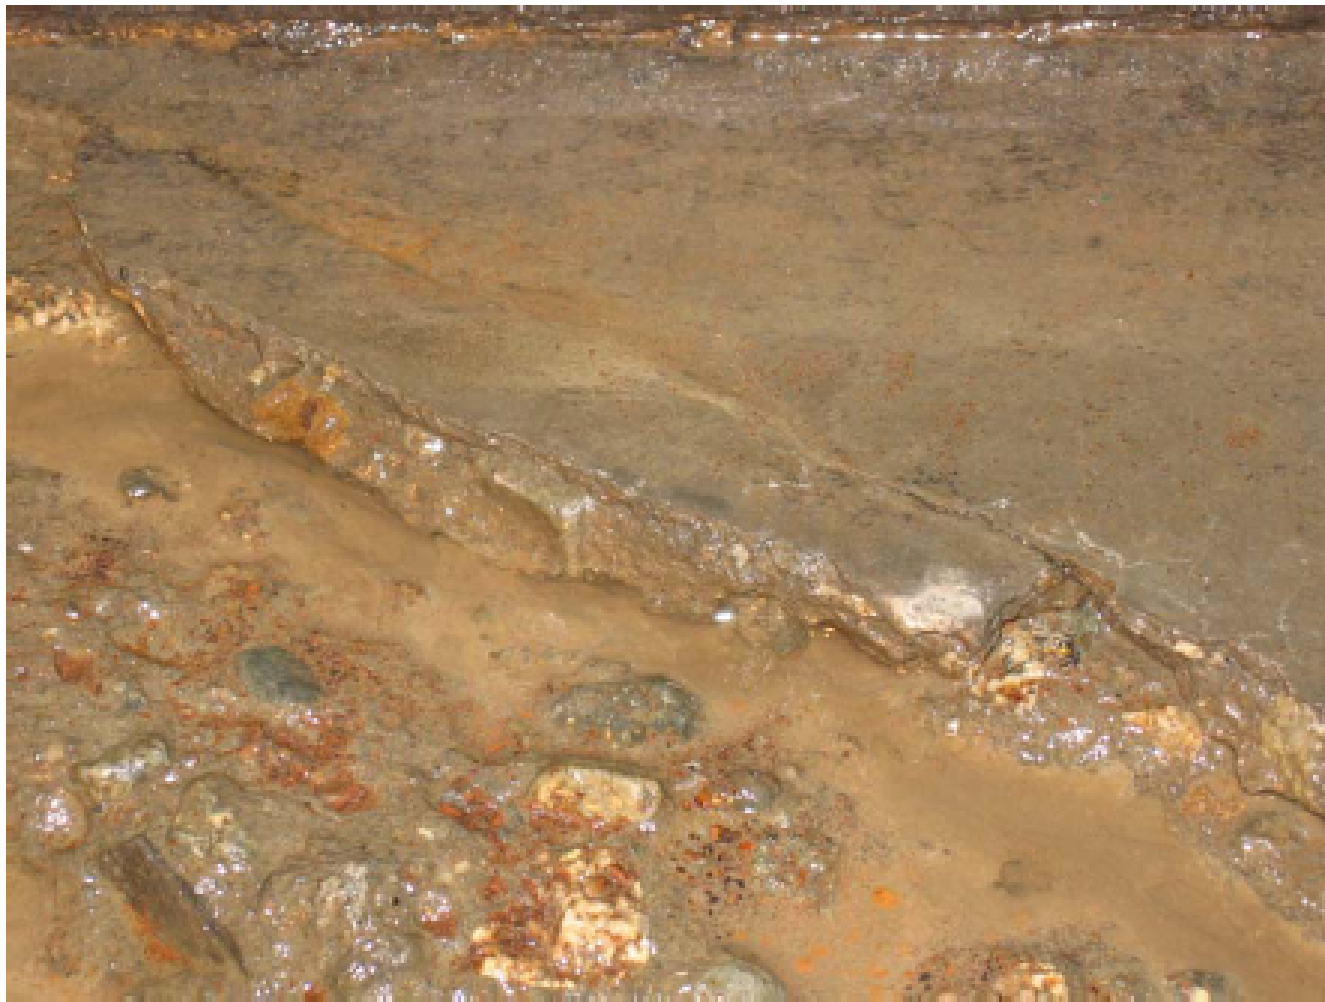
Slab 1 Damage Surface

Fig. 3a – Cracking, delamination, and erosion of Slab 1 surface

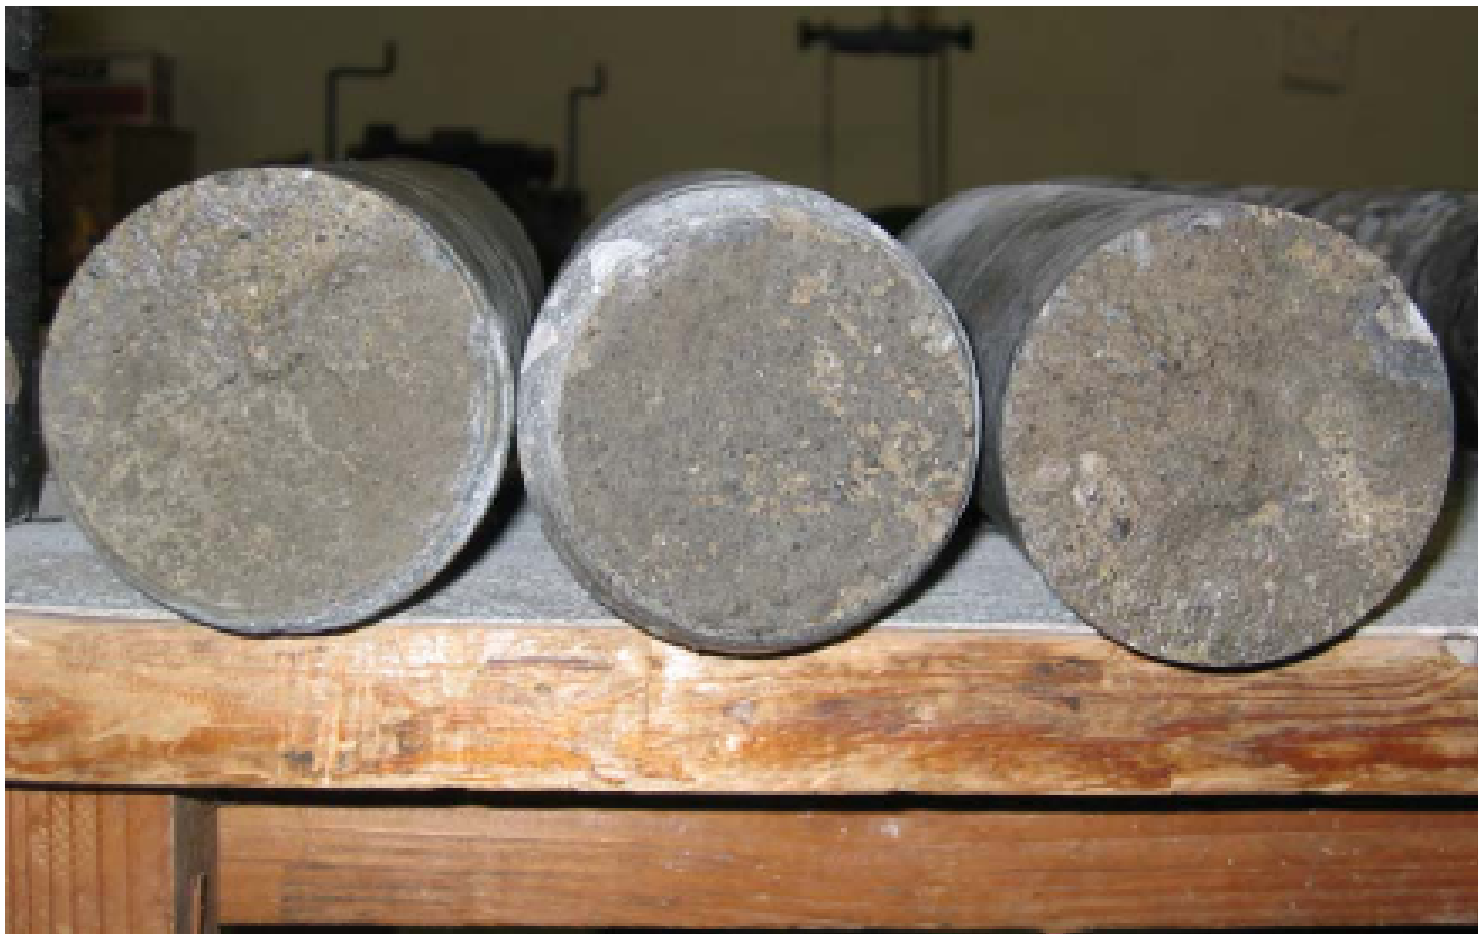
Slab 2 Concrete Cores

Fig. 6 – Top surfaces (SFC-CC interface) of Slab 2 cores

- Phase 2 – Additional Concrete Core Testing
 - > Completed – 4 May 05
 - > 63 % cores debonded
 - > Prelim detailed petrography confirms SC/CC interface exhibits layer of solidified carbonate-based residue;
 - > Inadequate surface roughness for mechanical bonding; weak concrete at interface due higher W/C;
 - > Final report pending

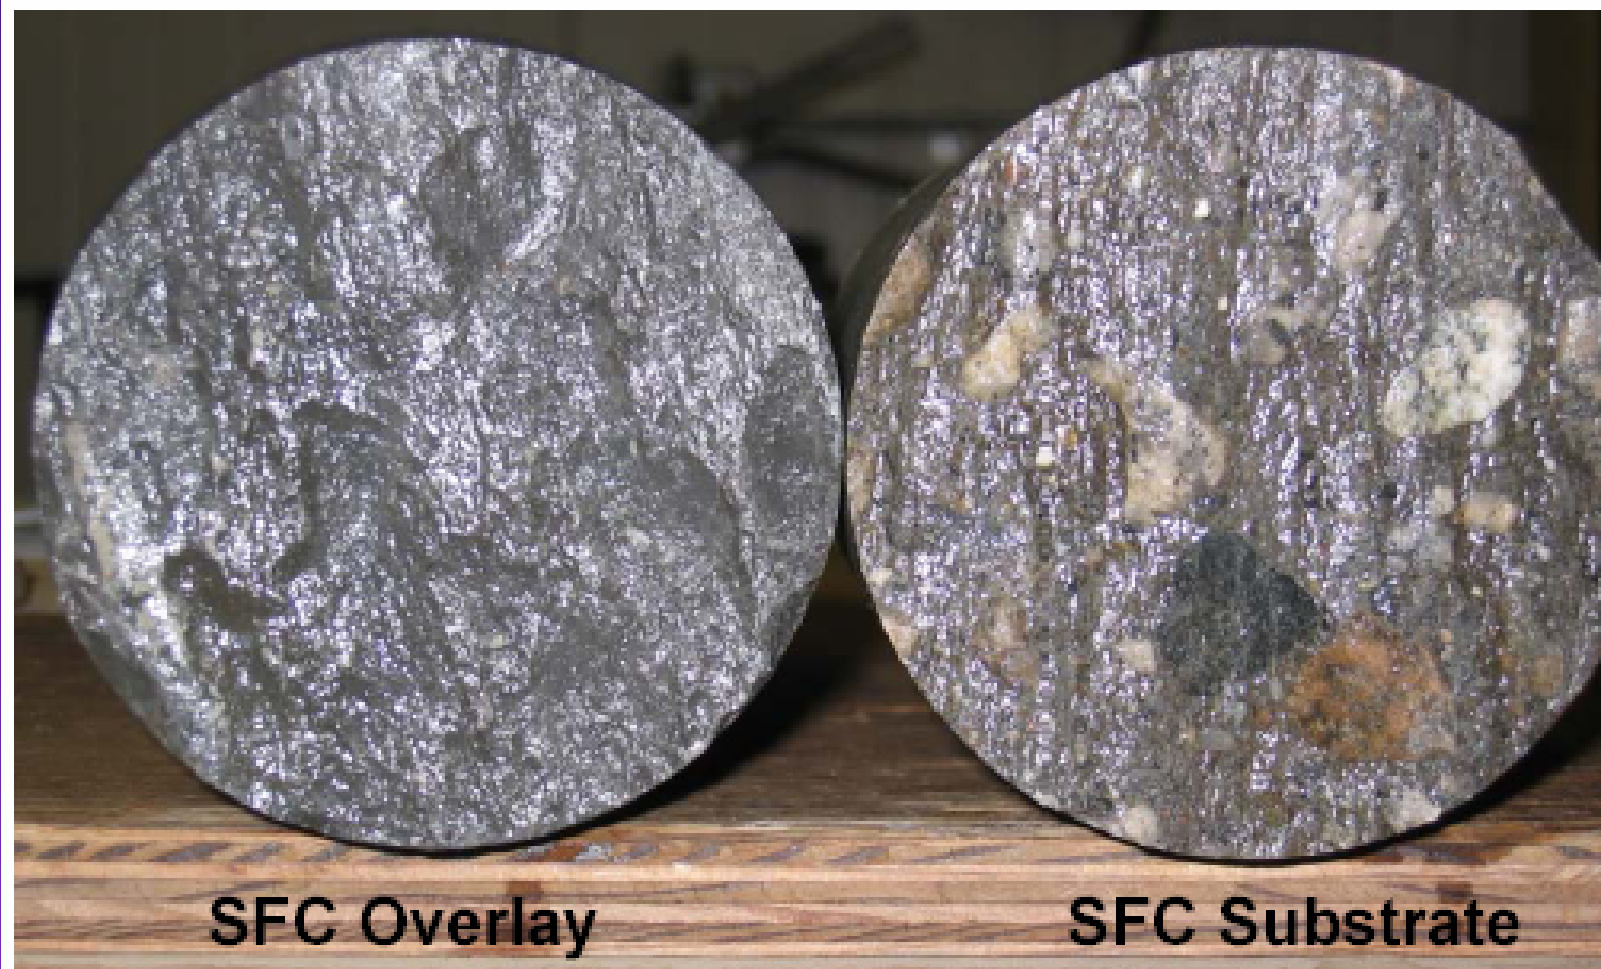
Slabs 1 to 17 Typical Concrete Cores

Fig. 9 – Typical failure surfaces on cores from Slabs 7-17

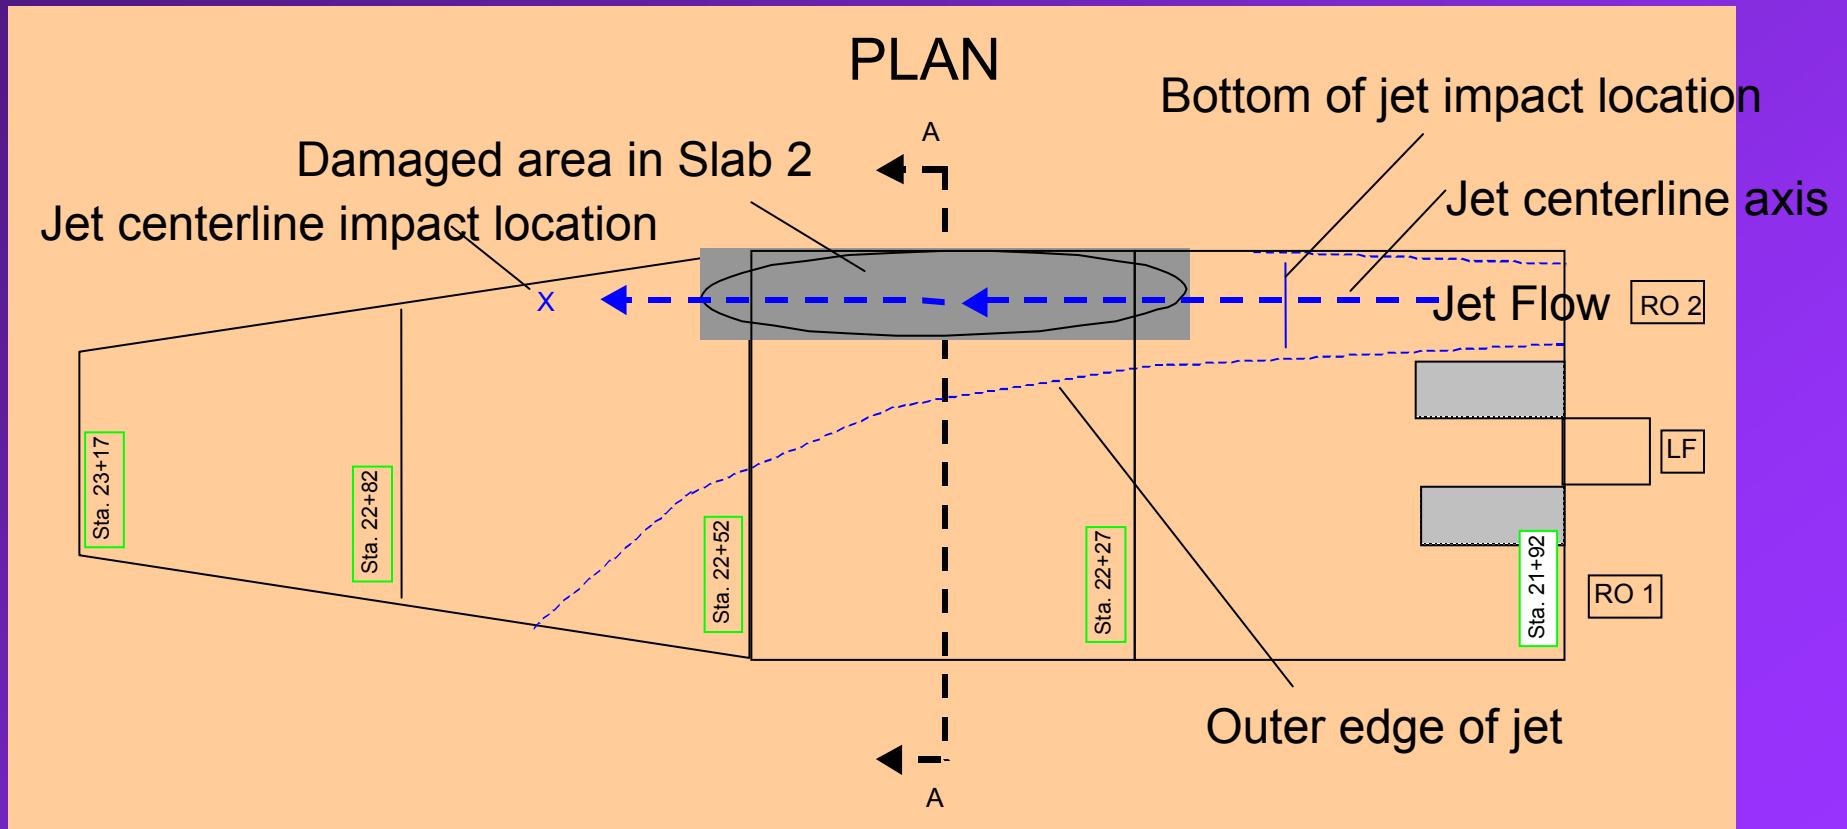
Plan View of Damaged Slab Area

- Reservoir at el.2392
- Gate opening at 5.0 ft
- Flow rate 2,520 cfs
- Velocity 130 ft/s
- Stagnation pressure 120 psi, but jet impingement pressure estimated 5 to 10 psi
- Pressure highest at invert joint with wall
- Only 0.7 psi to uplift silica fume layer

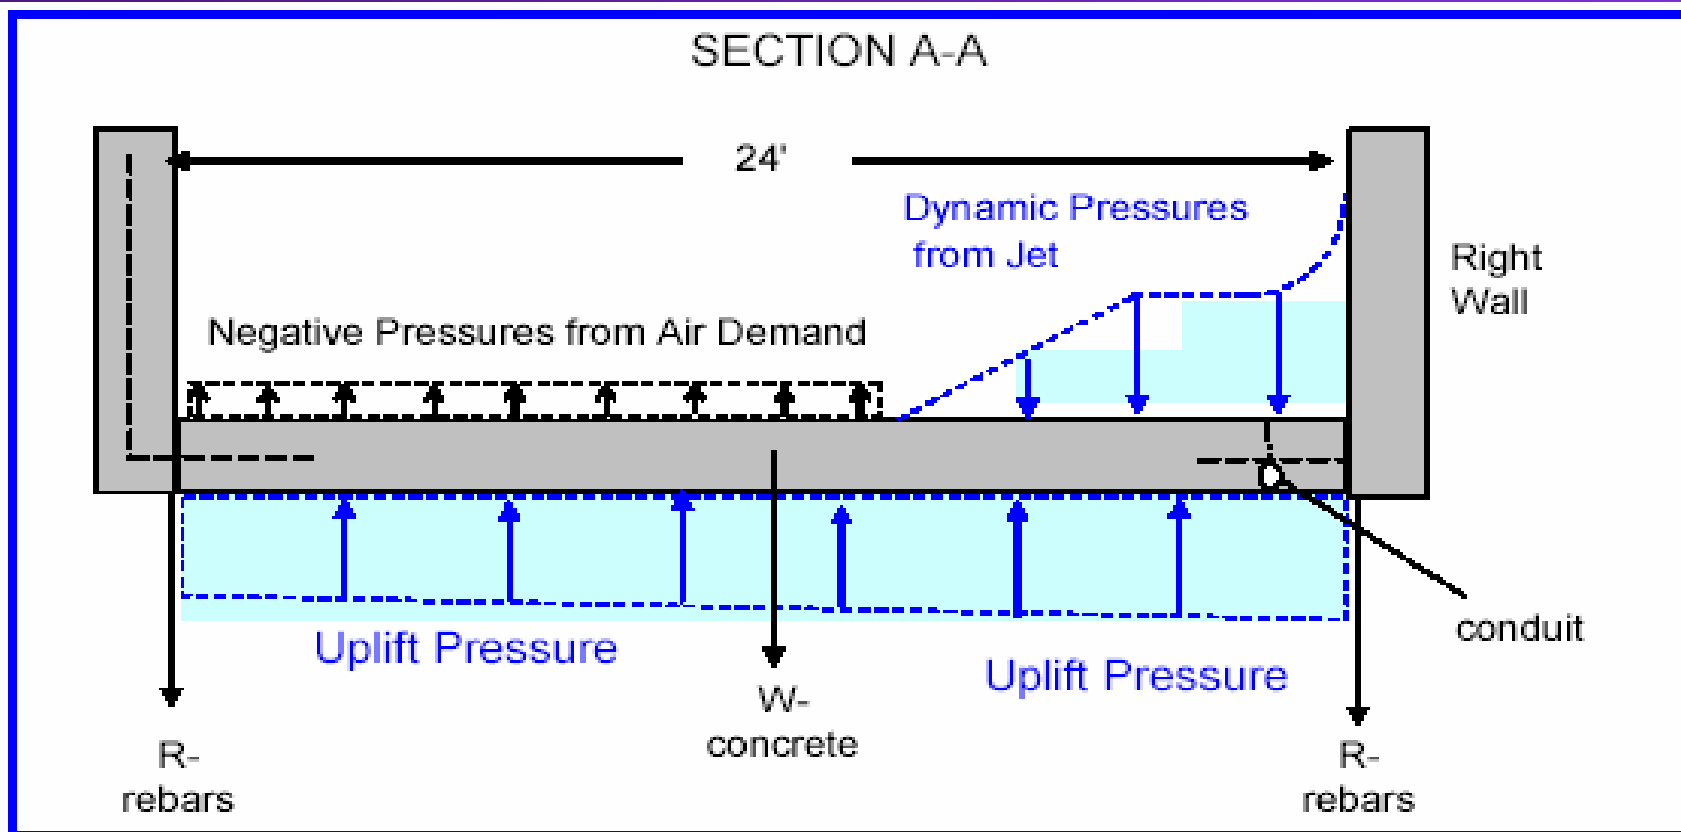
Figure 24 Tunnel Floor Free Body Diagram

- Pressure migrates through seams between poorly bonded to debonded silica fume concrete overlay and substrate concrete and increases.

- Water pressure under overlay combined with reduced air pressure breaks bond between overlay and substrate concrete, and lifts up overlay.

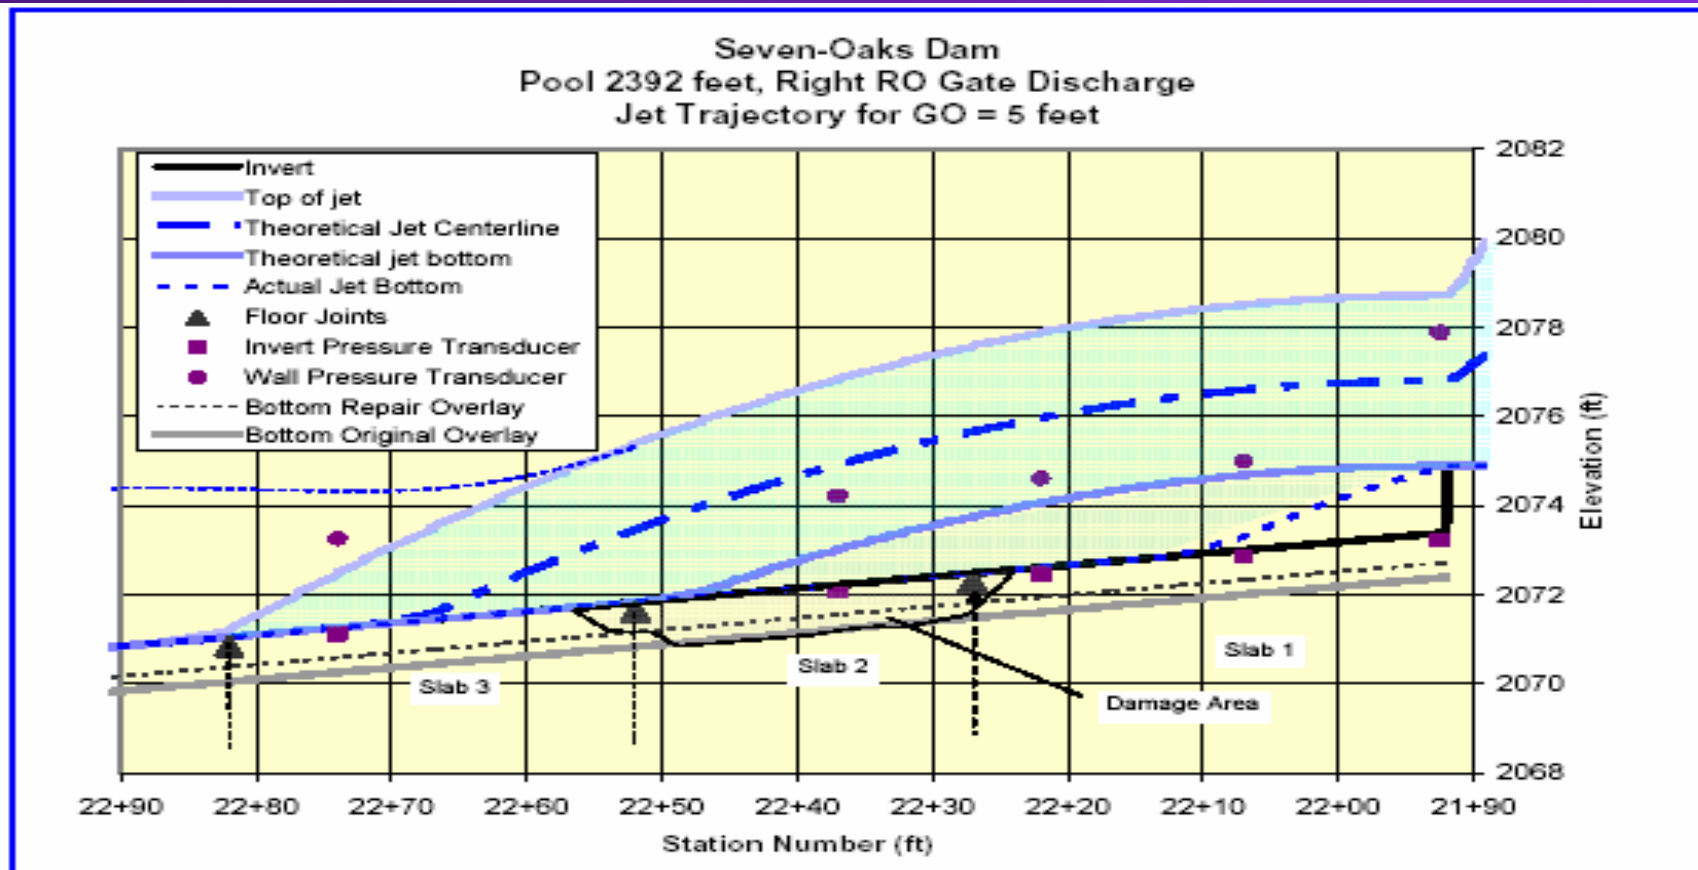
Figure 23 Schematic of Jet Trajectory at Gate Opening 5 feet, Prior to Failure Event

- Water Pressure from high velocity flow jet penetrates construction joints.

- Impact from jet breaks up overlay slab, pulverizes slab into smaller pieces, and completely erodes away edge of overlay.
