Geotechnical and Dam Safety Section
MISSISSINEWA DAM

Mississinewa Dam Foundation Rehabilitation

Jeff Schaefer

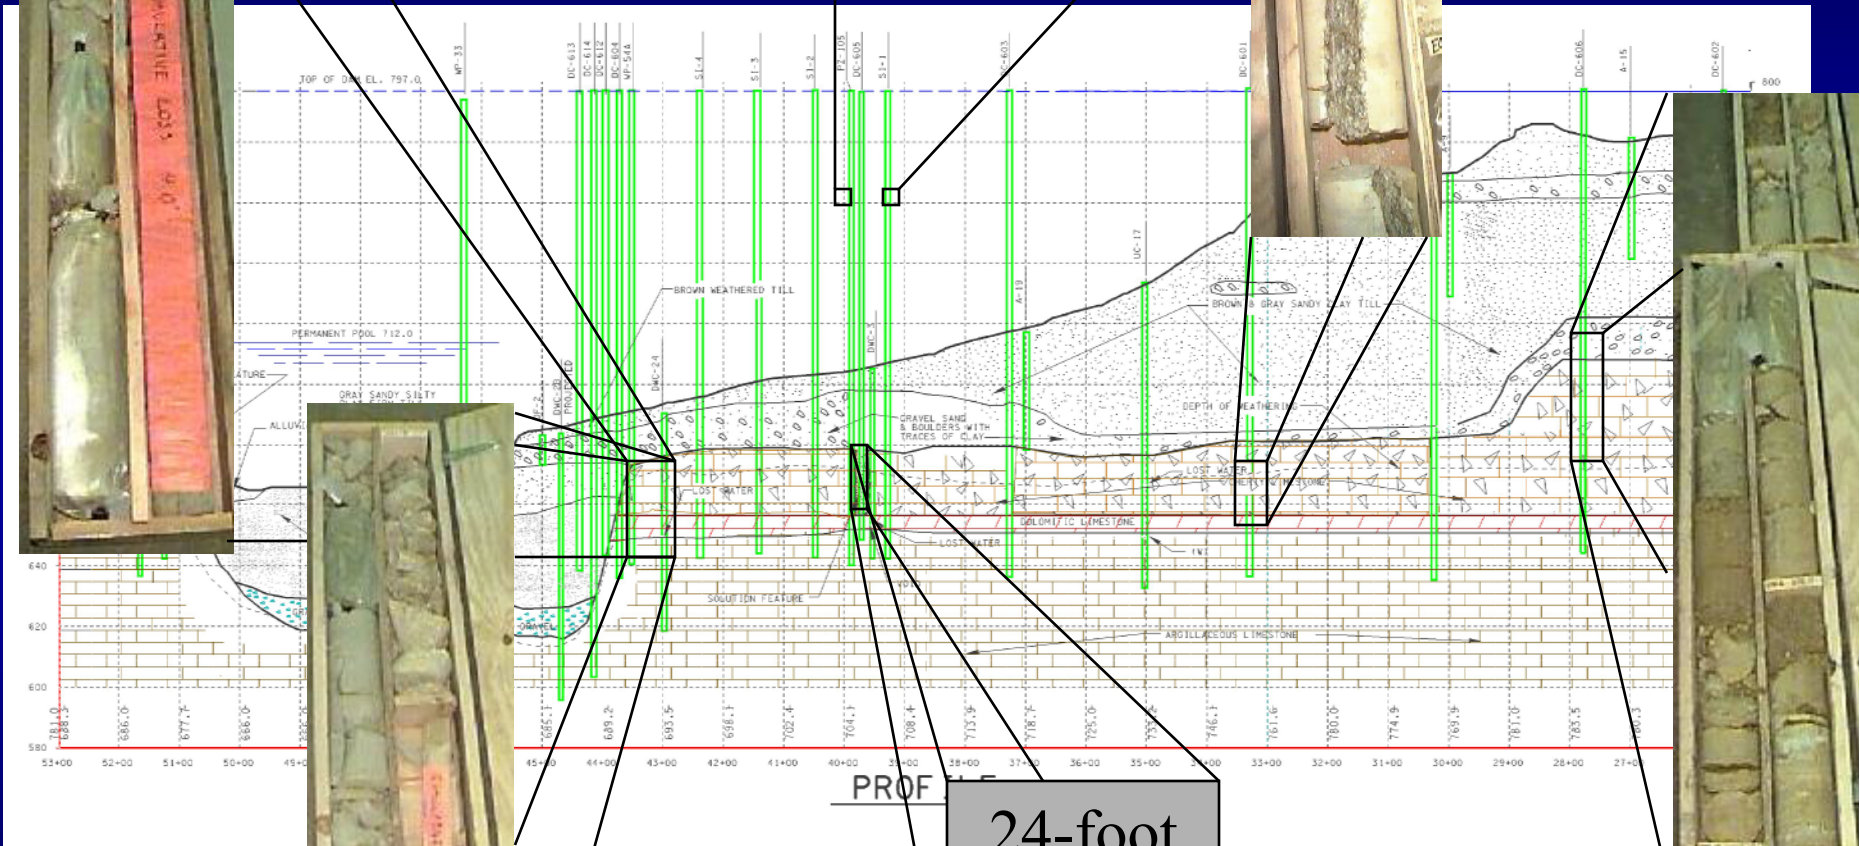
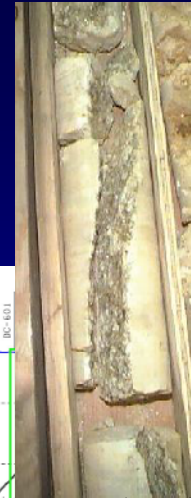
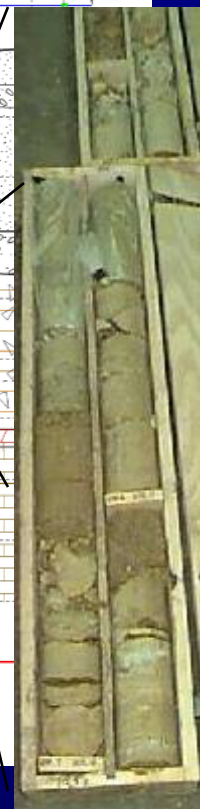
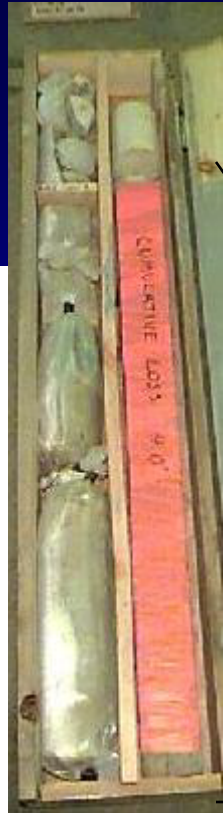
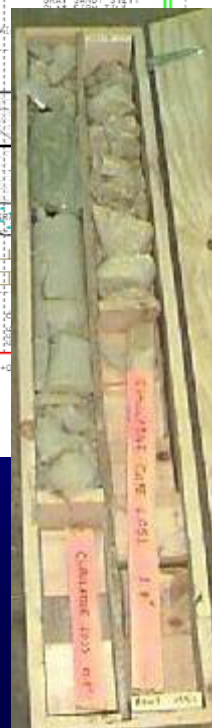
Voids

**Damaged
Instrumentation**

Open Joints

**Highly
Fractured**

**24-foot
Solution
Feature**

**Clay Filled
Features**

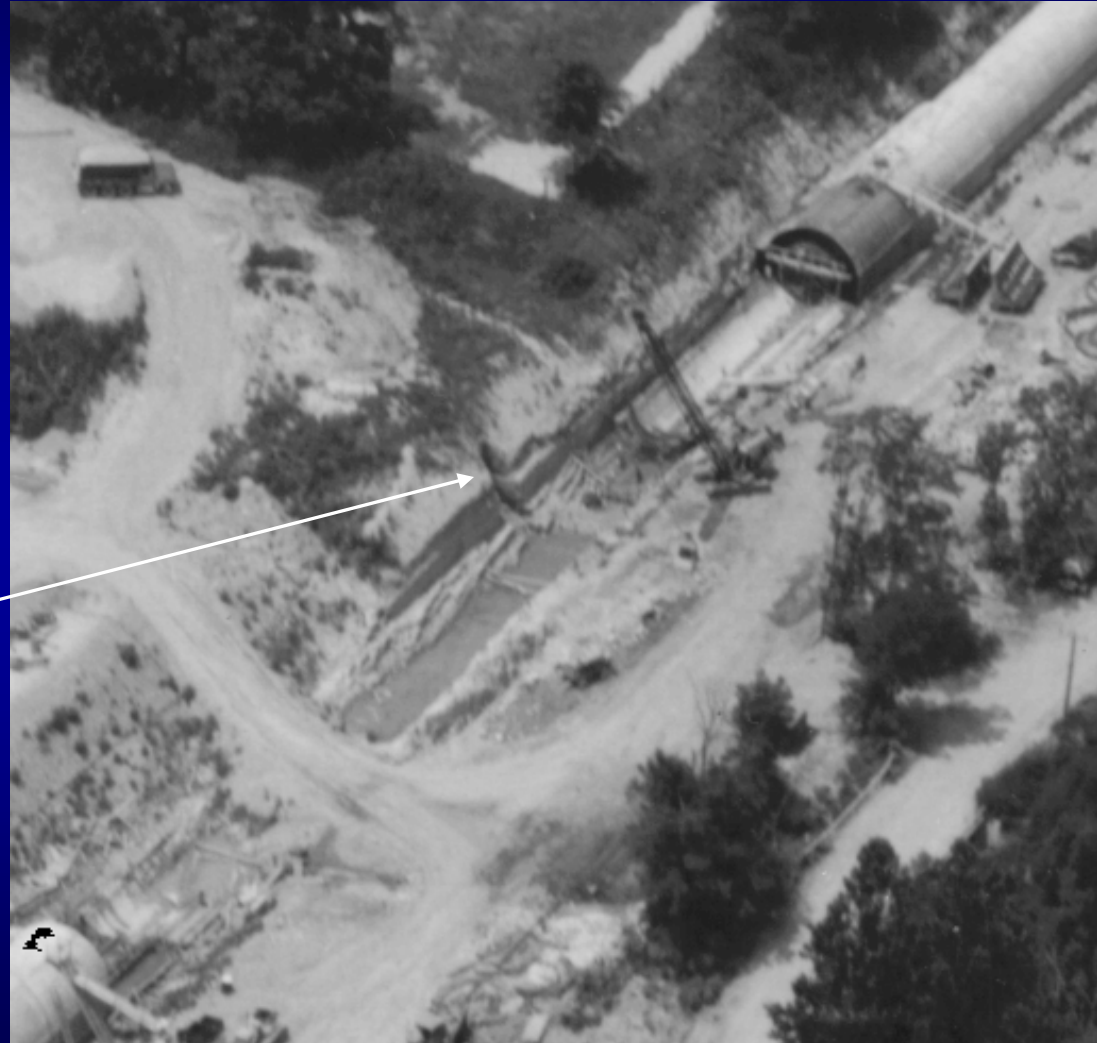
Solution feature
on left abutment
side of conduit
excavation

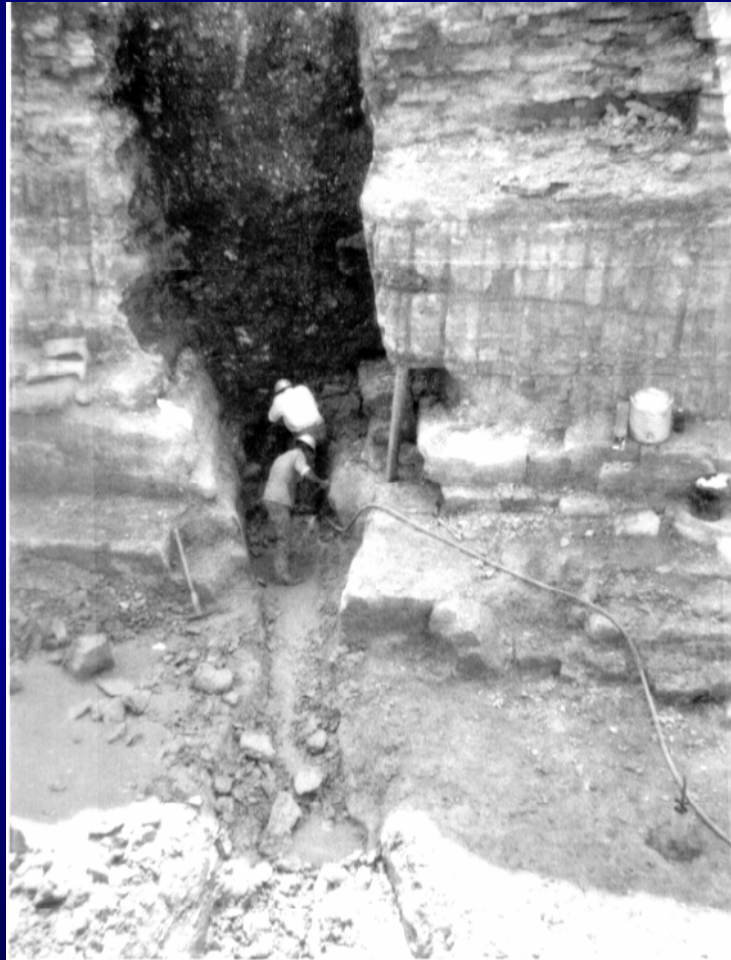
View of solution
channel, located at
dam station 51+00,
on left abutment side
of conduit excavation.

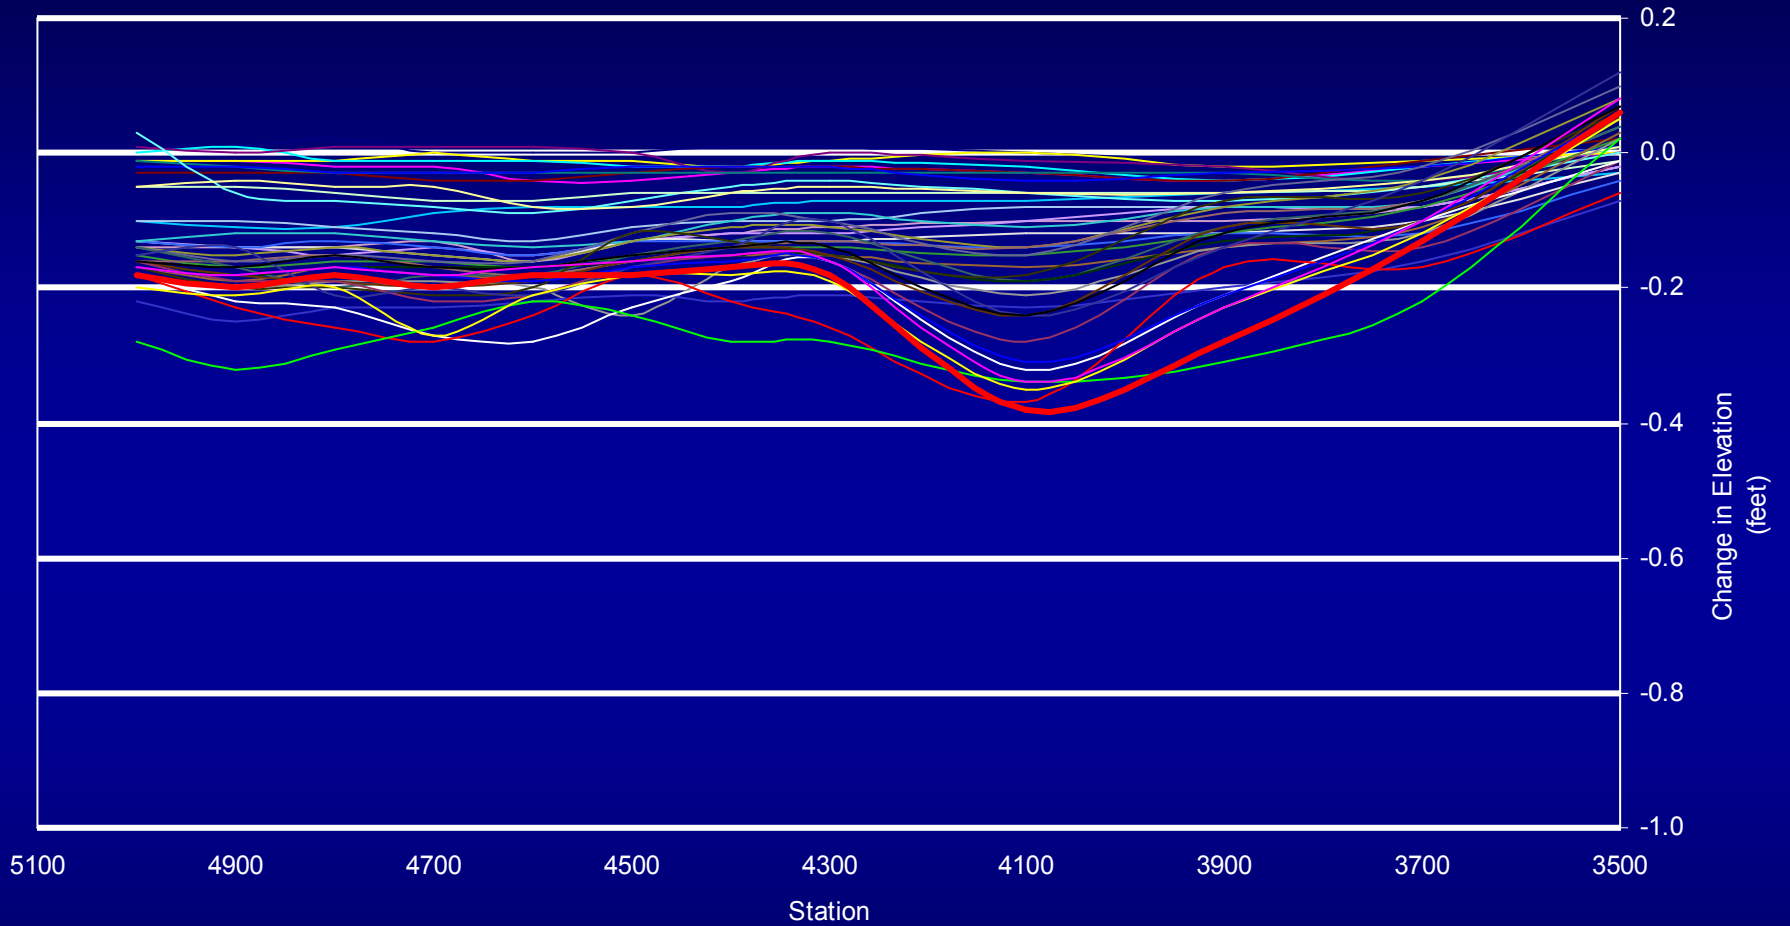
Operations Personnel Identify
Guardrail Deflections

Change In Elevation From Original Elevation

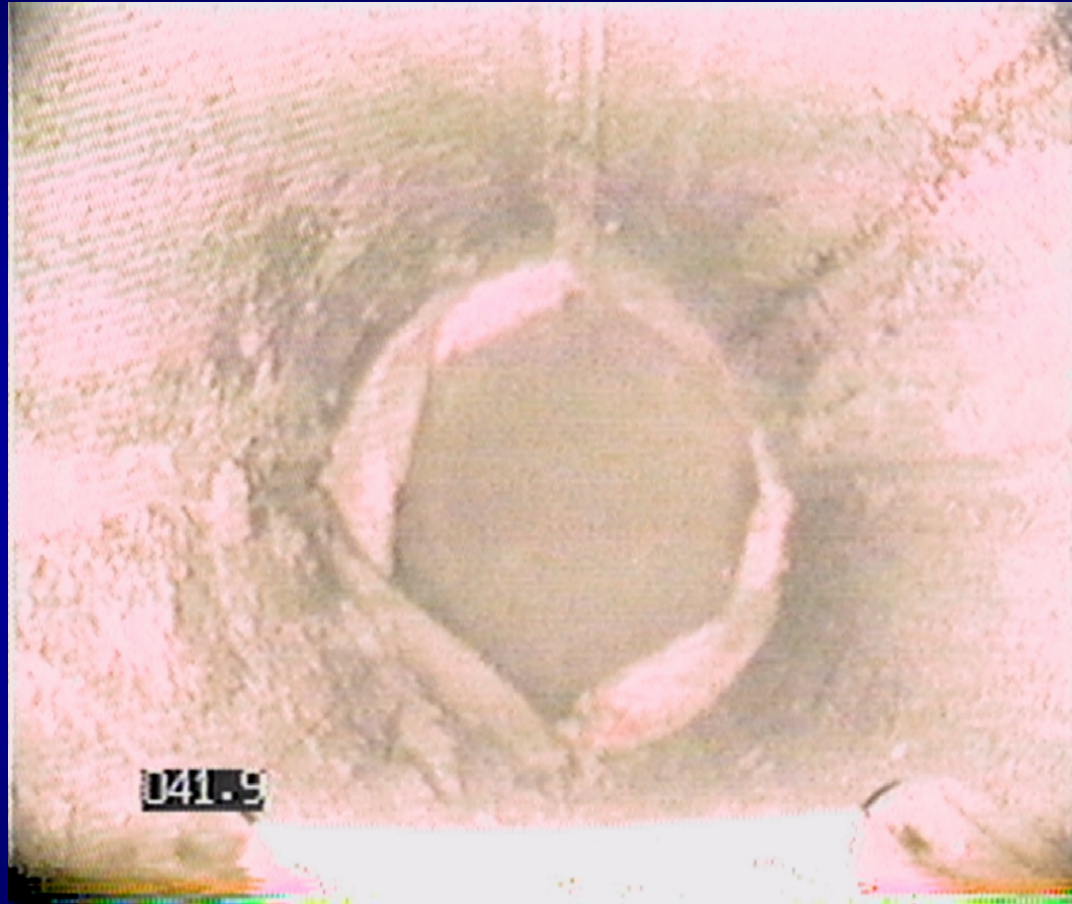
June 1999 view of SI-2 (station 40+25)
at approximately elevation 758

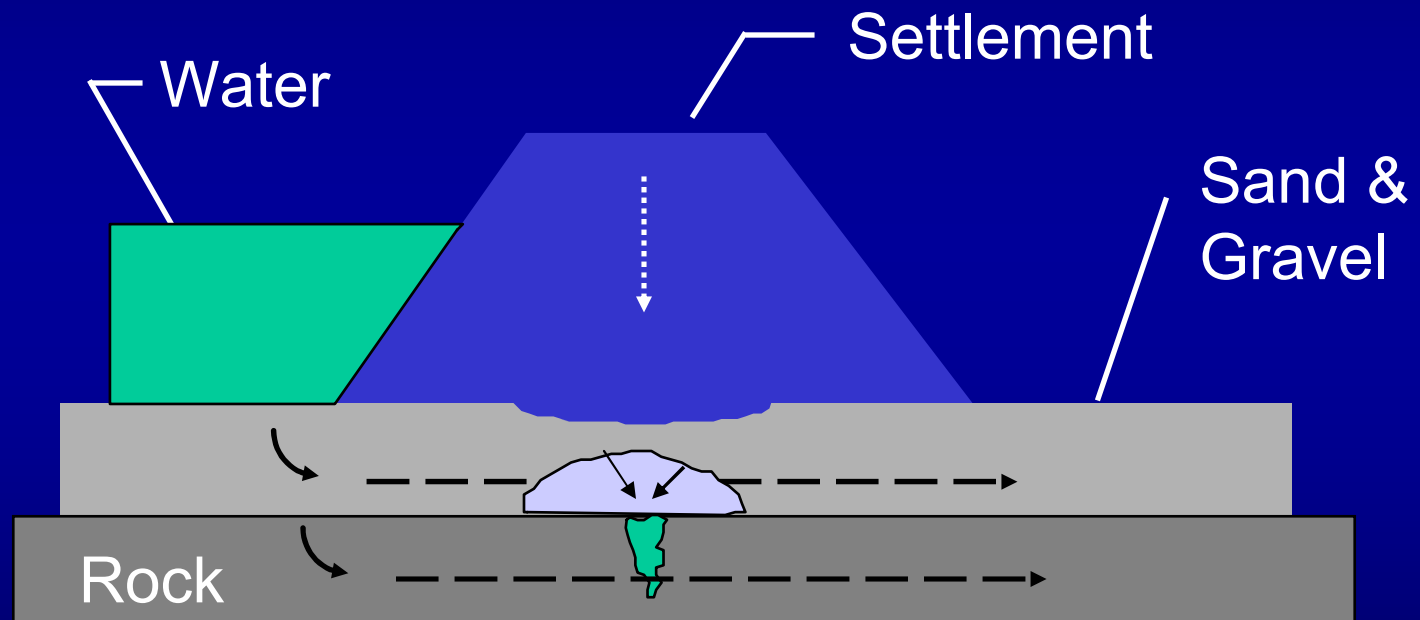
Settlement Mechanism Foundation Piping

A cut-off wall was selected as the only practical and certain method of repairing the foundation for the dam. The cutoff wall would extend to depths of 180 feet and up to 80' into rock.

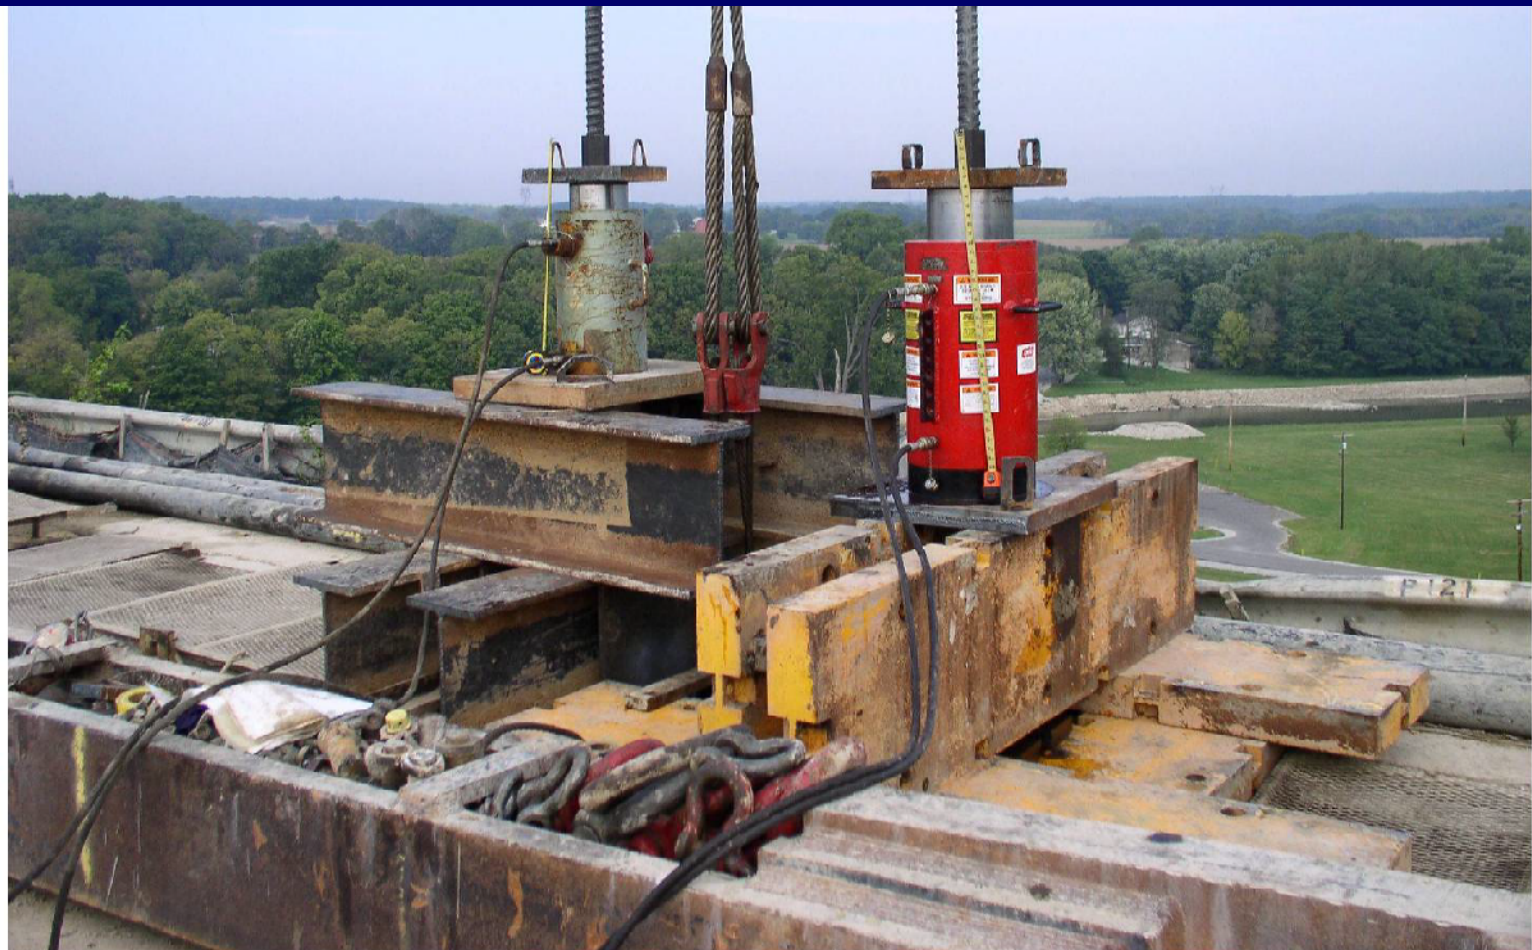
Mill Recovery

Mill Retrieval With Dywidag Bars
September, 2004

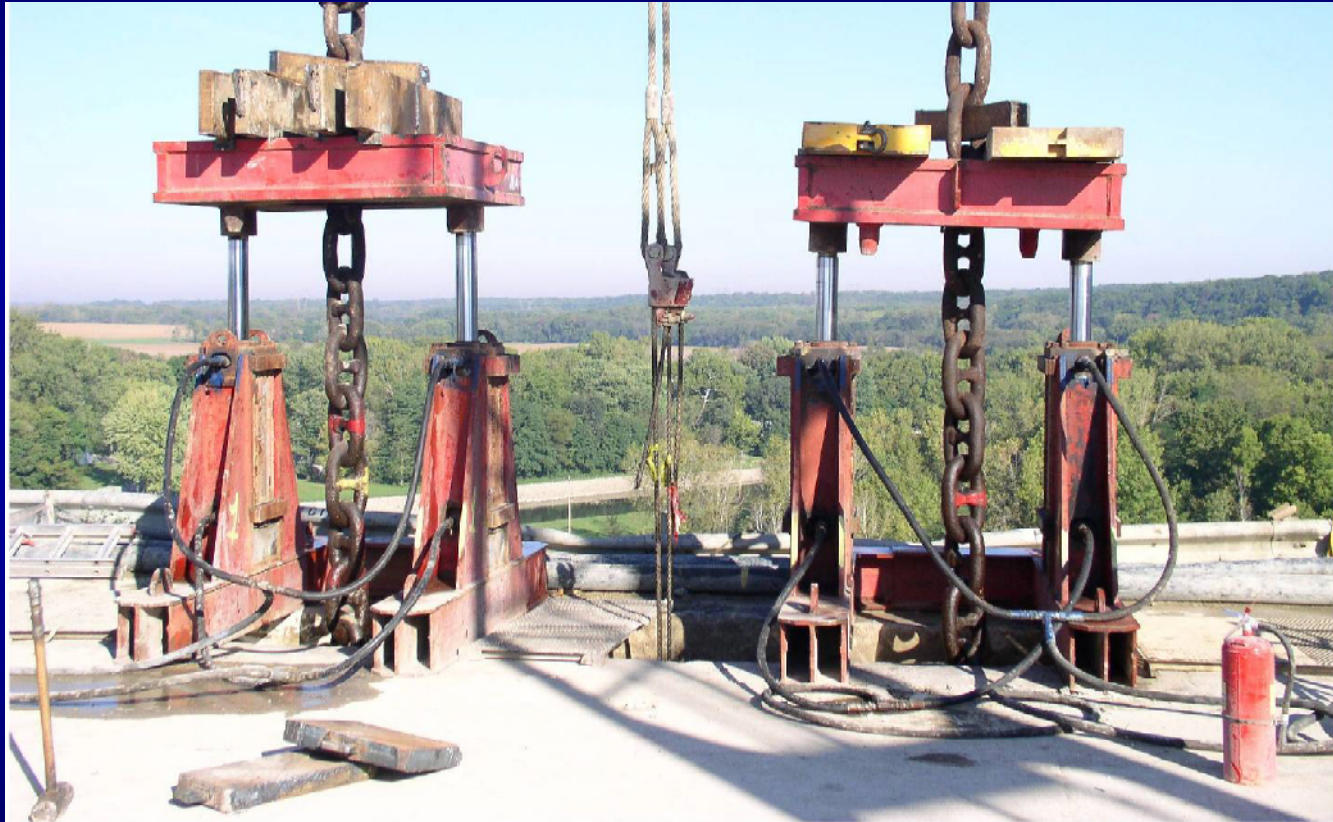
Mill Recovery

Mill Retrieval Hydraulic Jacks
September, 2004
Dam Foundation Remediation
Contract No. DACW27-01-C-0018

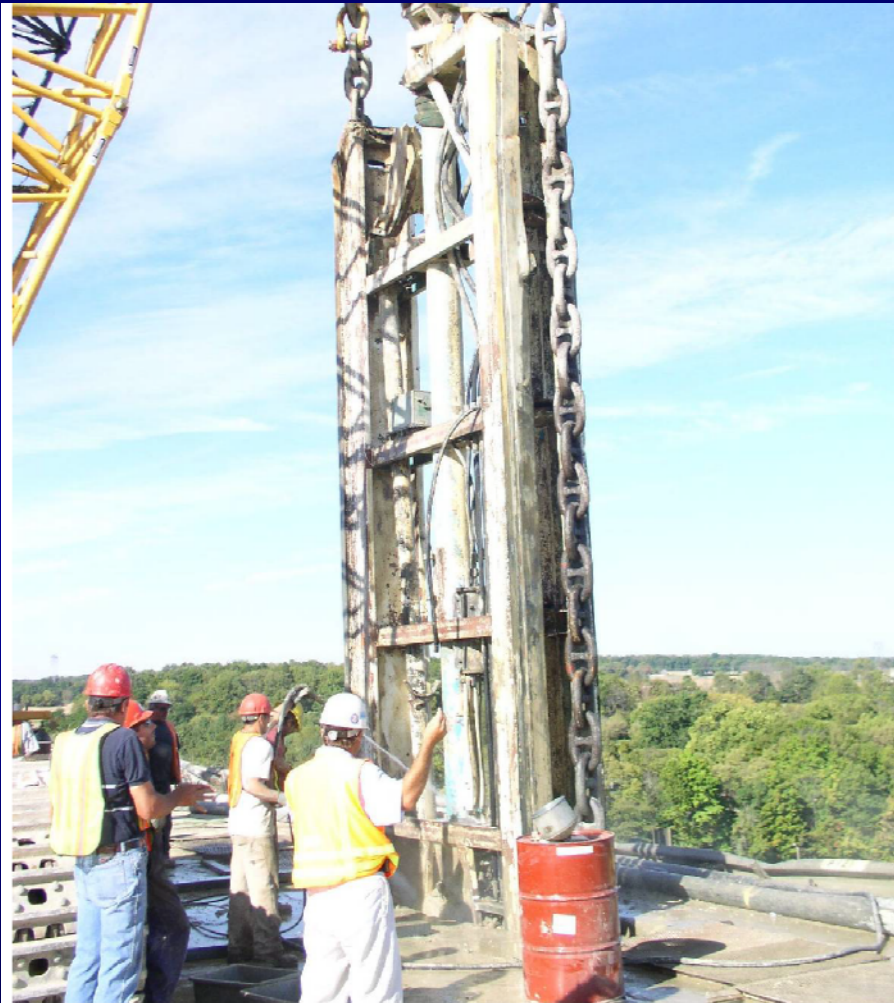
Mill Recovery

Mill Removal From Panel P-121
September, 2004
