Clearwater Dam Major Rehab Project

Geotechnical & Civil Section - Design Branch

Little Rock District Corps of Engineers

Significant Deficiencies

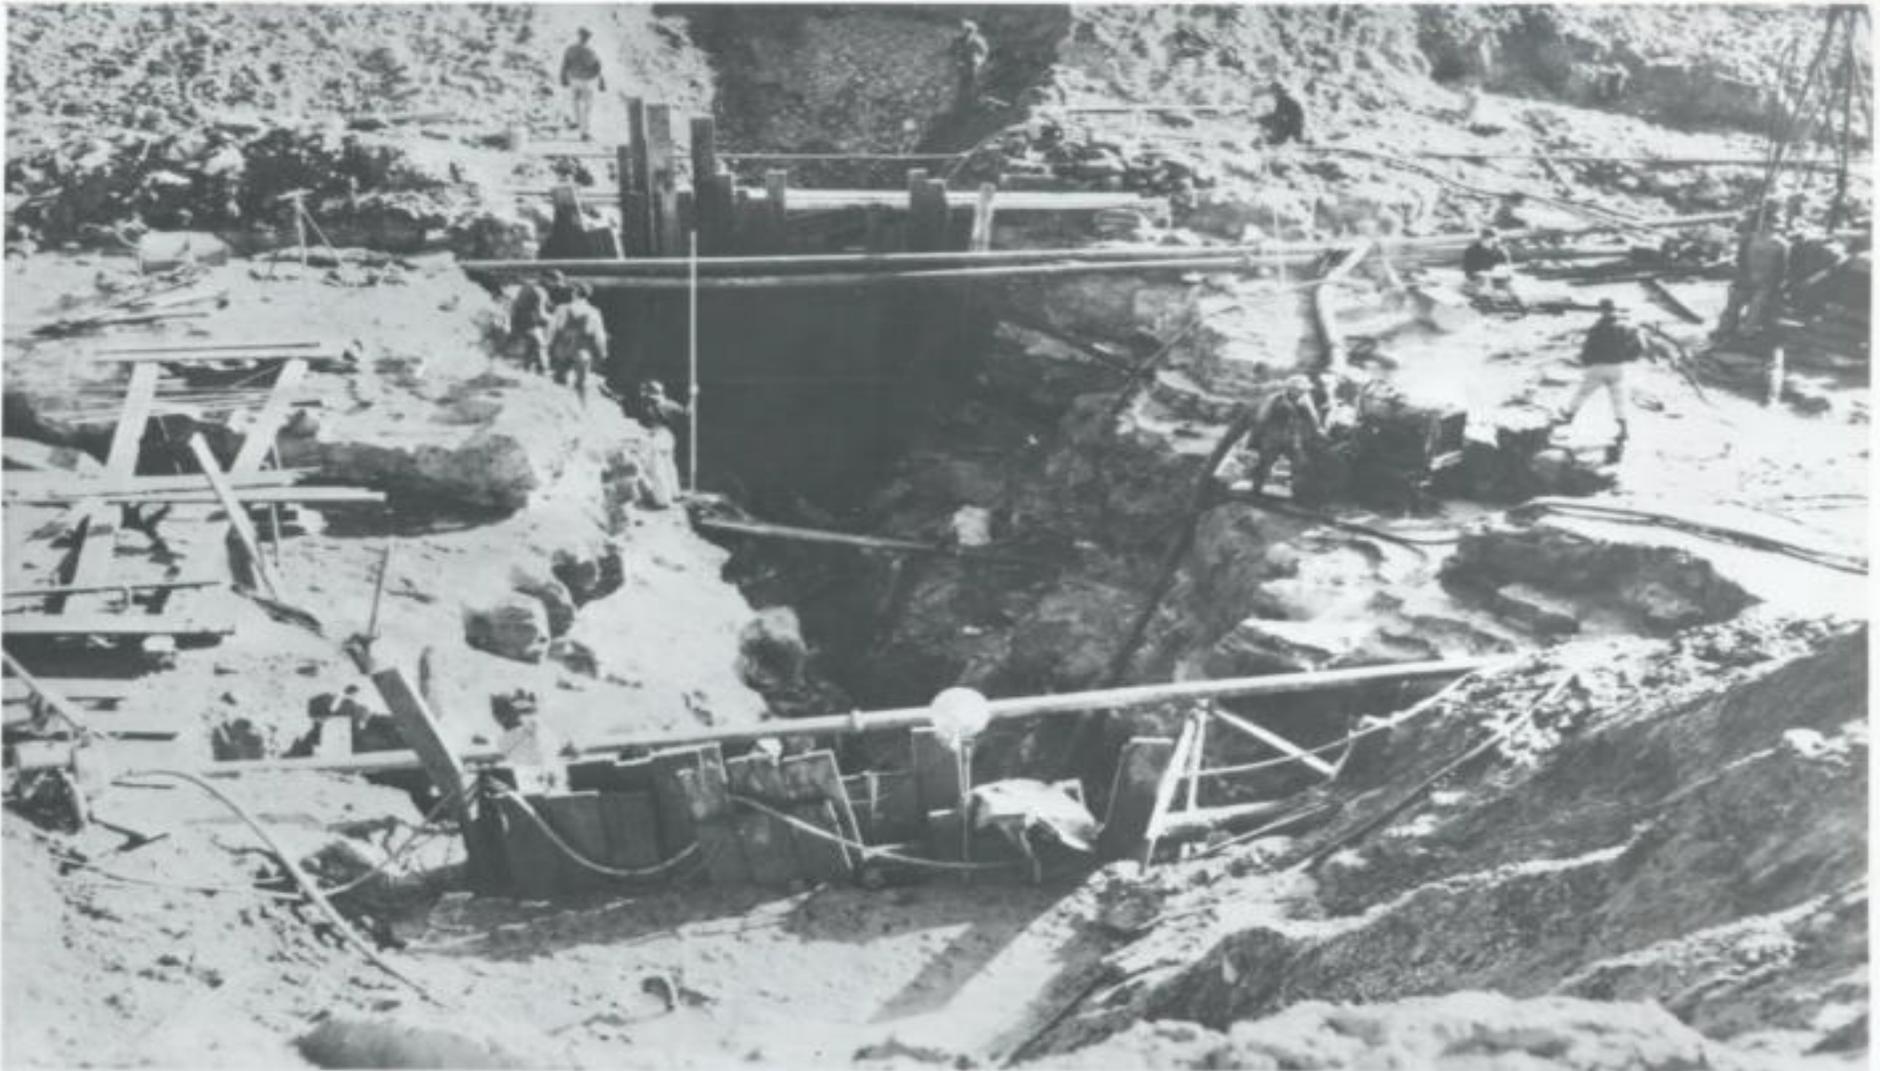
Original Construction – STA 39+20

Looking S from 175' US of station 39 / 20: Open joint in cut-off trench foundation.

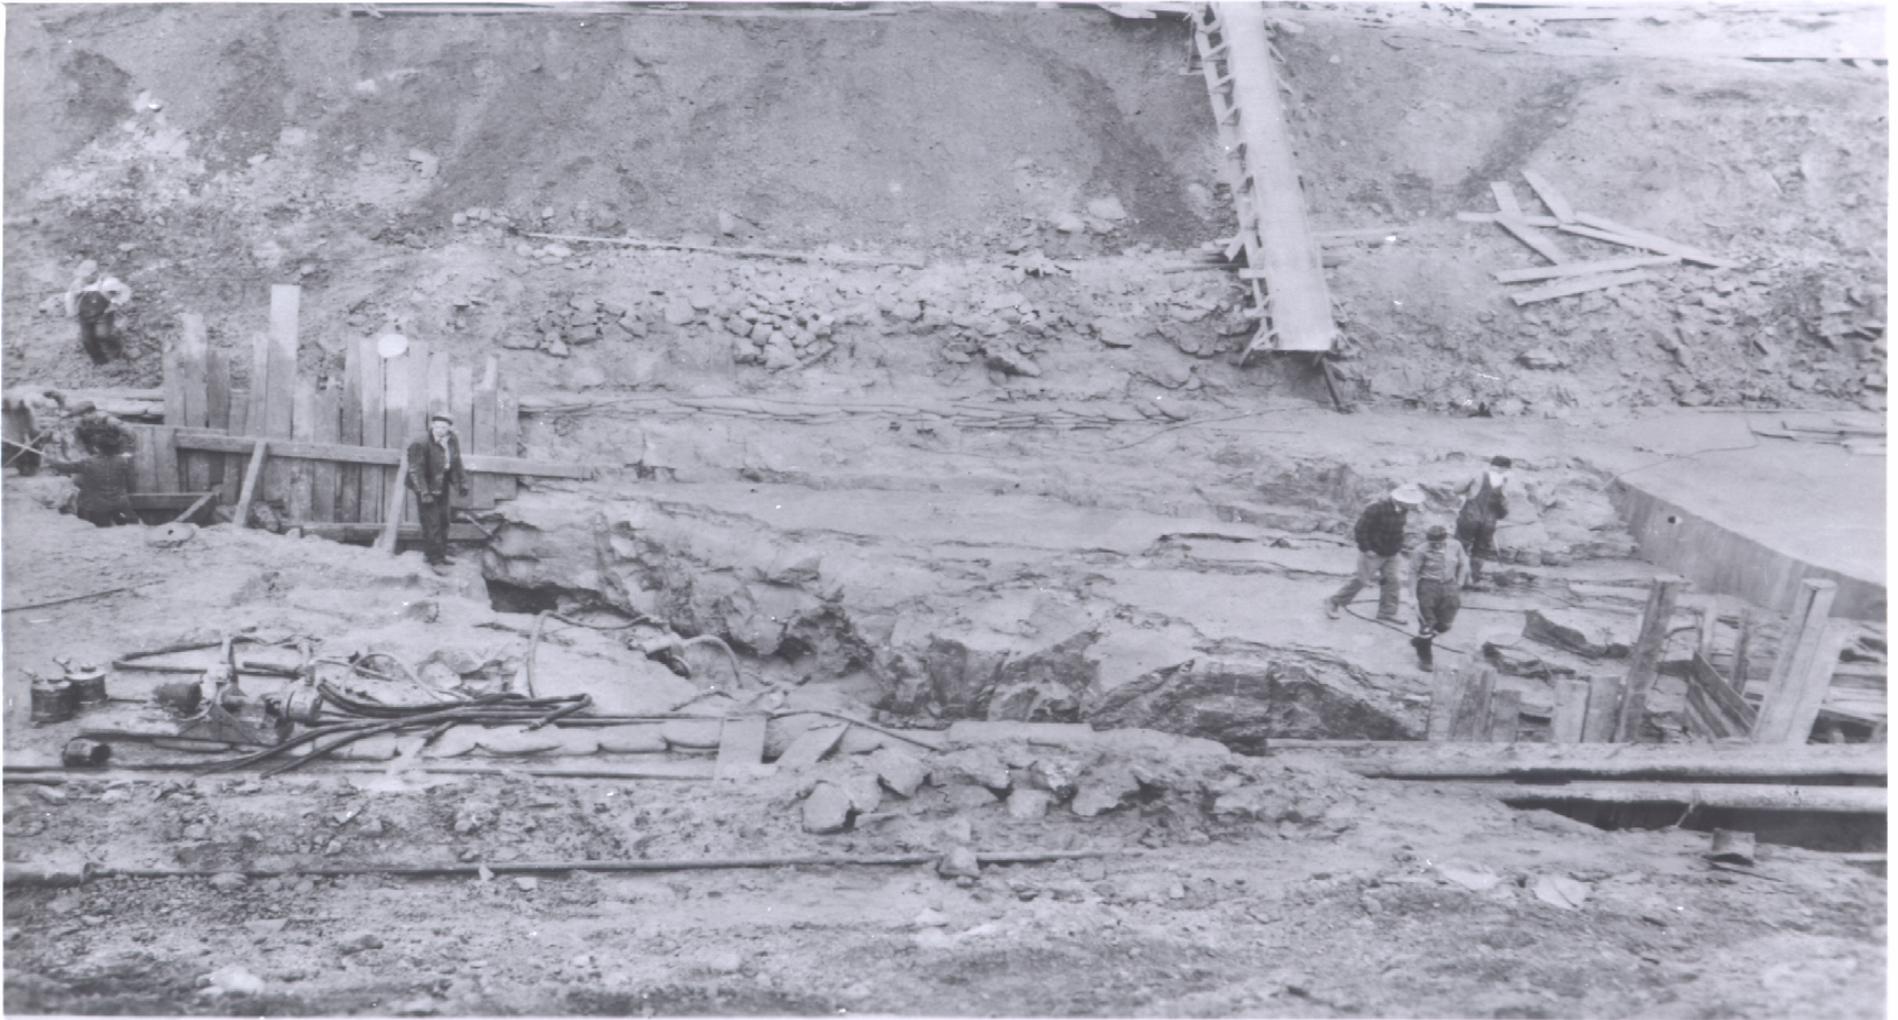
Original Construction – STA 40+15

Looking NW from 35' U.S. of station 40 + 15: Open joint in cut-off trench foundation.

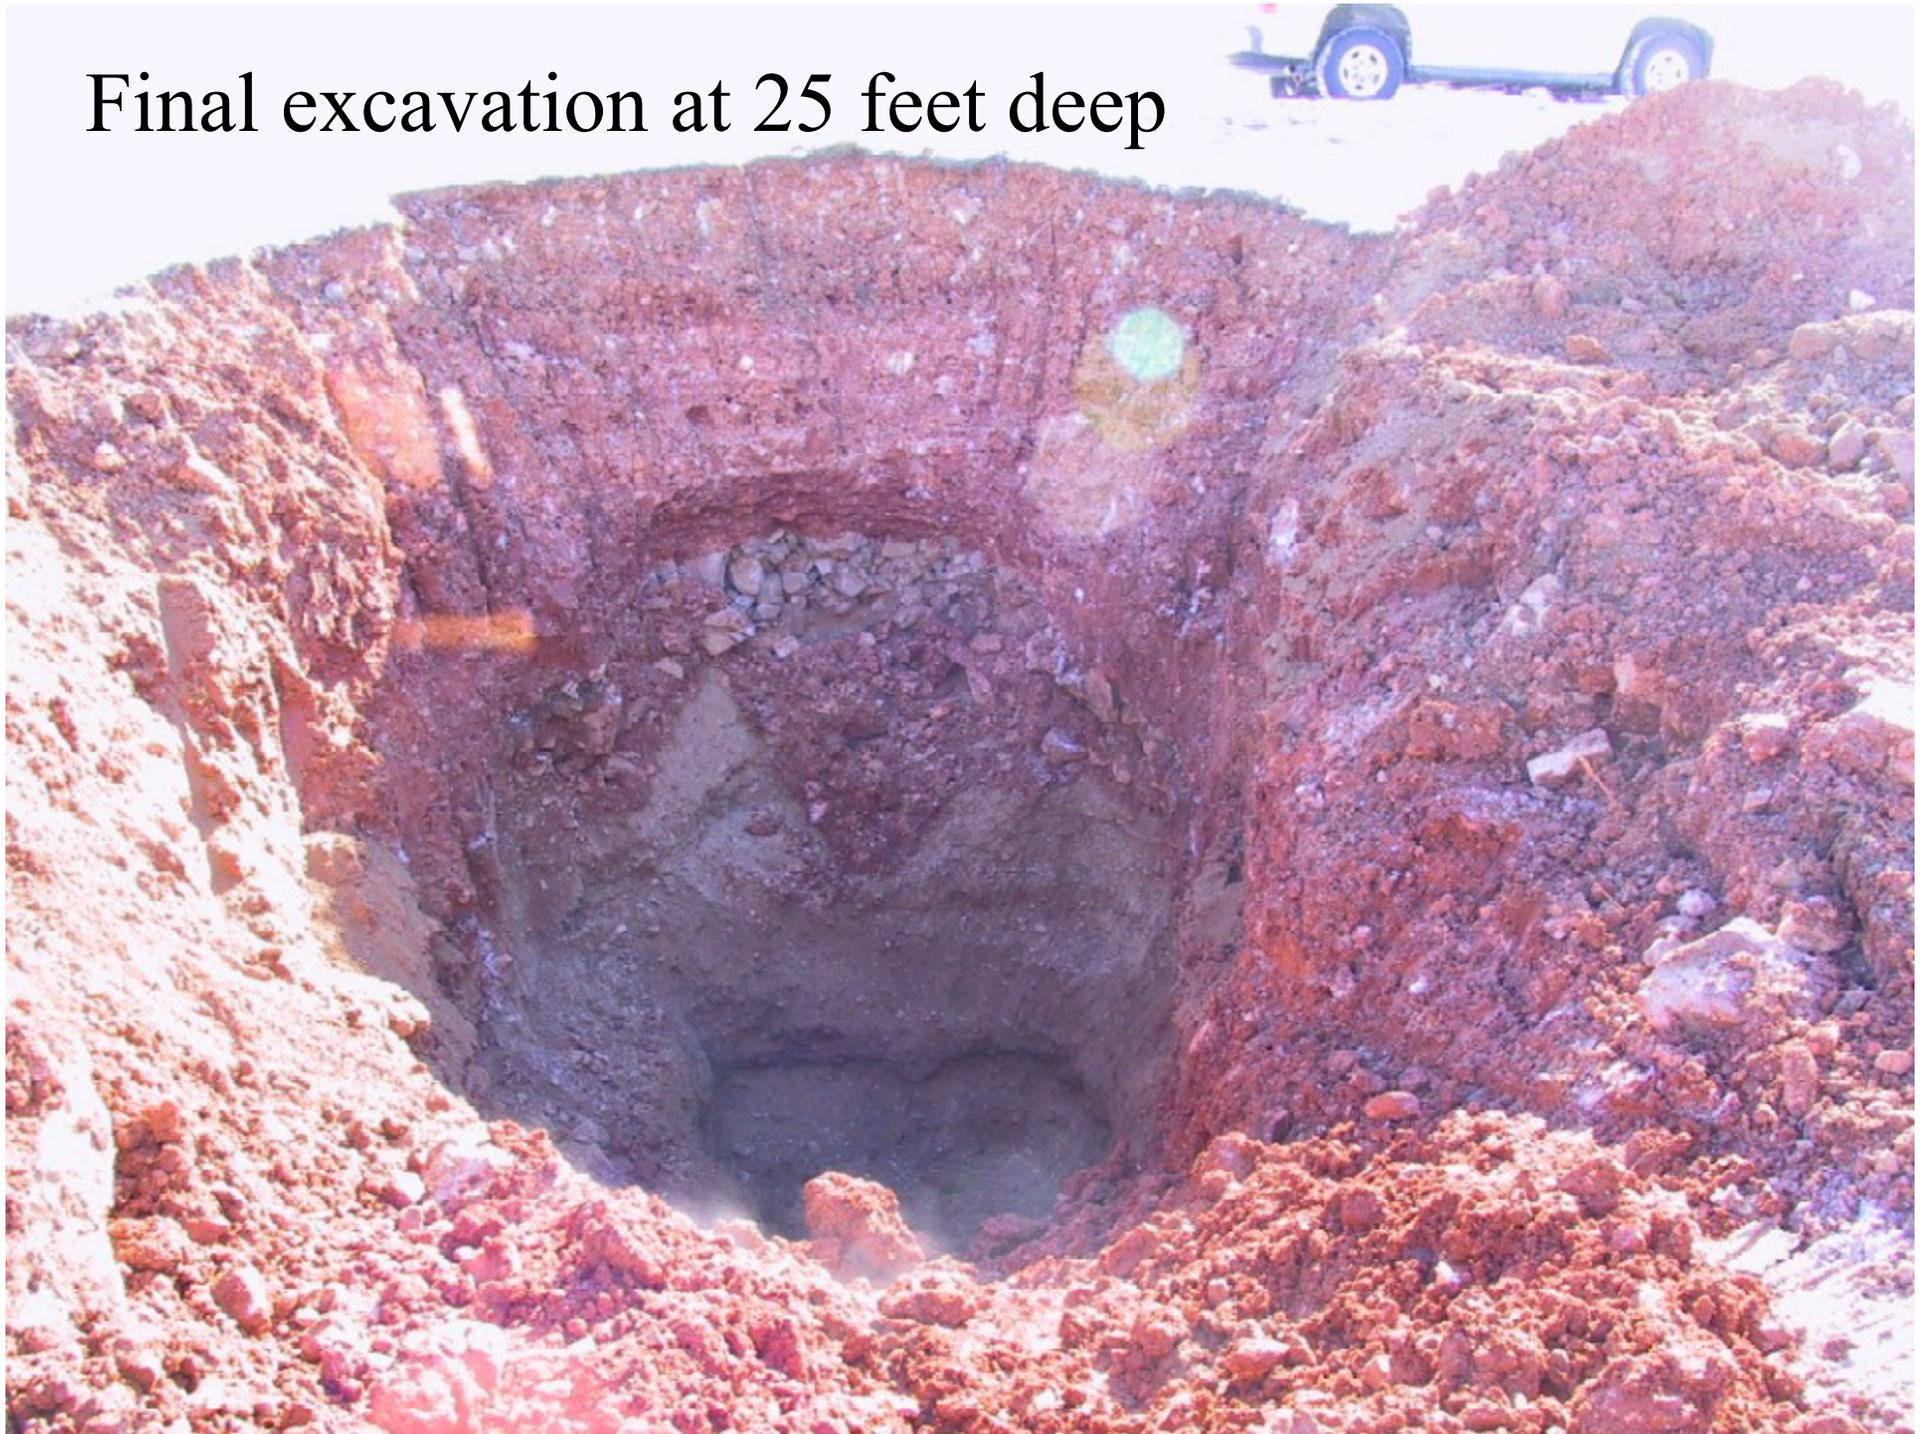
Final excavation at 25 feet deep

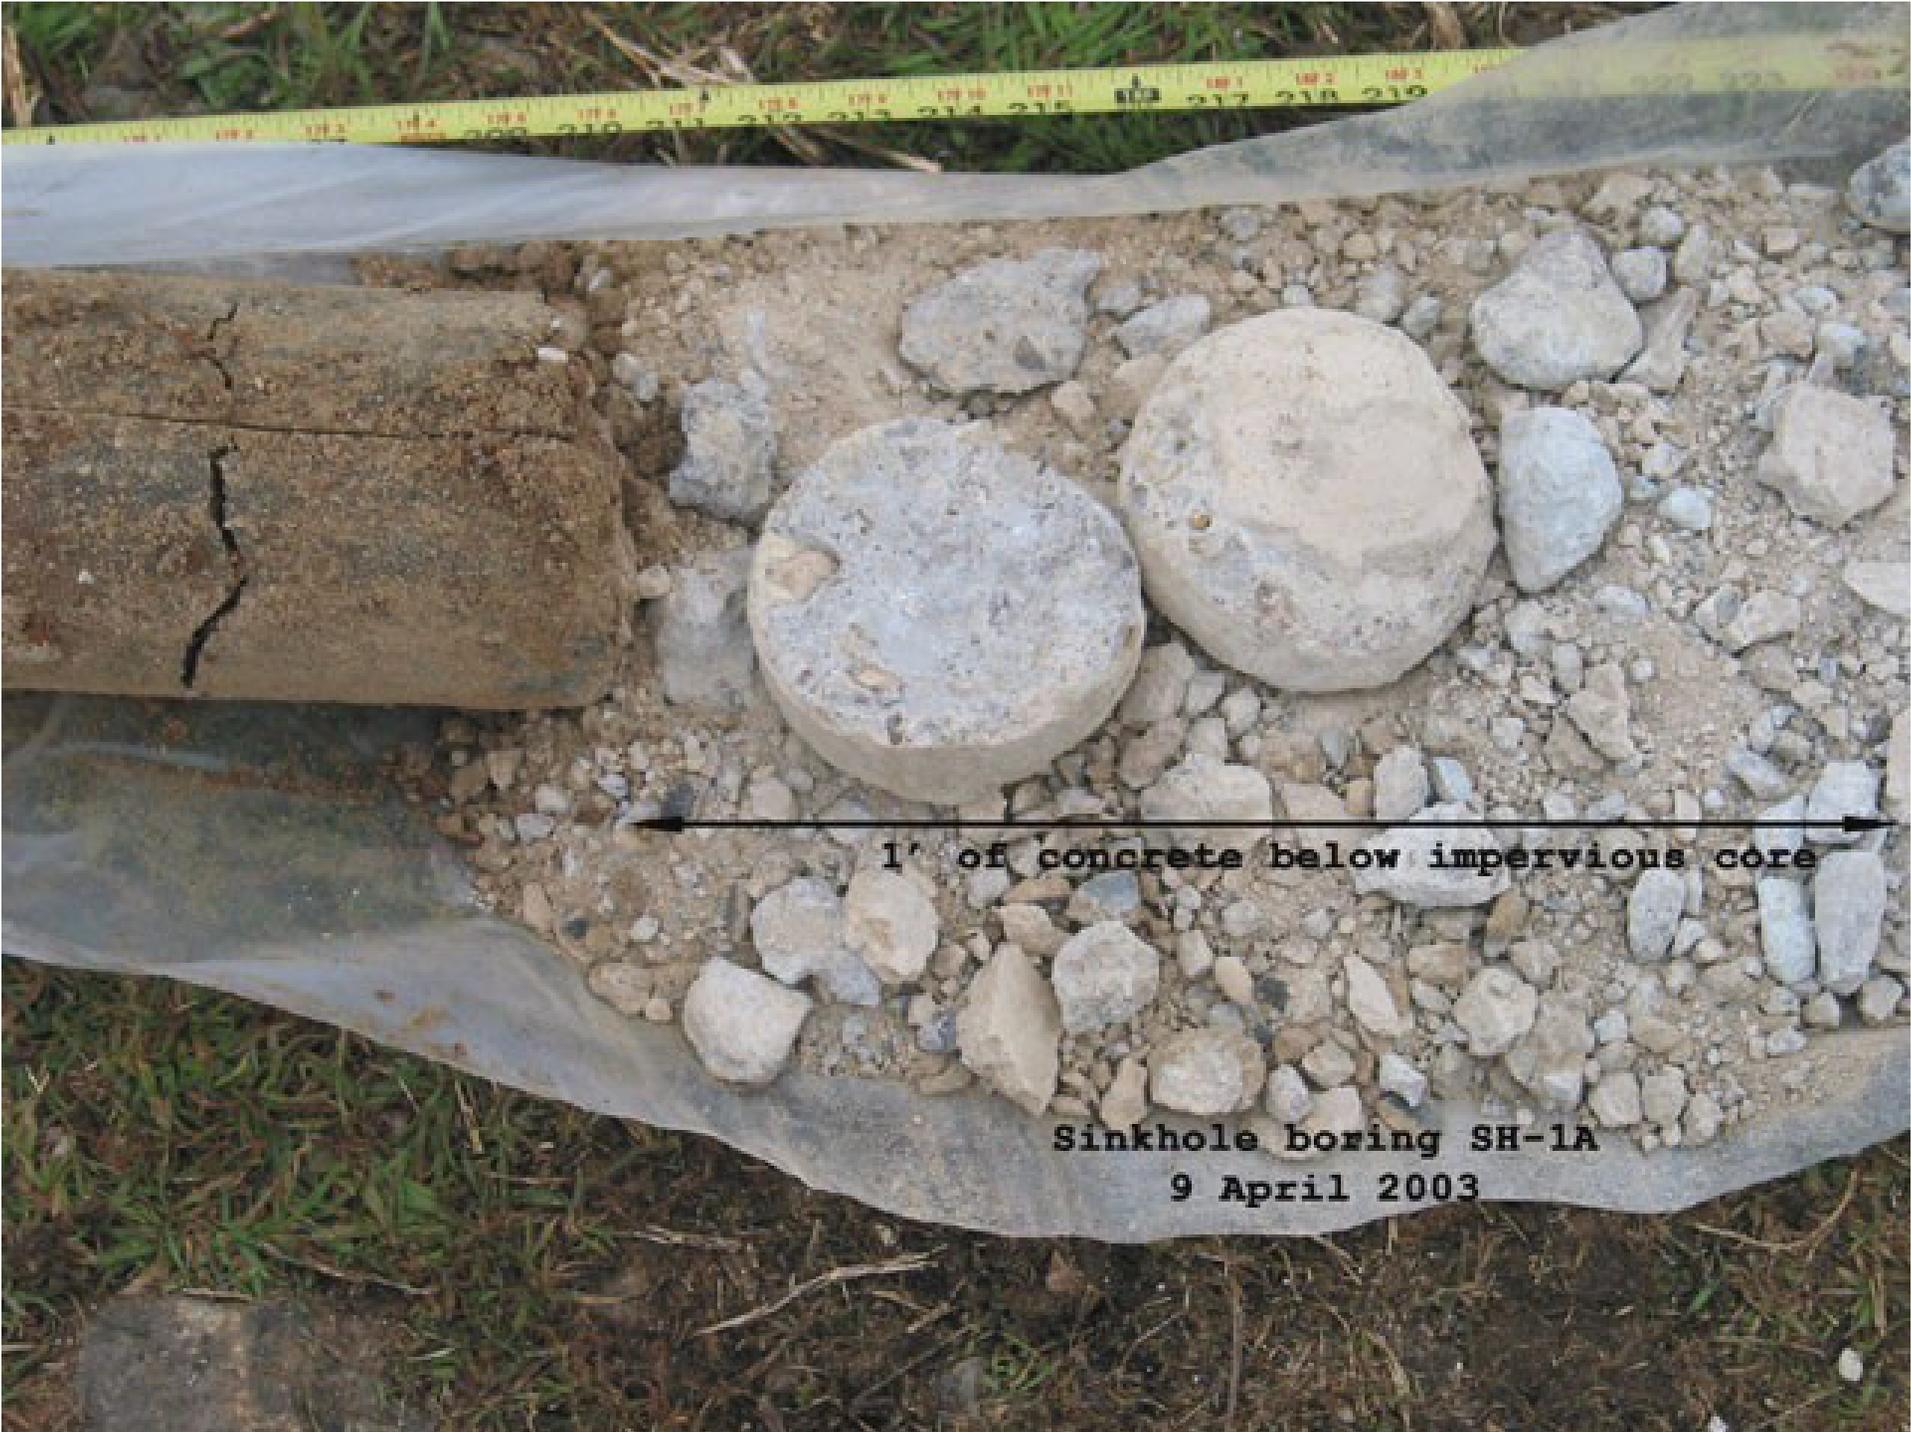
Sinkhole boring SH-1A
9 April 2003

1' of concrete below impervious core
