*US Army Corps of
Engineers,
Nashville District*

Wolf Creek Dam Seepage Major Rehabilitation Evaluation

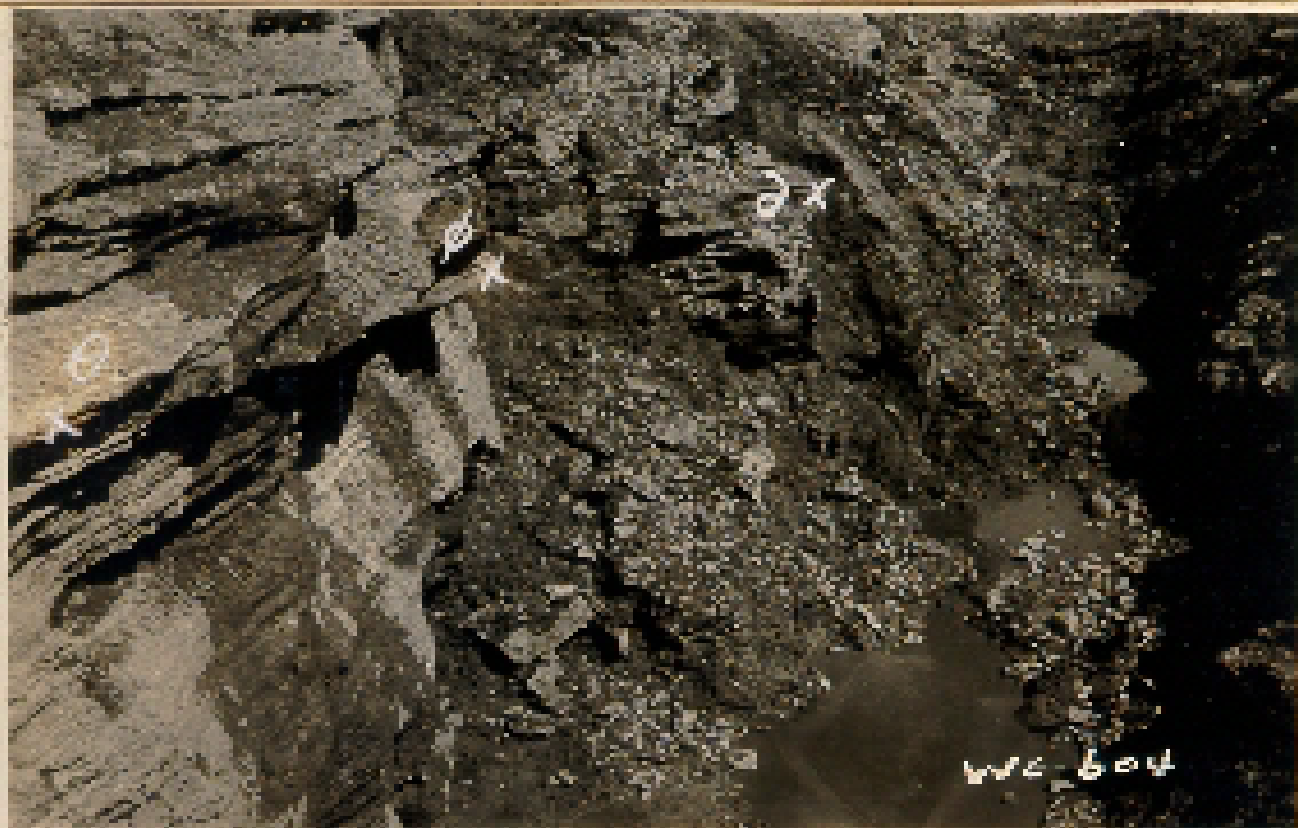
I-E

I-A, -B, and -E. The bottom of this section of trench, at this stage of excavation, is still in overburden except for a few narrow areas where the rock salients showing in the overburden slopes were connected across the trench line. It is proposed to excavate the floor of the trench to continuous sound rock for the great curtain. • Overhangs and loose rock

8-27-42. Looking SE in trench from sta. 5+50.

will be removed only where they cross the line of the trench, since the earthfill in the sides of the trench will have the function only of stability and not of an absolutely uniform tight contact with the trench walls. Tamping will supplement the regular rolling of the fill as required under the overhangs and irregular salients. •

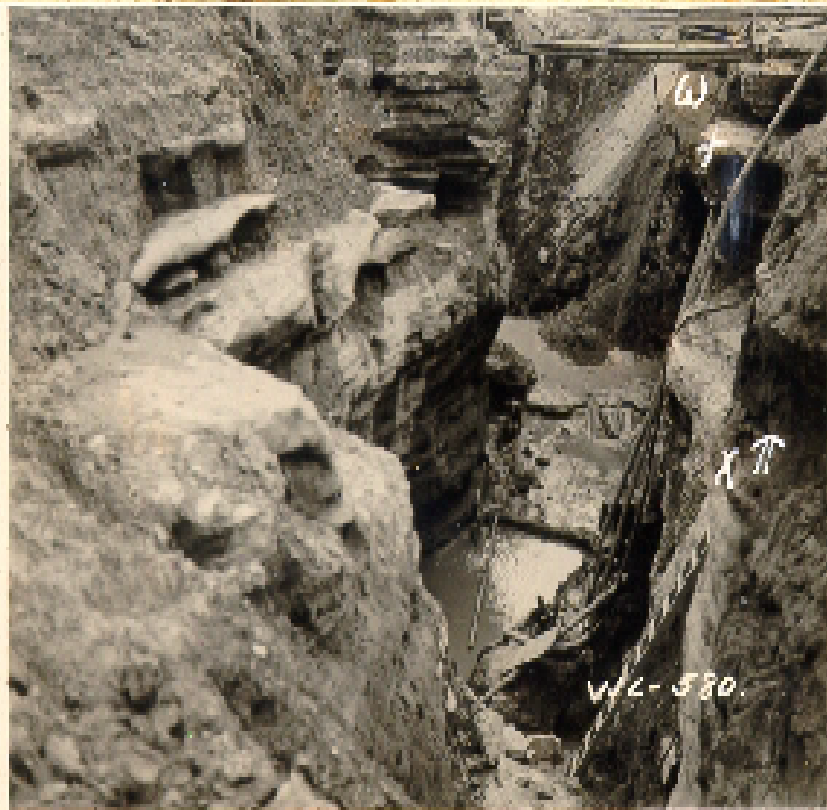
8-23-42/looking S in trench from vicinity embankment sta. 36+10. I-6

I-6. Note rock channel between points ω and γ , with abrupt ledge floor at level of π . This floor was underlain by solution weathered rock and was not continuous (see photo I-II). Above the floor, the walls were extremely irregular, with overhanging ledges. These were knocked off and weathered rock removed to condition shown in photo I-7.

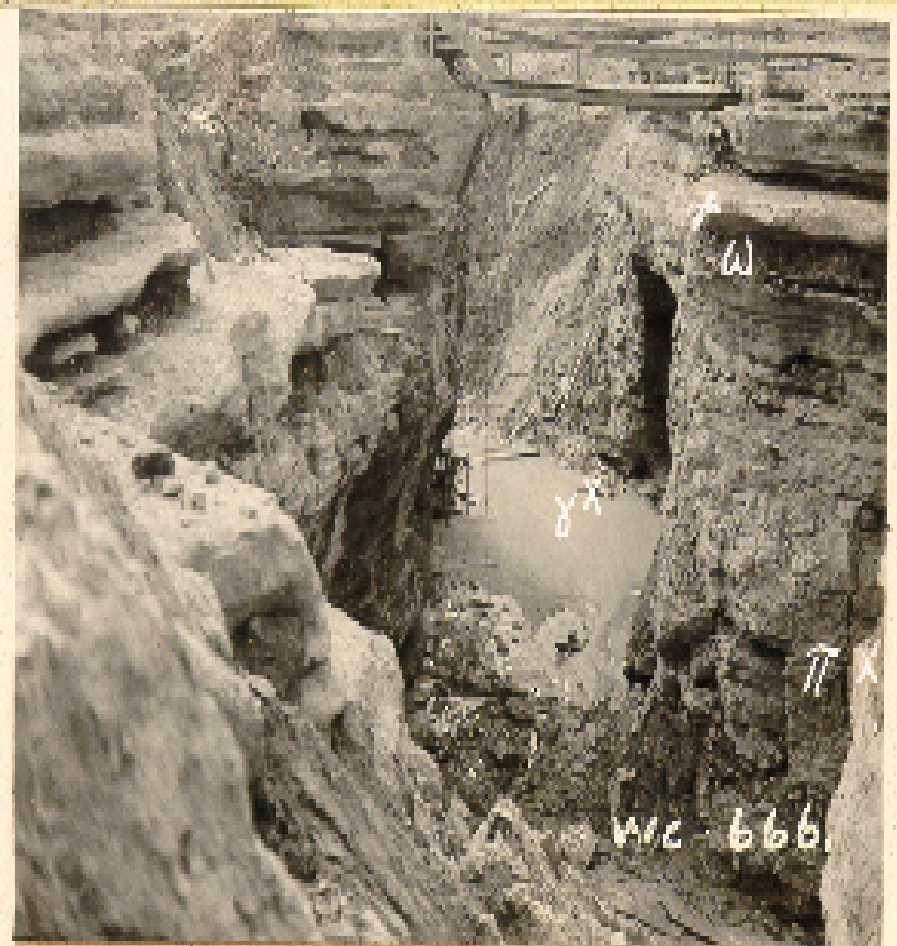
9-21-42/looking S in trench from vicinity embankment sta. 36+10. I-7

I-7. Note final condition of rock channel between points ω and γ (see photo I-6). This channel is along line 3A of Exhibit J. Note tapering continuation of the channel across intersecting channel.

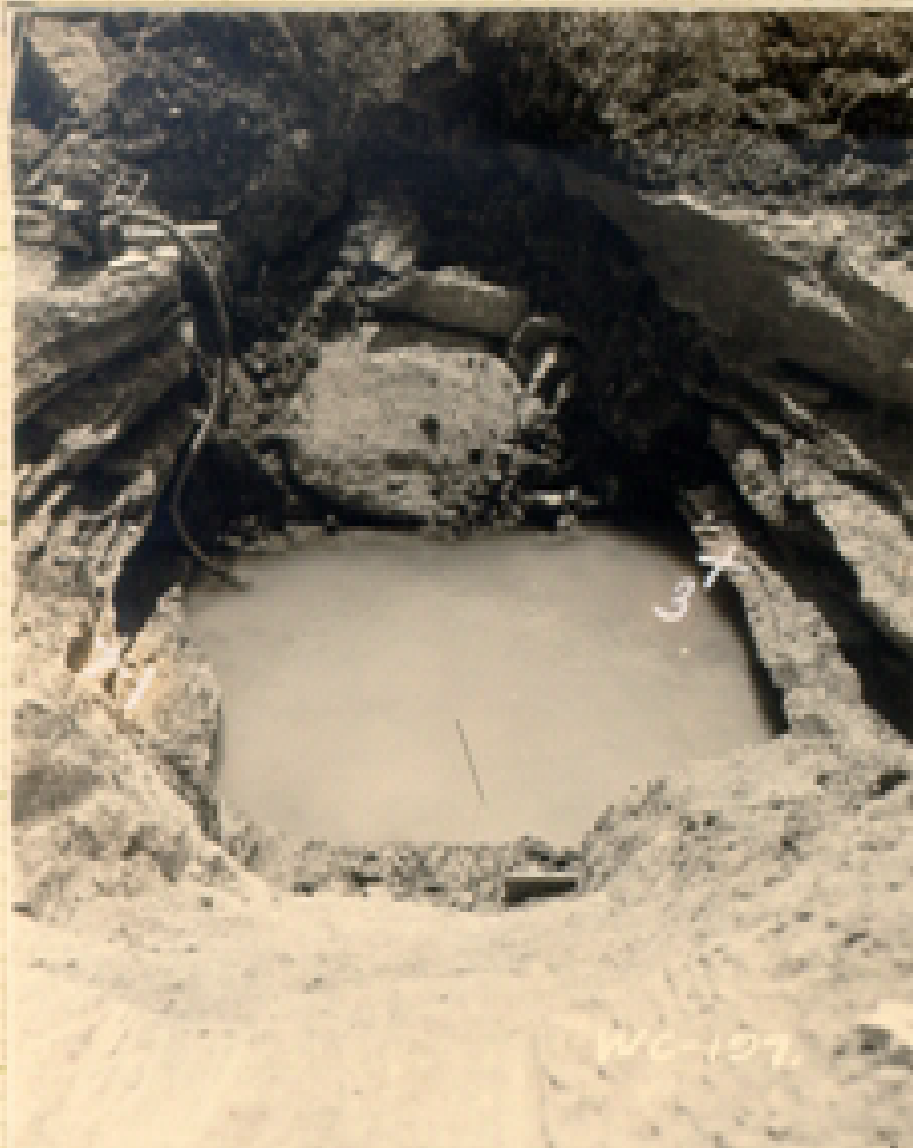
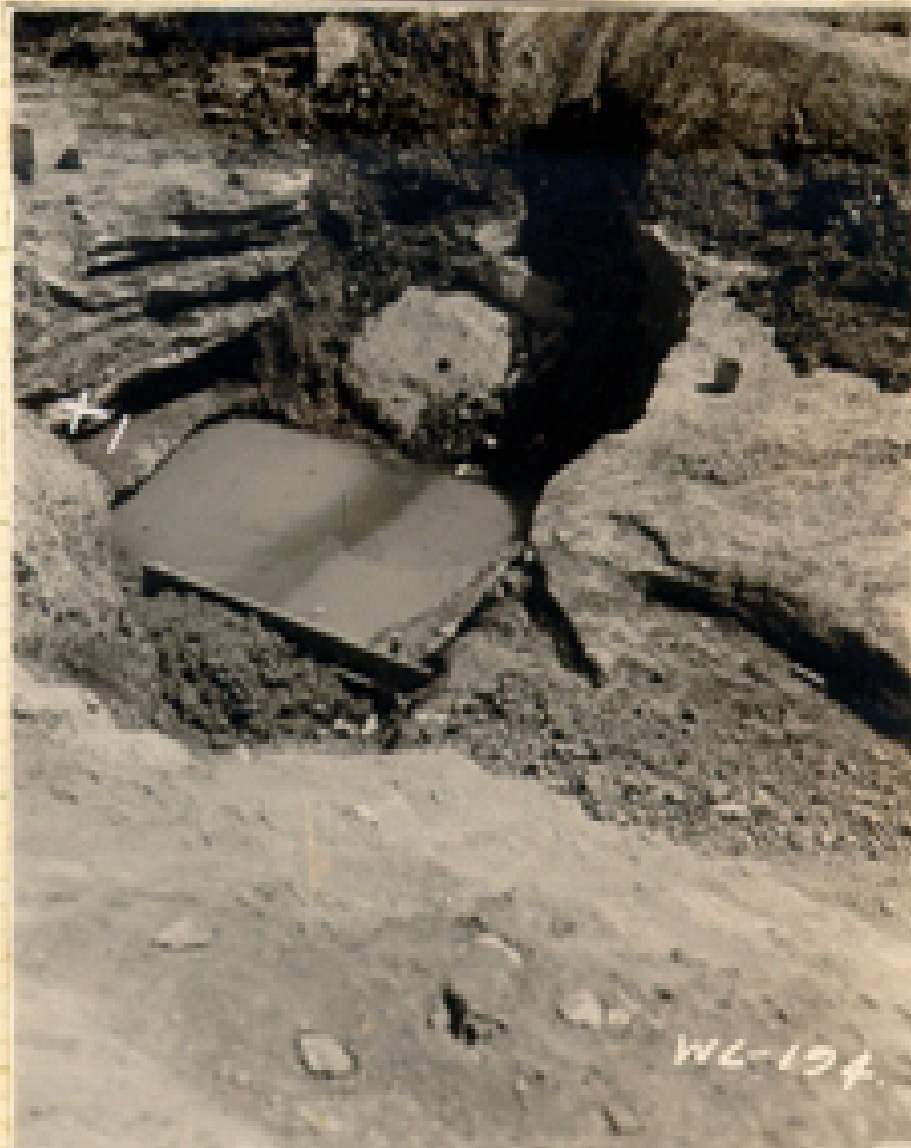
4-2-42. Looking SE along
hole at trench sta. 27+95. *IV-A*

4-2-42. Looking E across
hole at trench sta. 27+95. *IV-B*

IV-A and -B. The hole is a solution widened joint, crossing the trench at right angles. Note differential solution and resulting overhangs in rock faces. These re-entrants were apparently well filled with silt.

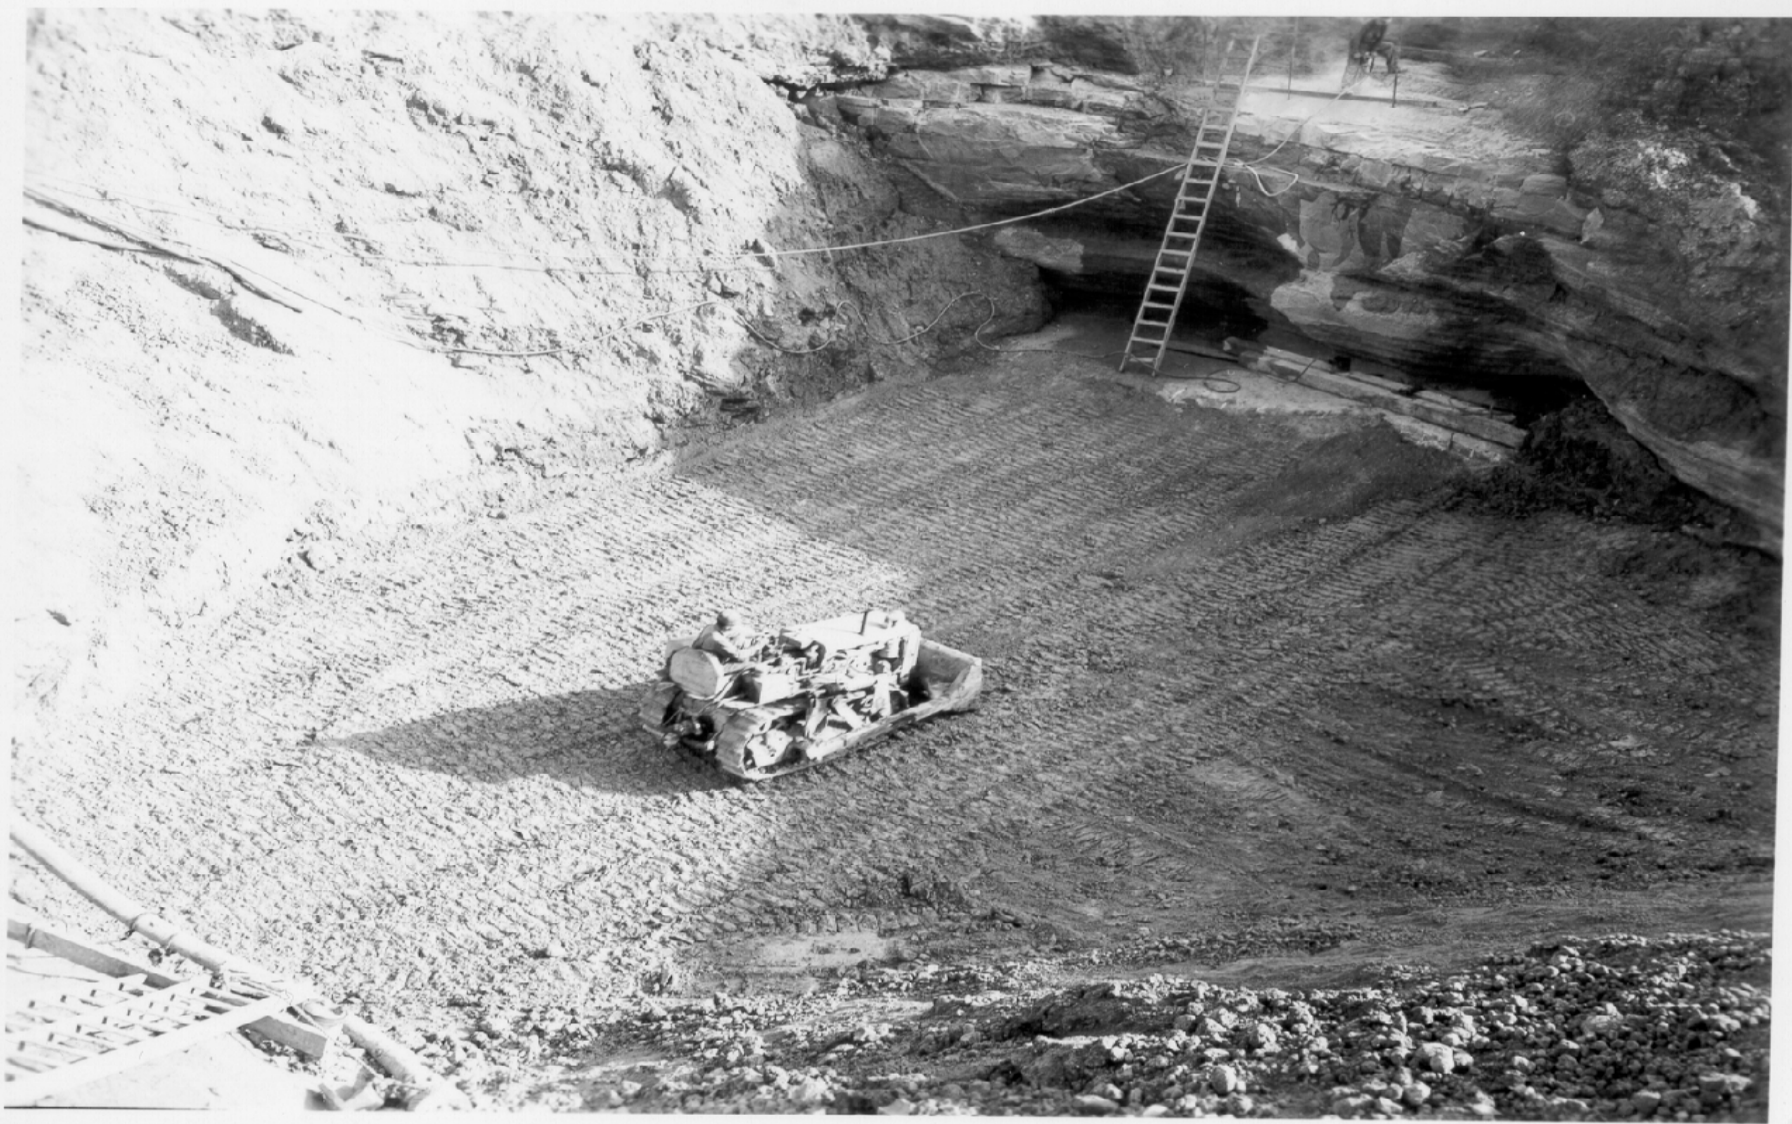
View of backfilling operations in cavity at
Sta. 50+00 on cutoff trench

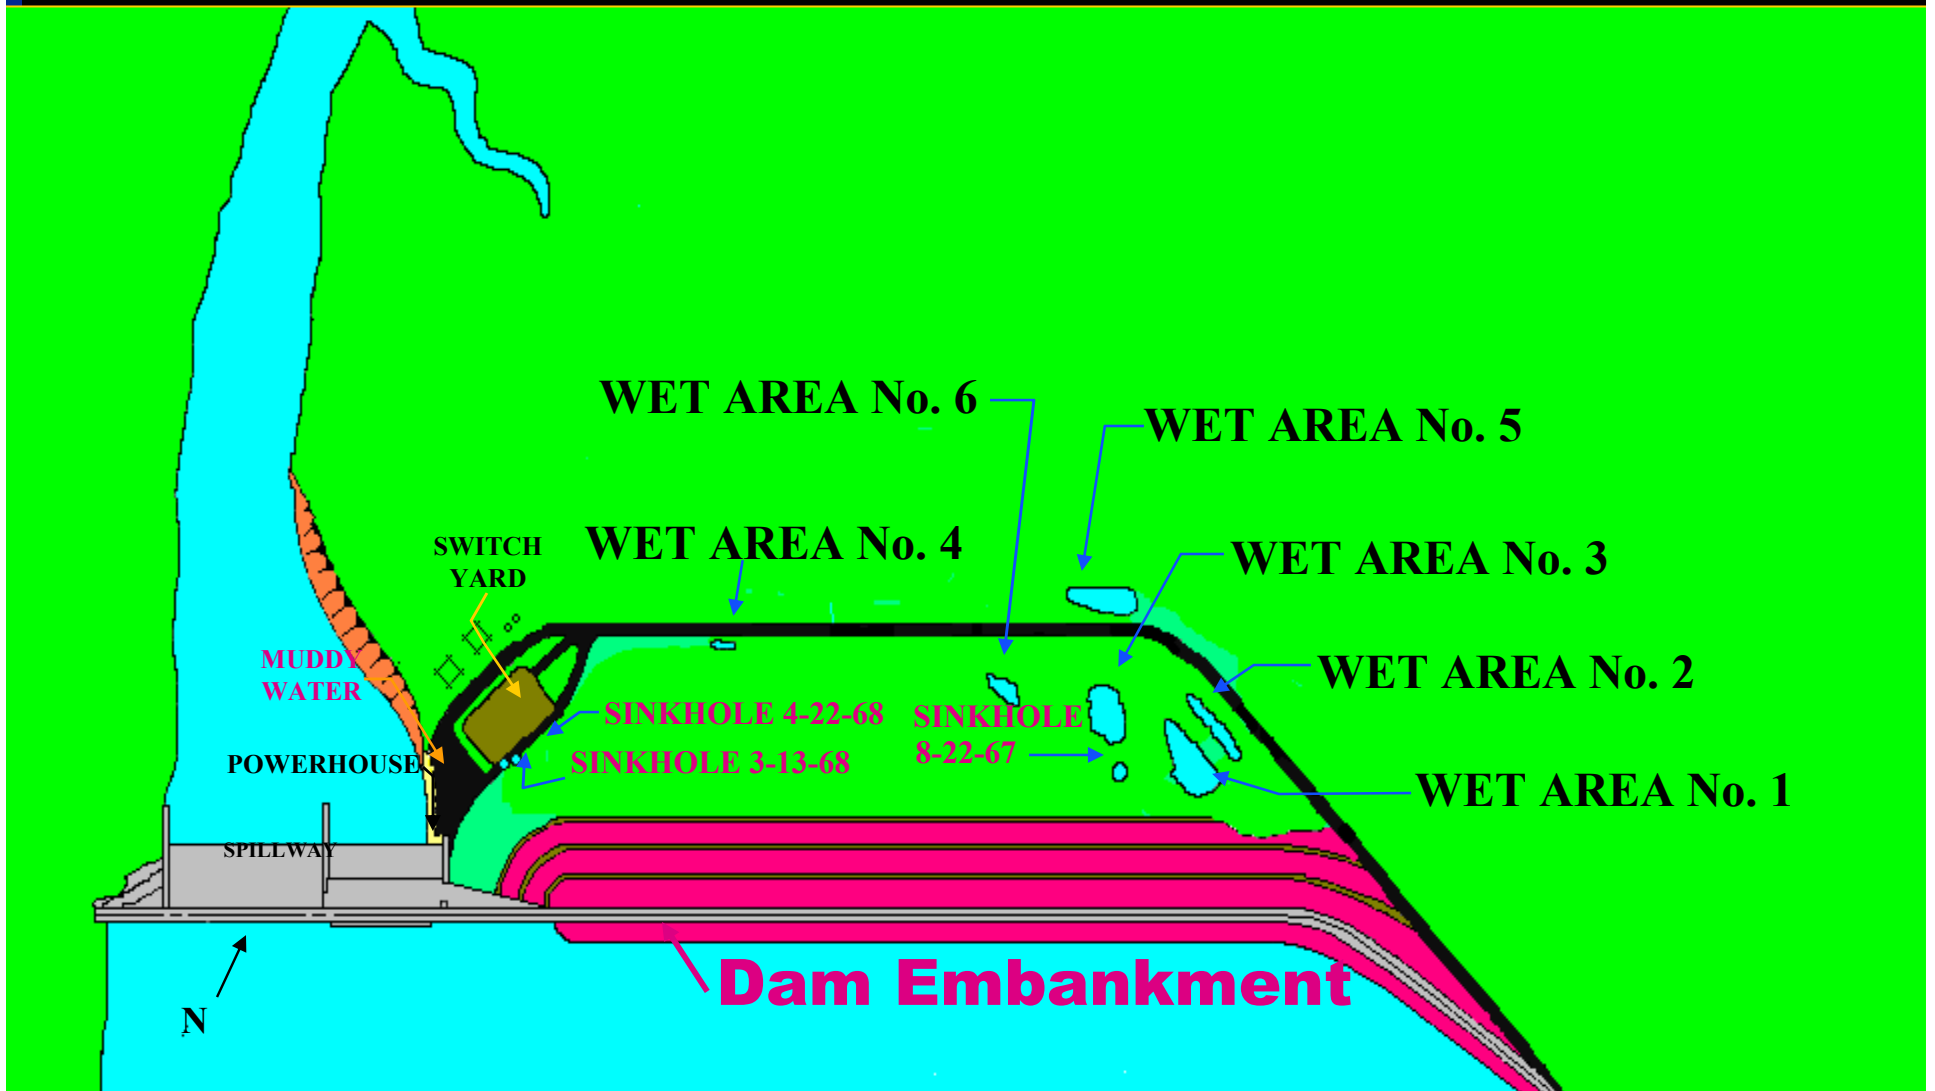
1968 Sinkhole

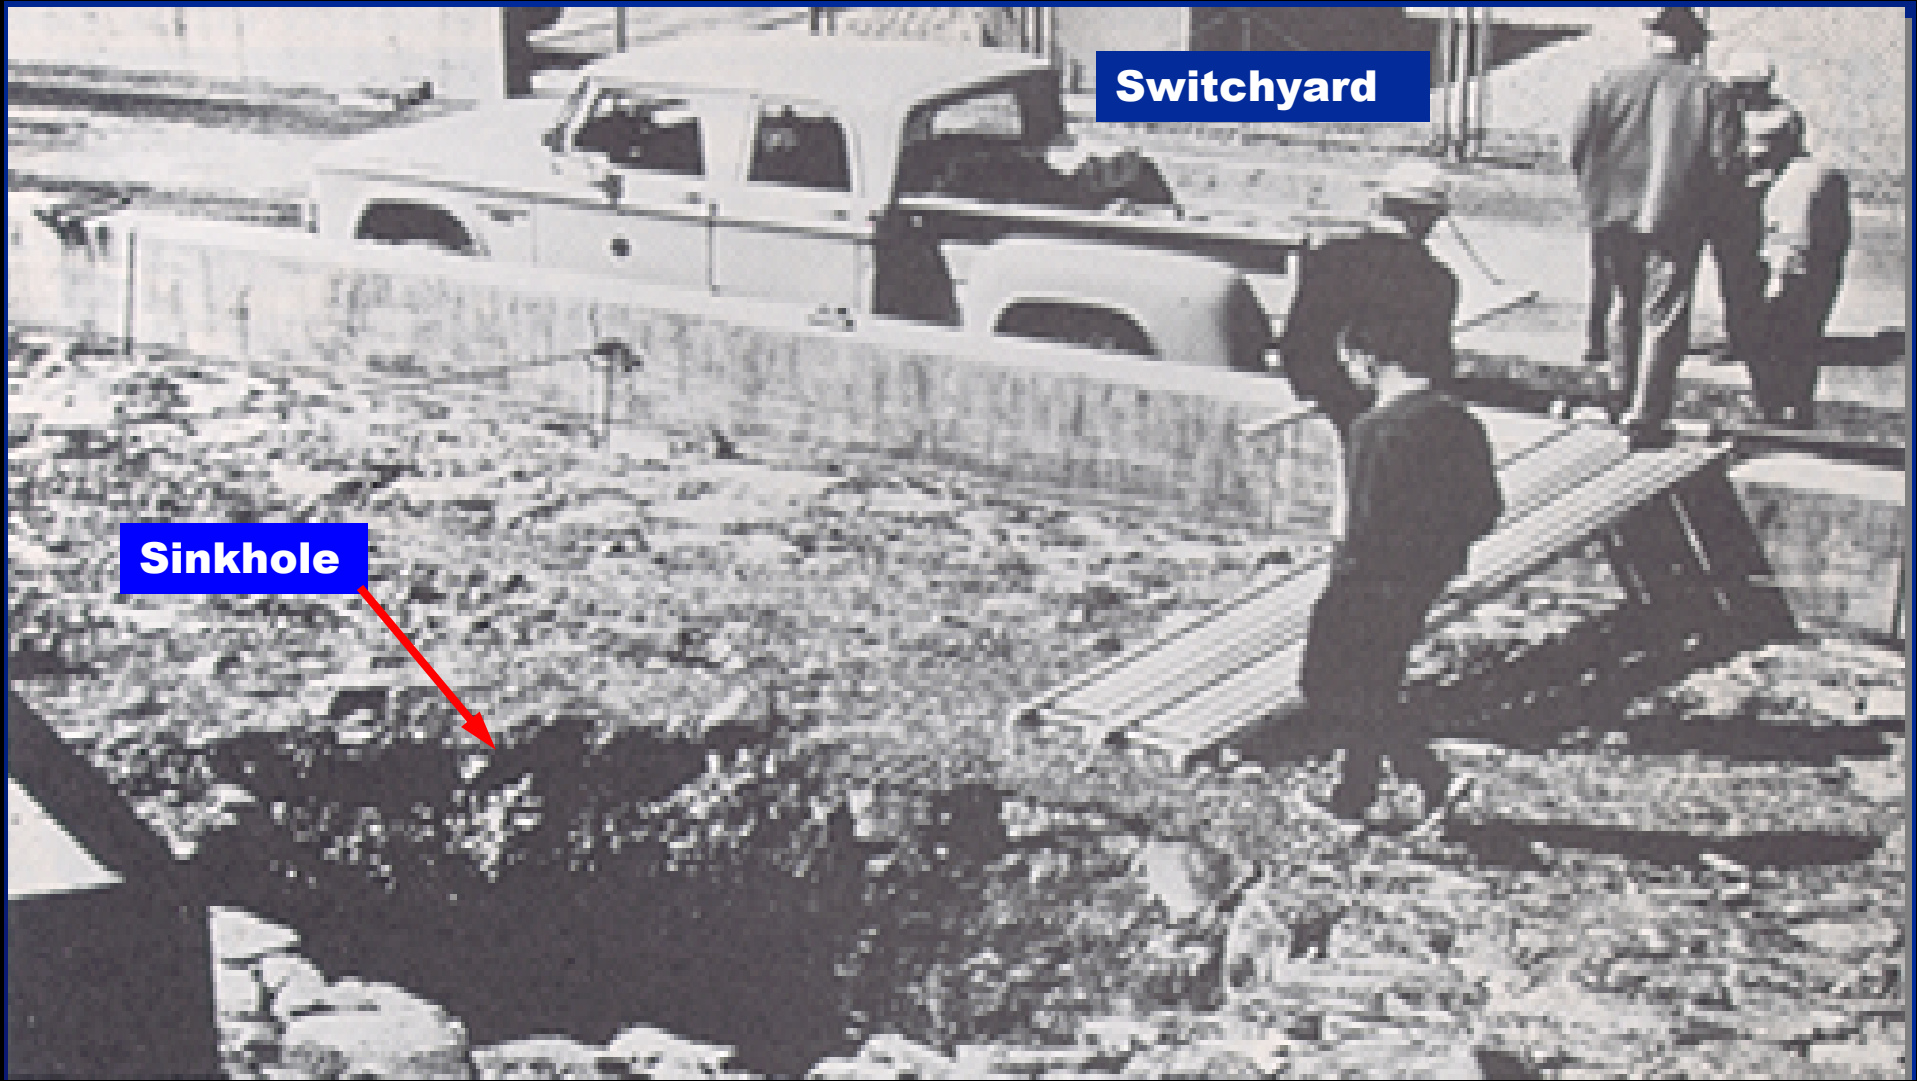
Sinkhole

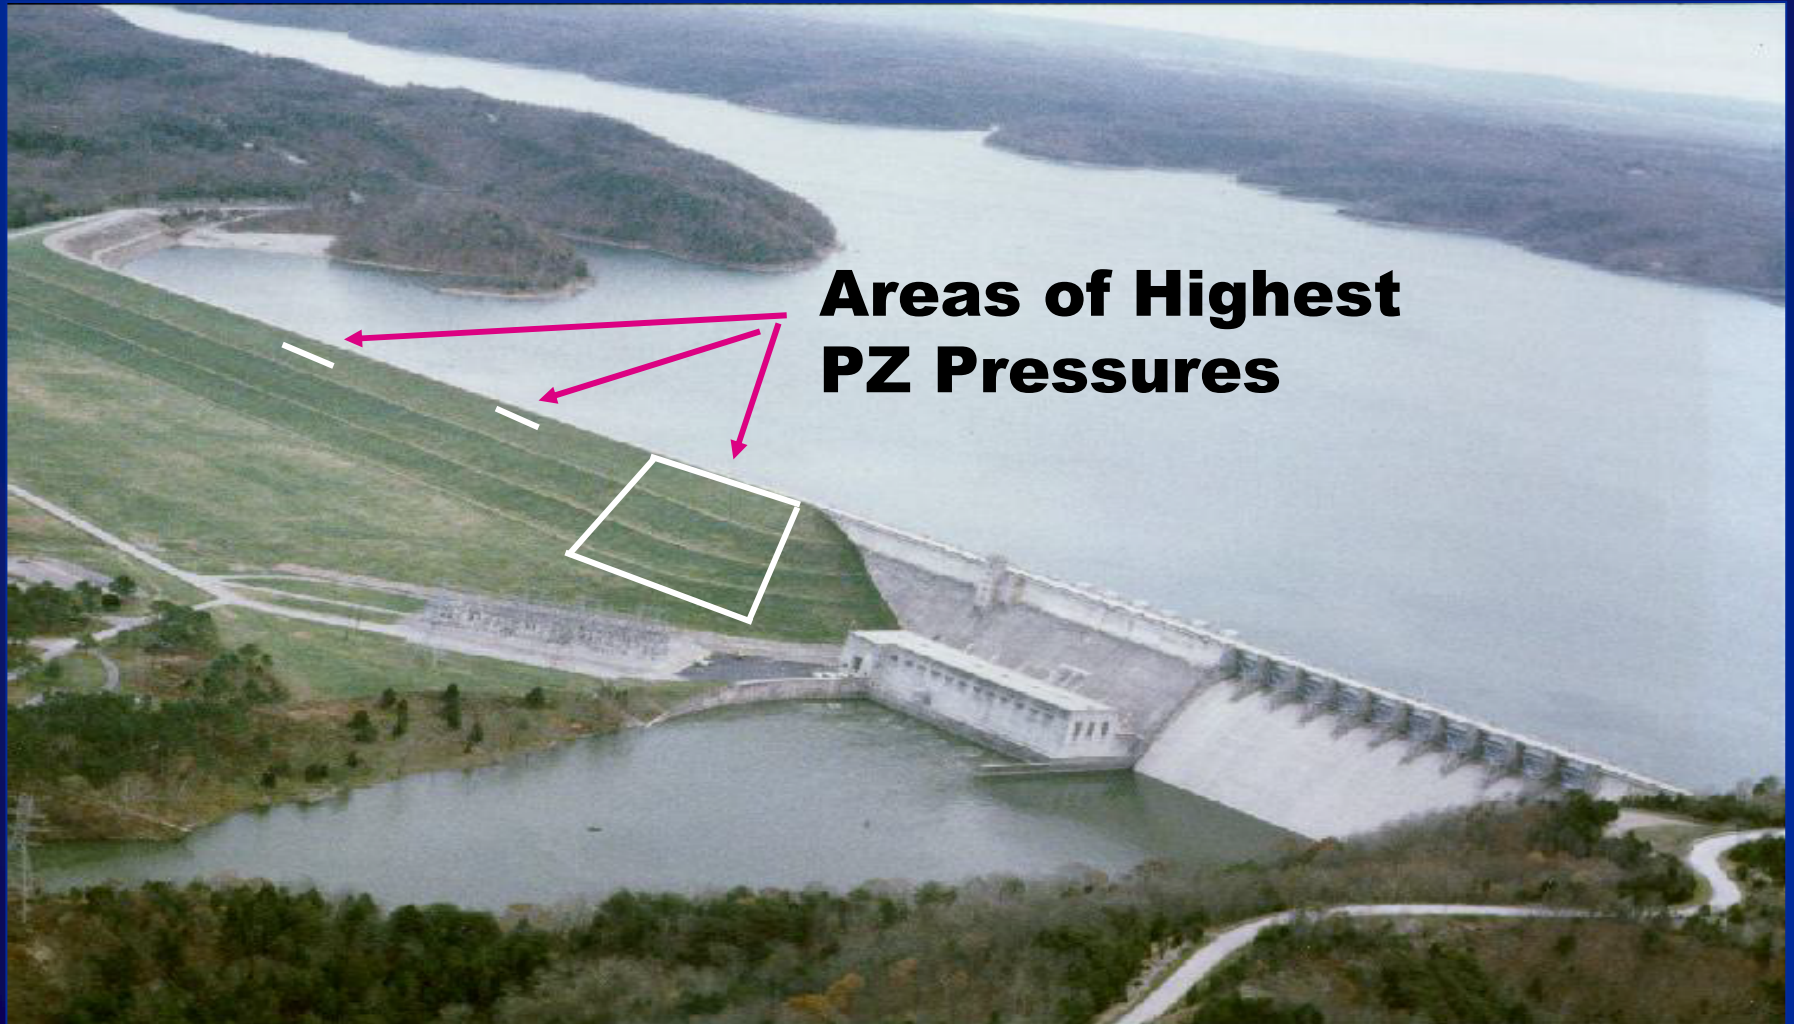
**Areas of Highest
PZ Pressures**

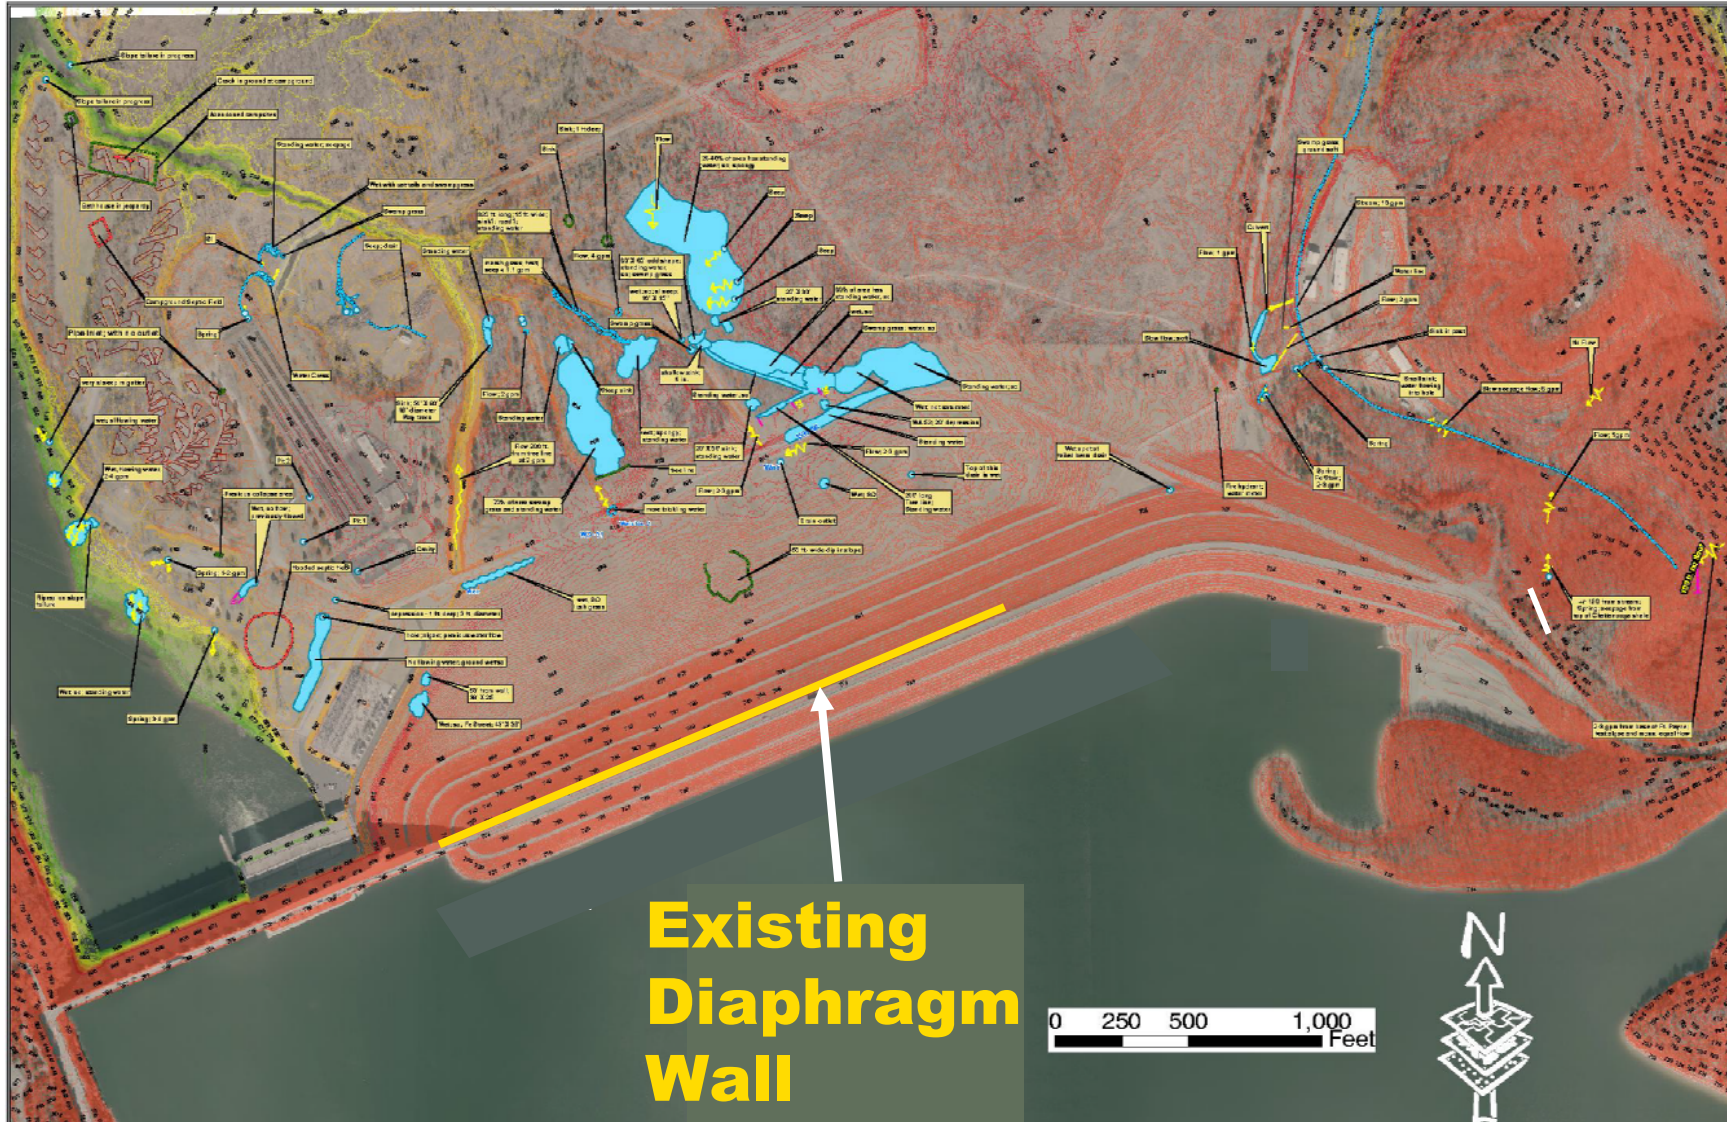
Post Wall Performance – Wet Areas
