US Army Corps  
of Engineers  
Portland District

# Status of HSS Inspections in The Portland District

## 2005 Infrastructures Conference

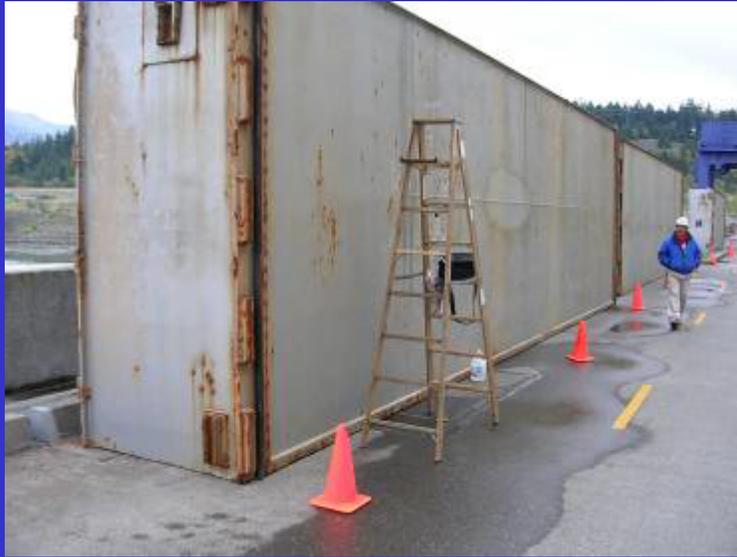
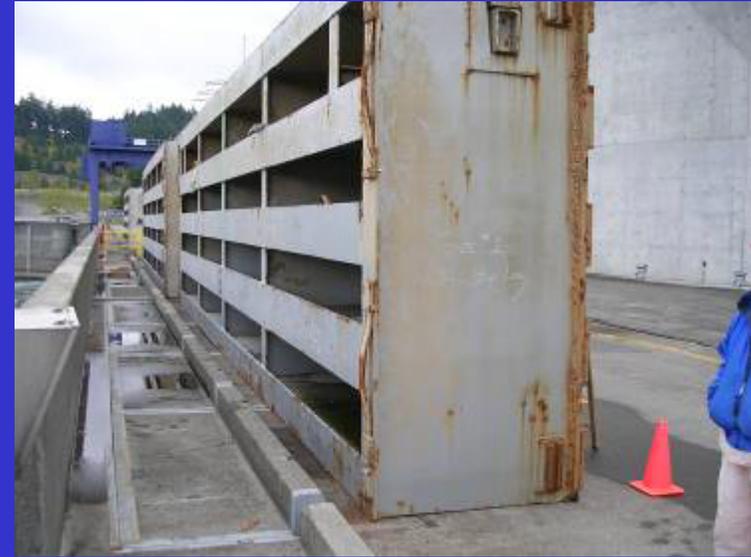
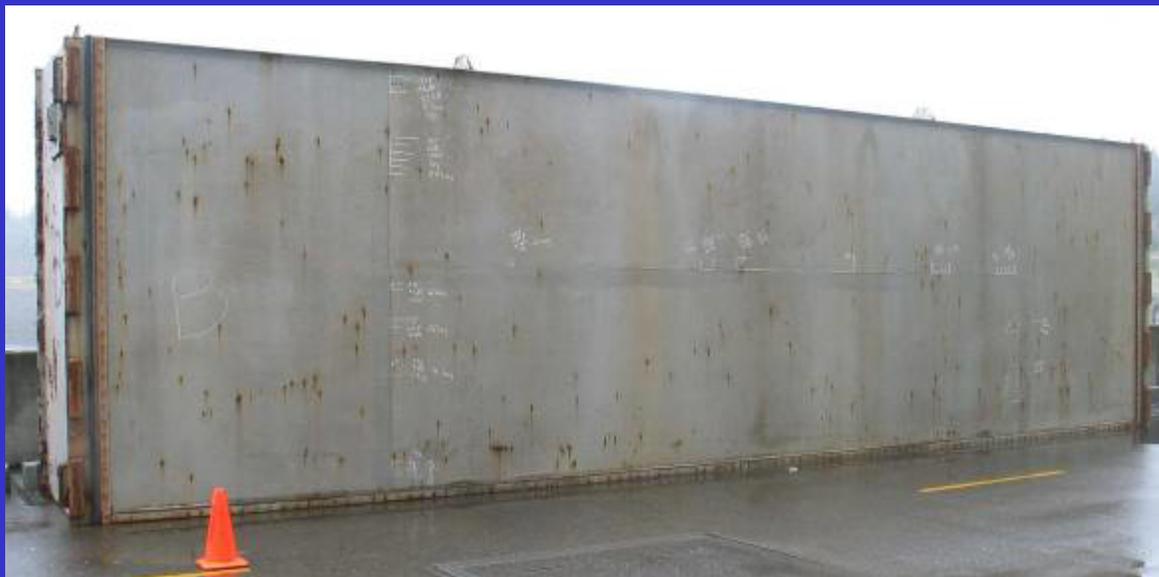
Bonneville Main Unit Taillogs: fabricated in the 1980's— UT flaws in fracture critical CJP tension splices in skin plate – 12 stoplogs removed from service.

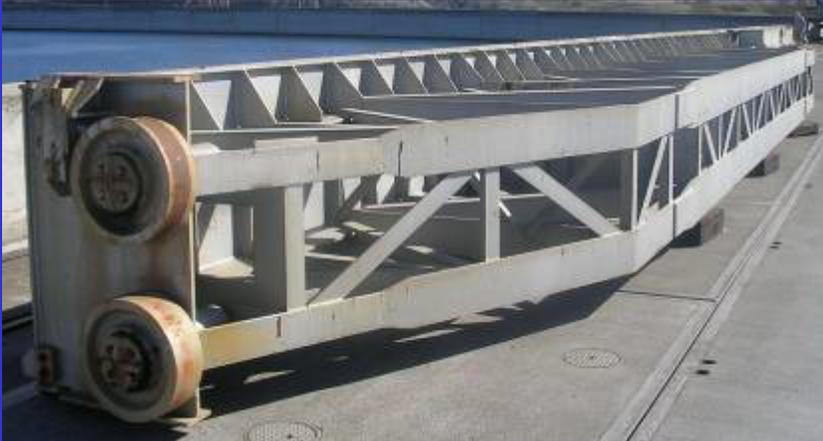
The Dalles Spillway Stoplogs – fabricated in the 1960's. Fracture critical truss structure with 24 CJP tension splices. 323 failed connections out of 481 tested. 67% failure rate

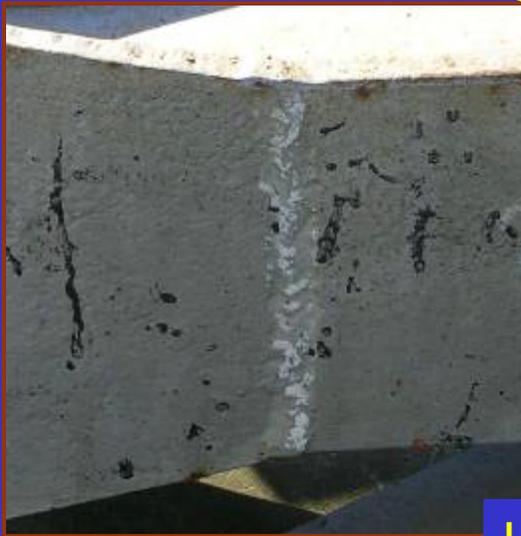
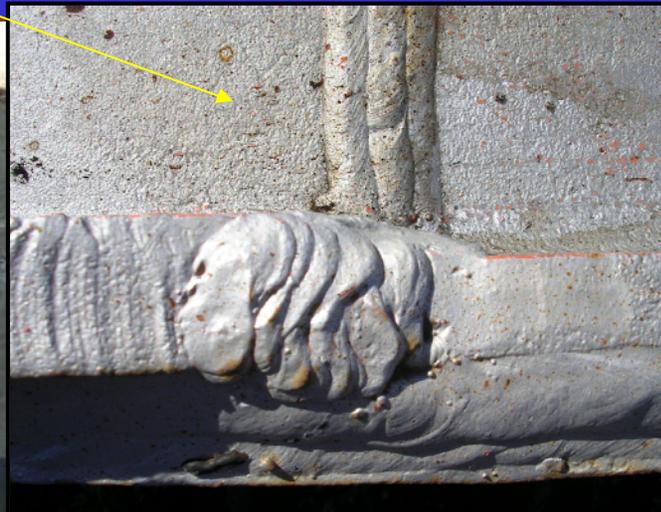
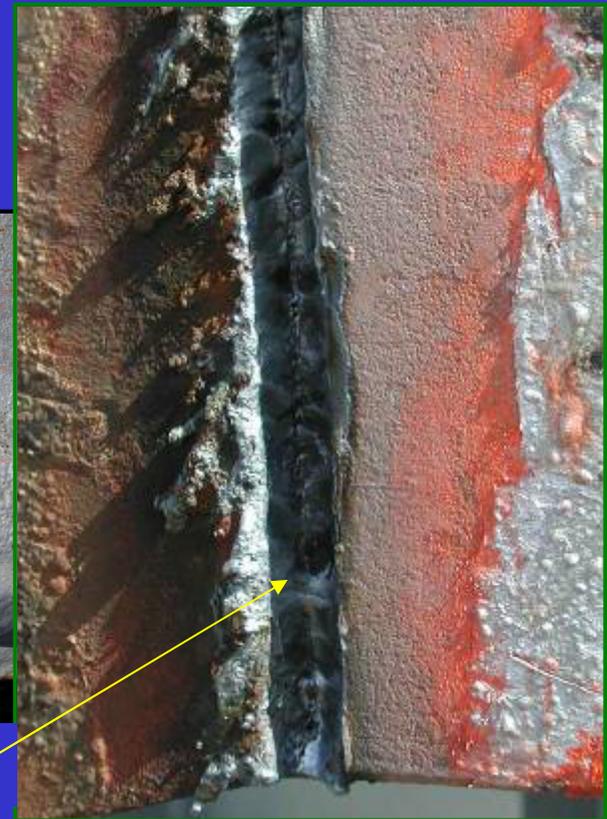
3/8" Plate      1 1/2" Wide Weld

UT Flaw at Root Arced Out

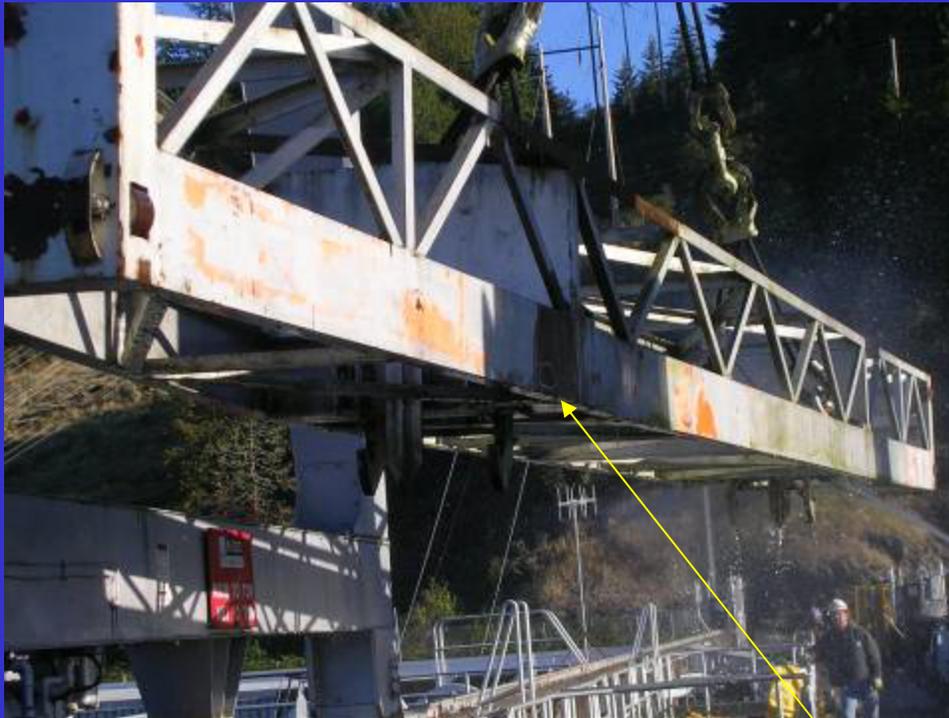
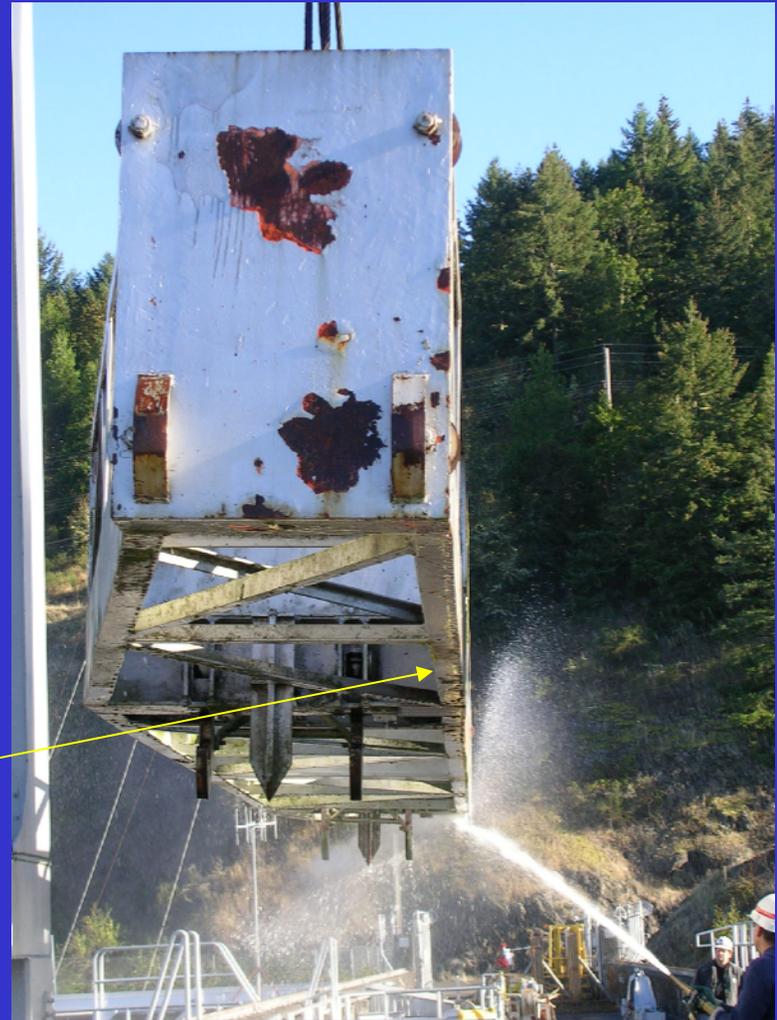
Brazed Splice

Dexter Spillway Stoplog Lifting Beam - missing hooks, failed UT, brazed splices, etc.

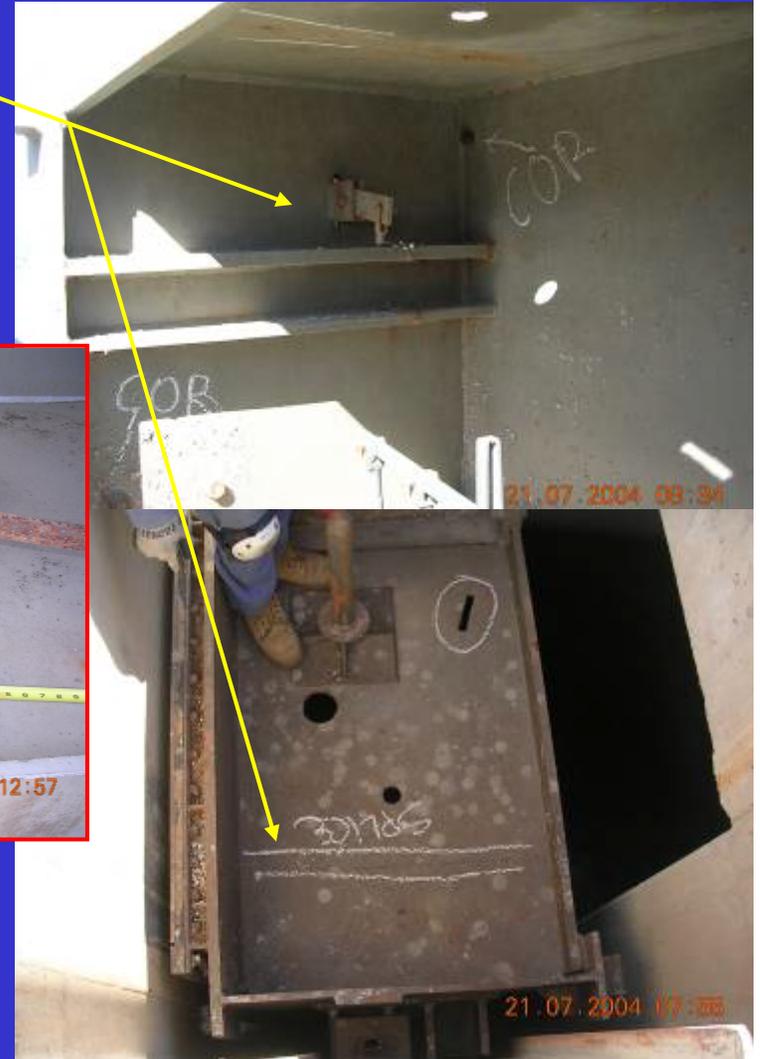
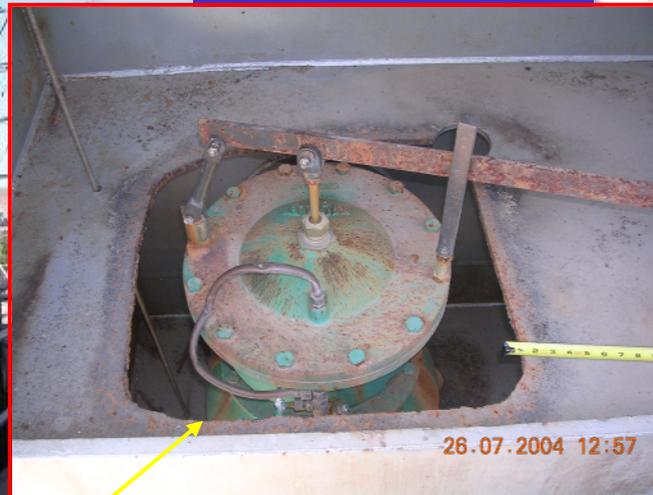
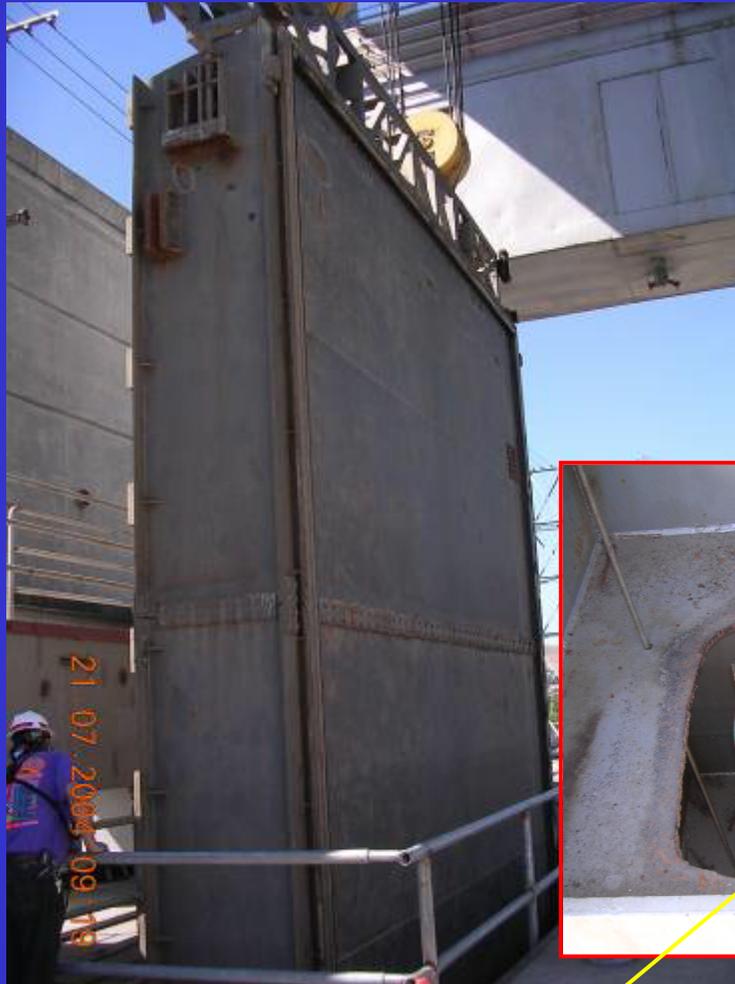
The Dalles Intake Bulkhead – Spliced back together after being dropped in the 1980's.

Splice  
Through One  
Side of  
Bulkhead

Girder Cut Out Directly  
Below Splice

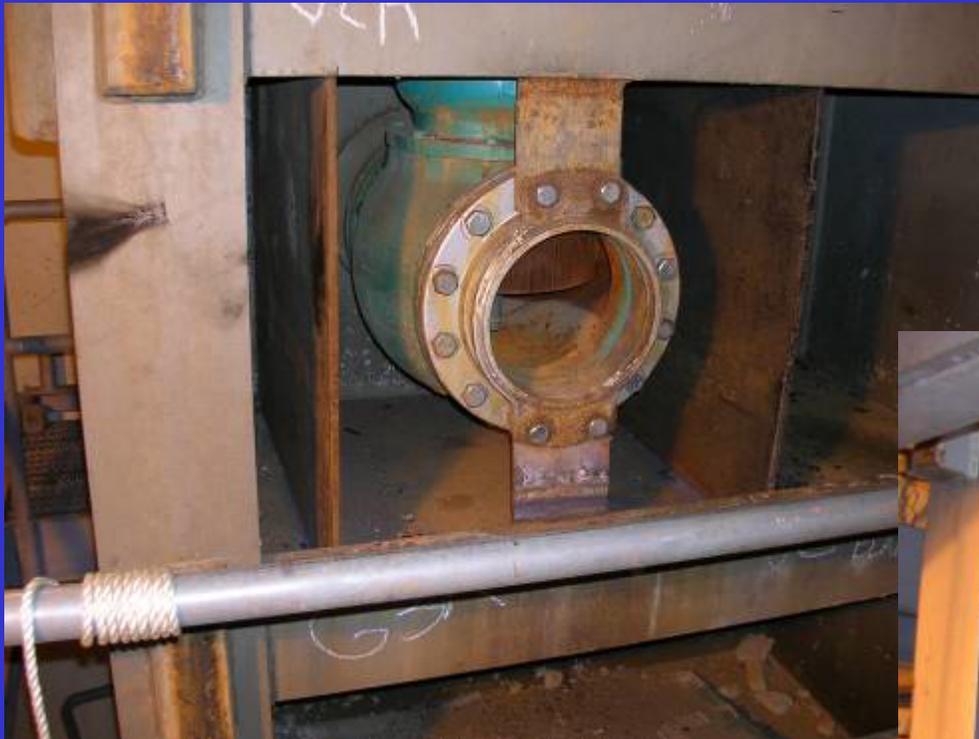
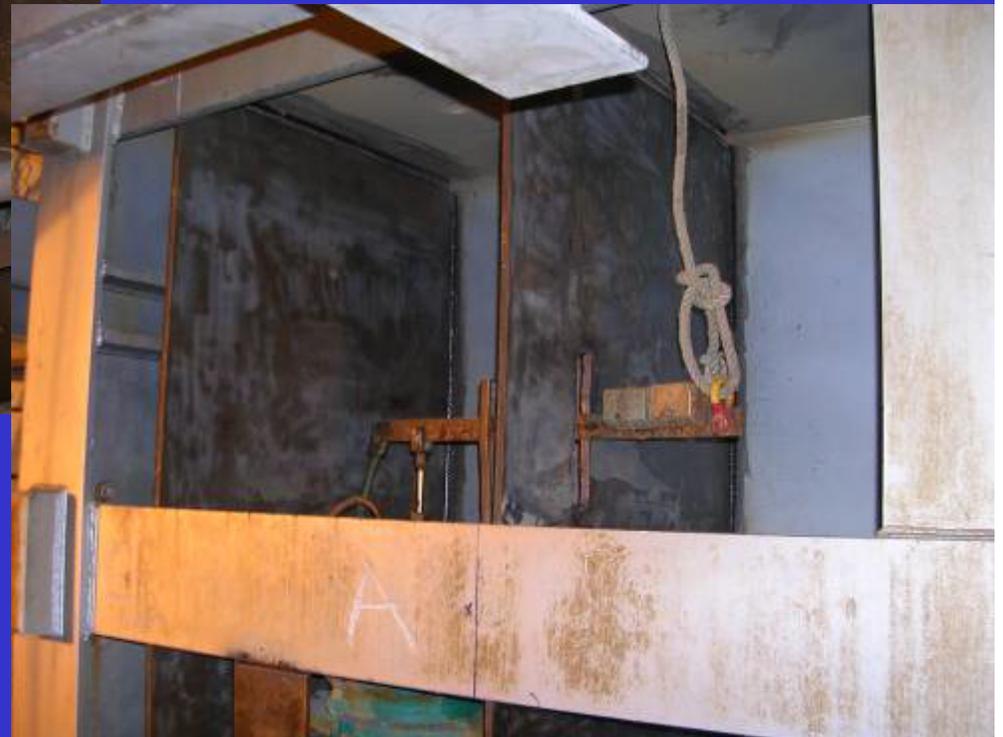
The Dalles Intake Bulkhead – Repaired.

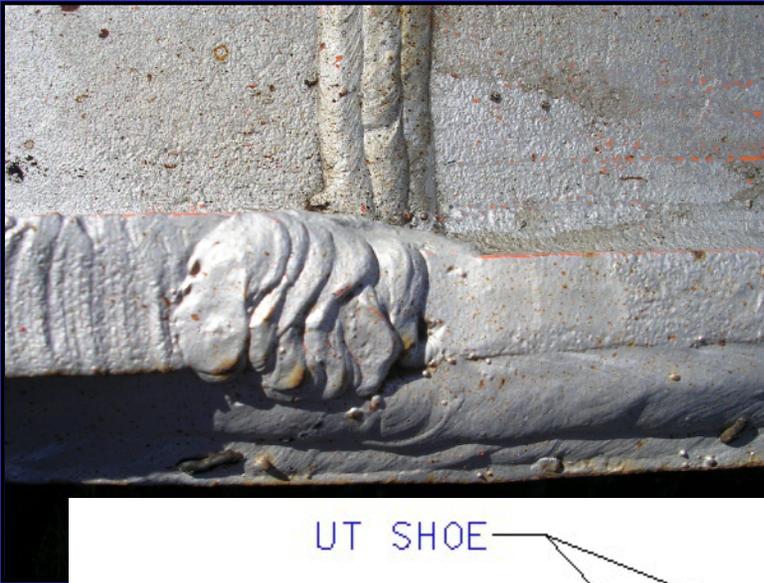
The Dalles Spillway Stoplogs – Fracture critical connections that can not be fully UT'd due to joint configuration.

First leg indications can not be found without grinding the welds flush.

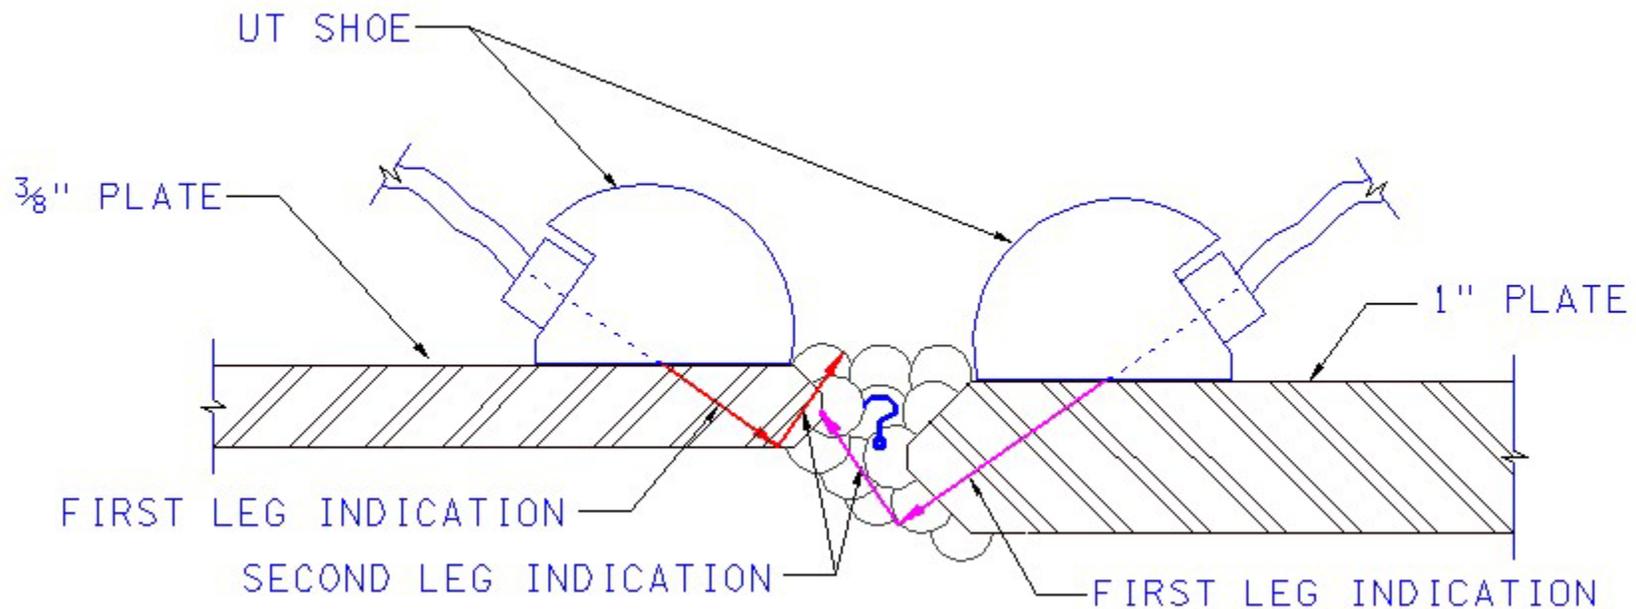
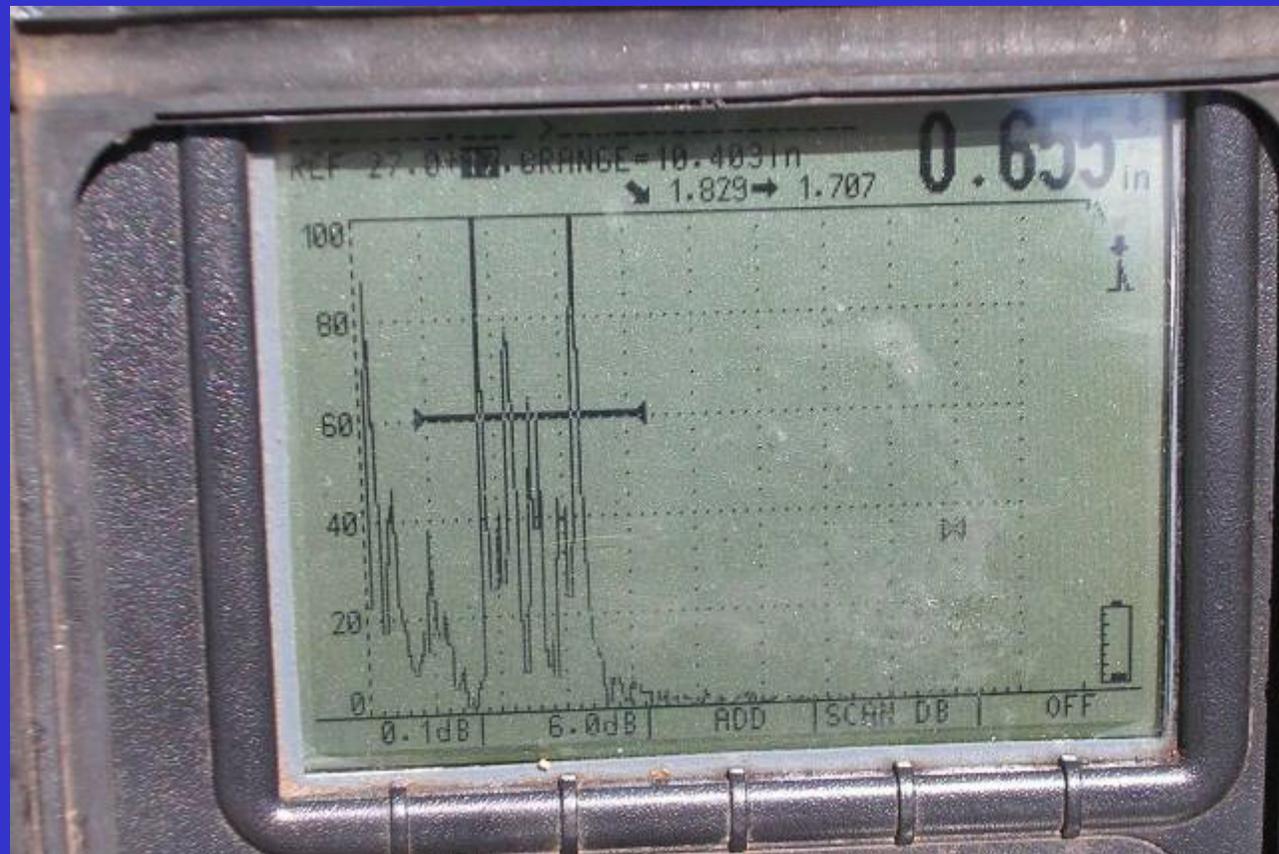
The Dalles Spillway Stoplogs – UT Screen Shot.

First leg indications cannot be found without grinding the welds flush.

CJP double bevel groove weld In tension – subjected to a 4 dB penalty – rejection at +2 dB or less – so each of these signals at +6 dB is rejectable.

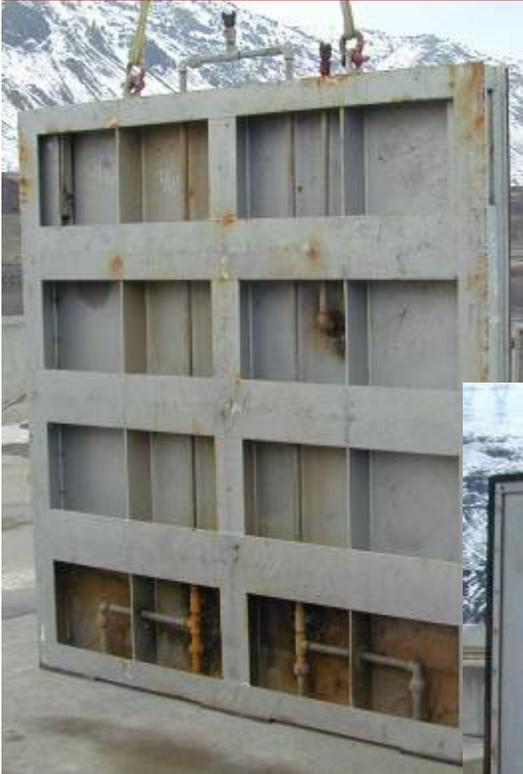
Air lines for  
cleaning the  
sill

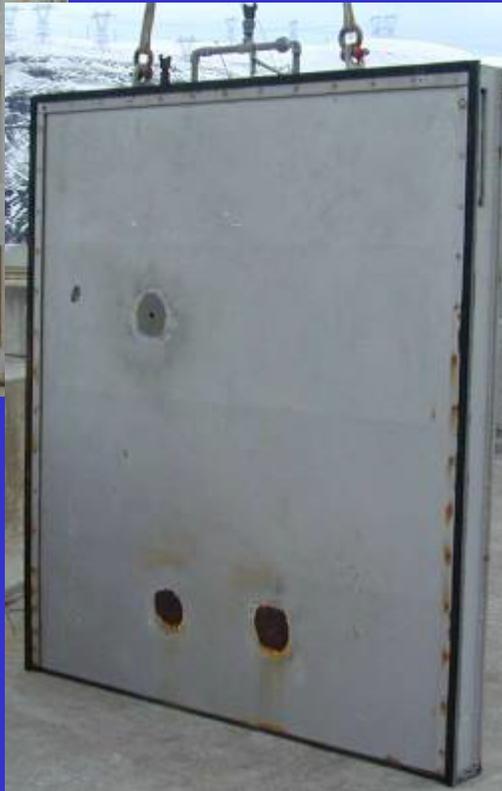
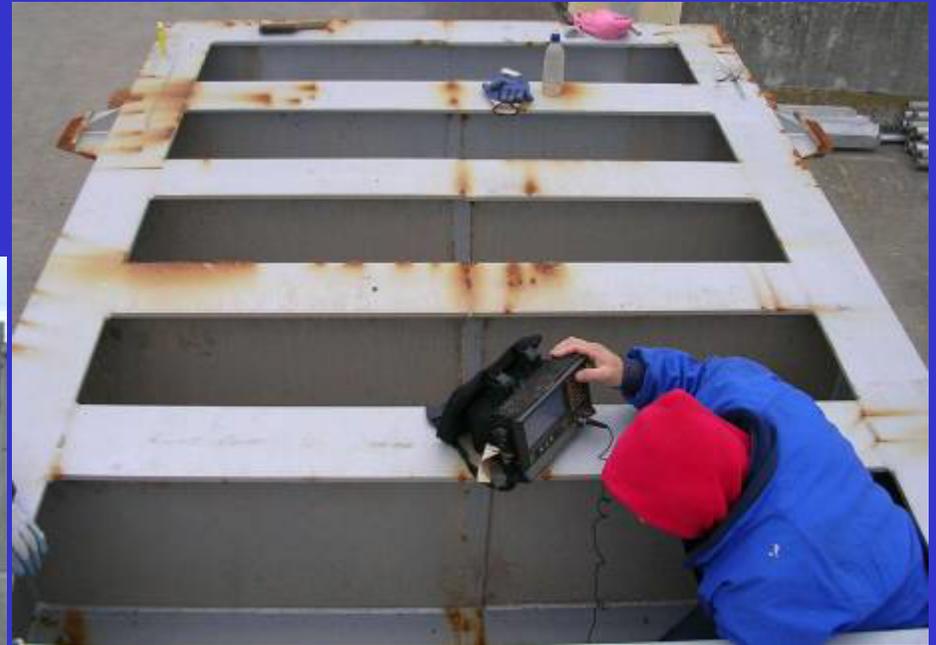
The fastest way to get a  
narrower gate
