#### Mel Price – Auxiliary Lock Downstream Miter Gate Repair

## Mel Price Accident 3 October 2004

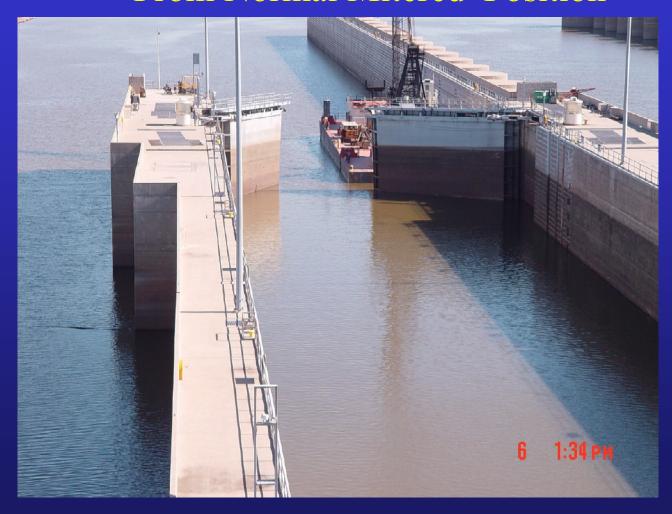
#### Gate Leafs Forced Downstream From Normal Mitered Position

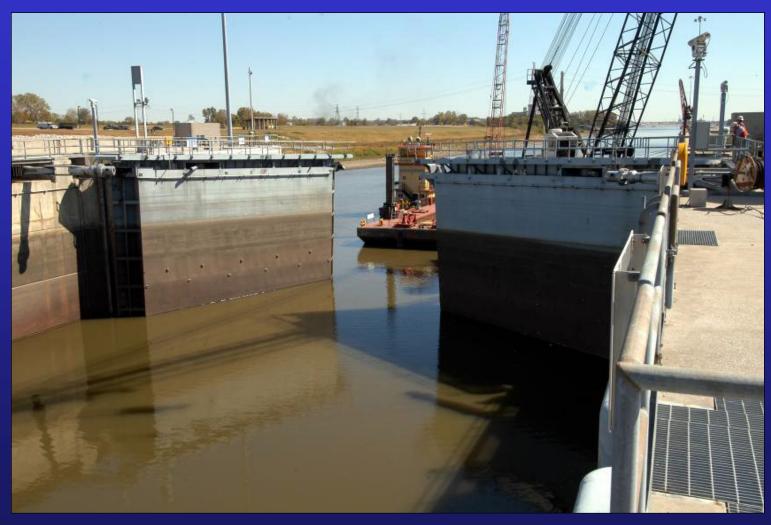
#### Gate Leafs Forced Downstream From Normal Mitered Position

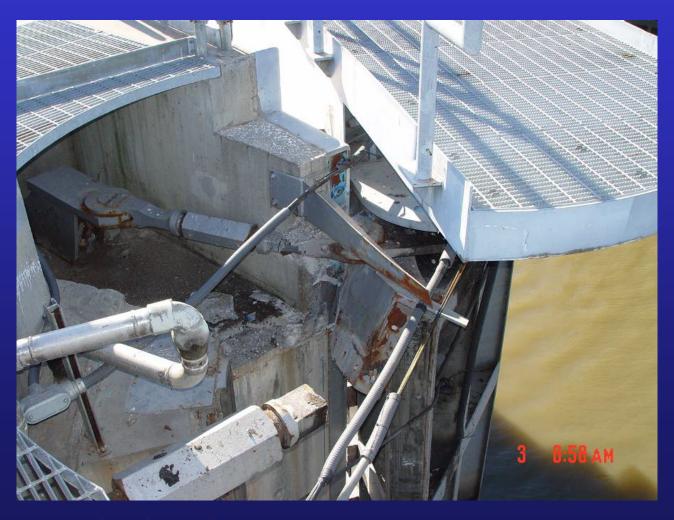
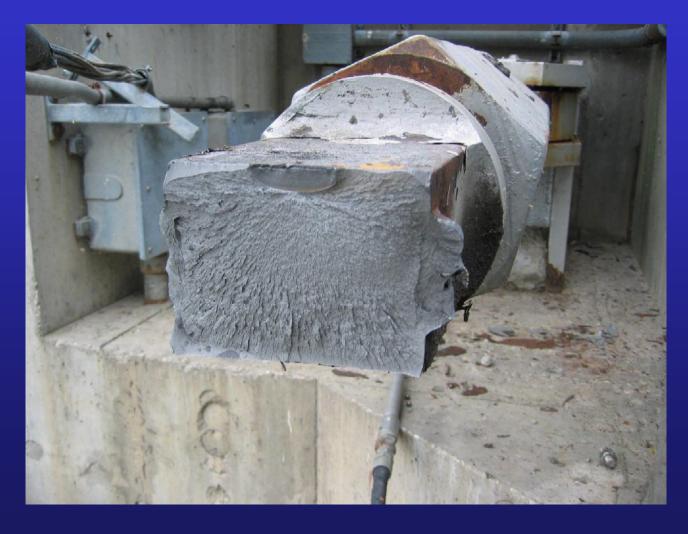
## Damage to Gate Anchorages

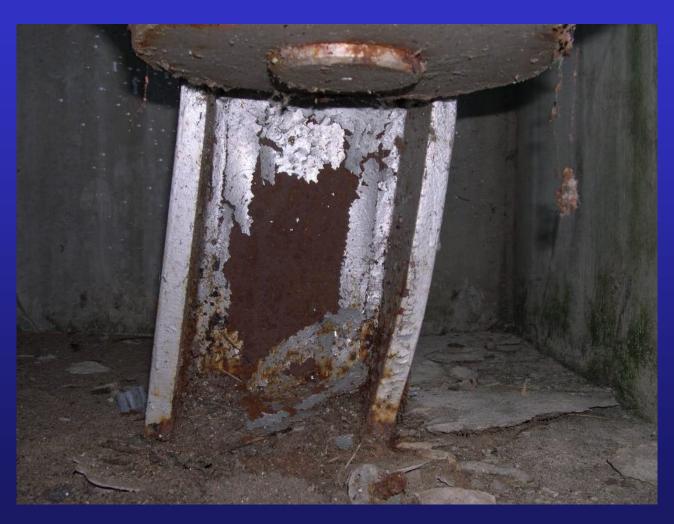
## Damage to Gate Anchorages

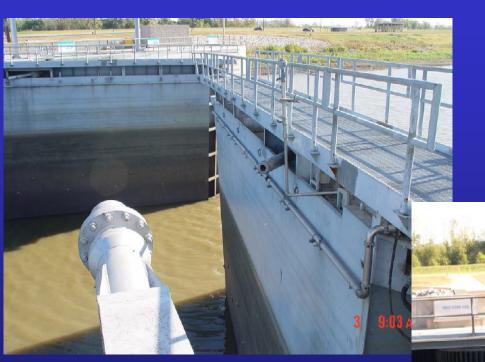
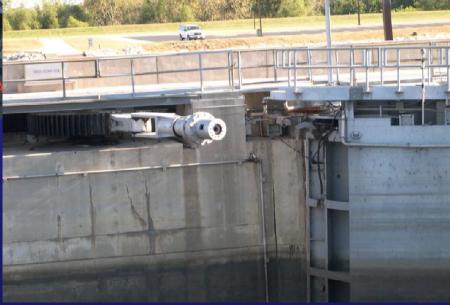
## Failed Operating Struts

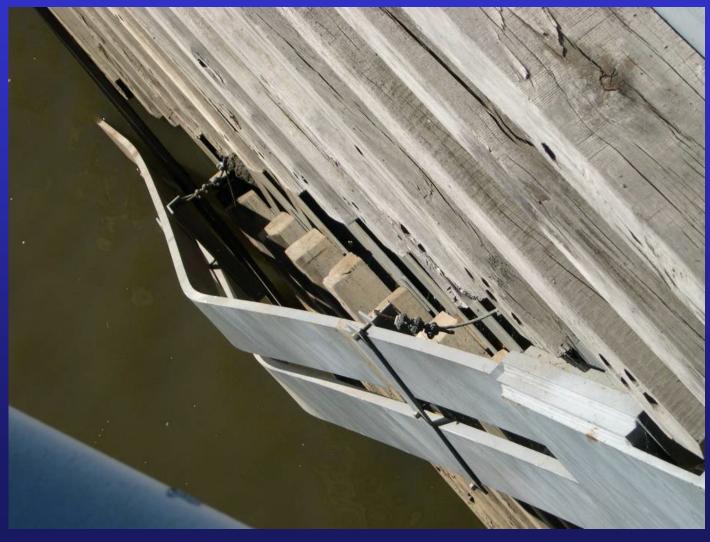
## Diagonal Failure

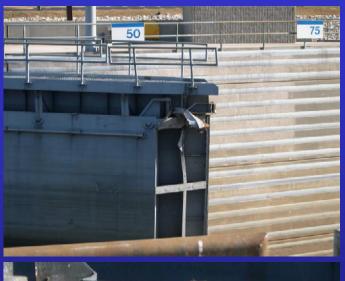
## Damage to Miter End of Leafs

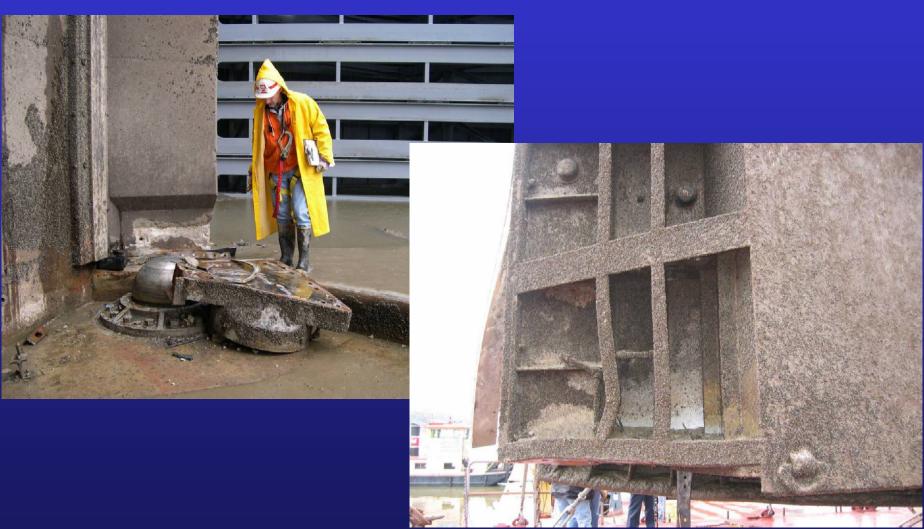
#### Pintle Socket Sheared Off

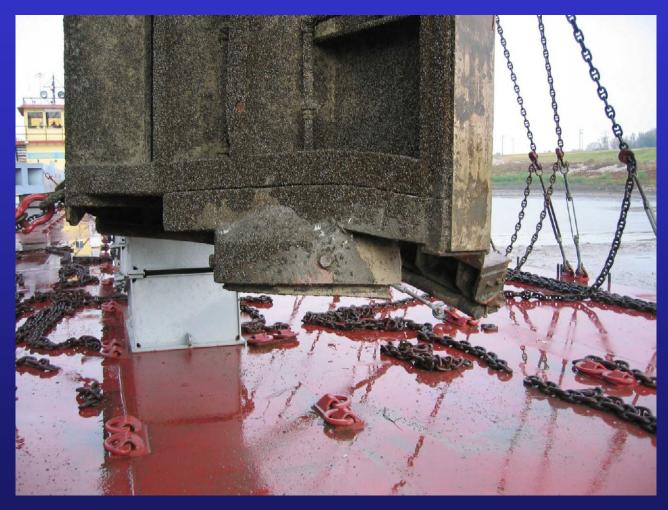
#### Bent & Cracked Pintle Socket

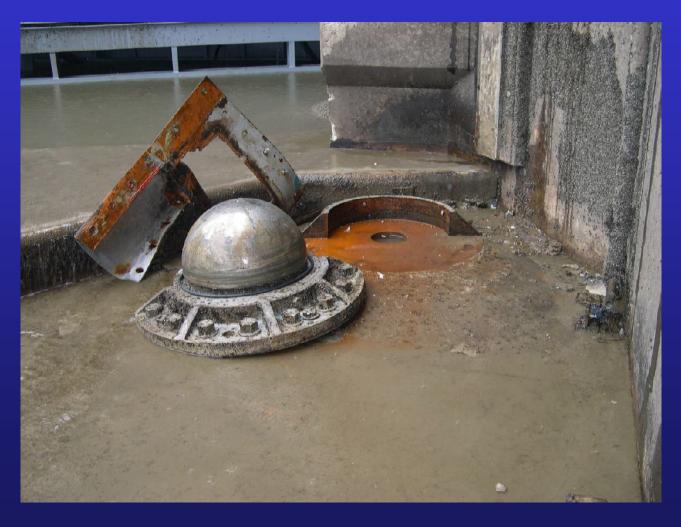
#### Pintle Ball Retainer Sheared Off

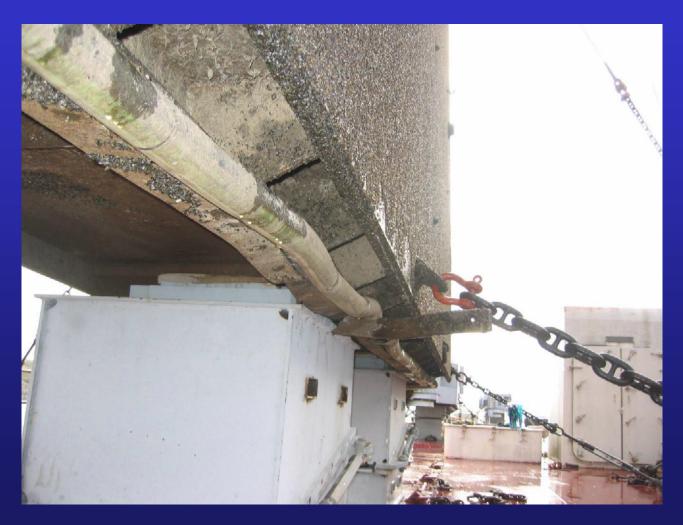
#### Bottom Seal Damaged

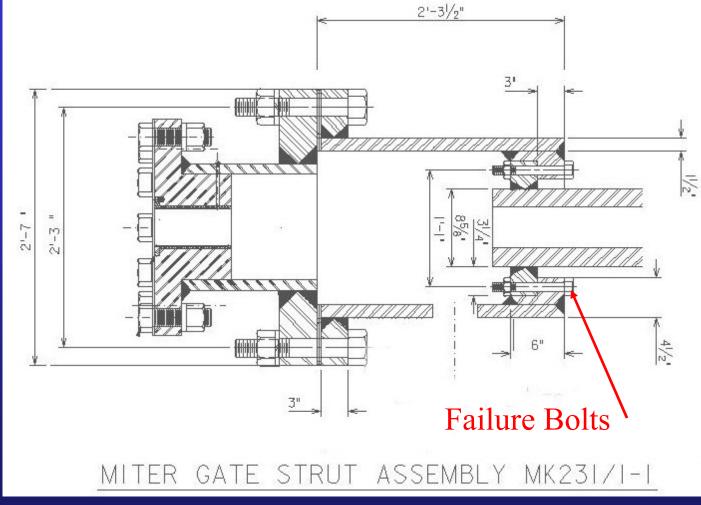
## Operating Arm Failure Tube

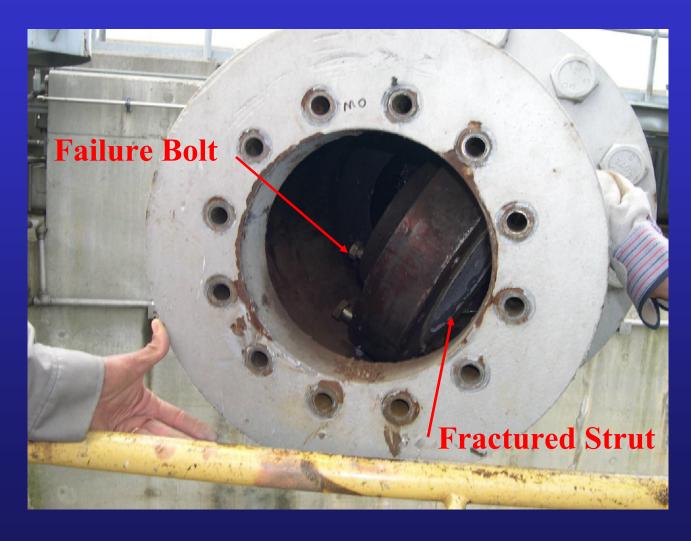
#### Failure Tube

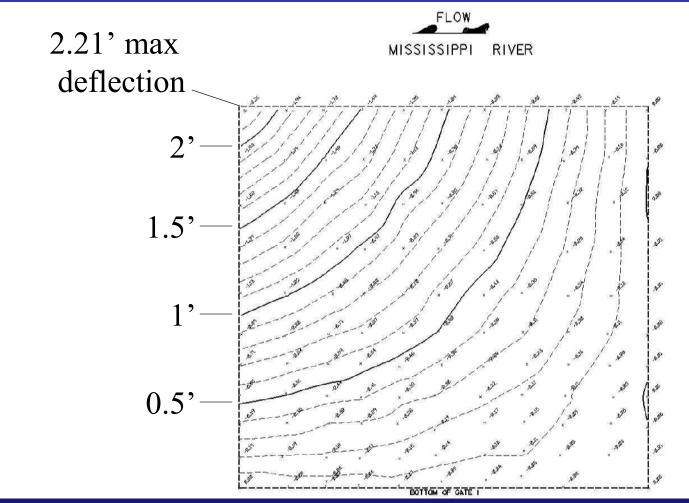
### Survey Results – Illinois Leaf

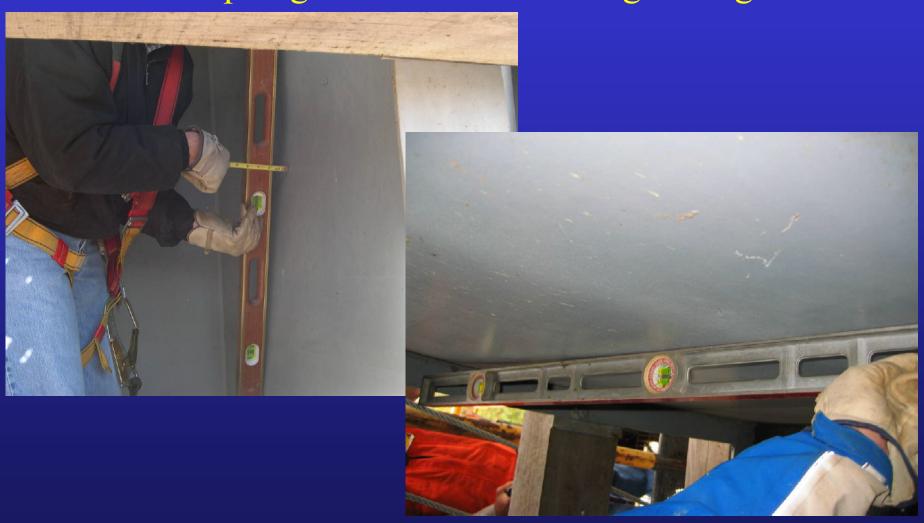
#### Diaphragms Before Heat Straightening
