J.T. Myers Dam Major Rehab

John T. Myers Dam Rehab

Major Areas of Concern for J.T. Myers Dam

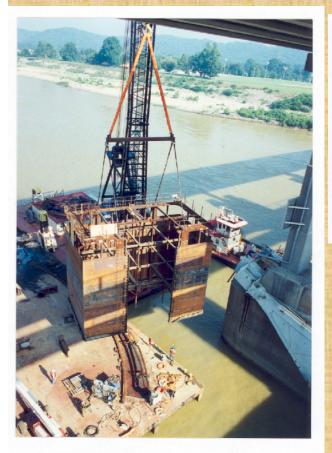
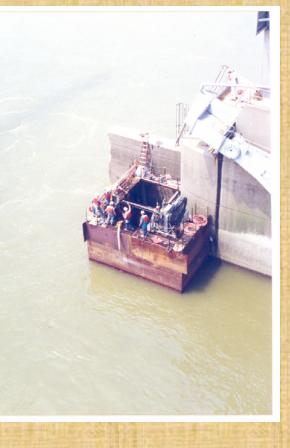
Temporary dewatering box built by LRS to make limited scour repairs around piers at the Markland Project.

Only allows for limited area of damage to be repaired. Not applicable for many other sites and types of erosion damage

Must be site adapted which is too costly and would not cover necessary areas

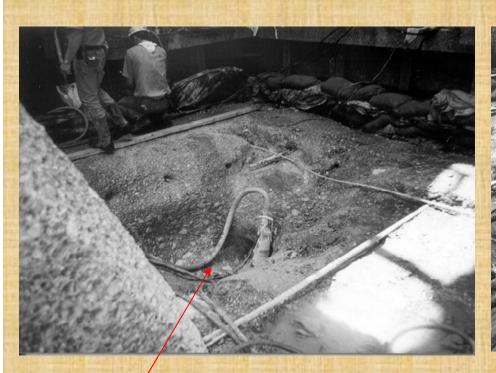
Note depth of scour hole around pier

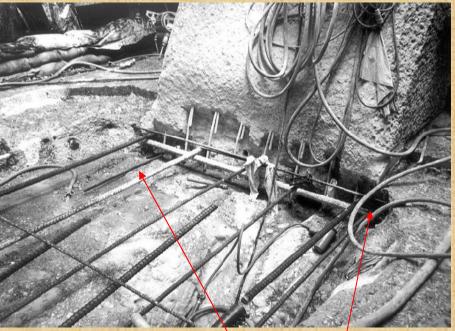
Note scour below baffle block & stilling $\xrightarrow{}$ Basin floor interface, exposed rebar, limits of scour hole

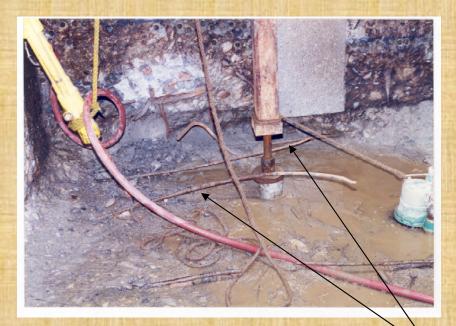
Note close-up of damage of exposed and worn rebar in scour hole prior to repairs

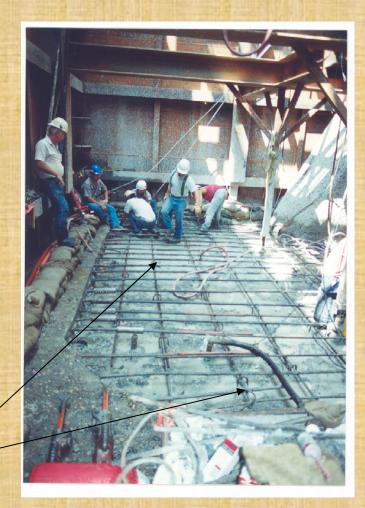
Limits of scour hole and repair of missing and damaged rebar throughout entire area around nose pier

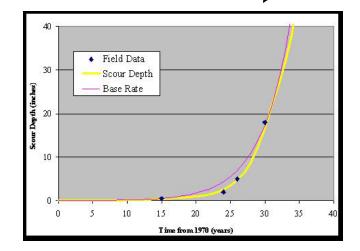
Deformation x50 ~18" Deep Scour Both Rebar Destroyed
