FATIGUE AND FRACTURE ASSESSMENT

JESSE STUART
HIGHWAY BRIDGE

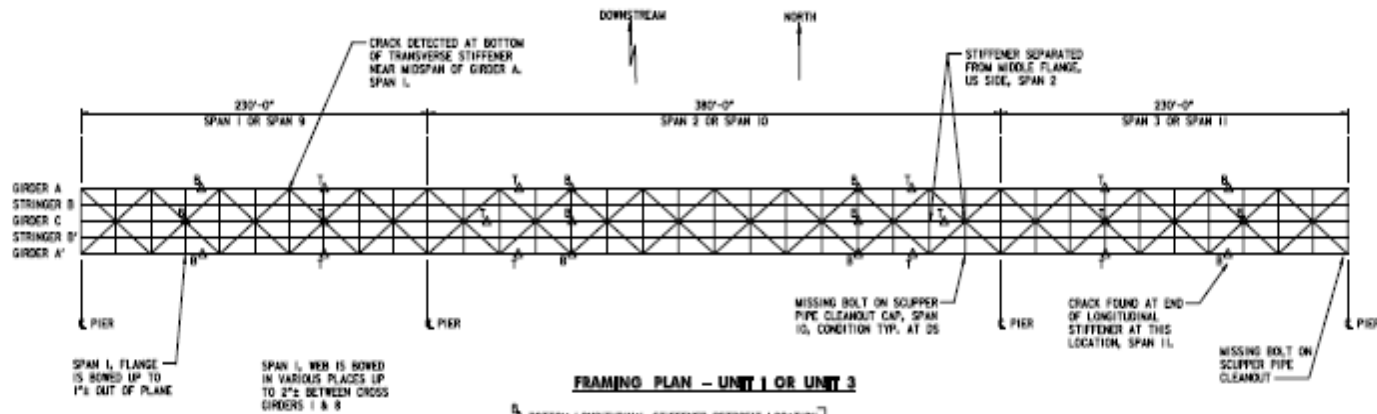
FRAMING PLAN - UNIT 1 OR UNIT 3

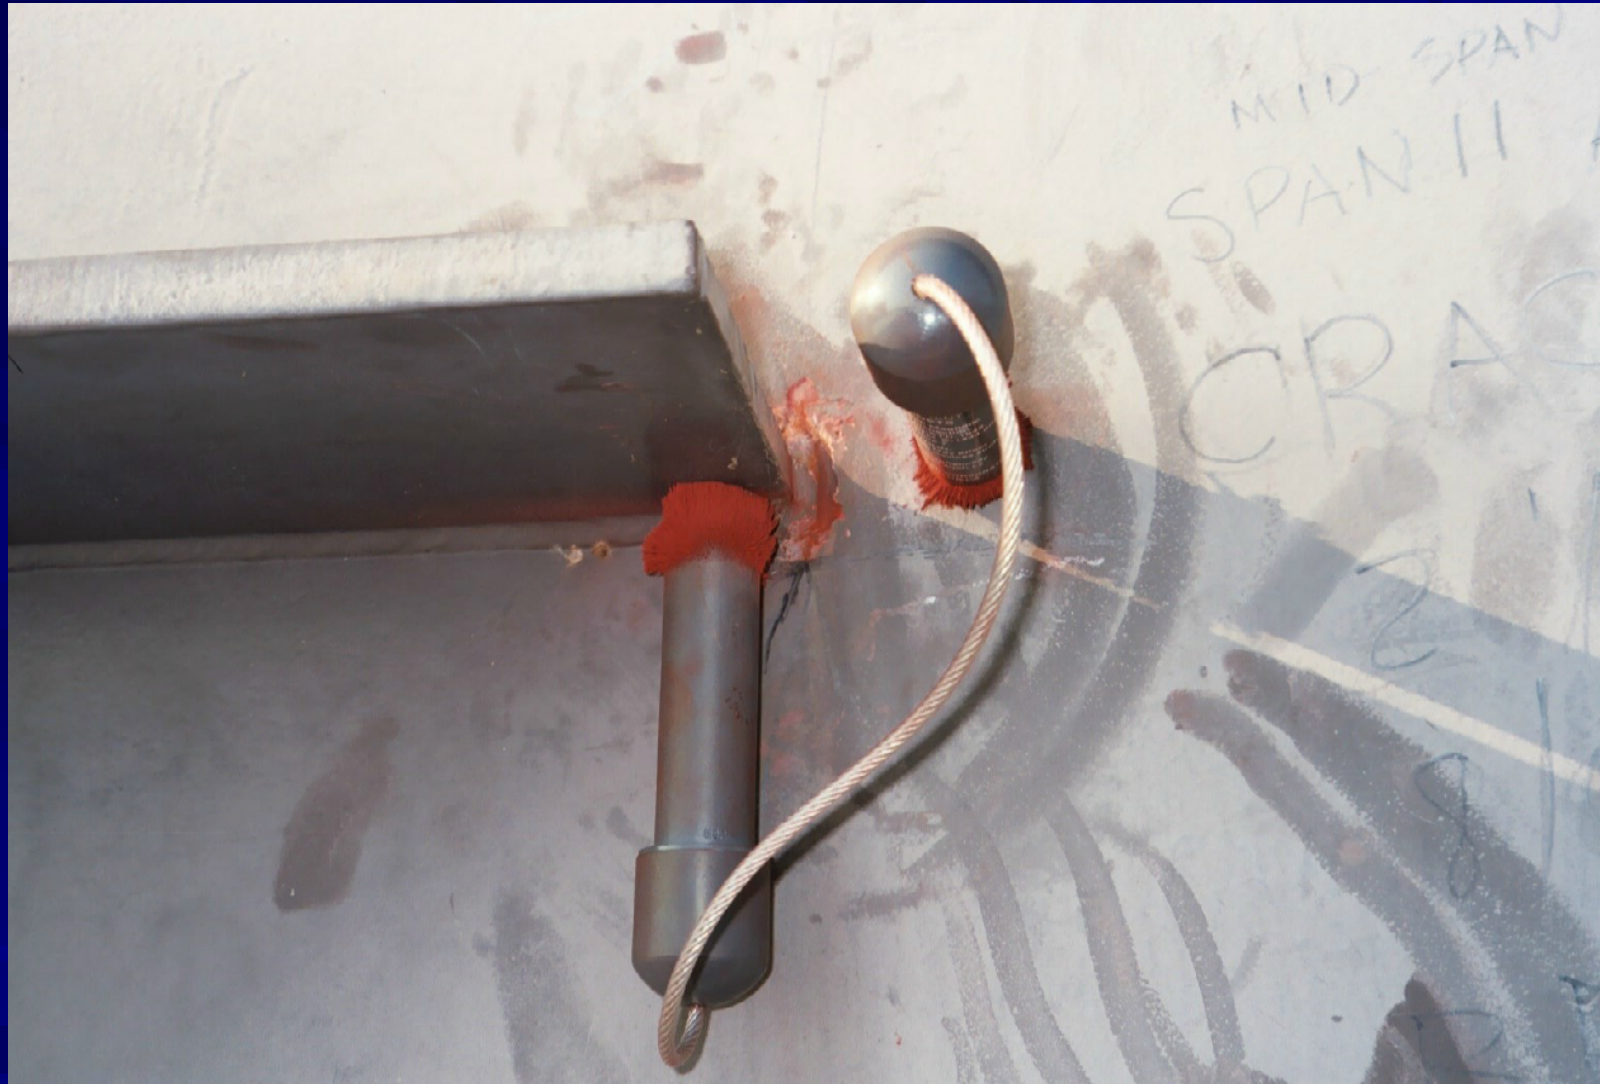
Crack at the Termination of the Longitudinal Web Stiffeners

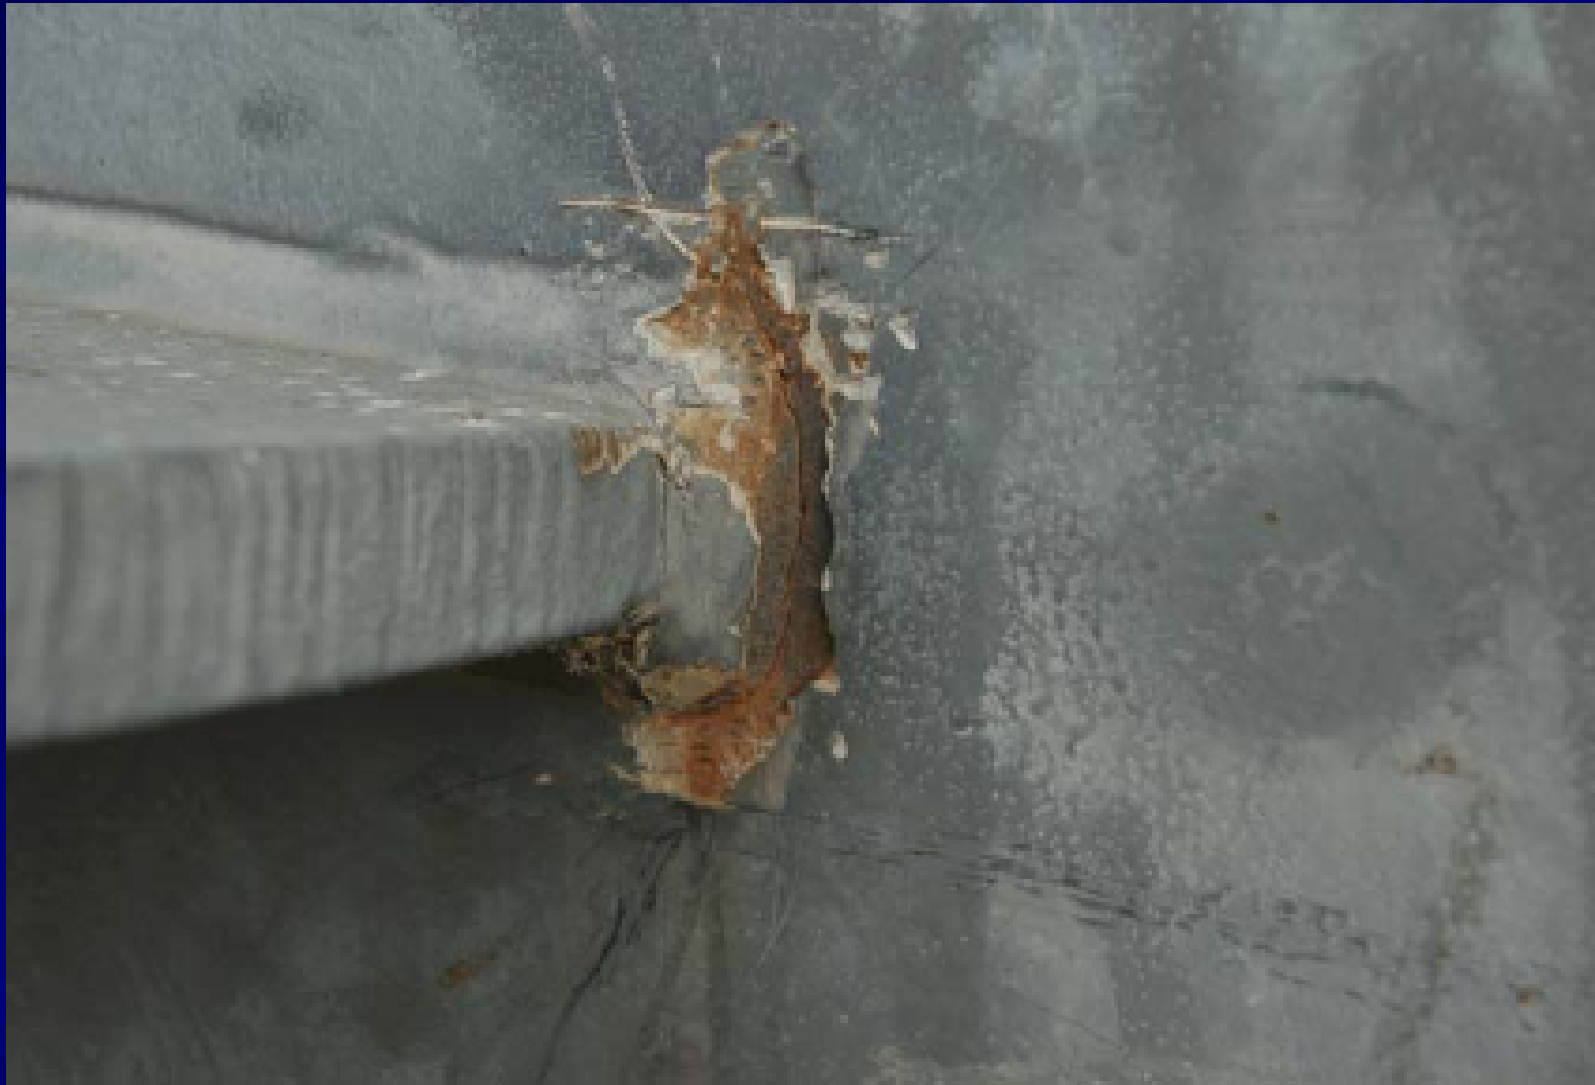
Close-up view of cracked longitudinal stiffener termination.

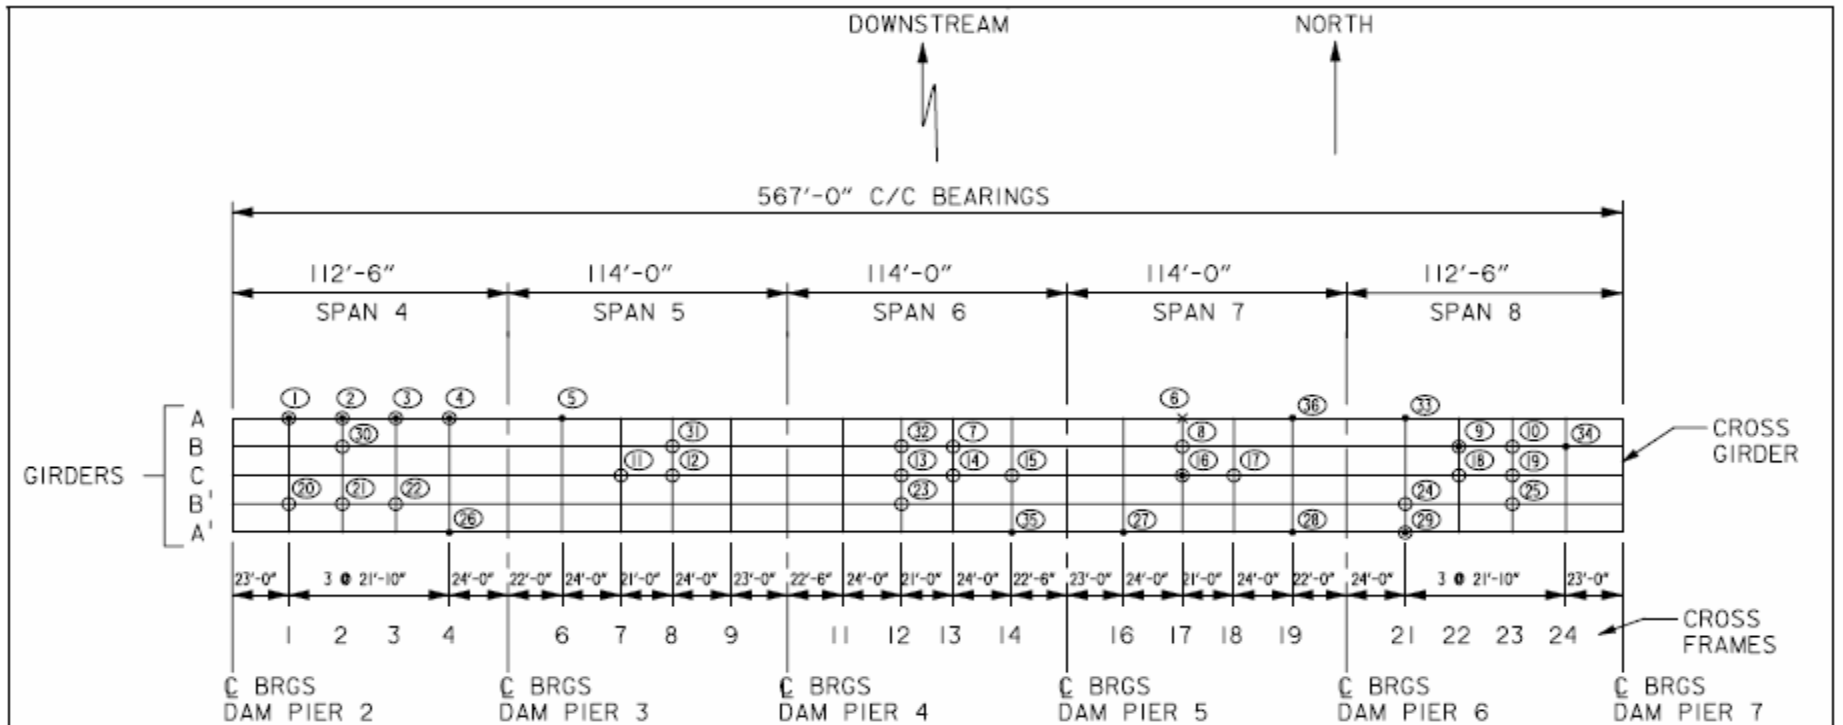
CRACK LOCATION PLAN (SUPERSTRUCTURE 2)

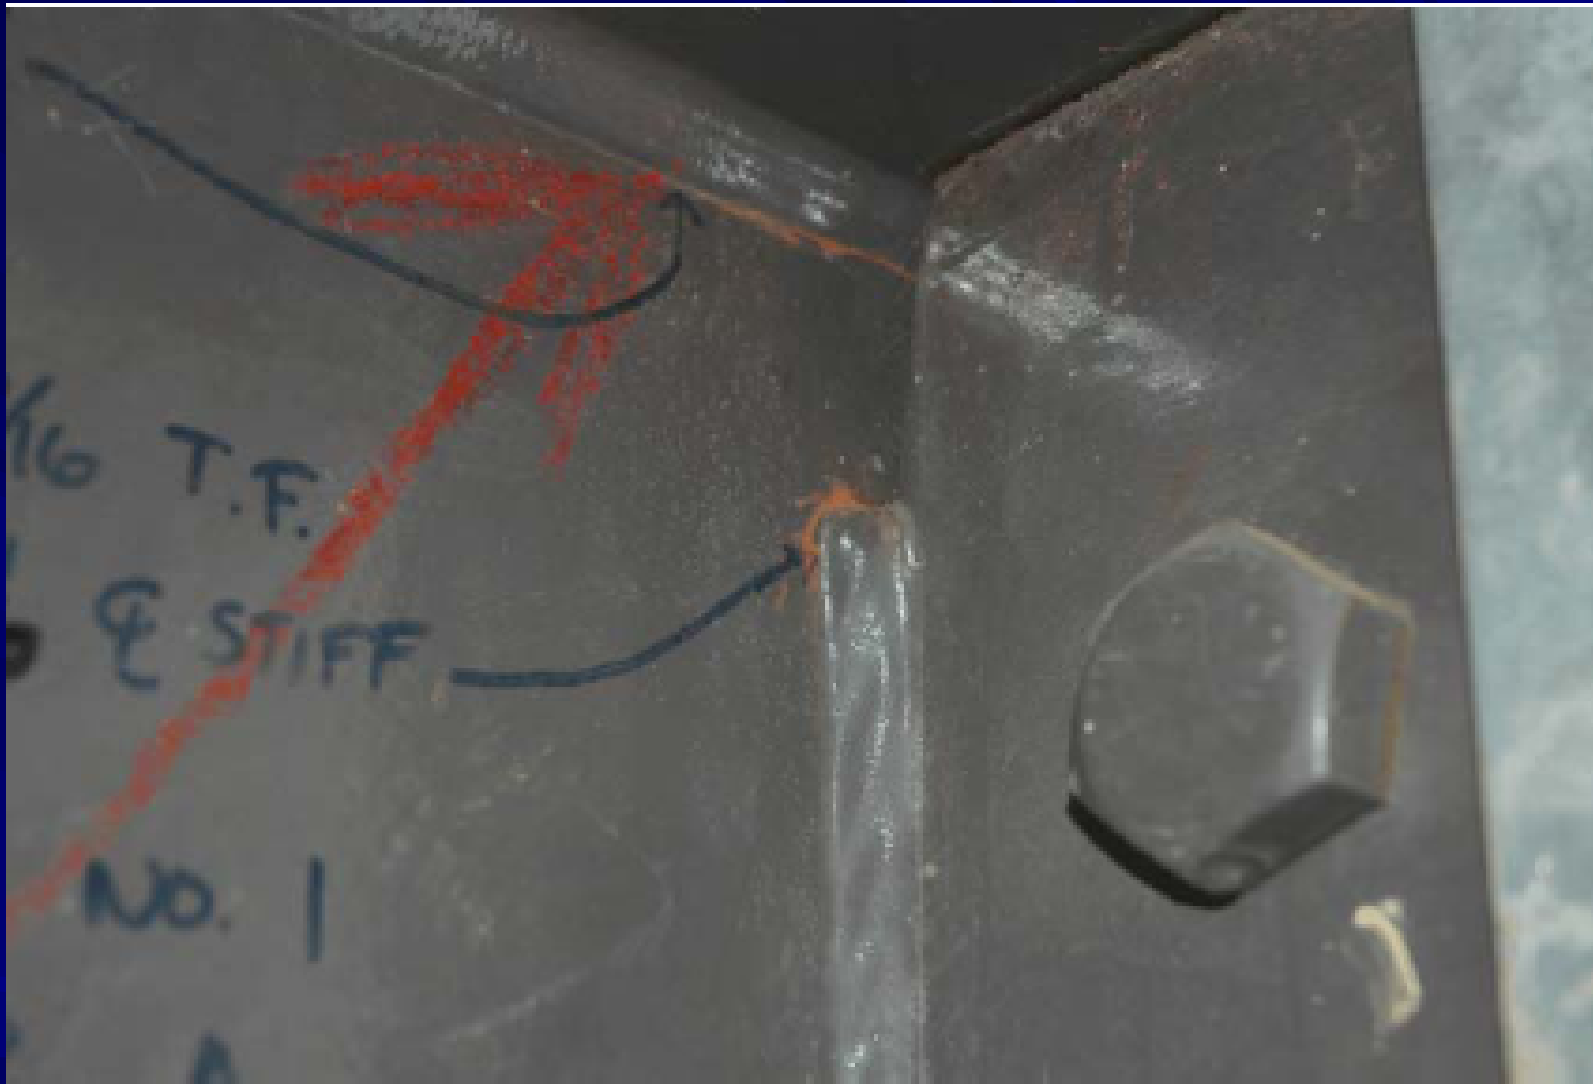
Web gap cracking at inside (upstream) web face
at Cross Frame 1, Span 4 of Girder A, Unit 2.

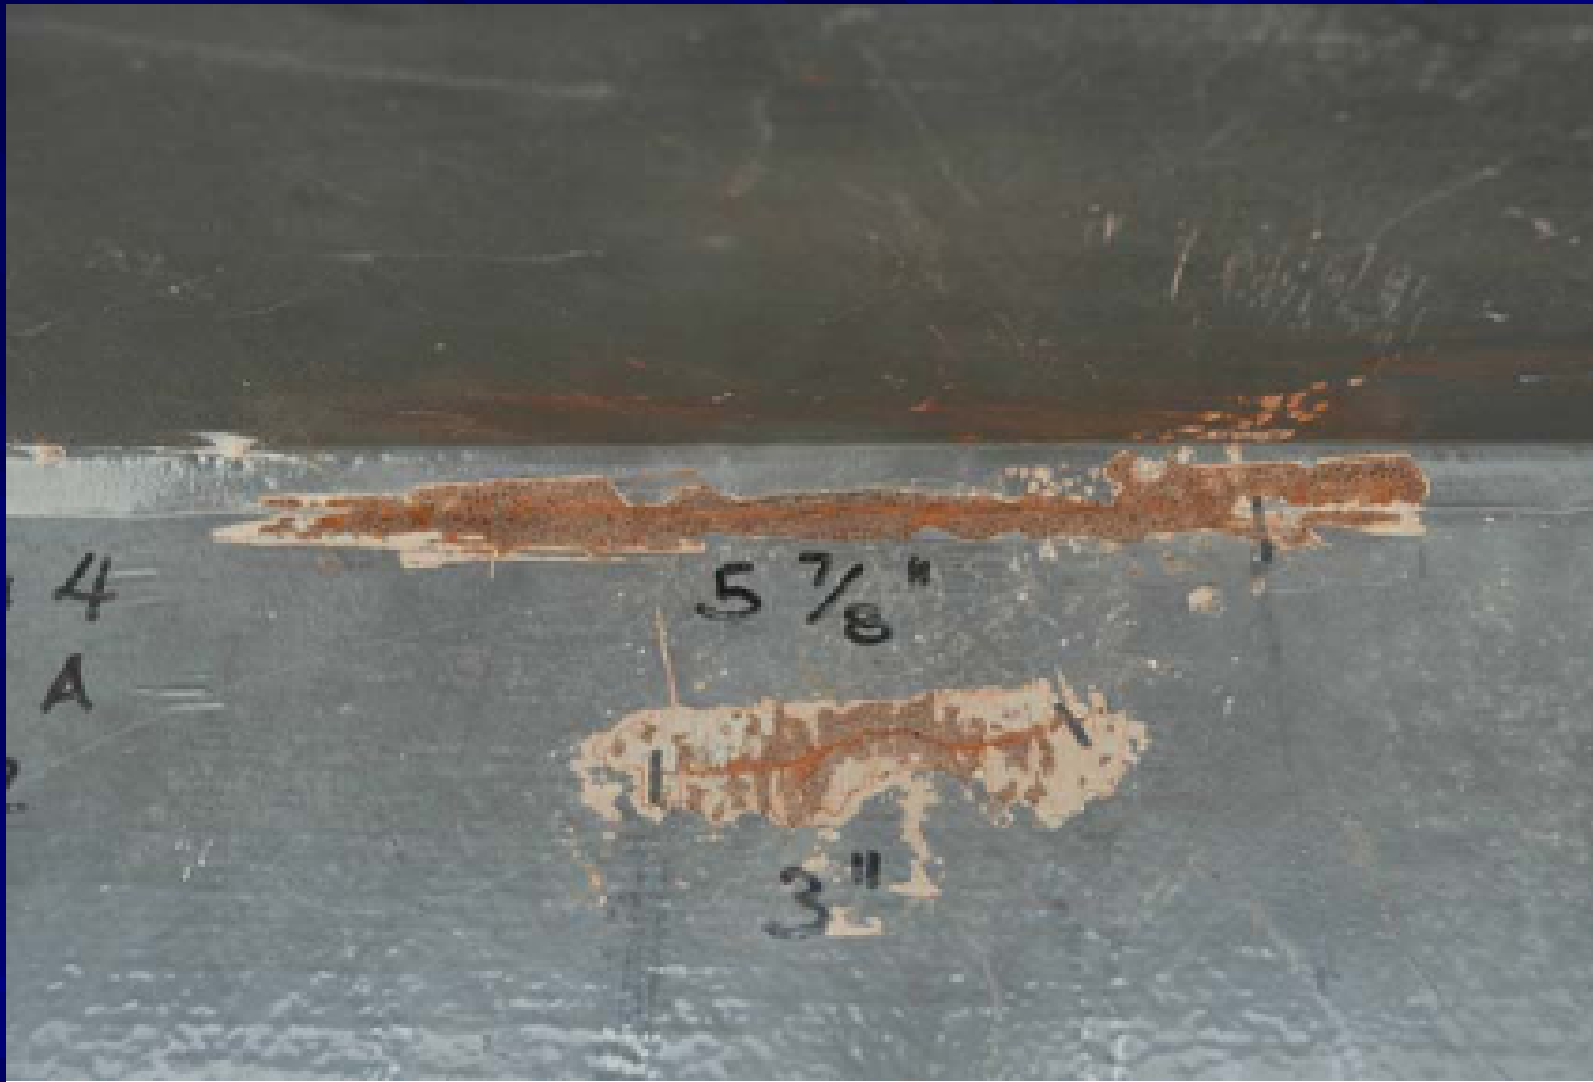
Web gap cracking at outside (downstream) web face at
Cross Frame 2, Span 4 of Girder A, Unit 2.

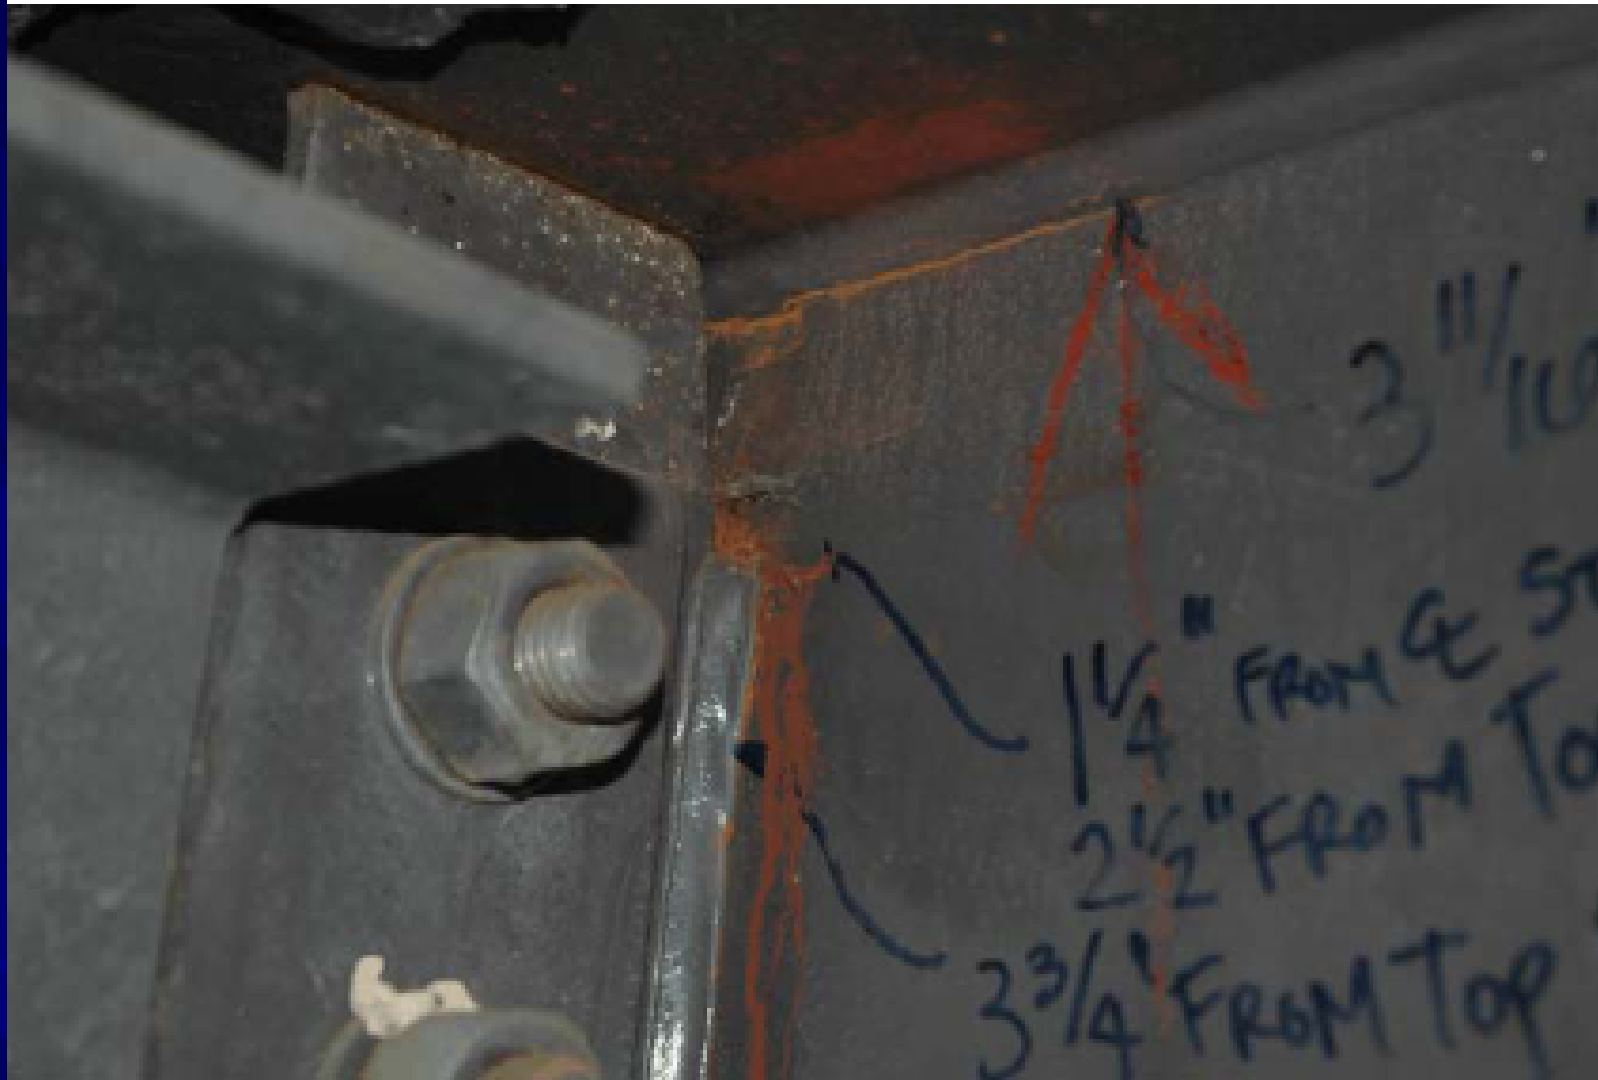
Web gap cracking at inside (upstream) face at
Cross Frame 2, Span 4 of Girder A, Unit 2.

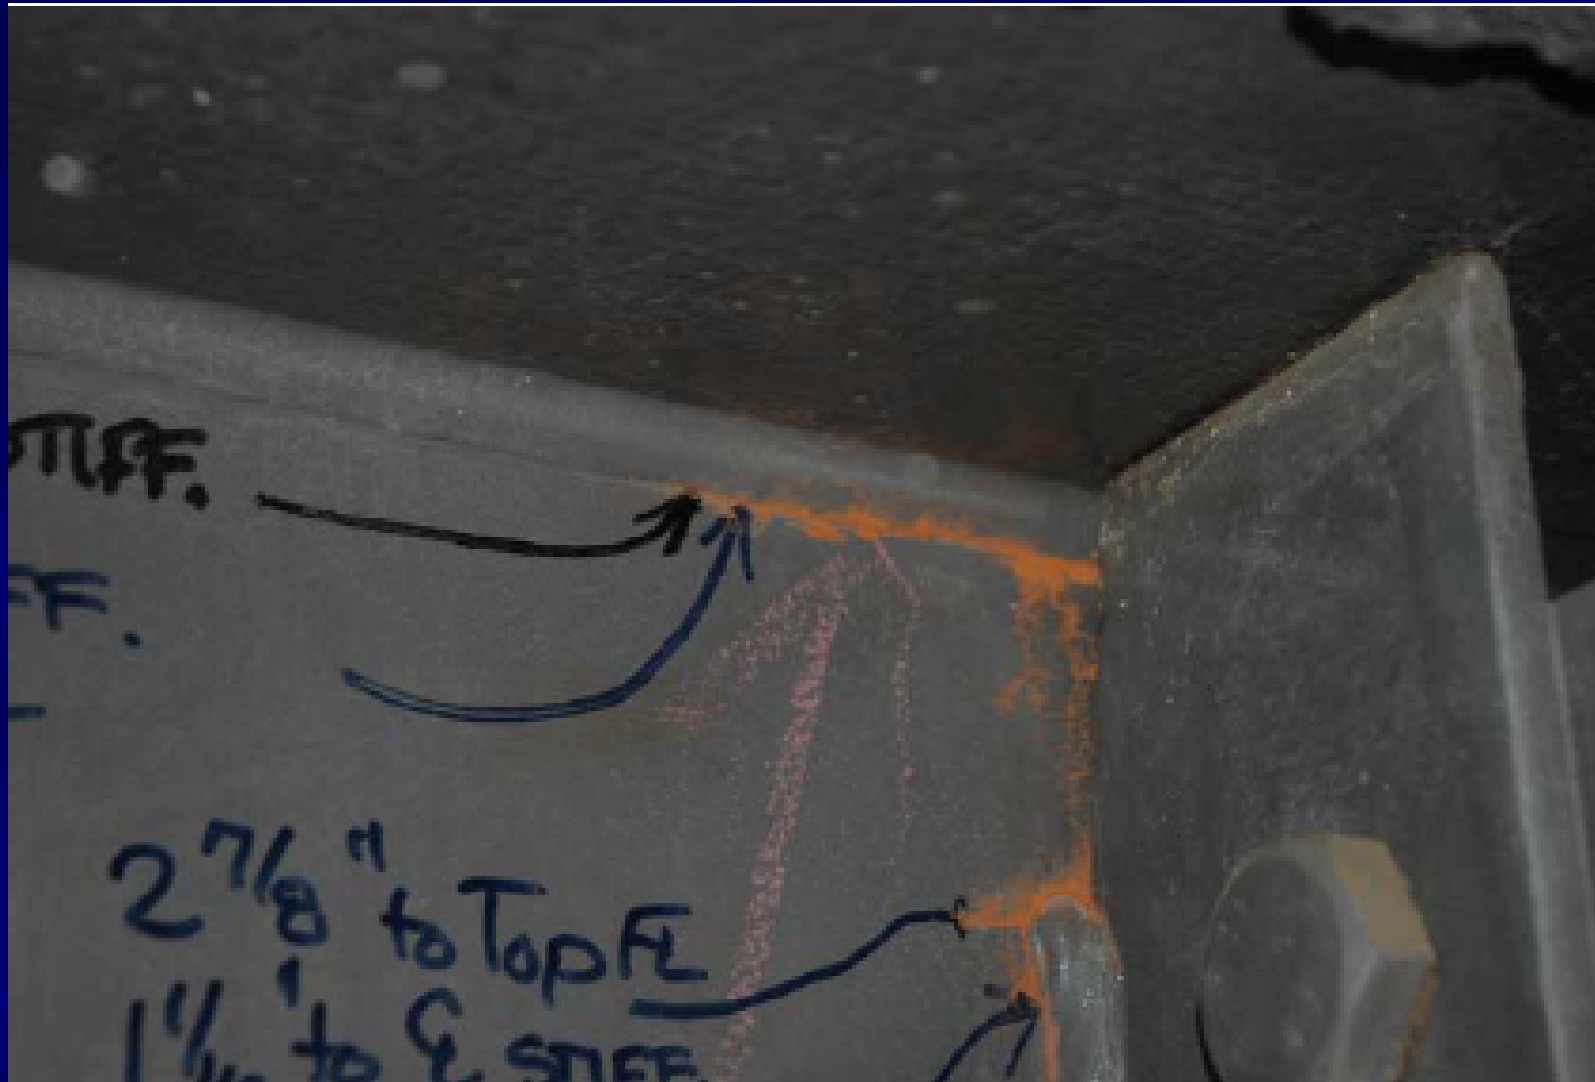
Web gap cracking at inside (upstream) face at
Cross Frame 3, Span 4 of Girder A, Unit 2

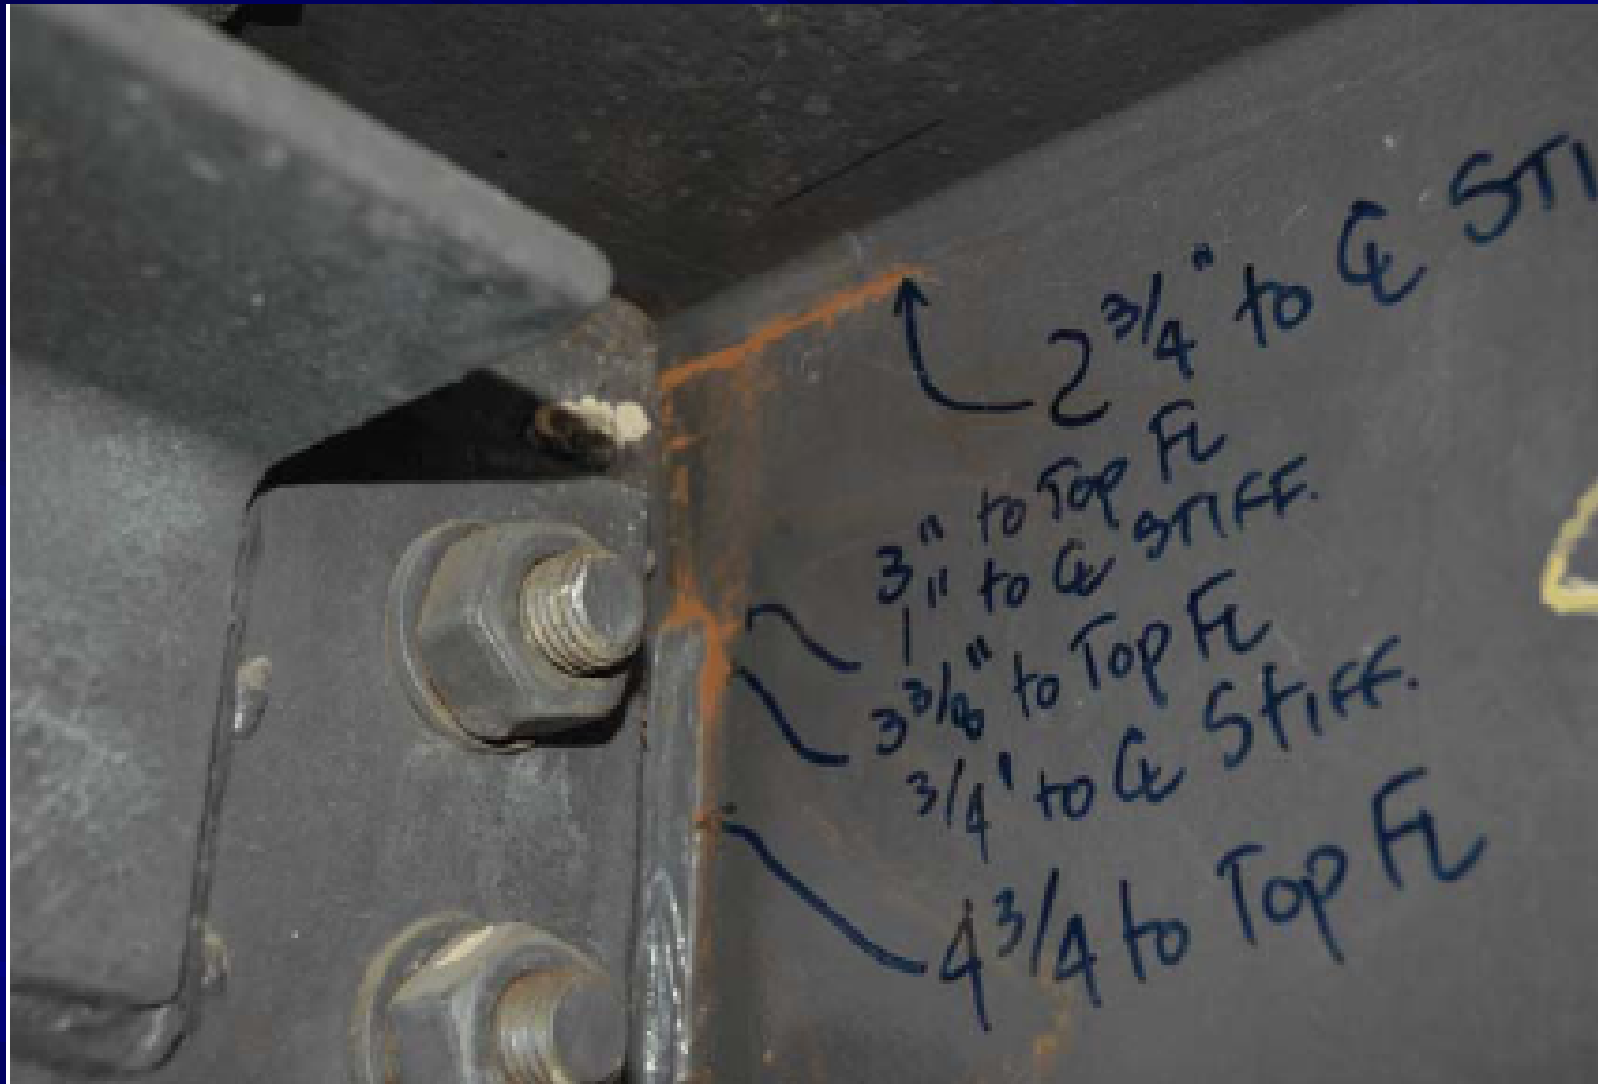
Web gap cracking at inside (upstream) face at
Cross Frame 3, Span 4 of Girder A, Unit 2.

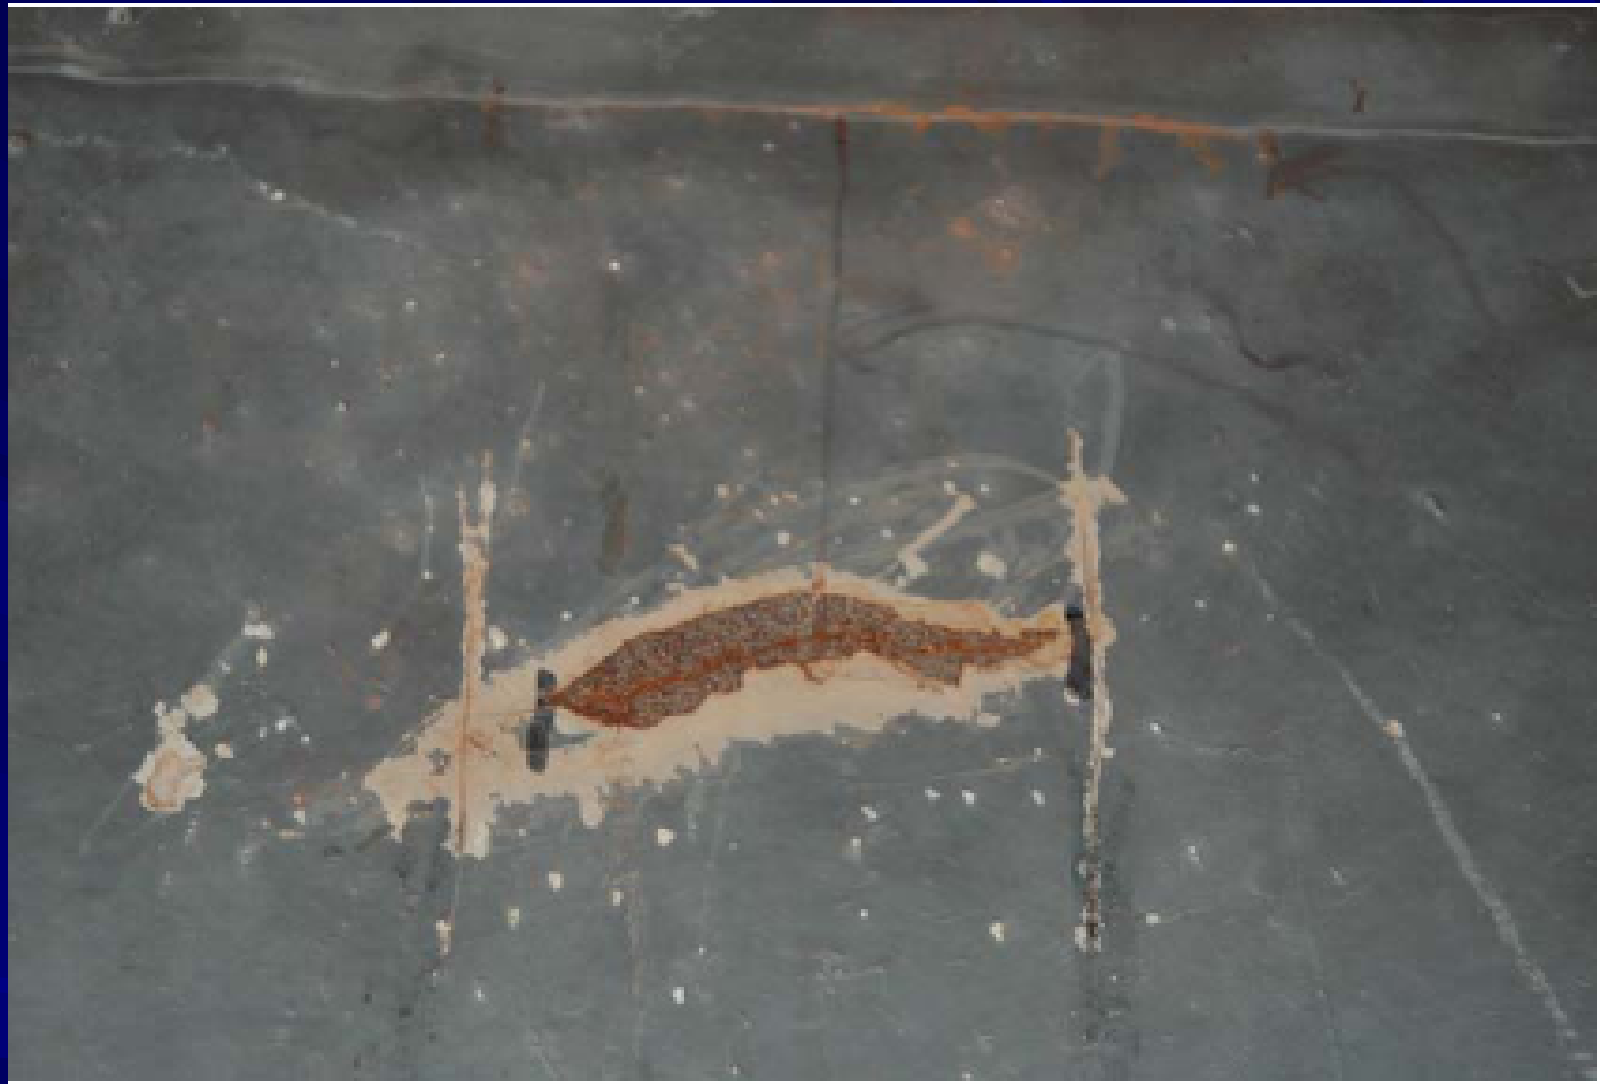
Web gap cracking at outside (downstream) web face at
Cross Frame 3, Span 4 of Girder A, Unit 2.

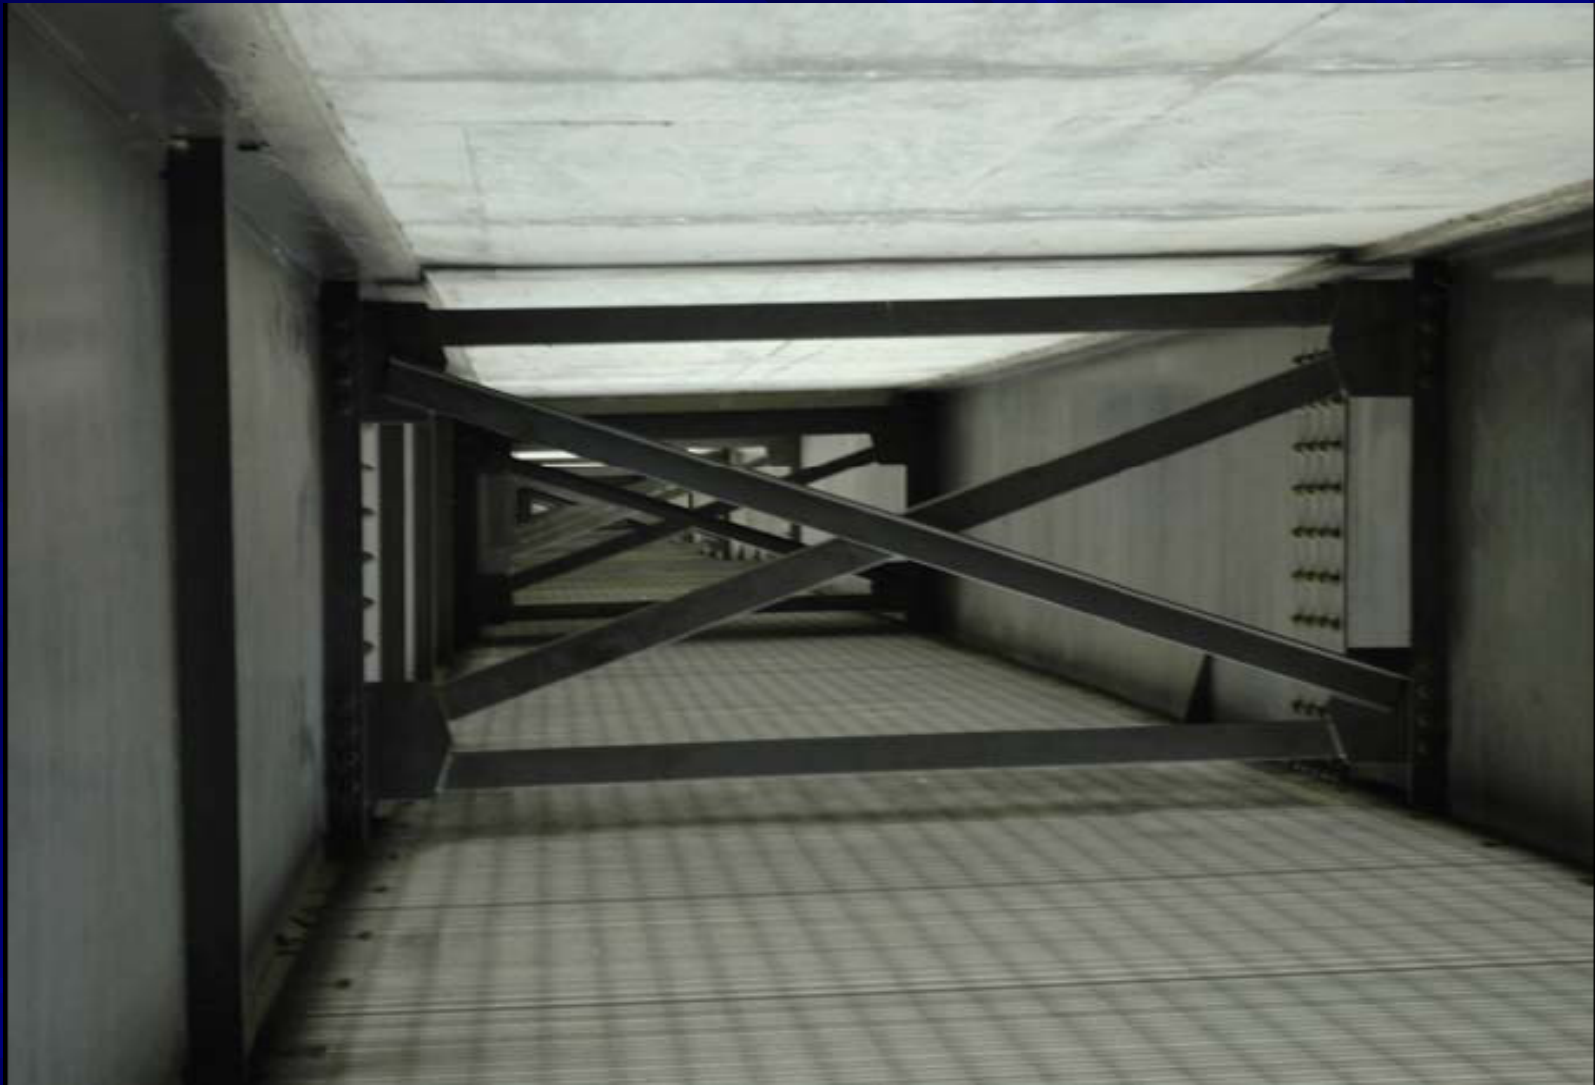
View of typical cross frame in Unit 2.

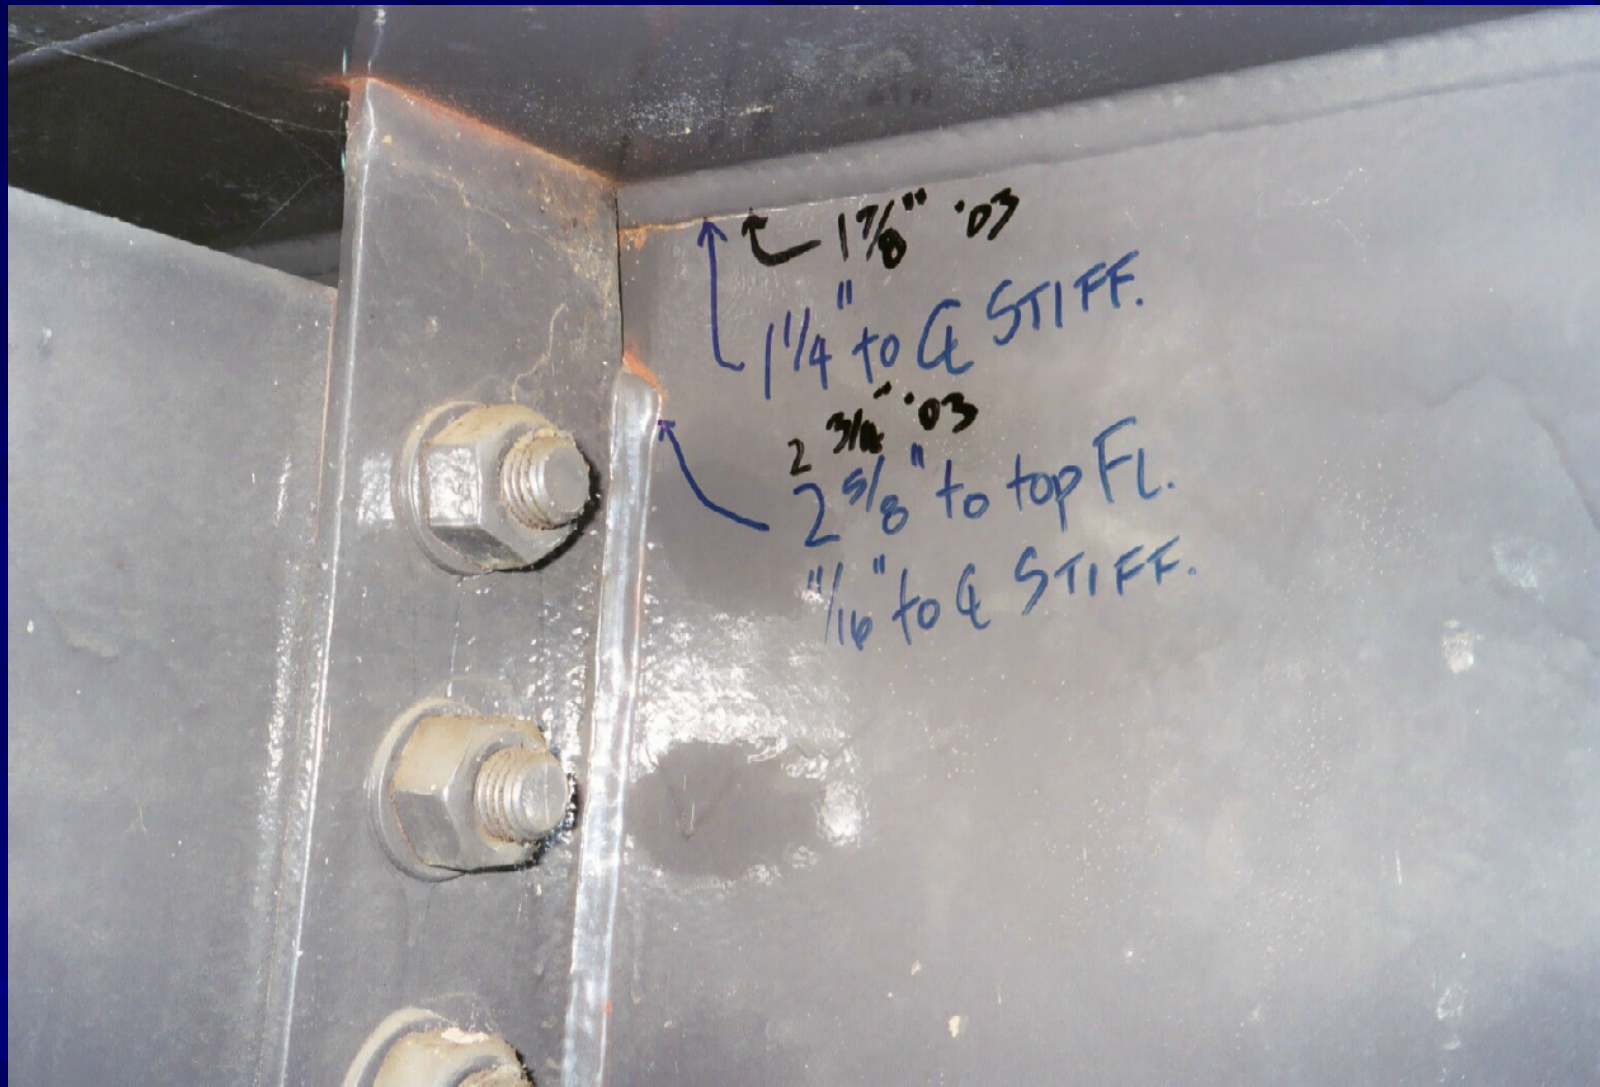
Typical Cracks in Center Spans

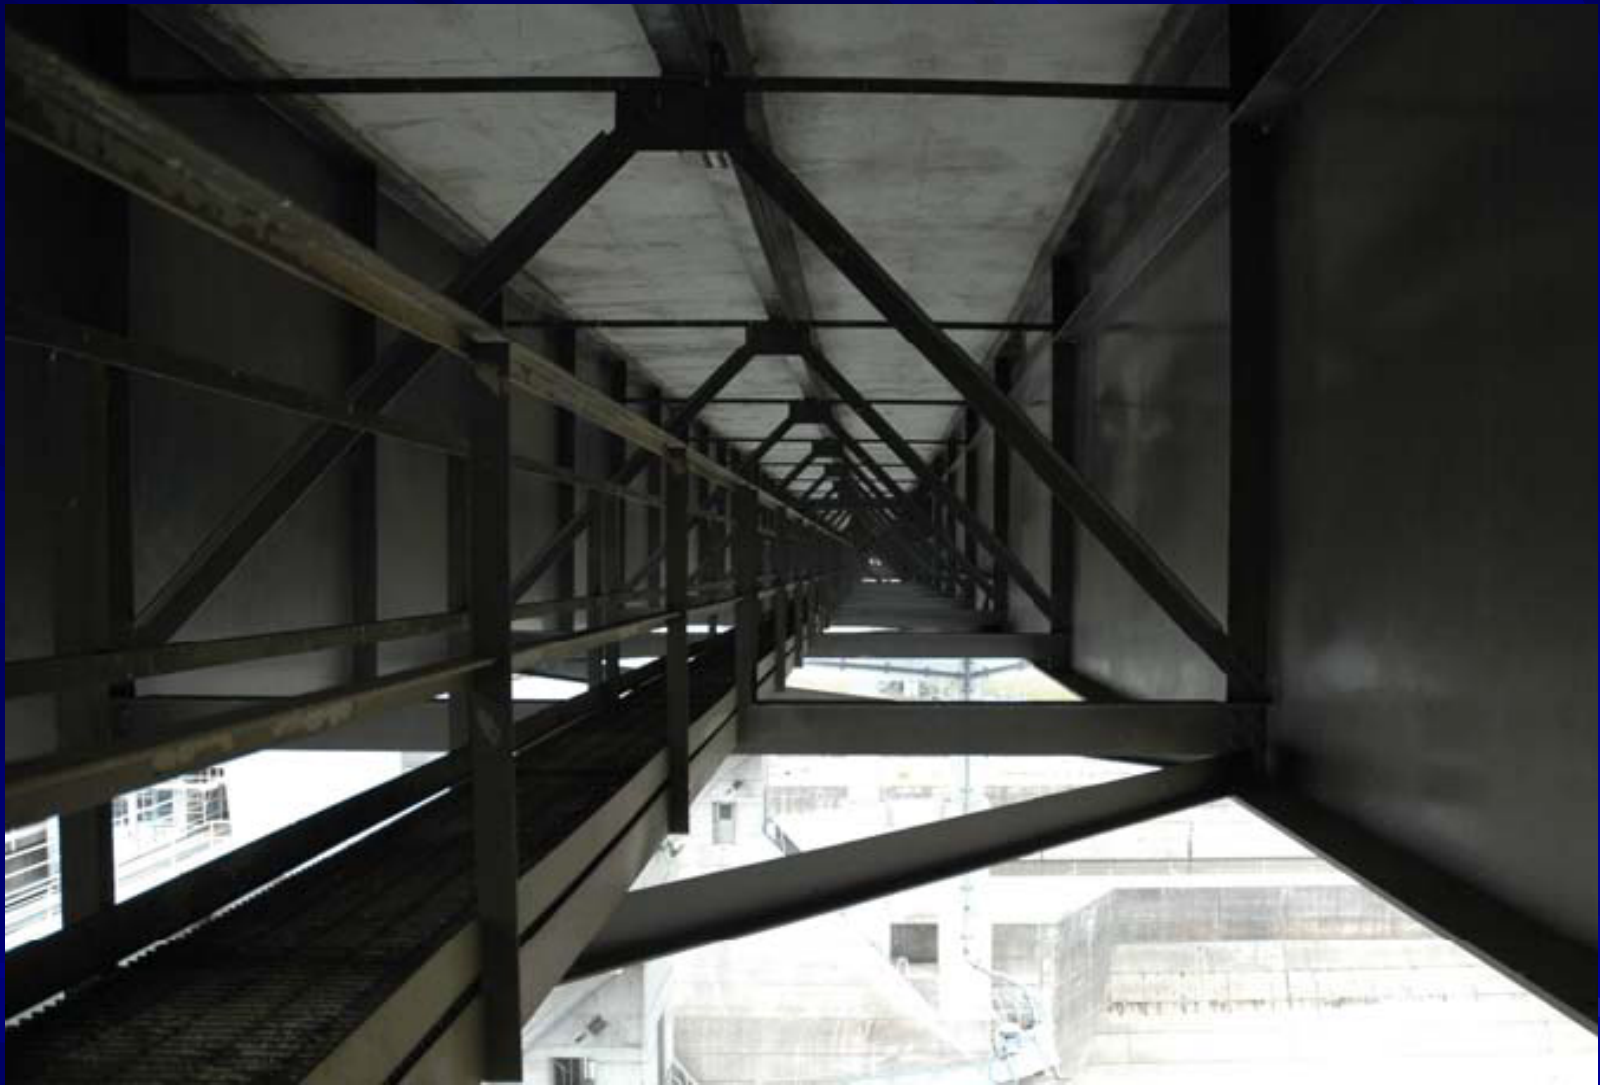
View of typical cross frame in Unit 1 (and Unit 3).

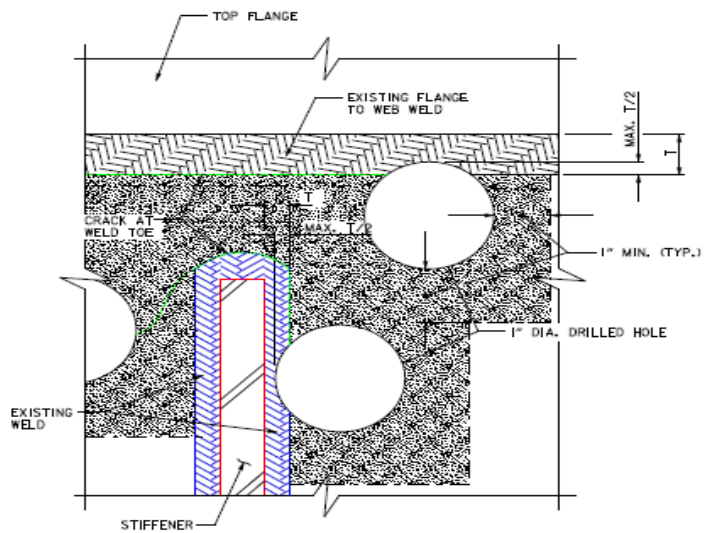
HOLE DETAIL
TYPE 1 AND TYPE 2 CRACKS
WITH CRACK FOLLOWING TOE
OF WELD

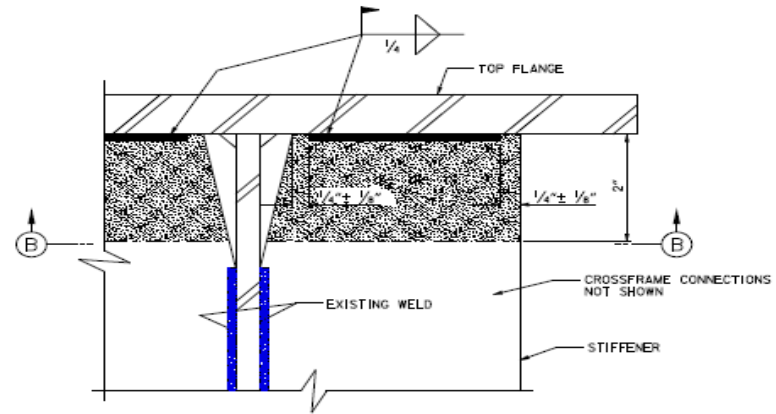
**TOP FLANGE WELD
TERMINATION DETAIL**

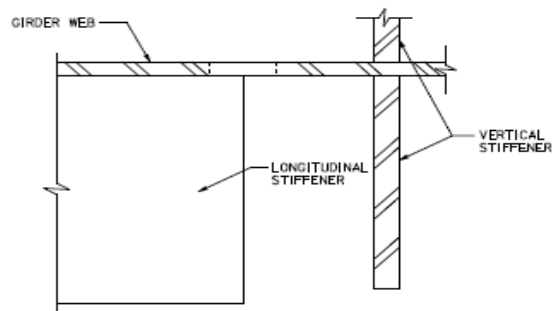
Retrofit for Type 3 Crack
