Evaluation and Repair Of Blast Damaged Reinforced Concrete Beams

MAJ John L. Hudson P.E.

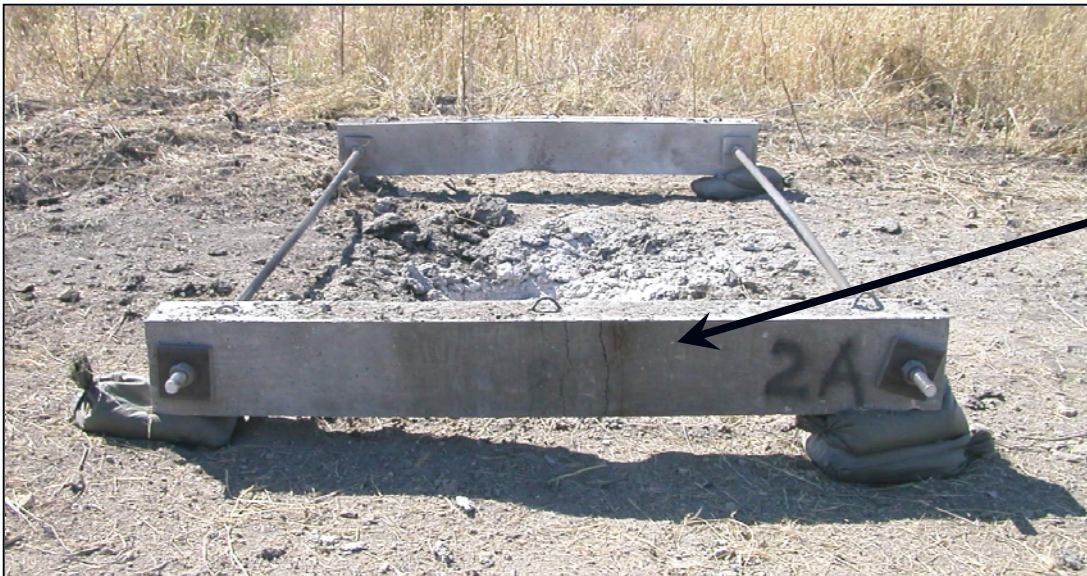
Set 2 after detonation of charge

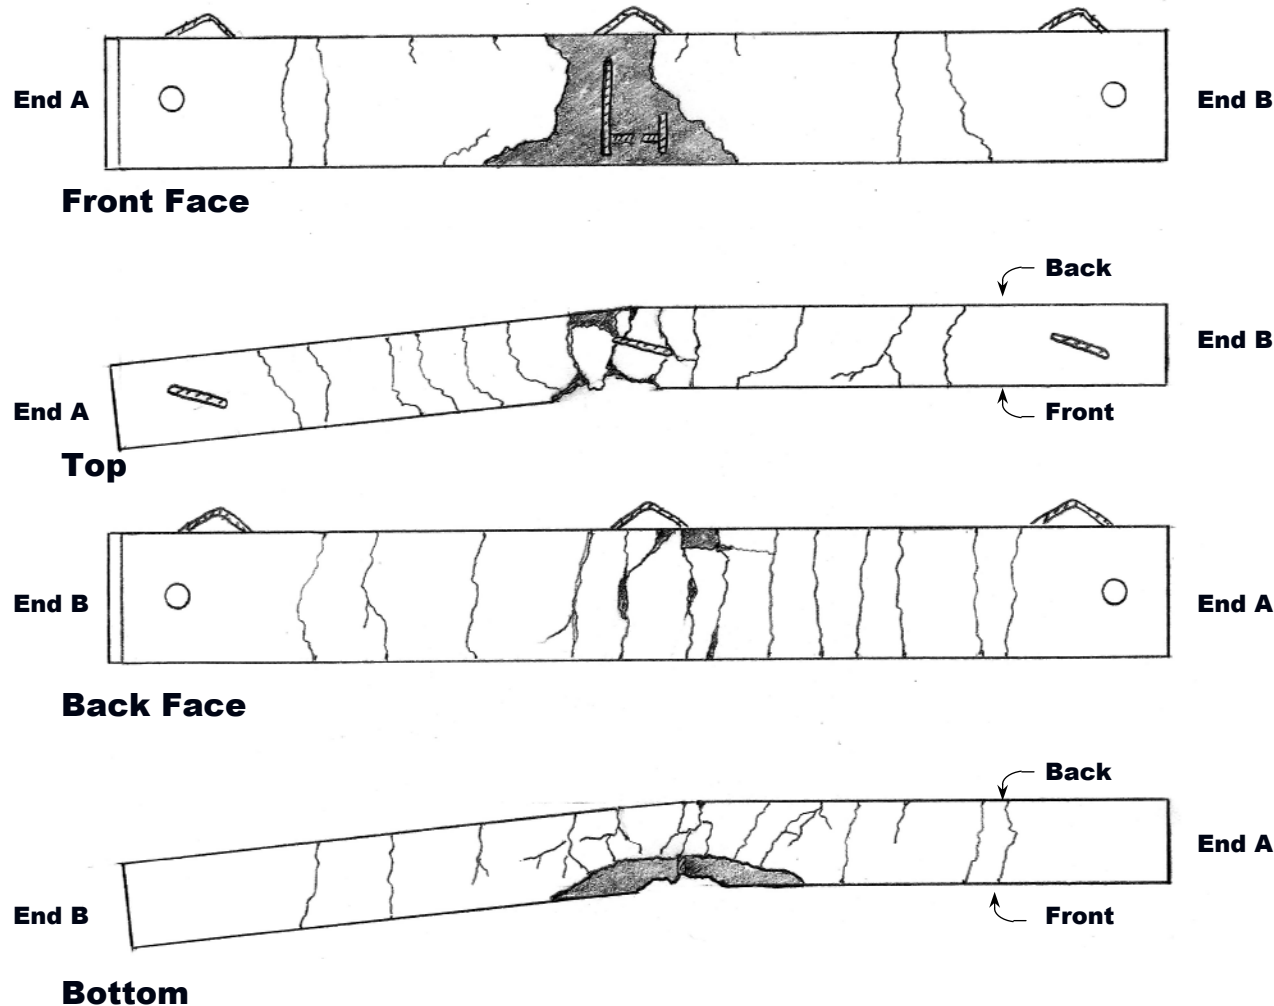
- Each beam was sketched and all cracking, spalling and exposure of reinforcement was identified

- 2 of the 4 sets were determined to have damage beyond repair

- 3 of the 4 sets experienced permanent horizontal deformations

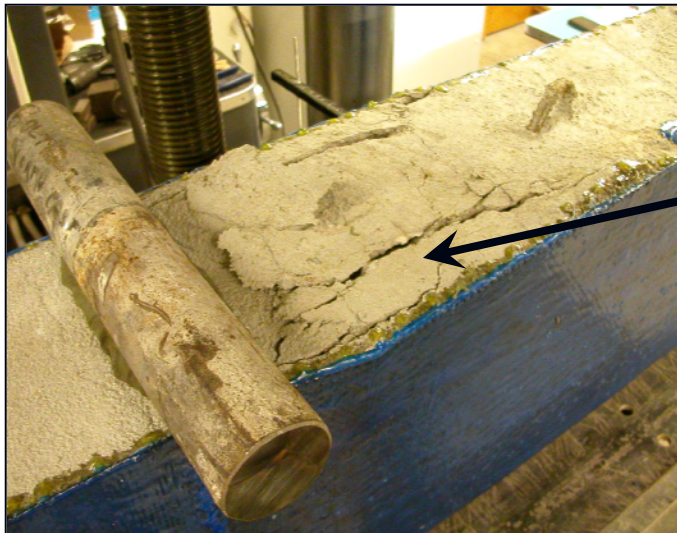
Compression failure in the concrete of beam 4A after reaching a load of 56,700 lb
