***CATHODIC PROTECTION FOR
THE SOUTH POWER PLANT
REINFORCING STEEL,
DIEGO GARCIA, BIOT***

***THOMAS TEHADA, NAVFAC - NFESC
MIKI FUNAHASHI, CORRPRO COMPANIES, INC.***

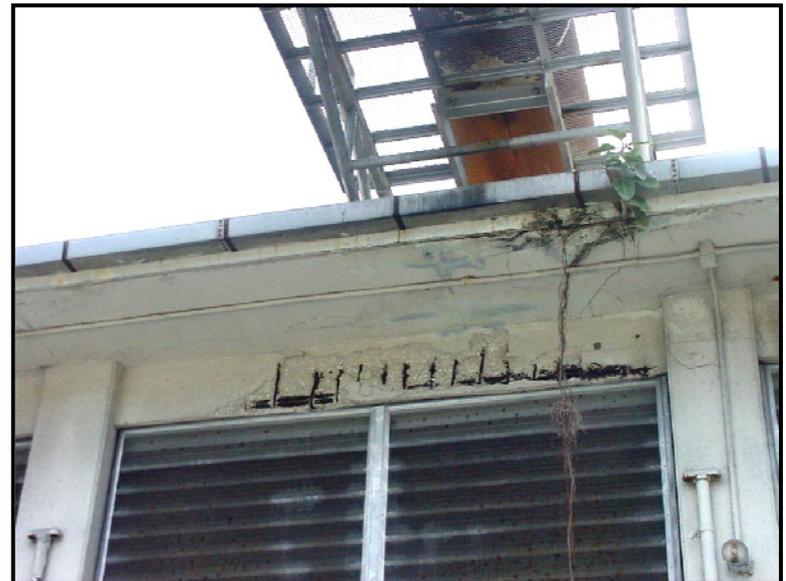
- **AFTER REACTIVATION AND SEVERAL WEEKS OF OPERATION OF THE POWER PLANT, SPALLING CONCRETE AND CORROSION OF THE REBAR WAS NOTED THROUGH OUT THE PHASE 1 STRUCTURAL MEMBERS INCLUDING:**
 - **Moderate to severe concrete spalling and rebar corrosion at west spandrel beam. Worst locations appeared to coincide with areas of poor roof drainage.**

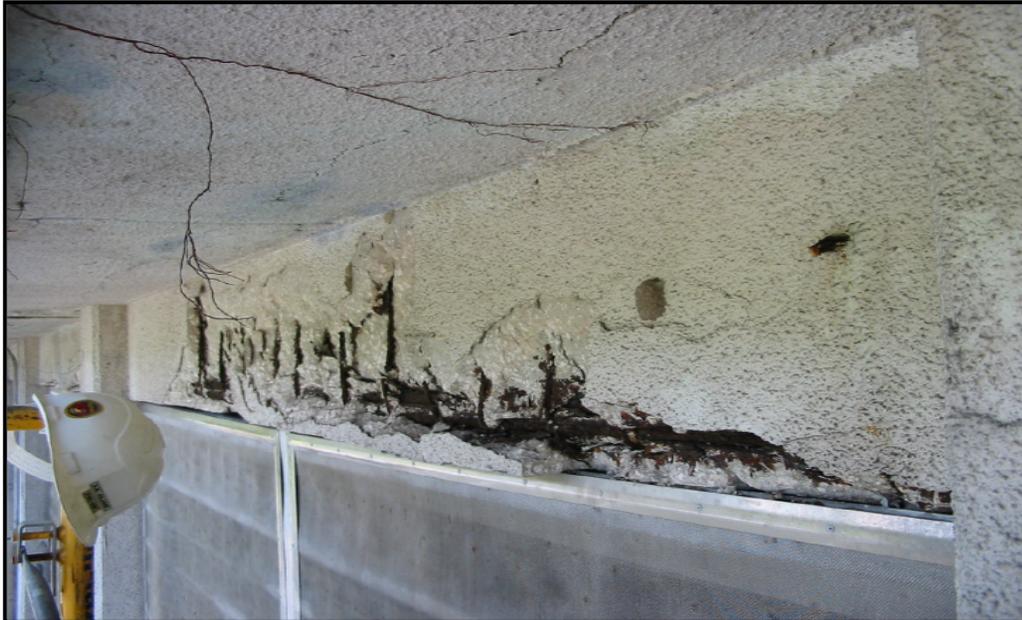
Corrosion of rebar and spalled concrete in the west side beam

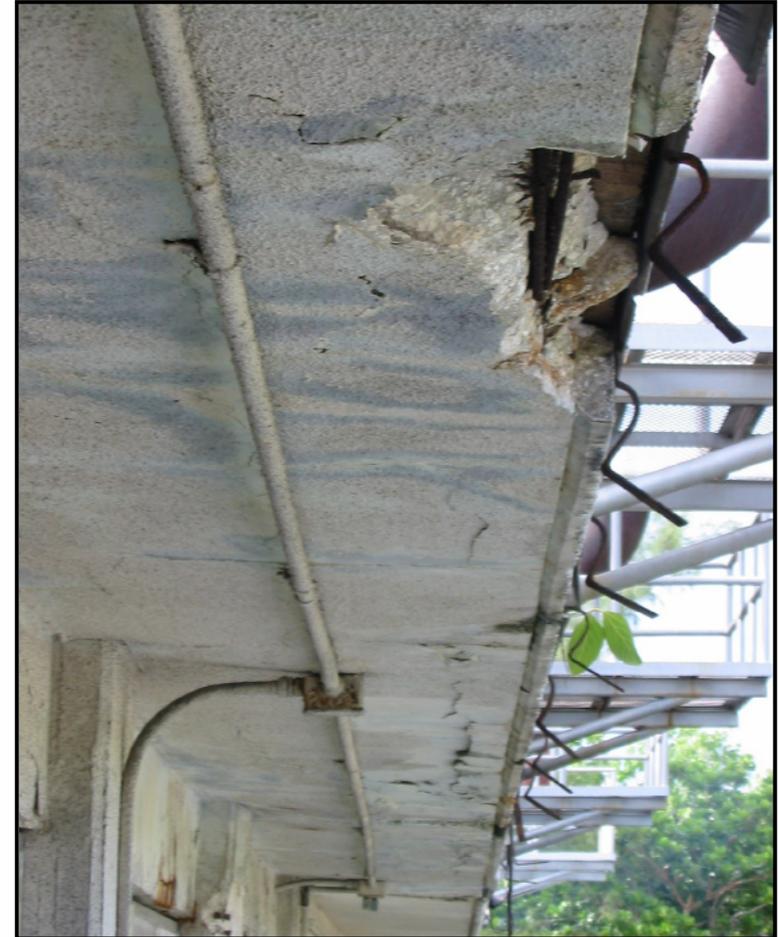
Corrosion of rebar and spalled concrete in the west side eaves

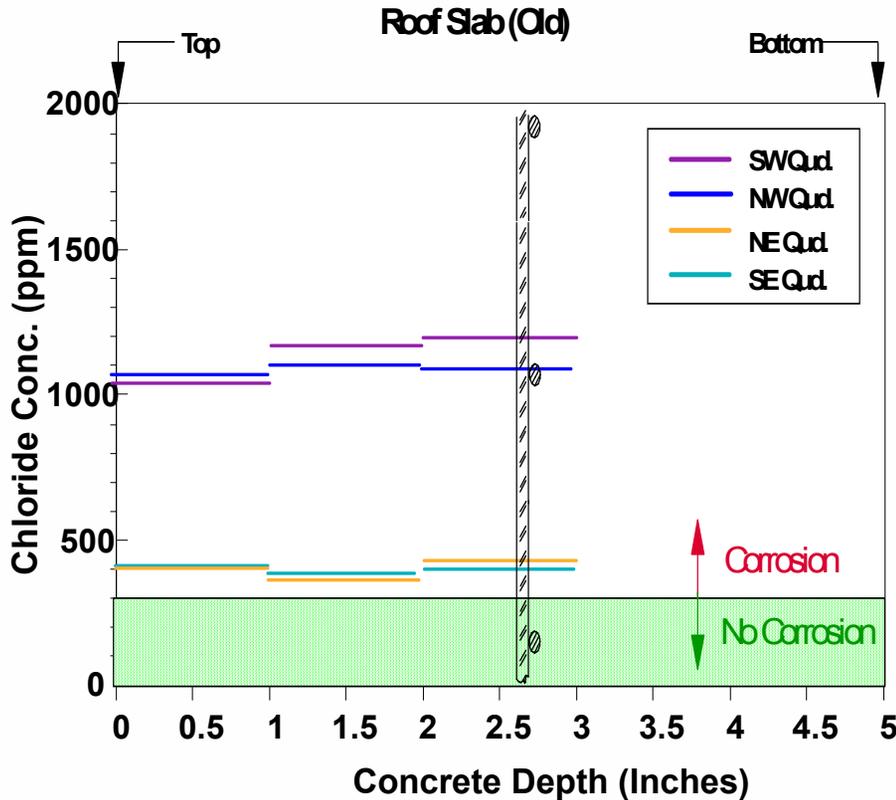
**Chloride Concentration
Profiles for the Roof Slab
(Old Section)**

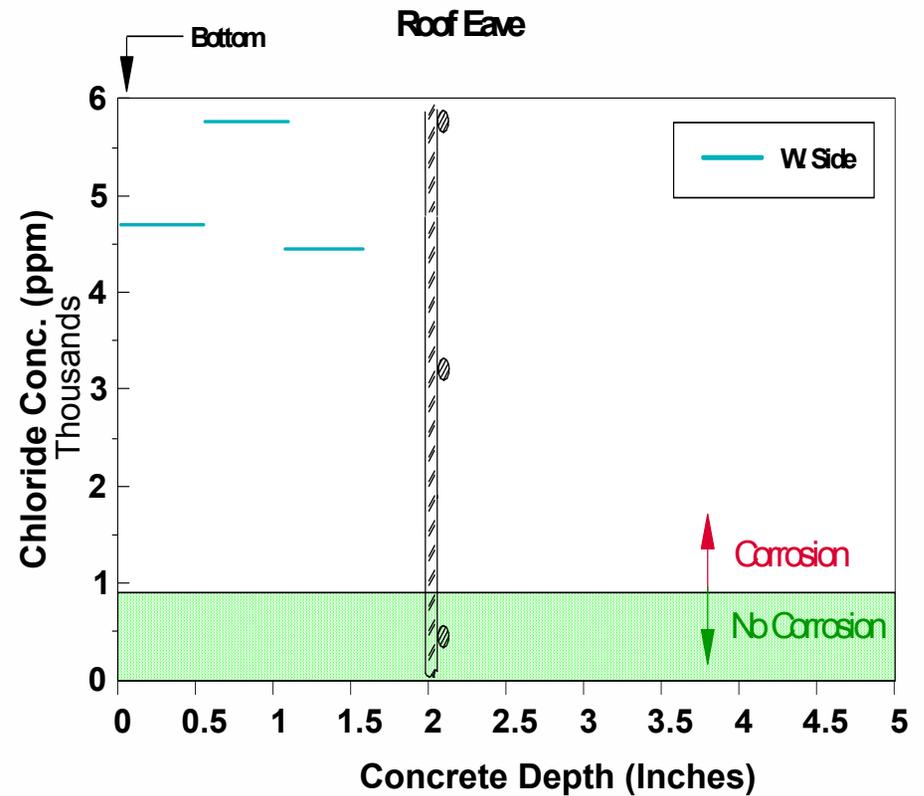
**Chloride Concentration
Profiles for the West Side
of Roof Eave**

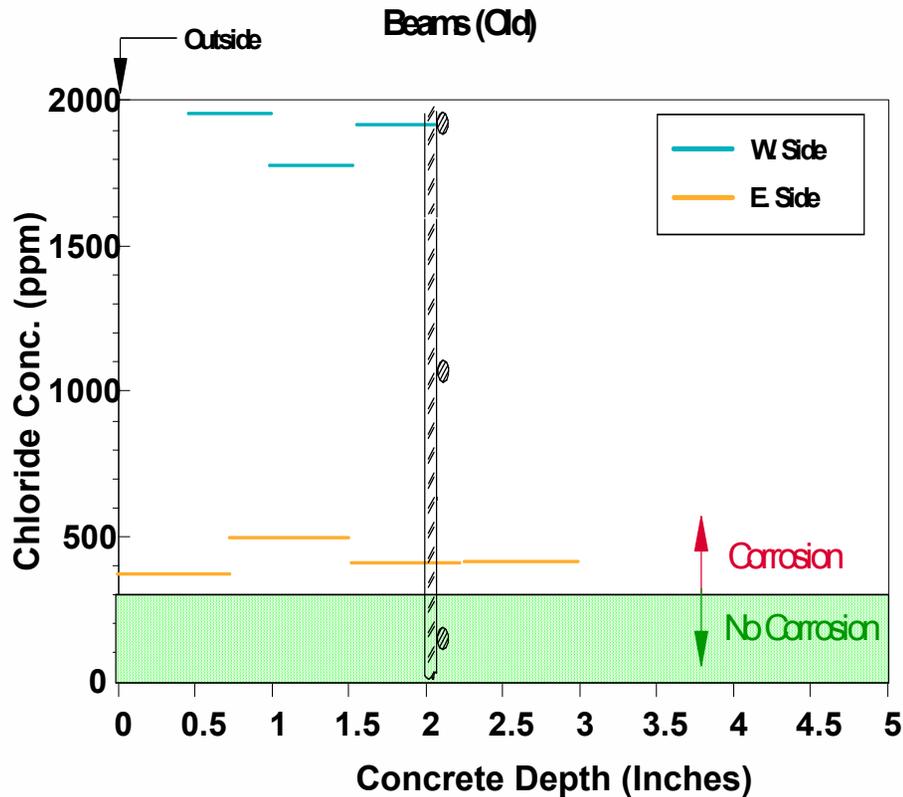
Chloride Concentration Profiles for the Beams (Old Section)

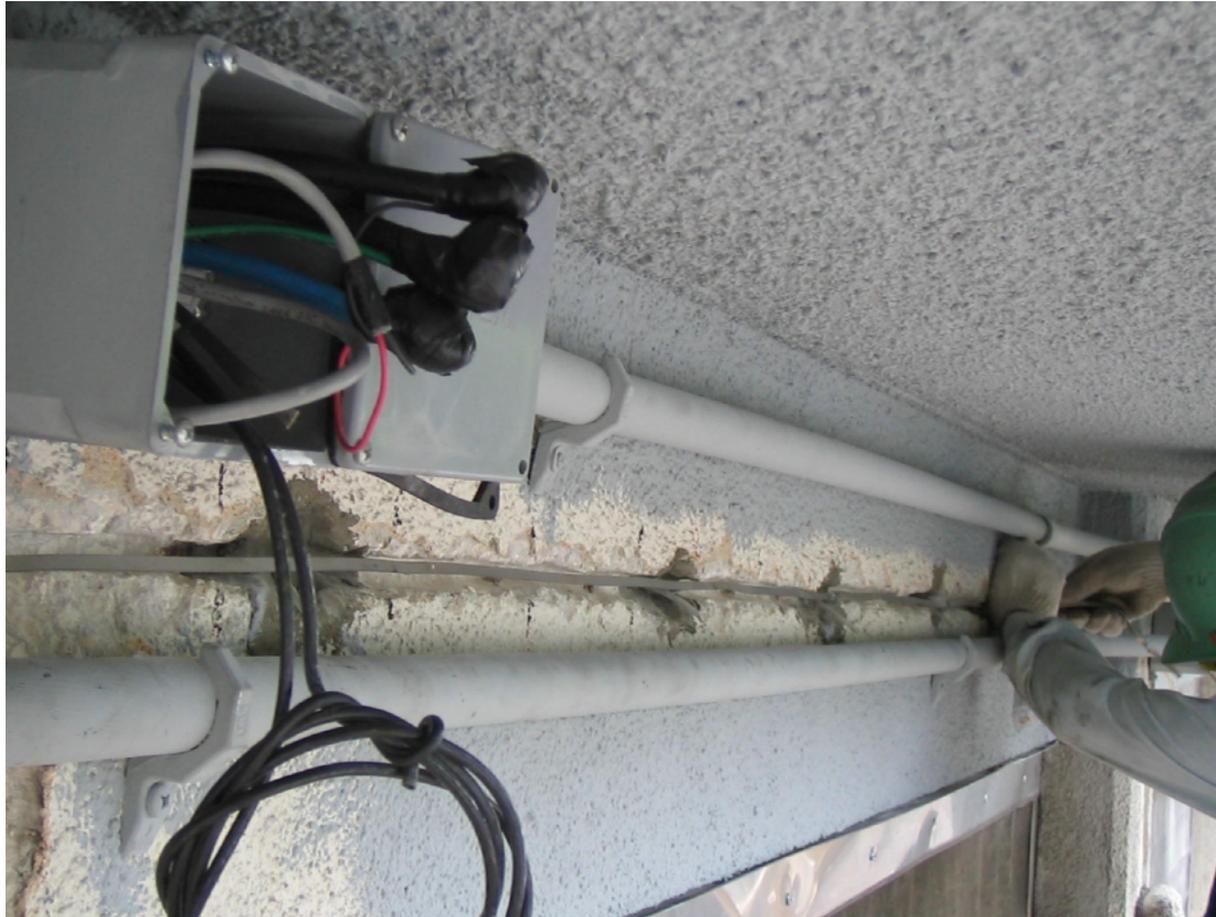
Discrete anode system being installed in the west beam

- **CONCRETE REPAIRS/ INSTALLATION OF CP SYSTEM COMPLETED APRIL 2005 BY ON-ISLAND BOS CONTRACTOR. CP MATERIALS, SUPERVISION AND SYSTEM COMMISSIONING SERVICES PROVIDED BY CORRPRO COMPANIES, INC.**
- **RIBBON MESH ANODE ORIGINALLY RECOMMENDED FOR WEST SIDE BEAM, TO BE INSTALLED CONCURRENTLY WITH STRUCTURAL REPAIRS. HOWEVER, DUE TO BAD CONDITION OF BEAM AND CRITICAL OPERATIONAL REQUIREMENTS, BEAM REQUIRED REPAIR BEFORE CP MATERIALS COULD BE PROVIDED ON-ISLAND. DISCRETE ANODE SYSTEMS PROVIDED INSTEAD.**

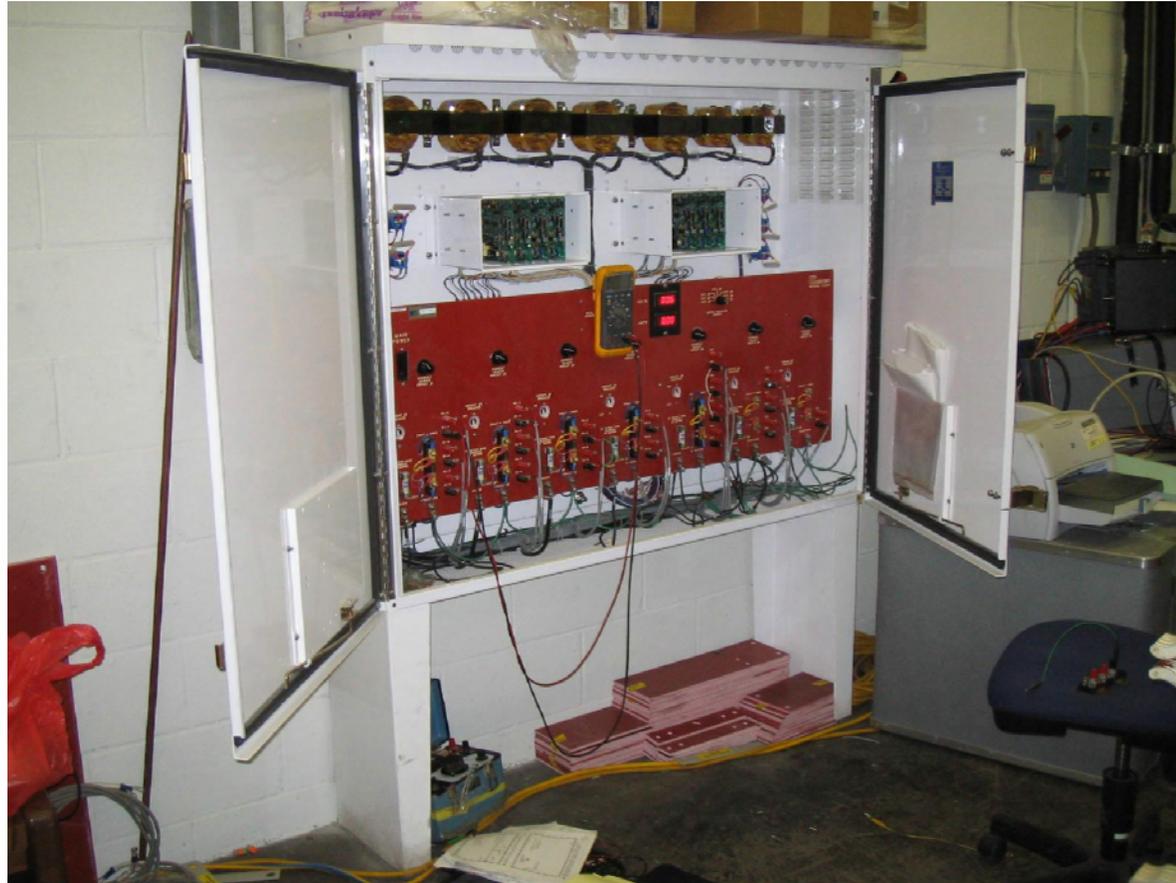
Multi-circuit transformer rectifier unit
