# **SEISMIC STABILITY EVALUATION FOR UTE DAM, NEW MEXICO**

**Presented by  
John W. France, P.E.  
URS Corporation  
Denver, CO**

**2005 Tri-Service Infrastructure Conference &  
Exhibition  
“Re-Energizing Engineering Excellence”  
St. Louis, Missouri  
August 2 through 4, 2005**

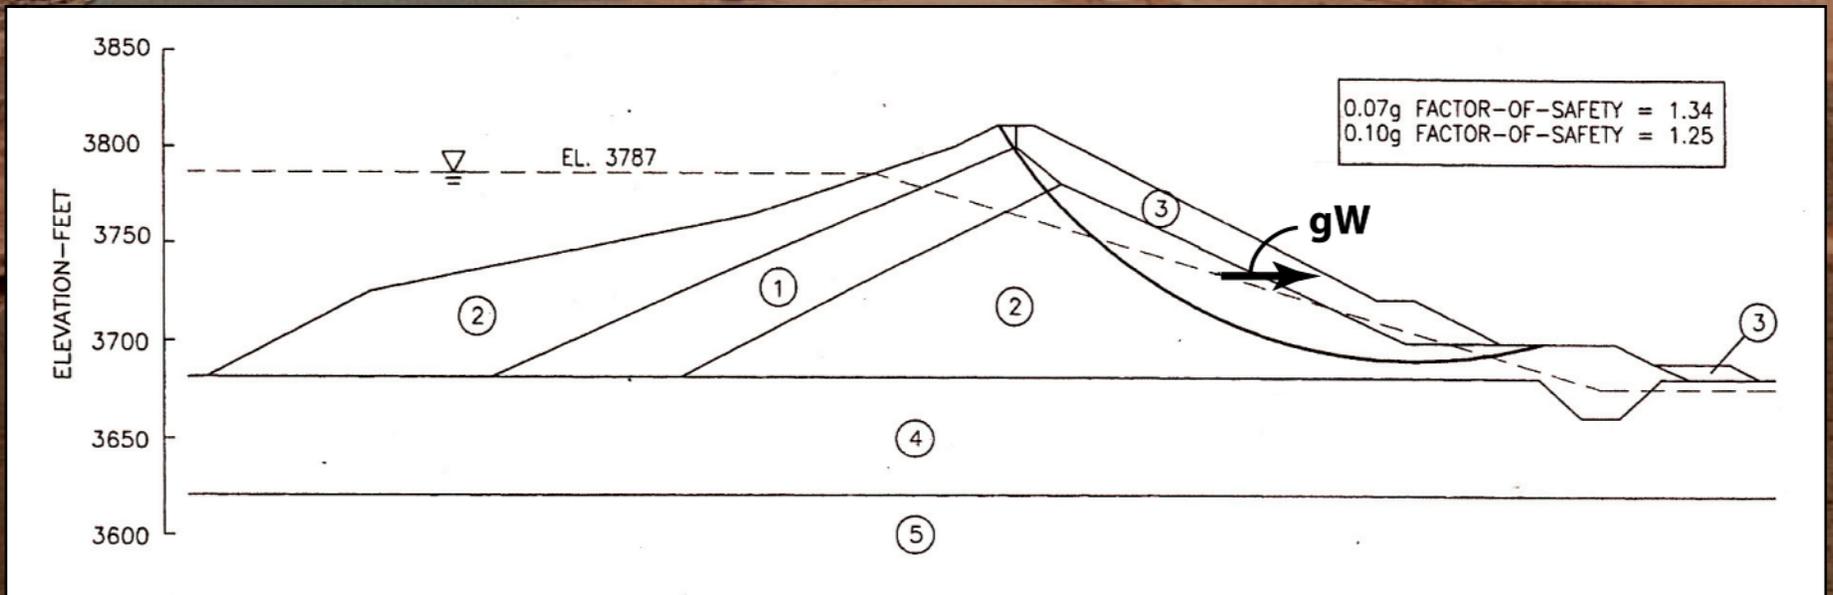
# EXAMPLE P-S STABILITY ANALYSES

Case	Calculated Factors of Safety	
	5,000 year 0.07g	10,000 year 0.10g
Downstream	1.34 to 1.48	1.25 to 1.36
Upstream	1.77 to 1.85	1.54 to 1.62

**NMOSE requires FS  $\geq$  1.1**

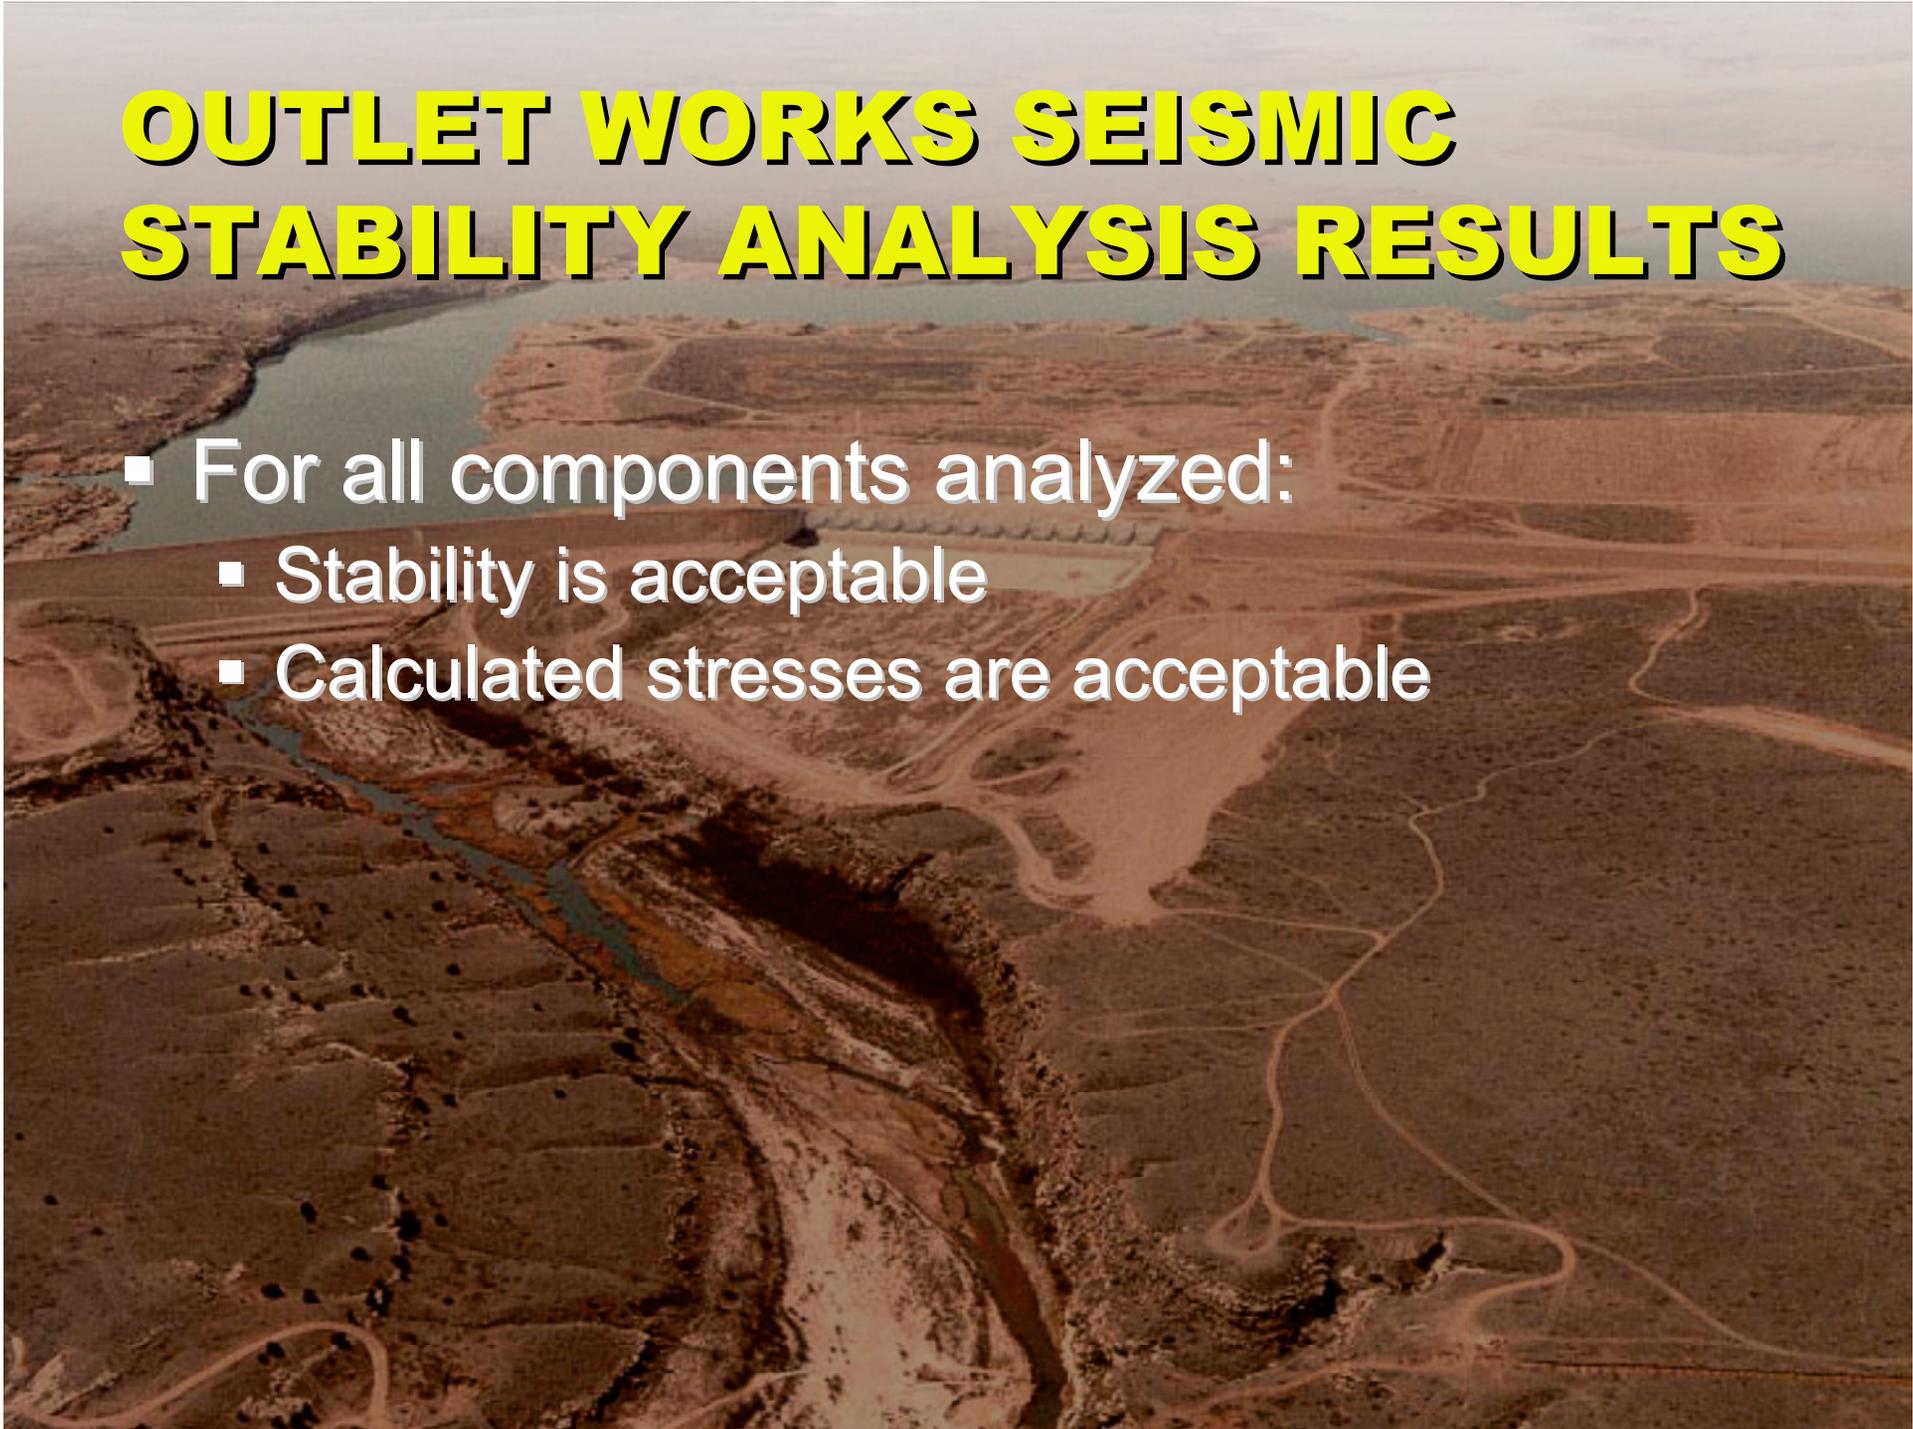
# OUTLET WORKS SEISMIC STABILITY ANALYSIS RESULTS

- For all components analyzed:
  - Stability is acceptable
  - Calculated stresses are acceptable

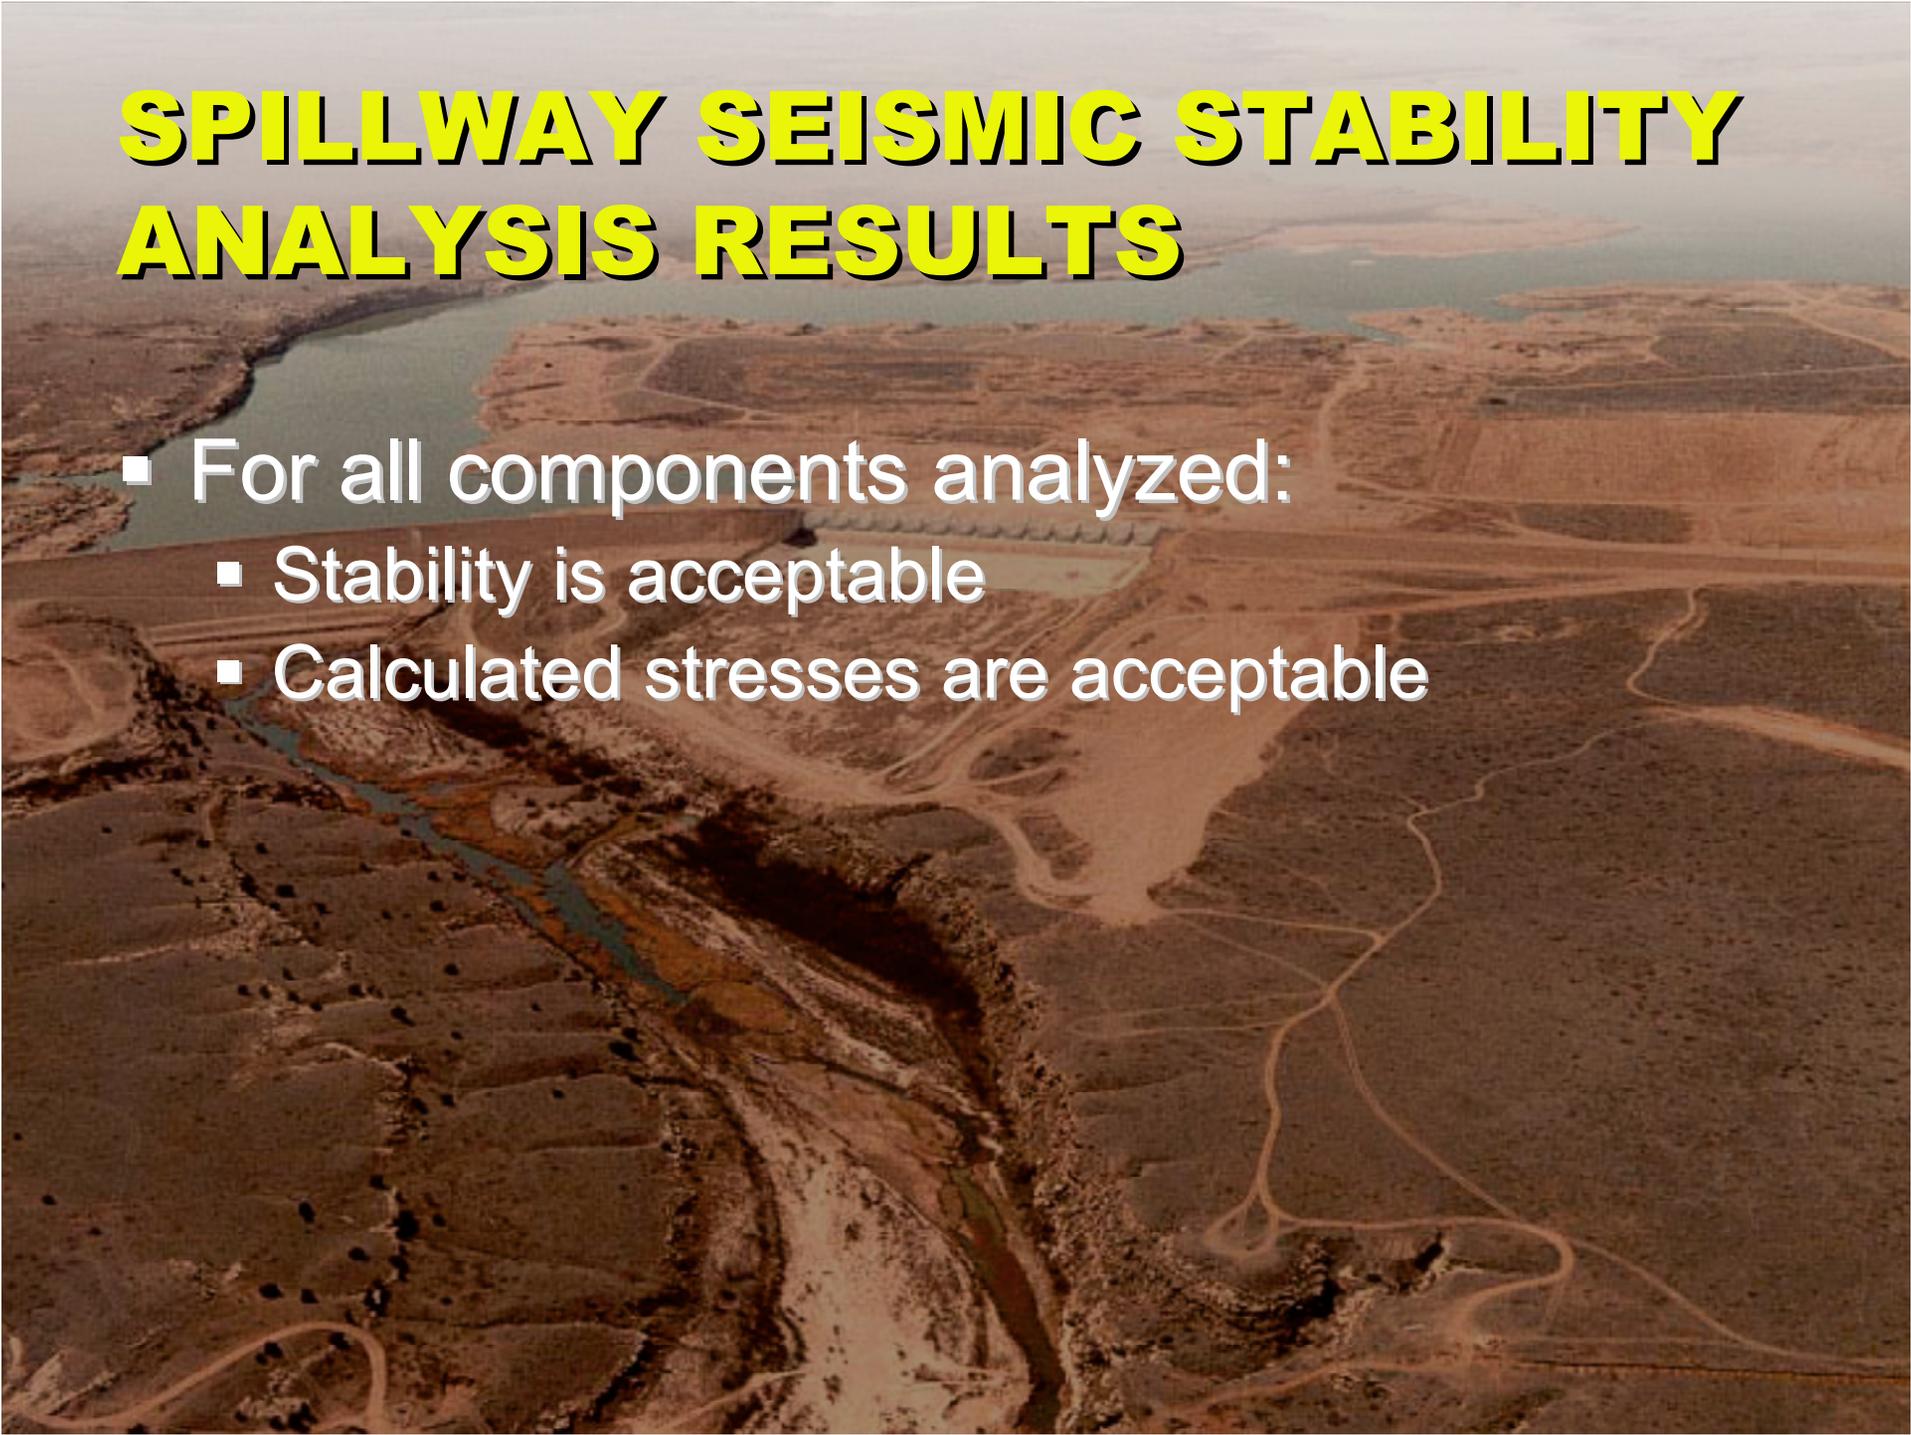
# **SPILLWAY SEISMIC STABILITY ANALYSIS RESULTS**

- For all components analyzed:
  - Stability is acceptable
  - Calculated stresses are acceptable
