***Grout Curtains at Arkabutla Dam  
Outlet Monolith Joints and Cracks  
using Chemical Grout,  
Arkabutla Lake, MS***

***Dale A. Goss, P.E.***

***August 3, 2005***

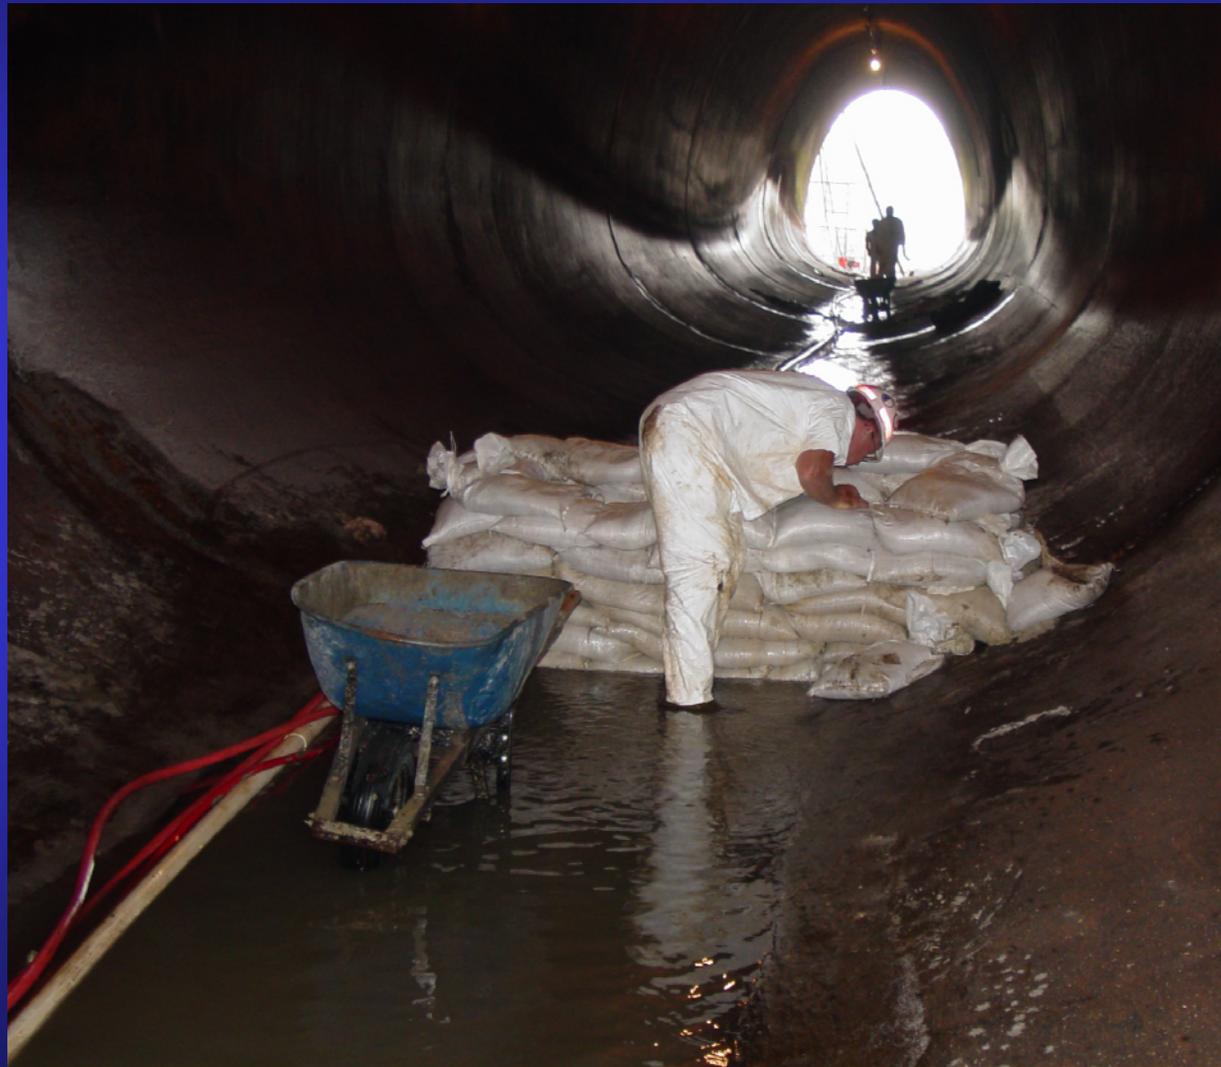
## Sand Bags, Three foot high, to Control Sand Boil at Monolith Joint 5/6, Aug. 2003

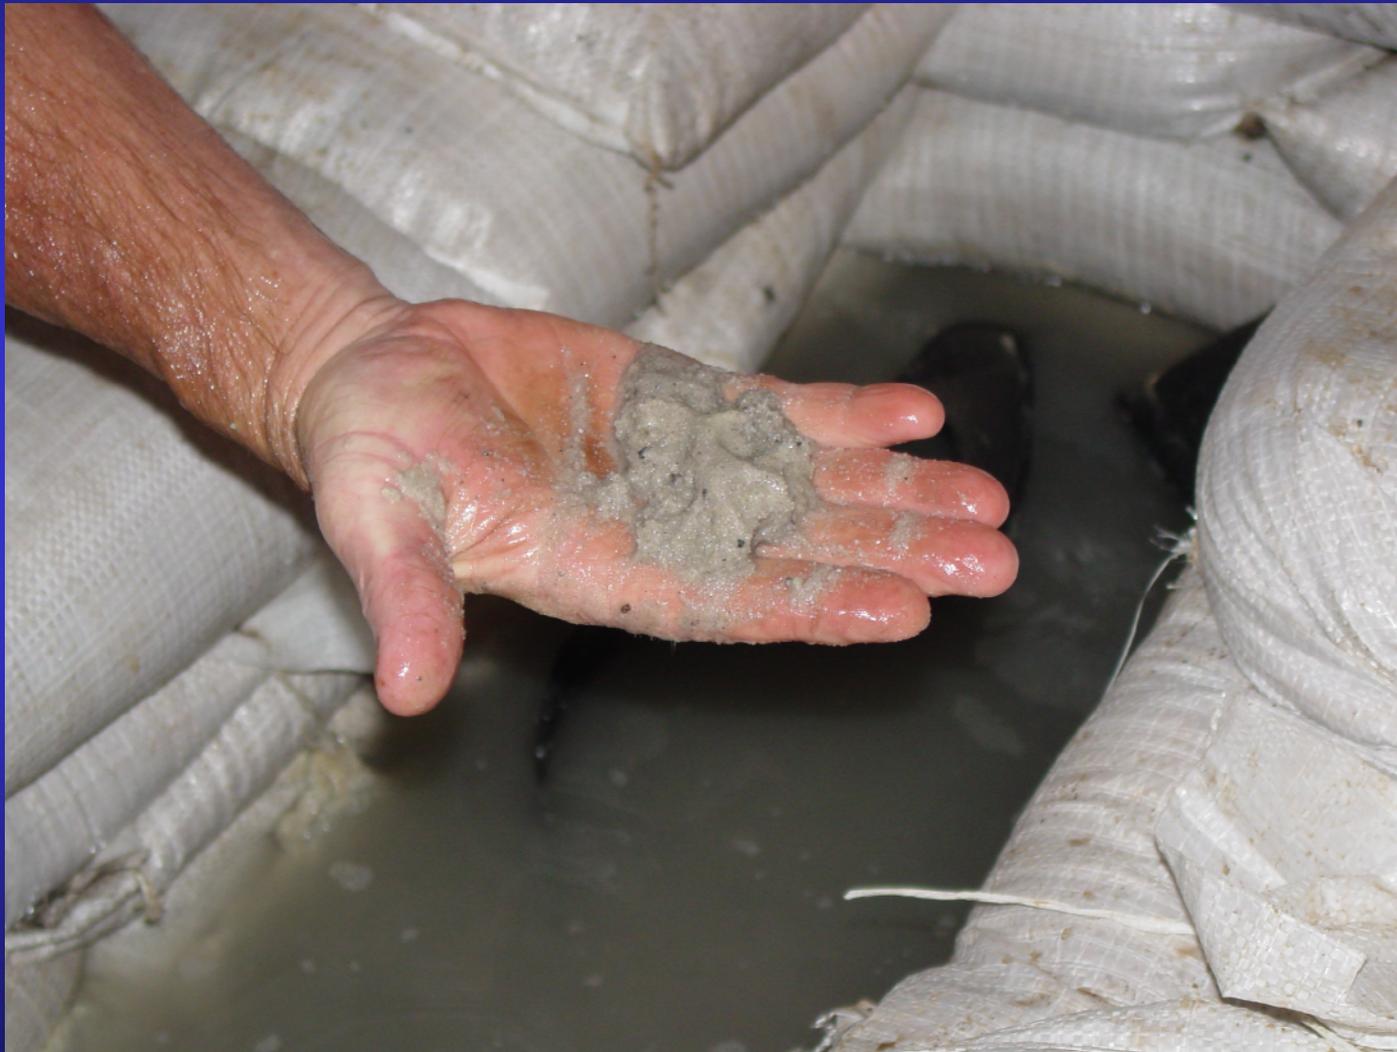
## 3/4 Cubic Yards of Foundation Sand piped through Monolith Joint 5/6, Aug. 2003

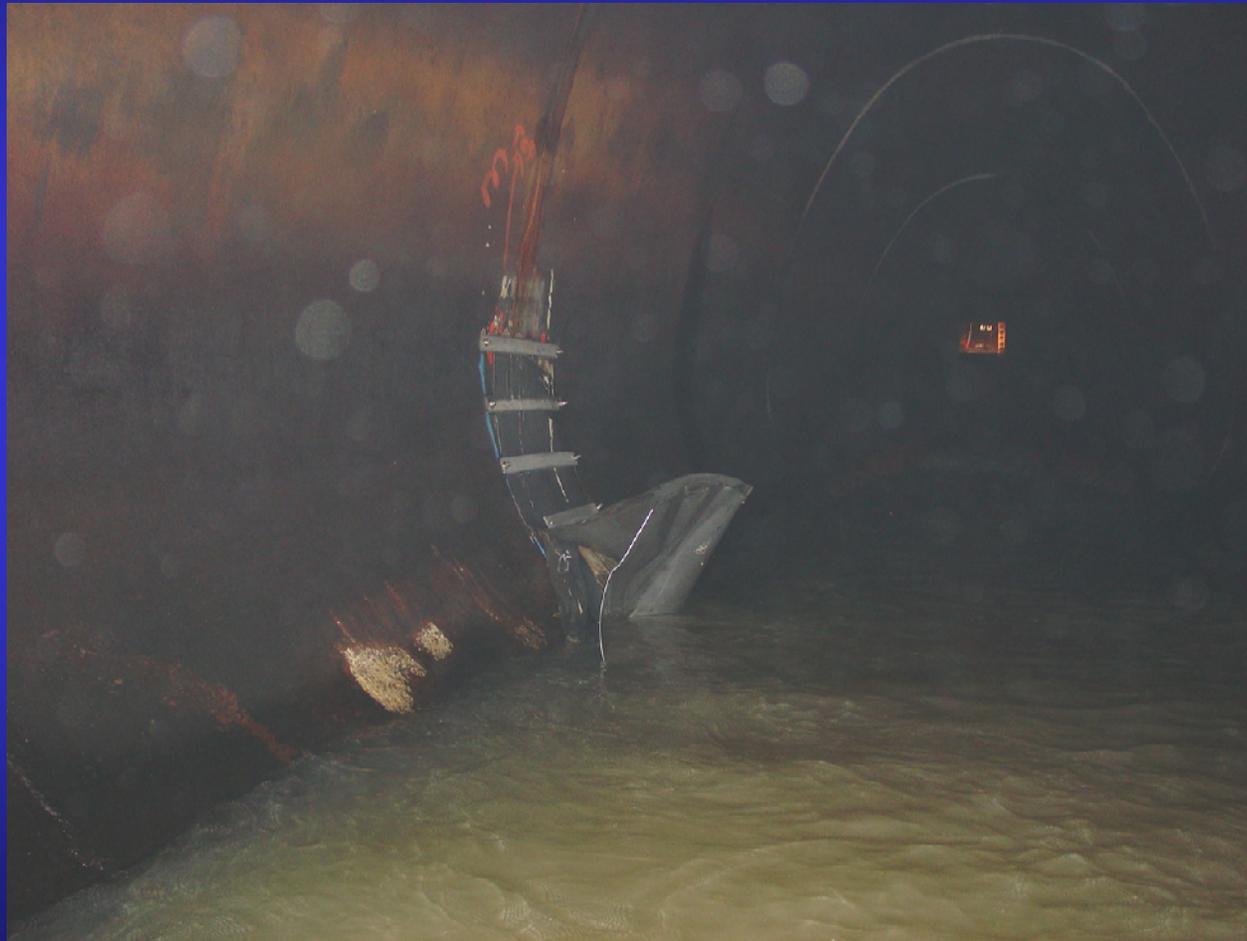
## Failure of Plate at Monolith Joint 5/6 a Few Weeks after Installation, 2 Sep. 2004

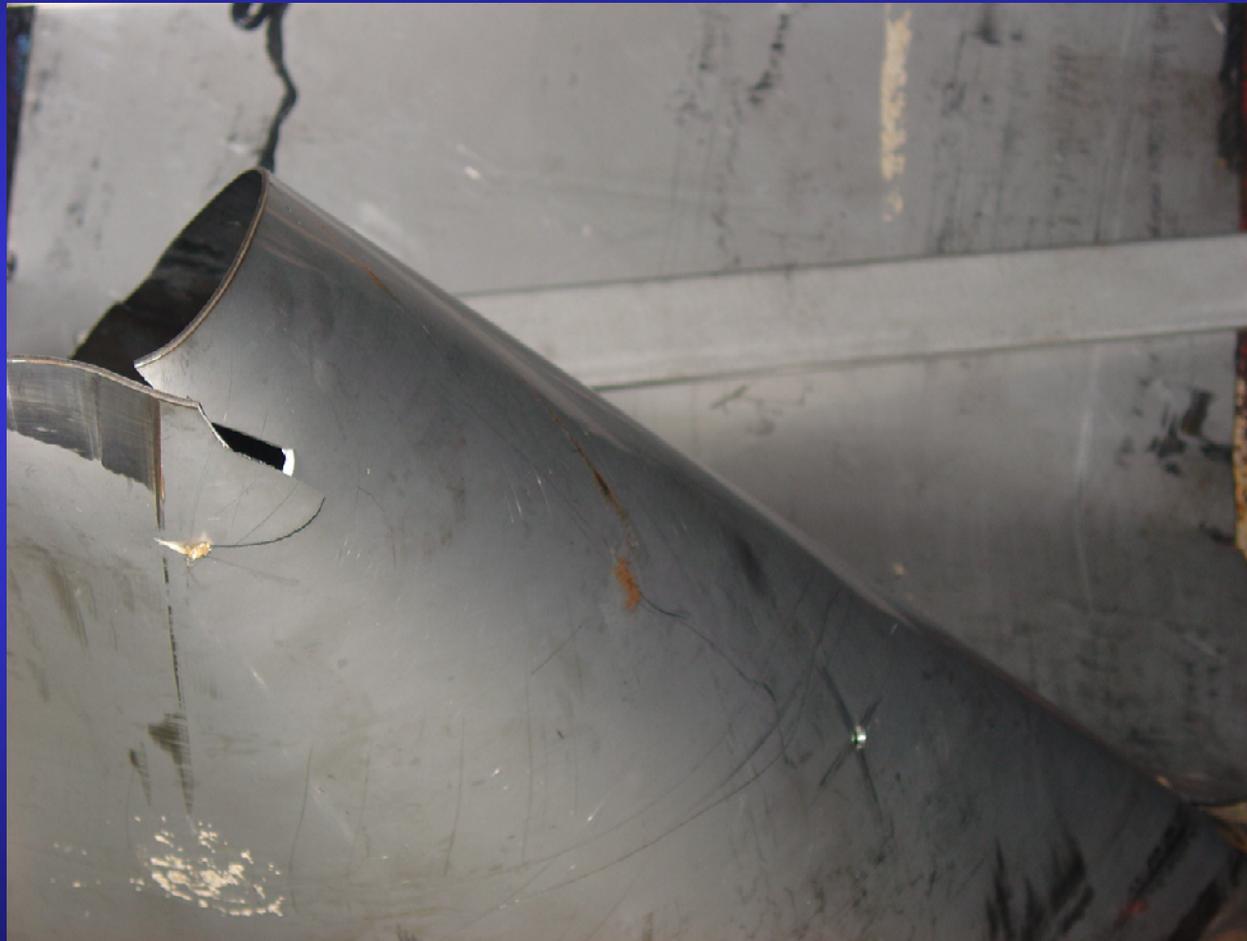
## Close up View of Stainless Steel Plate Showing Tearing and Bending of Plate, 2 Sep 2004

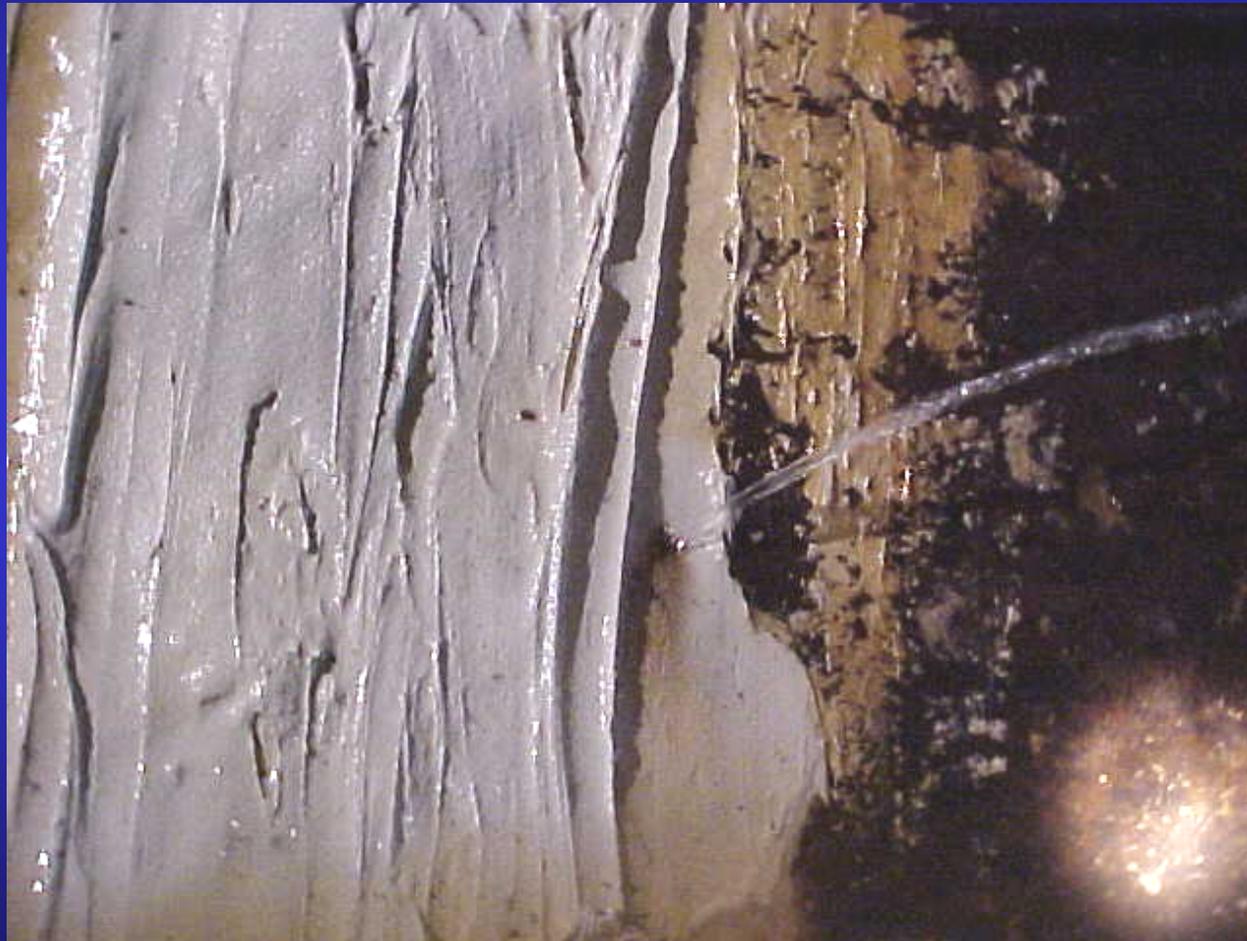
**Example of 1/4-inch diameter jets of water  
observed on 26 Jan 05 from one location Joint  
2/3 and from 3 locations Joint 3/4**

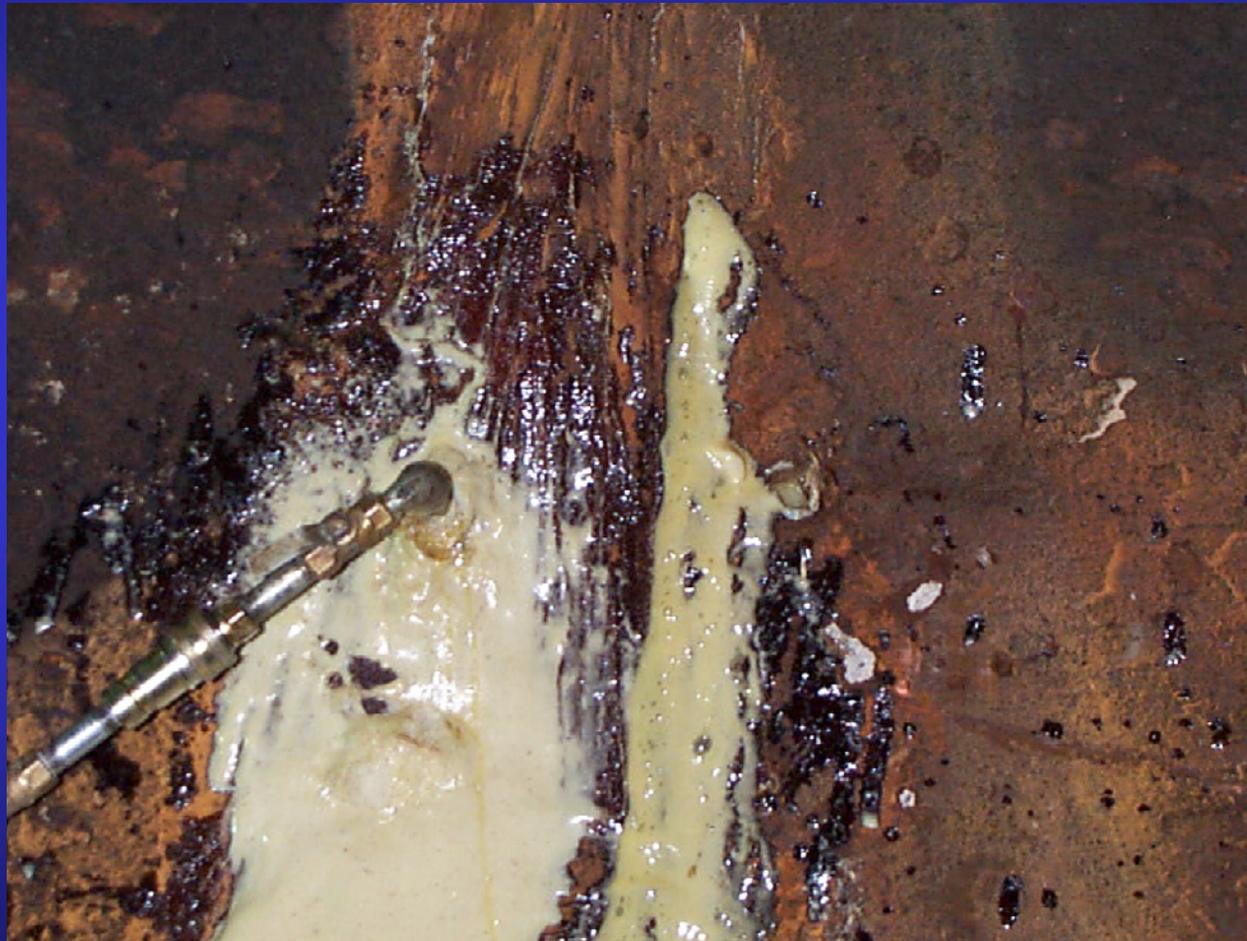
**Chemical grouting has setup after sealing off any voids in a joint or crack large enough to allow water seepage (0.02 in width).**

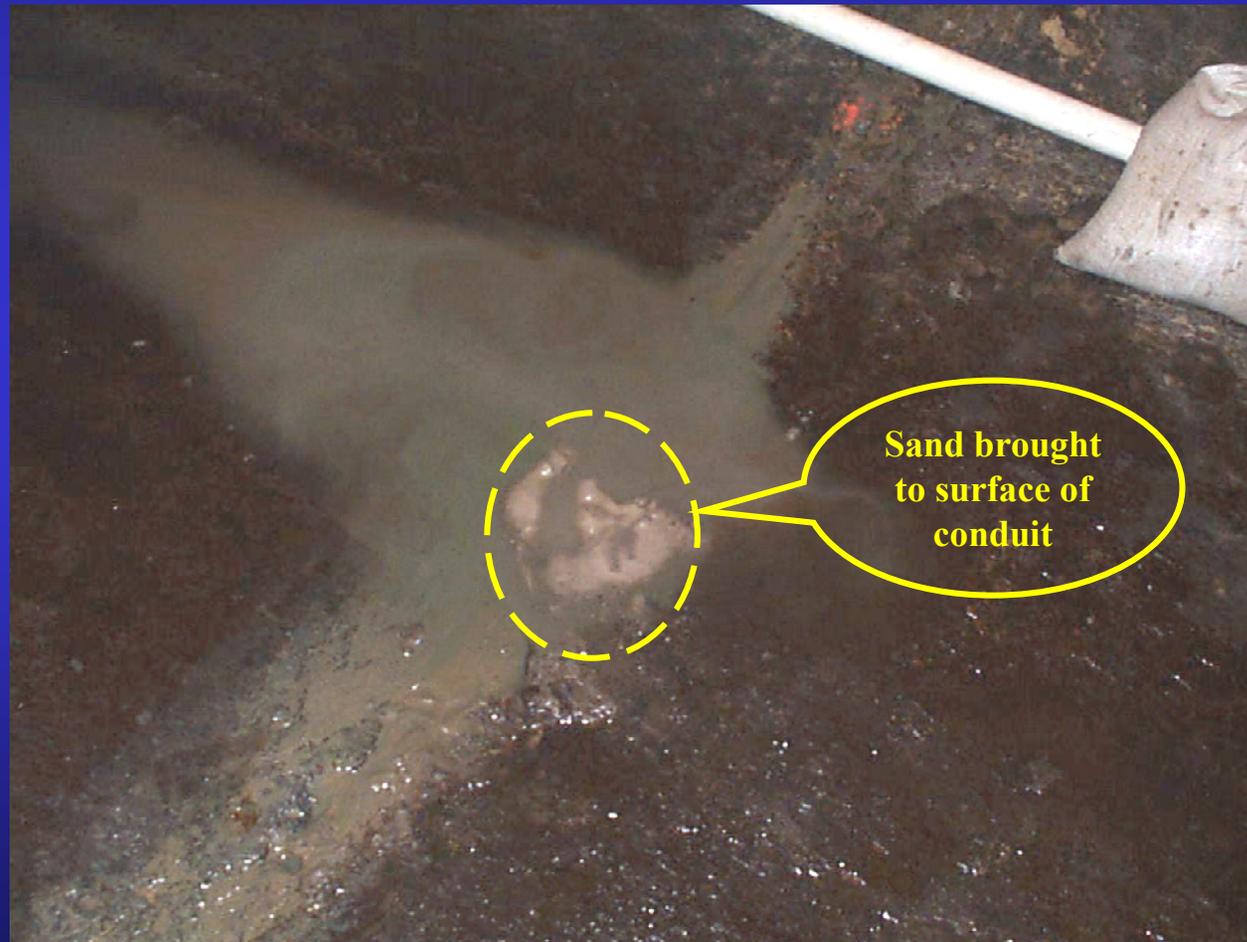
**Foundation sand being pumped at monolith joint T/1 by gases being released from chemical grout injected at monolith joint 2/3, 50 feet away, prior to grouting joint T/1.**

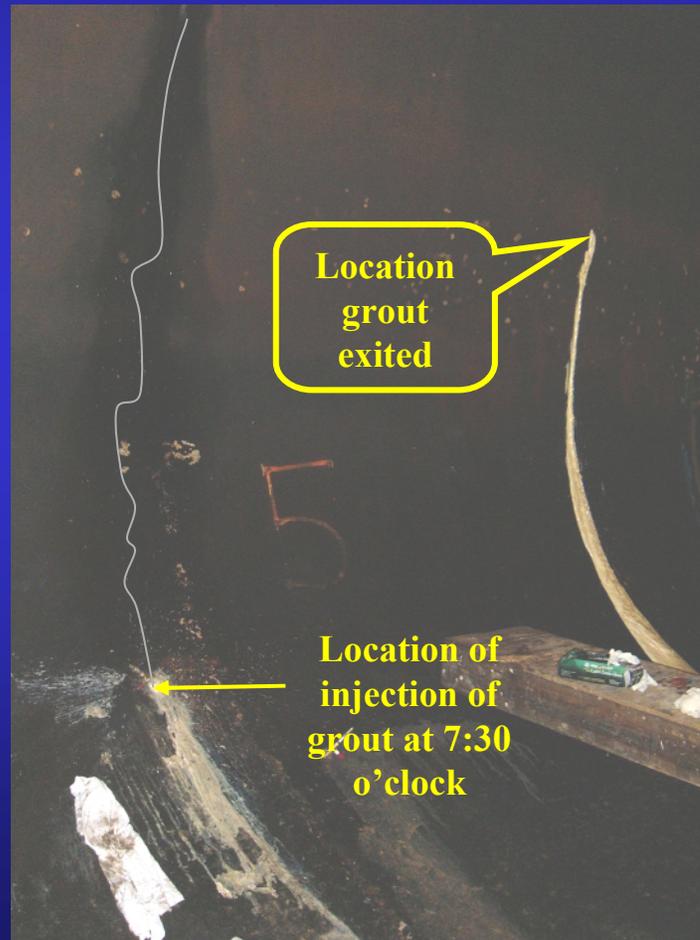
**Crack in monolith 5, the grout migrated up the crack to approx. 9 o'clock and then traveled through a zone of honeycombed concrete. Exited 7 feet downstream of crack**

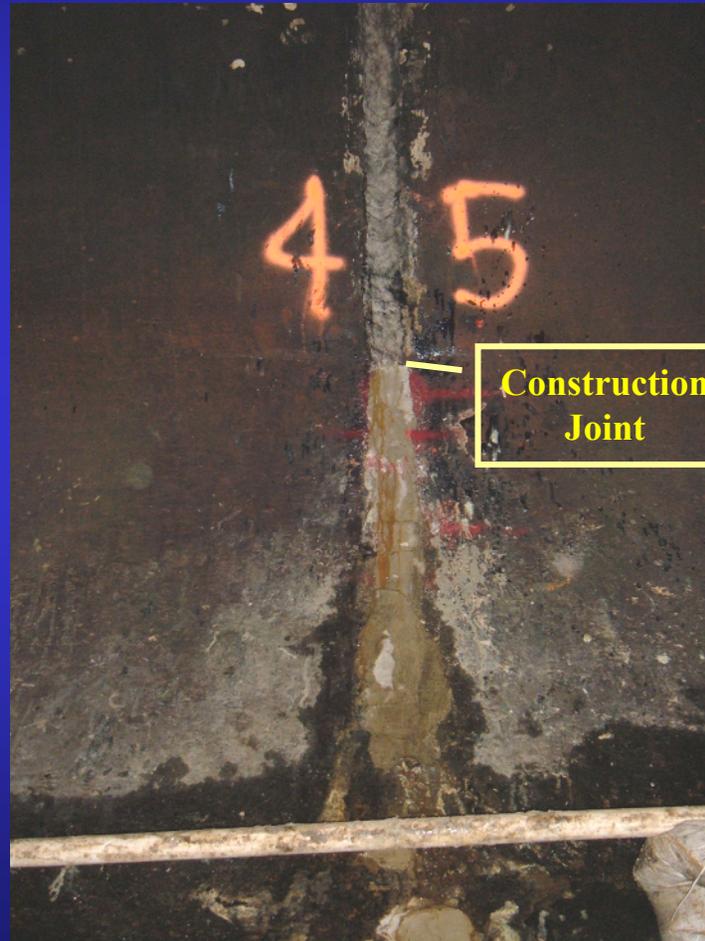
# Monolith joint 4/5 showing weeping from construction joint on left side of conduit when looking downstream, 24 Feb 05

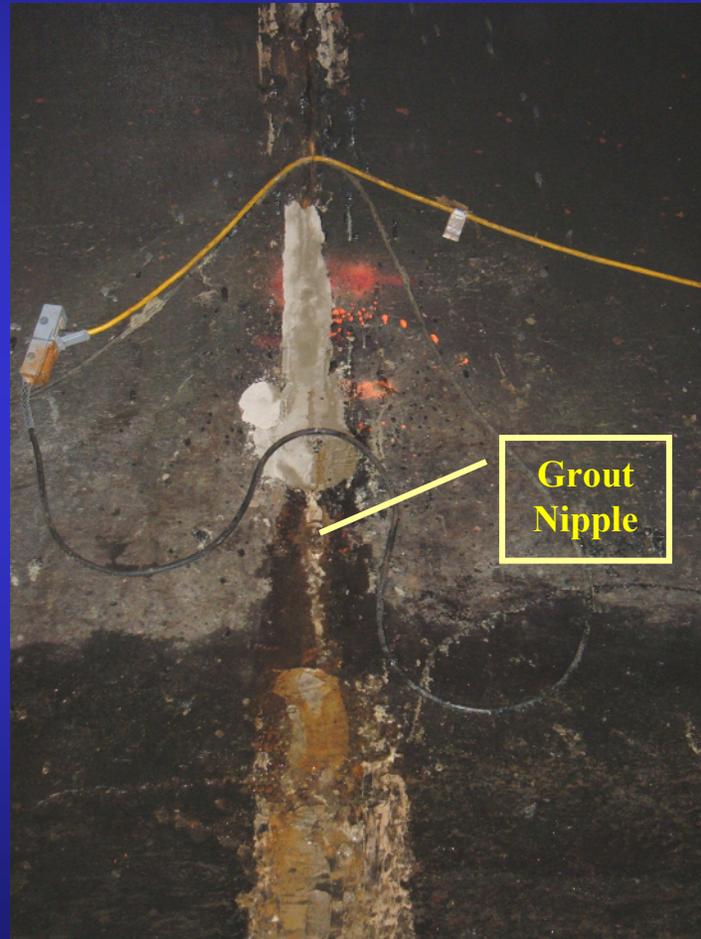
# Monolith joint 4/5 showing weeping from around grout nipple on right side of conduit when looking downstream, 24 Feb 05

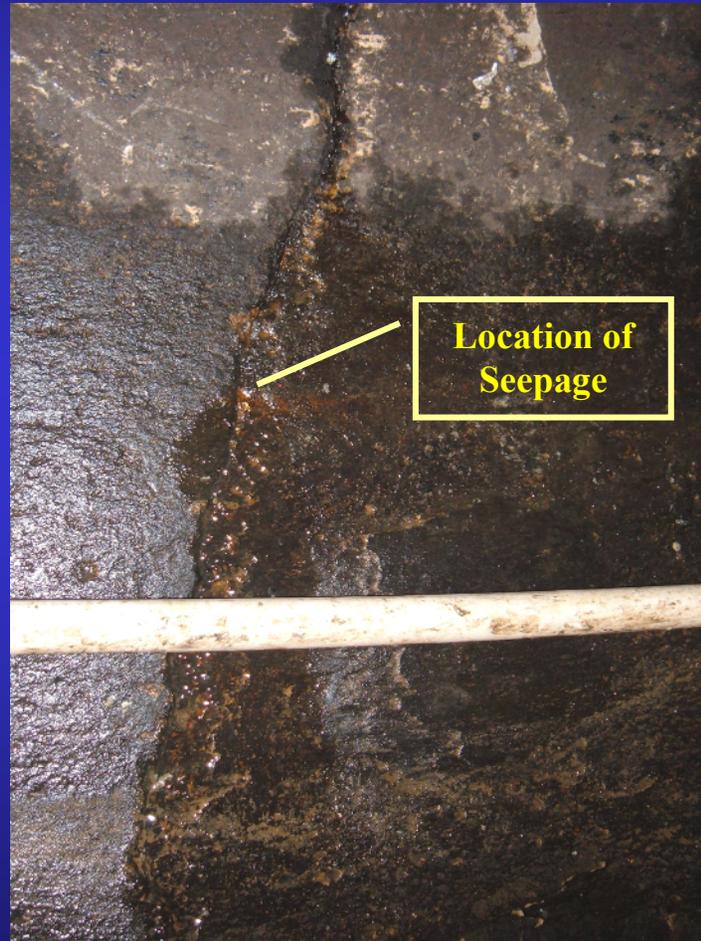
**Crack in monolith 5 which was not grouted.  
Seepage at 2 feet left of centerline when looking  
downstream, 24 Feb 05**

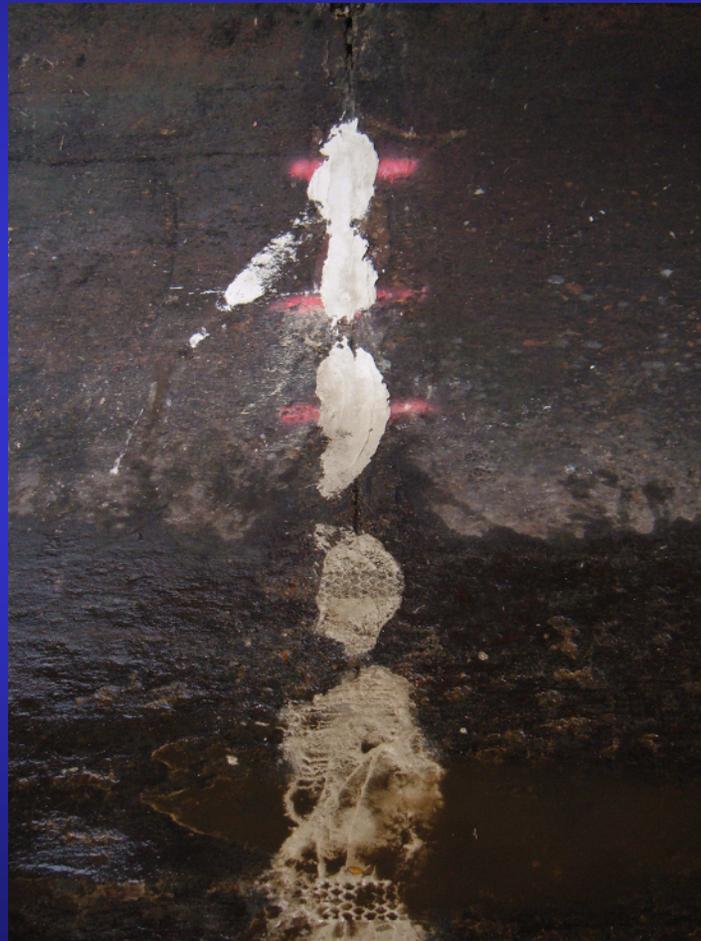
## Monolith joint 13/C showing a good seal due to the chemical grouting
