CLEARWATER DAM

Sinkhole Repair

Foundation Investigation and Grouting Project

Mark Harris, P.G. – USACE-SWL

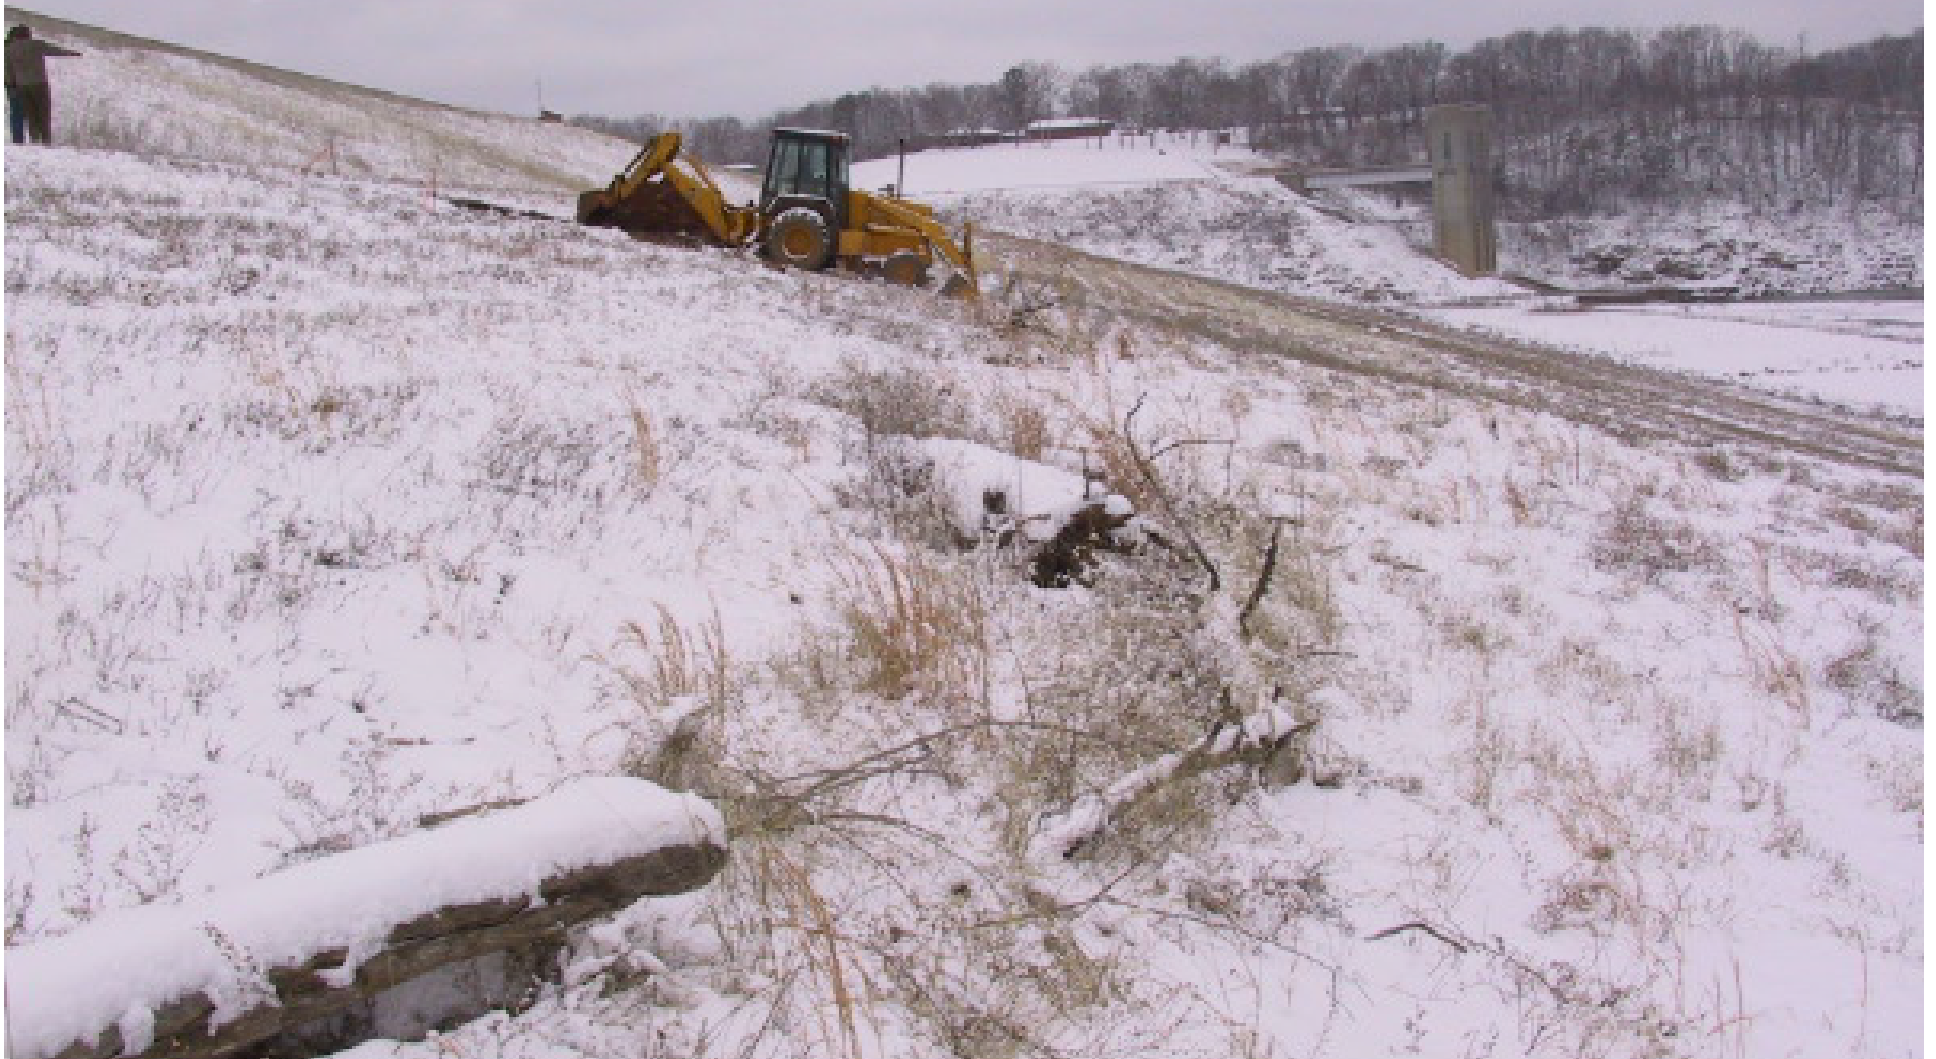
16 January 2003

Clearwater Dam - Sinkhole

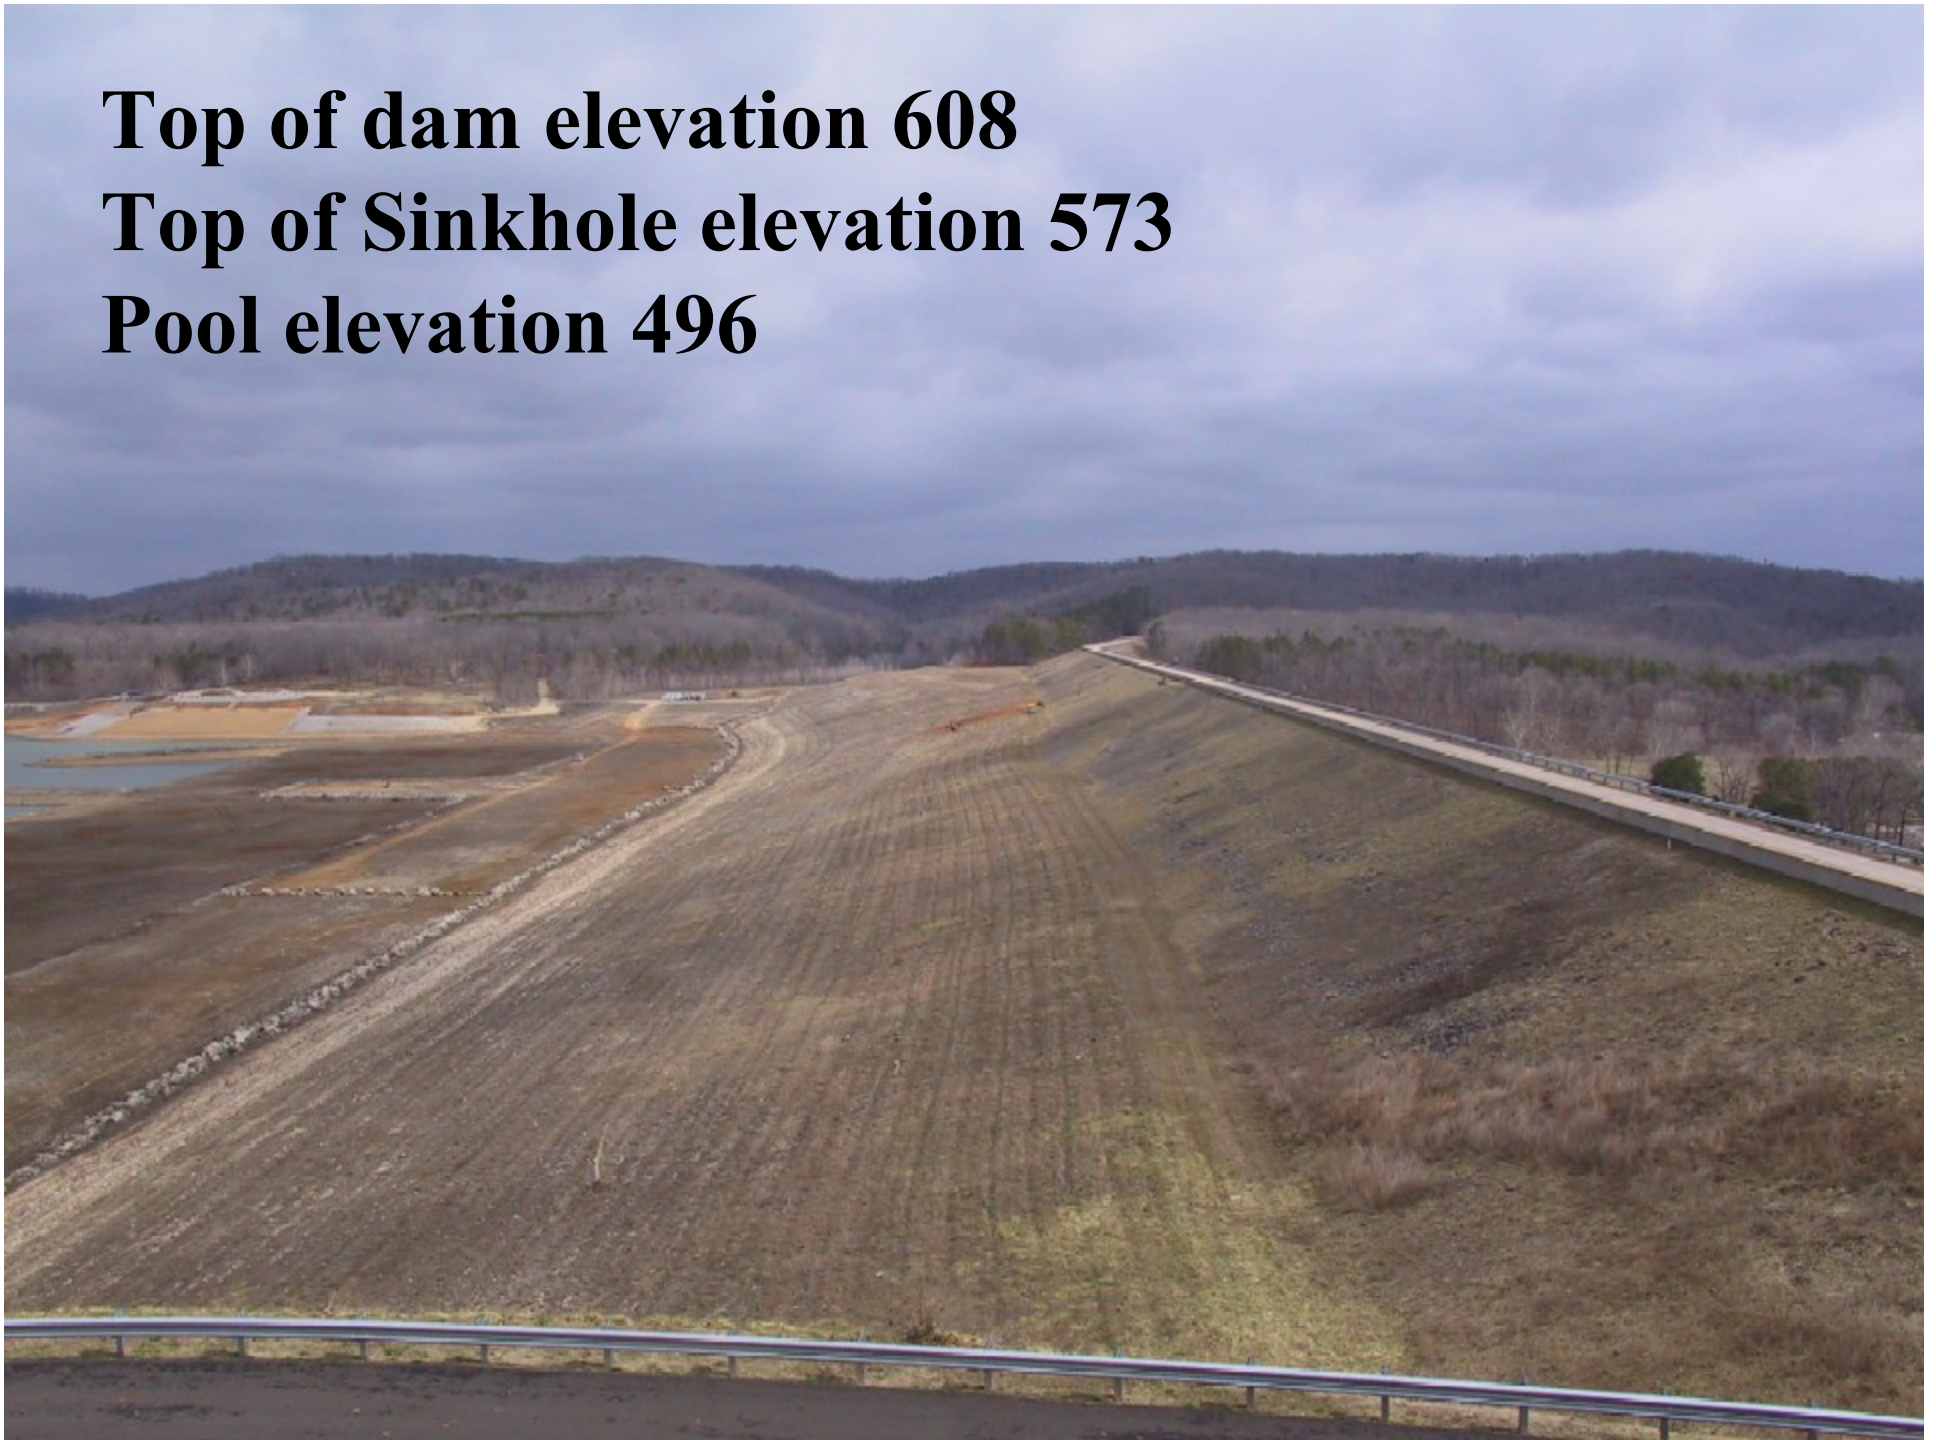
Top of dam elevation 608
Top of Sinkhole elevation 573
Pool elevation 496

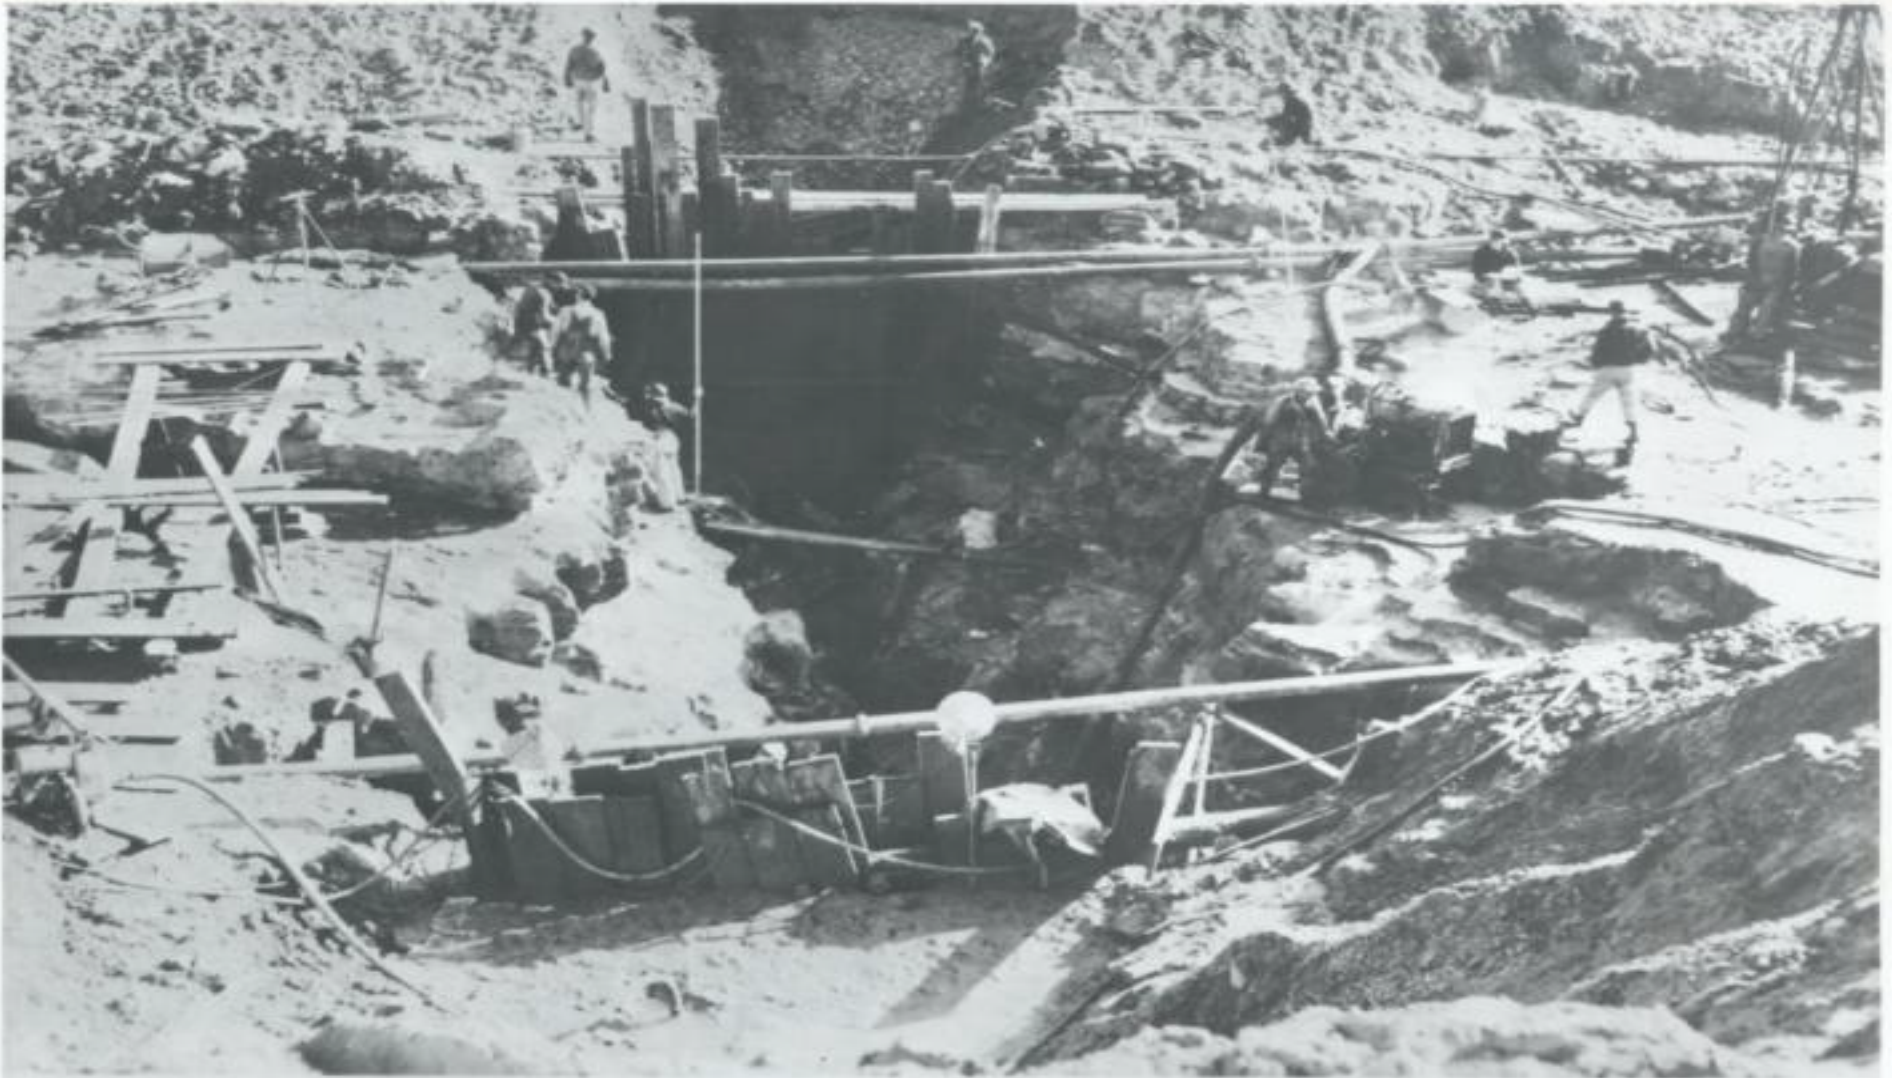
Original Construction – STA 39+20

Looking S from 175' US of station 39 / 20: Open joint in cut-off trench foundation.

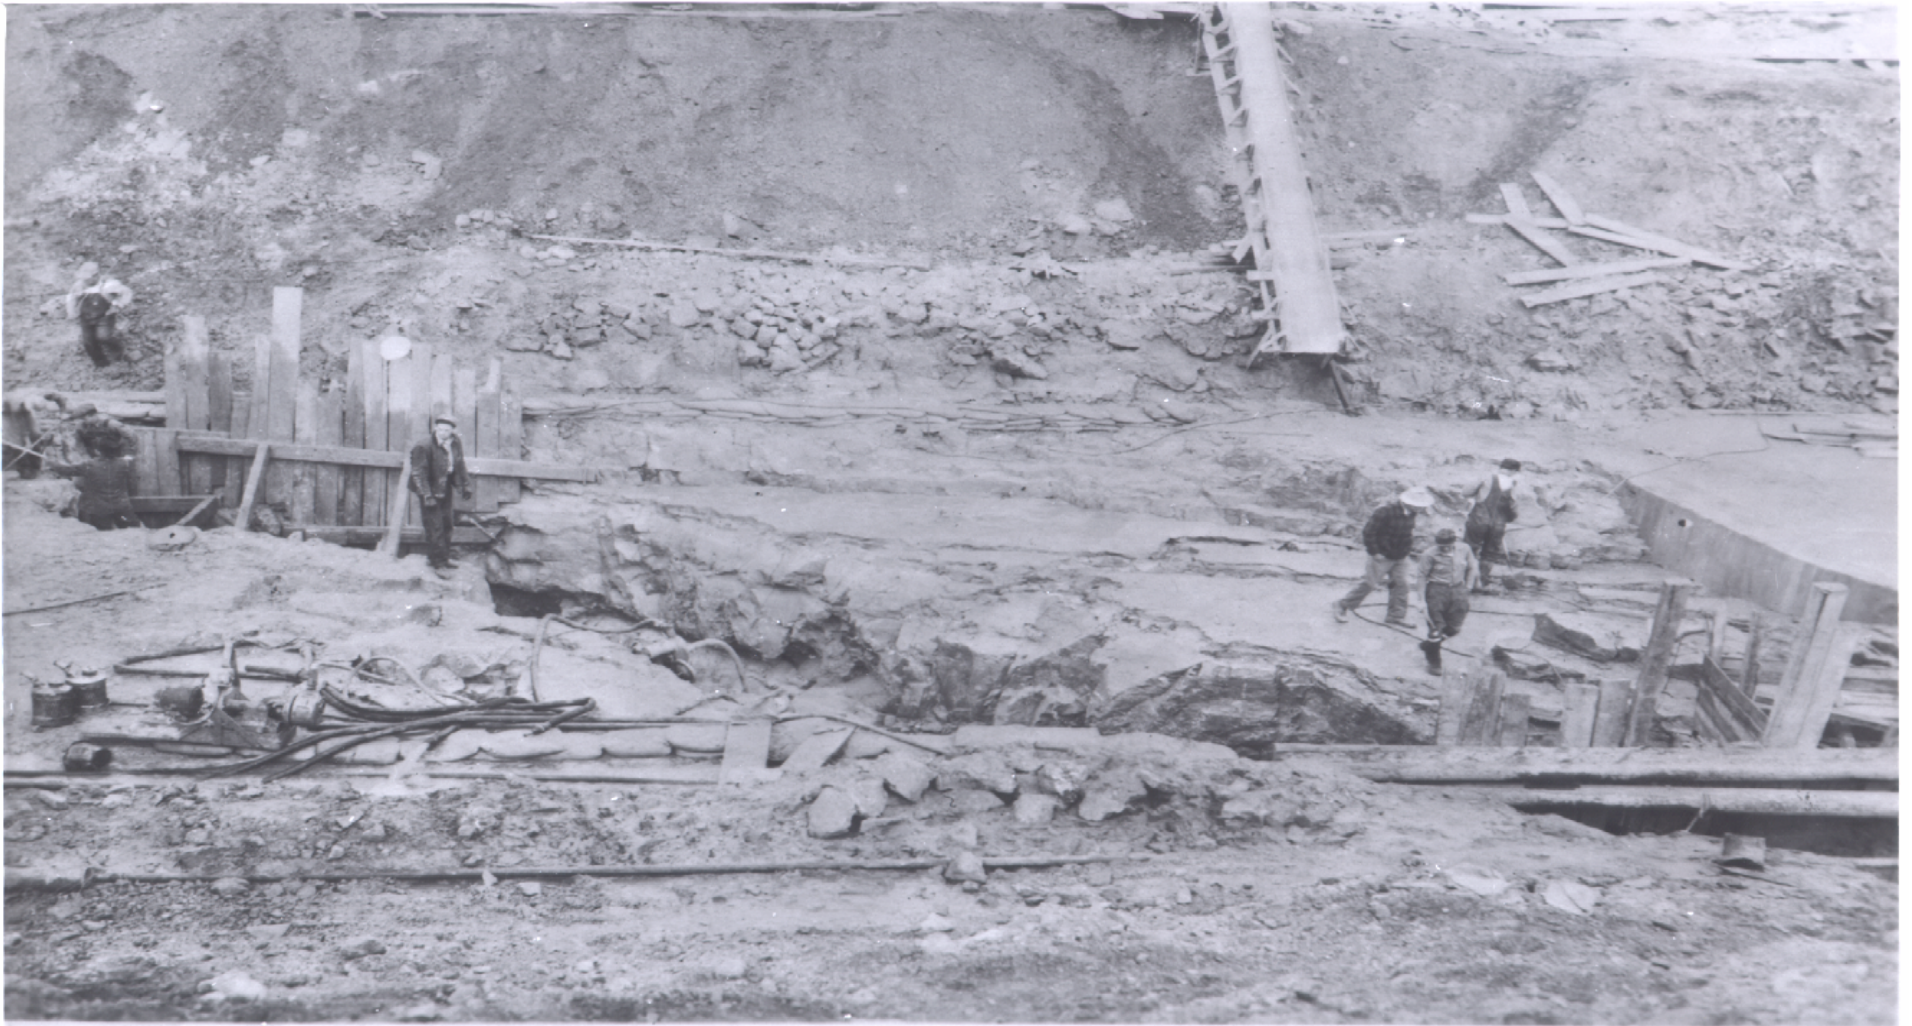
Original Construction – STA 40+15

Looking NW from 35' U.S. of station 40 / 15: Open joint in cut-off trench foundation.

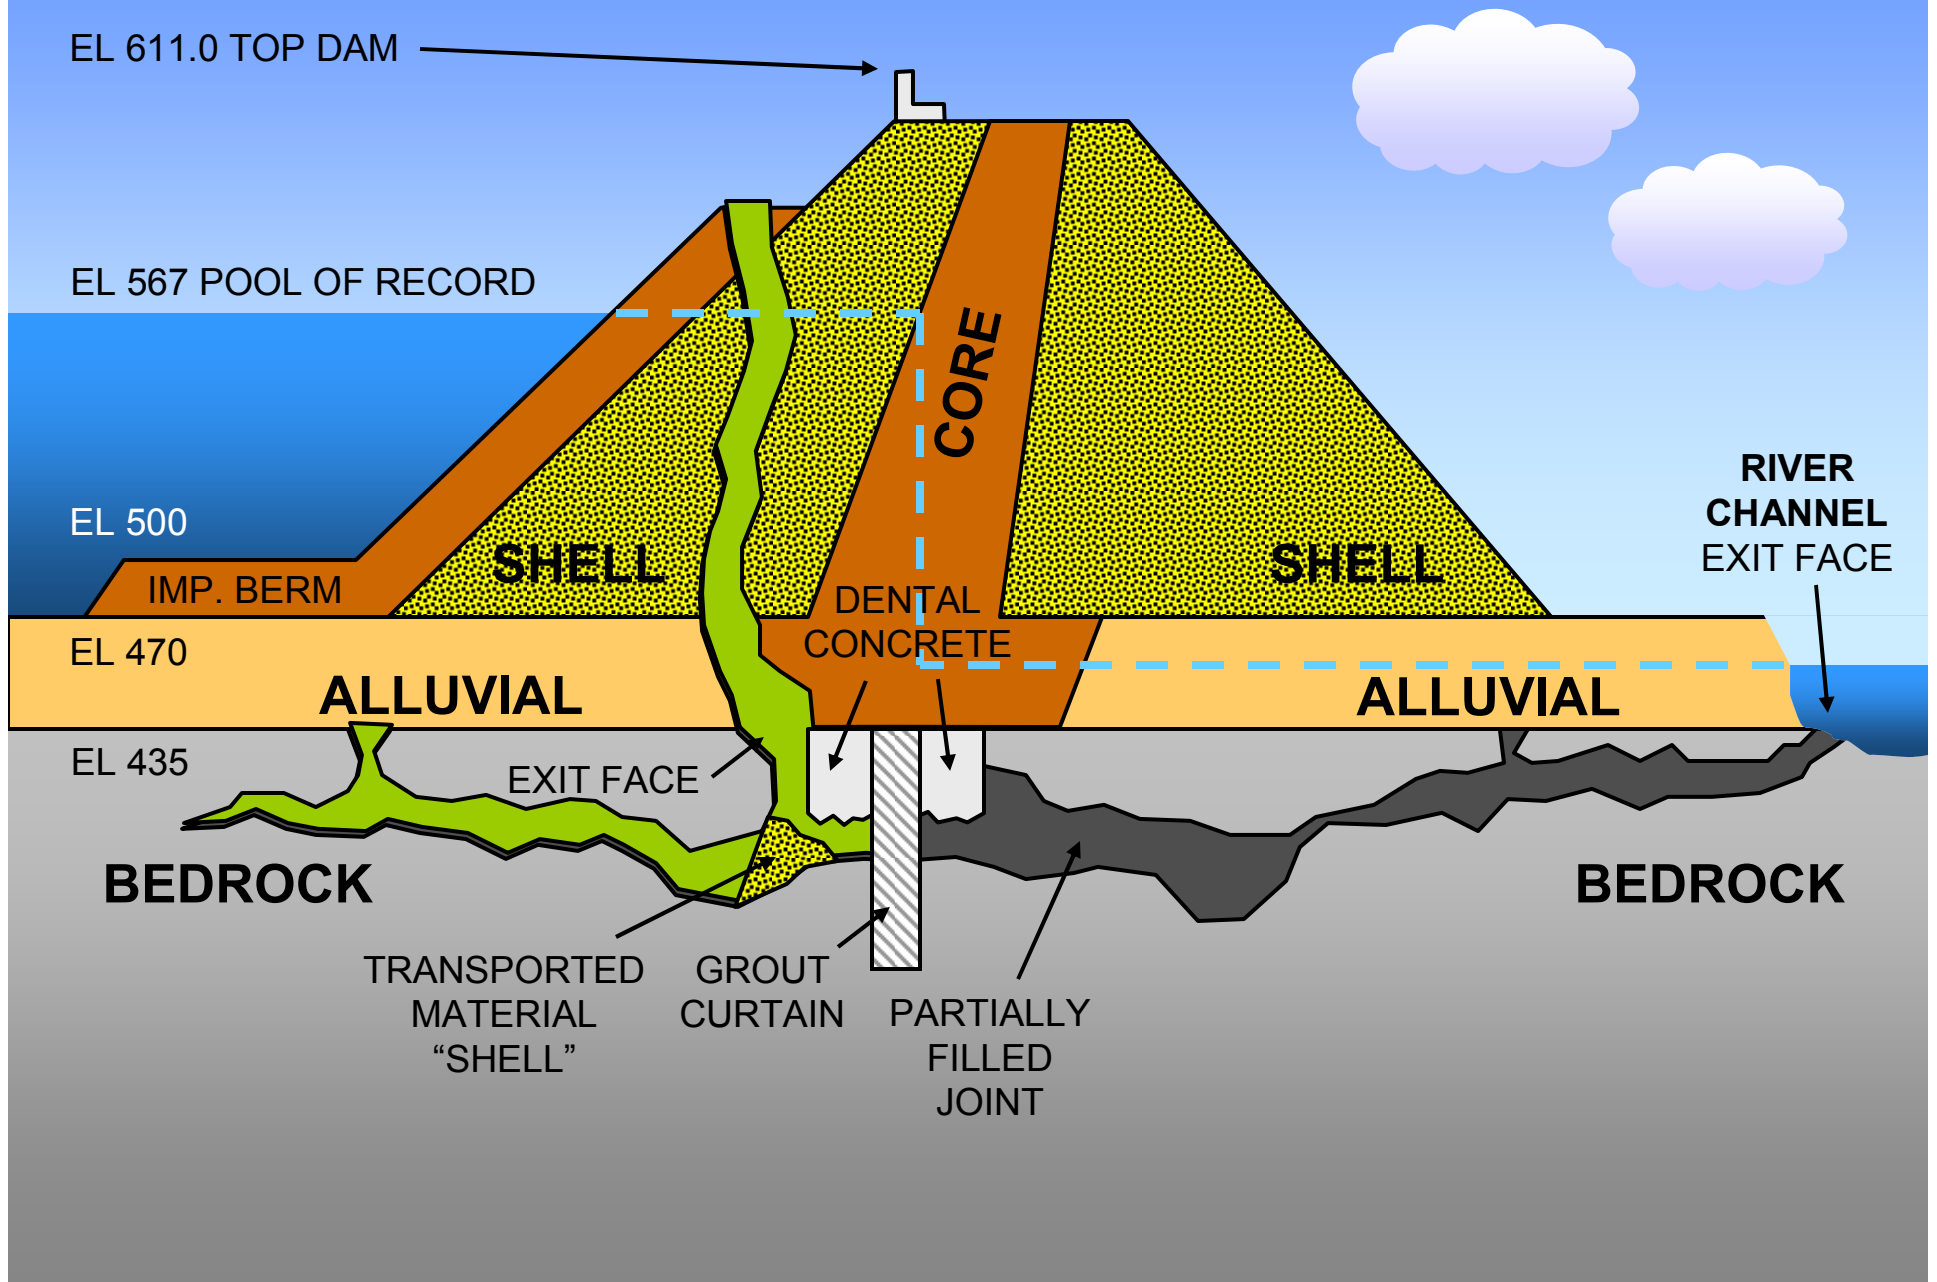
COLLAPSE INTO FOUNDATION ROCK

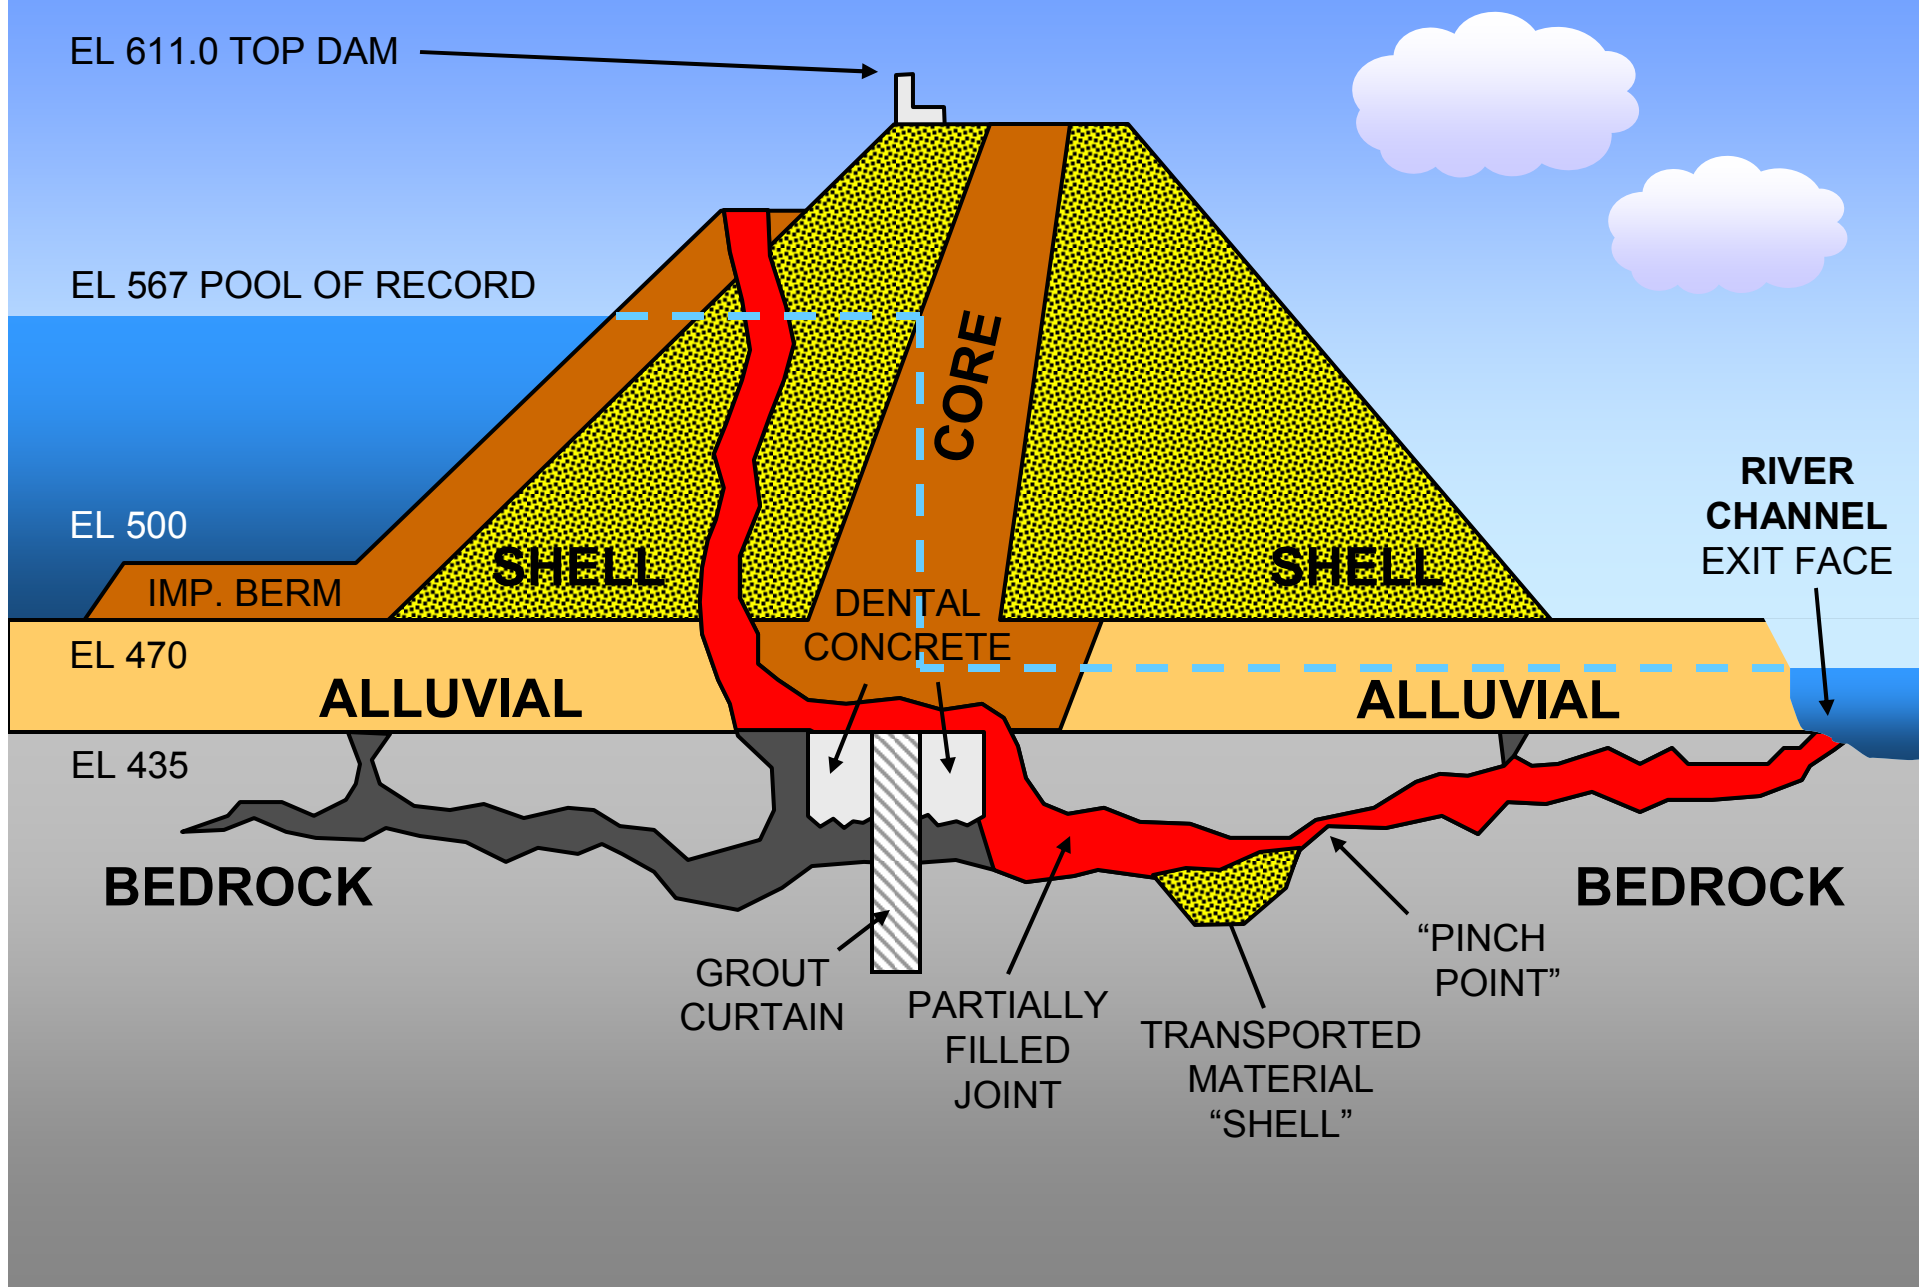
PIPE THROUGH CORE

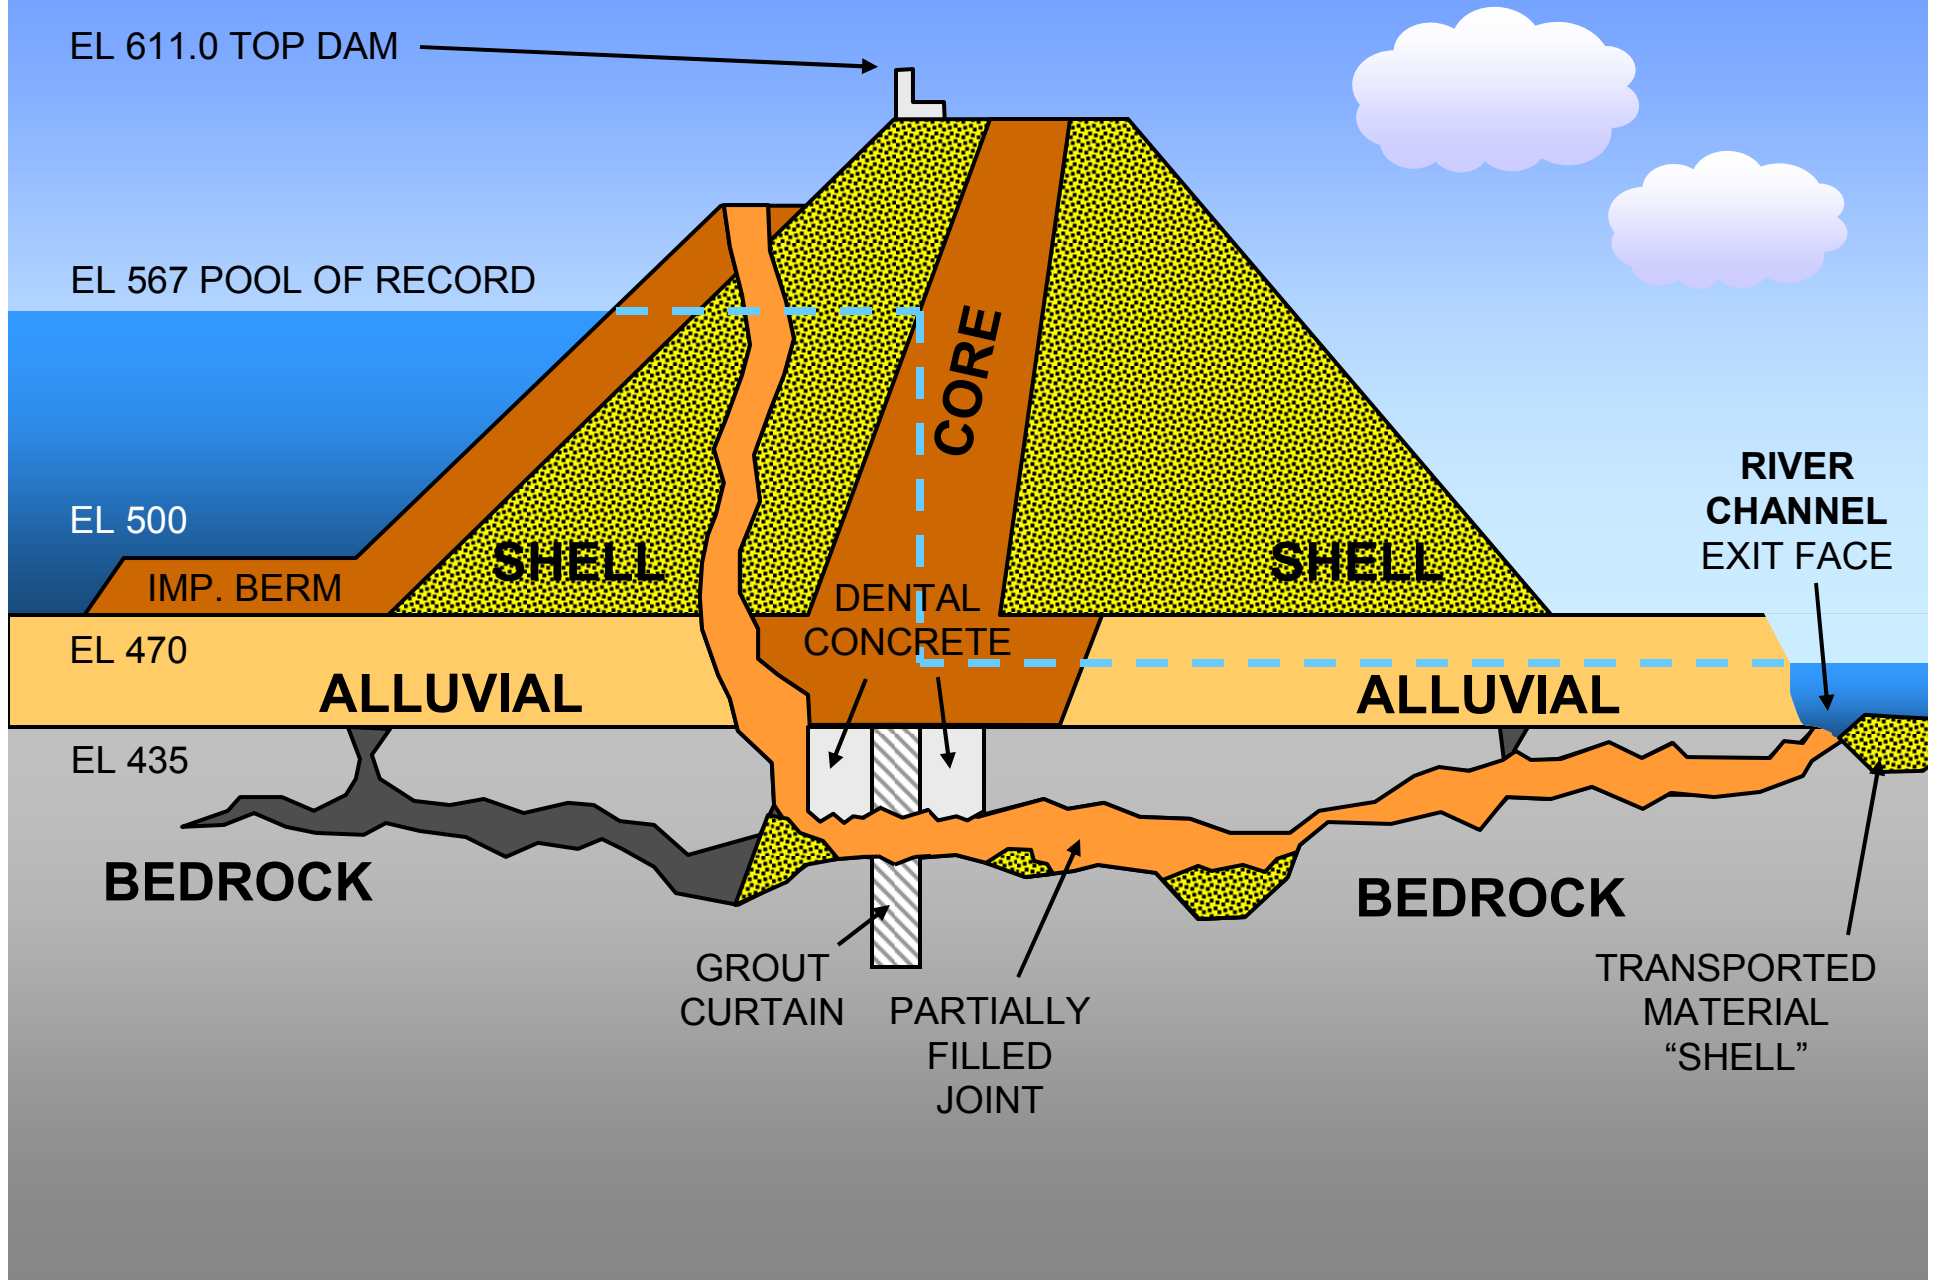
COLLAPSE AND EXIT DOWNSTREAM

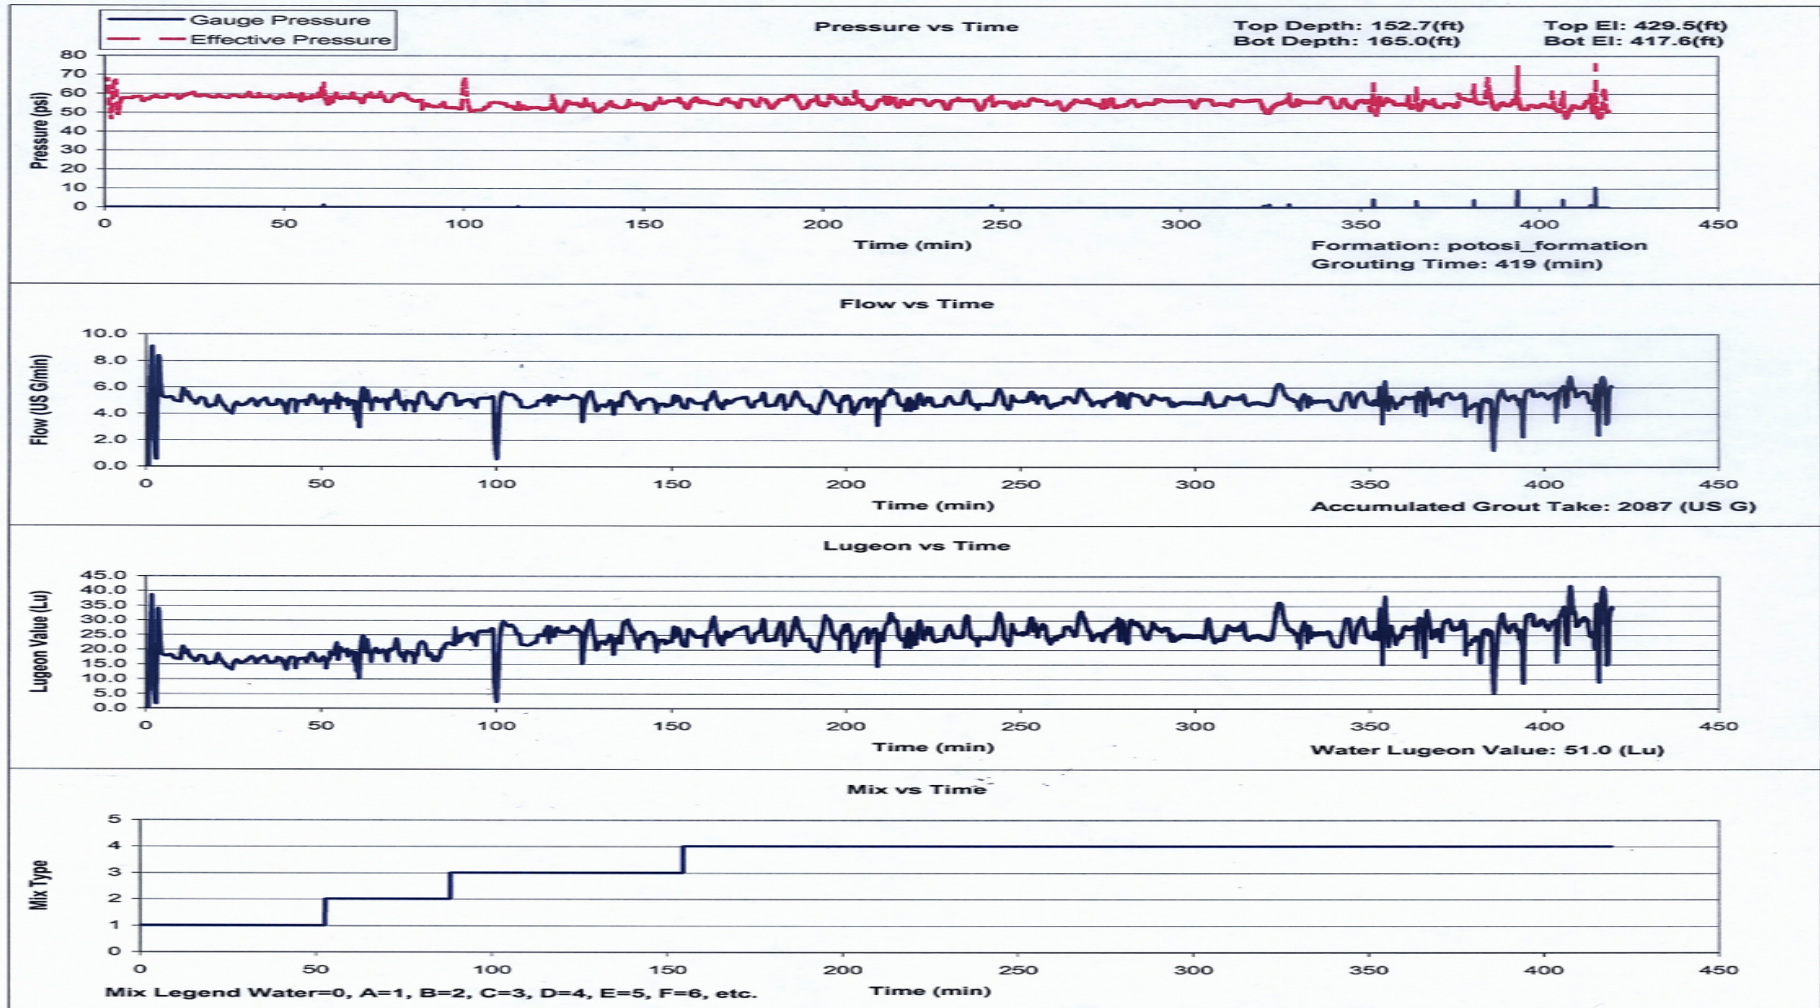
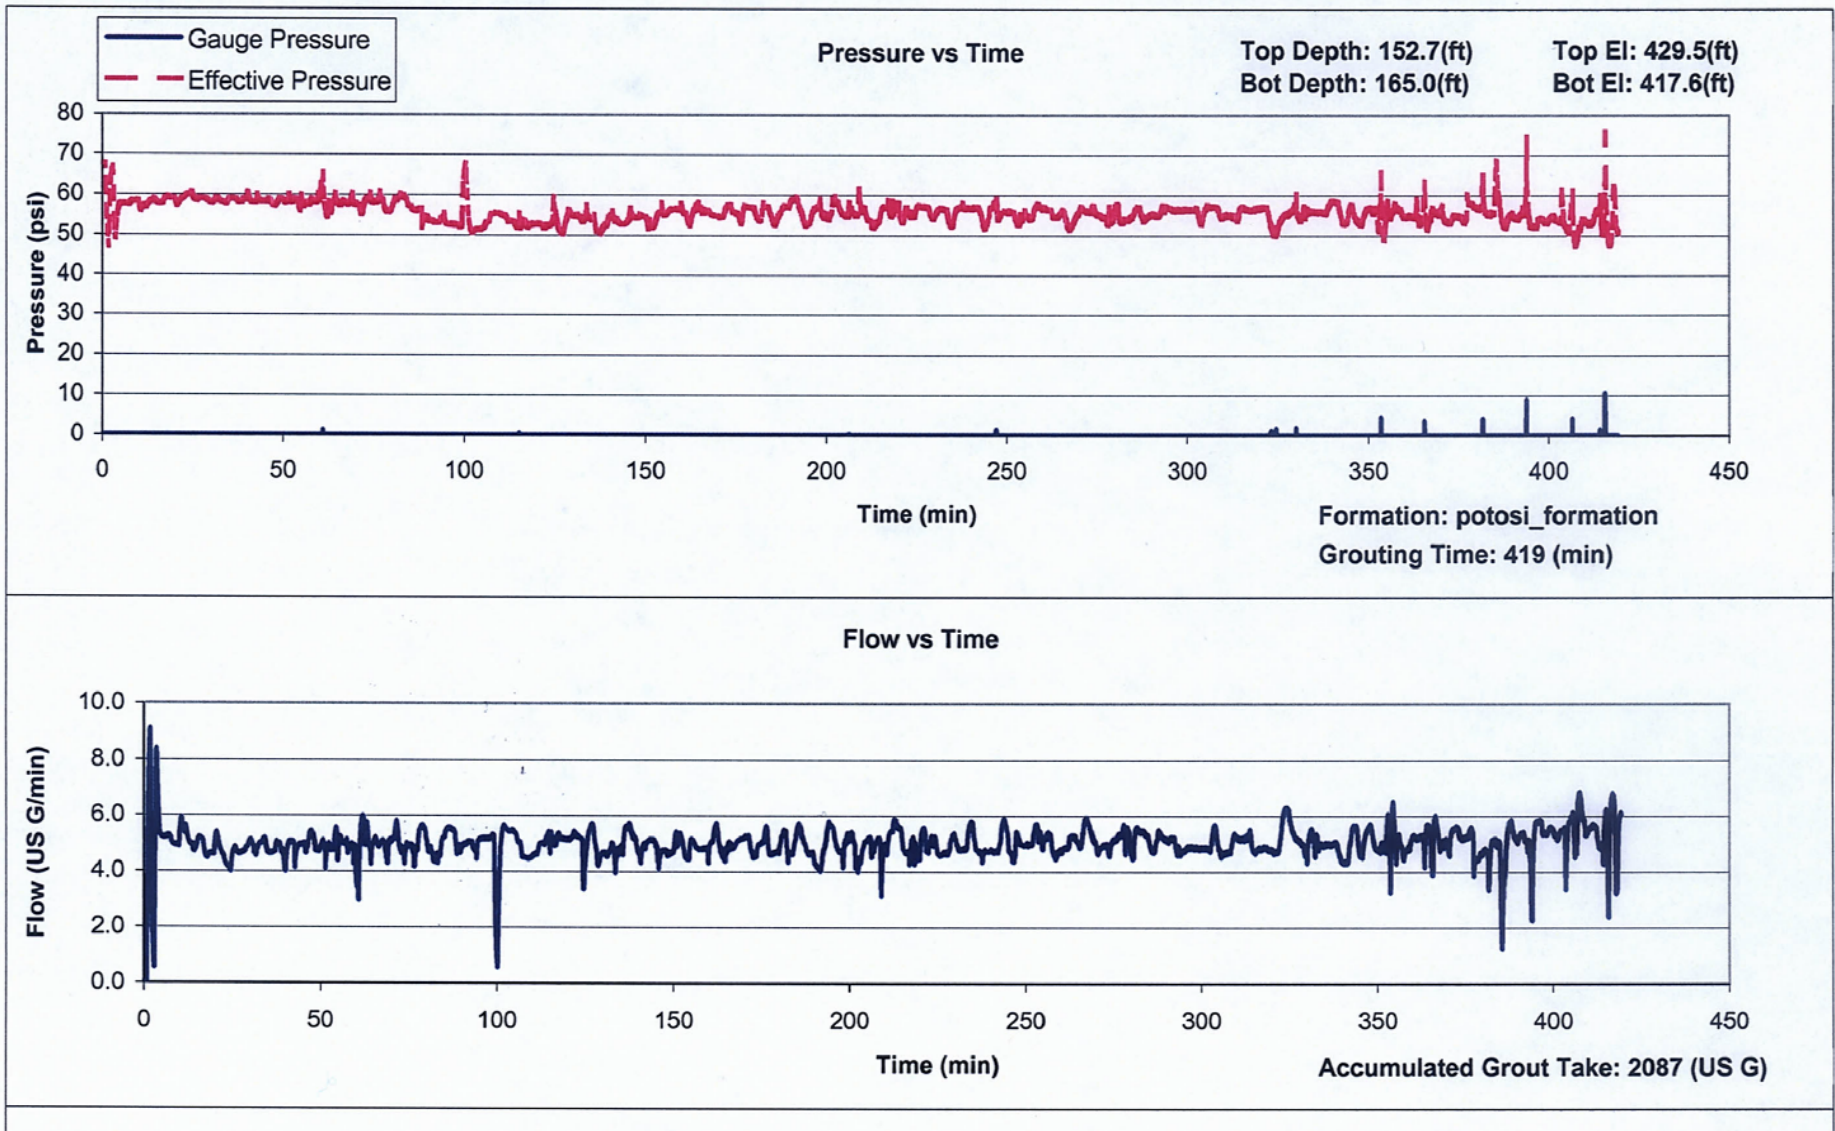
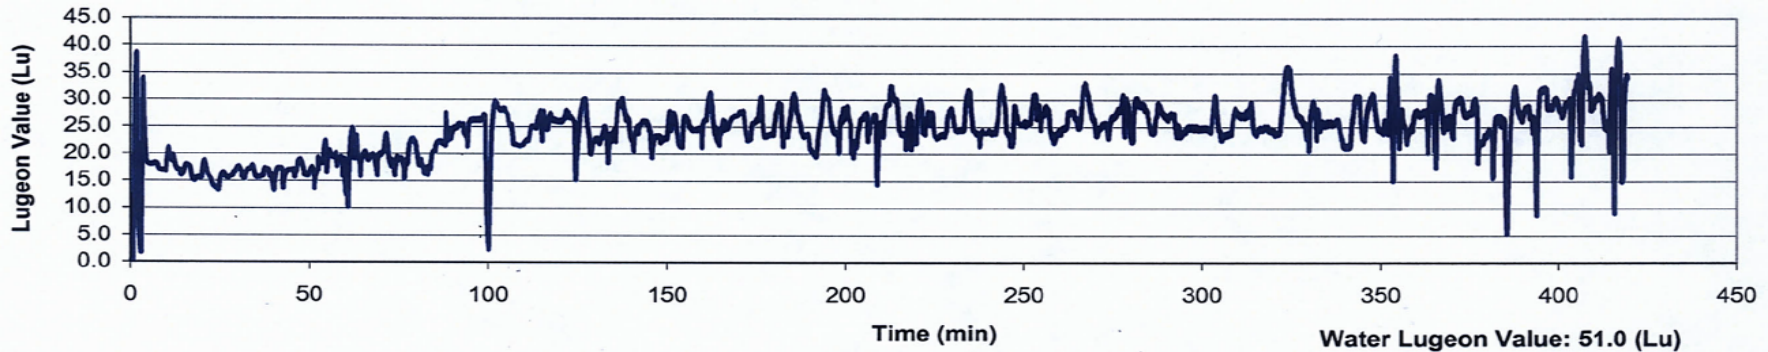
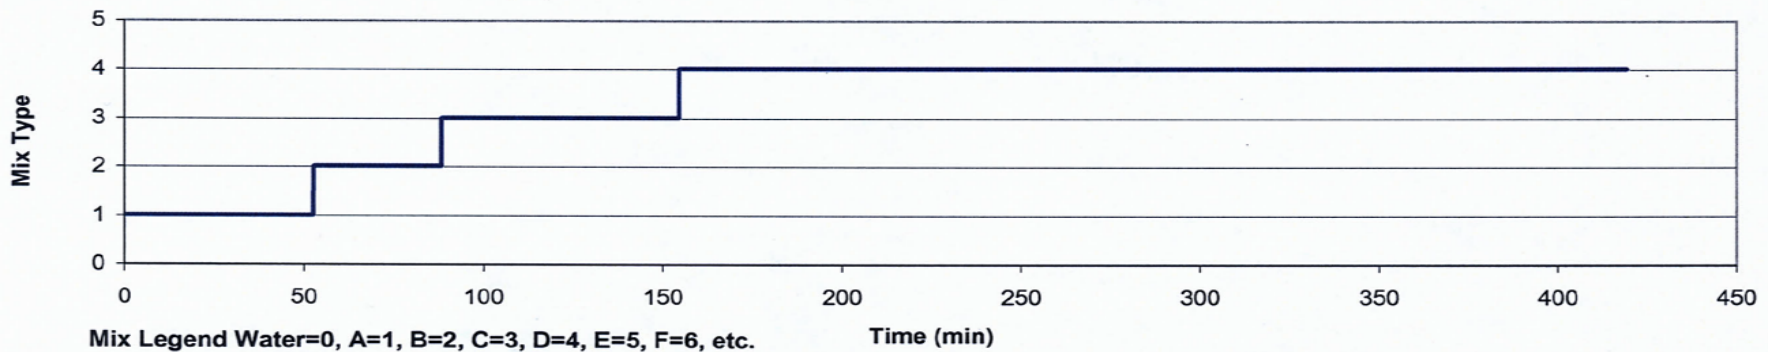
High Take – No Pressure

AP12-4	7/7/2004	Mobile-Blue Header Station - Cart 2.
AP12-4	7/7/2004	Packer set at 145'
AP12-4	7/7/2004	Stopped at approximately 2000 gallons for the day as agreed upon by ACT and COE.
AP12-4	7/7/2004	Stage NOT Complete.
AP12-4	7/7/2004	Tremied 10 gallons from time 0 to 1 minute. Inflated packer and started to Re-Grout at 2.5 minutes.
