Structural and Geotechnical Issues Impacting The Dalles Spillwall Construction and Bay 1 Erosion Repair

Jeffrey M. Ament, PE
U.S. Army Corps of Engineers,
Portland District
(503) 808-4950
Jeffrey.M.Ament@usace.army.mil

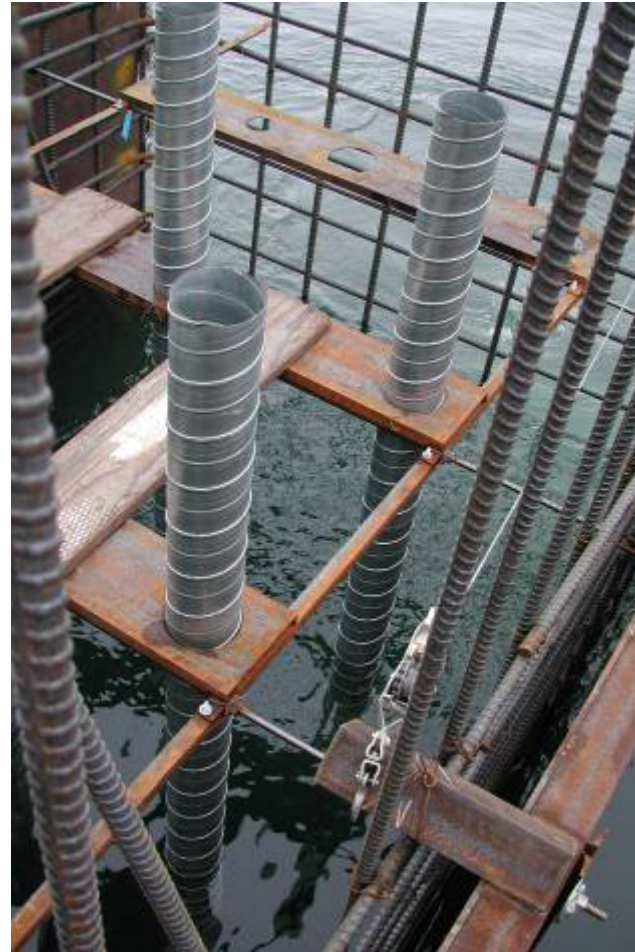
Rock Bolt Ducts

- Spiral wound steel ducts, used in prestressed concrete industry, specified as option for contractor
- Difficult to hold alignment during concrete placements
- Lesson learned: not a good choice for drilling through

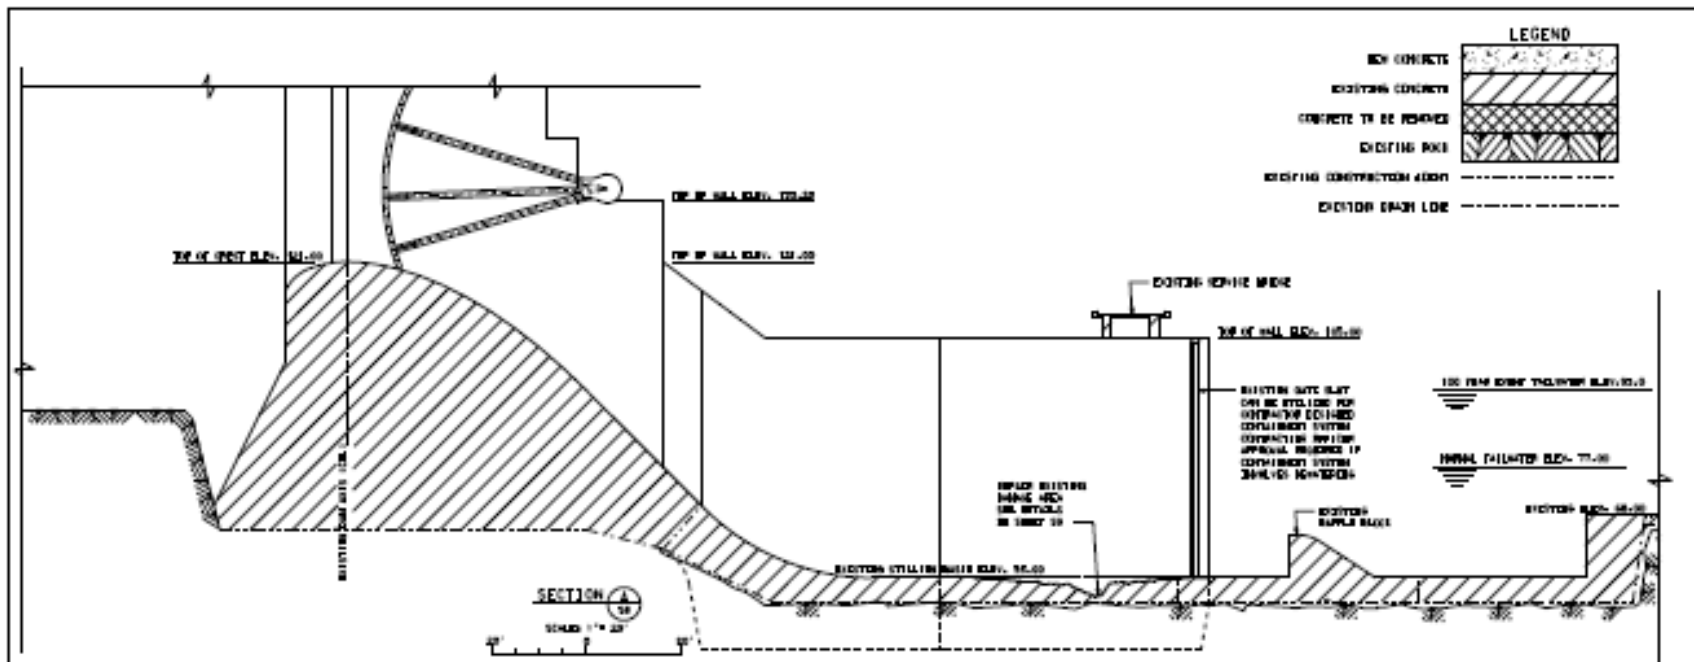
Bay 1 Stilling Basin Erosion Hole Repair

- 4' Deep Hole in 5' Stilling Basin Slab

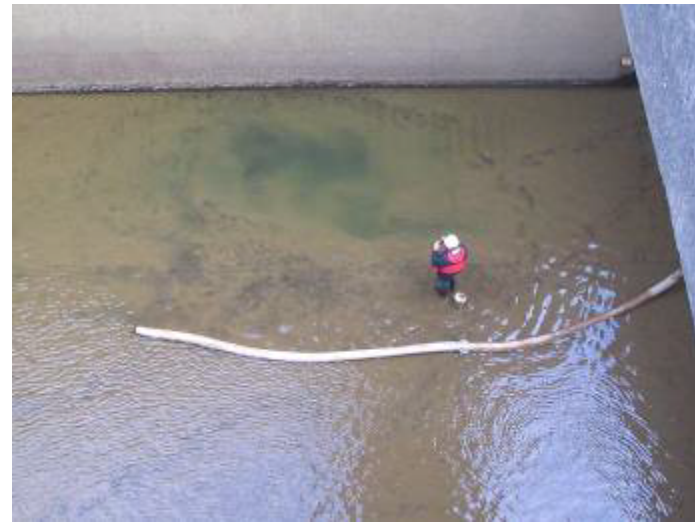
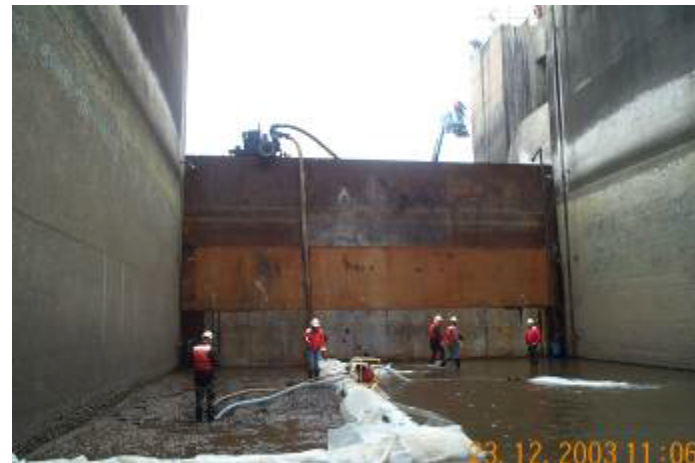
Contractor Chose to Dewater

- Very difficult to dewater
- Water coming in from:
 - Wall joints
 - Floor joints, Floor slab drains pressurized with tailwater
 - Contractor Temporary Bulkhead

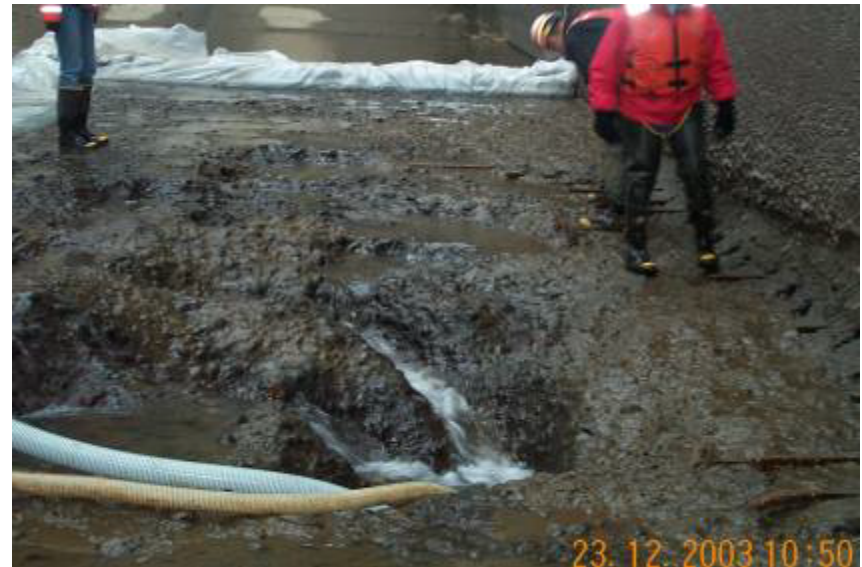
Causes of Erosion

- Not likely ball milling from large objects
- Possible erosion from
 - Small particles
 - Hydraulic conditions around wall
 - Poor initial concrete placement

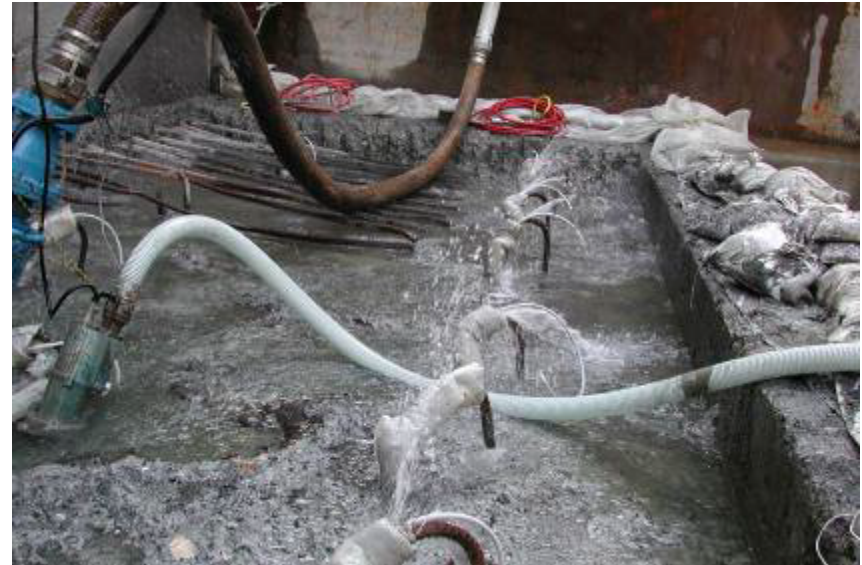
Dowels into Rock

- Holes drilled into rock giving water
- Grout socks used to enable placement of dowels – providing mechanical anchorage
- Dowels still gave water
- Average dowel tested – withstood ~10 kips before hook bent and test suspended, dowels declared acceptable

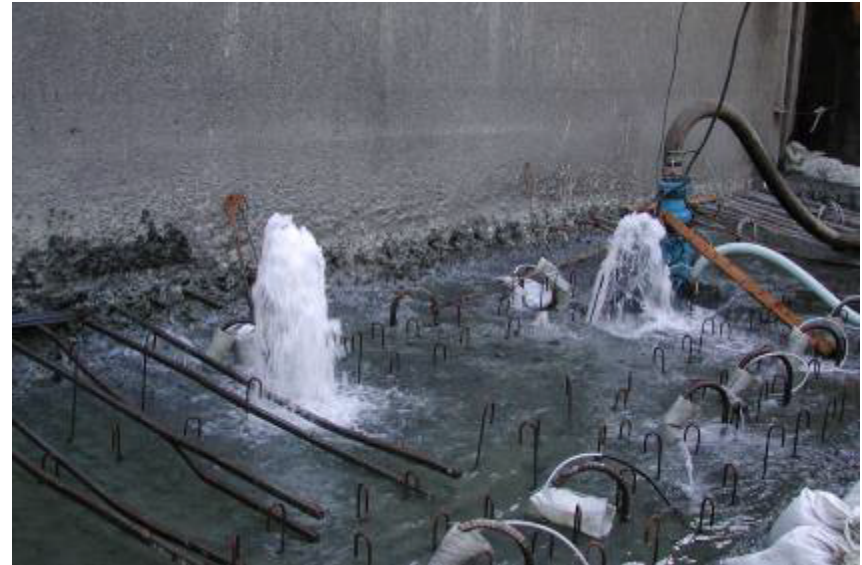
Dowels into Concrete

- Some holes penetrated slab and geysered
- Switched from cementitious grout to epoxy grout to shorten embedment length
- Geysering holes capped with PVC pipe to divert water out of concrete placement area

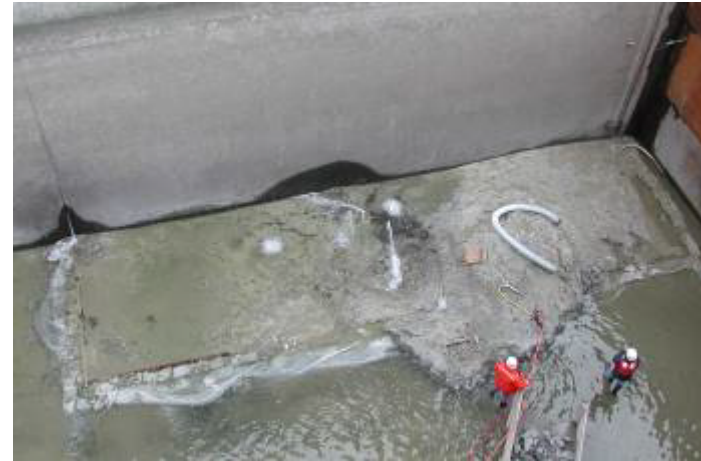
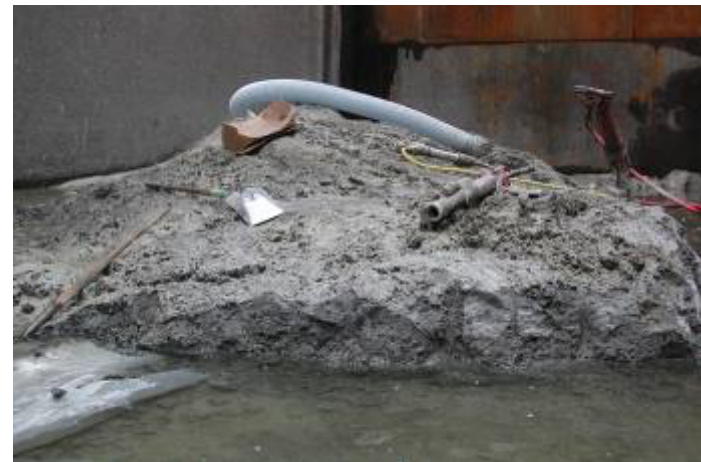
Bay 1 Dewatered after Concrete Placement

- Diver had difficulties seeing
- Possible Incompatibility between High Range Water Reducer Admix and Antiwash-out Admix reduced the slump
- 4' high mound formed that now had to be removed
- Some leaks existed
- Some low spots existed

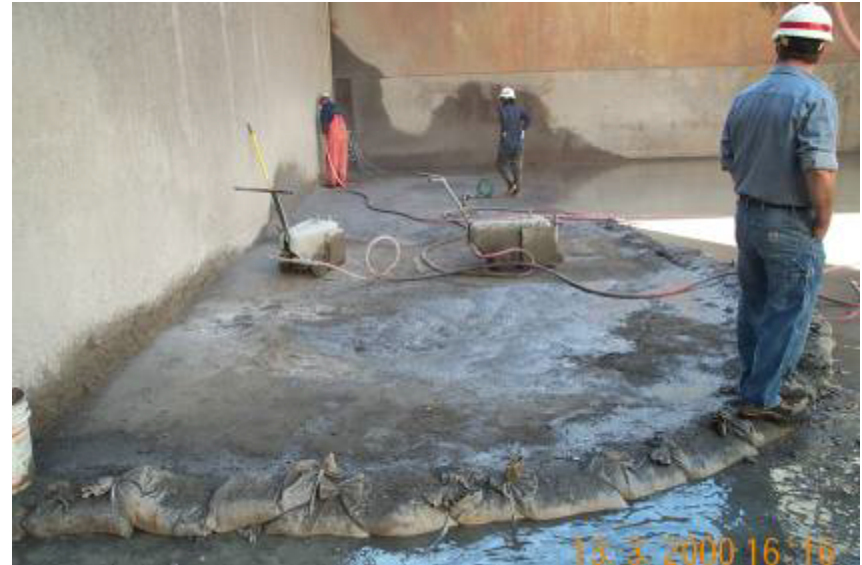
Final Repair Completed

- Final Repair was to stilling basin elevation +/- 3”
- Spill occurred from April 14, 2004 to August 31, 2004
 - Diver inspected in November 2004 – no signs of erosion
- Spill occurred from April 10, 2005 to present
 - Diver inspected June 21, 2005 – no signs of erosion
