**US Army Corps
of Engineers**
Pittsburgh District

The Sliding Failure of Austin Dam Pennsylvania - Revisited

Brian H. Greene, Ph.D. P.G.

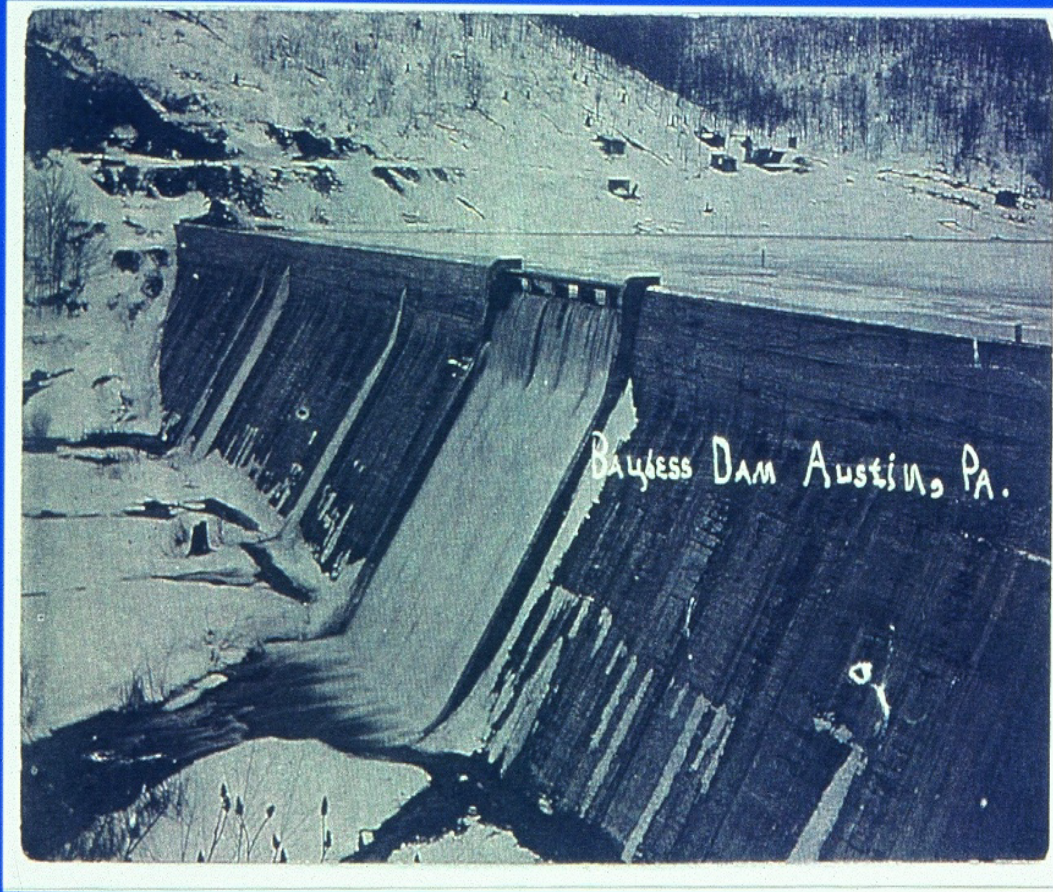
Leaking Dam

- First filling in January, 1910
- Extensive leaks developed downstream of toe and abutments
- Slid forward 18 inches at base
- Blasting used to drain water
- It was observed that the rock foundation had slid forward with the dam

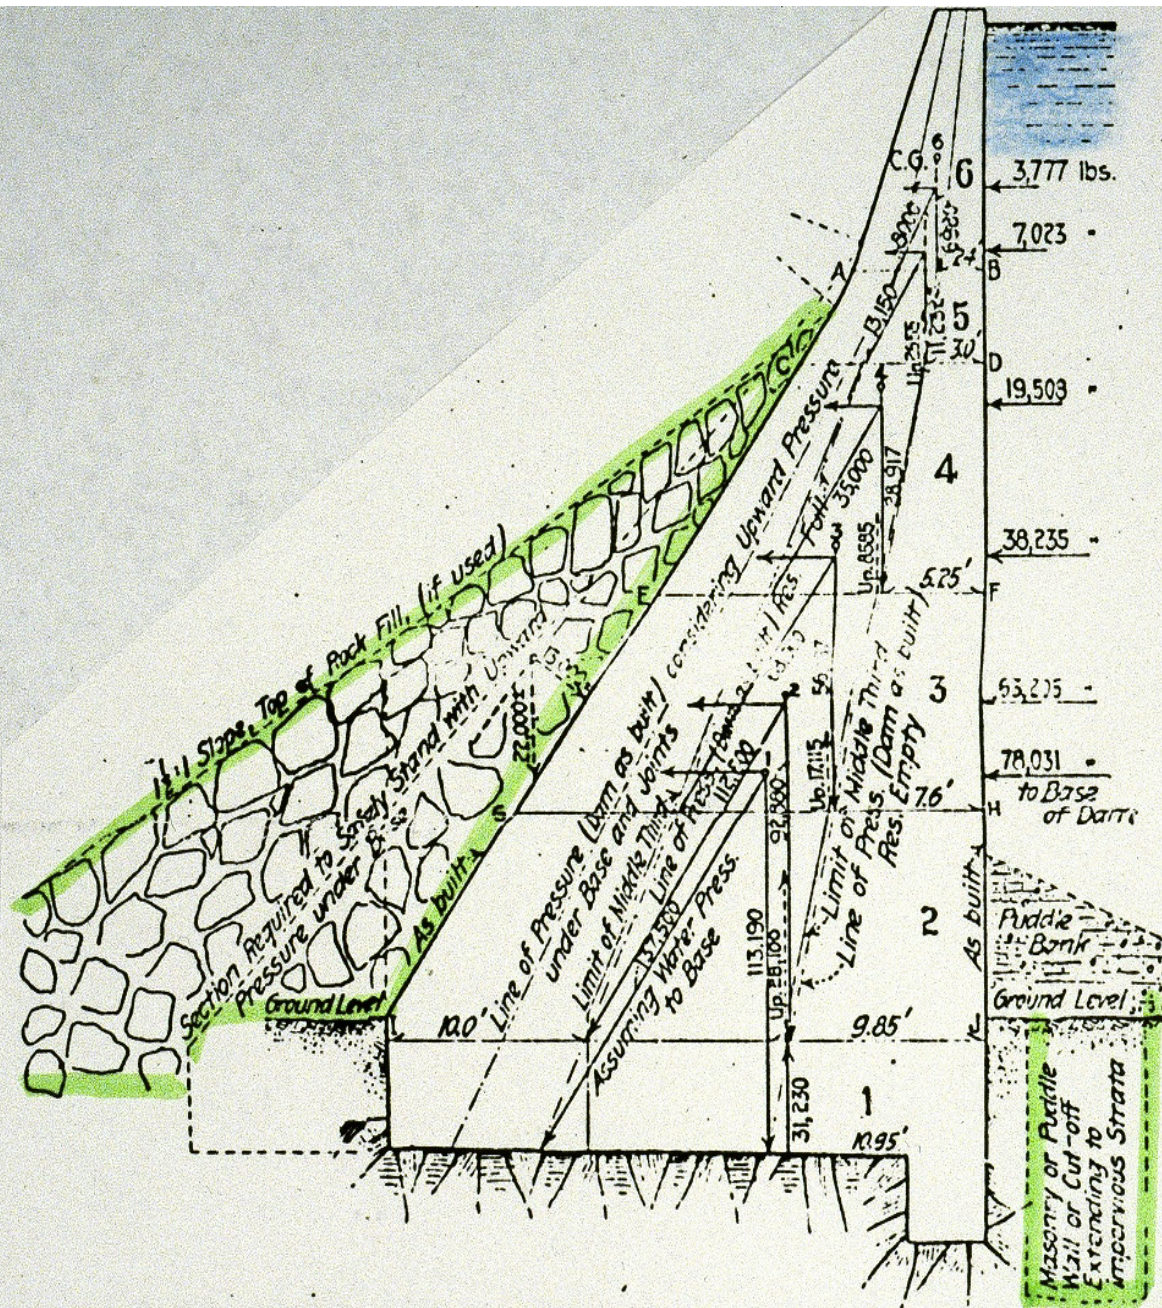
FIG. B.— STUDIES FOR REINFORCING MASONRY DAM AT AUSTIN, PA.
 FEB. 14, 1910: E. WEGMANN, CONSULTING ENGINEER.

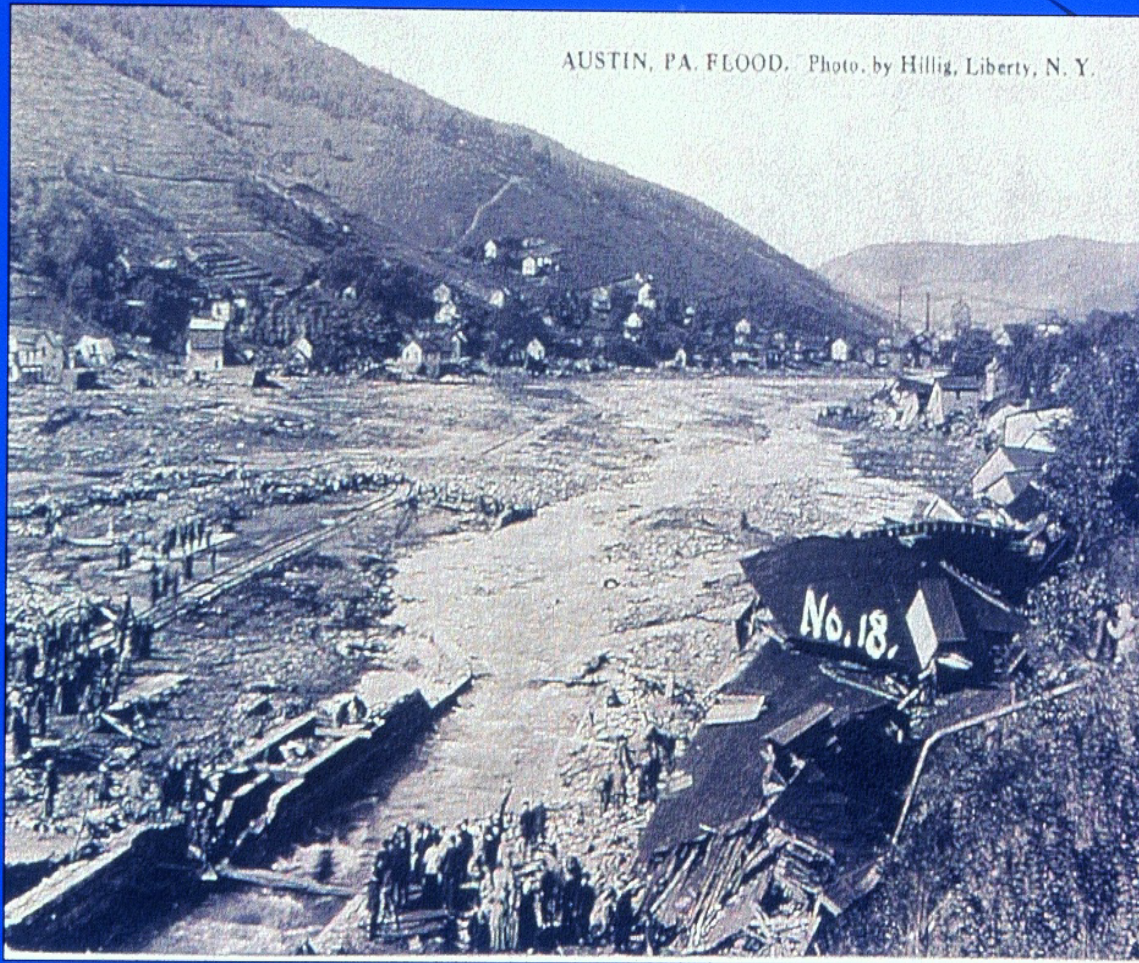
Freeman Run valley after failure

- o Seven factories destroyed and railroad destroyed
- o Damages estimated between 3 to 6 million dollars
- o 78 deaths reported
- o No definite cause of failure documented

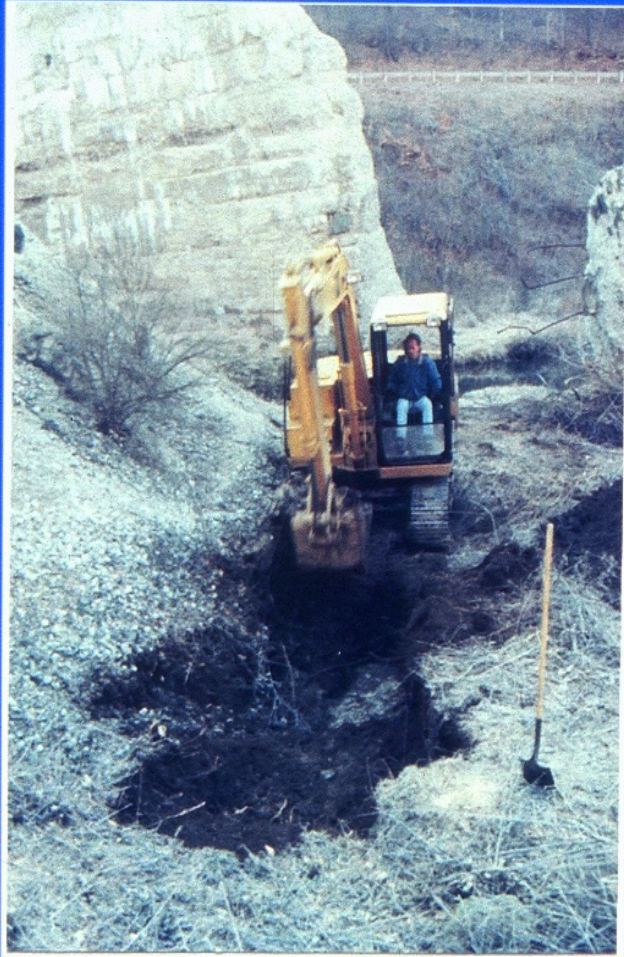
Test pit # 1

- Approx. depth of pit 12.5 ft.
- Water encountered at a depth of 2 ft.
- Sandstone (foundation material) at depth of 9.5 ft.
- Permeability of gravel and sand above sandstone approx. 2.6 cm/s (by recovery method)
- Clear water observed coming from under the dam into the pit

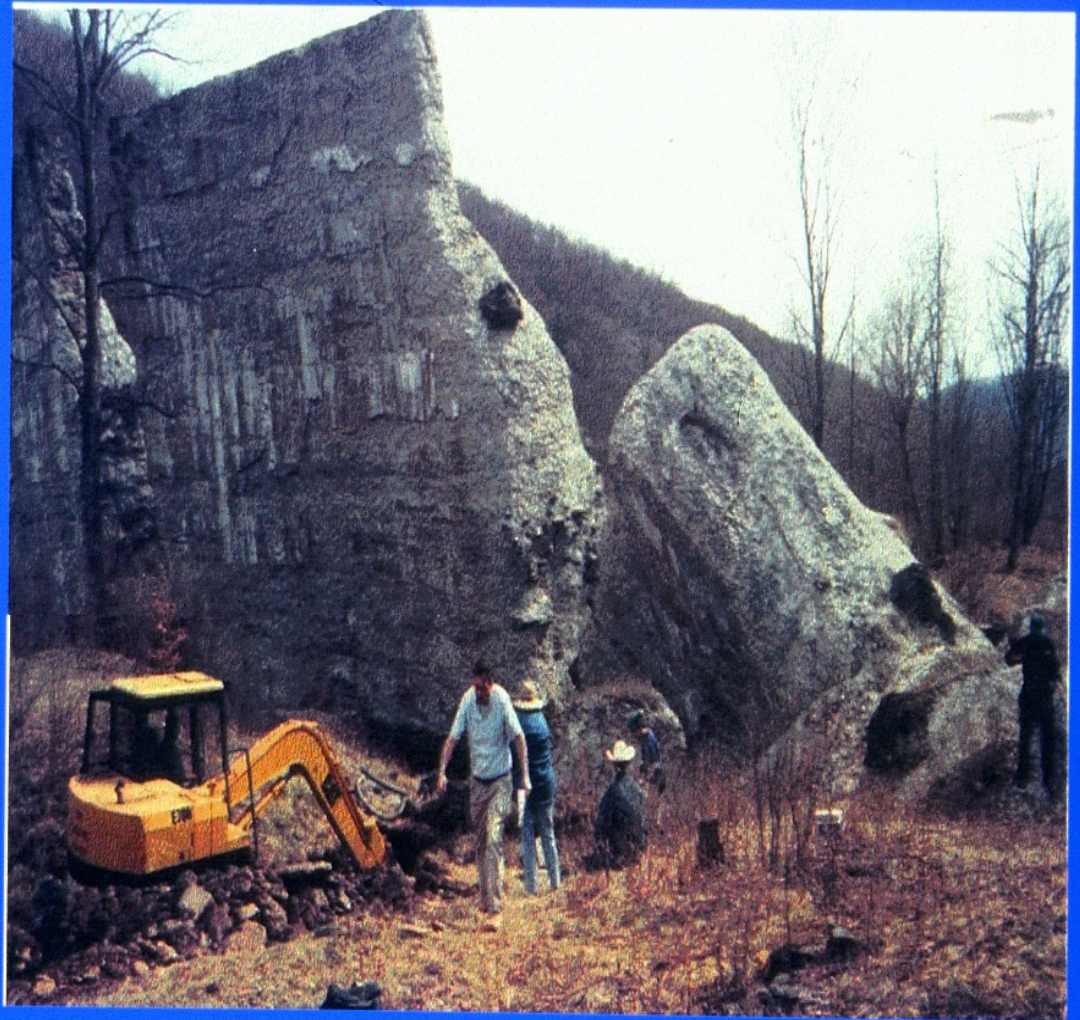
Test pit # 2

- o Approx 8 ft. deep.
- o Slow seepage of water.
- o 2 ft. of sandstone encountered at an approx. depth of 5 ft.
- o Shale found underneath the sandstone, shale interlayered with clay seams.

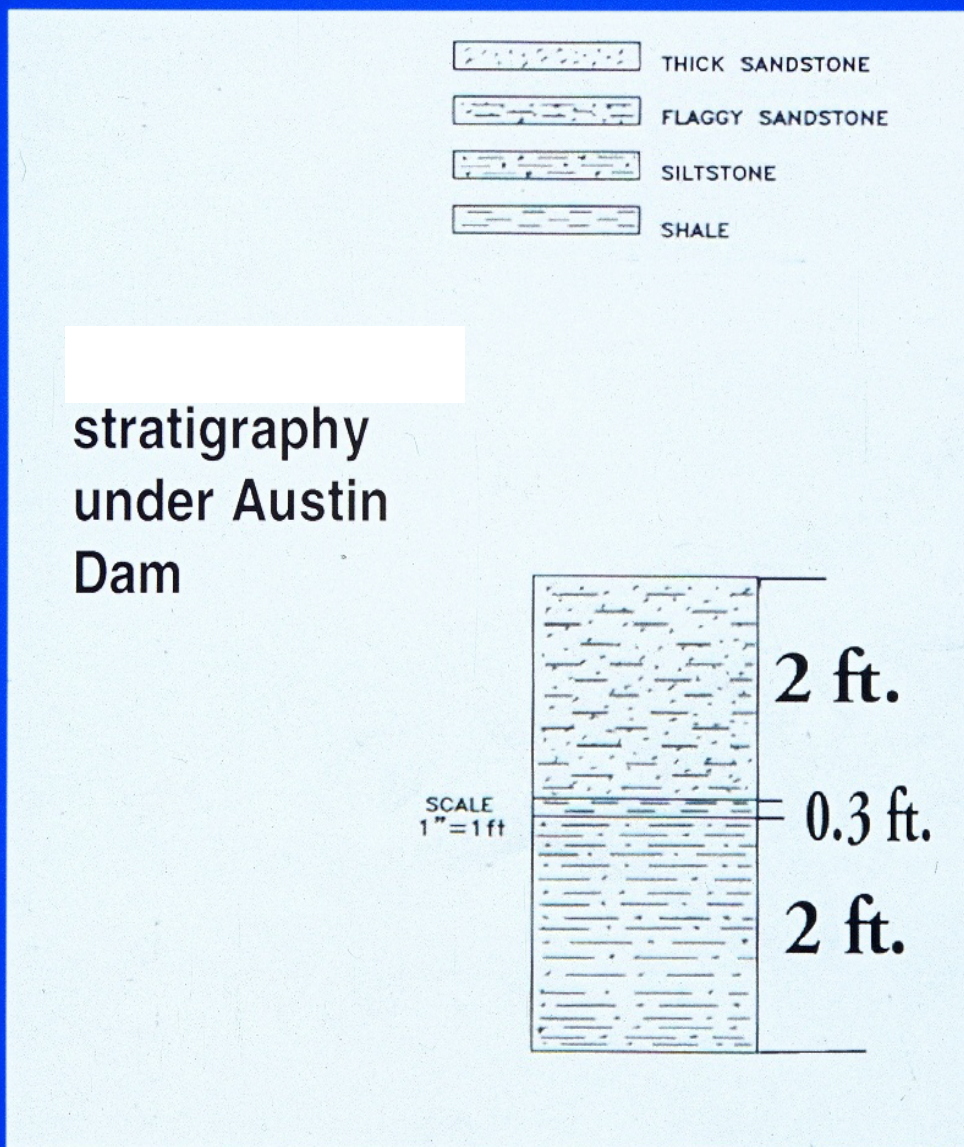
Subsurface (foundation)stratigraphy

- o The Austin dam failed on the weak shale layers beneath the foundation sandstone
- o The depth of water in the reservoir necessitated the provision of a deeper and wider key trench than was used
- o The tendency to overturn (F.S.= 0.88) probably contributed to the sliding failure of the dam
