McAlpine Lock Replacement Project

Foundation Characteristics and Excavation

**Presented to 2005 Tri-State Infrastructure
Systems Conference & Exposition
August 3, 2005**

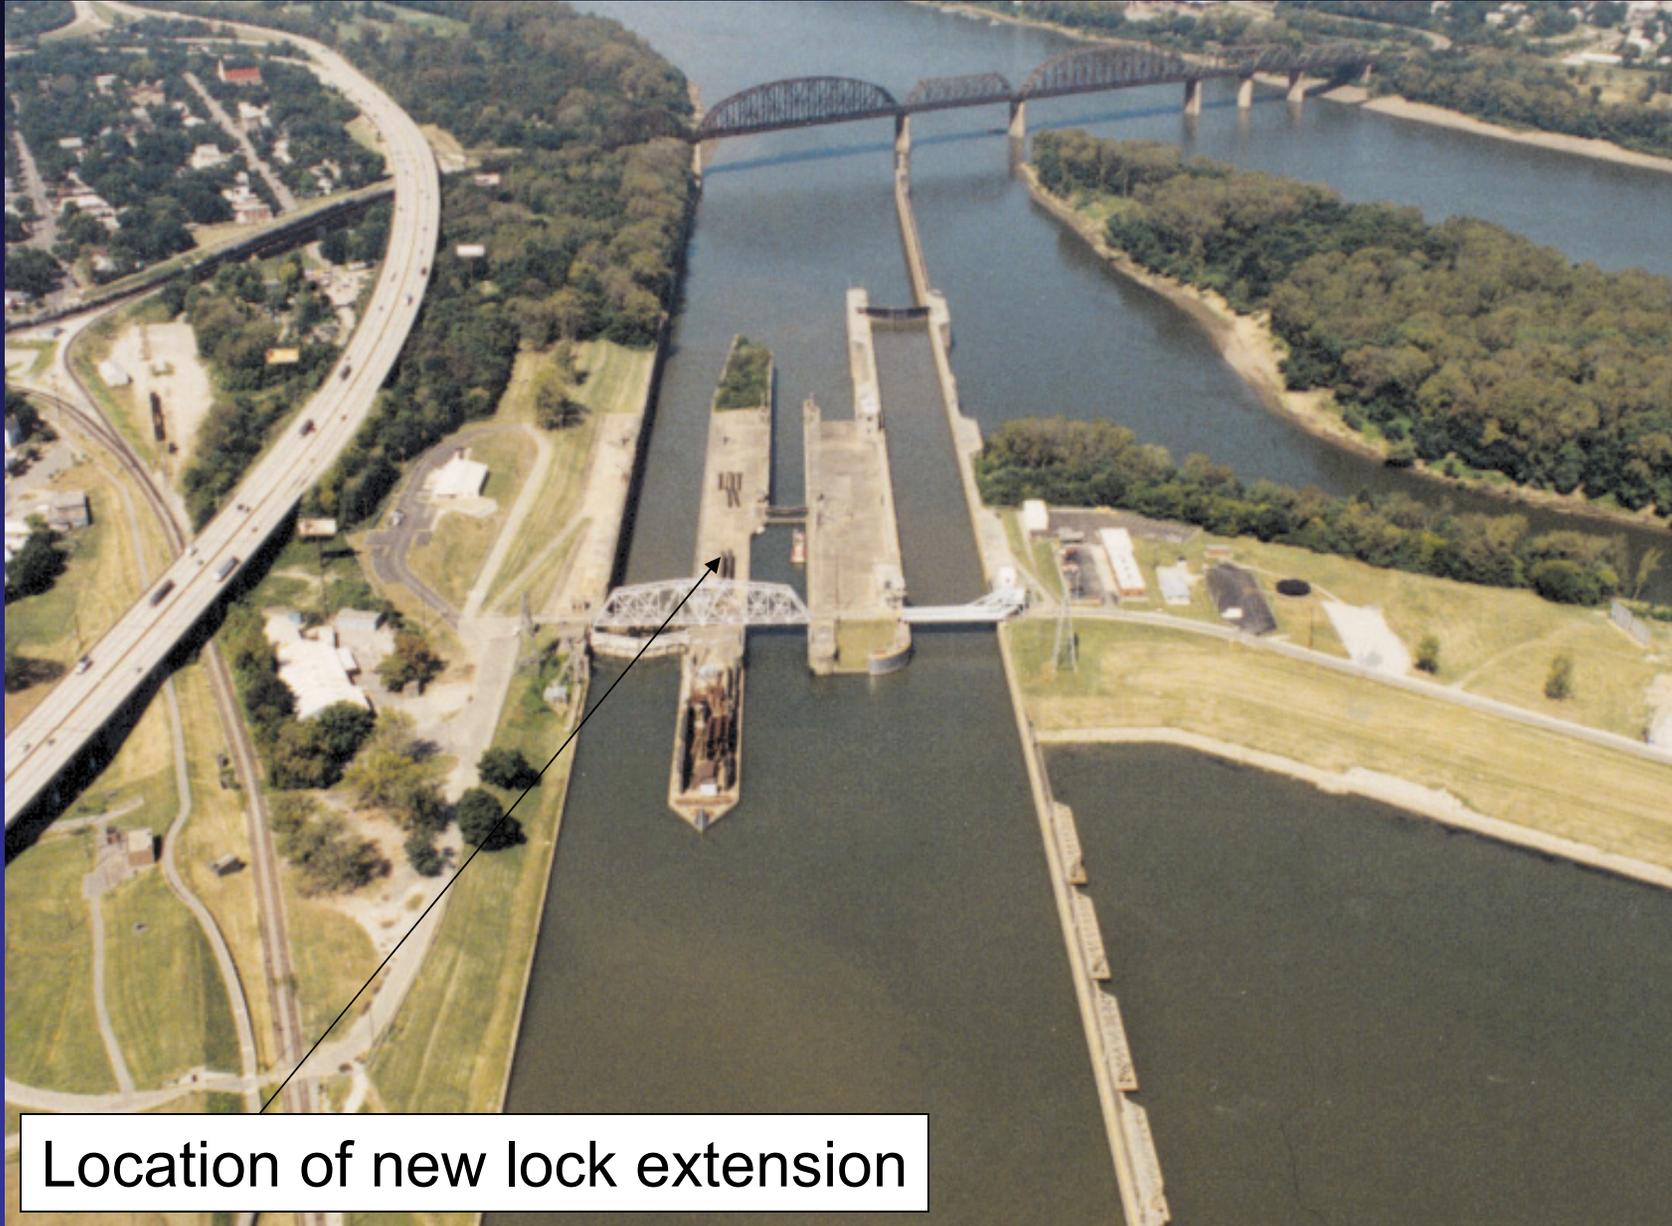
Location of new lock extension

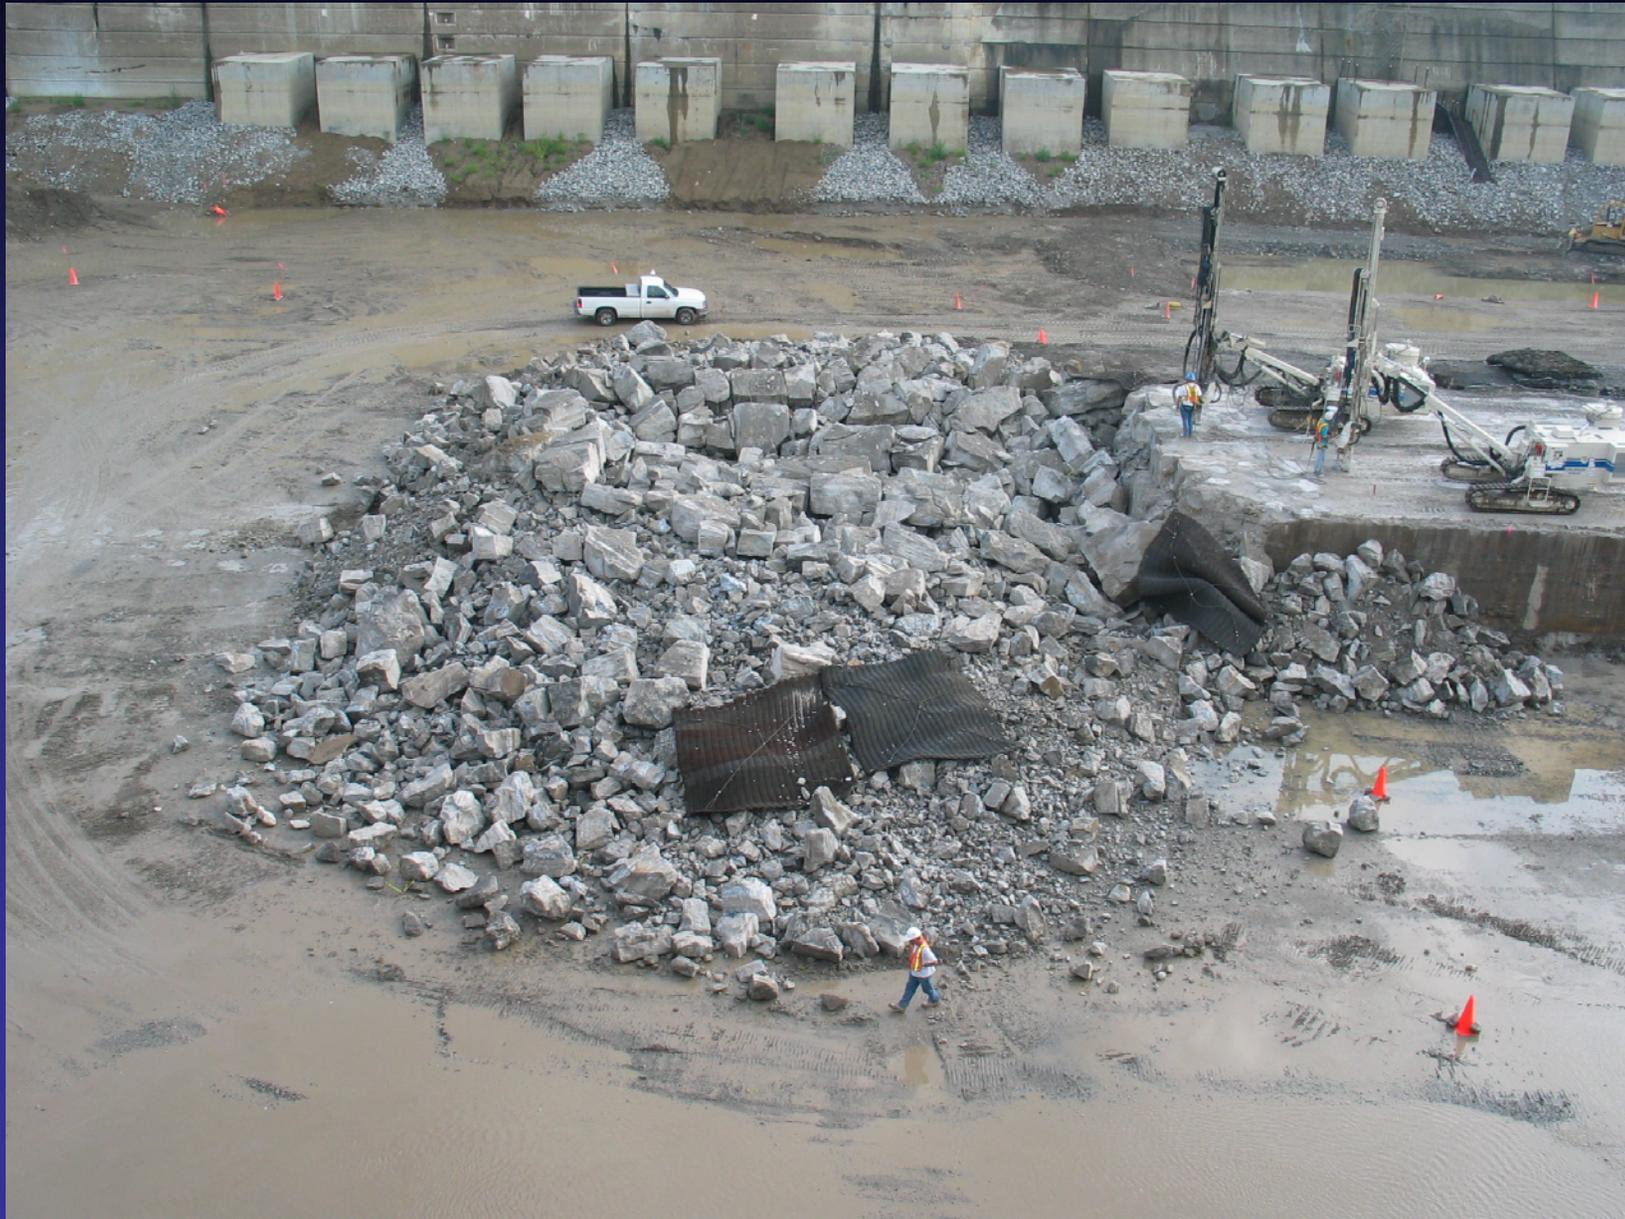
Excavations which penetrate into rock
anywhere from 5-feet to 35 feet,
requiring controlled blasting techniques.

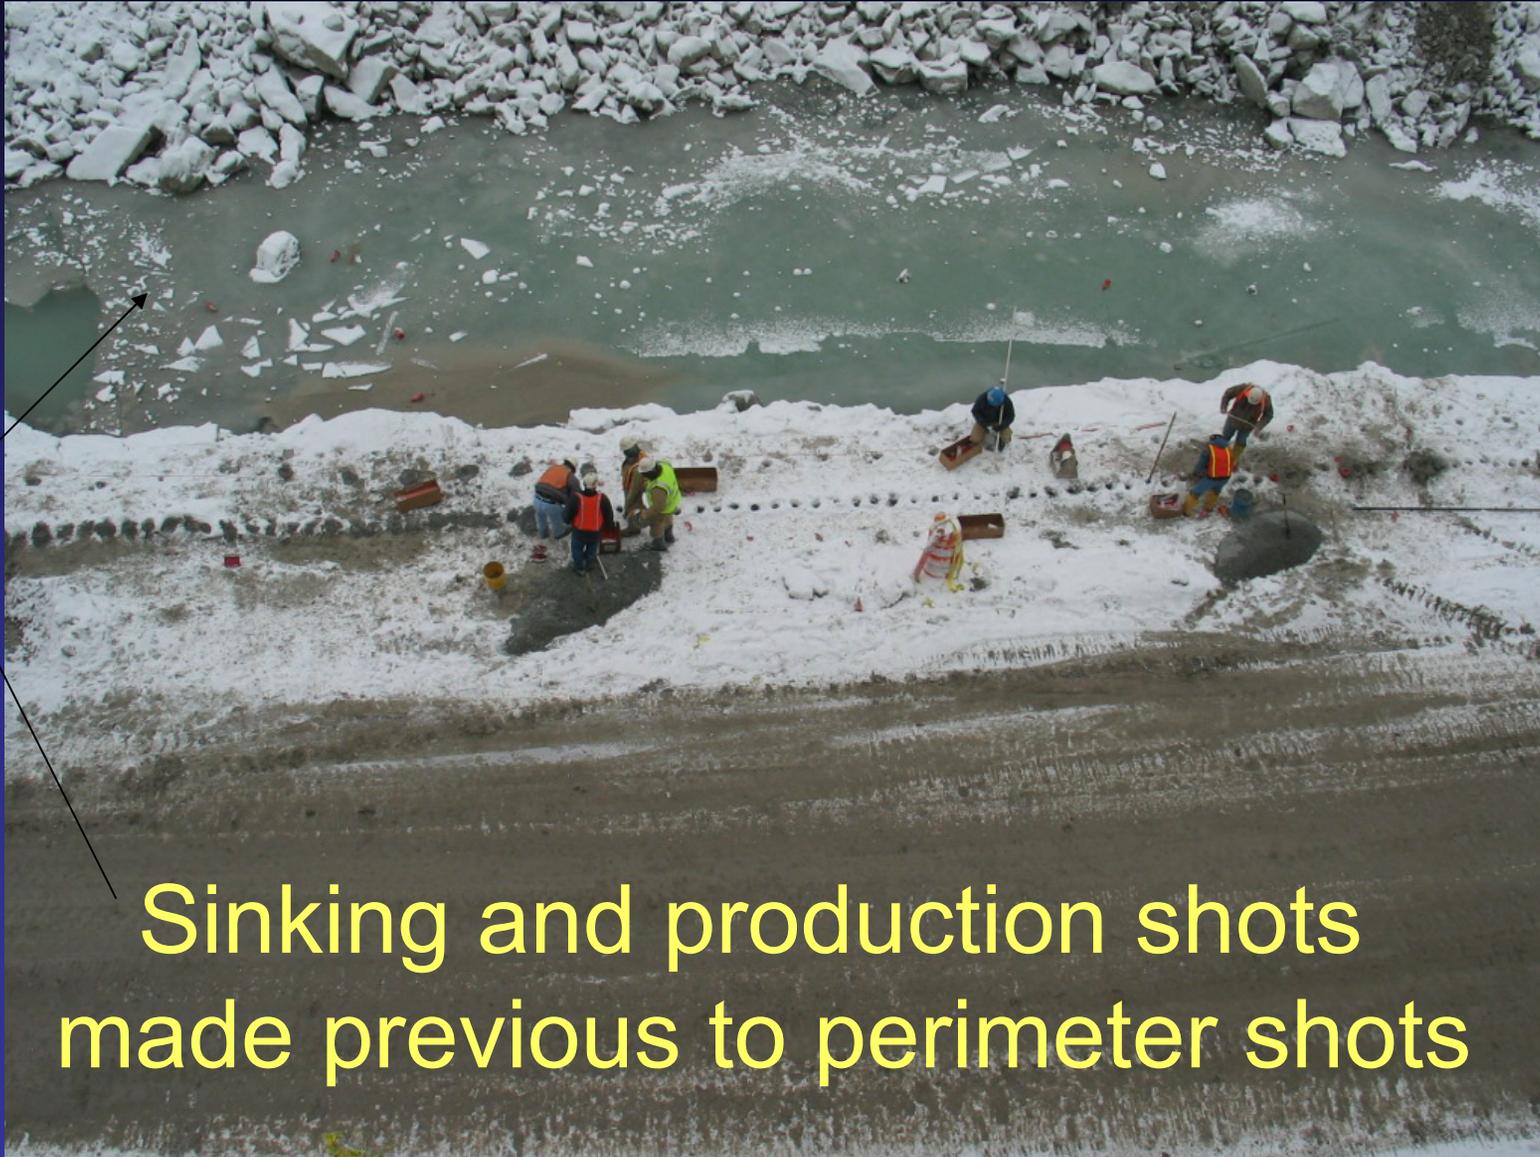
Sinking and production shots
made previous to perimeter shots

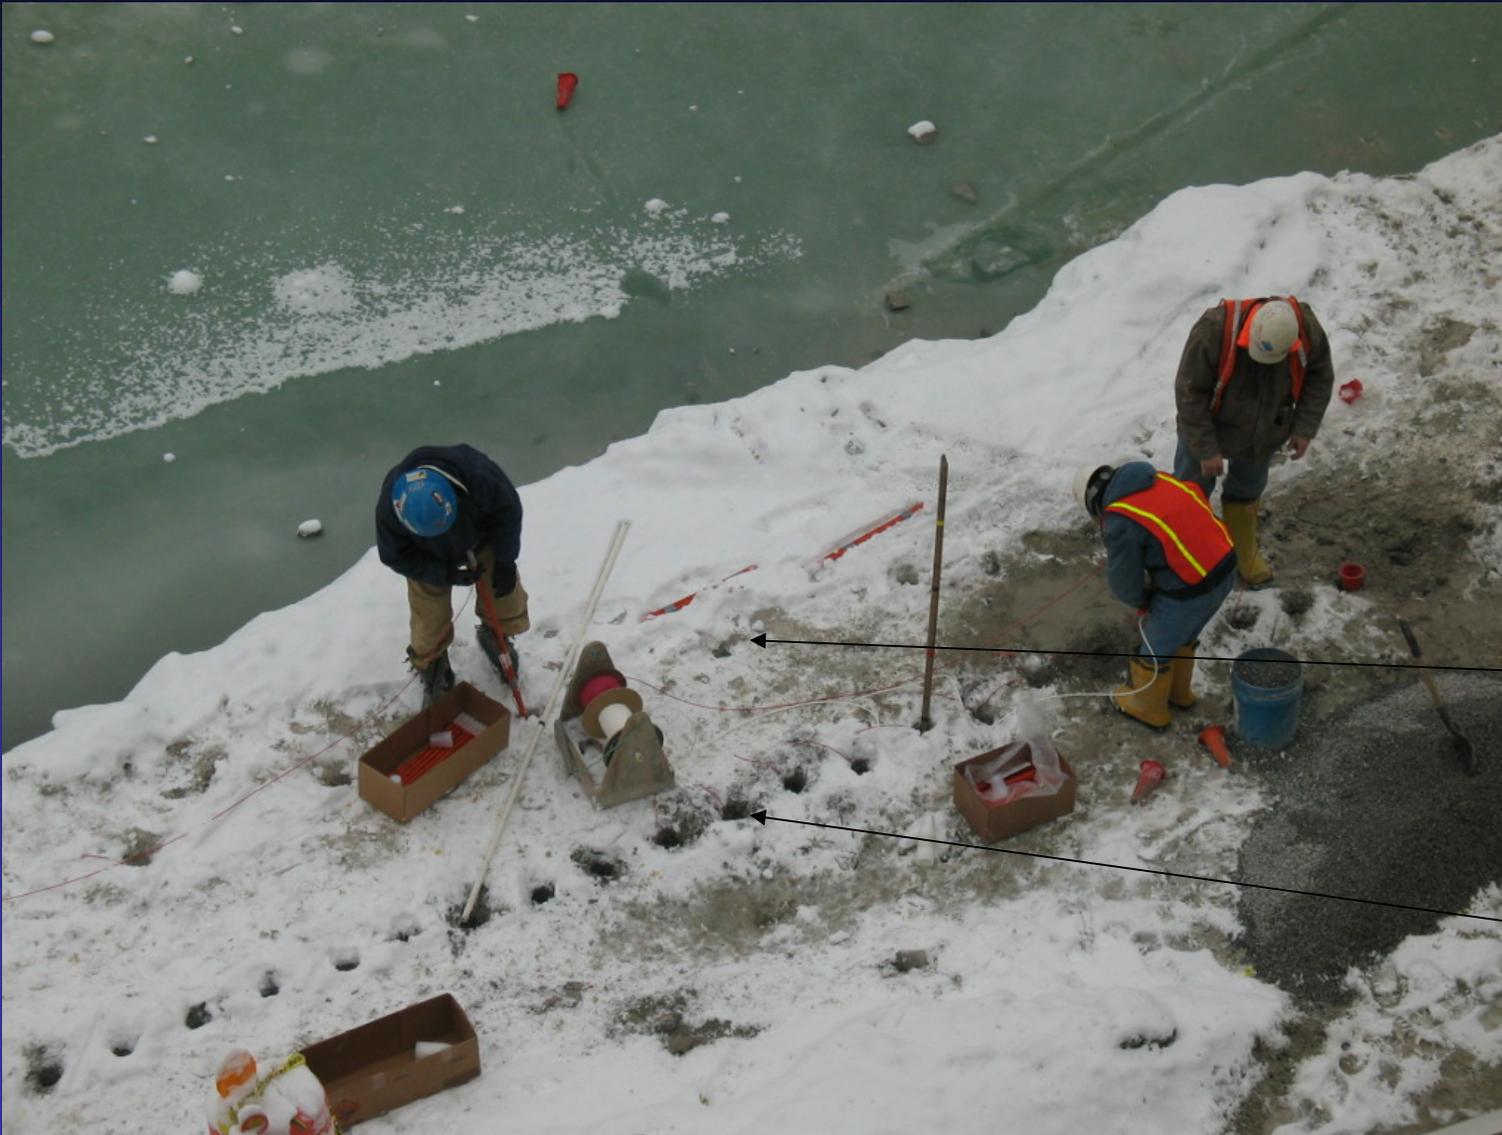
Trim Blast

Buffer Holes

Trim Holes

As a consequence of choosing a method with no perimeter control, a diligent quality control (QC) program needs to be implemented.

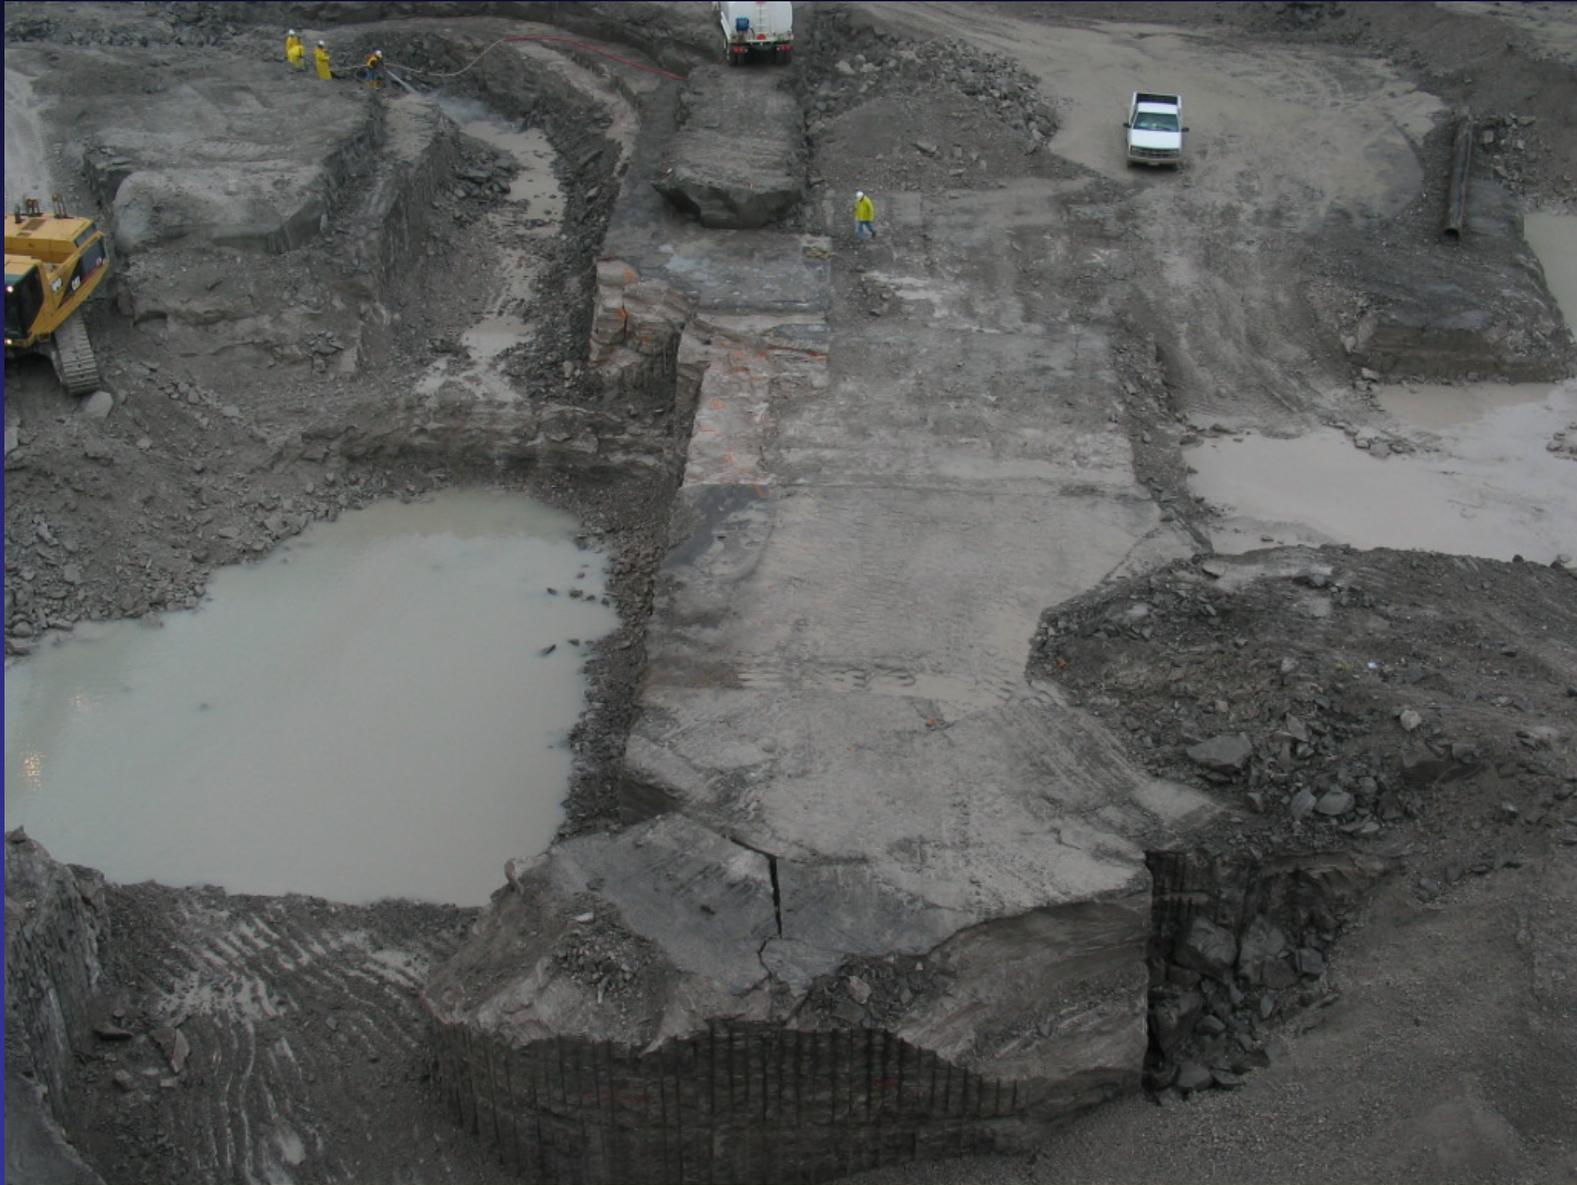
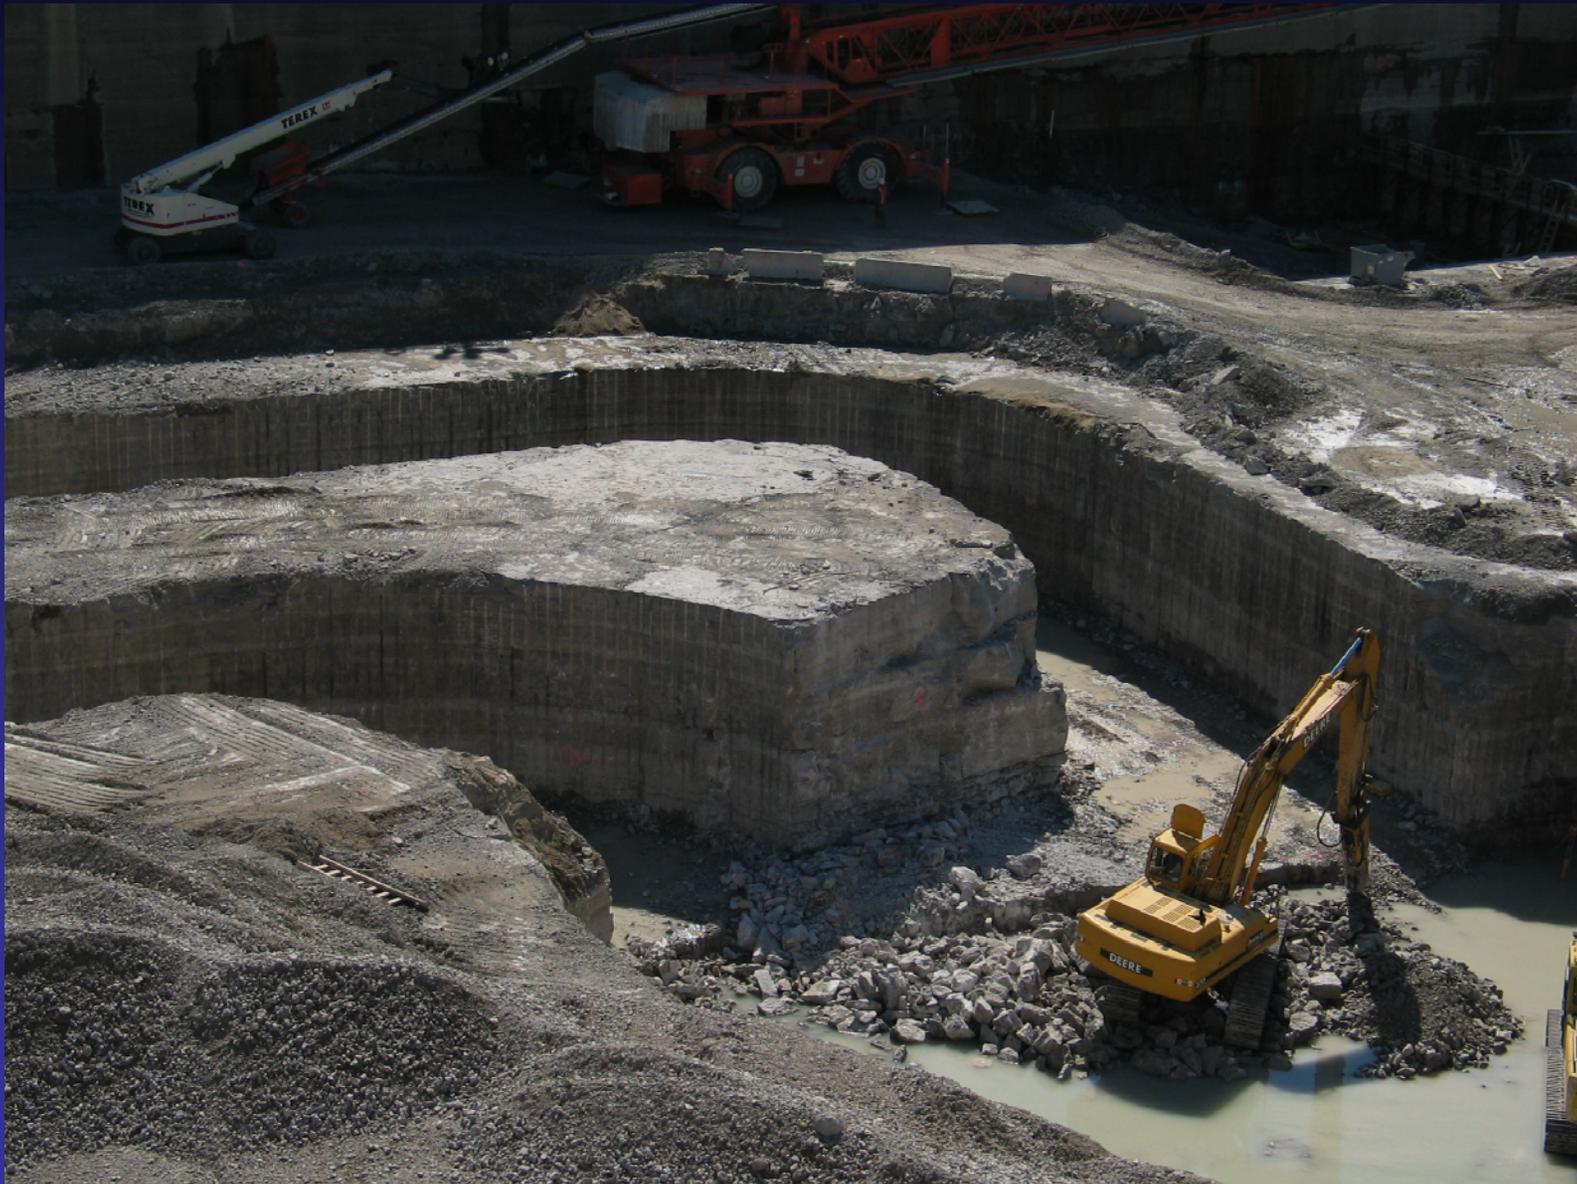
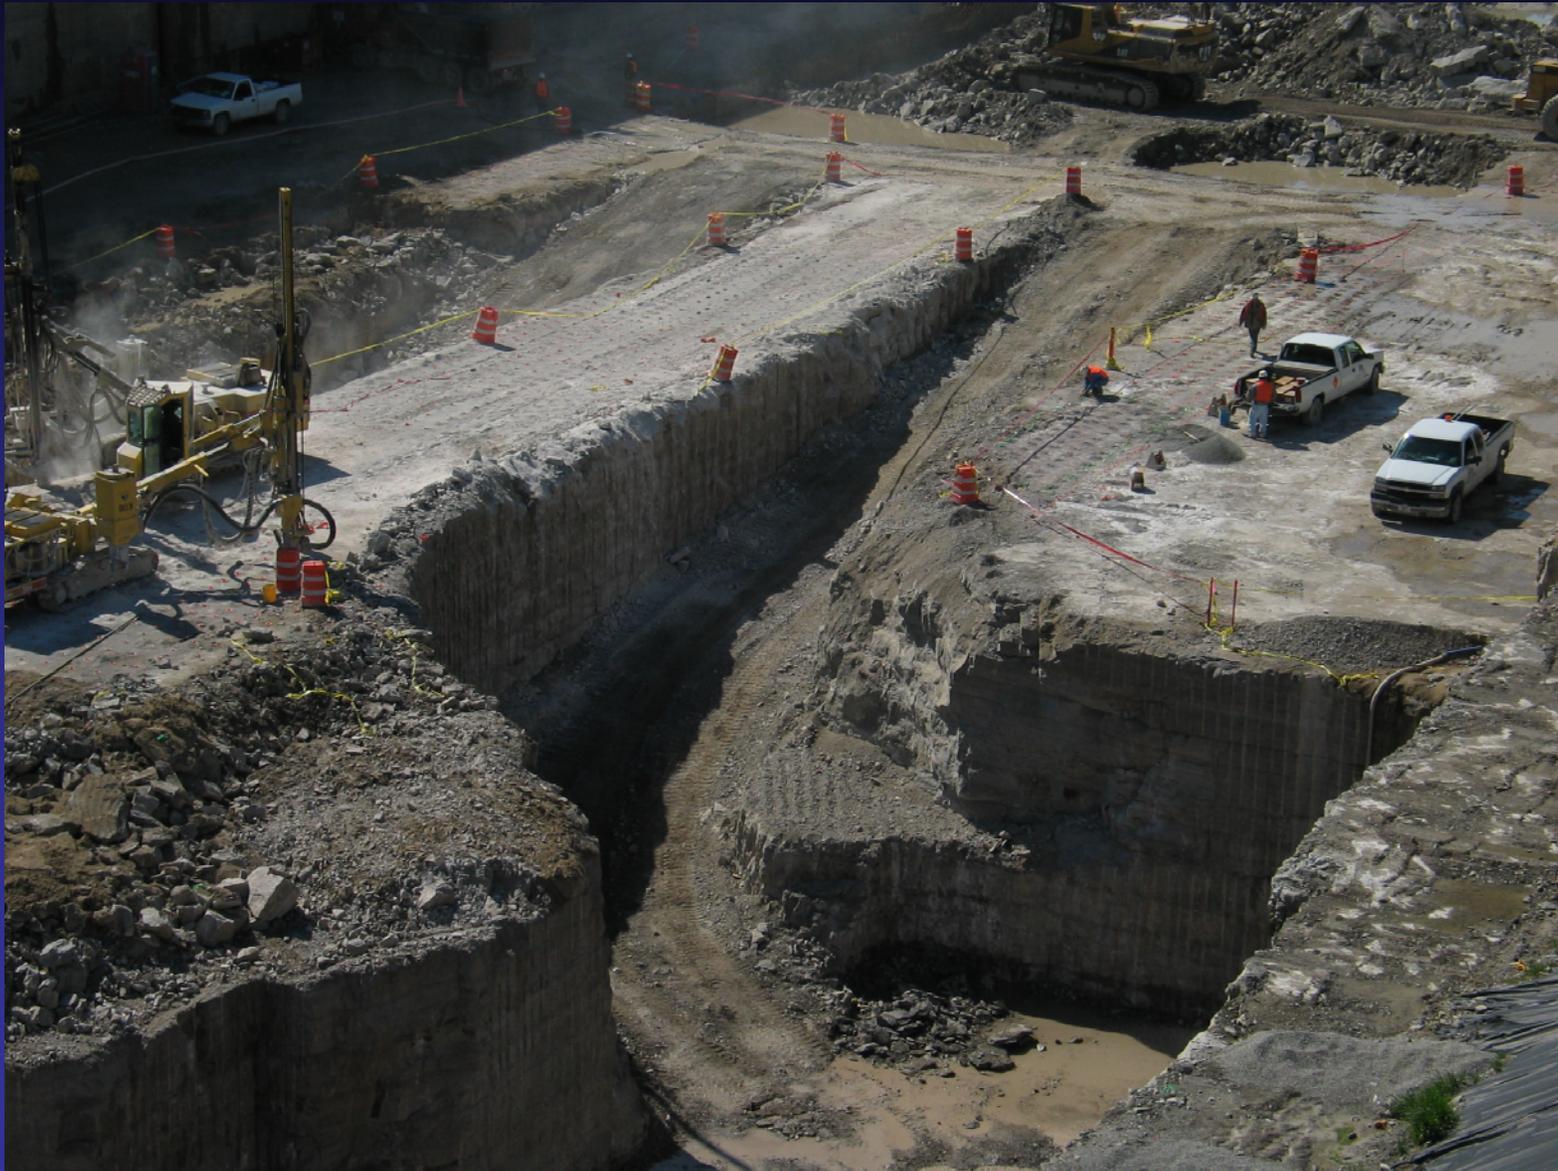
Examples of back-break due to lack of perimeter control.

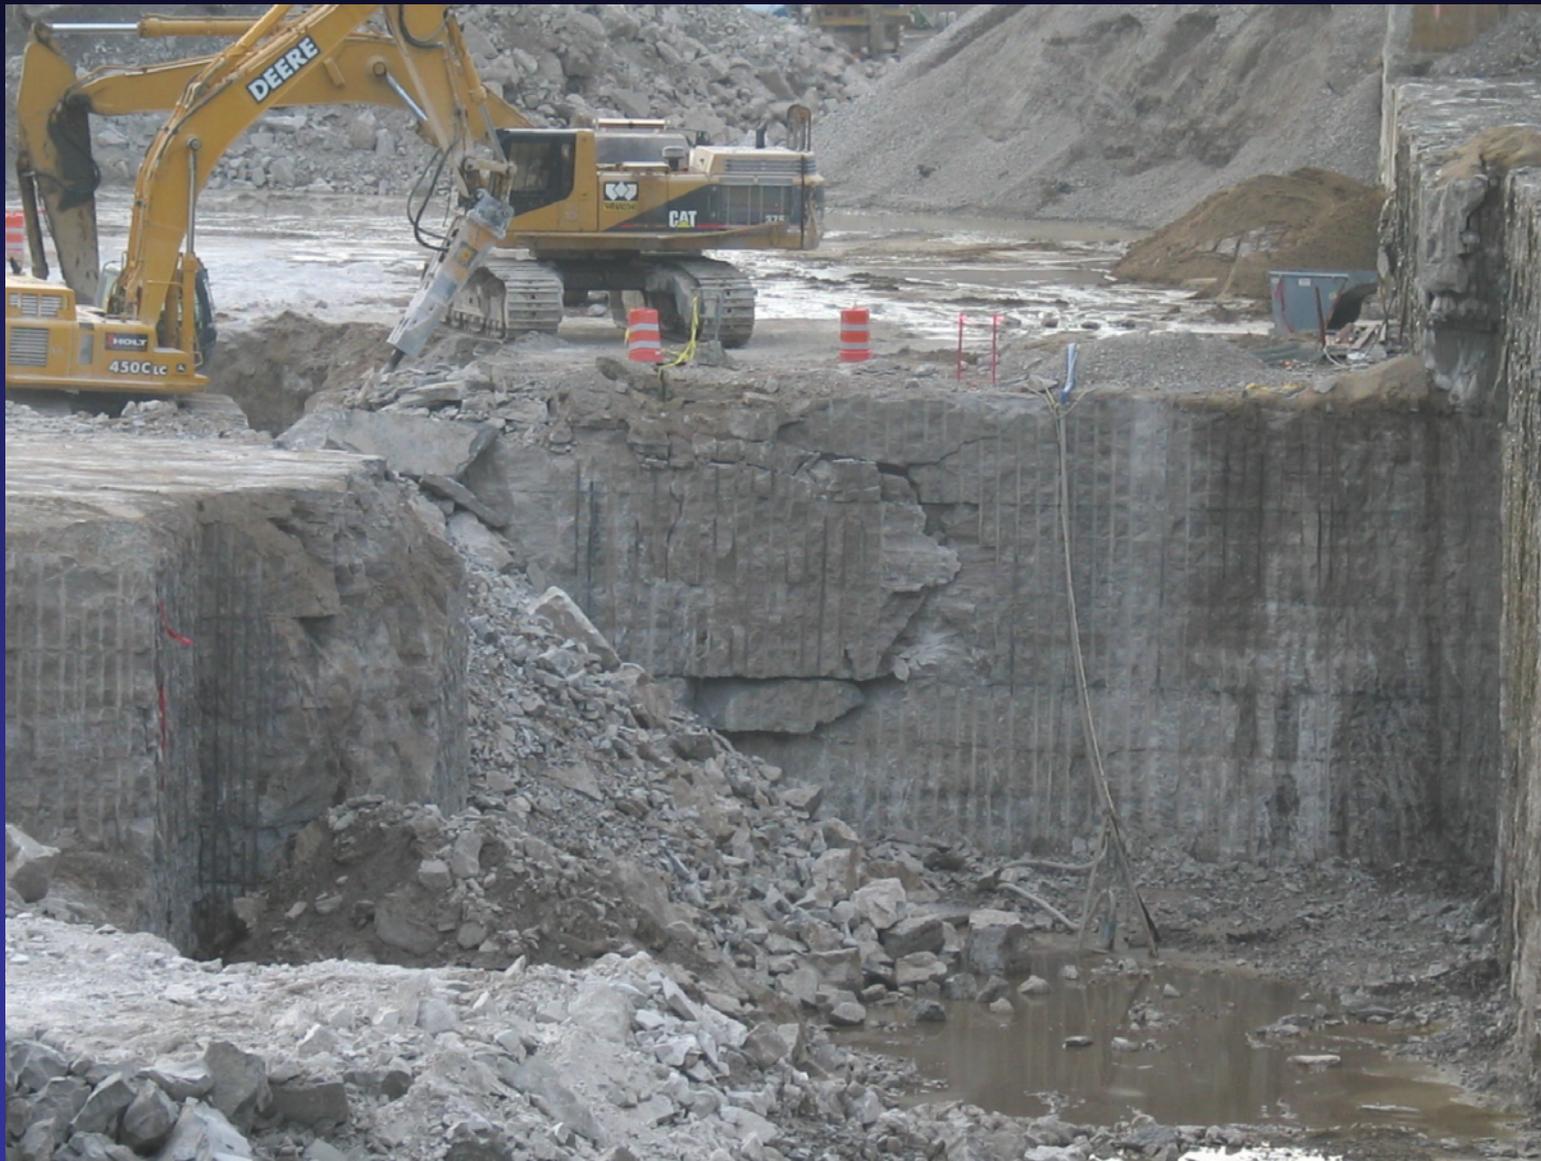
SM-17

Effects of back-break on foundation integrity

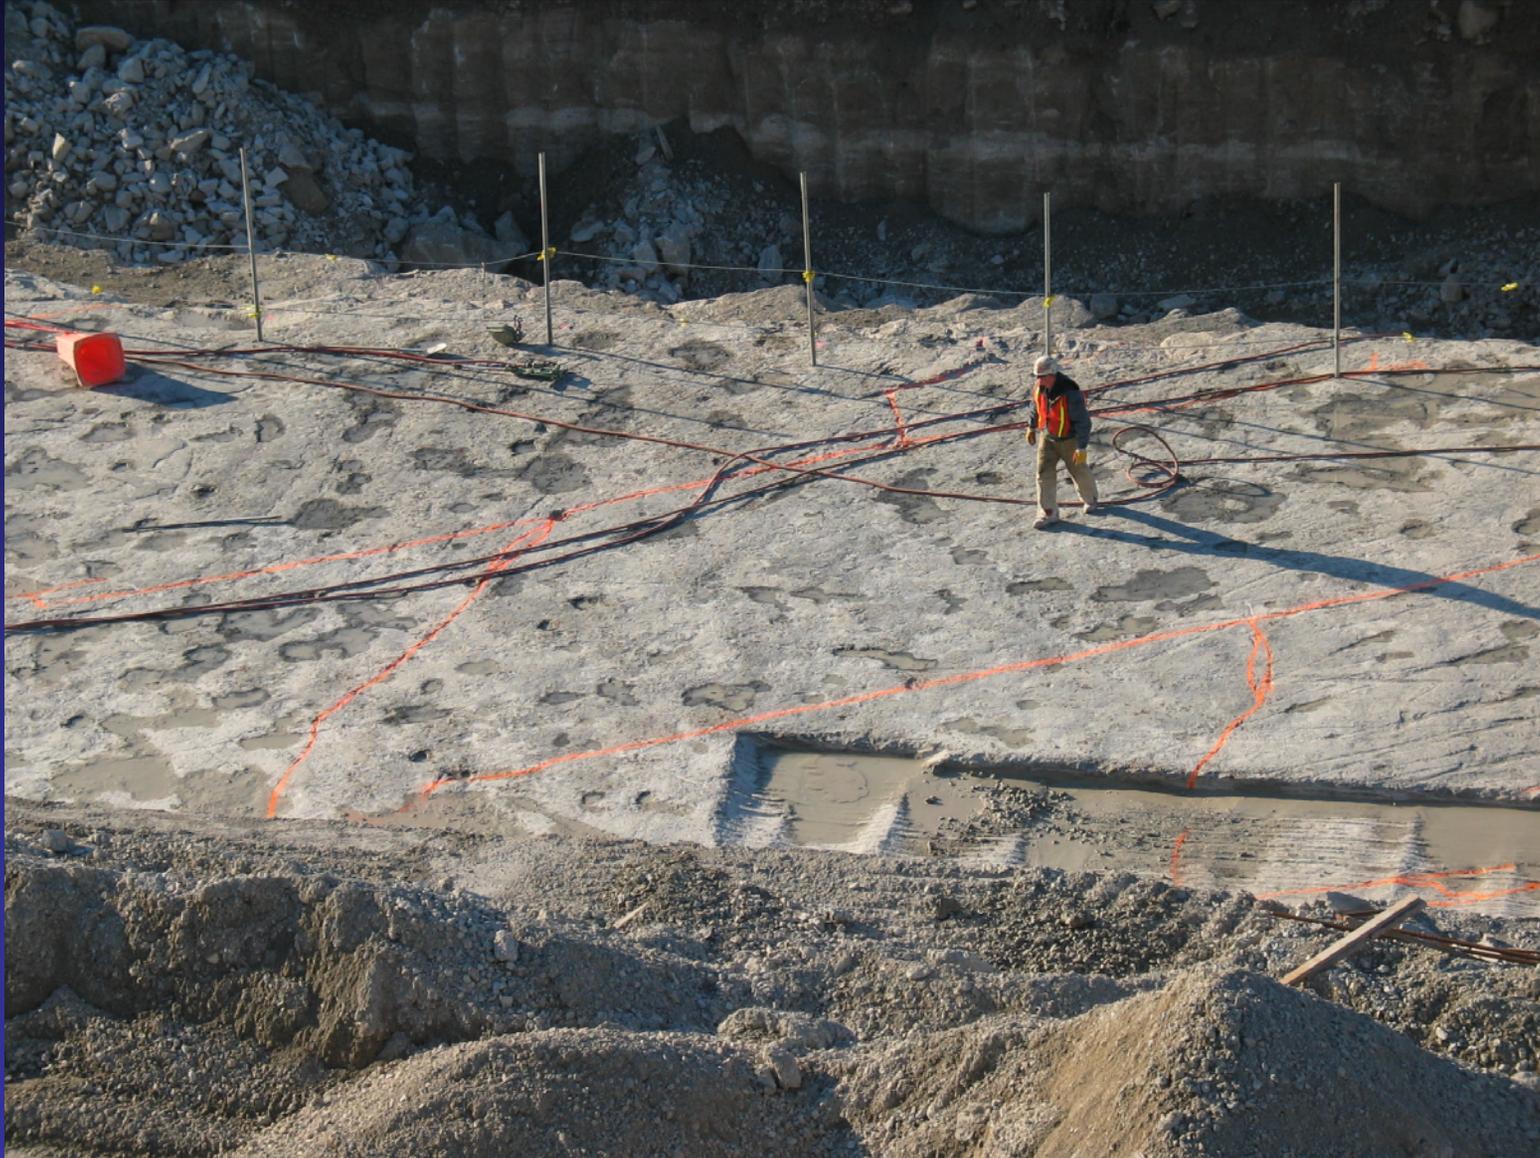
SM-8 through SM-11

Effects of back-break on foundation integrity

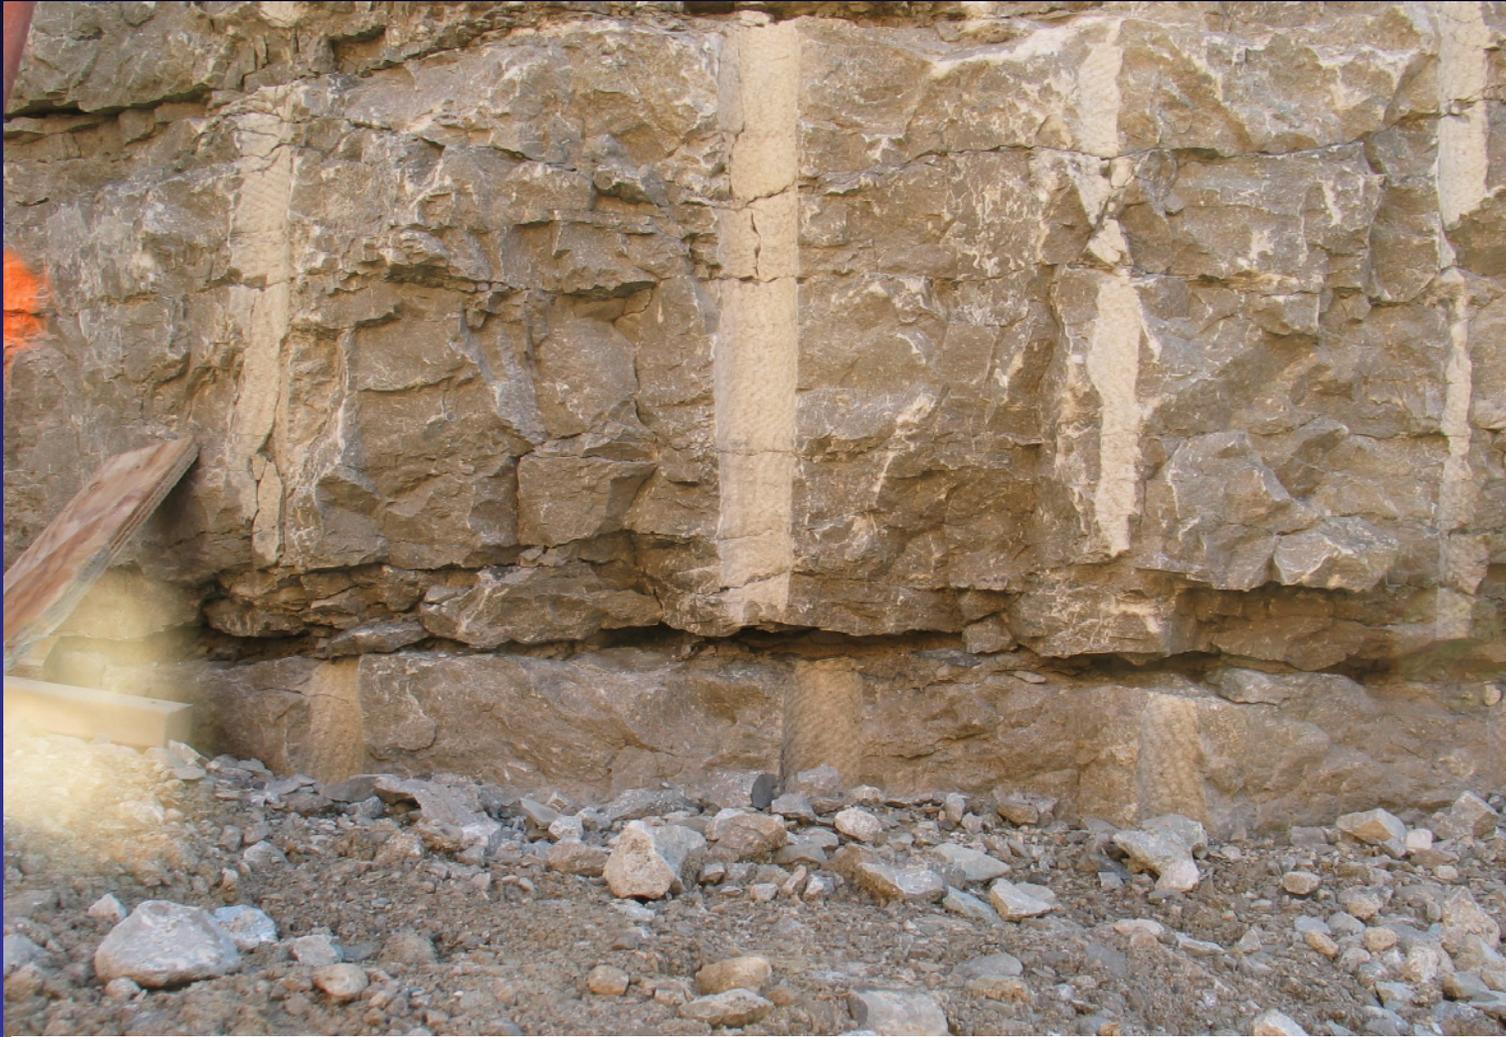
Offset boreholes observed in north face of north culvert

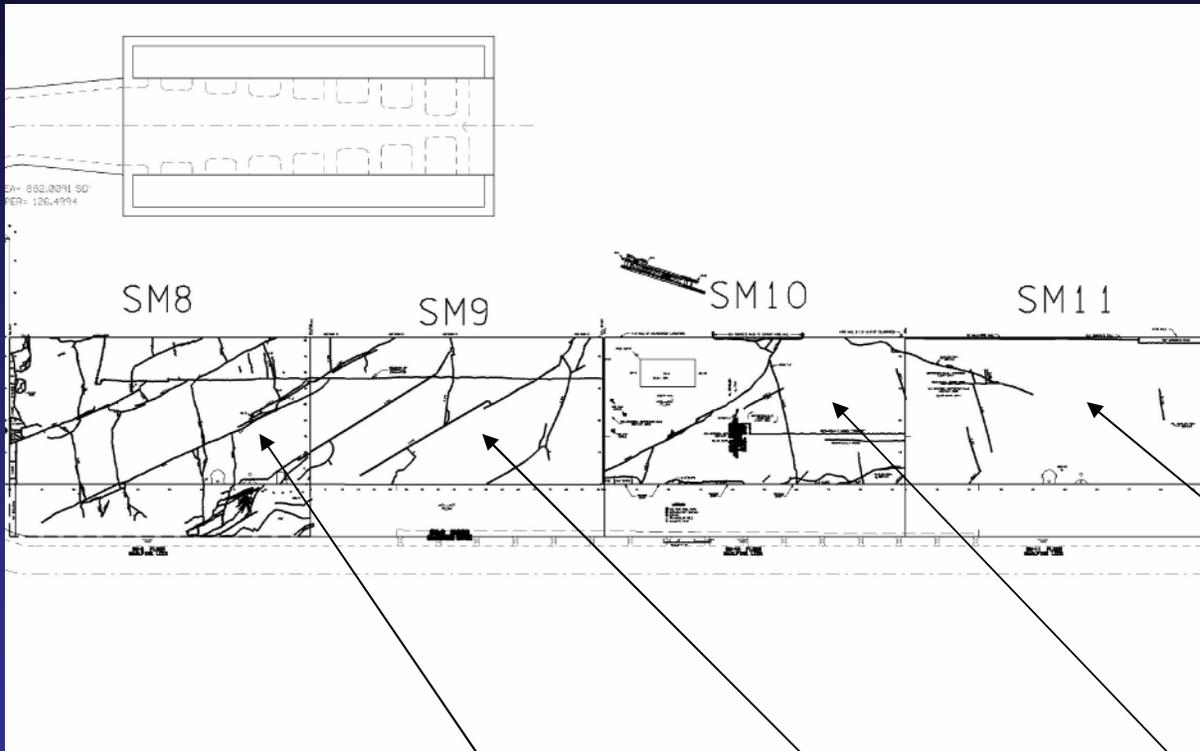
Sliding Resistance Strength

Reduced from
 $\phi = 35^\circ$
 $c = 5 \text{ psi}$

SM-8
 $\phi = 22^\circ$
 $c = 0 \text{ psi}$

SM-9
 $\phi = 25^\circ$
 $c = 0 \text{ psi}$

SM-10
 $\phi = 27^\circ$
 $c = 0 \text{ psi}$

SM-11
 $\phi = 29^\circ$
 $c = 0 \text{ psi}$

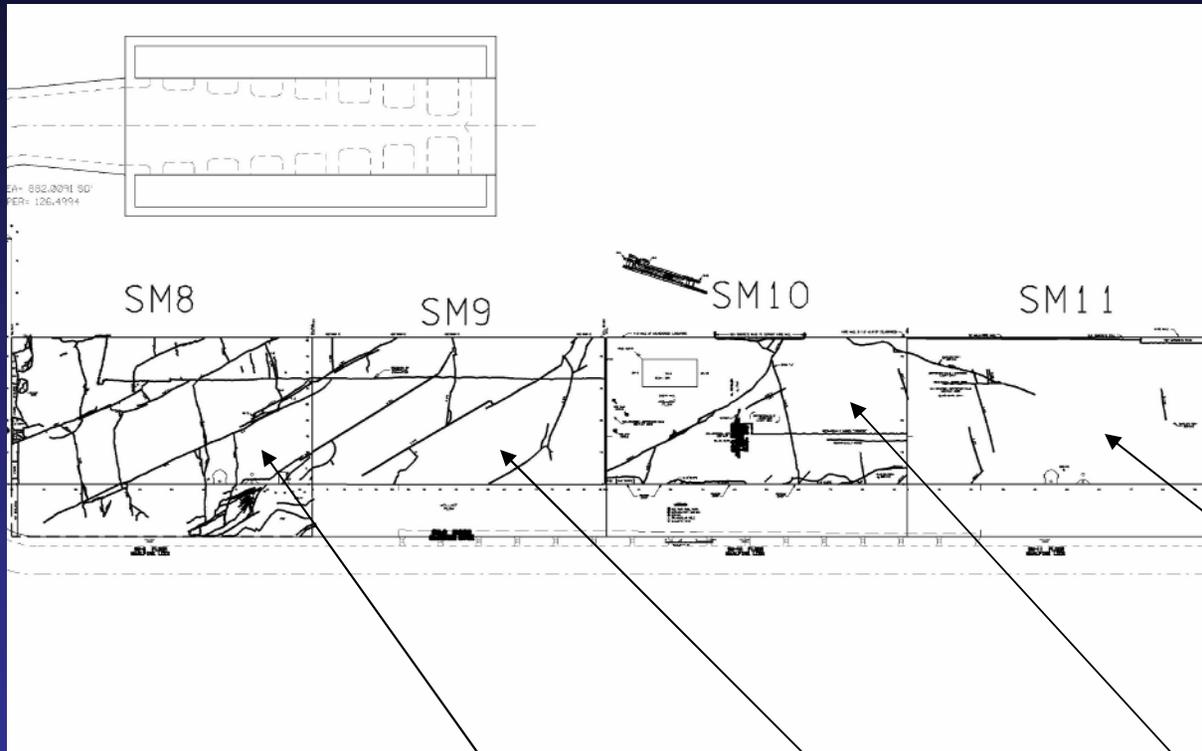
Allowable Bearing Capacity

Reduced
from
62 ksf

SM-8
29 ksf

SM-9
46 ksf

SM-10
46 ksf

SM-11
62 ksf

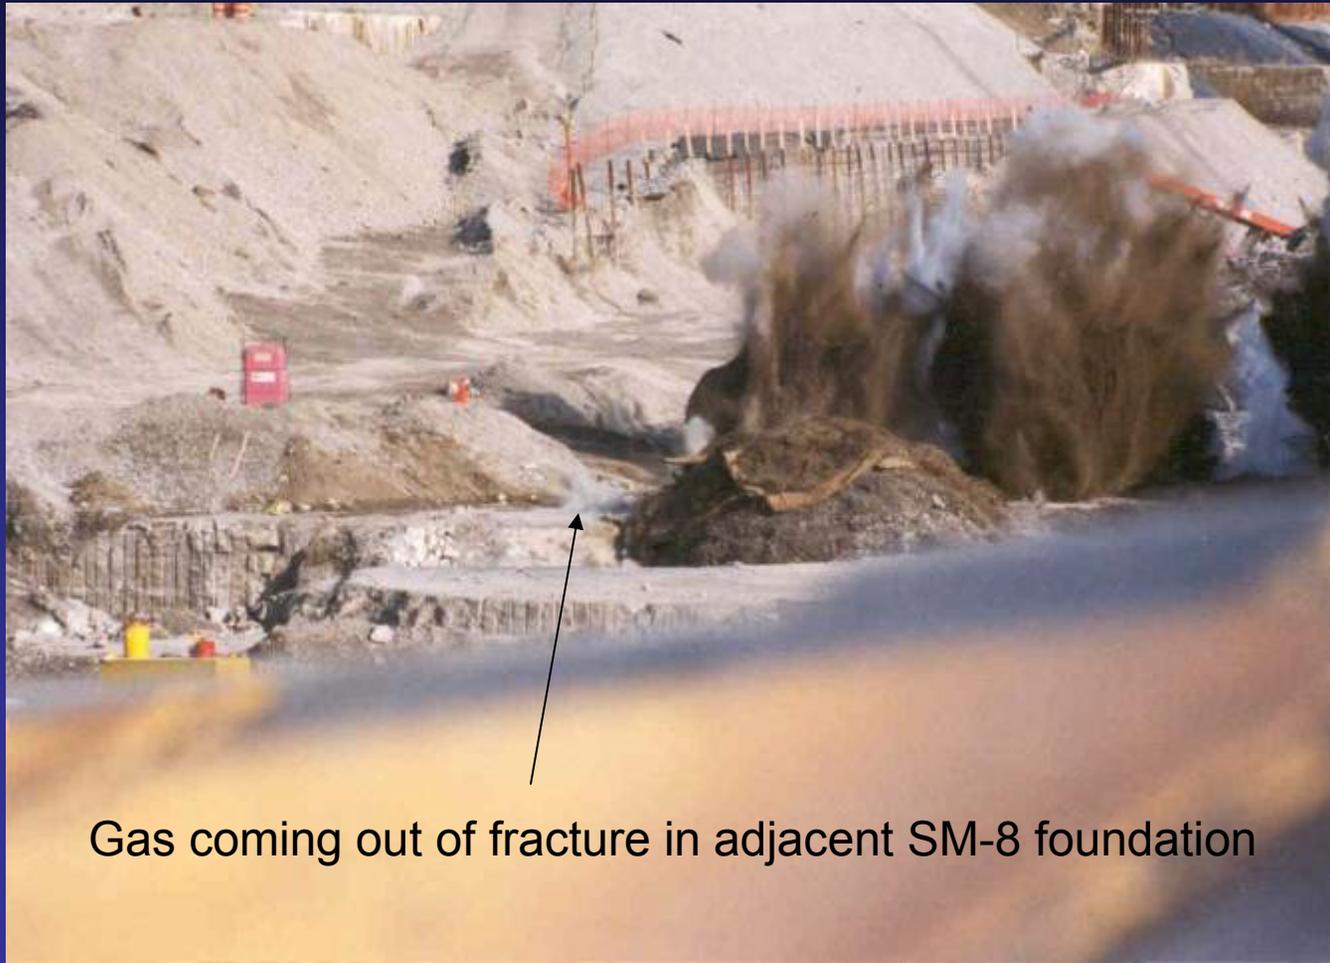
North Culvert Shots Adjacent to SM-8

Gas coming out of fracture in adjacent SM-8 foundation
