Fern Ridge Dam, Oregon

Seepage and Piping Concerns
(Internal Erosion)

SPRA Training – 25 May 2005

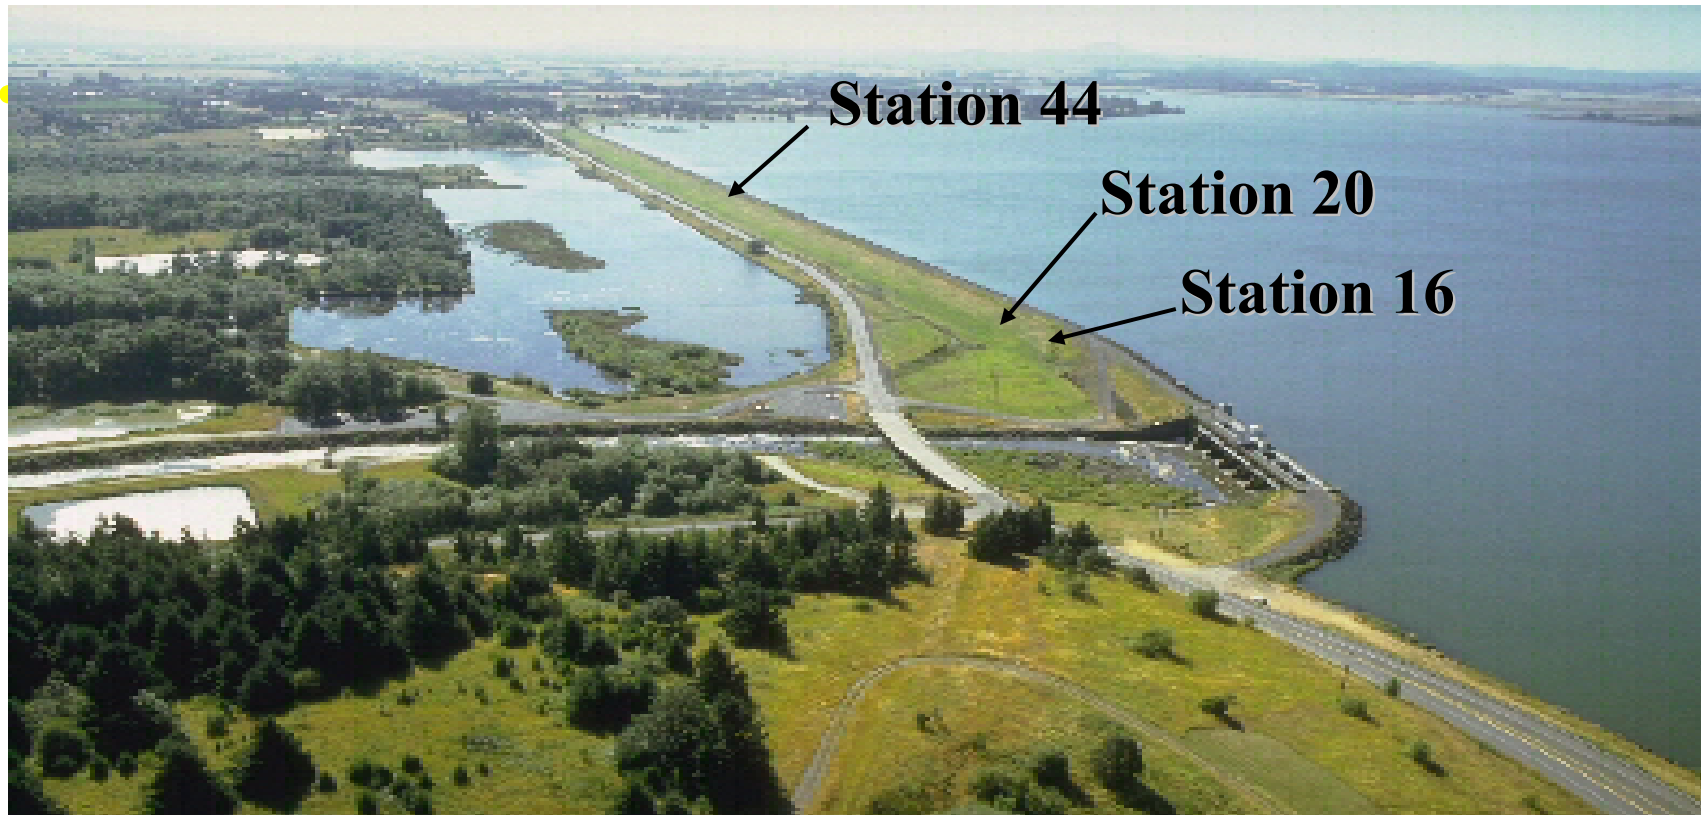
Location of Depressions

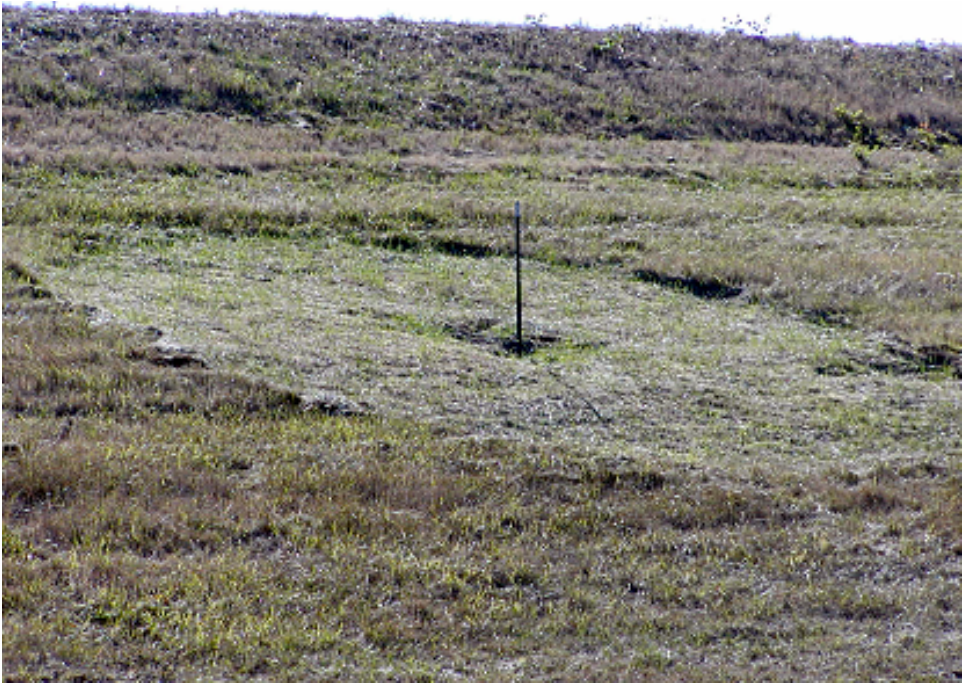
Station 44+00

Sinkholes on D/S face

September 2002

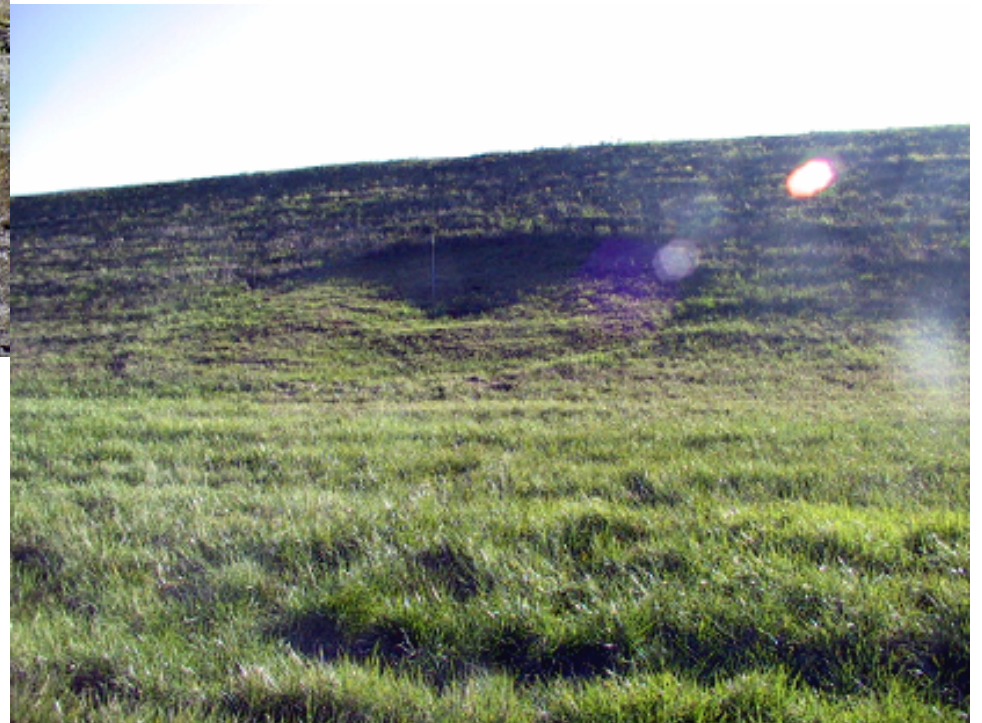
February 2003

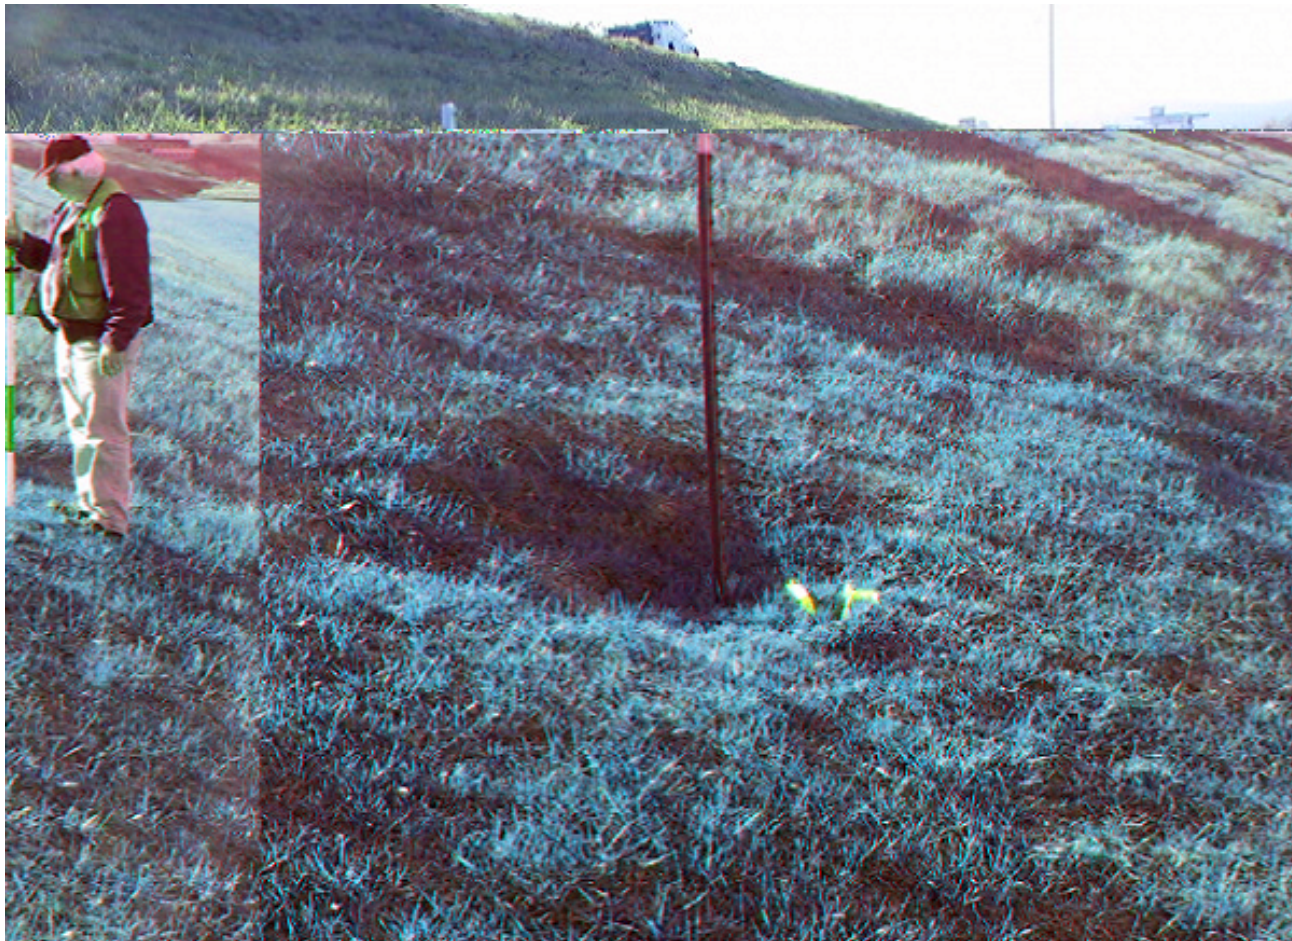
Station
20+00

Sinkholes on D/S face

February 2003

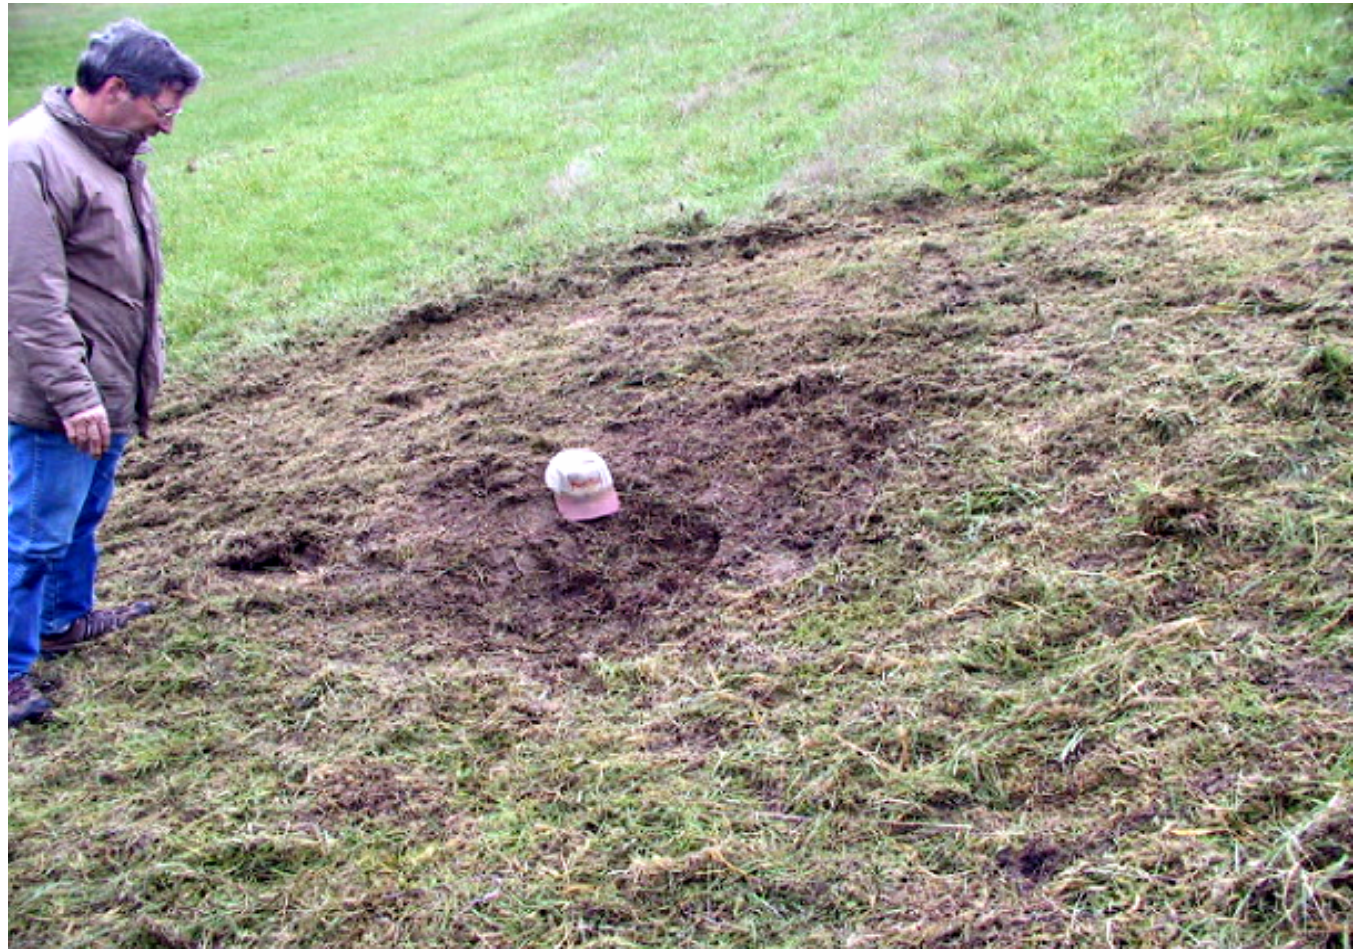
Station
16+00

Sinkhole on D/S face

February 2003

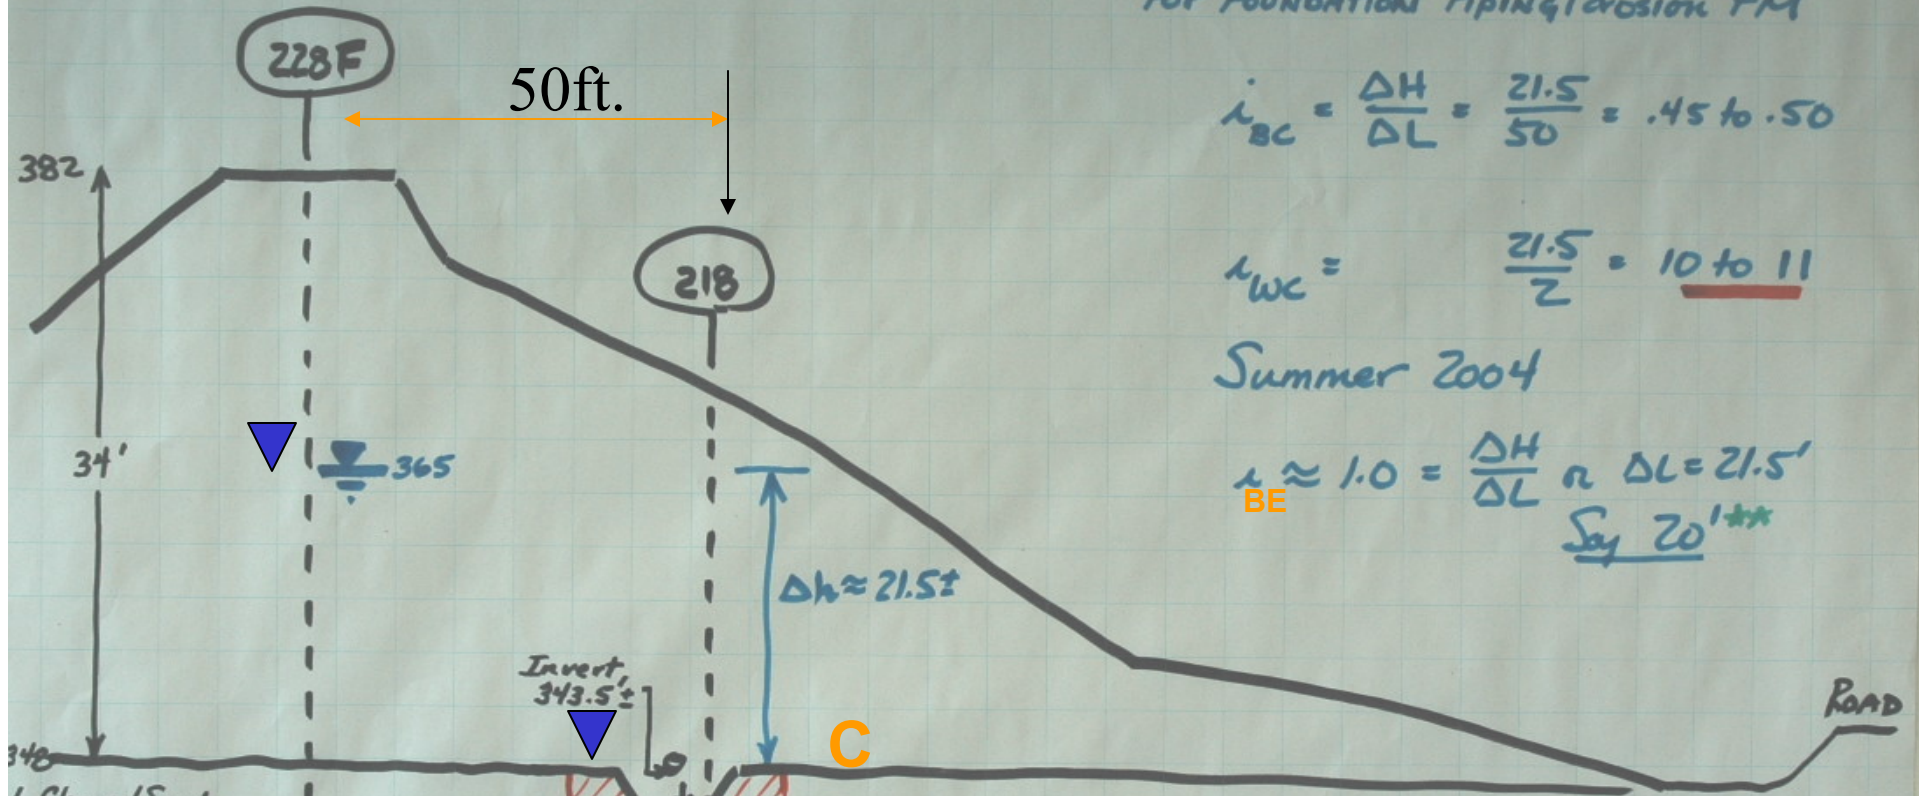
Station 14+40

At Pool Elev 373.5 (MAX. CONS. POOL)

FOR FOUNDATION PIPING/EROSION FM

$$i_{BC} = \frac{\Delta H}{\Delta L} = \frac{21.5}{50} = .45 \text{ to } .50$$

$$L_{WC} = \frac{21.5}{2} = \underline{10 \text{ to } 11}$$

$$i_{BE} \approx 1.0 = \frac{\Delta H}{\Delta L} \approx \Delta L = 21.5' \text{ Say } 20'^{**}$$

Res Elev	228 WL READ.*	ΔH	L _{WC}	i _{BC}	i _{BE} **
364	357	14.5	7	.30	.73
360	353	9.5	4	.20	.48
355	350	6.5	3	.13	.33

FM Initiation Zone (Rate = S)
FM Progression Zone (Rate = S to M)

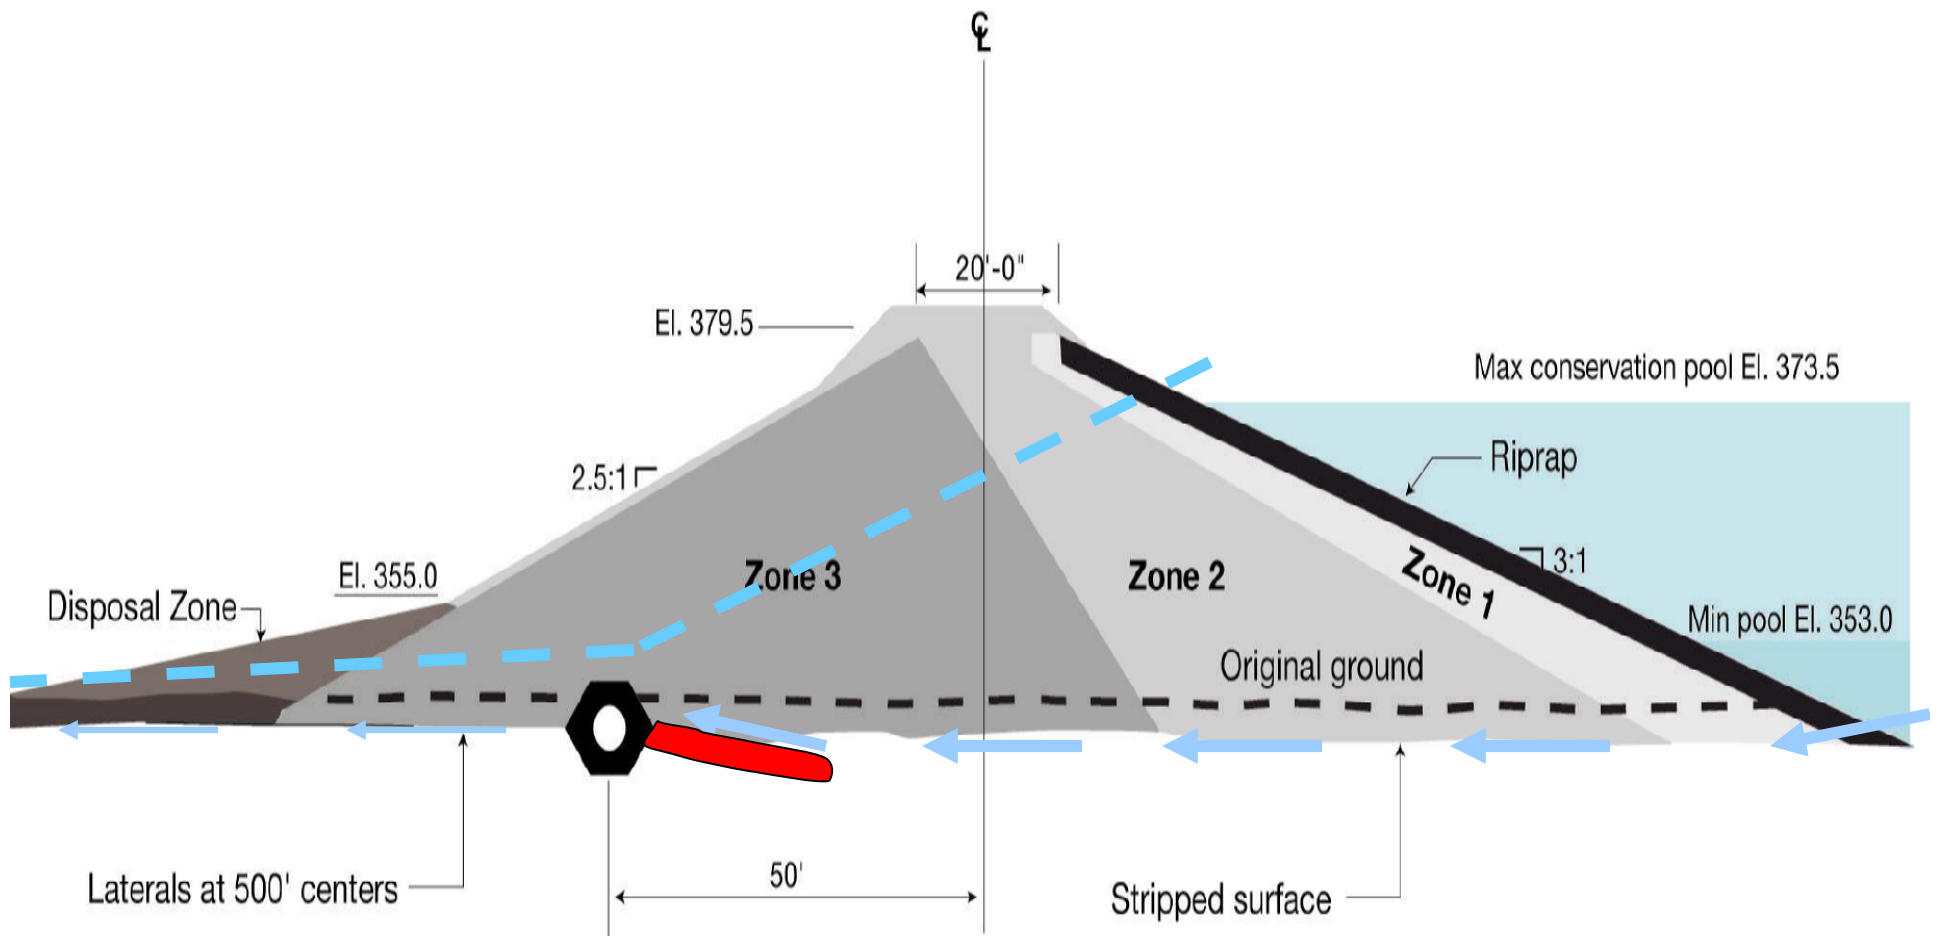
Fern Ridge Current Conditions

Continuation of Piping Failure
