# M789 LW 30mm HEDP Cartridge In-Bore Detonation Investigation

Mr. John Hirlinger, ARDEC  
&  
Dr. Scott Kukuck, ARL

26 April 2007

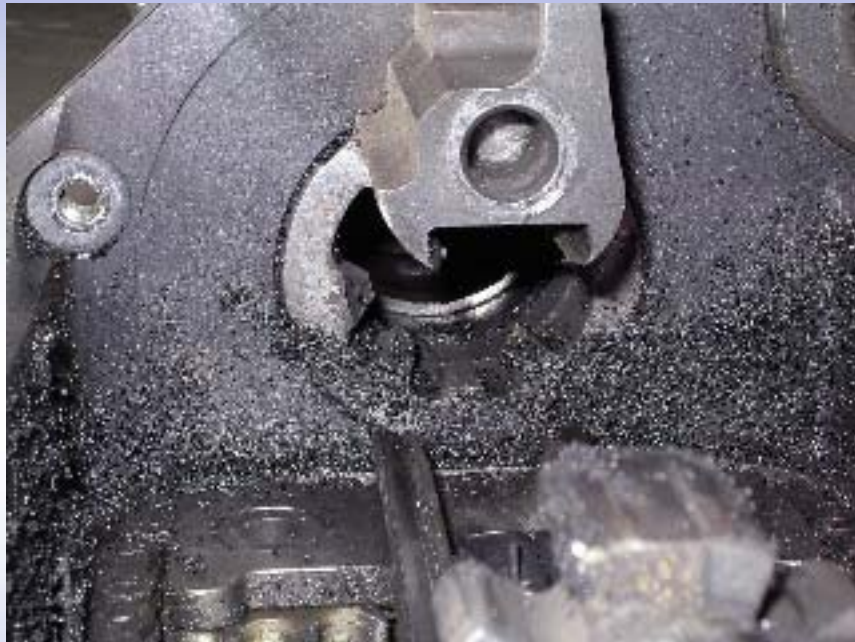
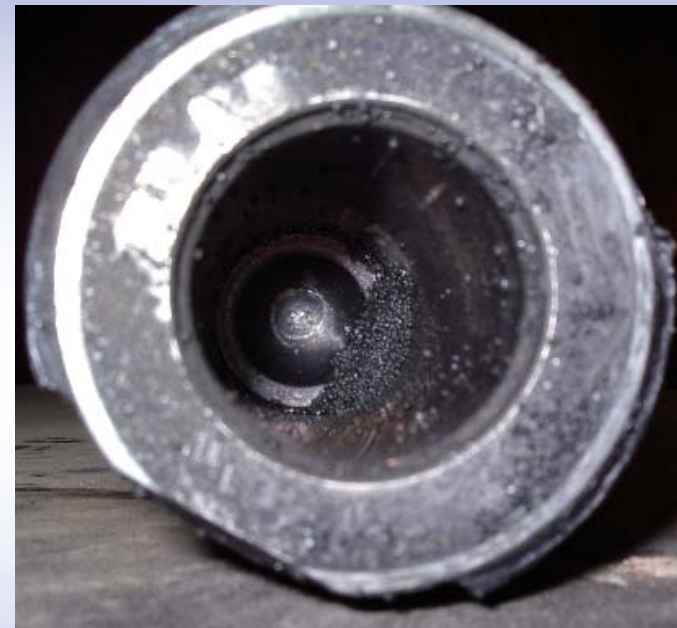
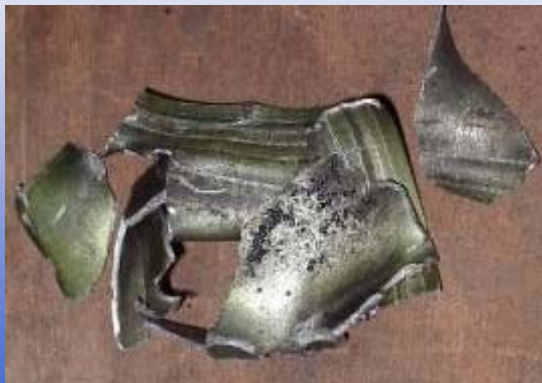
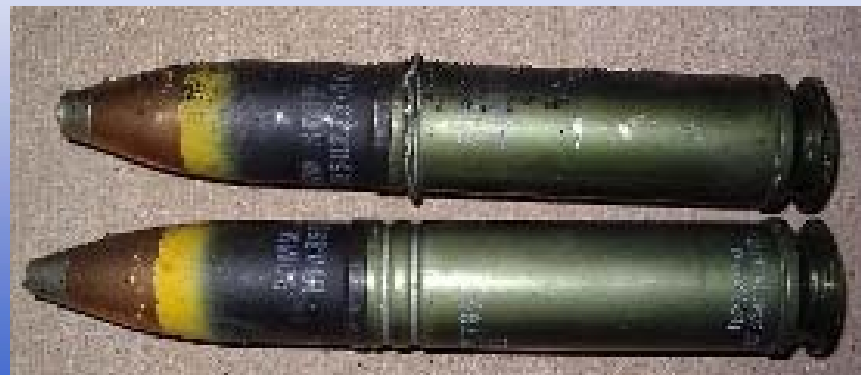
# Typical Damage “Minor Event” - Hangfire

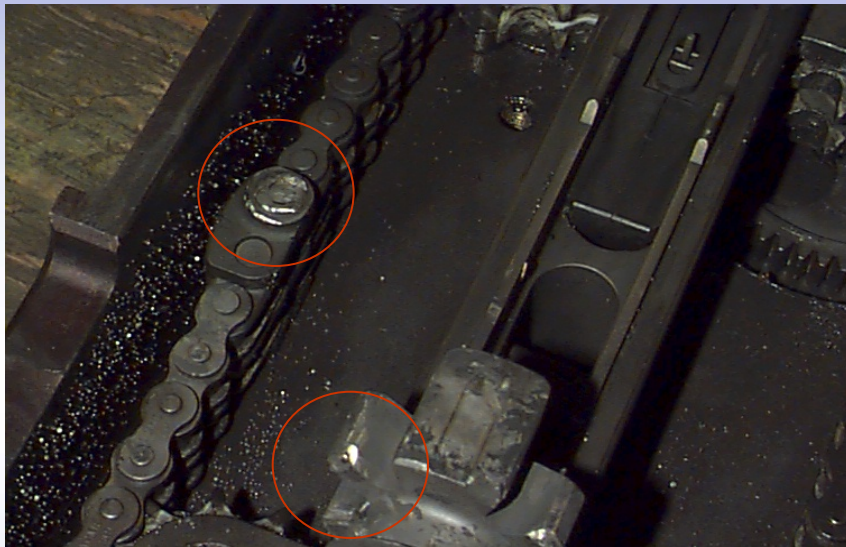
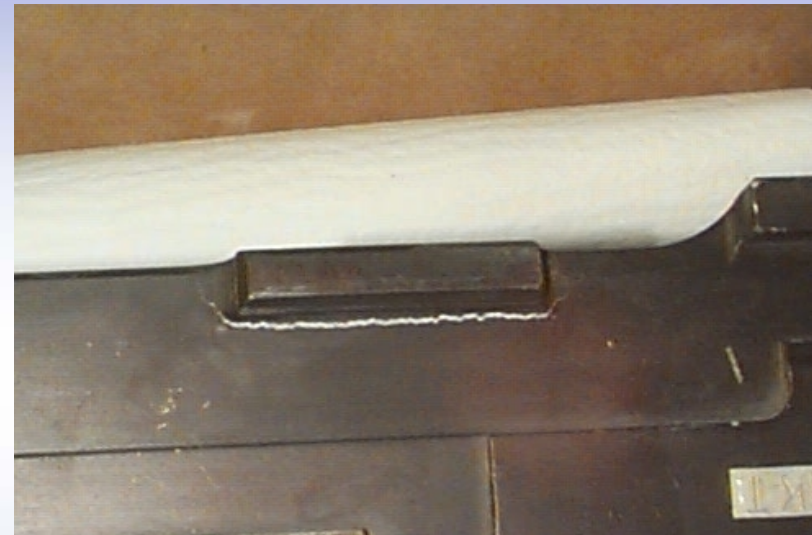
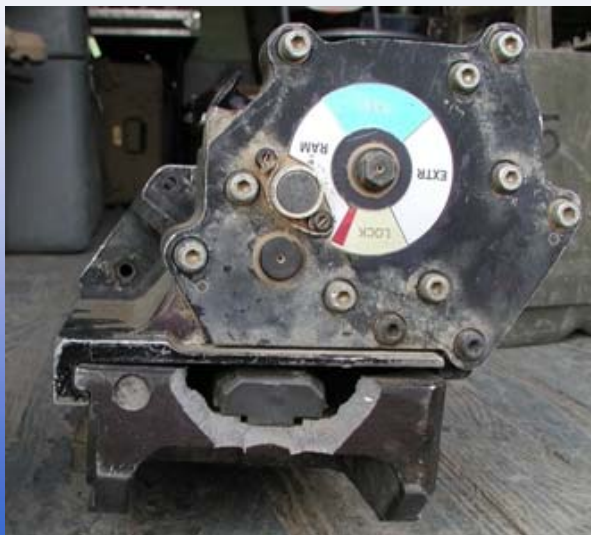
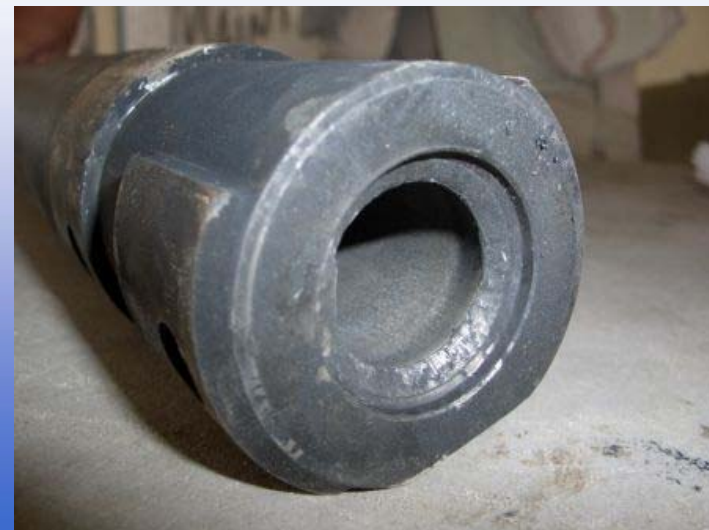
# Typical Damage "Severe Event"- Hangfire

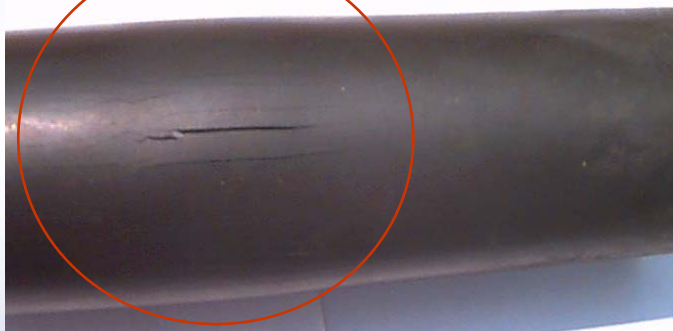
Typical

- Damage Similar to or Identical to Severe Hangfire/High Pressure Plus Barrel Cracking & Muzzle Break Impacts by Fragments

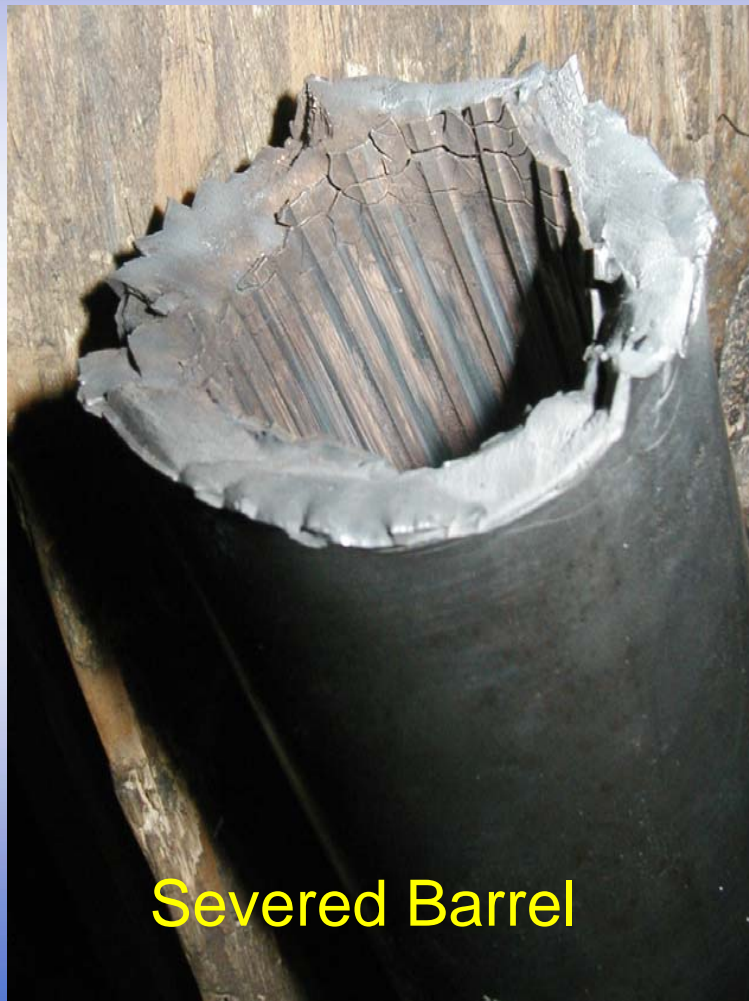
1/130th

Severed Barrel

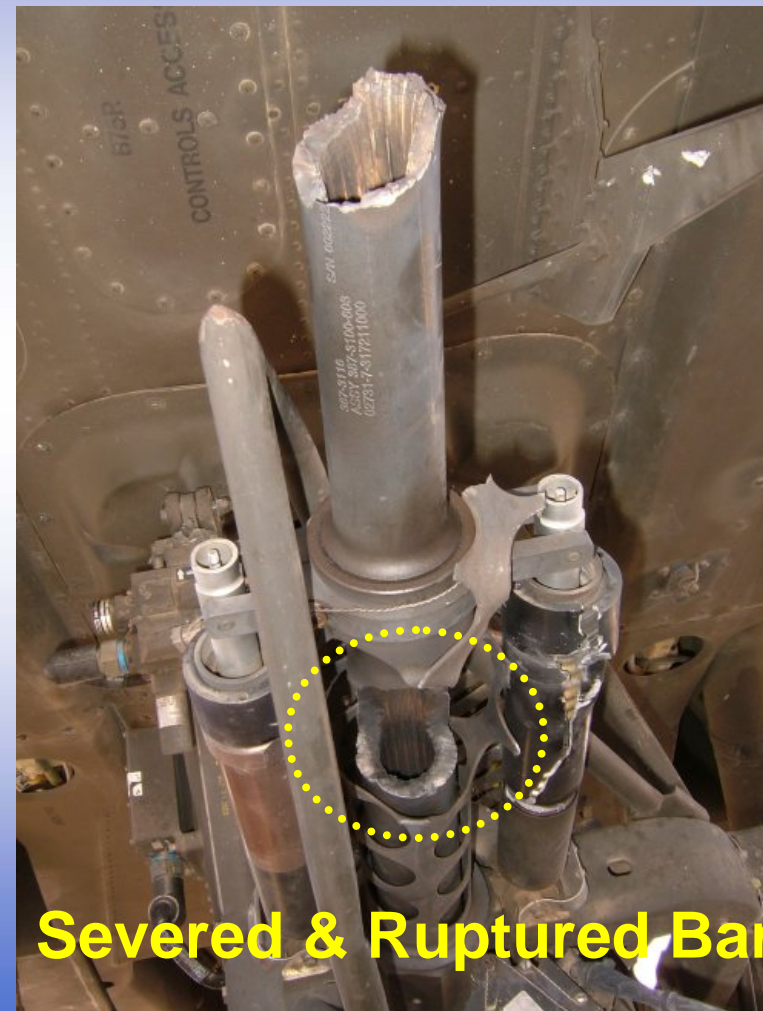
2/101st

Severed & Ruptured Barrel

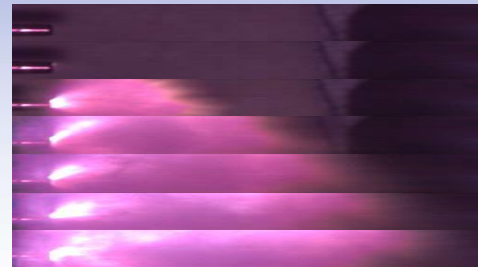
Damaged IB52

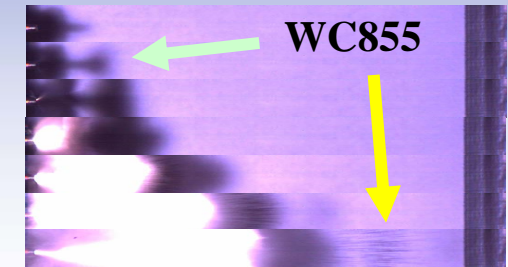
WC855 in Tube

WC855 in Flash  
Tube has Given  
Greater Than  
40 ms Ignition  
Delay

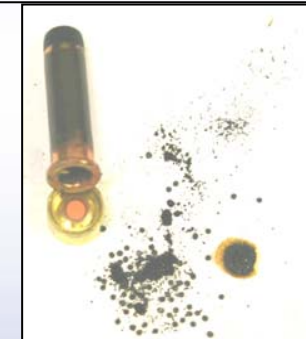
Some Damage IB52 Pellets

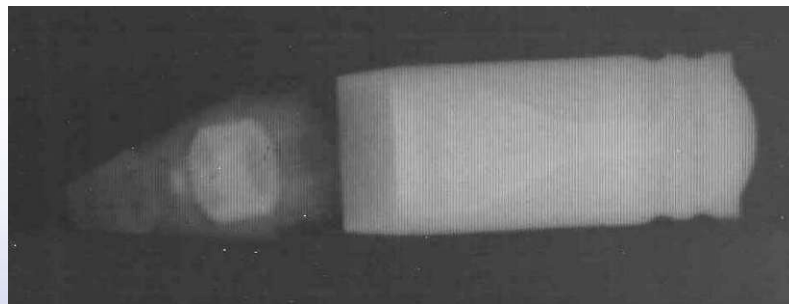
Gap between retainer and liner

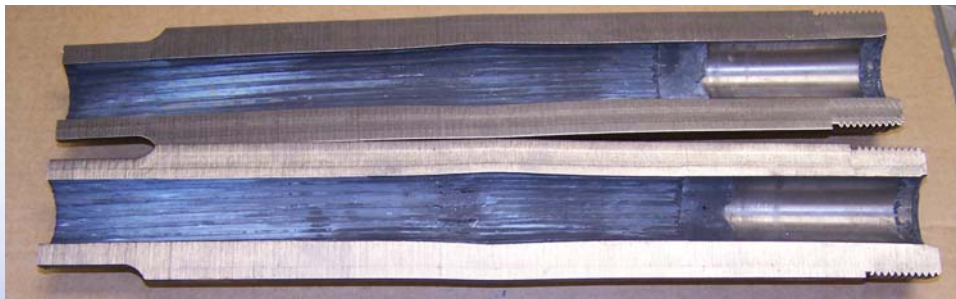
Bulged barrel centered at < 8 inches from breech

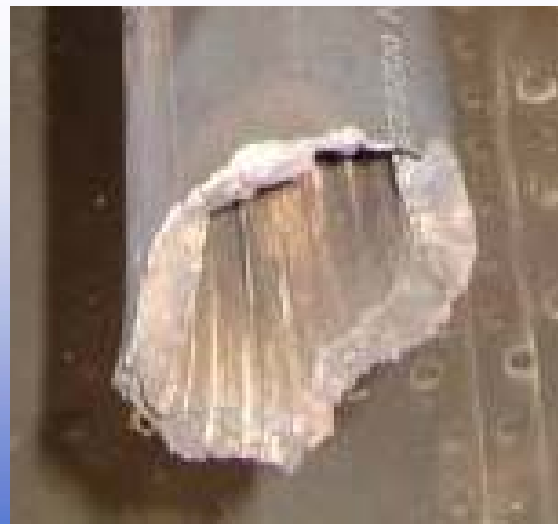
**Field Incident**

- A loss of propellant due to punctured case caused:
- 1 Increased Action Time (5 to 24 ms)
  - 2 Decreased Range
  - 3 Projectiles stuck beyond origin of rifling at ~15% propellant load
  - 4 Projectiles stuck at origin of rifling or failed to debullet at 5-10% propellant load.

- Most Likely Causes
  - ★ Cartridge Cases are Punctured and Propellant is Lost
    - Efficiency Loss to a Level of 10-15% (Replicated)
- Actions Taken to Reduce/Eliminate Issue
  - ASAM #AH-64-07-ASAM-13 Issued
    - Emphasizes Use of “Auto” Mode for D Model Apache Sideloader which Minimizes Risk of Creating and Firing Punctured Cases
    - Requires Download and Inspection of Ammunition at Aircraft Regularly Scheduled Maintenance
    - Re-emphasizes the Need for Caution Uploading/Downloading the Aircraft to Avoid Punctured Cartridge Cases
