# Computer Modeling to Solve Problems with the T-38 Propulsion Modernization Program

Presented on October 25, 2007  
at the NDIA 10<sup>th</sup> Annual Systems  
Engineering Conference  
by Randy Wimer  
USAF Propulsion Engineer  
Co-author: Andy Hall  
USAF Propulsion Engineer

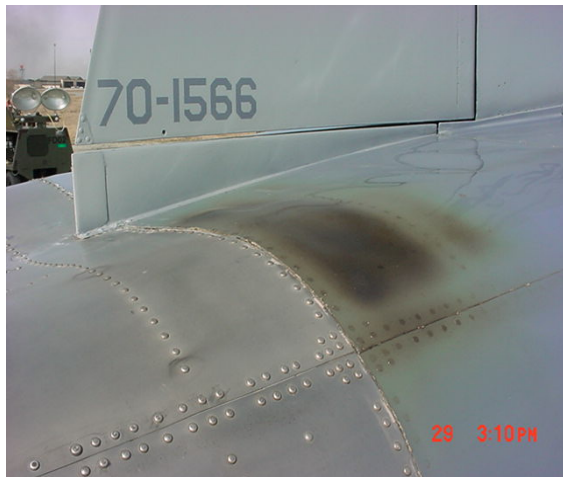
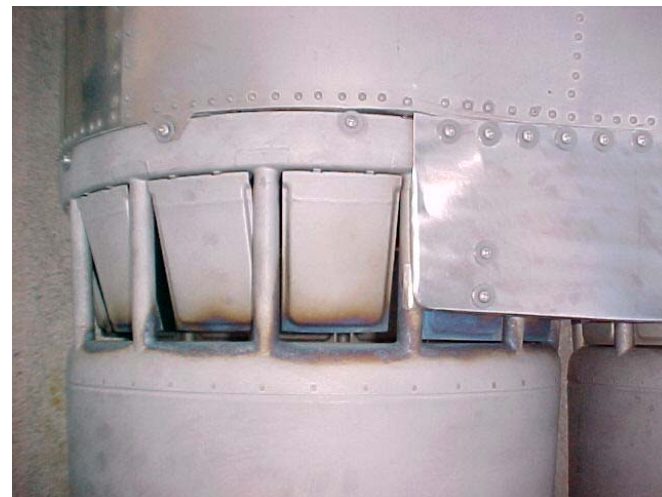
# T-38 PMP Issue #1– Engine Bay Overheating

- Two issues: Cockpit engine fire lights and engine bay overheat events
  - 8 Ground Occurrences
  - 32 In Flight Occurrences – all on functional check flights (FCF)

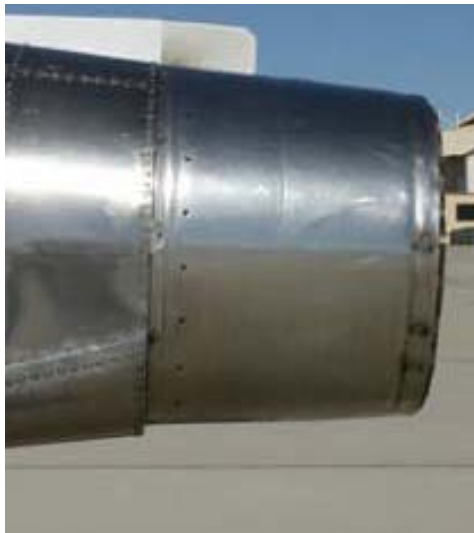
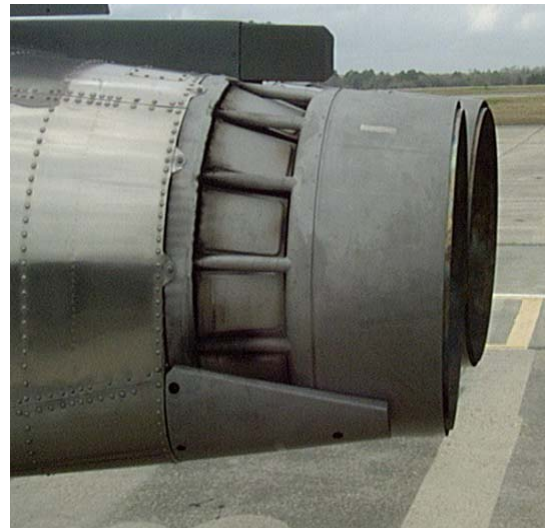
## Modified ejector

- PMP introduced a new inlet and ejector that reduced cooling airflows in engine bays and in keel cooling spaces. This decreased the tolerance of the system to heat-elevating conditions.

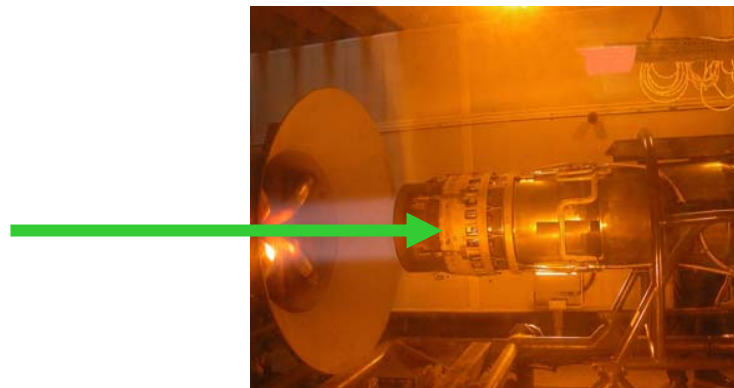
- No Single Solution, No Smoking Gun
- System Problem With Multiple Contributions
  - New ejector reduced engine bay cooling airflow
  - New inlet reduced keel cooling airflow
  - Hot air leaks around Variable Exhaust Nozzle (VEN) assembly compounded problem
  - Engine bay cooling degraded over time due to old aircraft (“tired iron”) – several leak paths
  - Part to part variability
  - Air framer not initially involved

Hot leaks  
forward  
of VEN  
housing

- Validate thermal model in order to determine optimum solution
  - Operational solutions (i.e. different FCF profile) need to be evaluated first and design solutions second
- Recalibrate trigger temperature for fire warning system
- Separate fire safety concerns vs overheat concerns
- Fire safety needs to be determined from validated model and design standards

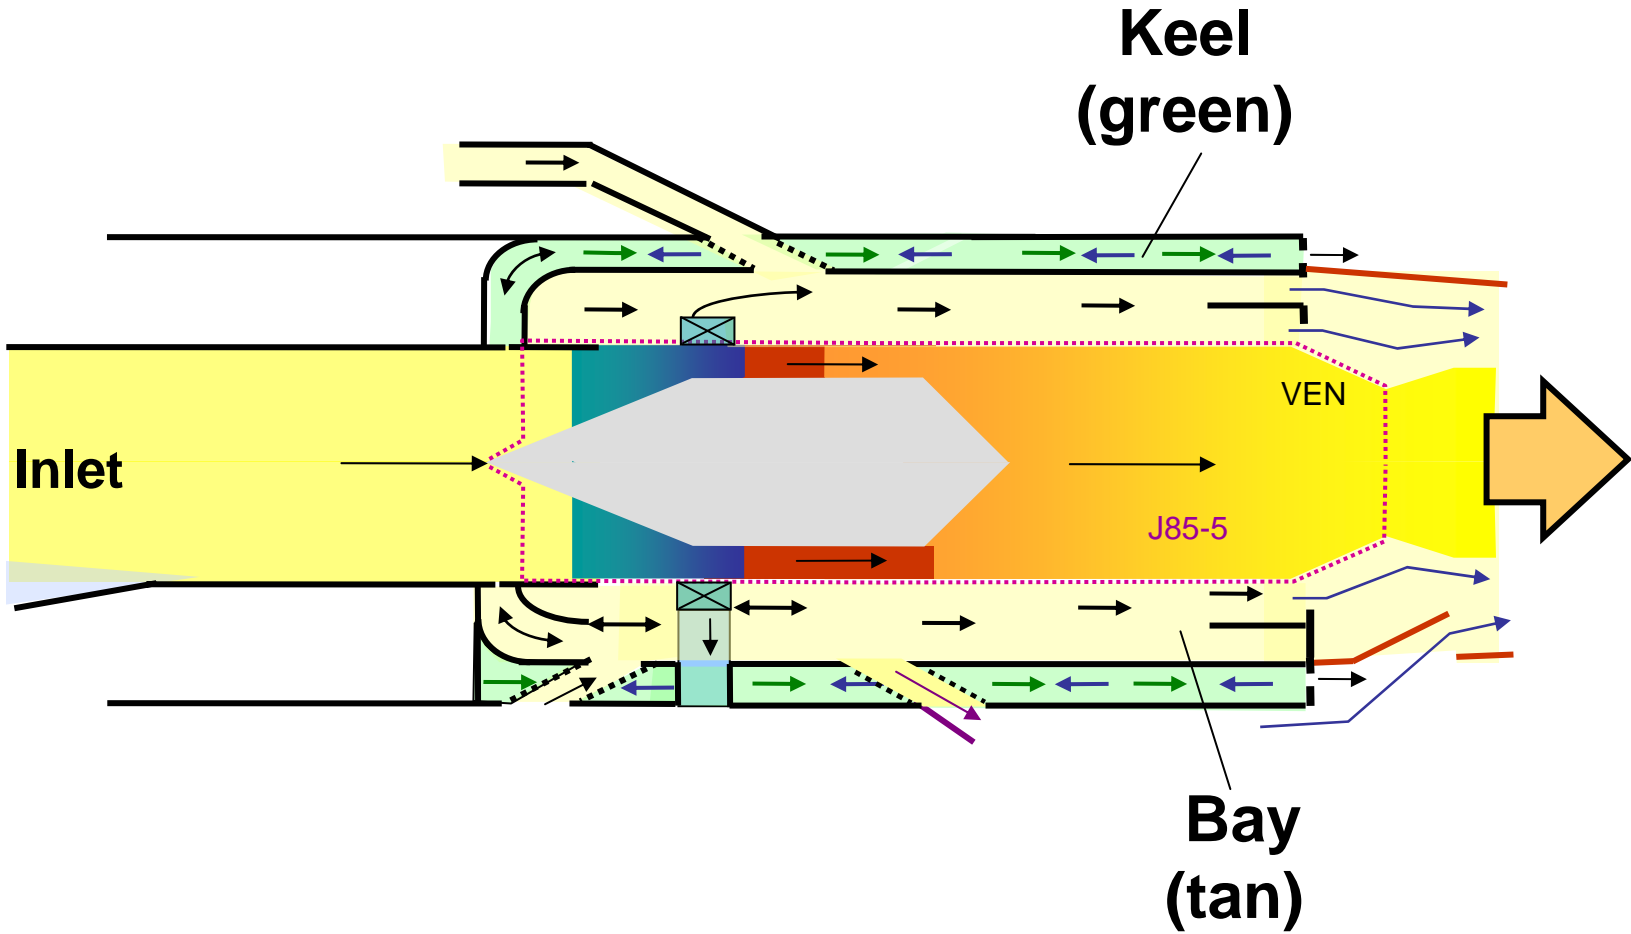
# Engine Bay and Keel Space

Blue arrows indicate keel airflow reversal under certain conditions
