Hazards of inappropriate fuzing design or

An accident waiting to happen

13:th of September 2003

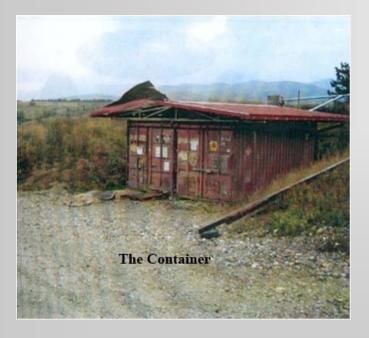
Photo of the Scene

The Scene of the Accident (II)
