# Performance Evaluation of Reduced Sensitivity Explosives with Novel Applications

# High Explosive Pellet Pressing Incident

Insensitive Munitions and Energetic Materials  
Technology Symposium 4/25/2018  
LA-UR-23440

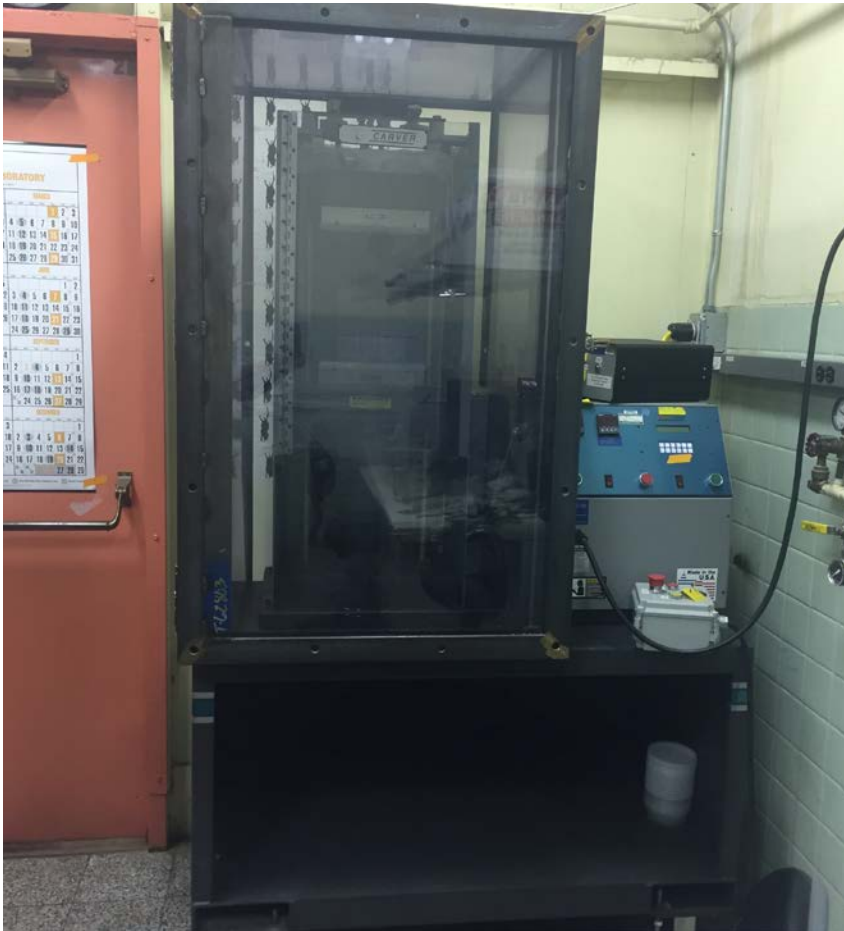
# 25 Ton Carver press (not the Event press)

- The press has heated platens
- There is a secondary controller for the heat
- Shielding consists of 1/2" Lexan, 1/4" air gap and another 1/2" Lexan plate/
- 30g of HE can be pressed with the operator in the room.

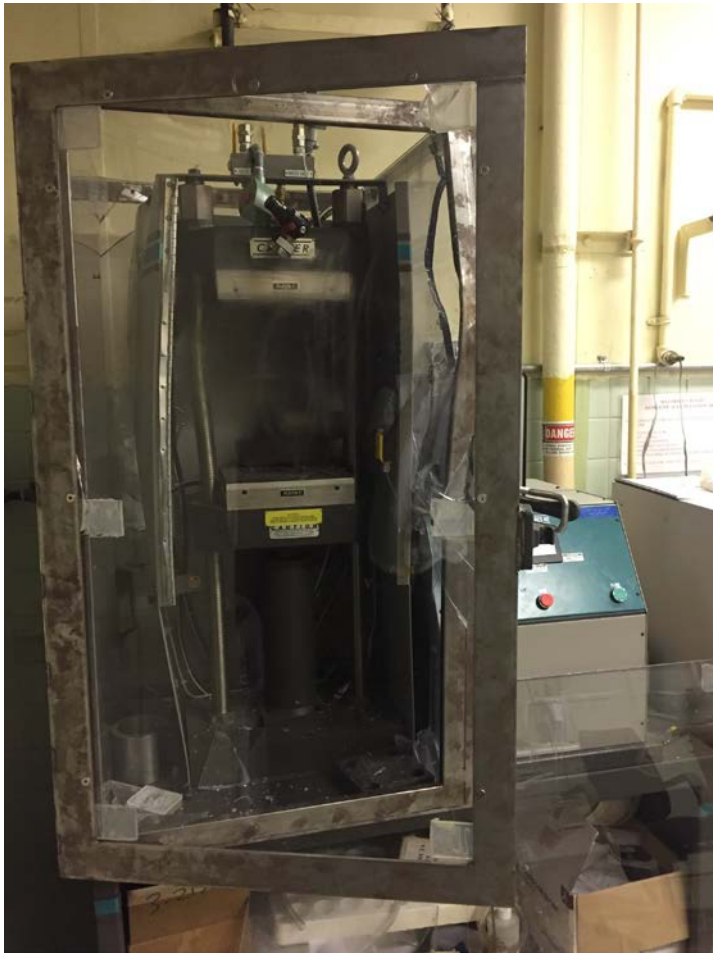
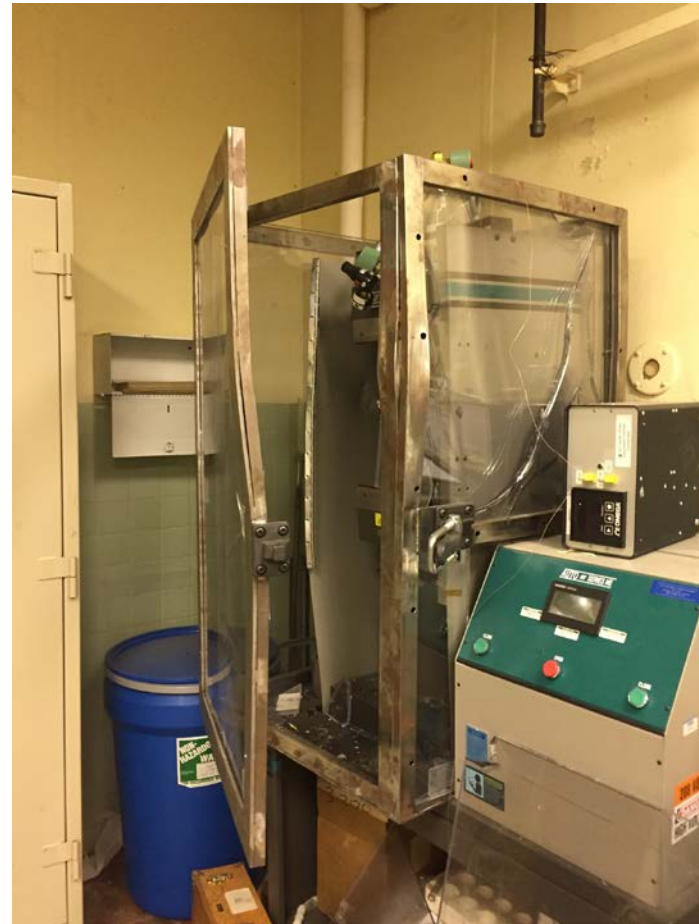
# The Press involved in the Event

- At 9am Monday 4/2/18 an operator was preparing to press 1" x 1" PBX 9501 pellets
- 930ish metal fatigue sound heard
- Event occurs

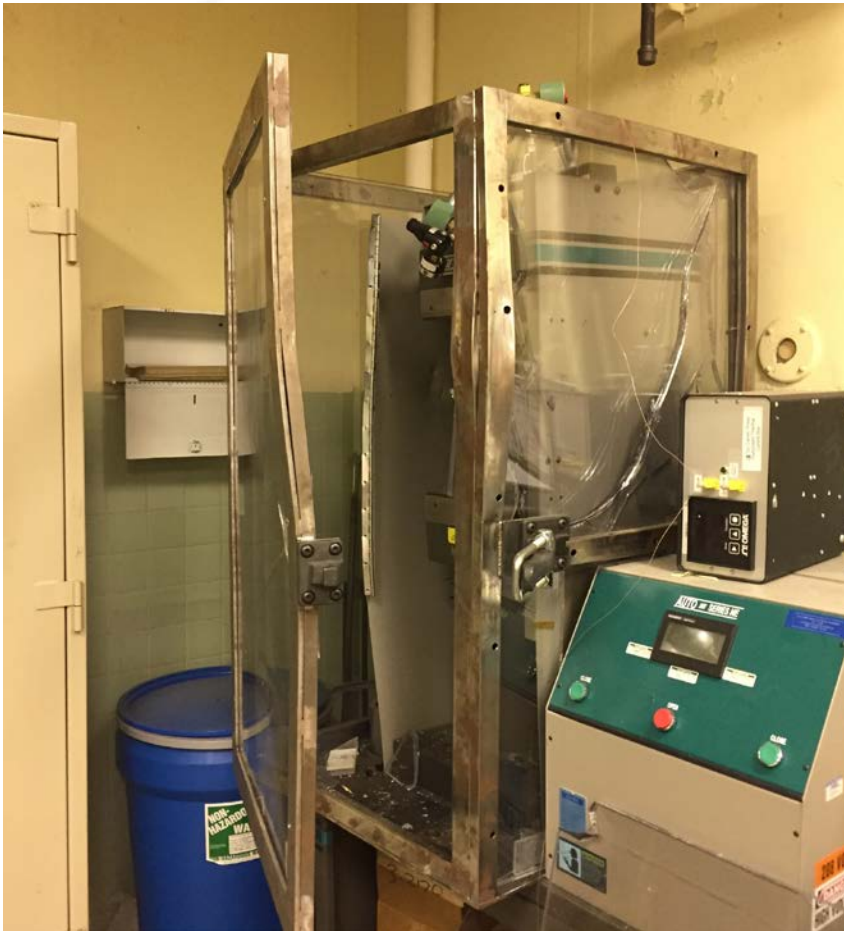
# The personnel present for the Event

- One worker and one escort were present.
- Both were 10-12 feet from the press.
- Both were OK!
- Both sustained hearing loss, possibly not permanent.
- Shielding worked. No frag escaped.

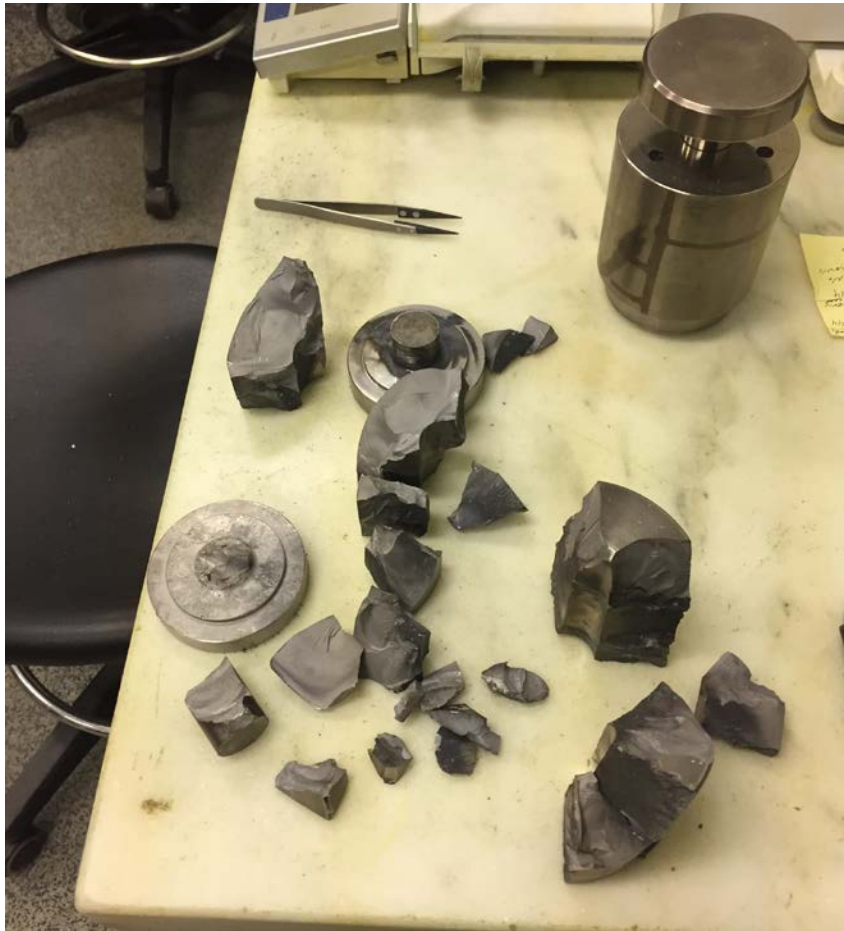
# One inch die, before and after

- The die was made of tool steel.
- The steel shattered, and showed no evidence of detonation.
- 23.6g of PBX 9501 was being pressed
- No HE was found after event.

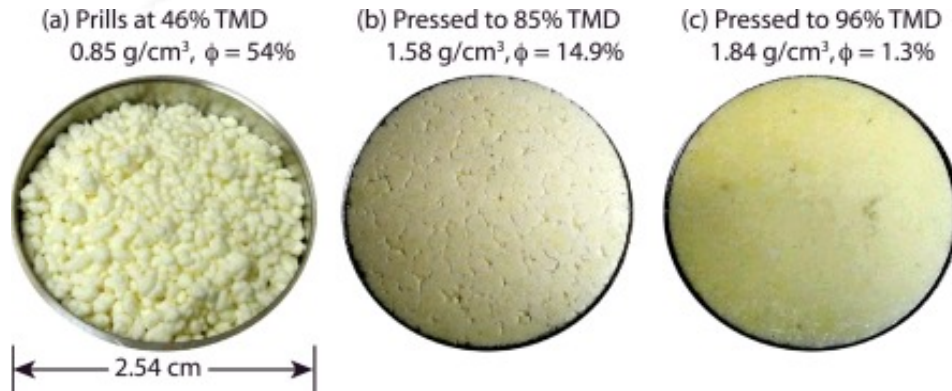
# Hypothesis #1 PBX 9501

Was there something wrong with the molding powder that caused it to react violently?

- This was a well characterized, ex-WR lot from 1989 that has been extensively studied
- Thousands tests incorporating millions of pellets have been performed.
- No previous accident at LANL with 9501 has been recorded.
- Small scale safety testing (Impact, Friction, DSC, VTS) showed it to be within normal parameters.

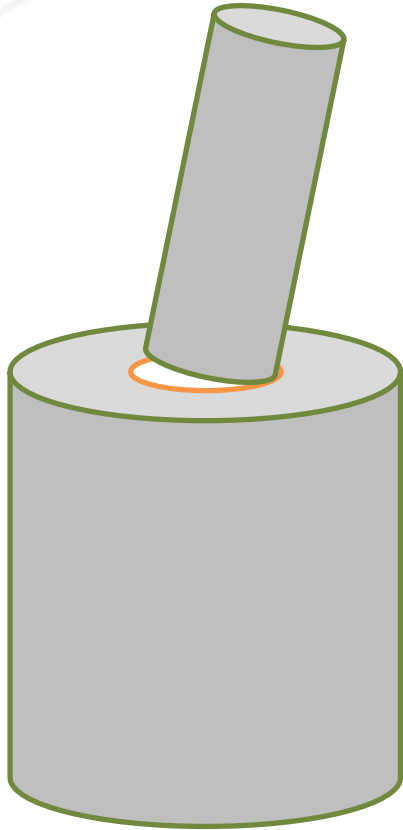
# Hypothesis #2 The stemple was angled

- The cause may never be known
- Hypothesis #1
  - The PBX 9501 was at fault in some way
- Hypothesis #2
  - The stemple was cocked in the die, gouging the die polish and creating friction heating.
- Hypothesis #3
  - Metal fatigue sound heard just before Event was the die body or stemple cracking and failing.

- Pellets are pressed in cycles
- A cycle consists of a pressing phase and a relaxation phase.
- This is done to increase density and pellet quality
- The stemple moves mostly during the first cycle only.
- The event occurred on the fifth cycle.

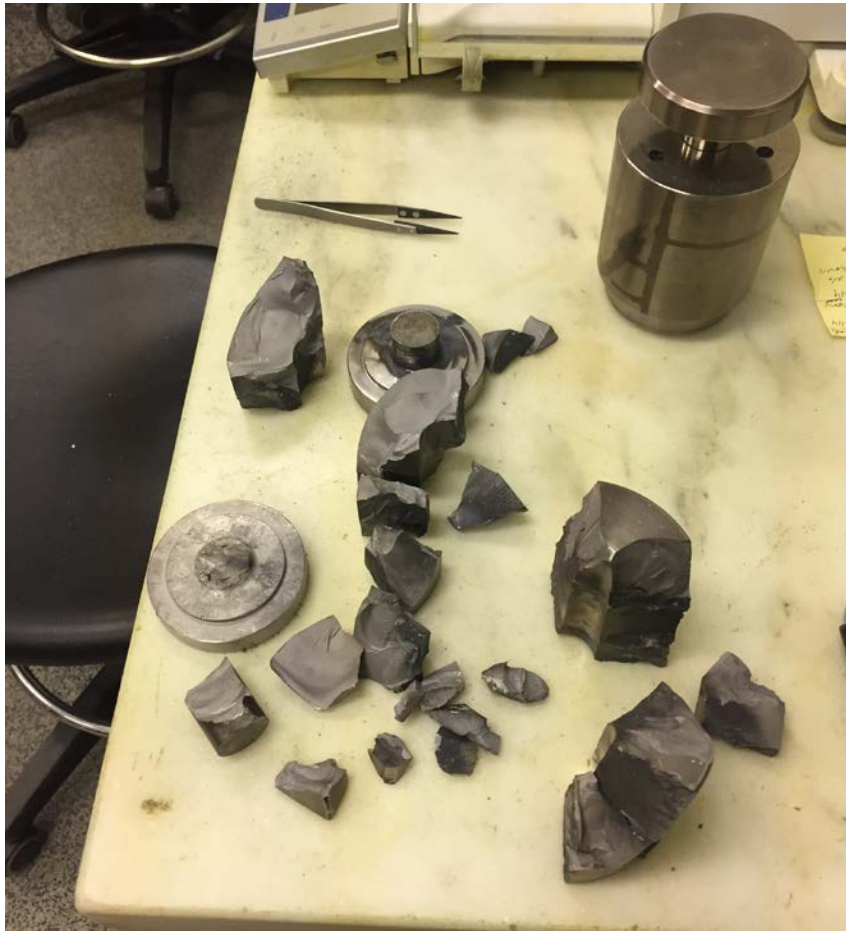
# Hypothesis #3 Metal Fatigue causing a die failure

- The operator heard a metallic sound immediately before the event occurred.
- The sound could have been from some failure of the die.

- Inspect Die set before each use.
- Measure tolerance of body and stemples before each use.
- Reject die if scratches and chips are found on body mirror polished surfaces
- Reject die if tolerance is less than 0.001” or greater than 0.002”.
- Rejected Die sets may be re-machined if possible.
