By: Ben F. Harrison IV, P.E., Technical Director, ABS Group, 140 Heimer Rd., Suite 300, San Antonio, TX, 78232, USA.

Abstract

1 Introduction

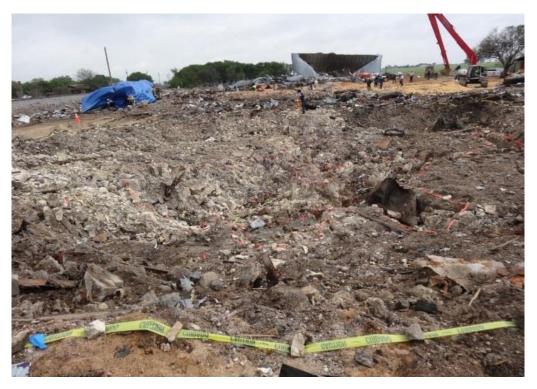
Figure 3 shows the West Fertilizer crater as observed after the explosion and altered during investigation. The crater lip to lip diameter was approximately 90 feet with an apparent depth of 7.5 feet. [i]

Figure 3. West Fertilizer Crater

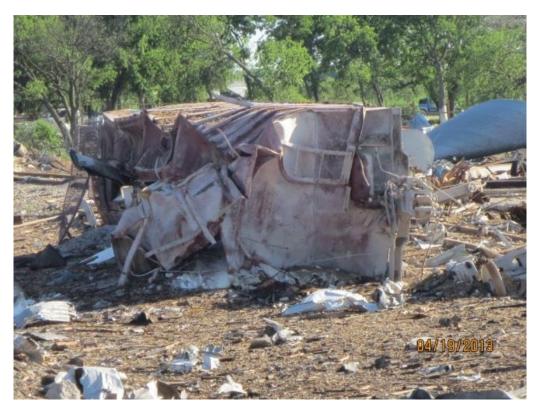
A rail car loaded with fertilizer grade ammonium nitrate (FGAN) was located on the West Fertilizer site, 190 feet to the north of the explosion center. The rail car, shown below in Figure 4, was overturned and heavily damaged by the explosion.

Figure 4. Rail Car Loaded with Ammonium Nitrate Overturned by Explosion

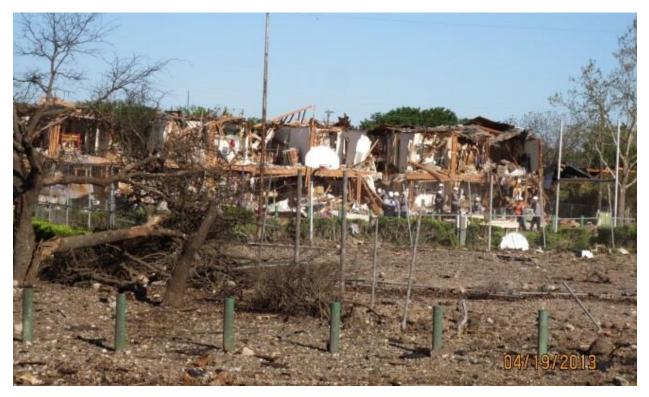
An apartment complex was located approximately 450 feet (K15) due west from the explosion center. The apartment building was a two-story wood framed structure with wooden roof trusses. The apartment building was heavily damaged by the explosion with failure of all walls and the roof as shown below in Figure 5. There were two fatalities reported in this building.

Figure 5. Apartment Complex East Façade – 450 ft. (K15)

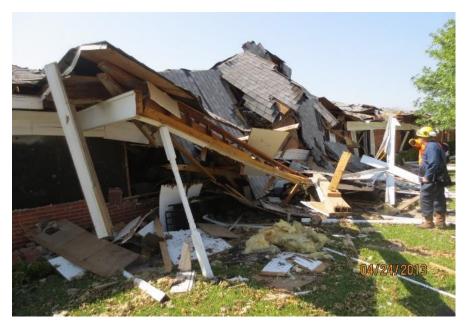
The Rest Haven Nursing Home was located 650 feet (K22) to the west of the crater and was also heavily damaged by the explosion, as shown below in Figure 6. The nursing home was constructed of load bearing wood stud walls with brick veneer and wood trusses that span from exterior wall to exterior wall.

Figure 6. Damage to Eastern Entry of Rest Haven Nursing Home- 650 ft. (K22)

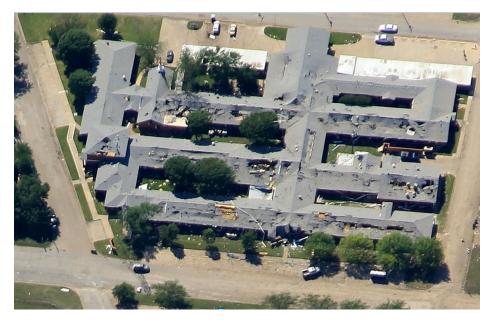
The Nursing Home was subjected to a large number of debris strikes from the crater ejecta which penetrated the roof, as seen in Figure 7. The size of the crater ejecta debris was large, even at this distance.

Figure 7. Post Incident Aerial View of Rest Haven Nursing Home (Roof Debris Impacts)

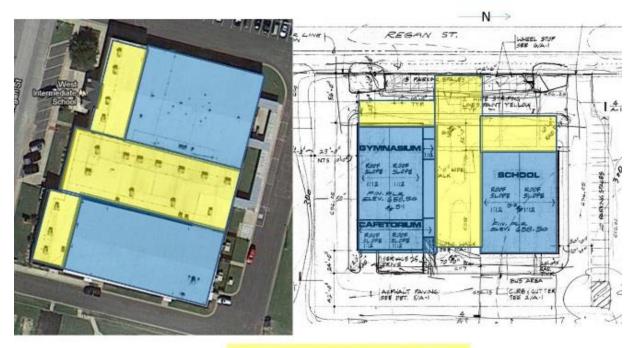
Figure 8. West Intermediate School Building Sections – 700 ft. (K24)

West Intermediate School was located approximately 700 feet (K24) to the southwest of the explosion center. The building was constructed in sections, which are identified in Figure 8. The first section, located nearest the explosion, was a pre-engineered metal building consisting of lightweight steel frames, cold-formed girts, and purlins supporting lightweight metal decking. The gymnasium and portions of the school were constructed of precast concrete tilt-up, load-bearing walls that supported open web steel joists and a metal roof deck. The school was not in session at the time of the explosion, which occurred at 7:51 pm [i].

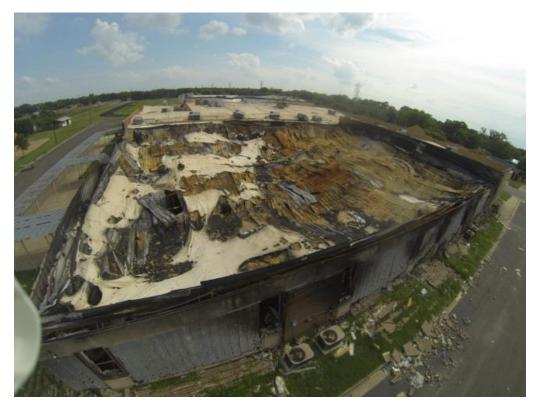
The pre-engineered metal frame/metal clad portion of the school in the northeast corner was heavily damaged by blast overpressure and was also fully involved in a fire. Damage to this portion of the building could not be evaluated due to the excessive damage associated with the fire. An aerial view of the roof is shown in Figure 9 and a view looking east down the hallway of this portion of the school is shown in Figure 10.

Figure 9. West Intermediate School – Original School Northeast Wing Roof

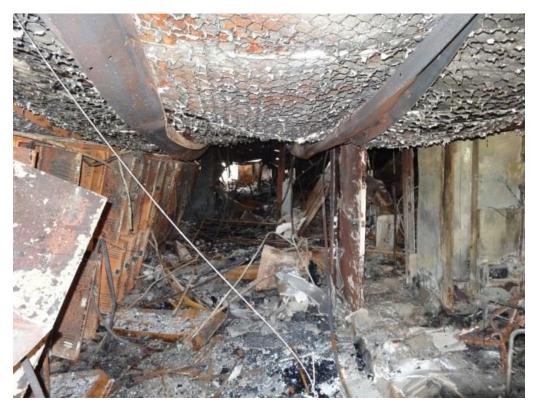
Figure 10. West Intermediate School Interior of Northeast Section that Burned

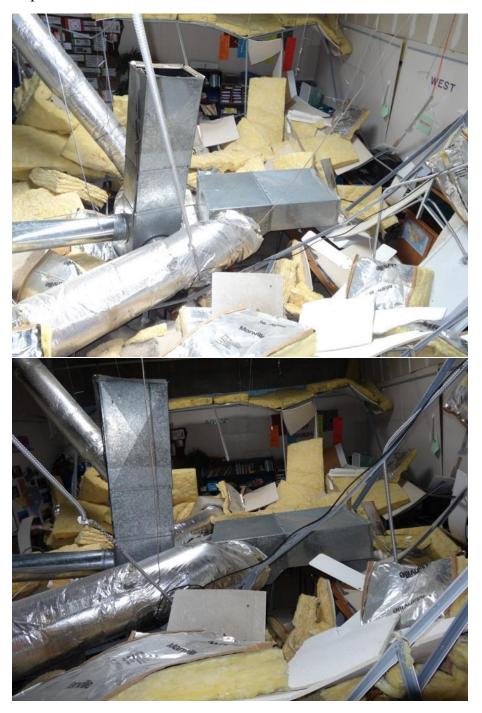
Classrooms in the center of the school were heavily damaged by the explosion and the interior of a classroom as shown in Figure 11. The acoustic ceiling, light fixtures and insulation have been forced to the floor from a combination of roof motion and air blast entering through the HVAC duct after the roof top air conditioner was displaced by the explosion. The entire ceiling plenum was found on top of the desks.

Figure 11. West Intermediate School – Classroom Nonstructural Debris

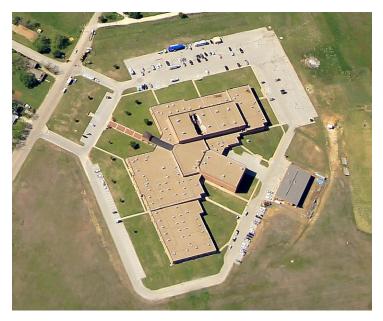
The school was arranged into two wings. The north wing of the high school faced the explosion and was subjected to reflected overpressures. The athletic gymnasium roof, shown overhead in Figure 12, collapsed as a result of the explosion. The joist girders, shown in Figure 13, failed from the in-plane load created by the blast reaction from the reflected wall facing the explosion.

Figure 12. Aerial View of West High School Roof-1,500 ft. (K50)

The West High School roof sustained light to heavy damage from the explosion with the exception of the large gymnasium which collapsed. The failure of the roof over the gymnasium was caused by a combination of out-of-plane blast loading and in-plane diaphragm loading from the wall blast reaction. The damage to the high school predicted by the FACED3D simulation for 25,000 lb_{TNT} is presented below in Figure 21. FACET3D results for the 25,000 lb_{TNT} CEBAM simulation show the predicted damage to the roof of the north wing of the high school. Therefore, the 25,000 lb_{TNT} yield that is consistent with the damage to the single family residences is also most consistent with the observed damage to the high school.

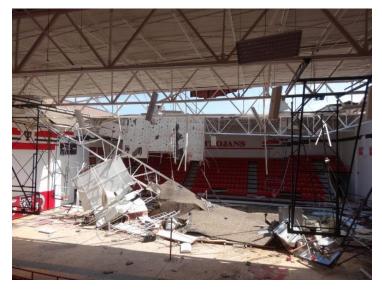
Figure 13. West High School Gymnasium 1 Roof Collapse from South Bleachers

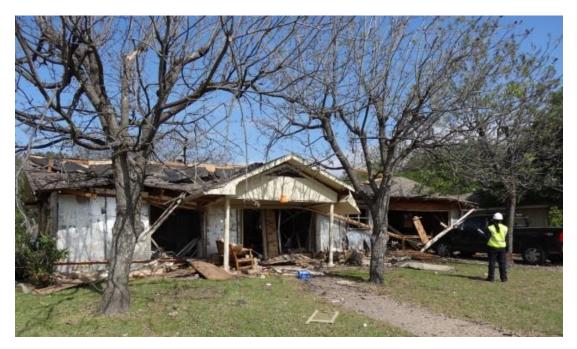
A total of 190 single family residential buildings were assessed as depicted in Figure 14. Window breakage, façade damage, and structural component failure (i.e. wall, roof system) were documented during the survey. The shock wave caused significant damage by breaking windows, failing roof trusses, and damaging exterior walls. An example of one heavily damaged home observed in the community of West are shown in Figure 15 and Figure 16.

Figure 15. Heavily Damaged Residence - - 700 ft. (K24)

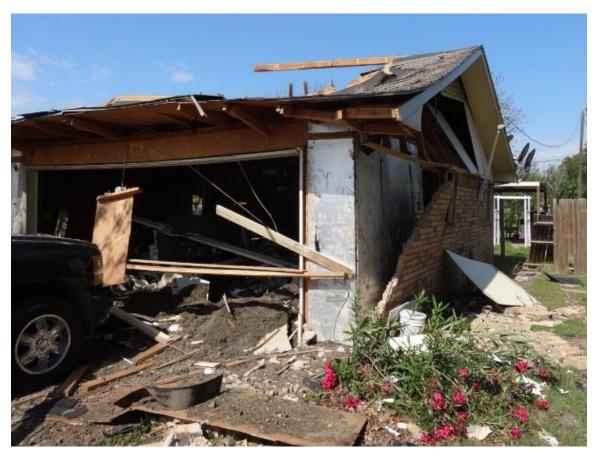
Figure 16. Examples of Observed Residential Damage – 700 ft. (K24)

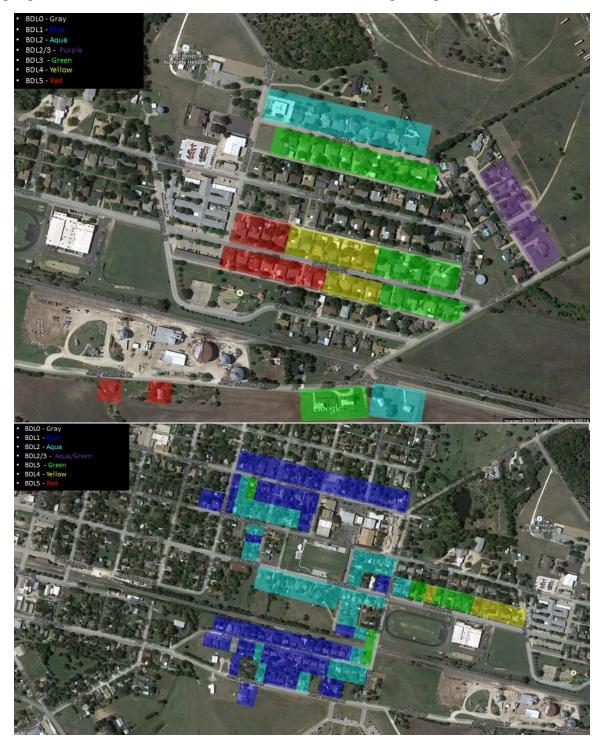
Figure 20. ABS Group BDL Levels of Surveyed Single Family Residences

A graphical map showing the building damage levels assigned to the single family residences are provided in Figure 20. Damage levels were previously defined in Table 2. The houses are highlighted to indicate the observed BDL as indicated in the figure legend.

The single family residences for the analysis were selected for BDL evaluation due to the proximity of the homes to the explosion center and the range of observed BDLs, which ranged from a BDL of 5 in the vicinity of the Rest Haven nursing home to a BDL of 2 farther from the explosion. The residences were divided into two groups based on their location with respect to the approximate explosion source: Group 1 - N. Reagan St. residences located to the North of the Rest Haven nursing home, and Group 2 - the N. Reagan Street residences located to the south of the nursing home. Charge weights, which produced damage that best matched the observe BDLs to these single family residences, were determined for homes grouped by building damage level. The results of the residential BDL assessment are summarized in Table 3. The charge weight that most consistently explained the observed damage from the West Fertilizer explosion was determined to be 25,000 lb_{TNT}.

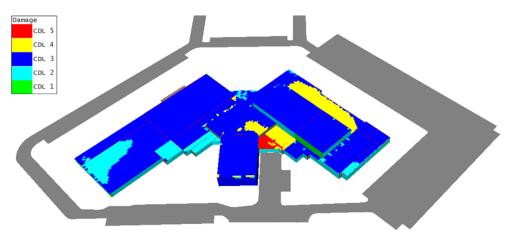
Figure 21. High School FACET3D Model Response – 25,000-lbtnt

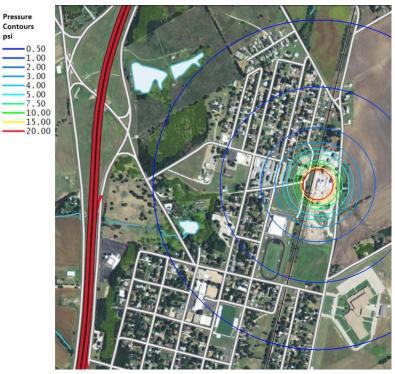
Pressure contours for the community of West, based on the predicted $25,000 \text{ lb}_{TNT}$ equivalent explosive yield, are presented in Figure 22. The apartment complex was at 5 psi free field contour and the nursing home and intermediate school were both at about 2.5 psi free field overpressure.

Figure 22. West Fertilizer Explosion Free-Field K-B Pressure Contours for 25,000 lb_{TNT}
