Lessons Learned from a Decontamination Accident

7 August 2018

2018 International Explosives Safety Symposium
San Diego, CA

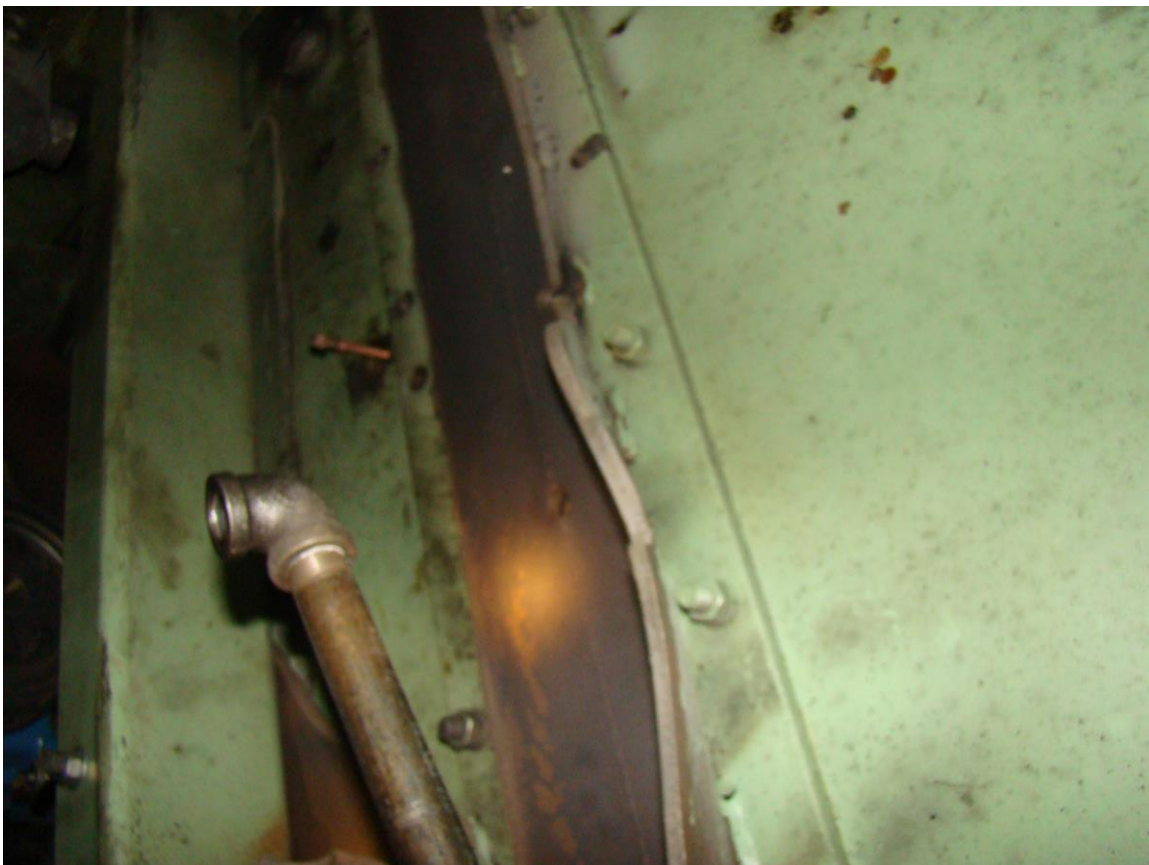
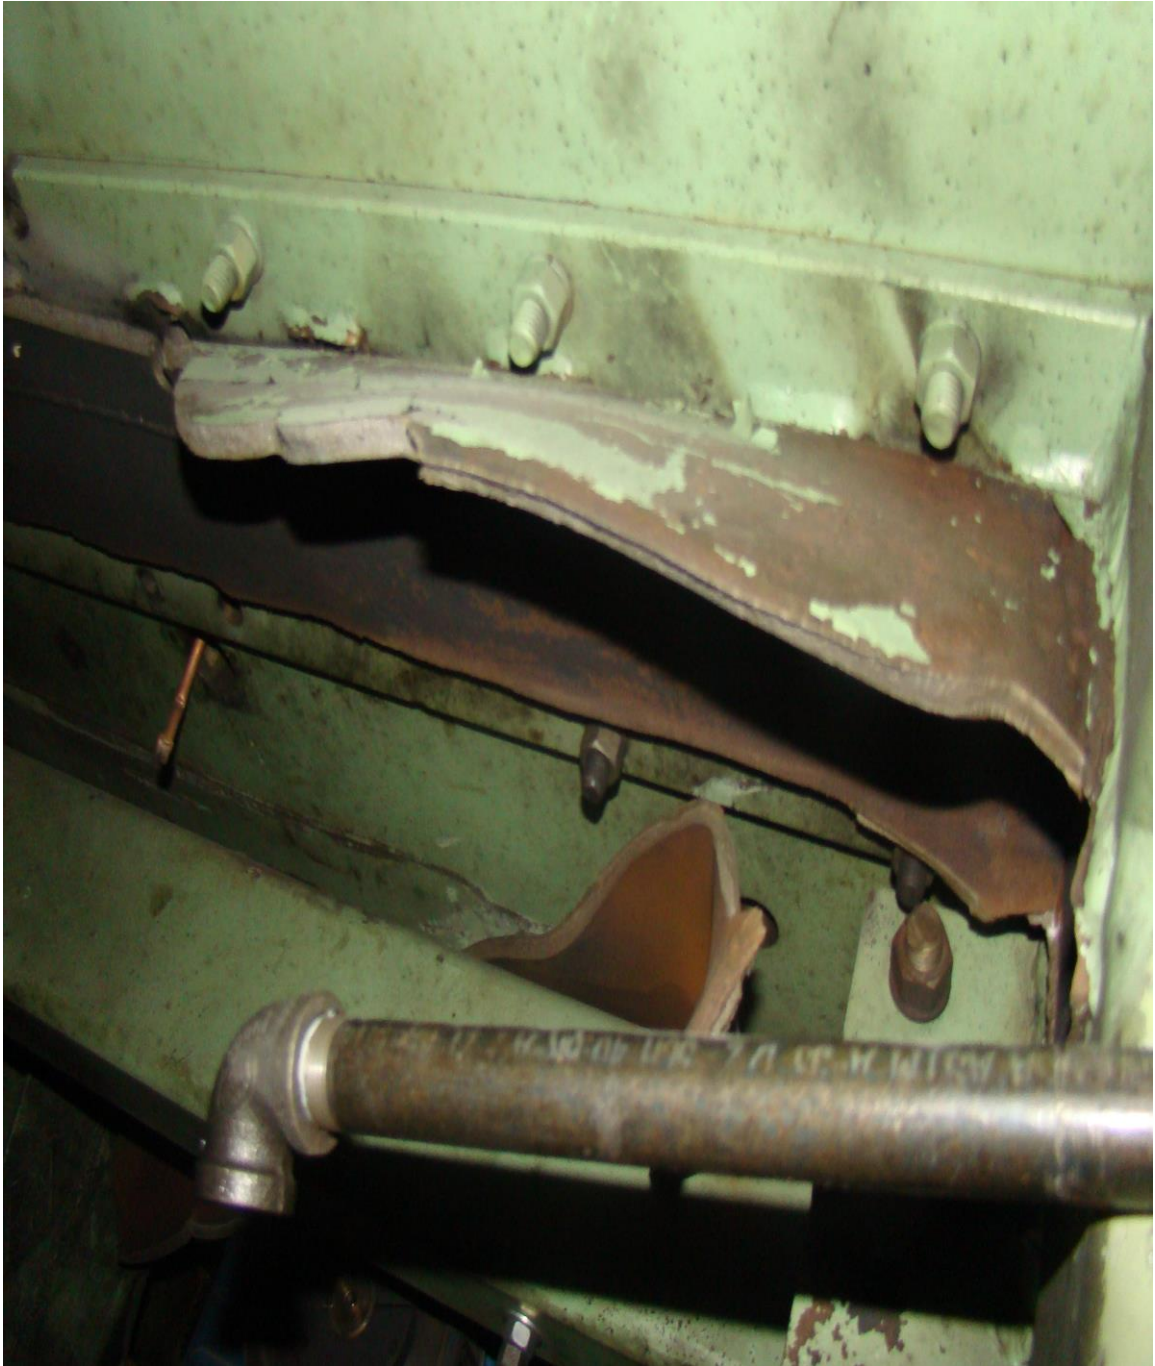
In March 2011 an explosion occurred in an operating bay at an Army ammunition production facility. The explosion involved an undetermined amount of propellant. The explosion caused significant damage to the bay including displacement of a temporary firewall that was in place to protect personnel in the bay from an accident in an adjoining bay that was actively producing small arms ammunition.

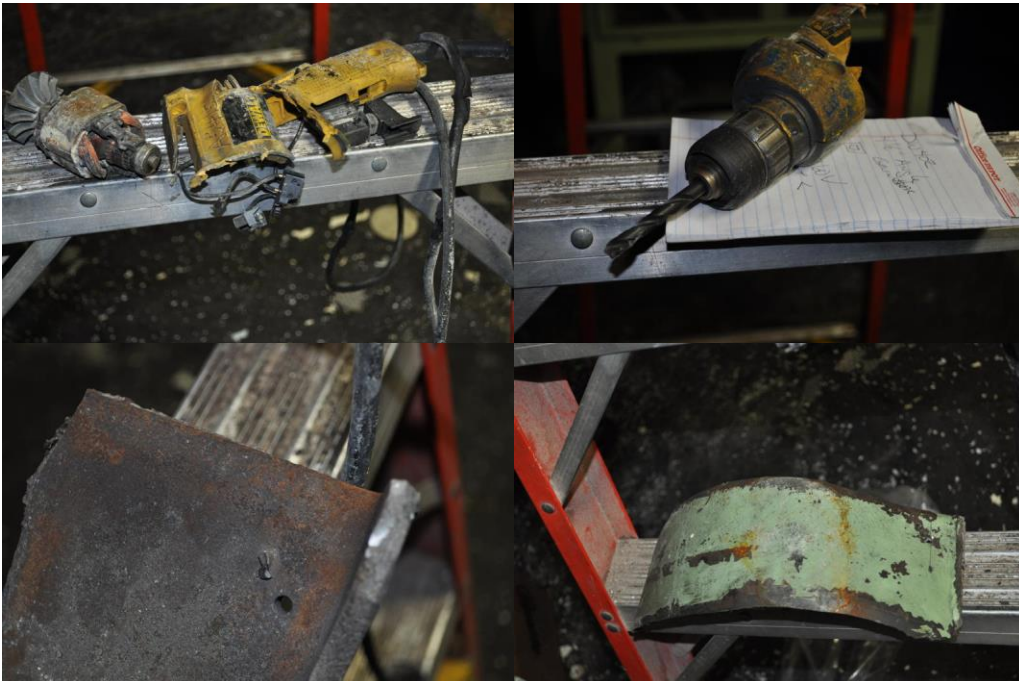
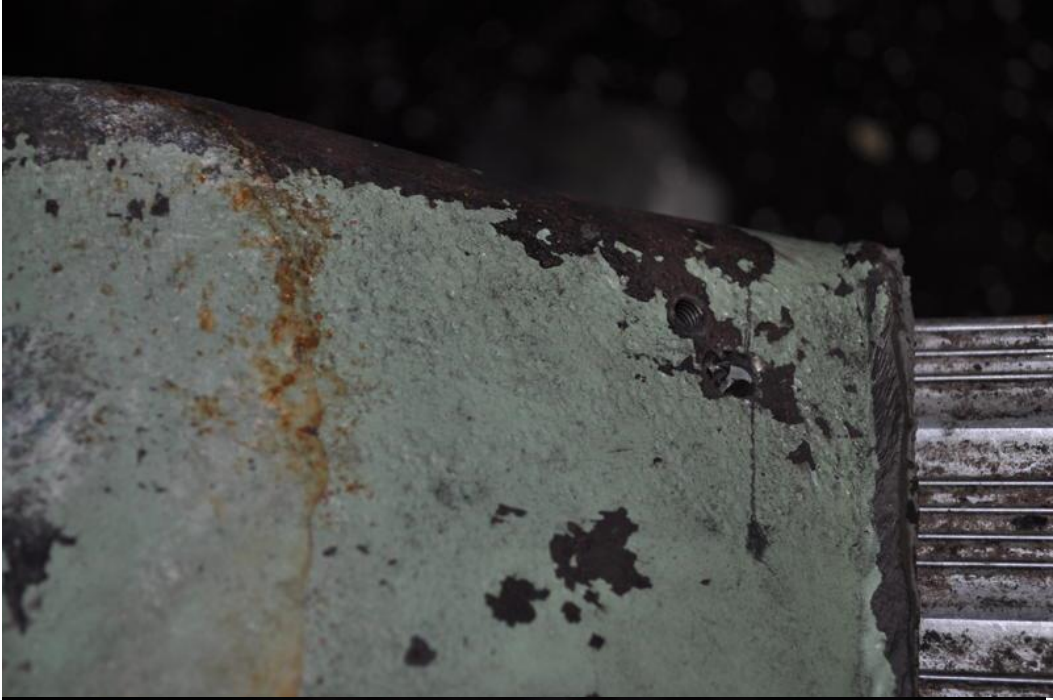
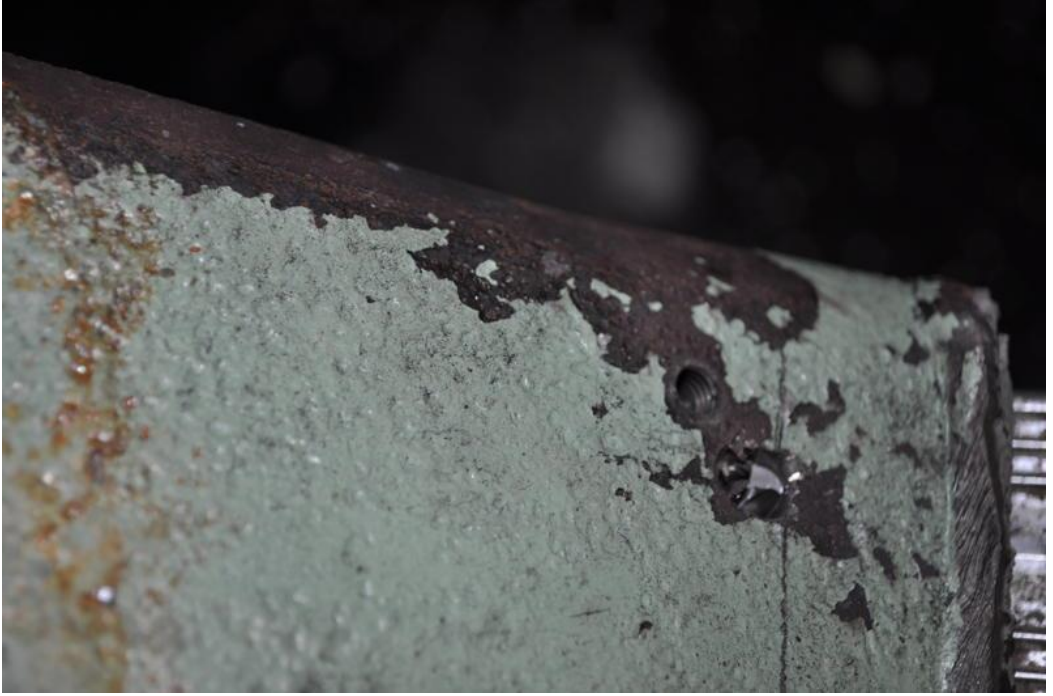
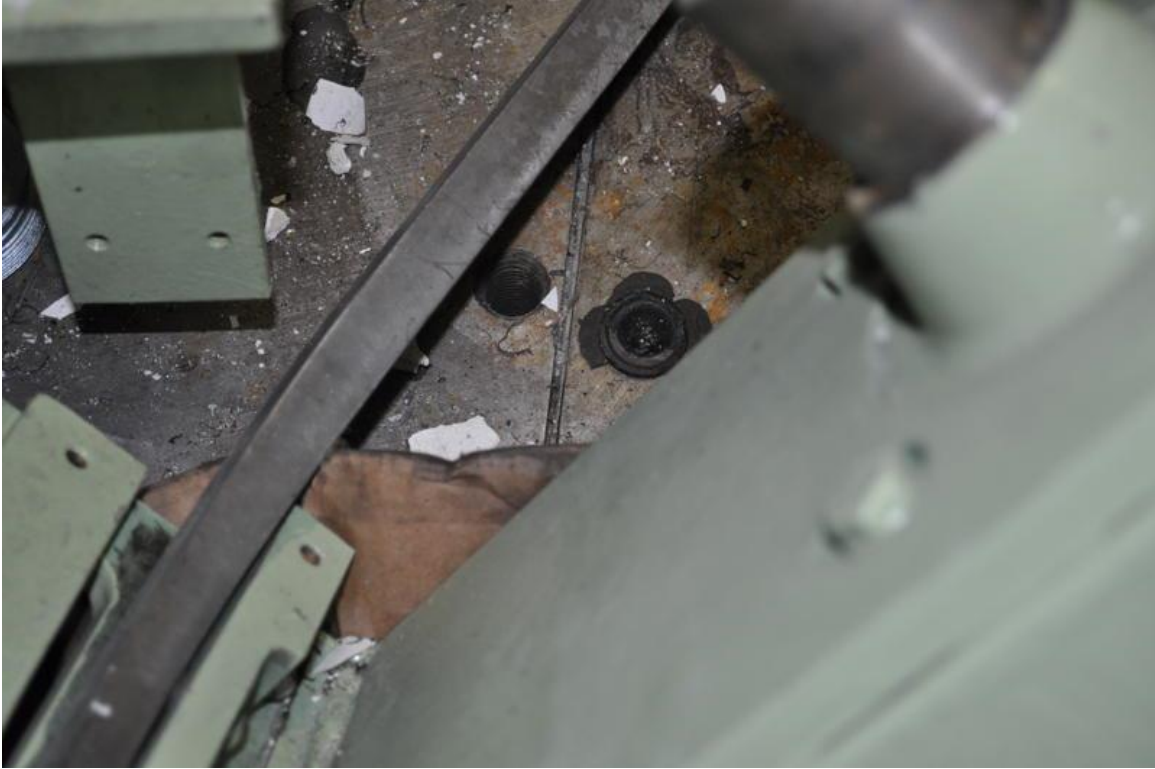
The accident occurred when a subcontractor employee drilled a hole in a piece of steel tubing that formed part of the framework for the platform that supported cartridge filling and bullet crimping equipment for the purpose of hanging brackets to support new electrical conduit. When the drill bit penetrated the tubing wall, the hot drill bit contacted propellant powder that had become lodged in the tubing, most likely during regular cleaning that occurred as part of the production process. Changes in the configuration of the production equipment over time resulted in blind holes in the platform framework that previously went undetected, allowing propellant powder to become lodged inside the framework.

6. Equipment designs should avoid hidden spaces where contamination might not be evident. In this case, use of steel tubing rather than channel/angle/I-beam resulted in opportunities for hidden contamination.
