Multi-Option Fuze for Navy (Mk 437 MOFN)

51st NDIA Fuze Conference

May 22-24, 2007

Naval Surface Warfare Center, Dahlgren Division, Fuze Branch - Code G34

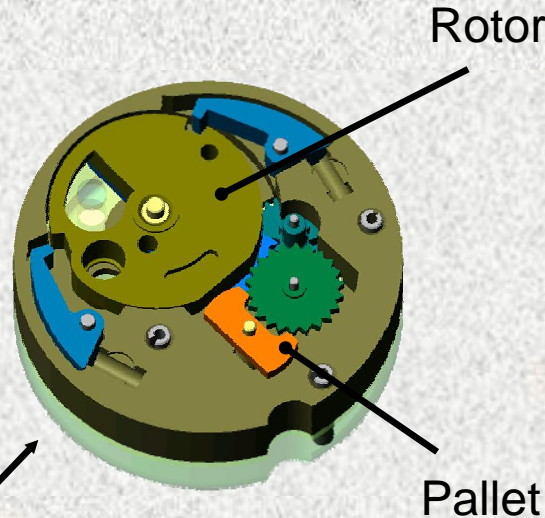
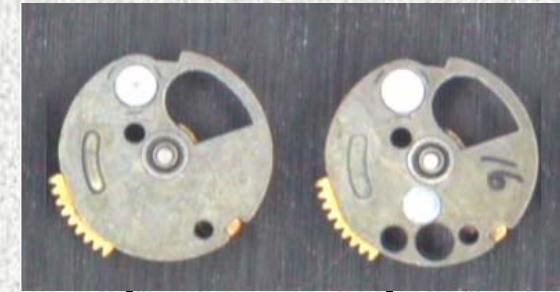
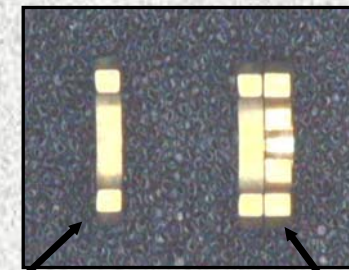
Standard **MOFA**
Rotor

MOFN Rotor:
3 holes drilled

Standard **MOFA**
Pallet

MOFN Double
Thick Pallet

- Achieve > 420 ft Min Arming Dist. (AVG - 3σ)
- Reliability Gunfire Test resulted in 19/22 successful

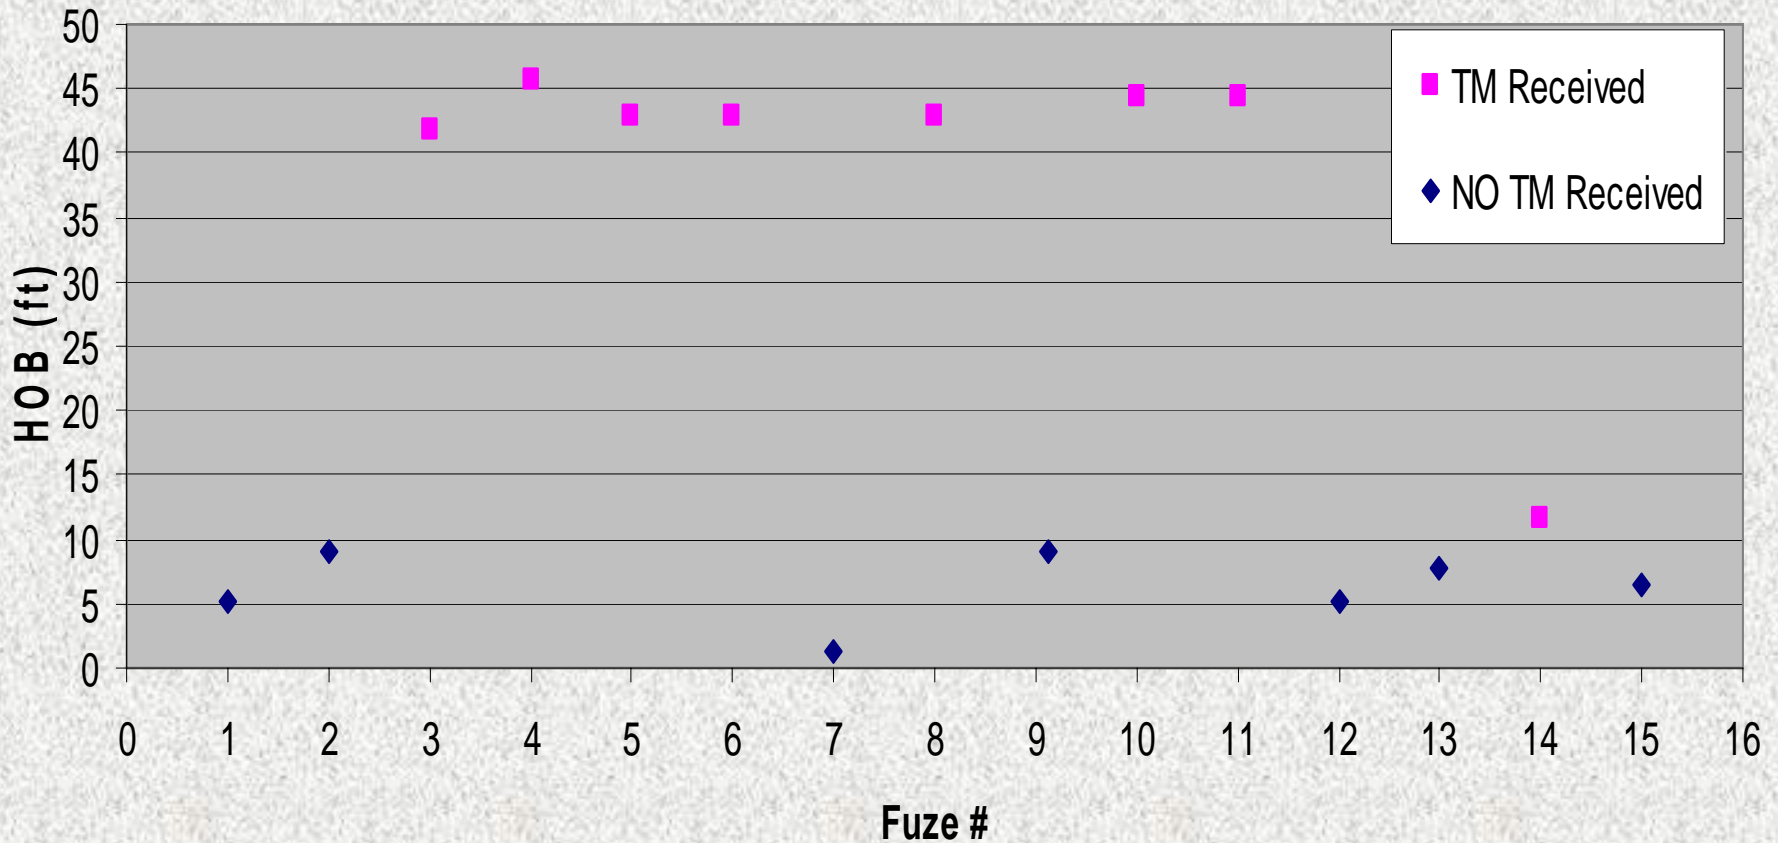
Bi-modal HOB over water Heights of Burst

- ◆ ET met specification
- ◆ HOB over water did not meet specification
 - ❖ 8/15 functioned below the minimum HOB
 - ❖ Bi-modal HOB ~5' & ~40'
- ◆ Gross Leak Testing results did not meet specification

Lot A Bi-modal HOB Issue

- Root Cause Investigation Performed
 - ◆ Root Cause Panel consisted of representatives from Navy, Army, KDI and EDC
 - ◆ 24 Potential Root Causes were identified
- Over land tests did not show same bi-modal response
- Army has never seen bi-modal response in MOFA testing
- Lot B testing did not show bi-modal response
- Phenomena remains unexplained

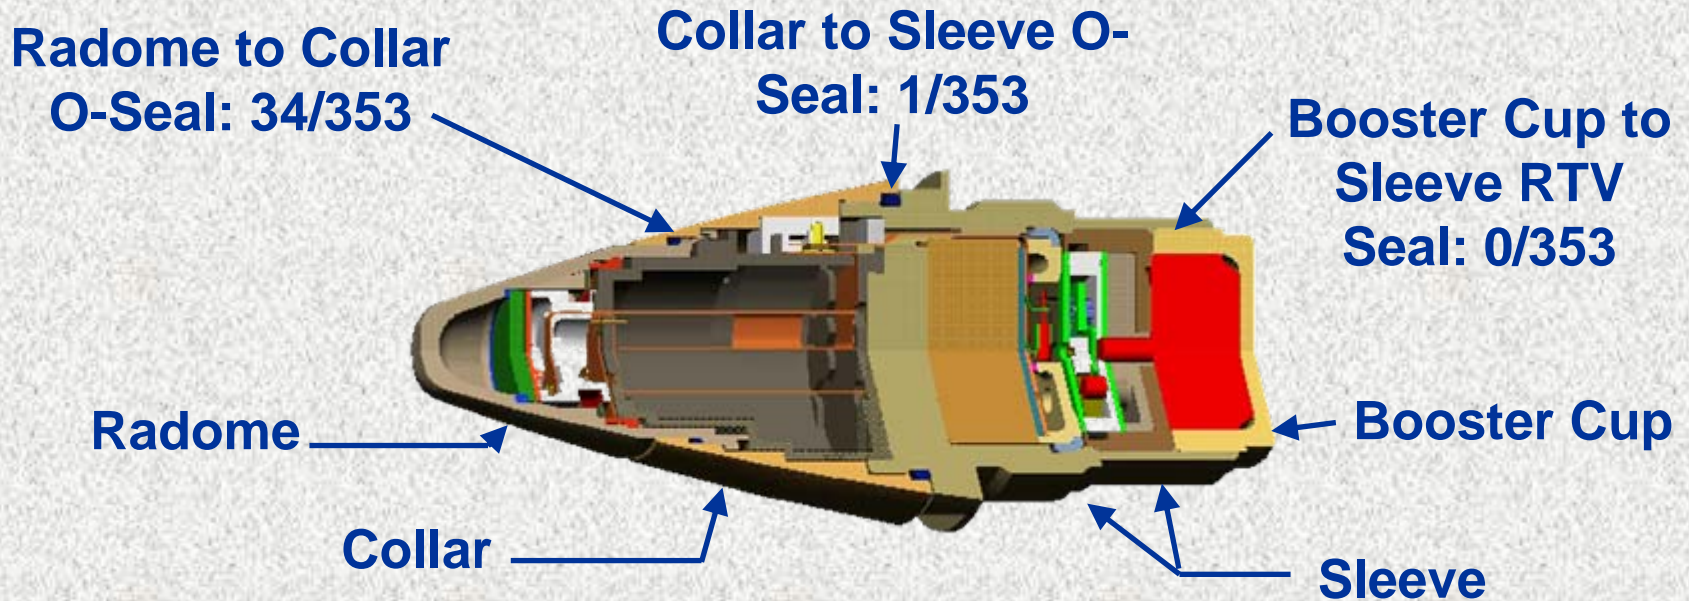
MOFN Seal Locations with # Occurrences of Leaking During Lot B Qual Build Leak Tests

➤ 10% Fail Gross Leak Test

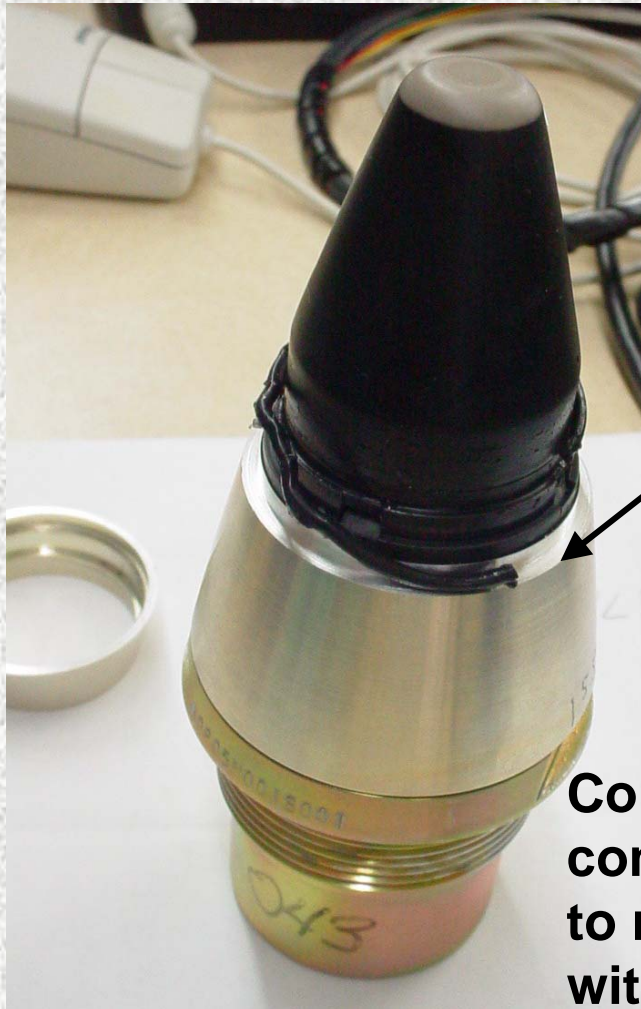
Radome to Collar O-Seal Damage

O-Seal

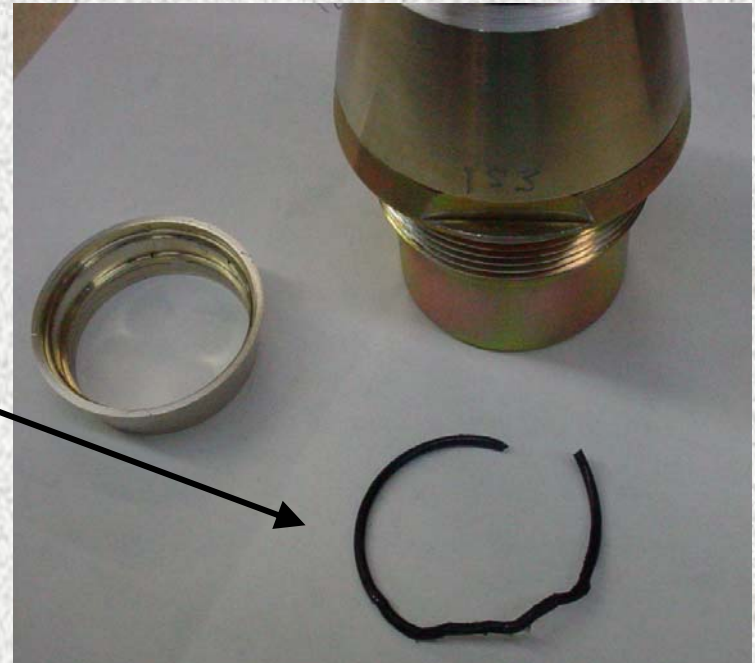
Collar Cut completely through to reveal O-Seal without disturbing it.

Inspection shows that O-Seal was Damaged in installation process

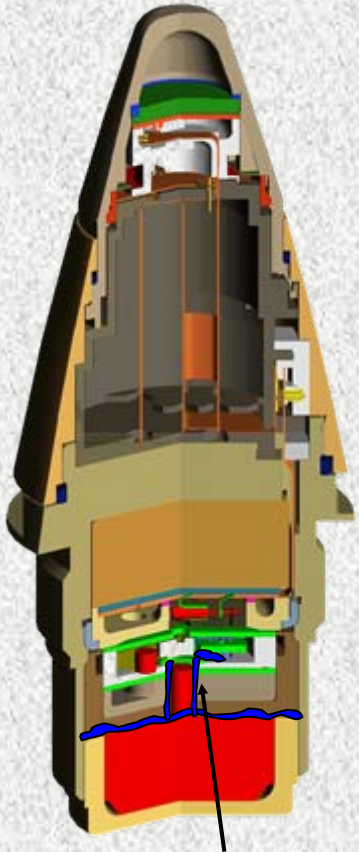
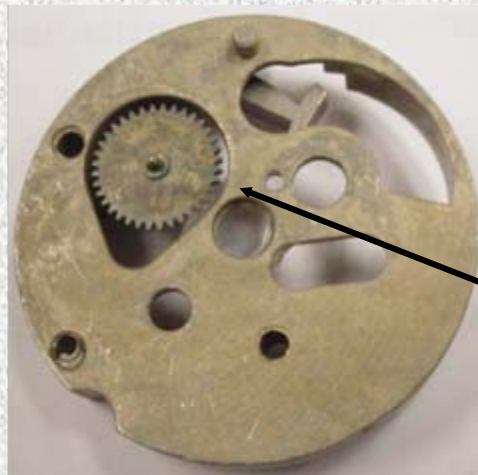
- Change to method of sealing Booster cup lead to failures.
 - Lot A – RTV applied to top threads and was blown out by pressure as booster screwed in.
 - Lot B – RTV applied to bottom to prevent this.
- Too much RTV squeezed into S&A and seized S&A creating a dud.

As Lot B Booster cup is screwed in- Excess RTV is forced up into the S&A

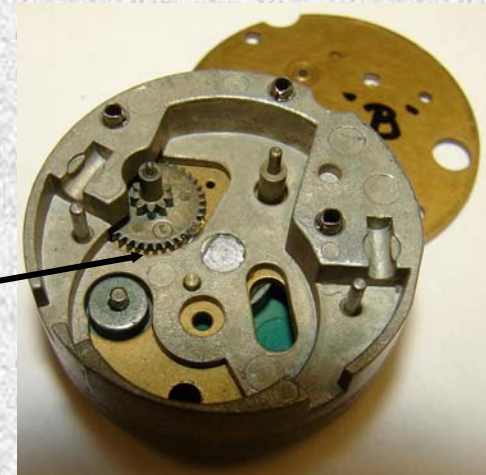
RTV on S&A Gears

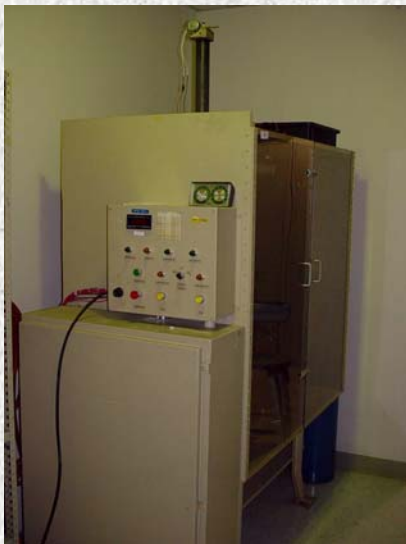
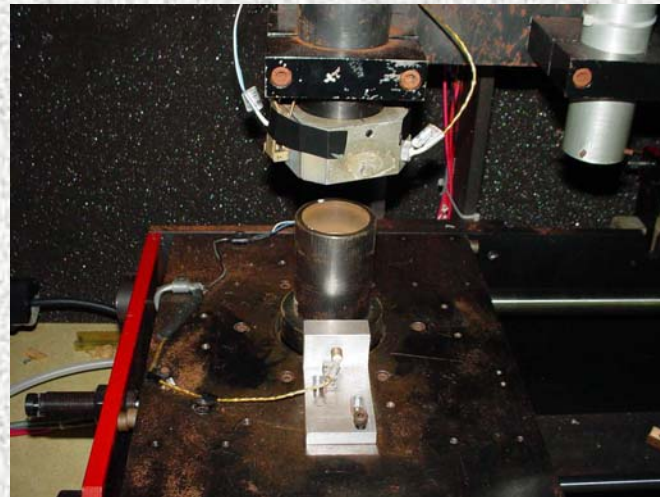
- Failure analysis conducted by KDI
 - ◆ Ferrite Core possibly cutting Transceiver Flex Circuit during gun launch
 - ◆ Spin drop tests to test this possibility
 - ◆ 2 of 10 had cut circuits
- Solutions: Key ferrite core to prevent rotation

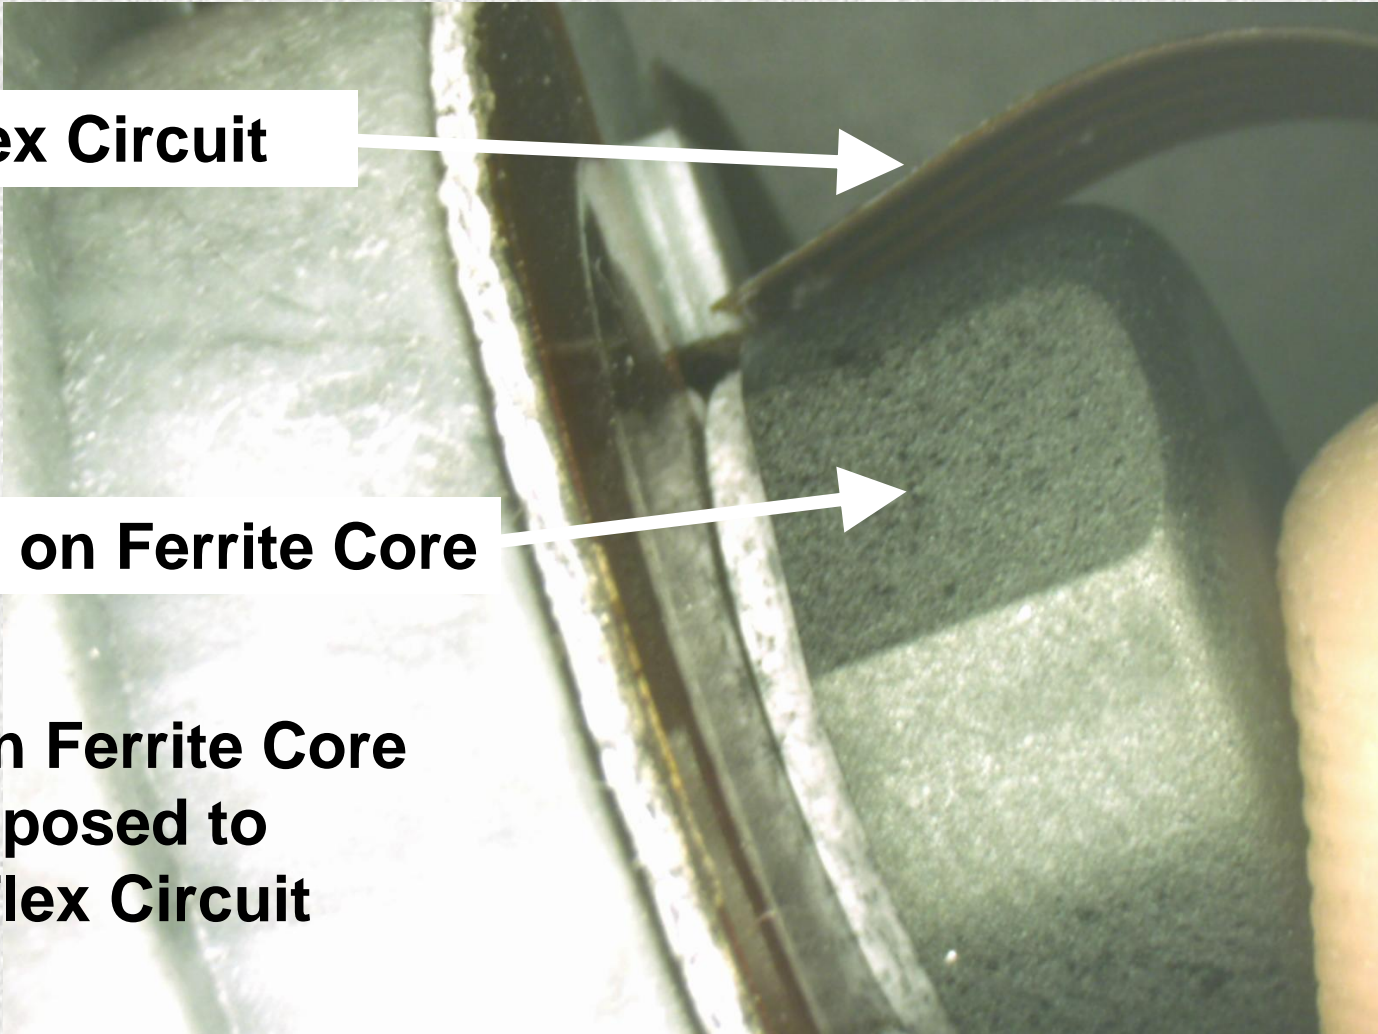
MOFN Lot B - Prox Failures

Flex Circuit

Flat on Ferrite Core

**Flat on Ferrite Core
is supposed to
face Flex Circuit**
