Cost-Effective Strategy for Installation and
Operation of a Bioventing System to
Remediate Jet Fuel Contamination Beneath
the Former Refueling Apron at
Griffiss AFB

Rome, New York

Parsons

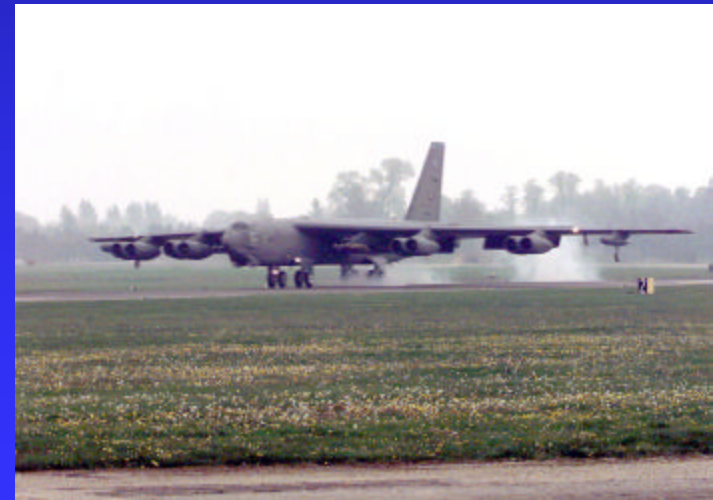
- *Apron 1 covers a 29-acre area*
- *Fuel was supplied via two independent fueling systems (east and west)*
- *Fuel was supplied to systems from two pumphouses*
- *Each system included 9 lateral control points and 9 refueling hydrants*
- *Systems were decommissioned in 1996 after 50+ years of operation*

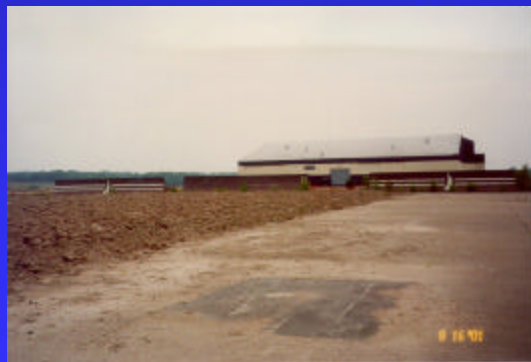
- ◆ *Apron surface is used for ex situ remediation of approximately 80,000 cy of soil from various locations on the base*
- ◆ *Remediation is accomplished using both active and passive applications of biopile technology*

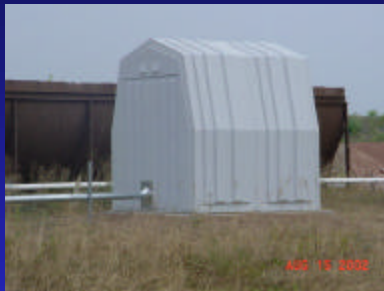
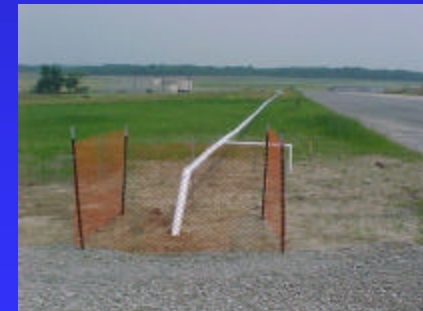
Construction Summary

- *22 air injection wells (AIWs) installed at fuel hydrant and lateral control point (LCPs) locations where soil contamination exceeds NYSDEC TAGM 4046 Soil Cleanup Objectives*
- *16 vapor monitoring points (VMPs) installed for system monitoring*
- *Header piping installed above-ground adjacent to apron surface*

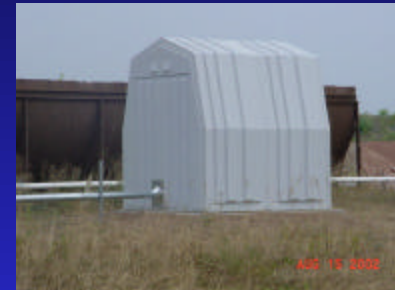
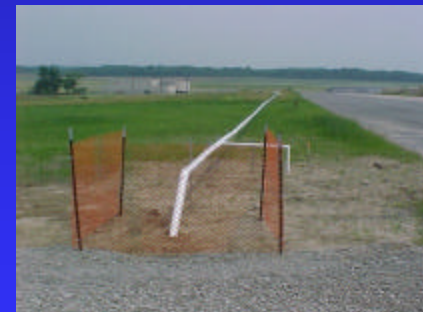
Construction Summary (cont'd)

- *Six-inch fuel supply piping pressure tested and reused to supply air to hydrant locations*
- *Two rotary-lobe air supply blowers installed*
