# **Environmental Baseline Survey at DoD Facility Proposed for Joint Use**

**Randa Chichakli**

**April 8, 2003**

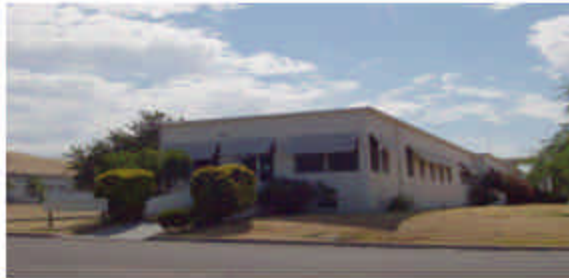
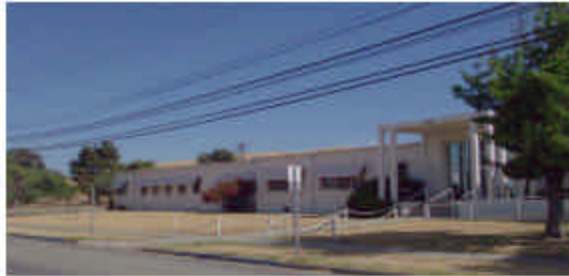
**Building:** X

Visual Inspection Findings: No concerns.

Generator shed, wood shed, refrigeration machines, and infectious waste storage locker on outside. Some stains (oily in appearance) corrosion in mechanical room on NE side of building (inner parking lot) with generator. Rooms in building mostly empty, some lab equipment (sterilizer) floor drains plugged.

Inspection date: 7/11/02
