M865 TID Improvement Study

Presented by: Jason Gaines, M865 Systems Engineer, GD-OTS

Project Objective

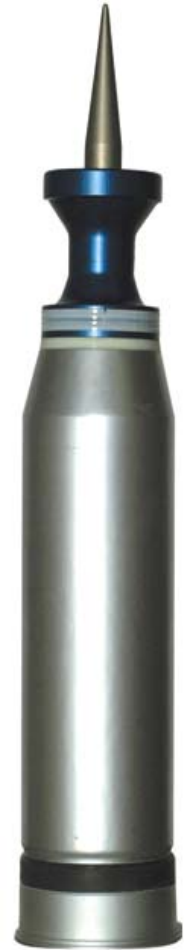
Introduction to the 120mm M865

- The M865 Kinetic Energy (KE) training round, in service with the United States Army's main battle tank fleet, provides a realistic training device displaying the accuracy and time-of-flight of the M829 series service rounds.
- The fin stabilizer provides a safety feature limiting the overall flight range to under 8 km.

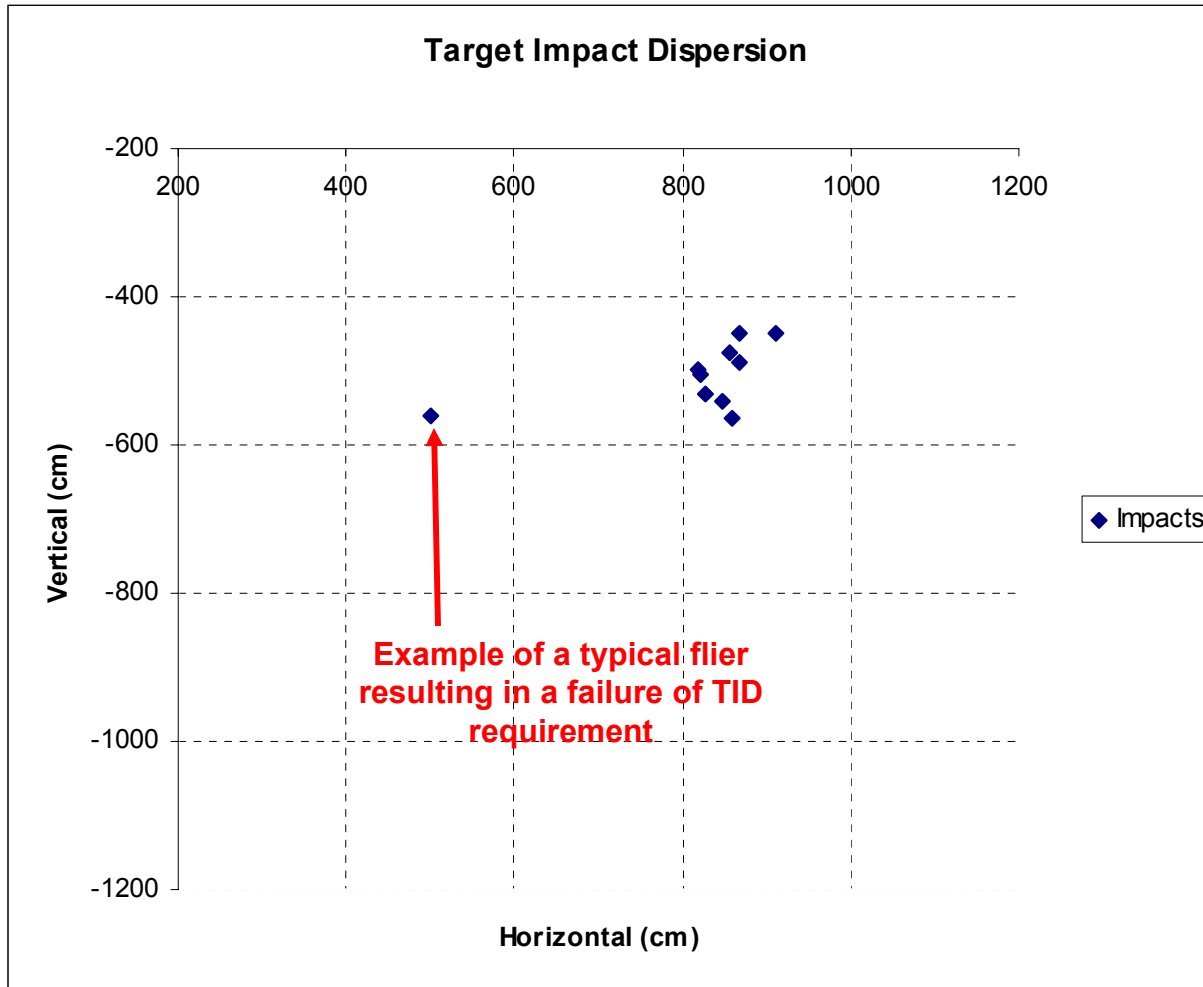
Impact Result at -32°C

TID (mils)		
	X	Y
First 5	0.61	0.12
Second 5	0.12	0.13
Pooled	0.44	0.13

The M865 Performance Specification requires a TID of .30 x .30 or lower to accept a cartridge lot.

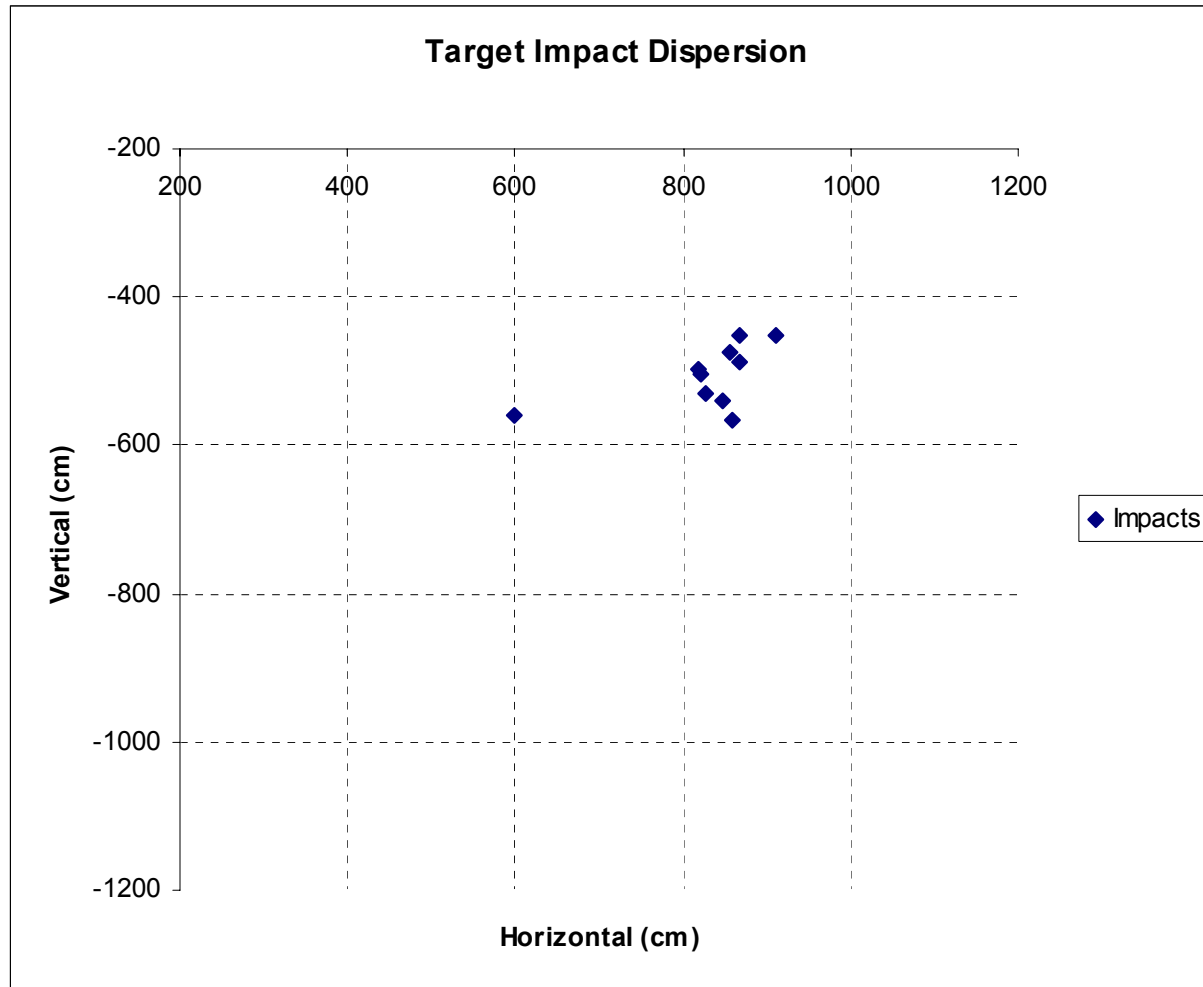
Improved Impact Result at -32 °C

TID (mils)		
	X	Y
First 5	0.43	0.12
Second 5	0.12	0.13
Pooled	0.32	0.13

The M865 Performance Specification requires a TID of .30 x .30 or lower to accept a cartridge lot.

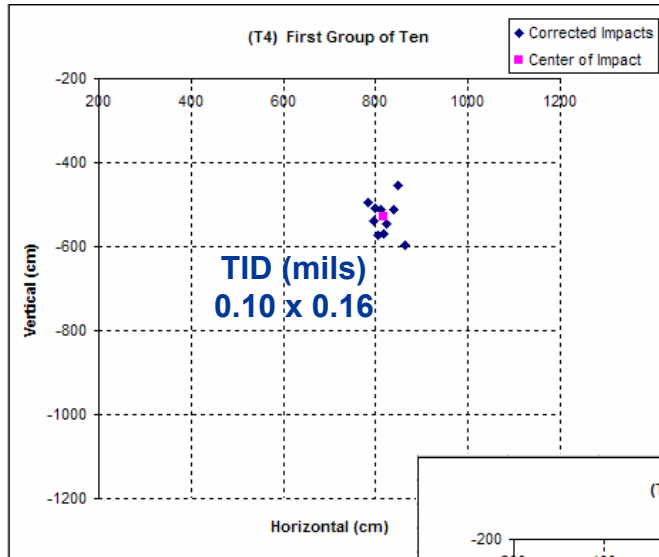
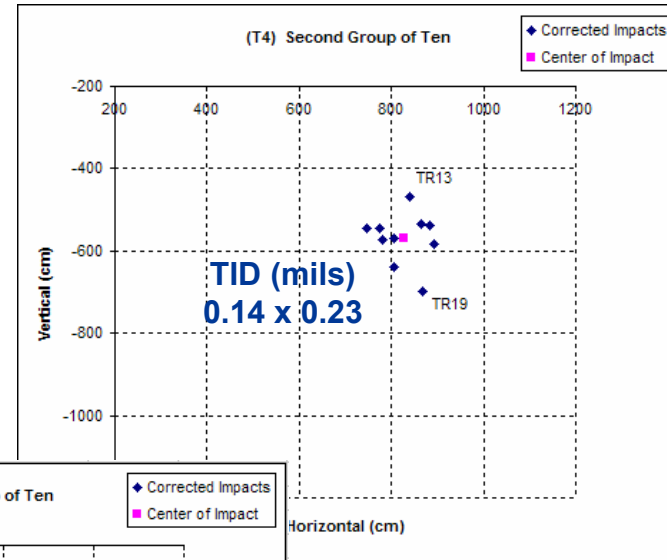
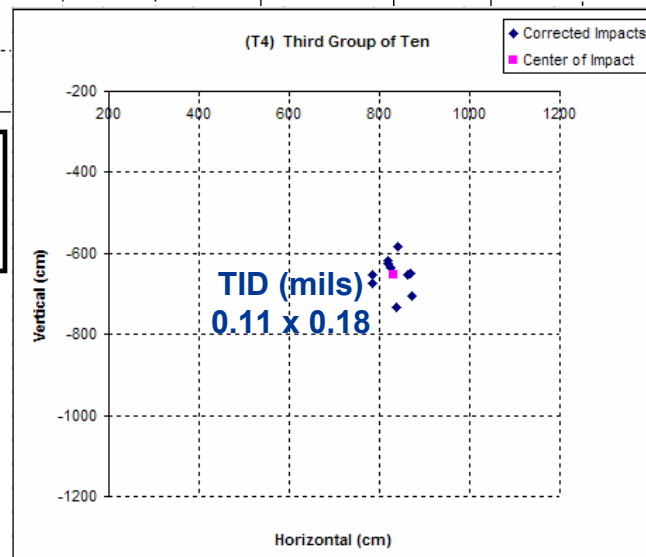
Design 4 Resultant Impacts

3 out of 40 test since the design change have had a TID result below a 0.20 x 0.20.

No of Rounds Fired	Fliers ¹	Percent Fliers	Improvement over Control Rounds	Total Average TID
Design 1	30	7	23.3%	8.3%	.20 x .27
Design 2	30	6	20%	11.6%	.25 x .25
Design 3	30	6	20%	11.6%	.27 x .26
Design 4	30	2	6.6%	25%	.12 x .19
Design 5	30	4	13.3%	18.3%	.21 x .23
Controls	60	19	31.6%	-	.26 x .26

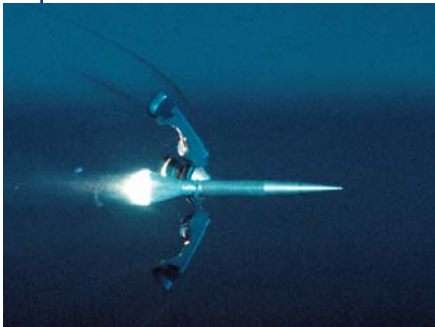
Design 4 (Plunge cut and Anchor slots) performed significantly better than the current M865 design.

- Significant improvement in TID
- 25% lower rate of fliers than current design
- Increased muzzle velocity by an average of 20 m/s
- Recovered sabot segments exhibited characteristics similar to what is seen after +52°C and +21 °C tests.
