# CANTON DAM SPILLWAY STABILITY

## Is a Test Anchor Program Necessary?

## Dam Safety Assurance Project

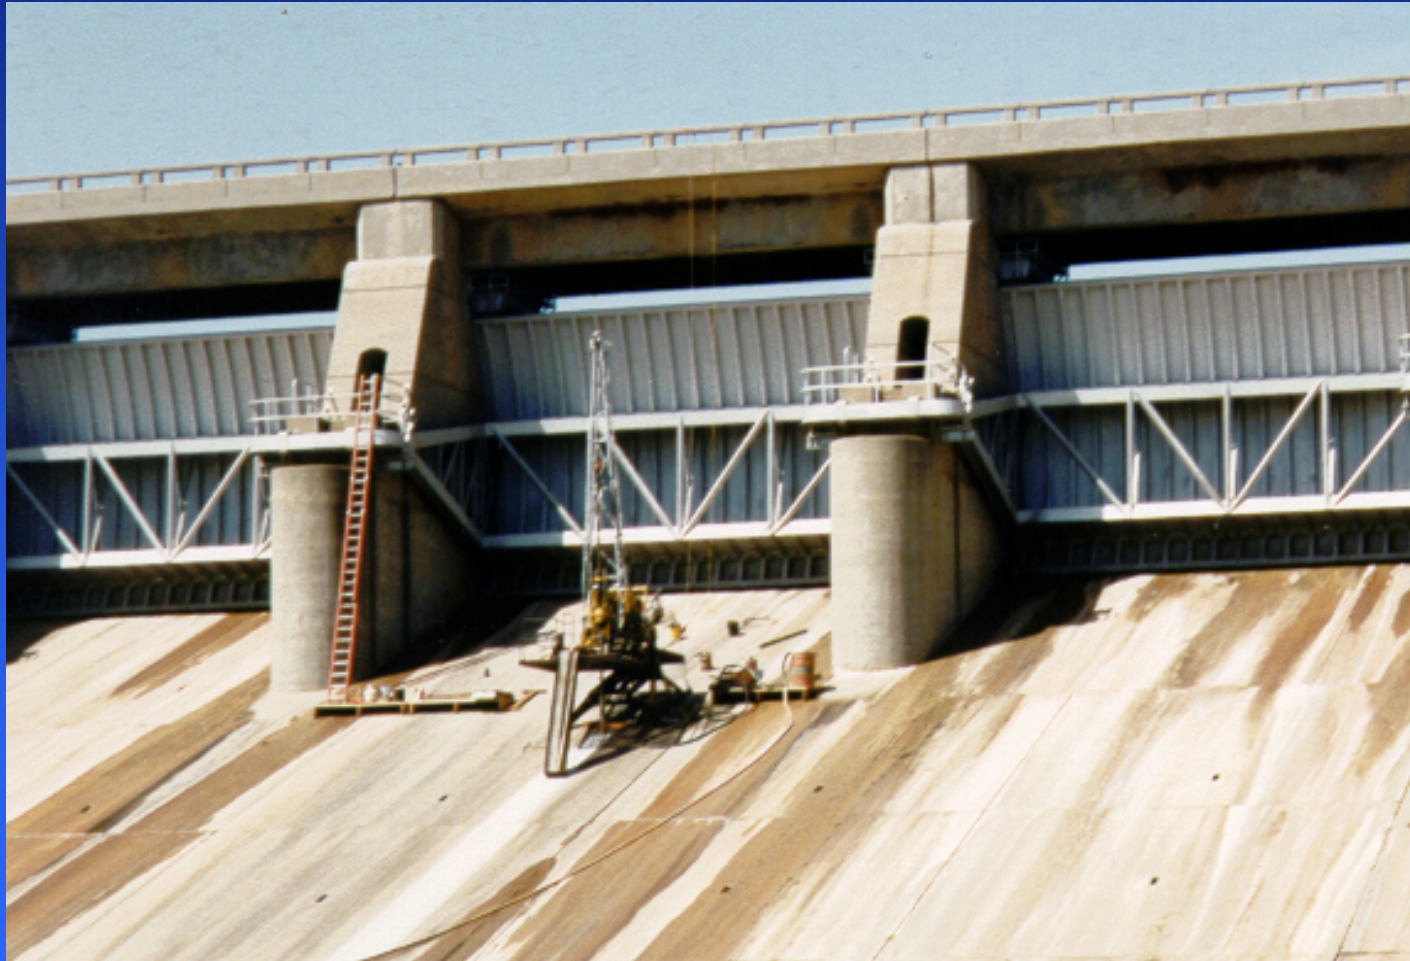
# CANTON DAM SPILLWAY STABILITY

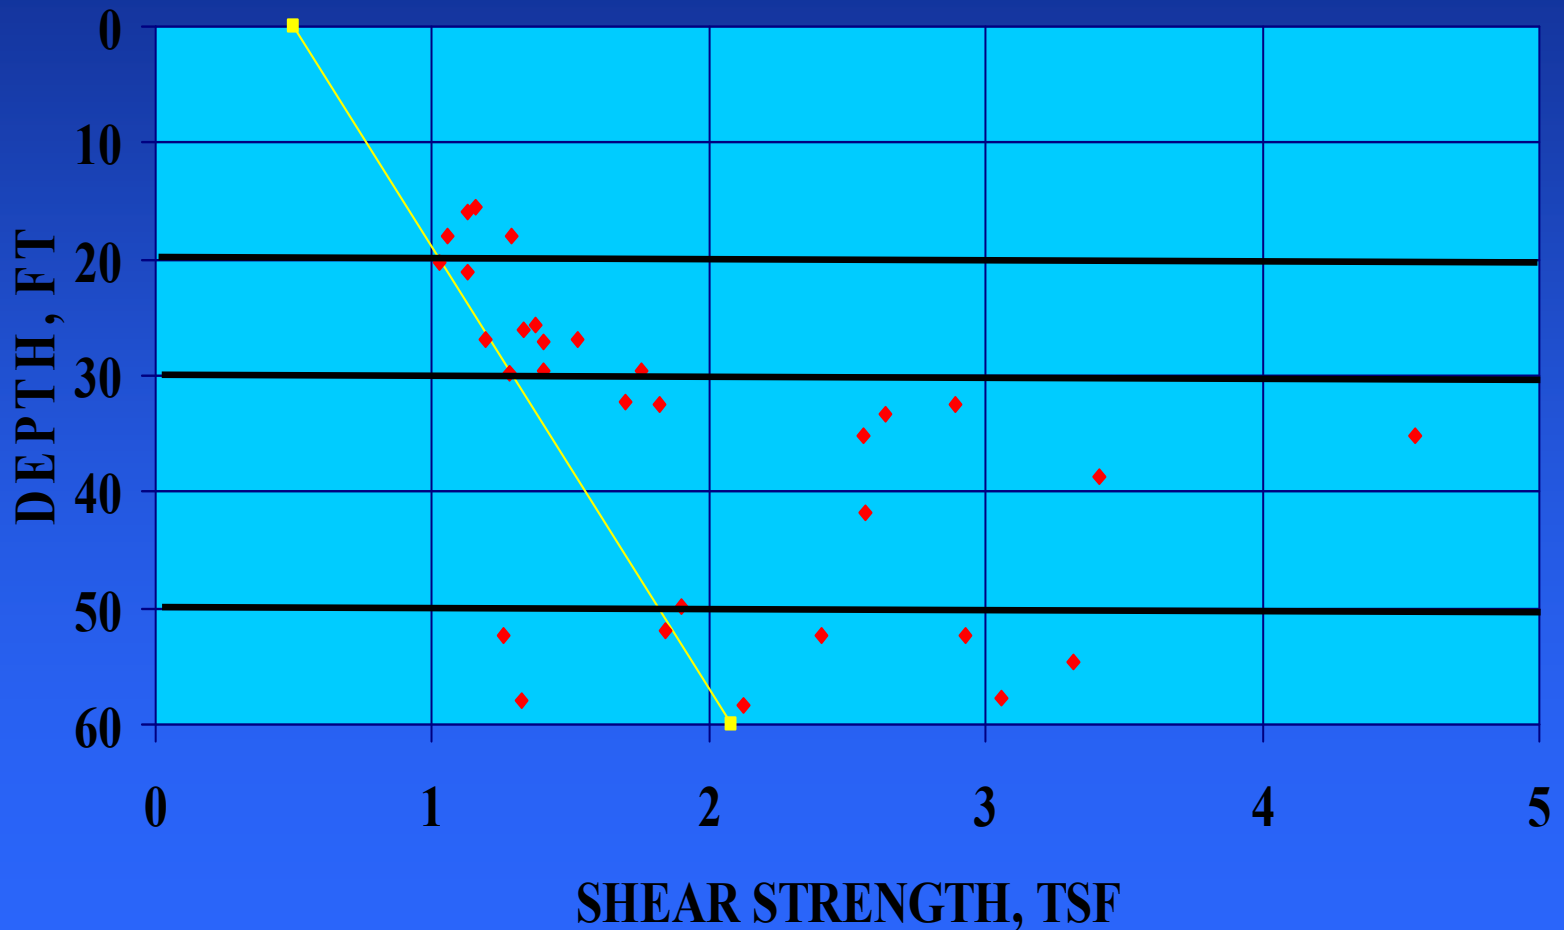
# DATA FROM ALL SHEAR TESTS

- **OVERCONSOLIDATED**
- **DILATES WHEN SHEARED (AT LOWER CONFINING PRESSURE)**
- **LOWEST STRENGTHS 20-30 FEET, OR 1570-1580 ELEVATION, AND BELOW 50 FEET**
- **HIGHEST STRENGTHS BETWEEN 30 AND 40 FEET**

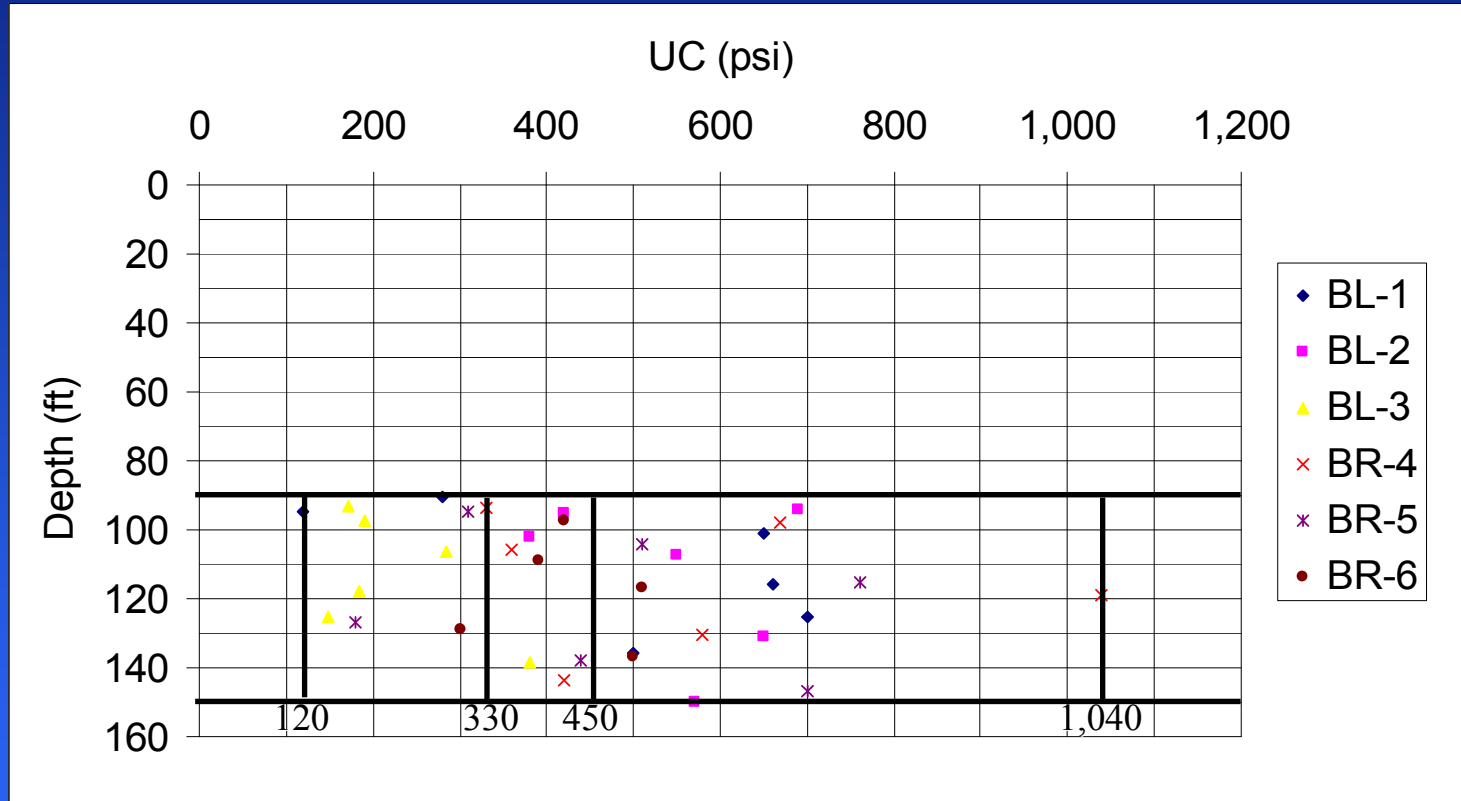
# TEST ANCHOR PROGRAM PHASE I CORE STRENGTHS

Minimum = 120 psi

Maximum = 1,040 psi

One Third = 330 psi

Median = 420 psi

Average = 456 psi

- **Ultimate Bond Stress = 10% of the Unconfined Compressive Strength of the Rock**
- **Minimum Value = 5 to 12 psi**
- **One Third Value = 30 to 33 psi**
- **Median Value = 42 to 44 psi**
- **Average Value = 46 psi**
- **Maximum Value = 86 to 104 psi**

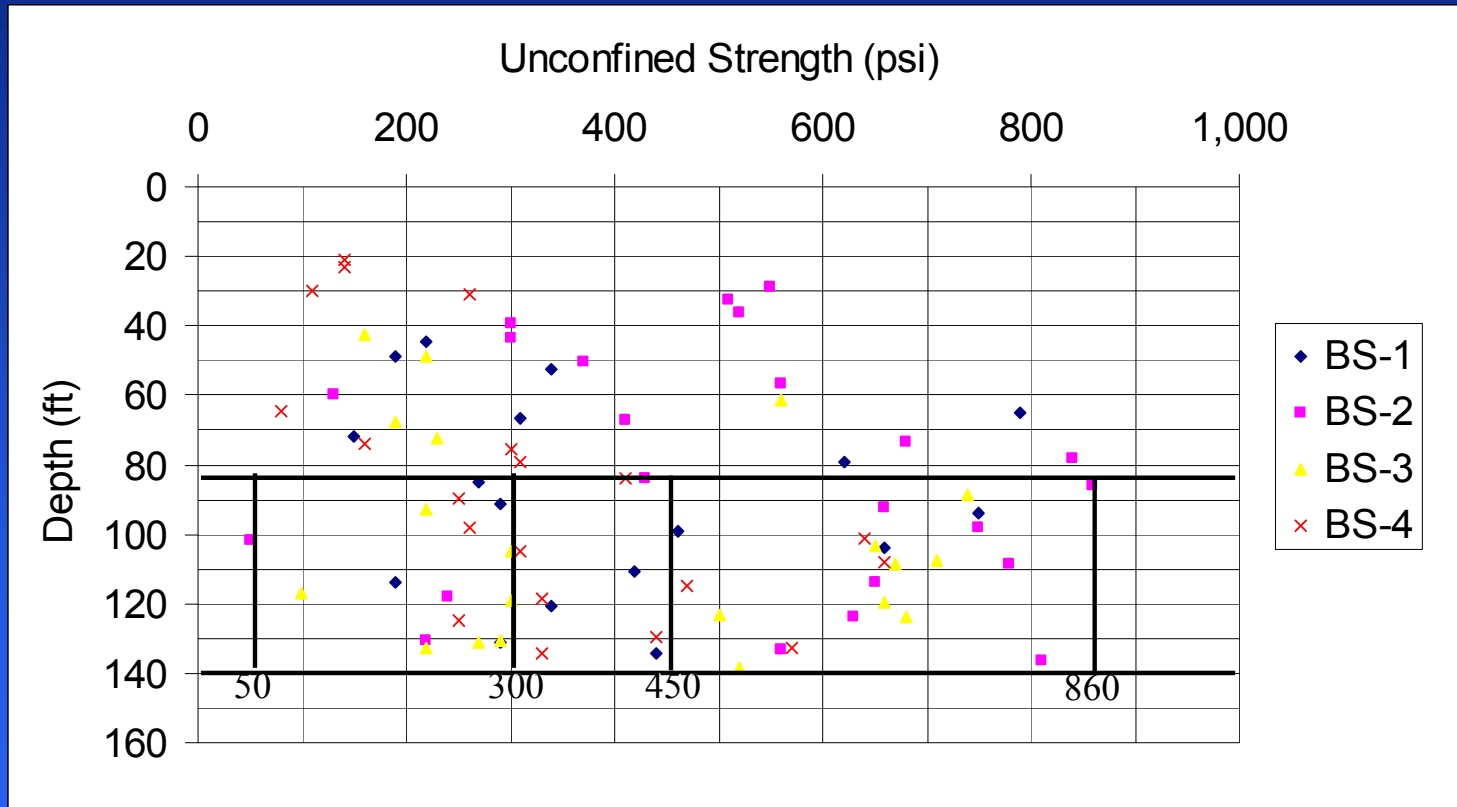
# TEST ANCHOR PROGRAM PHASE II CORE STRENGTHS

Minimum = 50 psi

Maximum = 860 psi

One Third = 300 psi

Median = 440 psi

Average = 460 psi

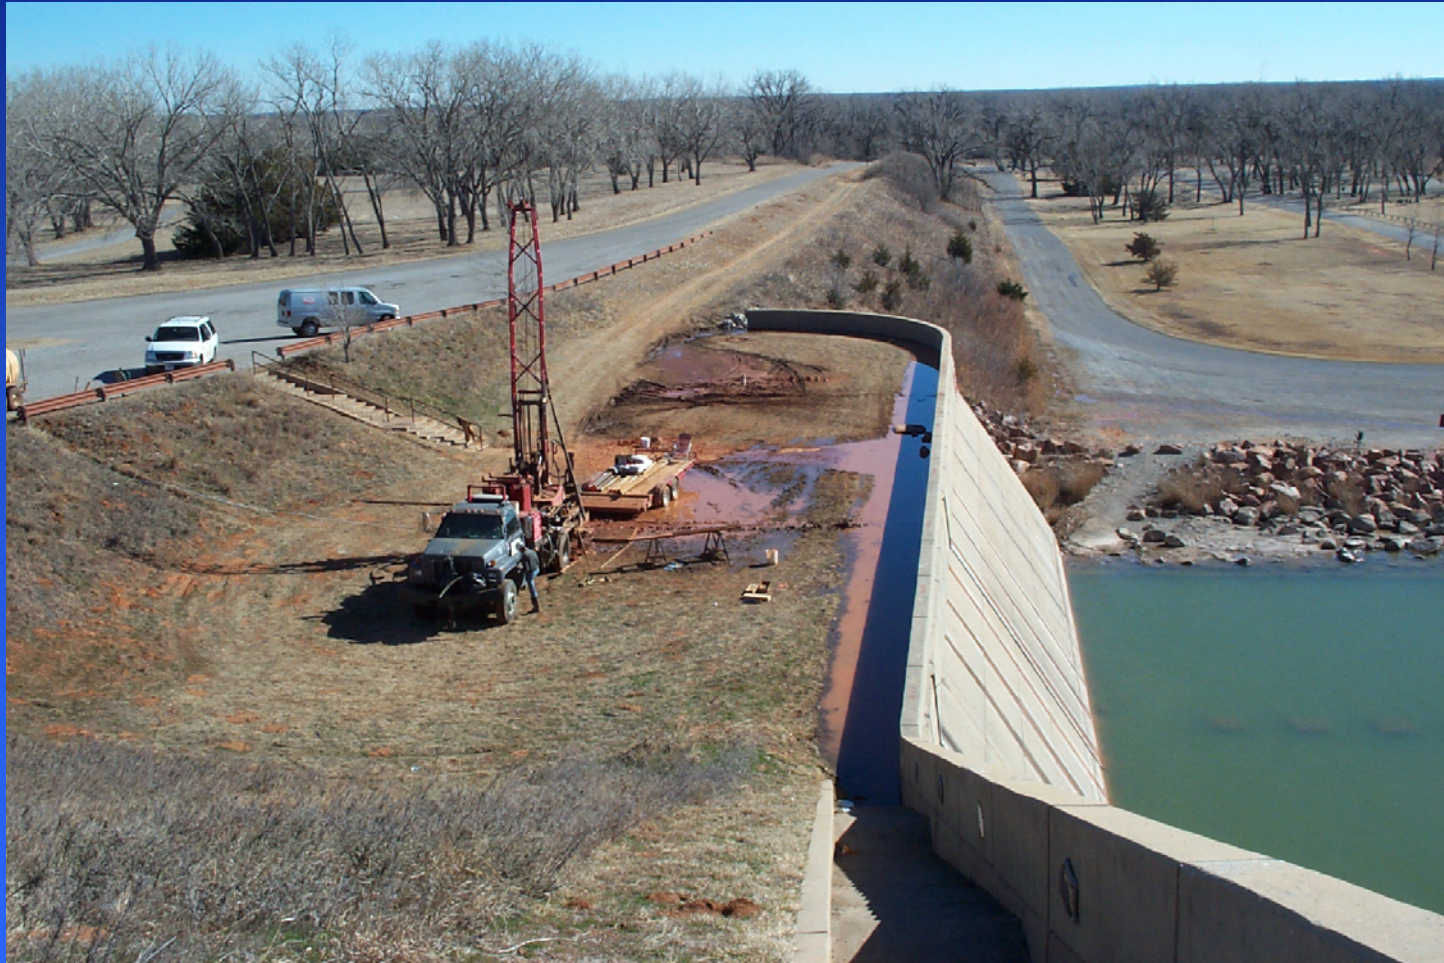
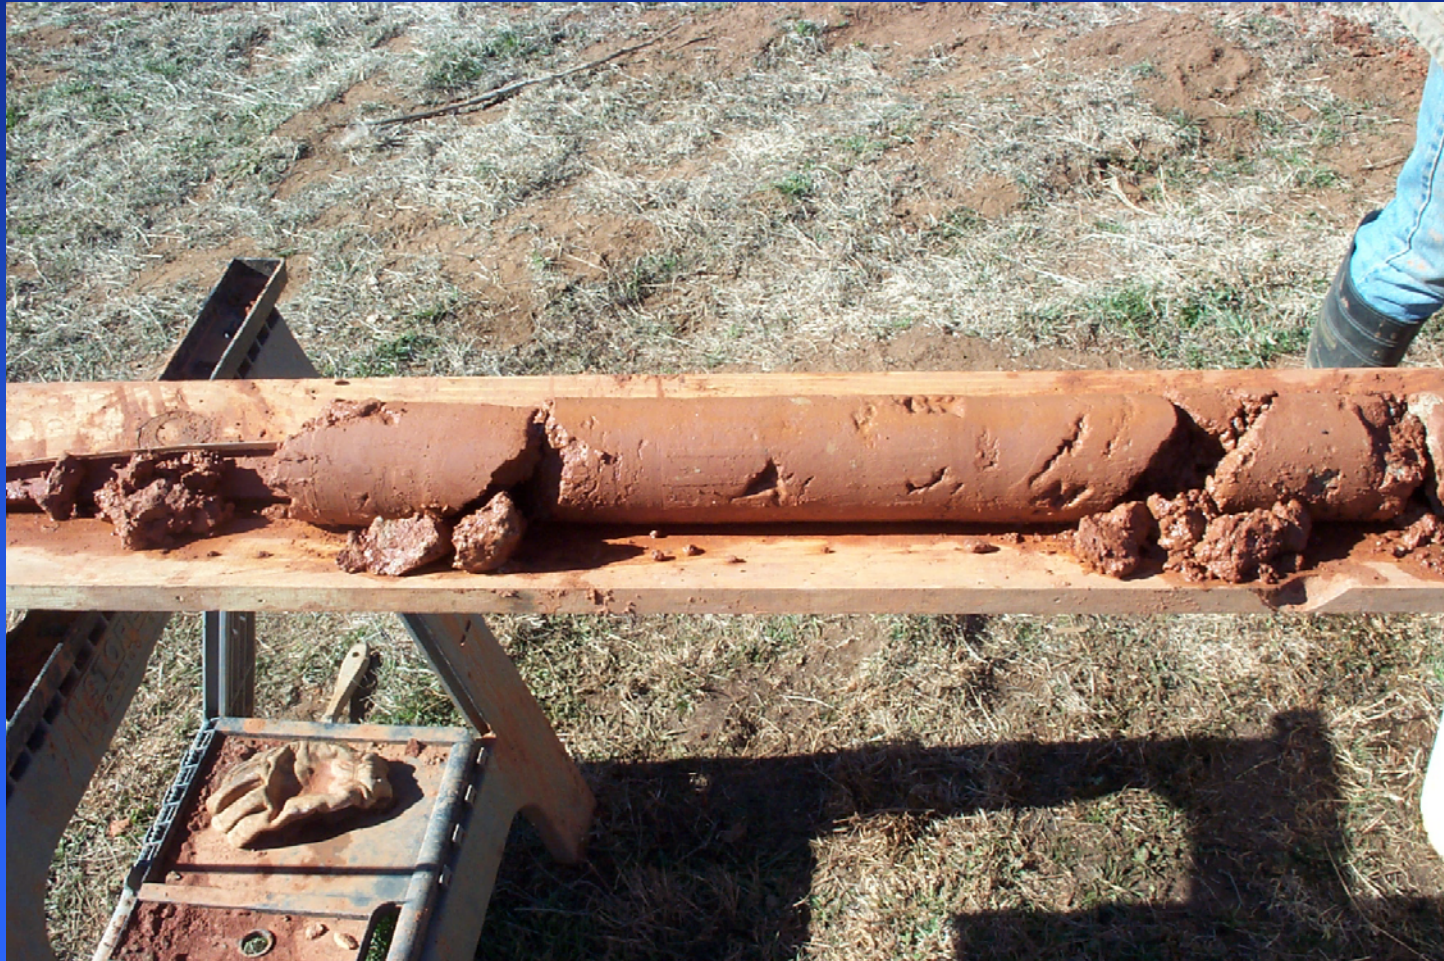
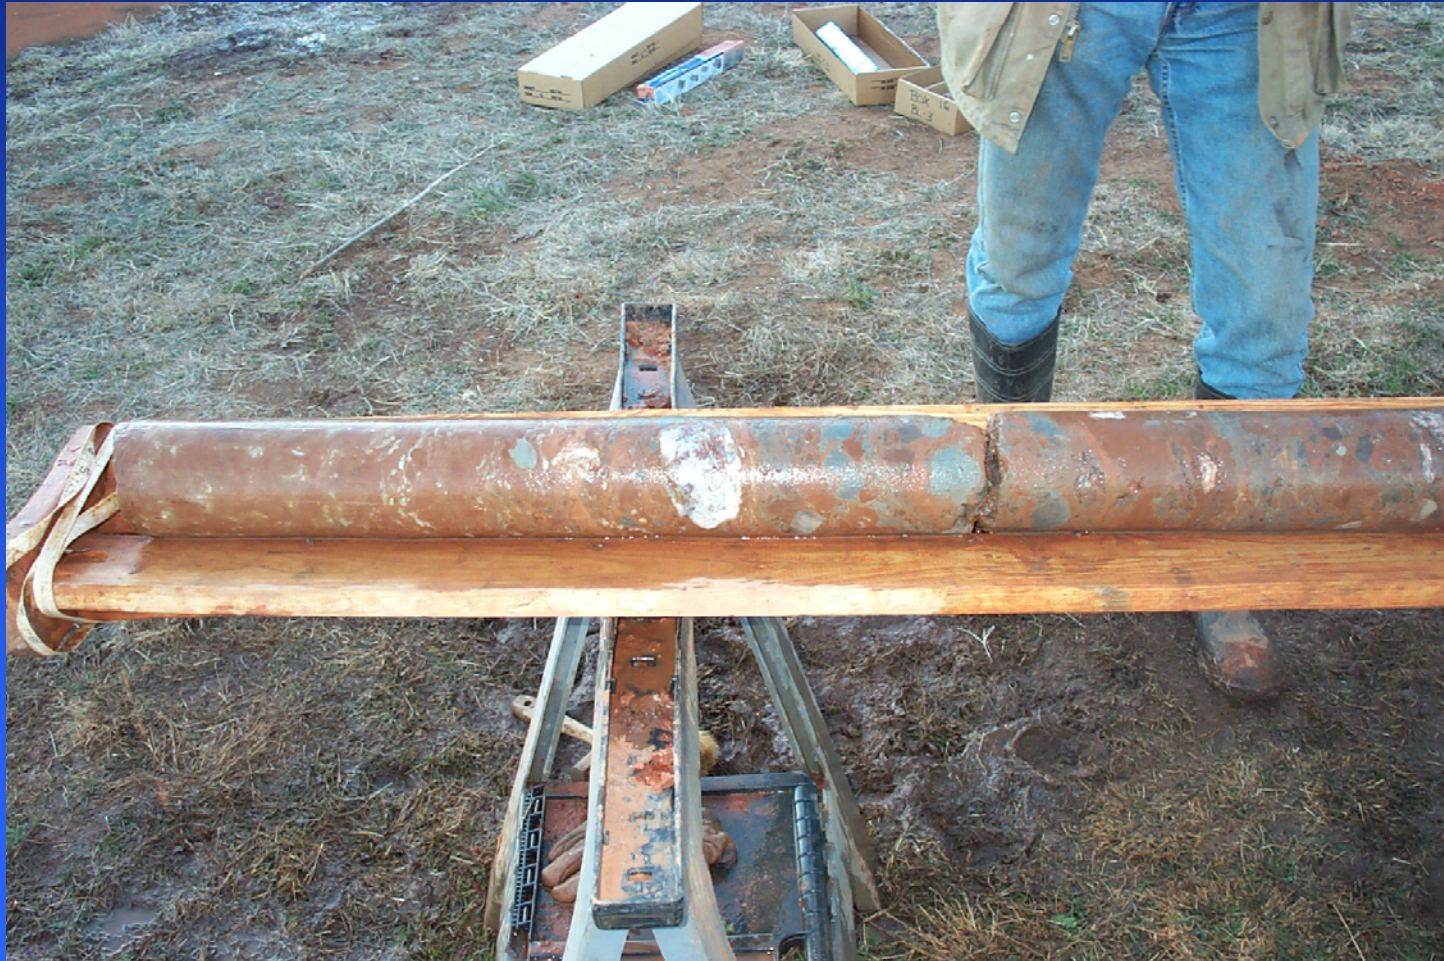
- **Original boring logs indicated caved material**
- **Caved material turned out to be the result of dissolution and collapse**
- **Noticeable increase in core recovery, RQD, and strength of core below 90 feet**
- **Rock dips slightly to the southwest**

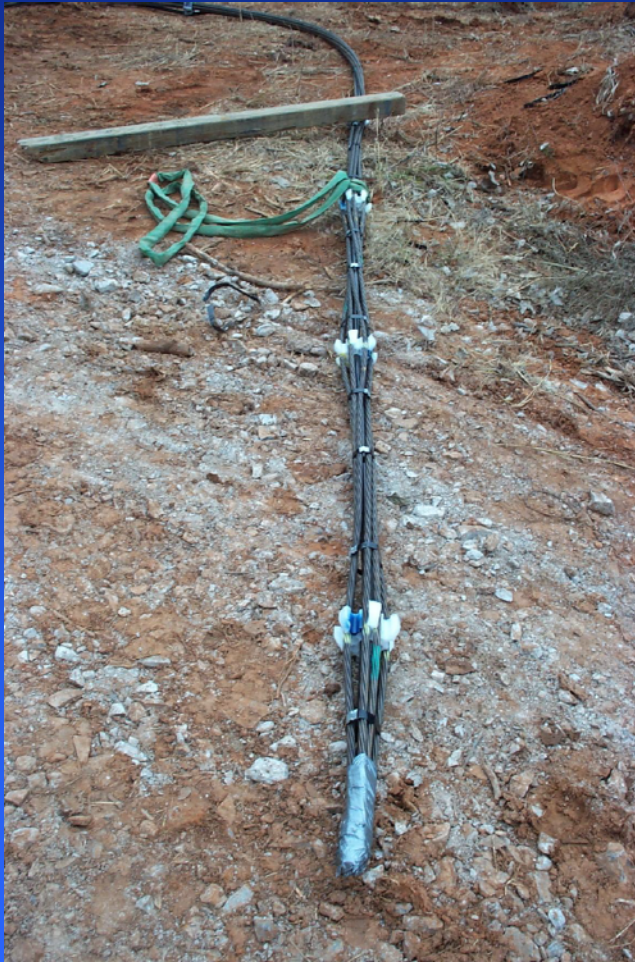
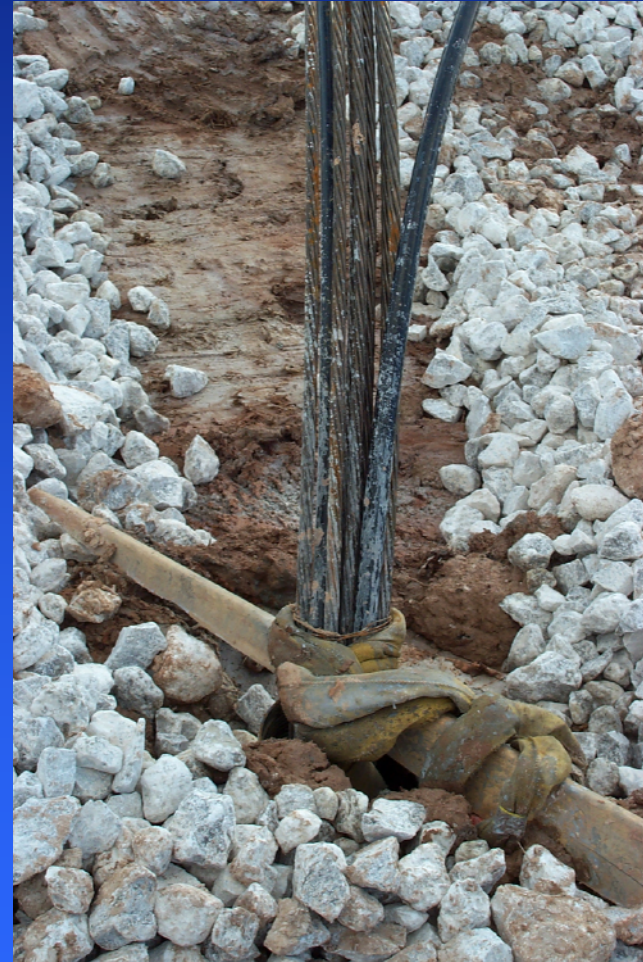
# TEST ANCHOR PROGRAM PHASE I

- **3 core holes on each side of the spillway**
  - 2 to 140 feet
  - 1 to 180 feet (top of gypsum)
- **2 test anchors on each side of spillway**
  - 105 and 140 feet deep
  - 6 inch diameter hole
  - 7 strand tendon instrumentation
  - 15 foot bond zone
  - Perform pullout test to failure
    - Could not fail anchors

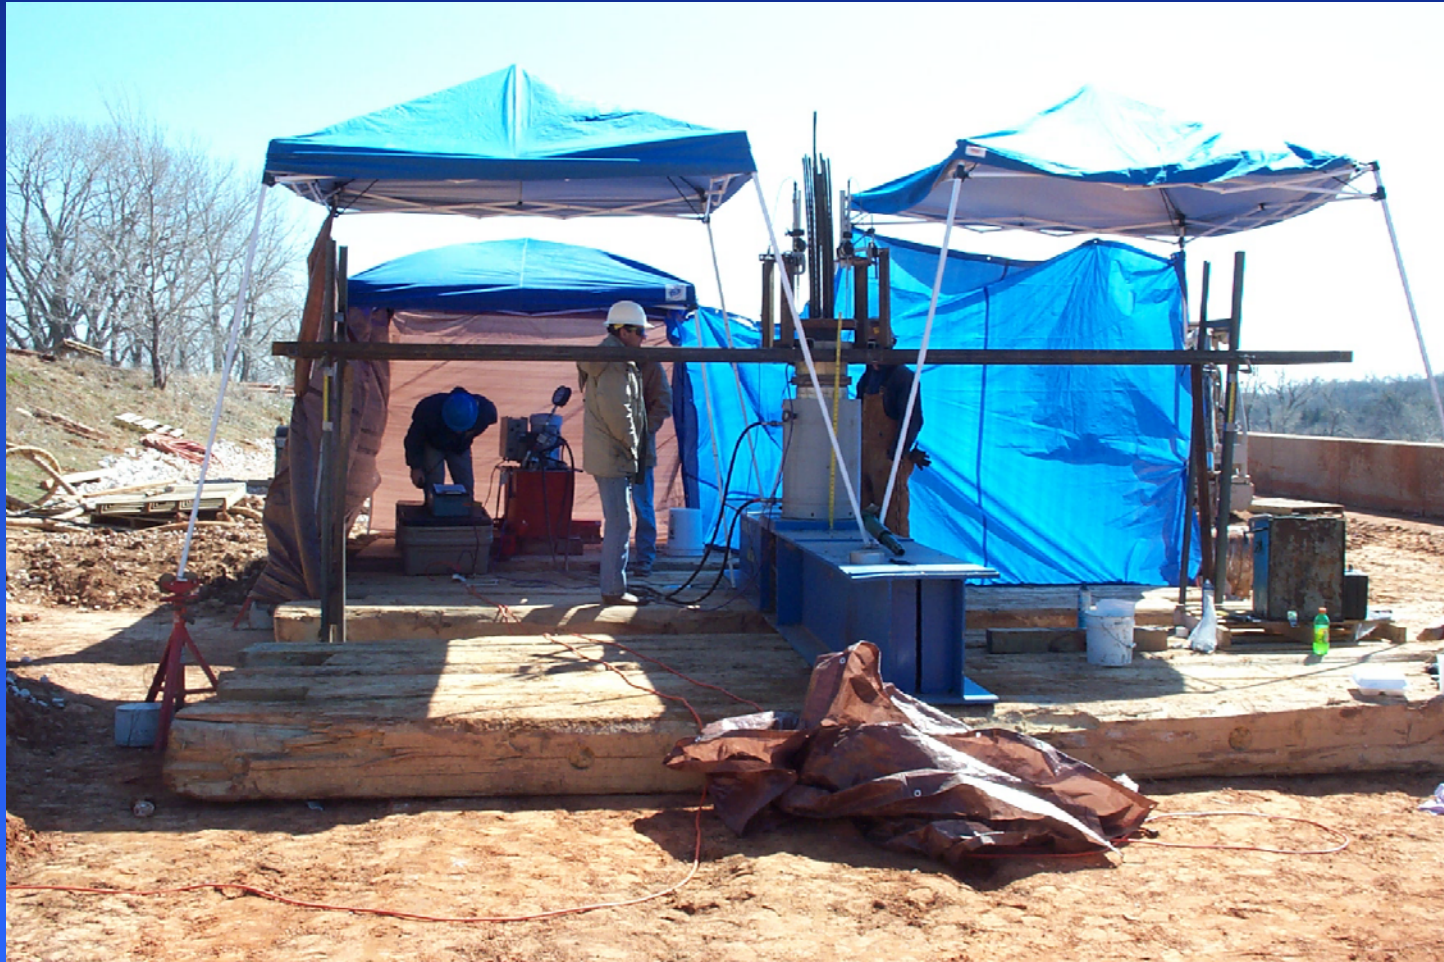
# TEST ANCHOR PROGRAM PHASE I REVISED

- **2 test anchors on each side of spillway**
  - 105 feet deep (one grouted and one not grouted)
  - 6 inch diameter hole
  - 16 strand tendon
  - 15 foot bond zone
  - Perform pullout test to failure
- **2 test anchor on each side of spillway**
  - 105 feet deep
  - 6 inch diameter hole
  - 16 strand tendon with instrumentation
  - 40 foot bond zone
  - Conduct performance test and creep test

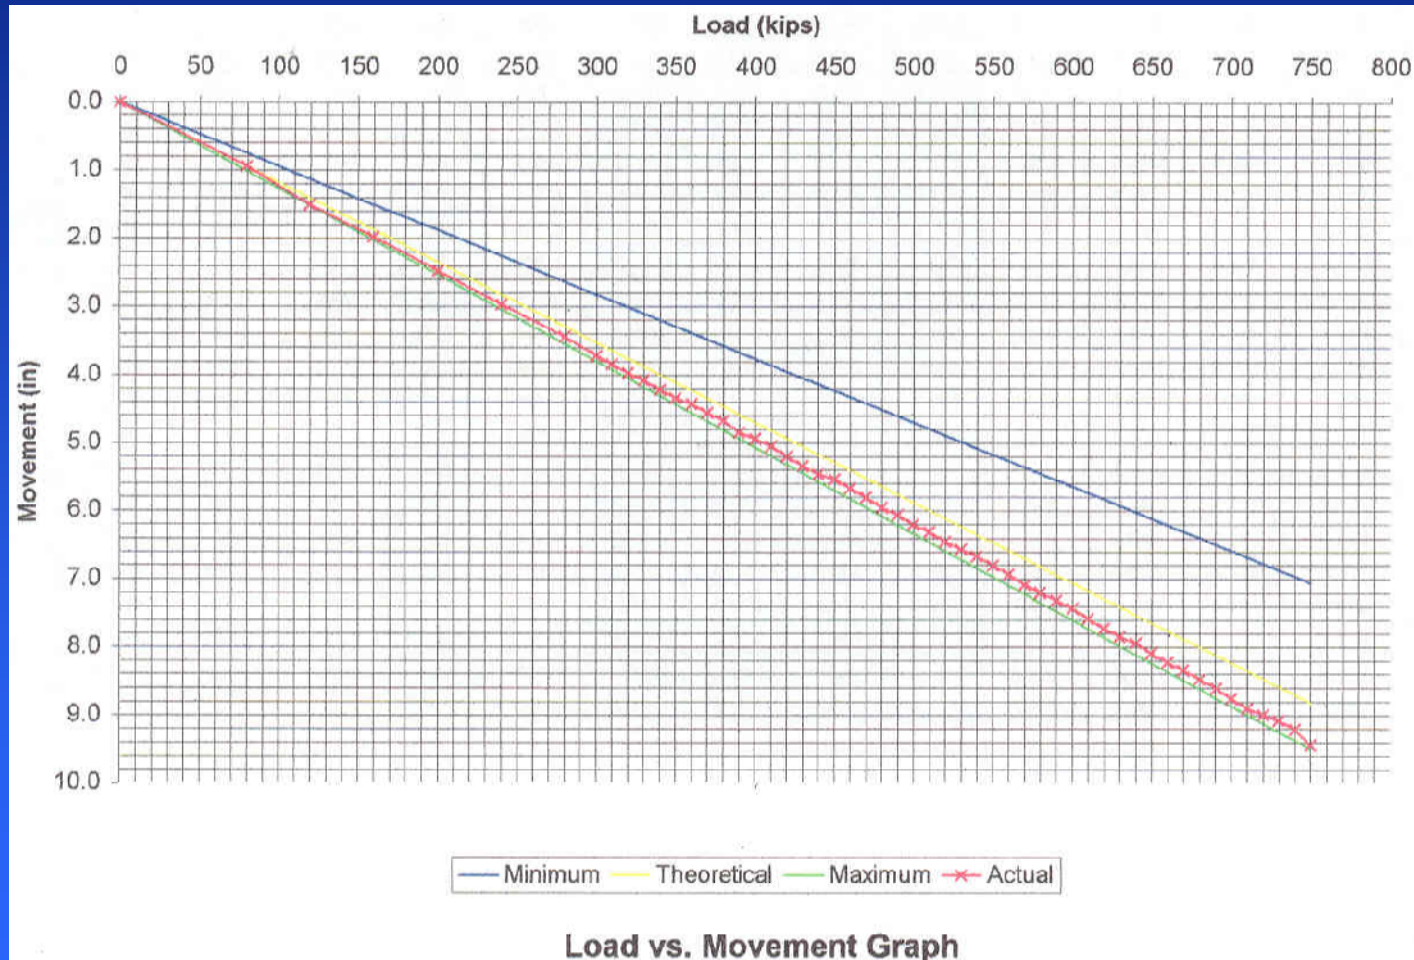
Load vs. Movement Graph

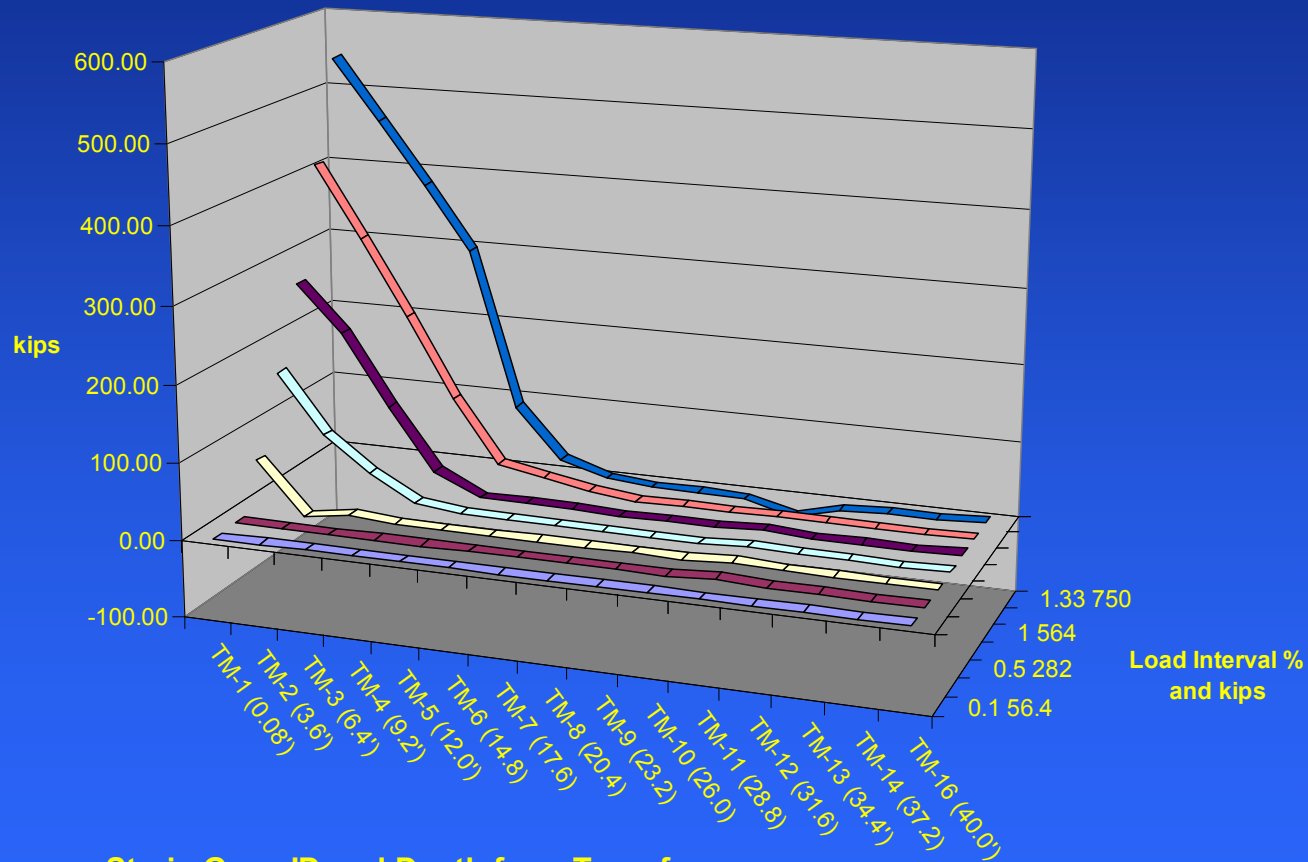
Canton Dam, A4 Left Load Test - Load Per Depth in Bond Zone

Tensmeg Strain Gage ID and Depth from Top of  
Bond Zone
