West Bank of the Mississippi River in the Vicinity of New Orleans, Louisiana East of Harvey Canal Hurricane Protection Project Cousins Pumping Station Complex Jefferson Parish, Louisiana

Waterline Support Failure: A Case Study

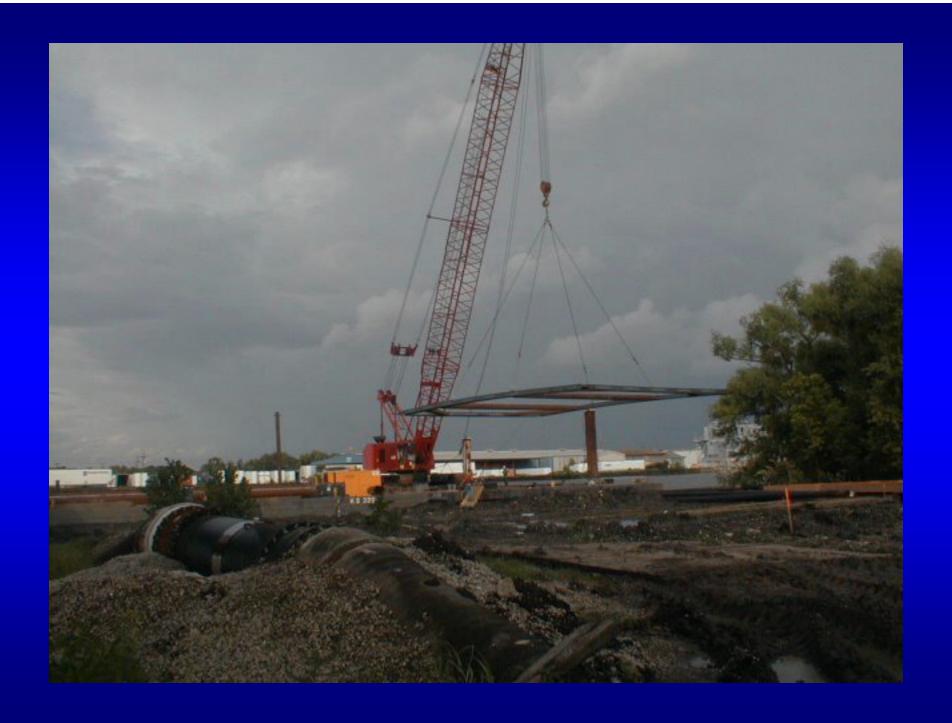
COUSINS PUMPING STATION COMPLEX ORIGINAL WATERLINE CROSSING (WATERLINES "A" AND "B")

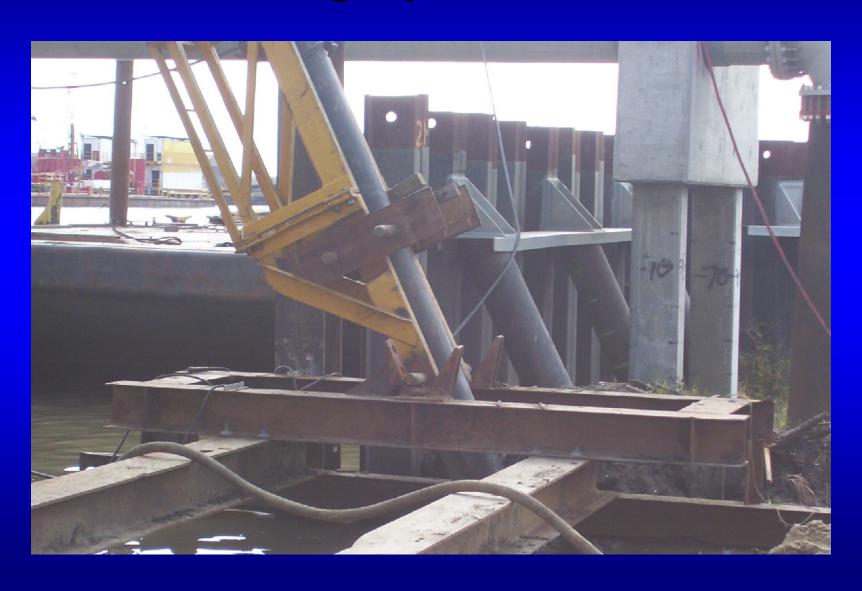
Pile Driving by Waterline "A"

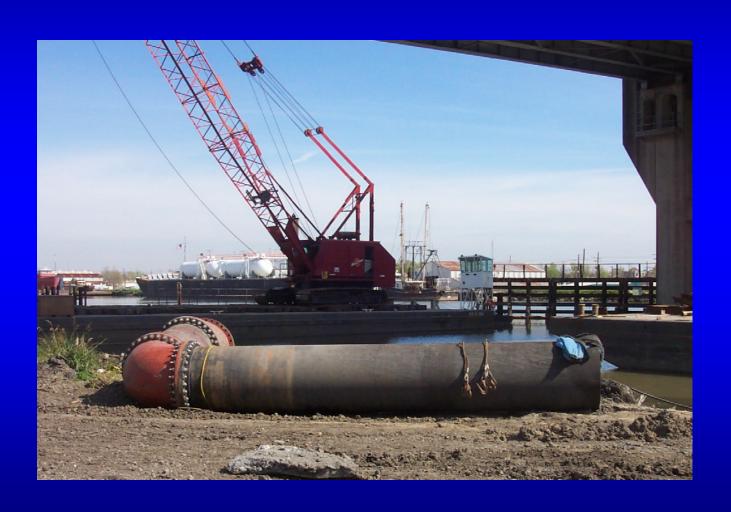
Waterline Segment

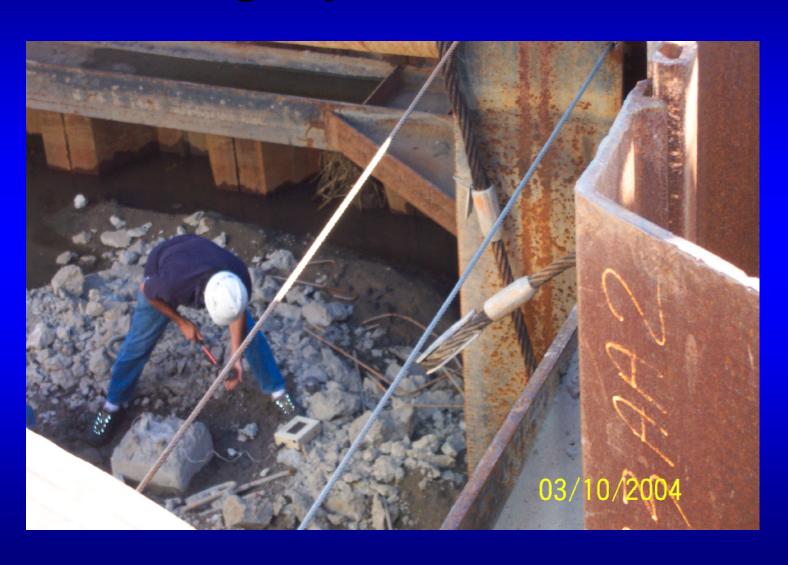
Pile Integrity Test — Bent A-6

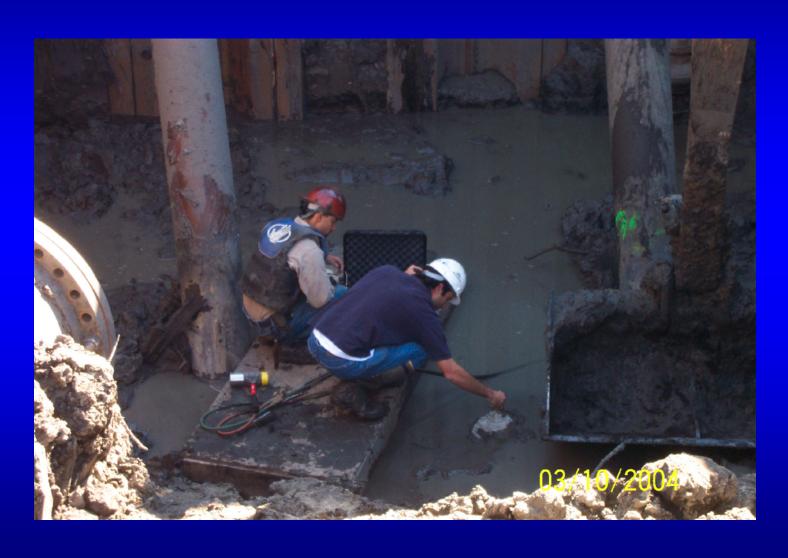
Pile Integrity Test — Bent A-1
