John Day Navigation Lock

Monolith Repair

Presented by Matthew D. Hanson, P.E.

Portland District

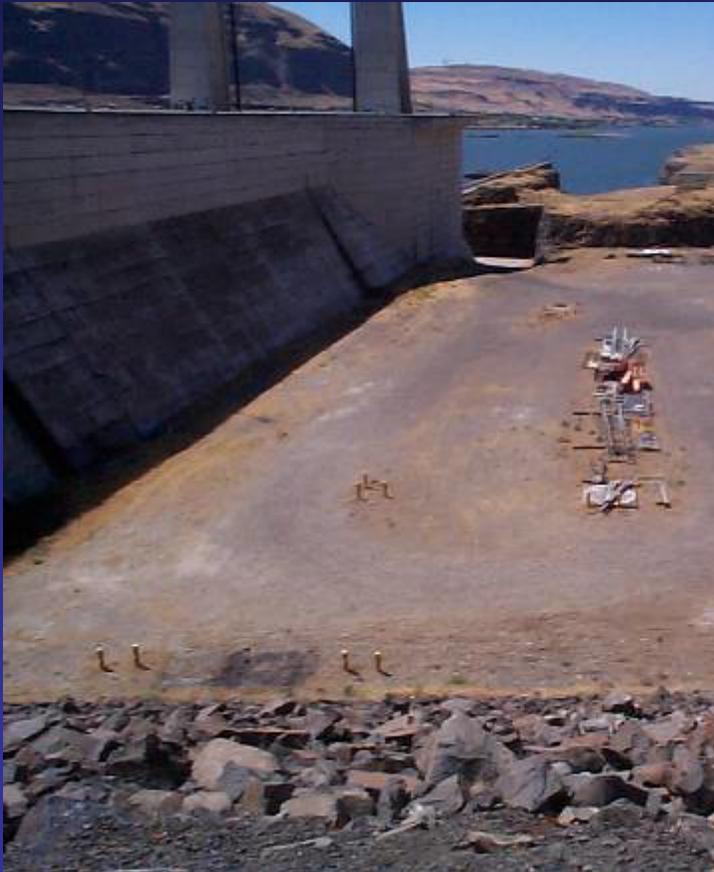
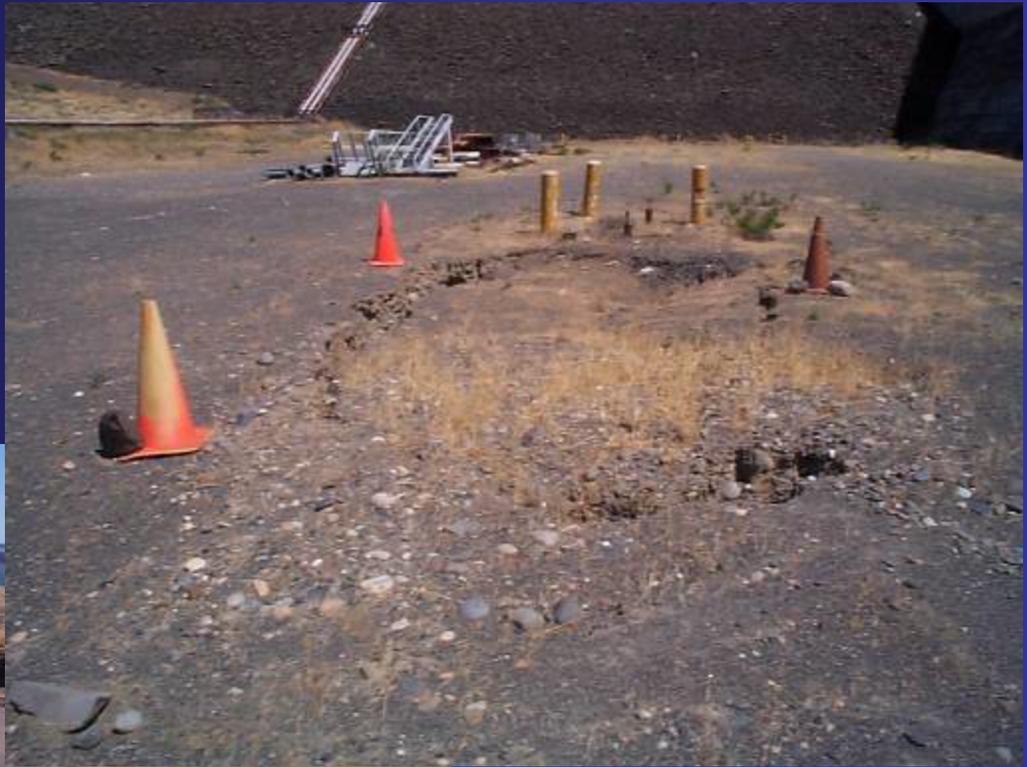
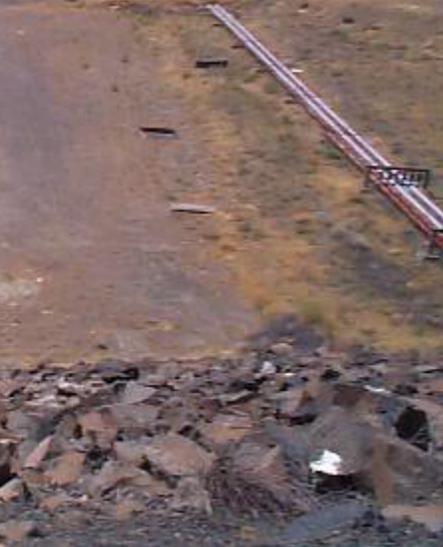
Boneyard Sink Hole

- **Primary Problems necessitating repair (2003)**
 - Monolith 8 split in two pieces
 - Monolith 27 in danger of failure
 - Monolith 8 valve shaft spalling and Tainter valve out of service – no operational redundancy
 - Leakage into backfill and boneyard (sinkholes)
 - Monolith movement, cracking, spalling, etc.
 - Customer complaints

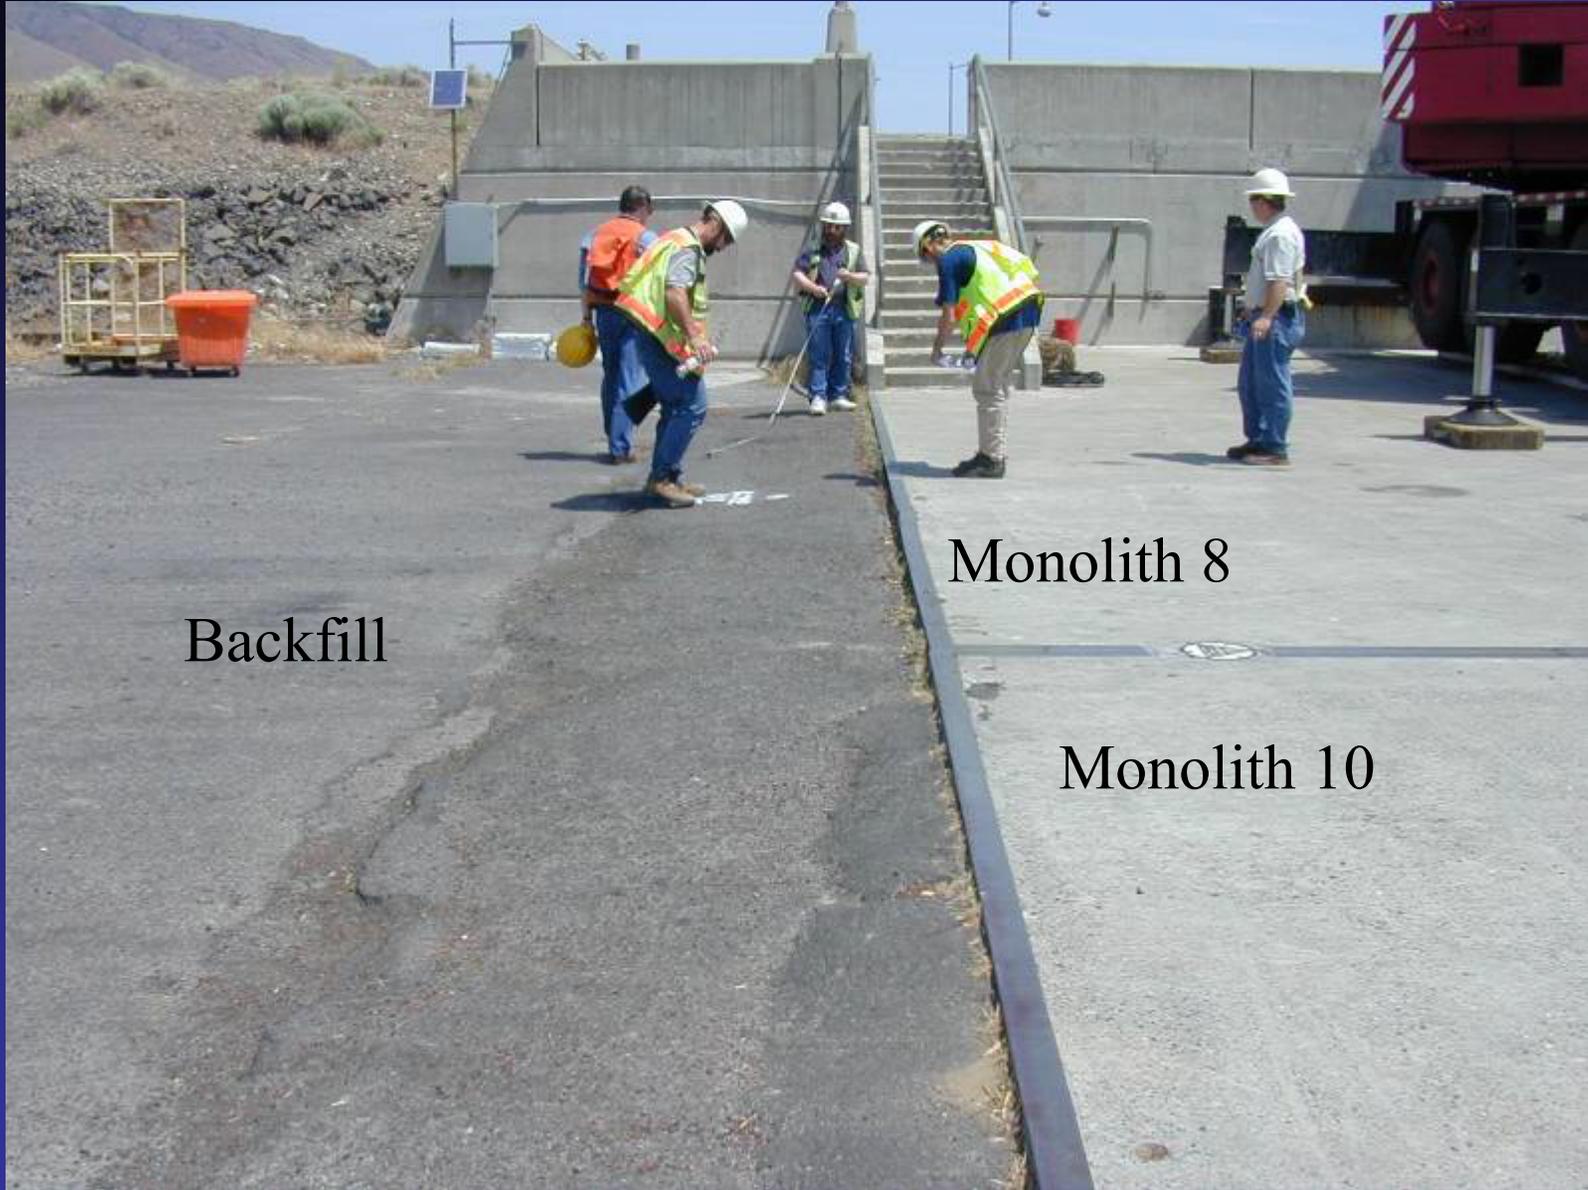
Backfill

Monolith 8

Monolith 10

Settlement

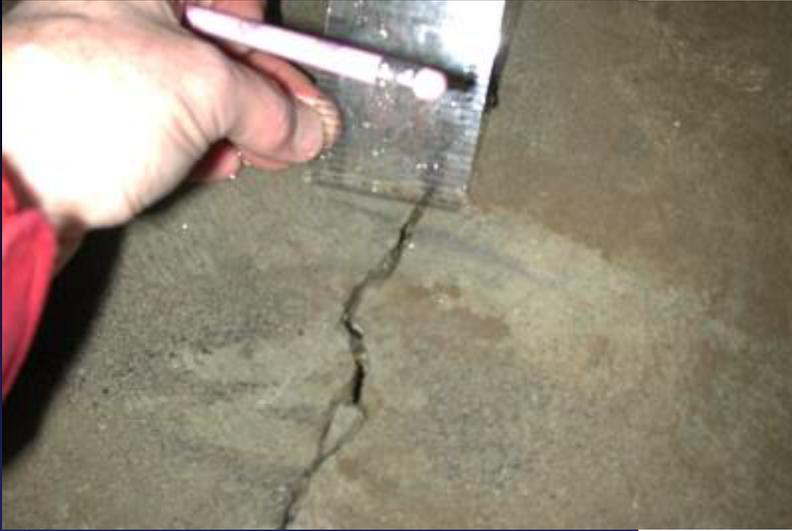
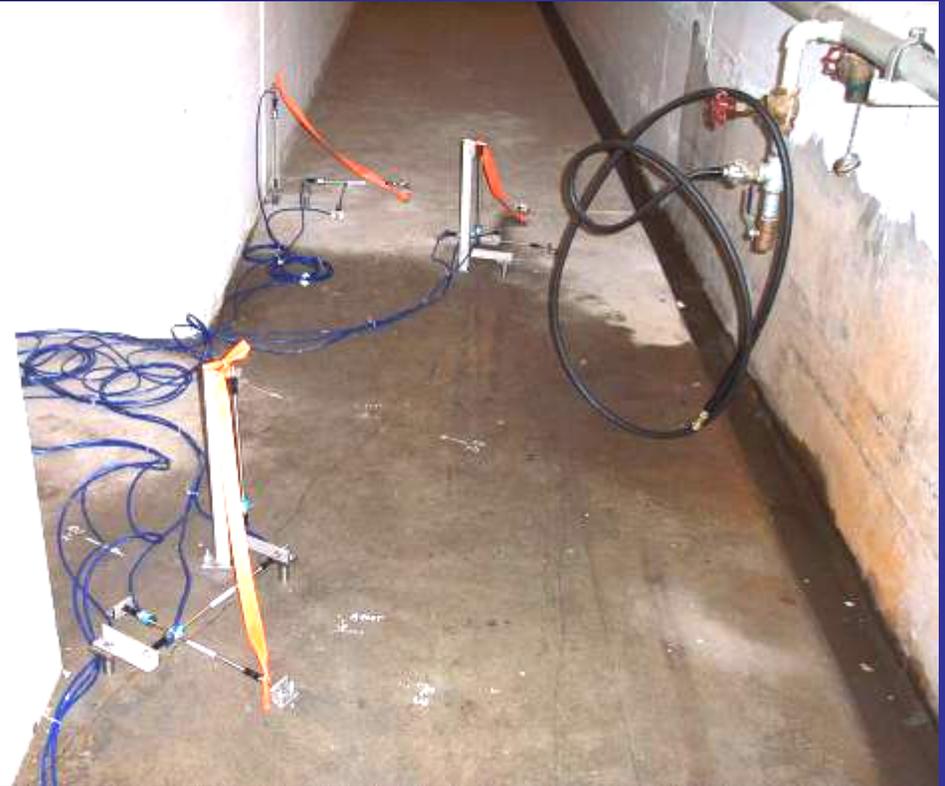
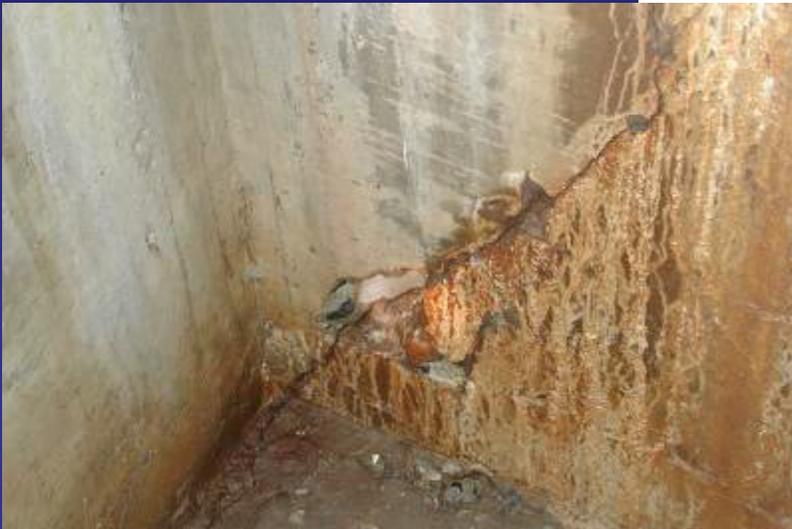
Monolith 8 Service Gallery – Tainter Valve Shaft

Monolith 8 Service Gallery Concrete Cracking

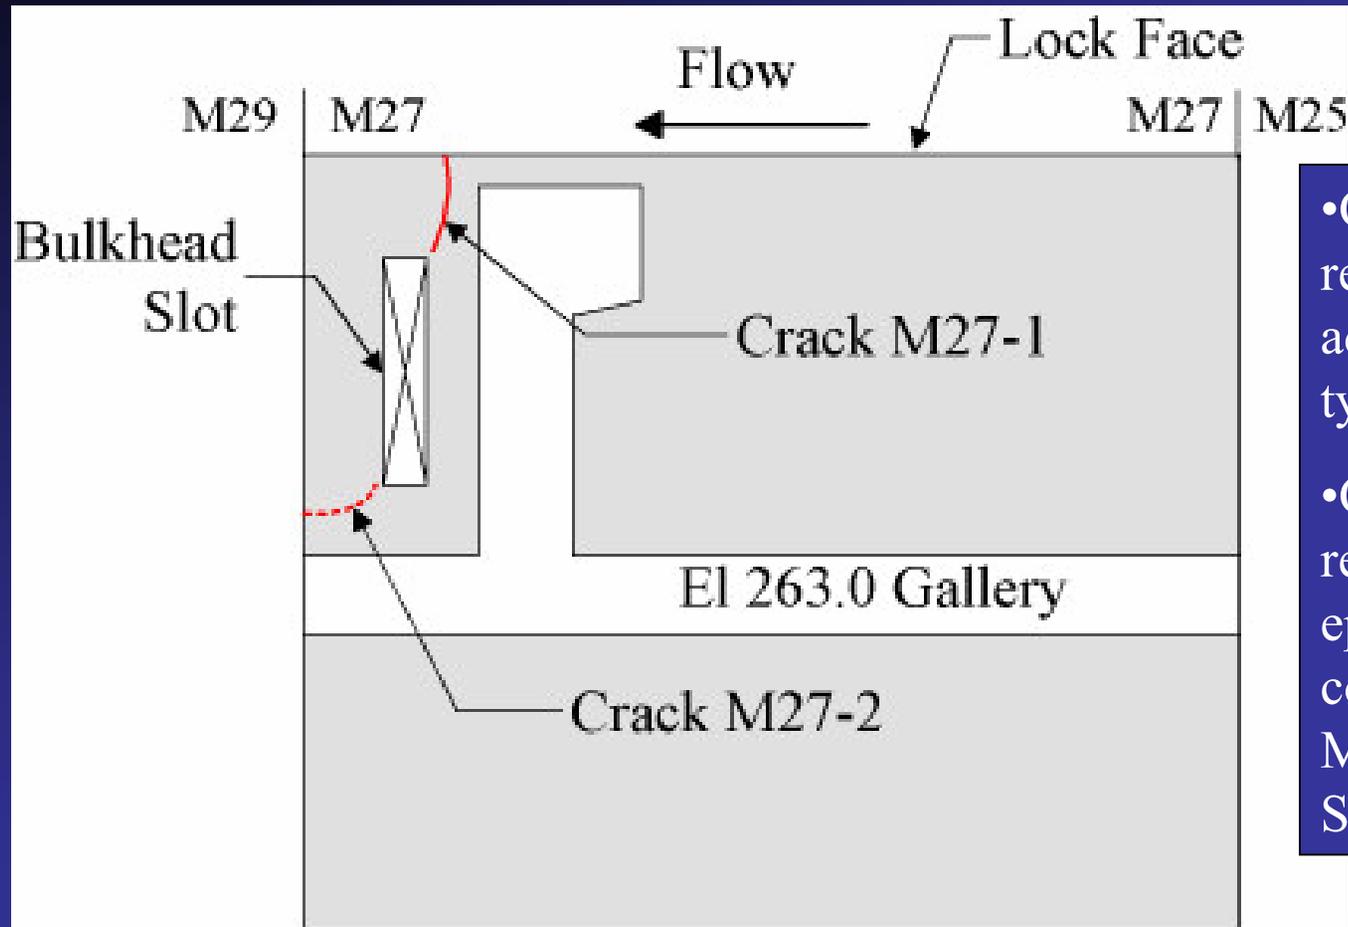
John Day Navigation Lock – Confirmed Crack Planes

Monolith 27 El. 263.0 Service Gallery

- Crack M27-1 to be repaired using epoxy adhesive grout in typical fashion.
- Crack M27-2 to be repaired using paste-epoxy adhesive for condition similar to Monolith 8 Bulkhead Slot

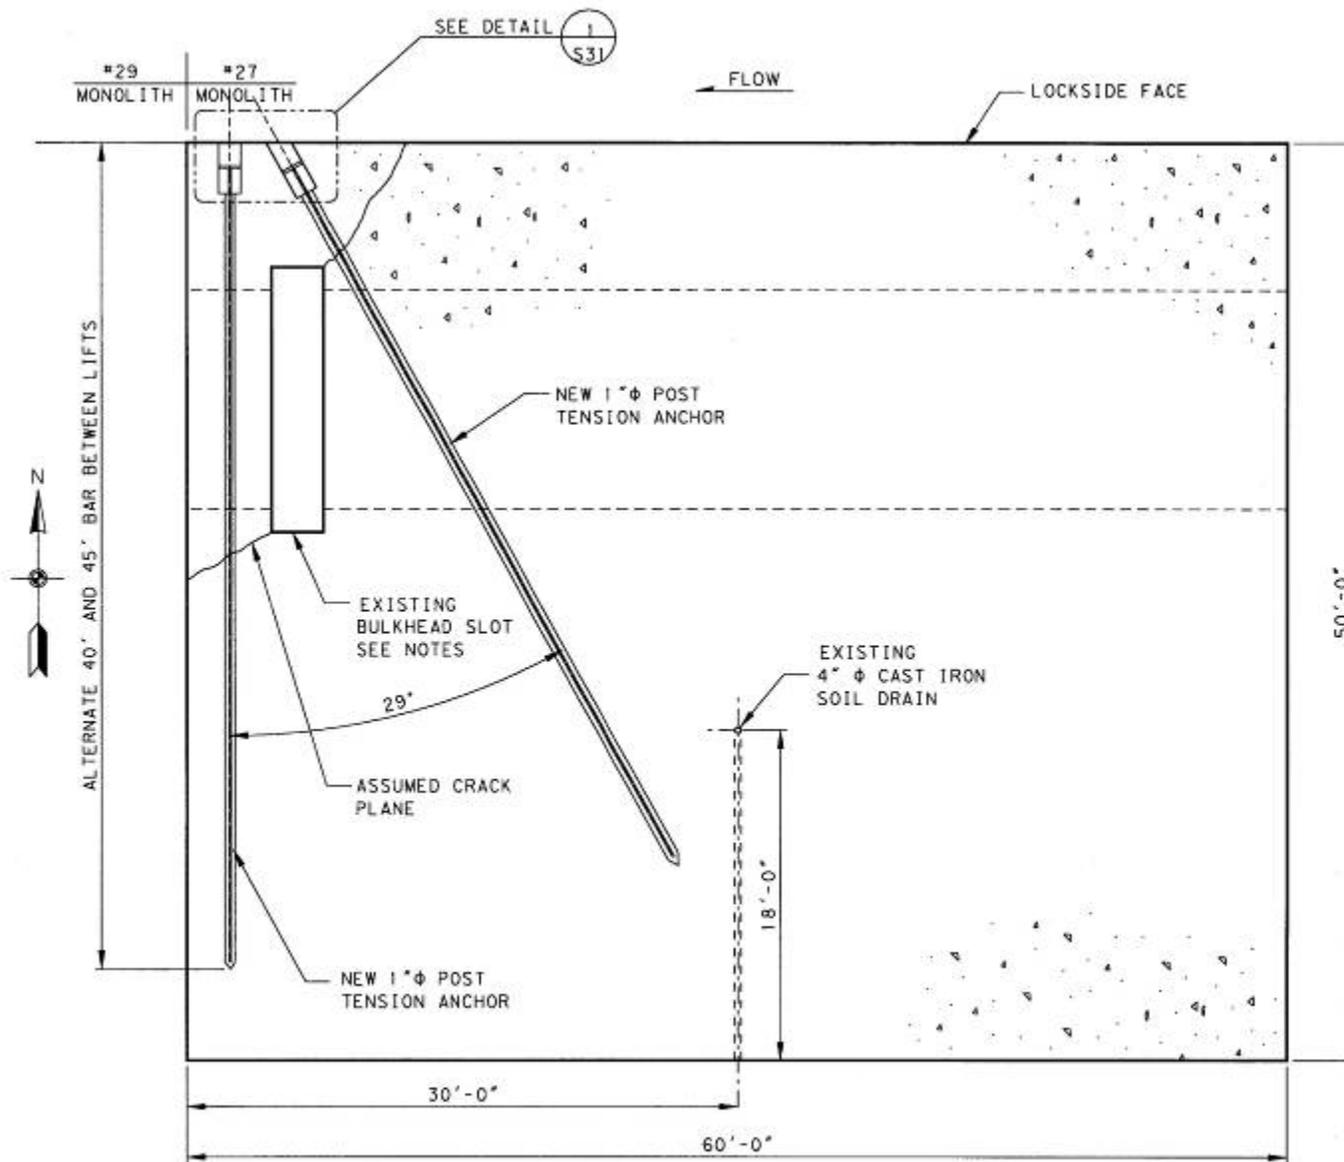
PLAN EL. 250.0

- **Monolith 27 Post Tensioning Design Cont...:**
 - **New PT was angled and smaller bars were used to eliminate the need to develop bars in the rock strata.**
 - **Fewer monolith penetrations and the no existing PT made the location of these new anchors much less complicated.**
 - **Anchorage details similar to monolith 8 repairs.**

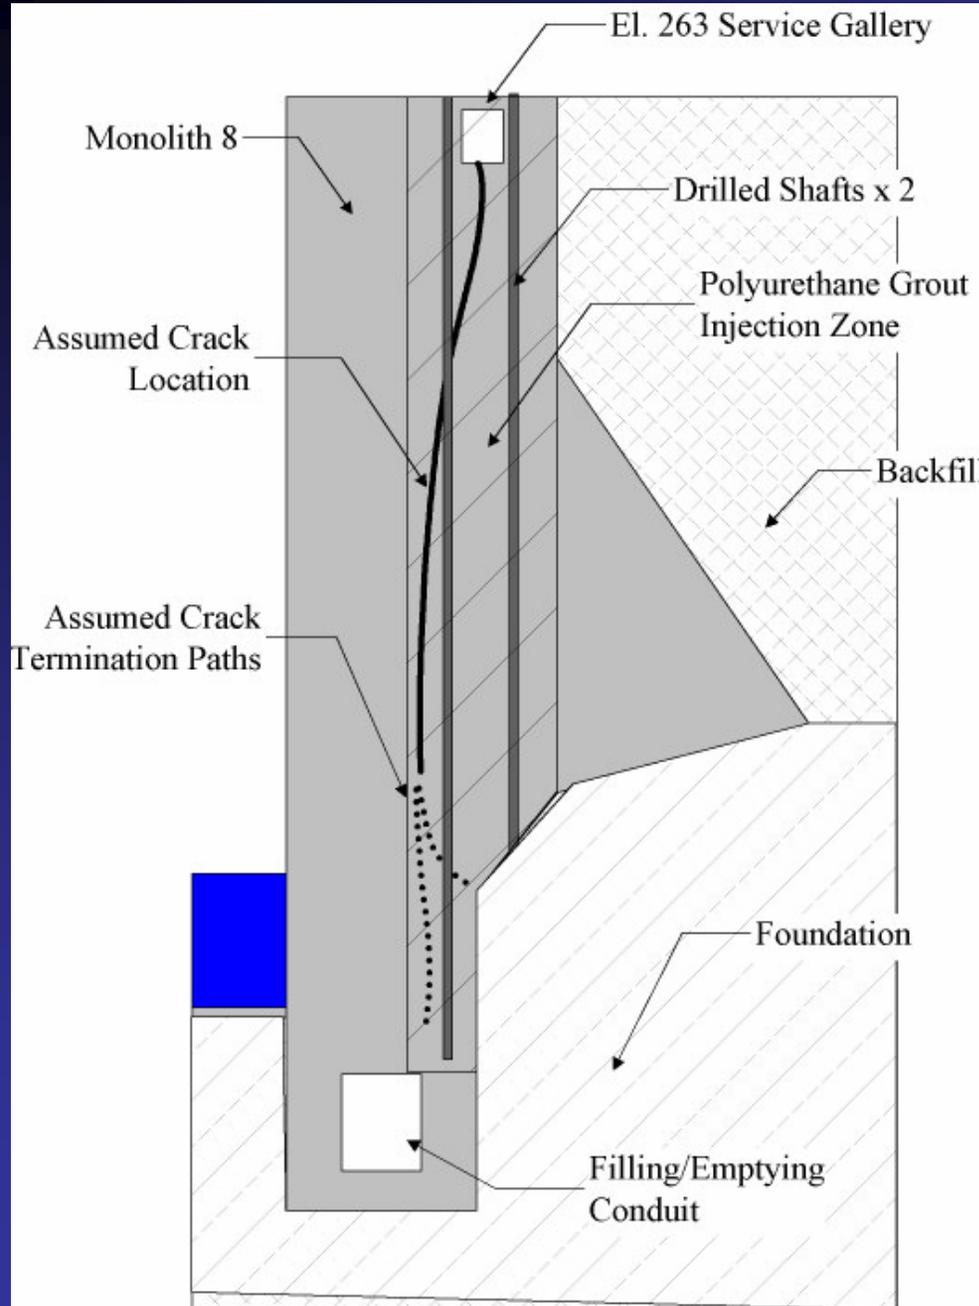
Monolith 8/10 Joint Isolation

1. Isolate joint from crack to prevent epoxy grout from bonding joint.
2. Drill two vertical 10-inch dia access shafts.
3. Place expanding chemical “foaming” grout to fill Polyurethane Injection Zone
4. Grout Crack.

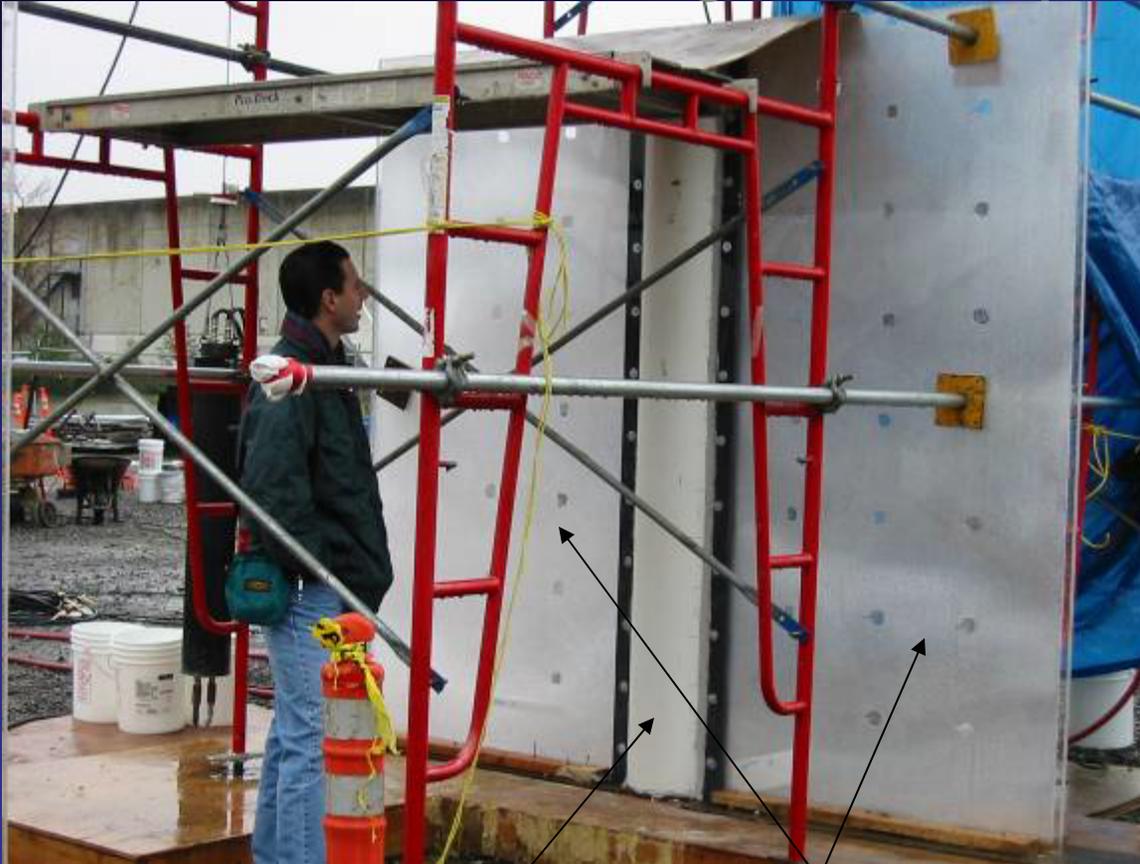
John Day Monolith Repair Contract Joint Sealing Mock-up Testing

Drilled shaft

Simulated monolith joint

Effectiveness of joint
filler

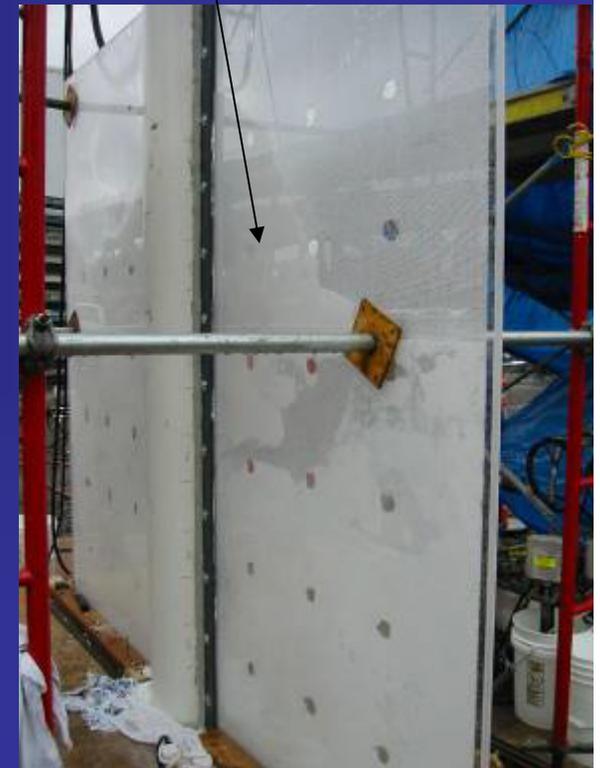
Monolith Joint - Paste Epoxy Injection

- Paste-Epoxy injection allows a controlled placement due to a predictable and consistent epoxy distribution “bulb.”
- Applicable in a “blind” crack situation

1. Stage 1 injection until epoxy is observed at 2nd port above.
2. Stage 2 injection at intermediate ports.

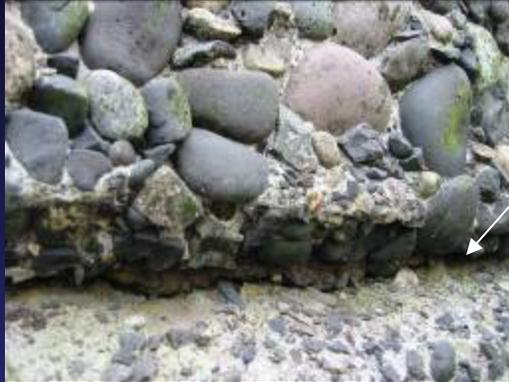
Monolith
joint

Injection
Ports

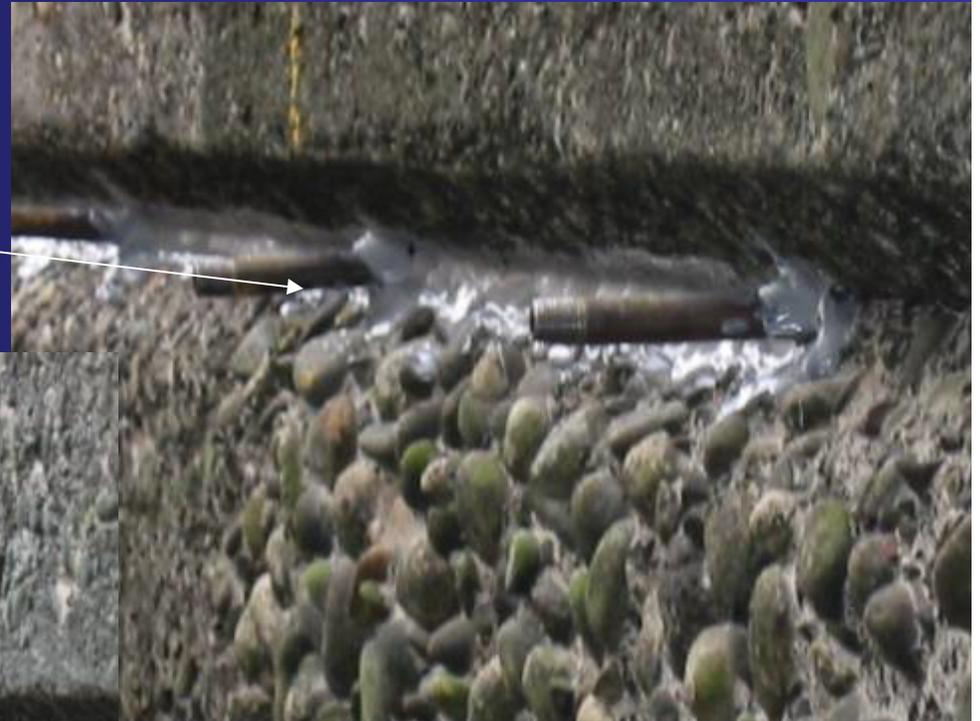
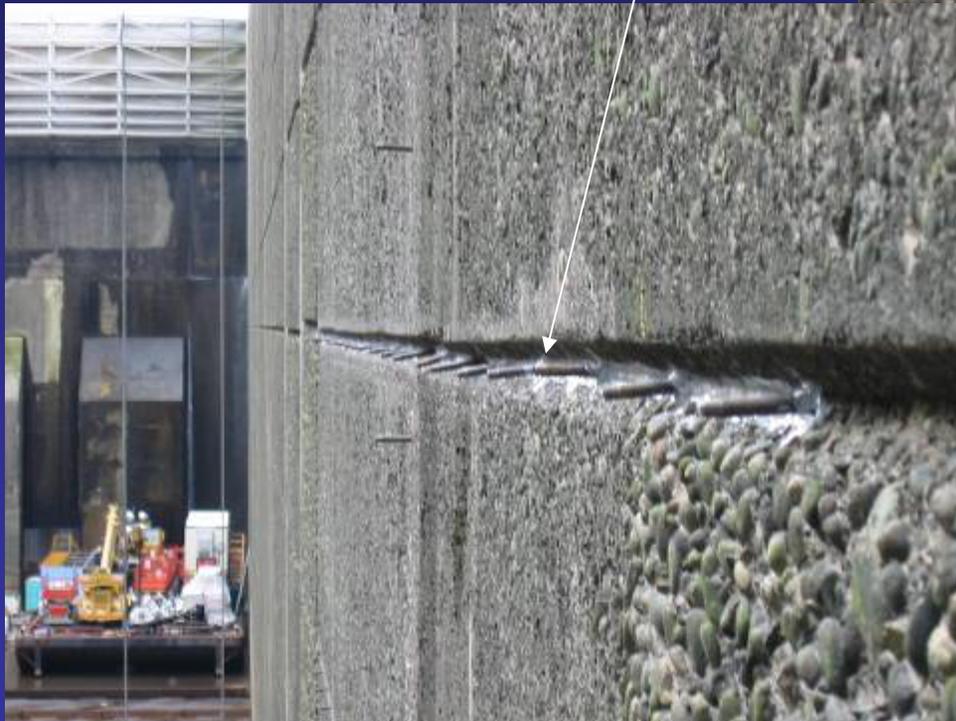
Post Tension
anchor holes

Epoxy
Injection Ports
