Belleville Locks & Dam

Barge Accident on 6 Jan 05 John Clarkson

Belleville Barge Accident

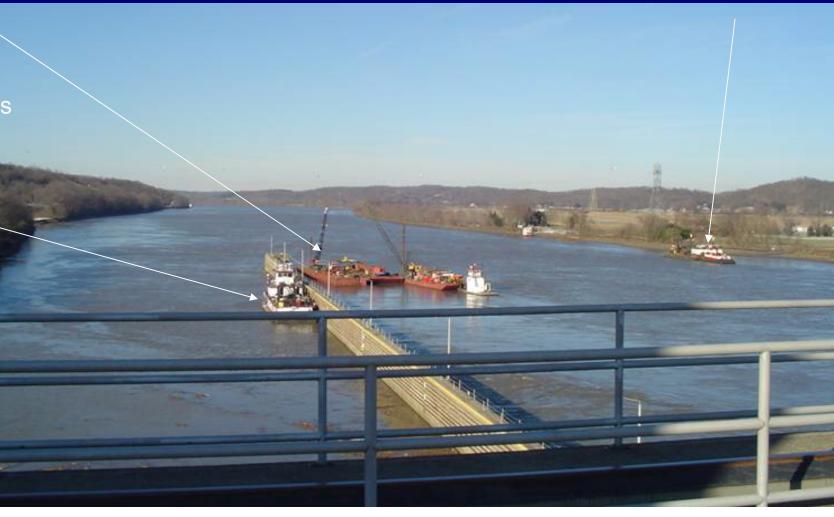
Salvage Equipment Upriver

River Salvage digging with a crane to anchor a barge with winches to lower down their excavator with a hydraulic shear

Okie Moore Equipment: Frane barge pulling barges I/V Capt. Val

M/V James Moorehead

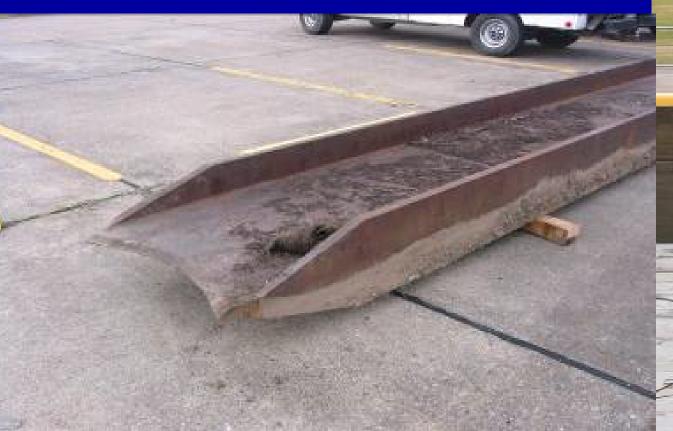
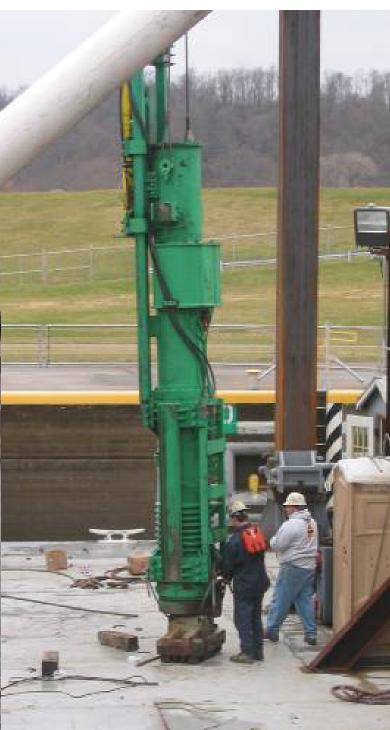
Cutting Beam and Pile Driver

Started to use cutting beam (Successfully used by the Louisville District) Ultimately not used, only had one barge that might be able to use, restriction that the beam could not extend beyond pier

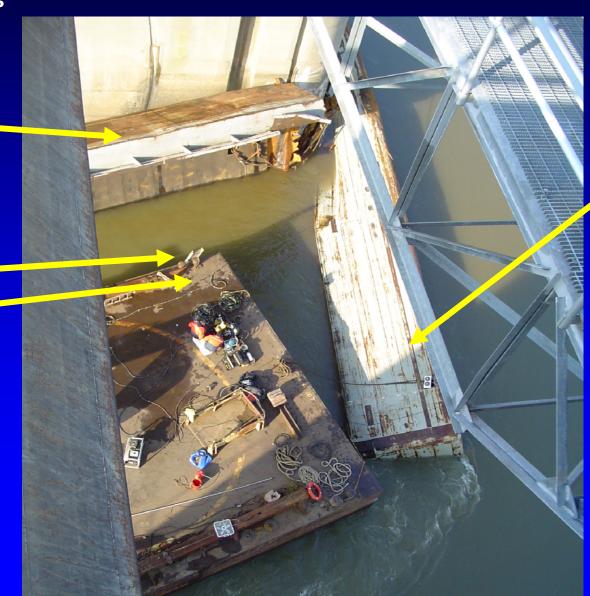
Divers ladder and support lines

Divers cutting PEN 207

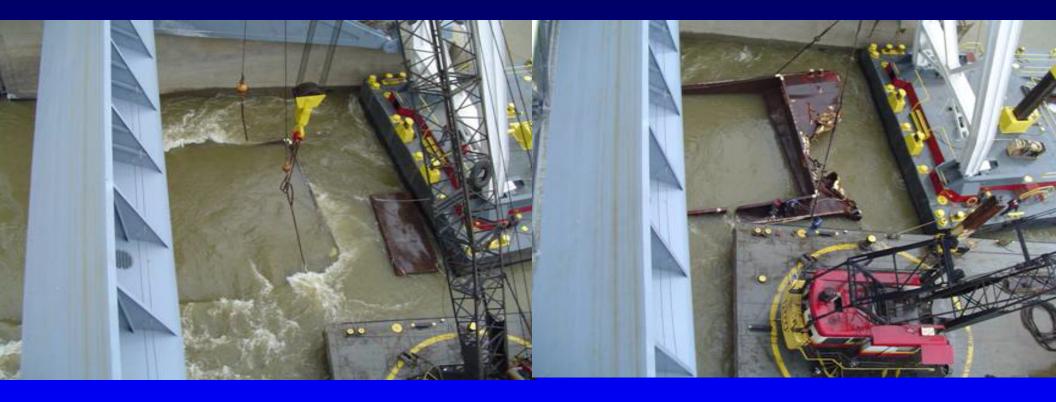
Saturday, Jan 29th

Worked a sling under the bow of AEP 8815.

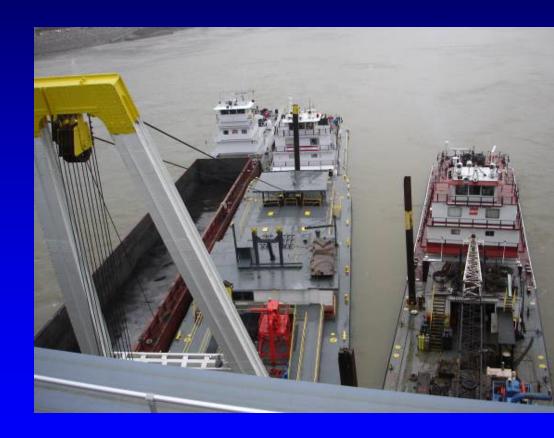
Last Barge

Running out of options and tried pulling the downstream rigging with three towboats. While unsuccessful, there was some movement, the barge appeared to be hung up on a part of the dam sill.

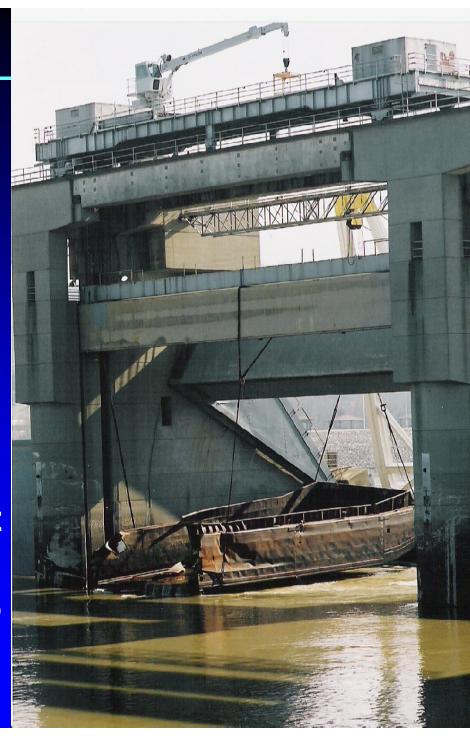
Lifting out with Bulkhead Crane and the 454 metric ton (500 ton) A-frame to lift the barge. The salvager raised one end of the barge with the A-Frame crane and worked a sling under the mid-section to rig to the dam's bulkhead to lift the other end out of the water and then cut the barge into two pieces.

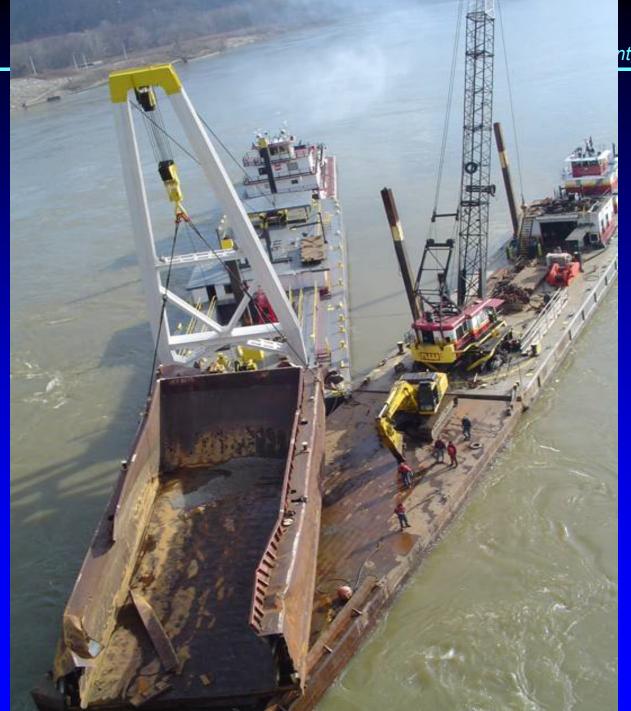
M/Vs Capt John Reynolds and James Garret coordinated the movement out of Gate 3 and down river.

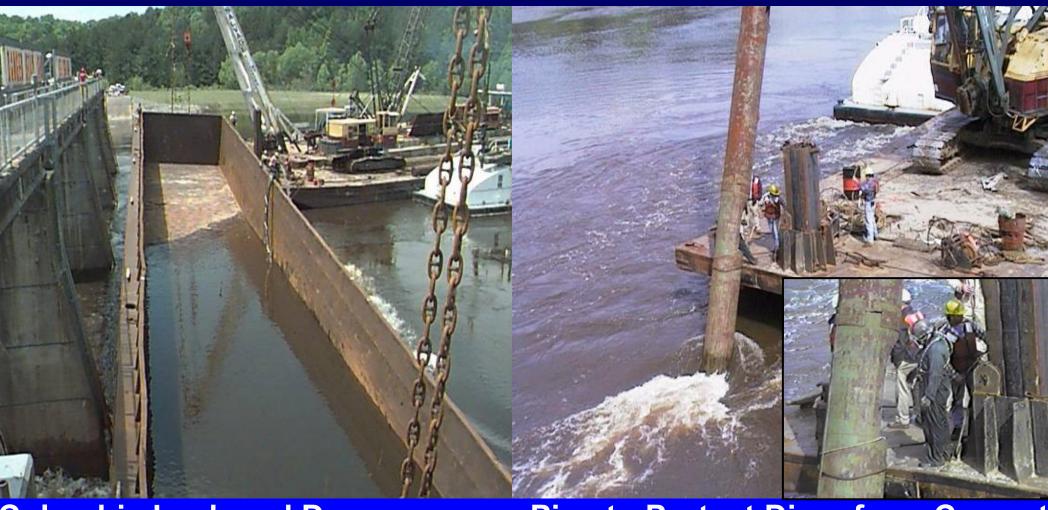
Columbia Lock and Dam

Pipe to Protect Diver from Current
