**Branchbox Breakwater Design
at
Pickleweed Trail, Martinez, CA**

Pickleweed Trail, Martinez, CA

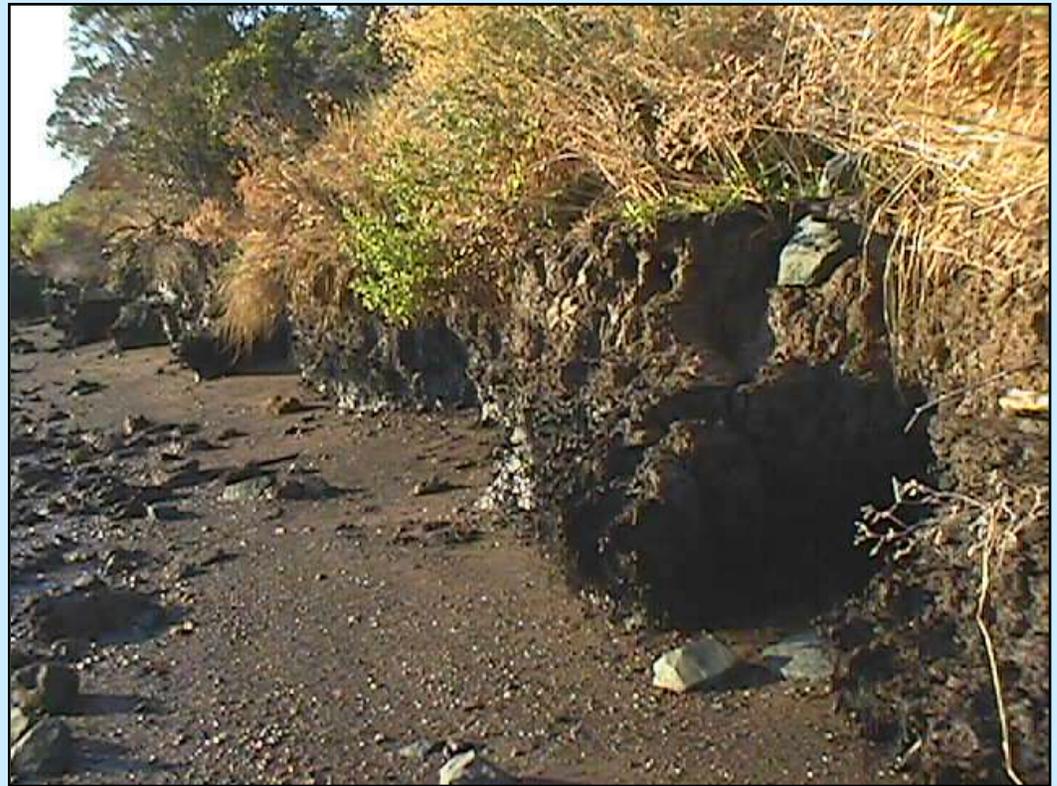
Erosion at the Pickleweed Trail

- ❖ Erosion probably caused by tidal currents and waves (wind and boat)
- ❖ Natural shoreline consists mostly of mudflat to berm of bay mud covered by vegetation
- ❖ Failure mechanism appears to be slumping and removal of berm by waves and currents

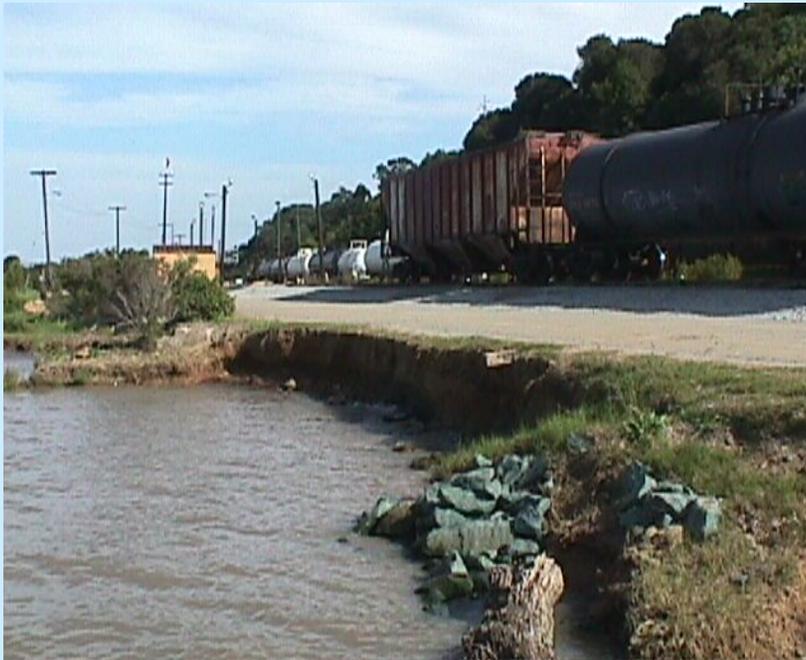
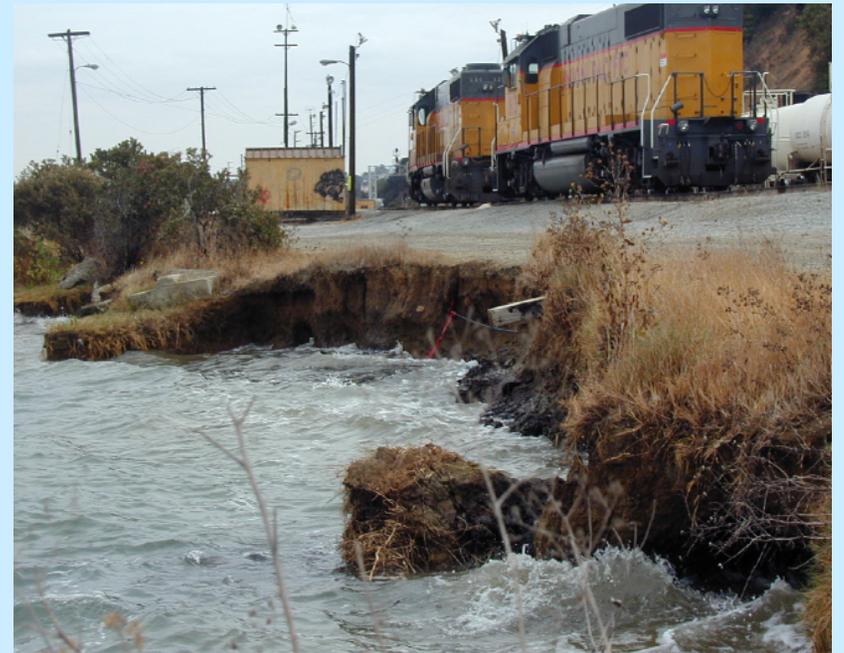
2000

2002

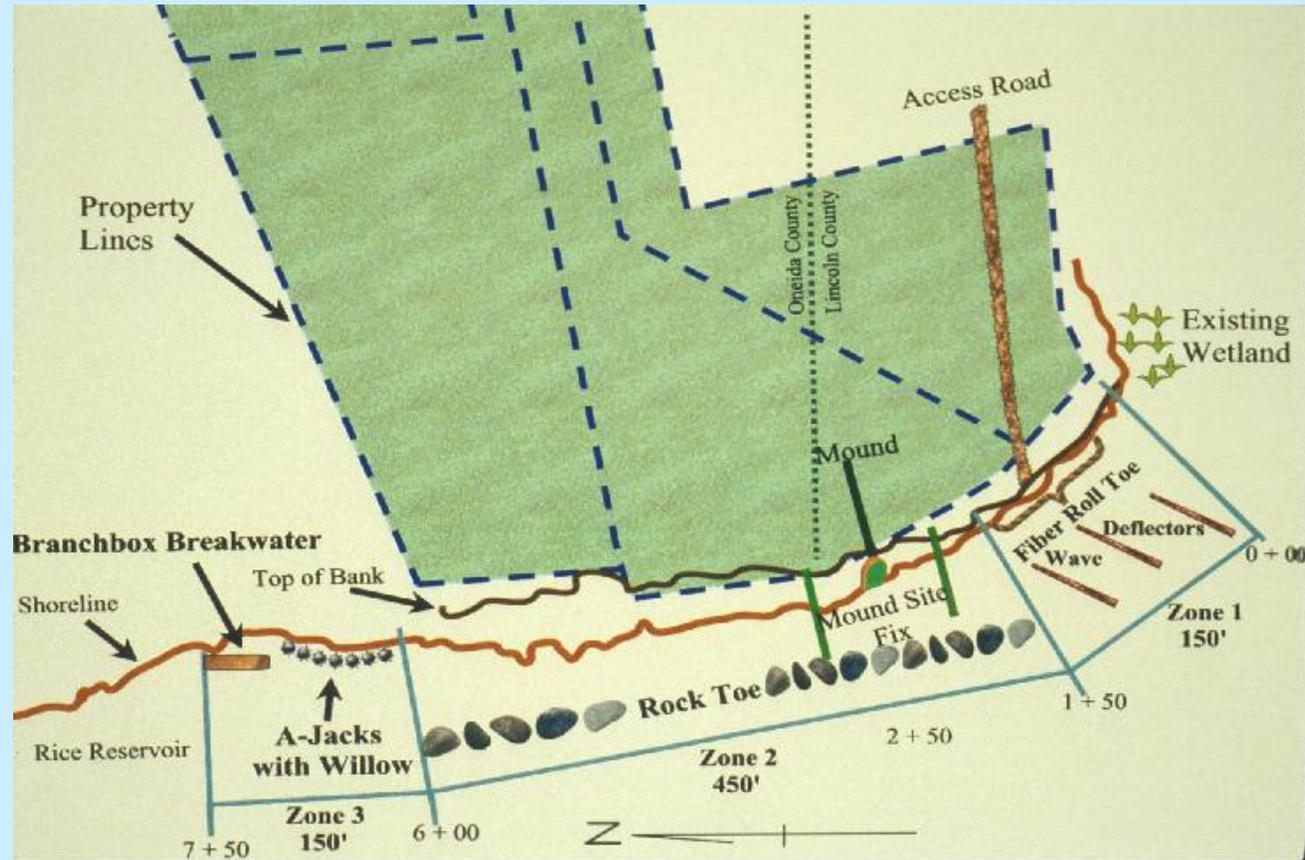
Branchbox Breakwater Rice Reservoir

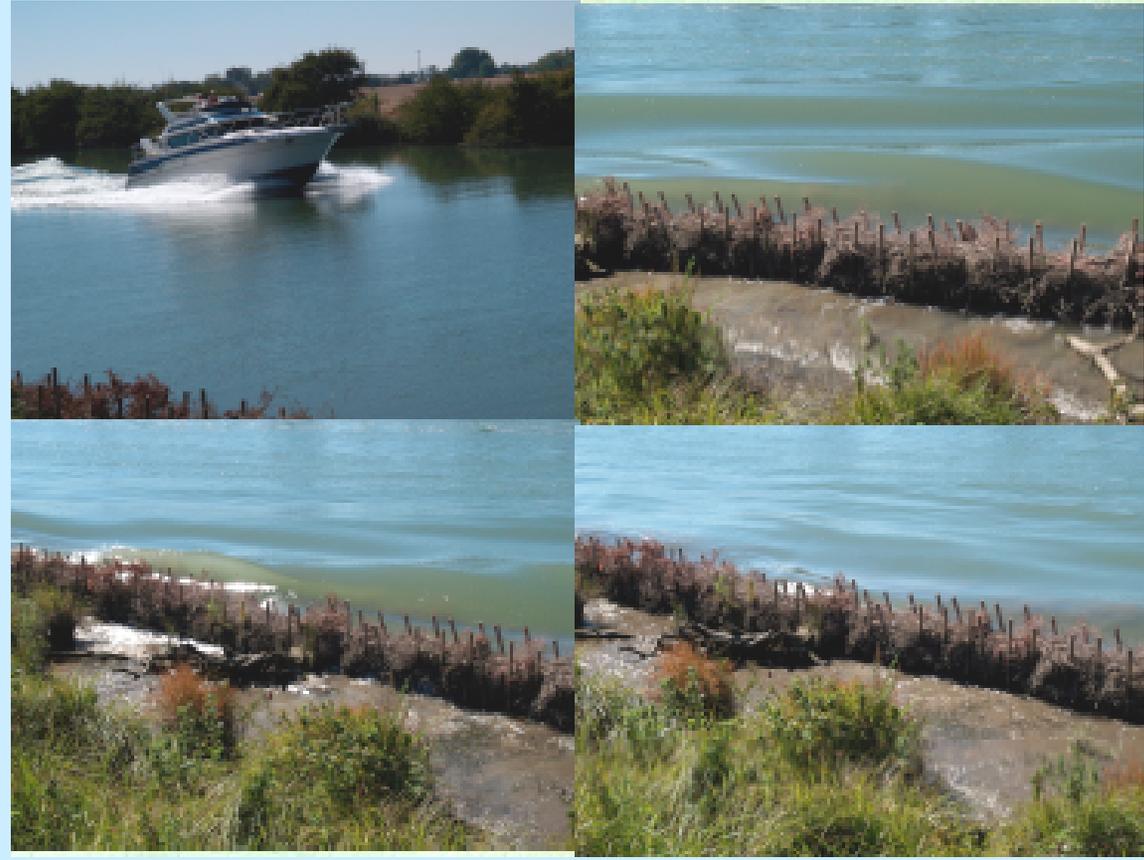
Branchbox Breakwater Georgiana Slough

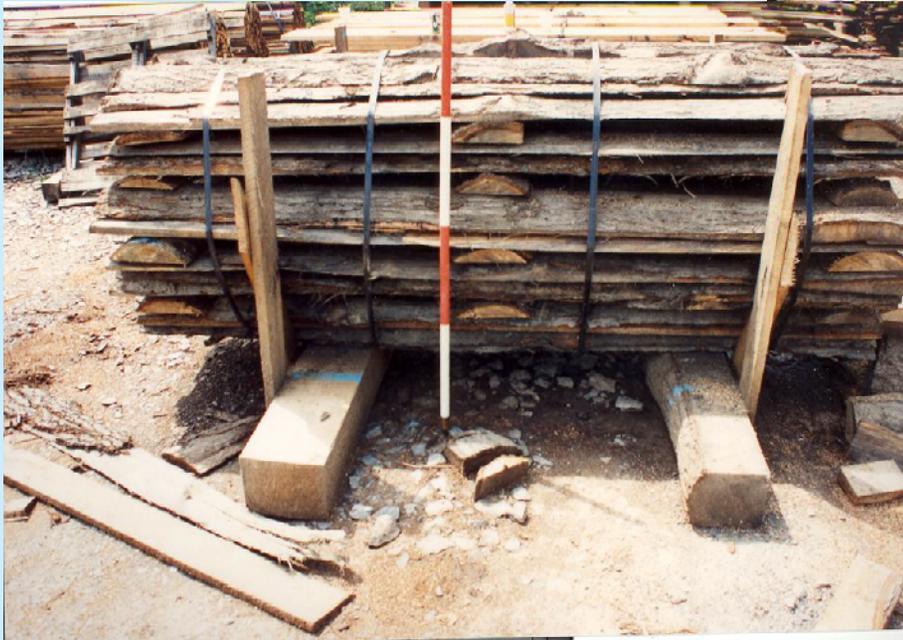
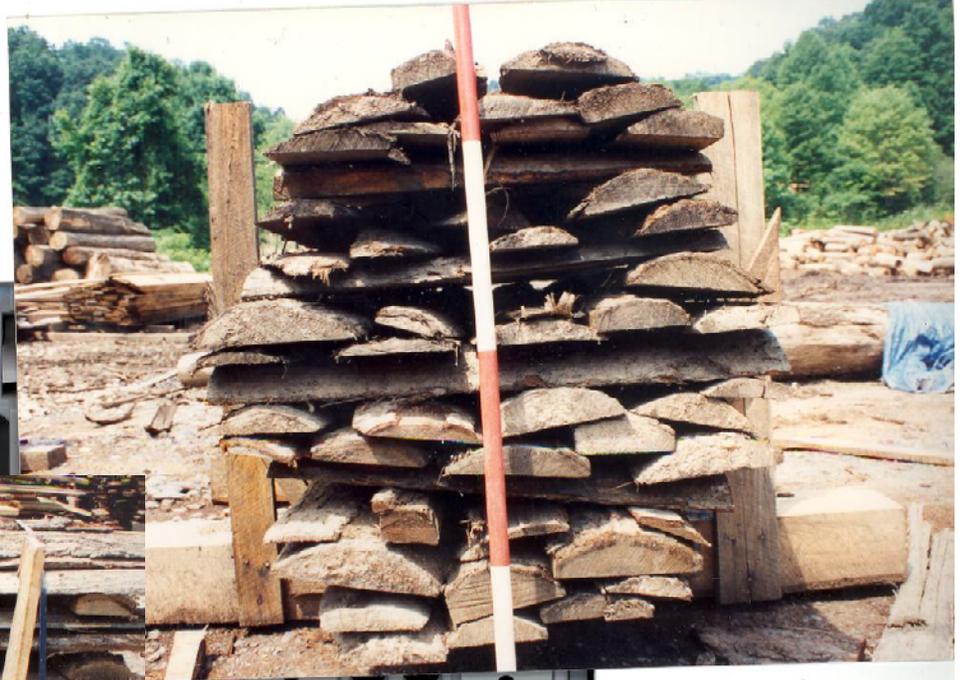
Slab Bundles

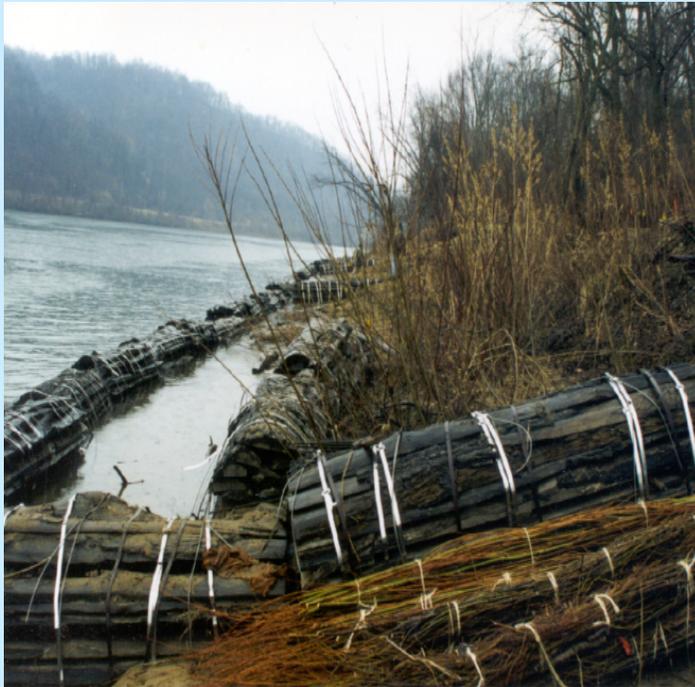
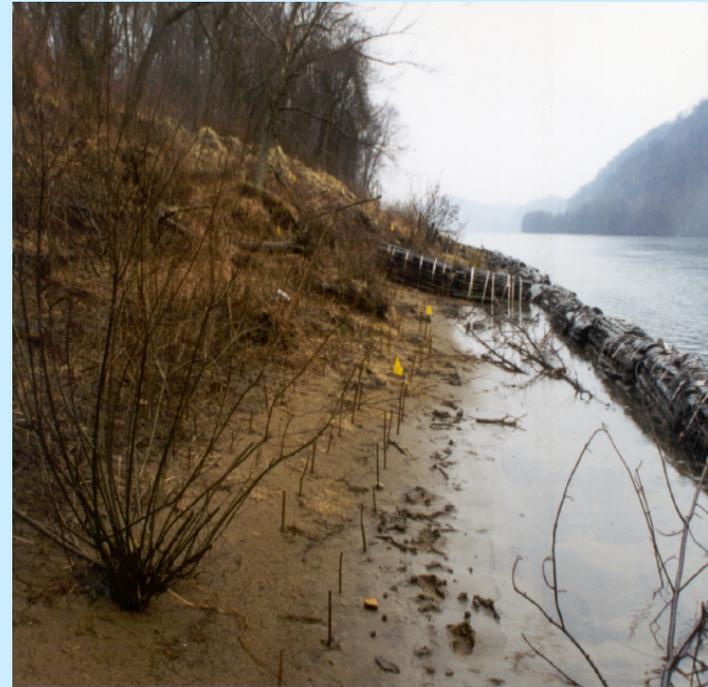
Slab Bundles Ohio River

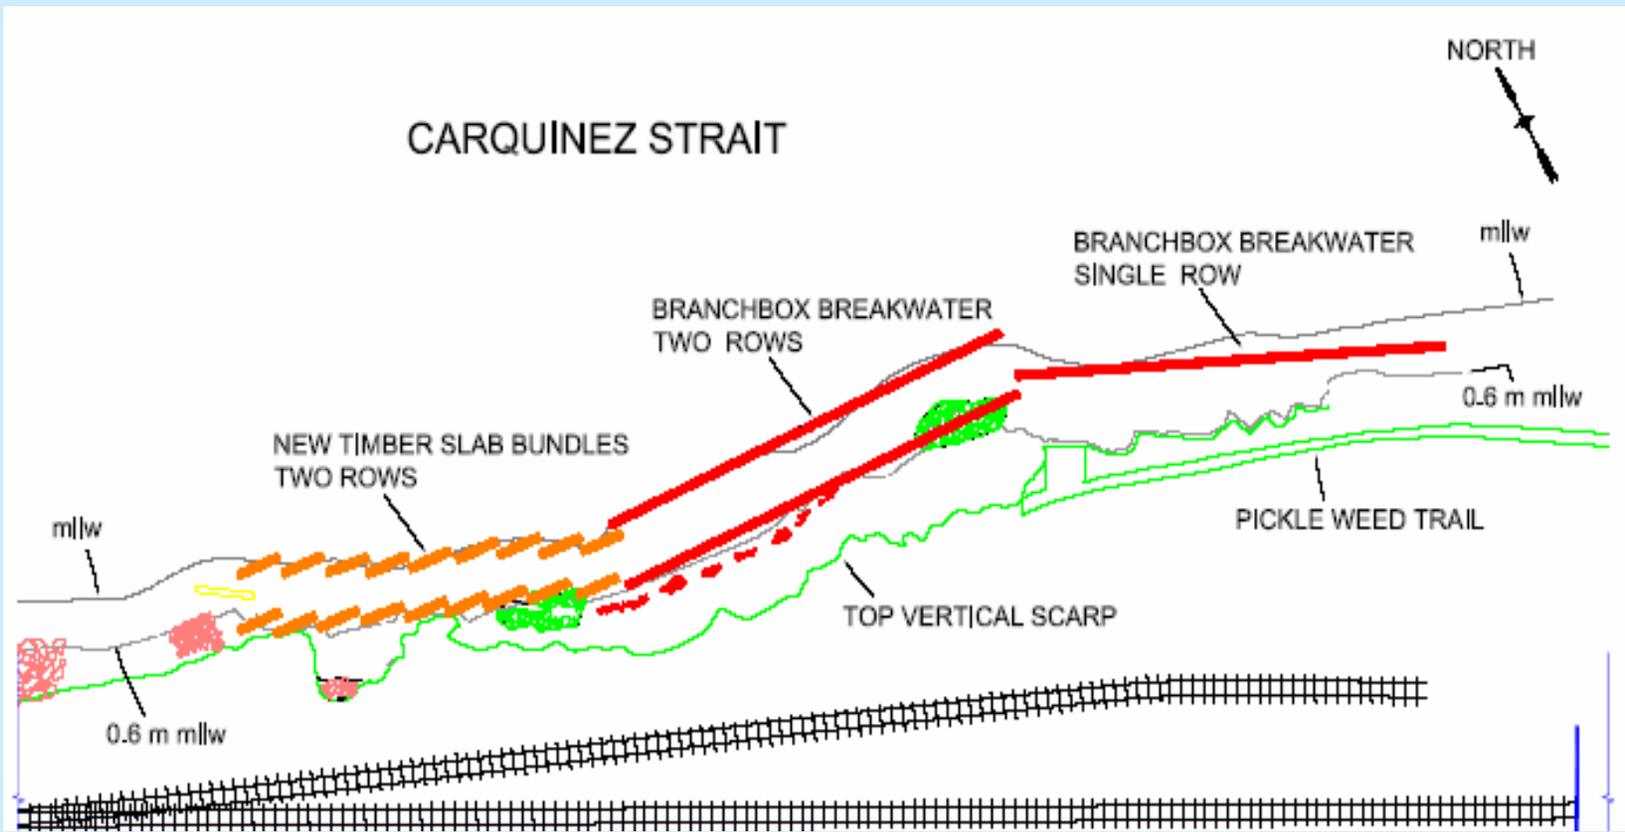
Proposed Design for Pickleweed Trail
