Bank Erosion and Morphology of the Kaskaskia River

US Army Corps
Of Engineers
St. Louis District

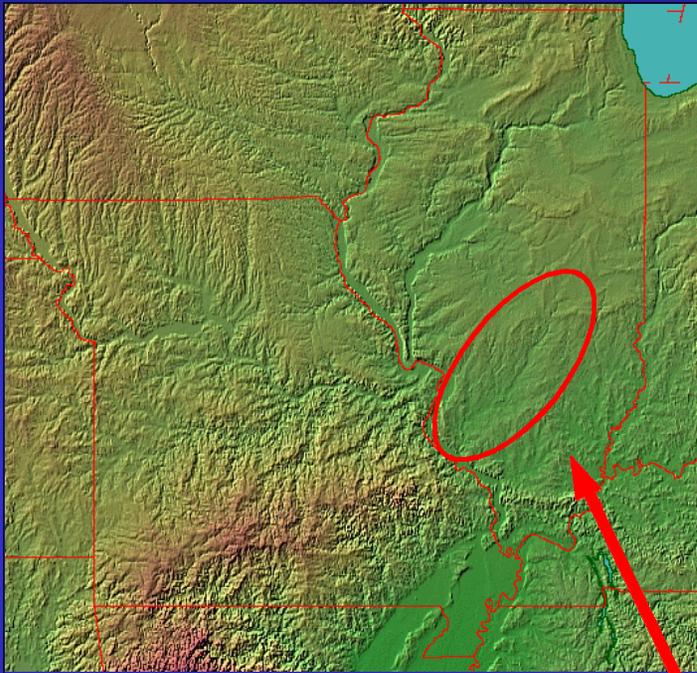
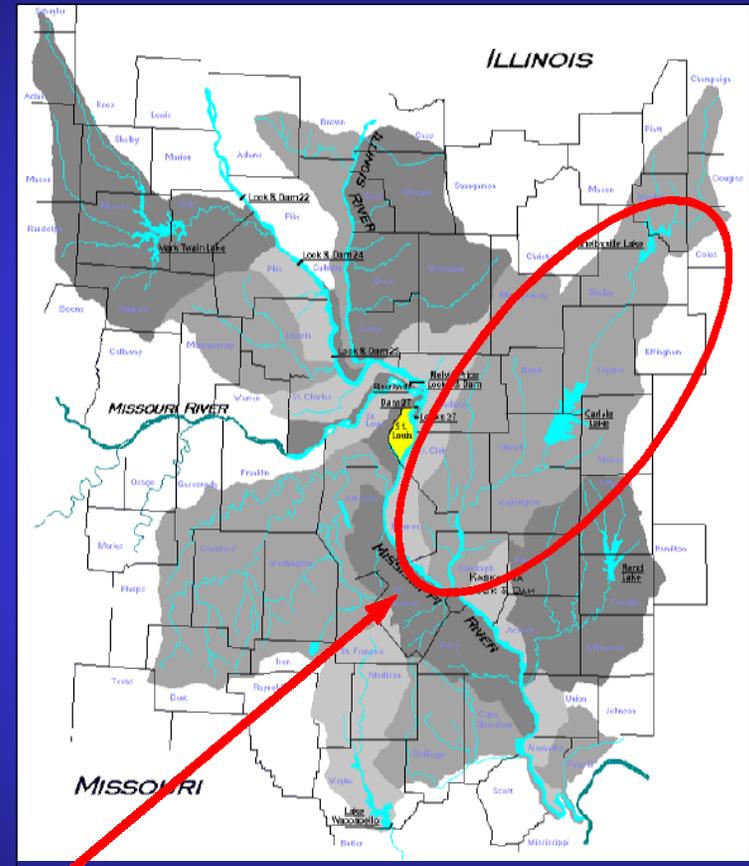
Study Reach

Vicinity

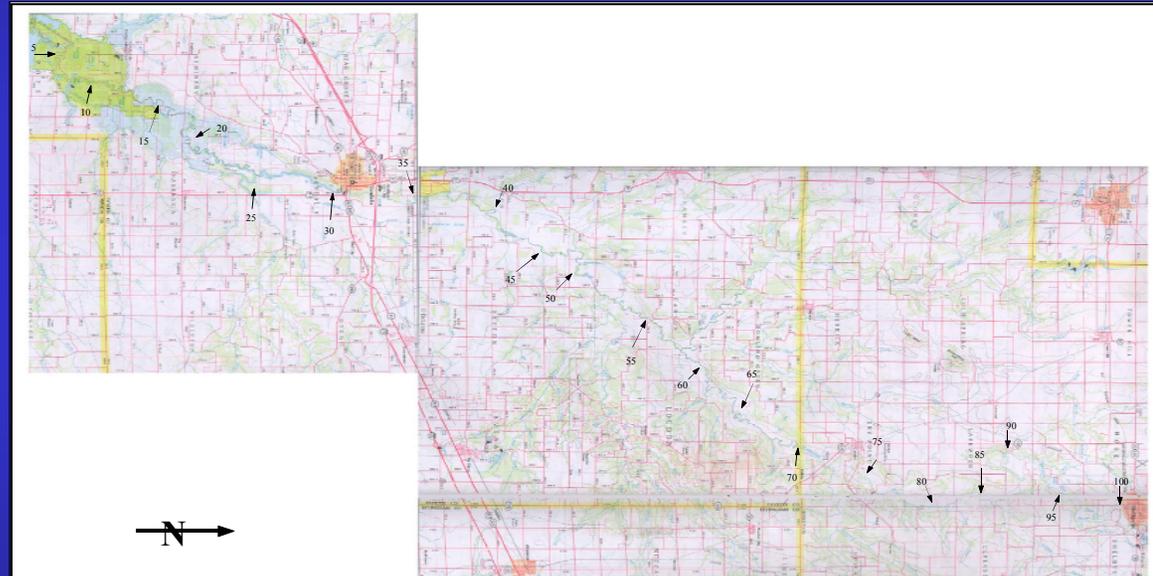
Middle Kaskaskia Section Shelbyville Dam to Carlyle Lake

- Drainage area of 2140 mi²
- Peak flow at Vandalia 19,300 cfs
- Researched several land use maps and aerial photos
- Analyzed over 100 river bends

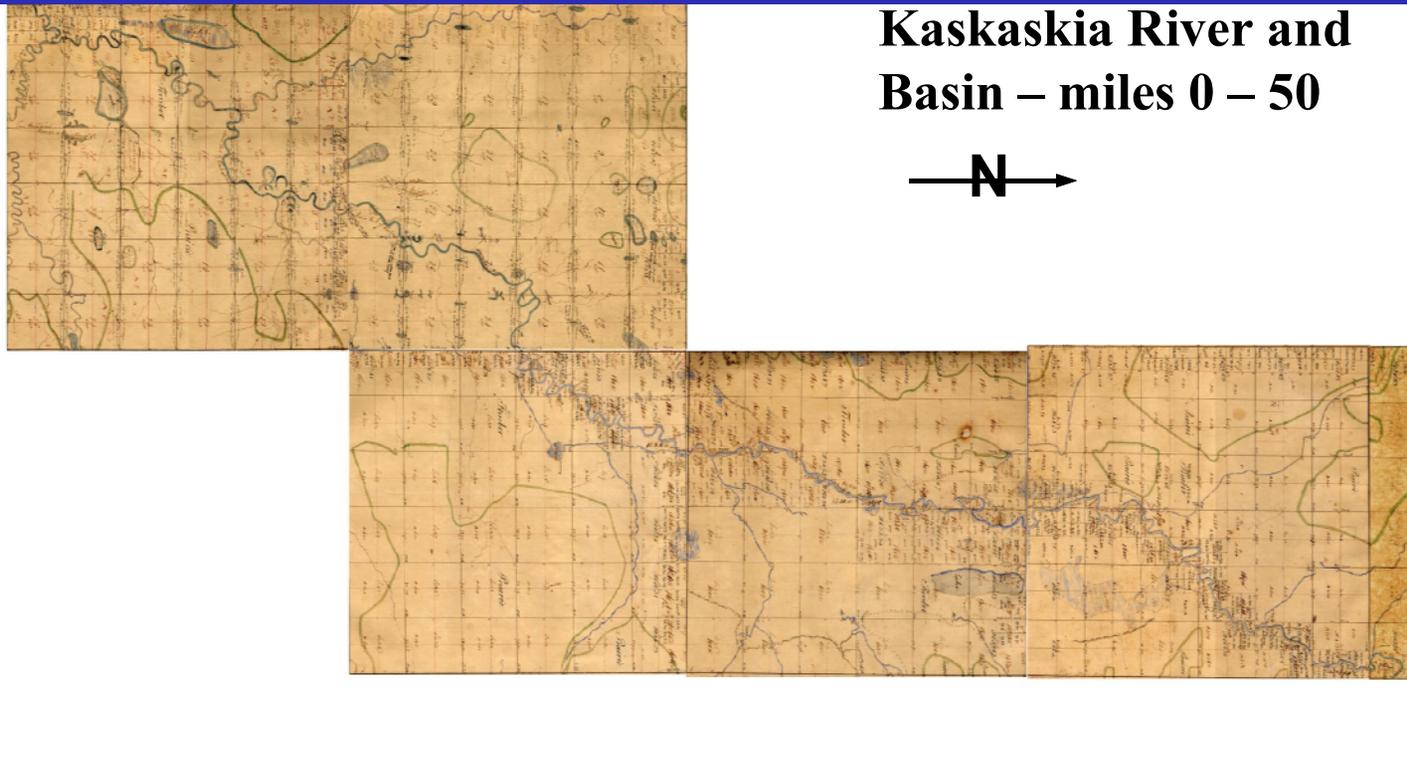
1820 GLO Survey

- **The first complete survey of the State of Illinois was conducted by the Government Land Office (GLO) between 1820 and 1830. Of the GLO, only miles 0-50 of the Kaskaskia River and its floodplain were available**
- **Aerial photos of the entire main channel and floodplain of the Kaskaskia River were gathered for the years 1938, 1966, and 1998. The aerial photos were scanned in and large mosaics were generated**
- **The GLO was used for qualitative comparison of the relative position of the river in 1820 versus 1998. It was also used for land use changes of the floodplain in 1820 versus 1938, 1966, and 1998**
- **The 1938, 1966, and 1998 aerial photos were used for qualitative comparison of relative position of the river attributes such as width, length, wetted edge, etc. and also for land use changes, feet of bare bank, etc.**

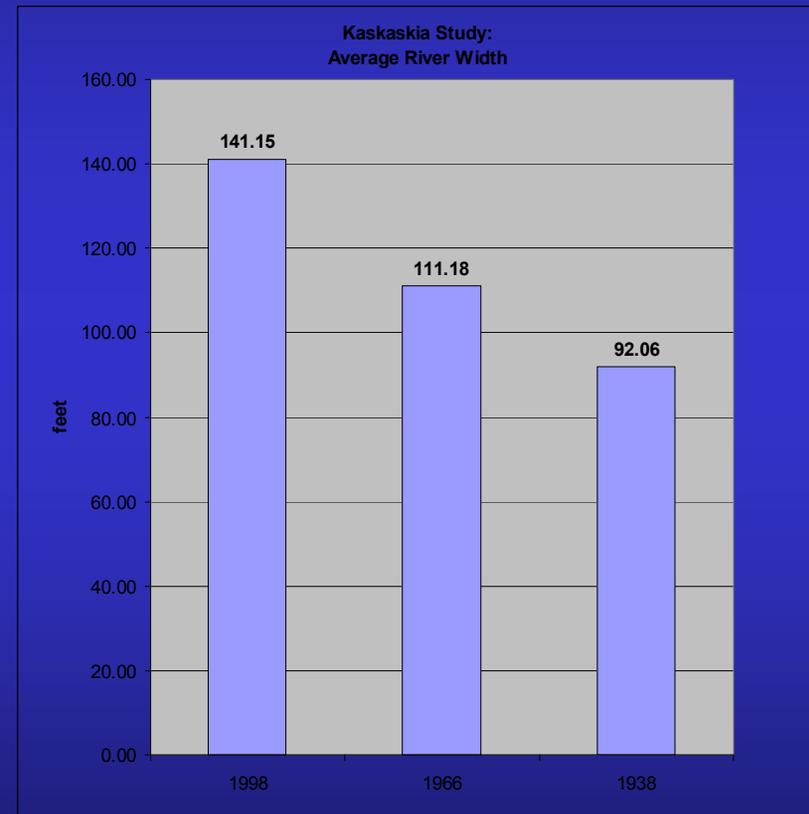
Average Channel Widths and Widening Rates

- The average channel width was approximately 92 ft in 1938, 111 ft in 1966, and 141 ft in 1998
- This resulted in an overall channel width increase of over 54% from 1938 to 1998
- The channel widened, on average of 0.8 ft/yr between 1938 and 1998
- Widening rate immediately downstream of Shelbyville Dam is the same as the average widening rate

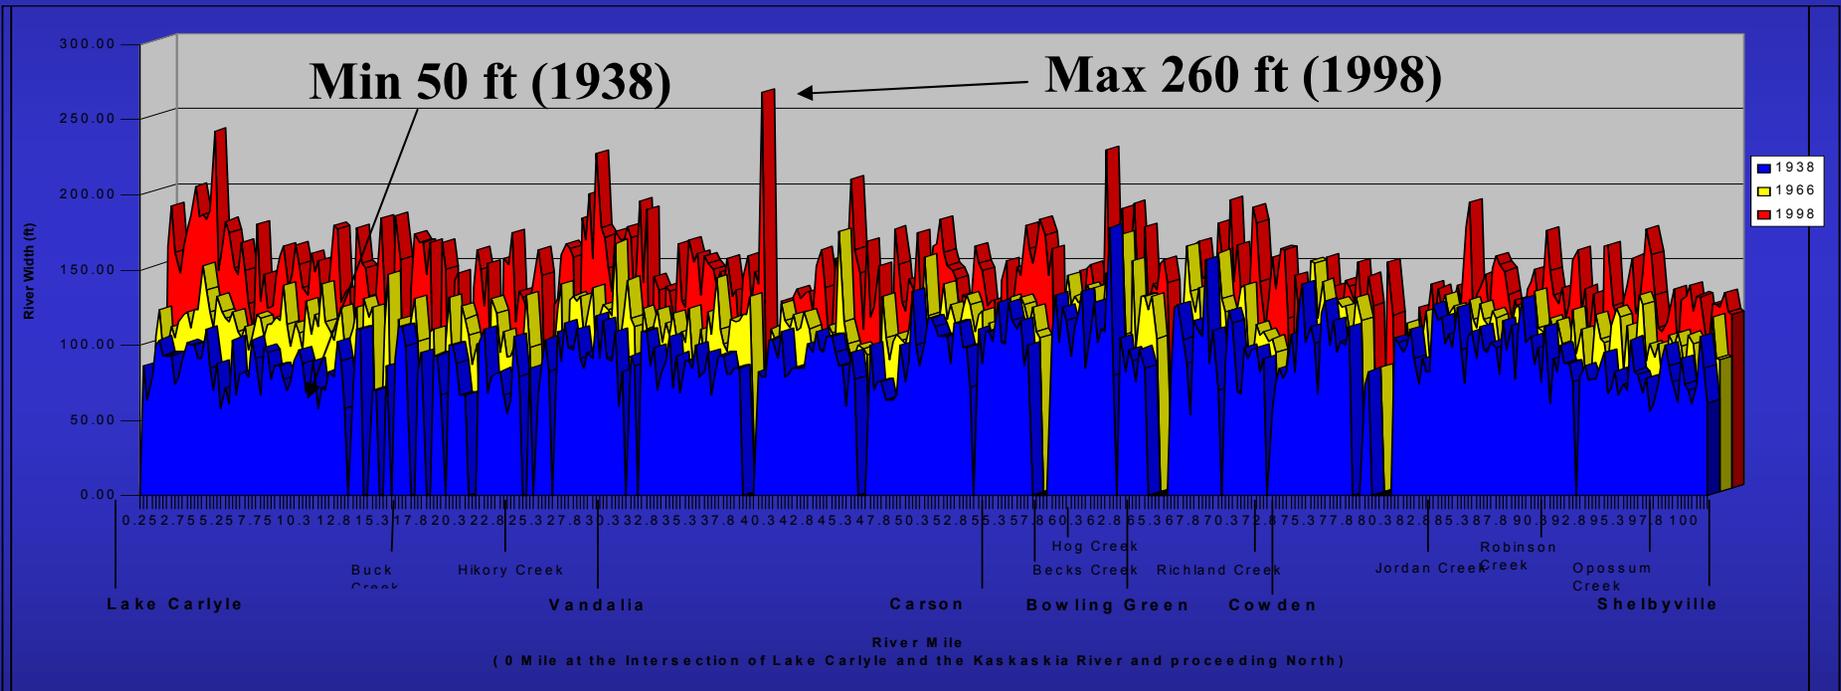
Channel Widths (1938, 1966, and 1998)

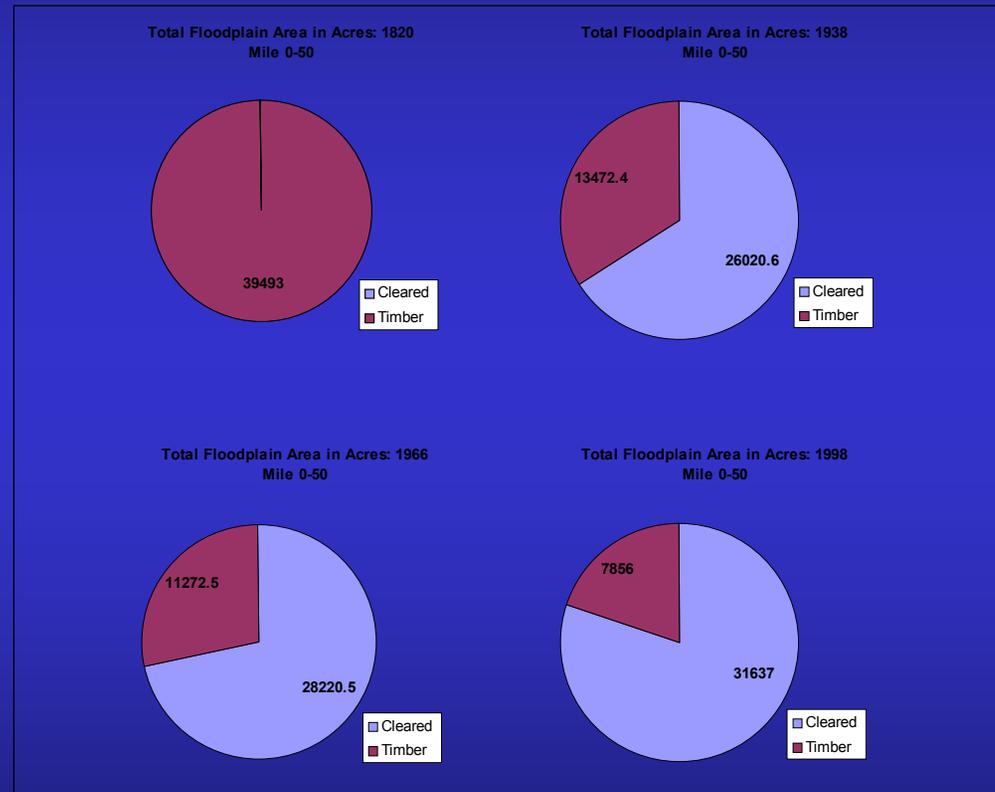
Land Use Change (River Miles 0-50)

- The total floodplain area between miles 0 and 50 was approximately 39,500 acres
- In 1820, 99.9 % of the floodplain was forested
- By 1998, 80% of the floodplain was cleared

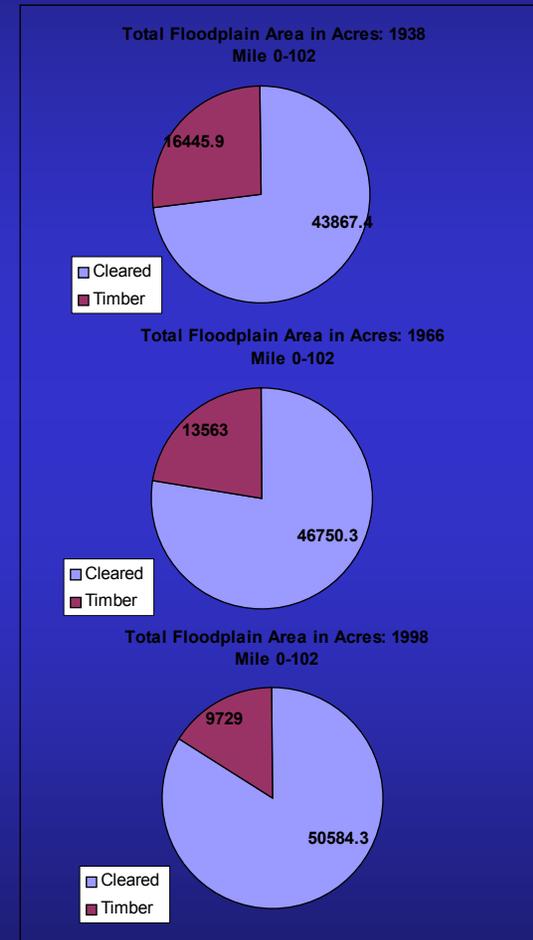
Land Use Change (Total Floodplain)

- The total floodplain area between miles 0 and 102 was measured as approximately 60,300 acres
- It was estimated that by 1966, 73% of the total floodplain was cleared and by 1998 over 84% was cleared

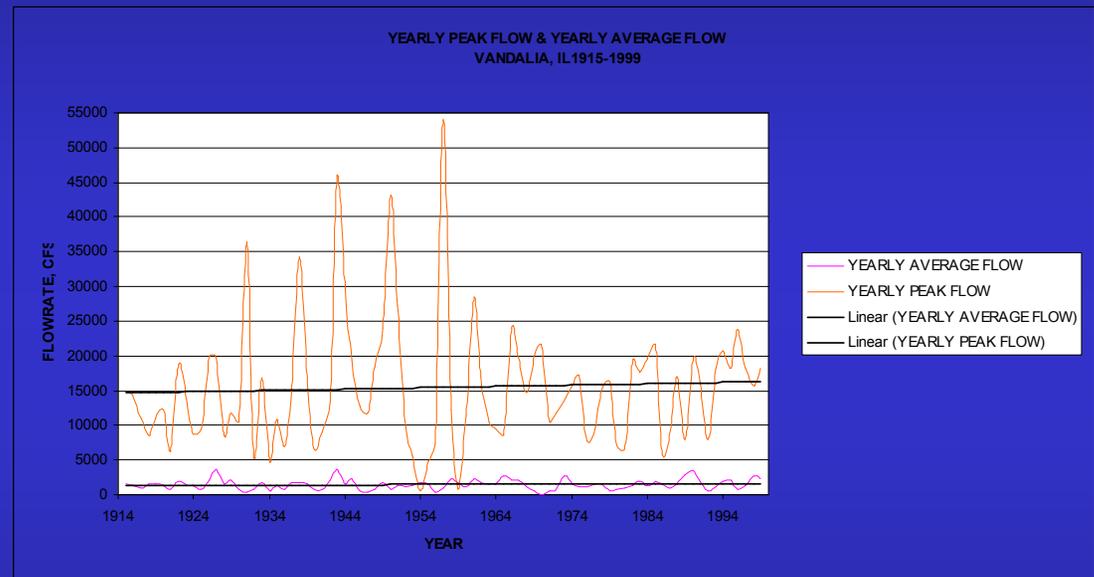
Historical Flow Trends

- Historical flow trends were examined at the Vandalia and Shelbyville gages
- Average annual flow rate increased 17% between the period 1972 to 1999 (1,841cfs) compared to the period 1842-1969 (1,532cfs)

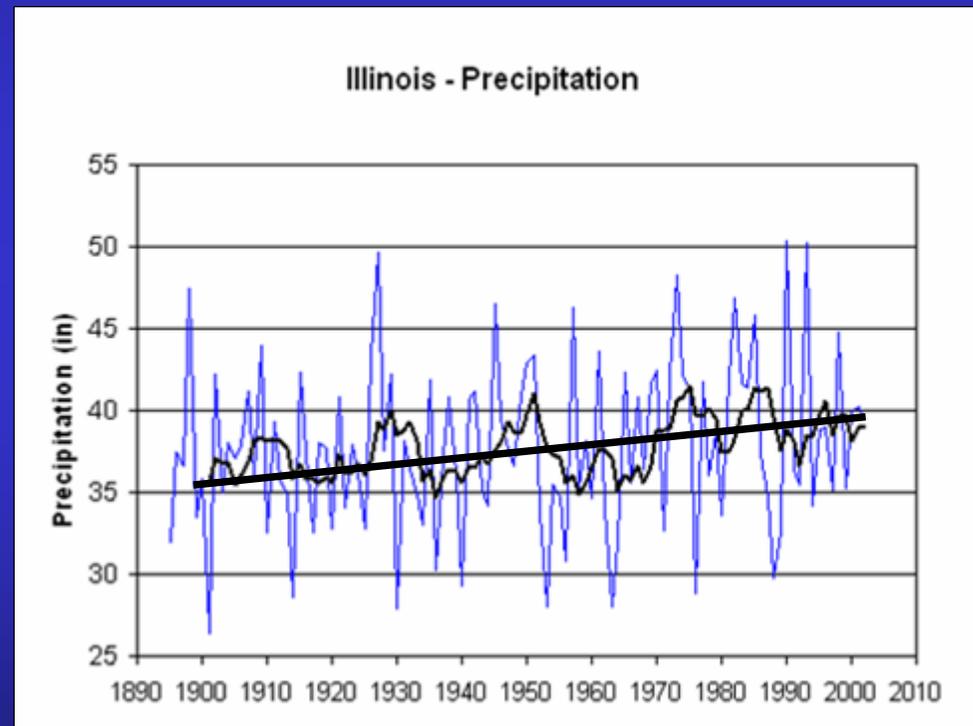
Historical Precipitation Trends

- Annual precipitation at Urbana, Illinois between 1900 and 2001
- Trend line indicates that the average annual rain fall is increasing

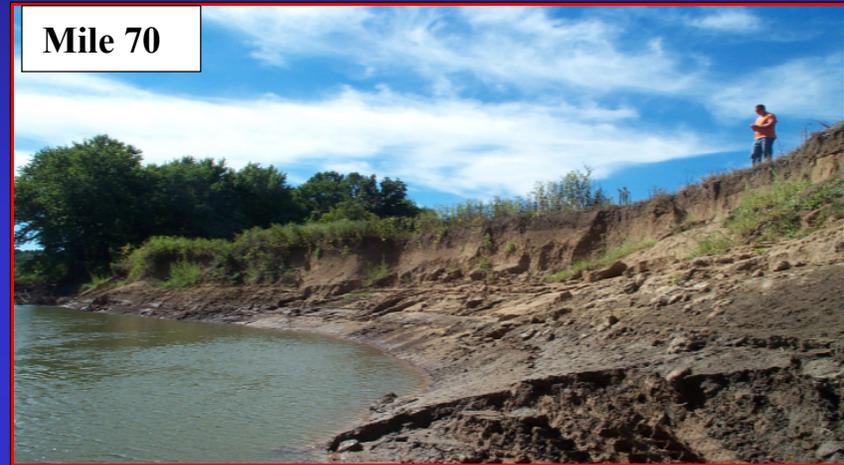
Mile 70

- **Bank erosion was prevalent throughout the study reach**
- **Most bend channels were actively eroding, containing vertical banks, large sand bars, downed trees and channel blockages**

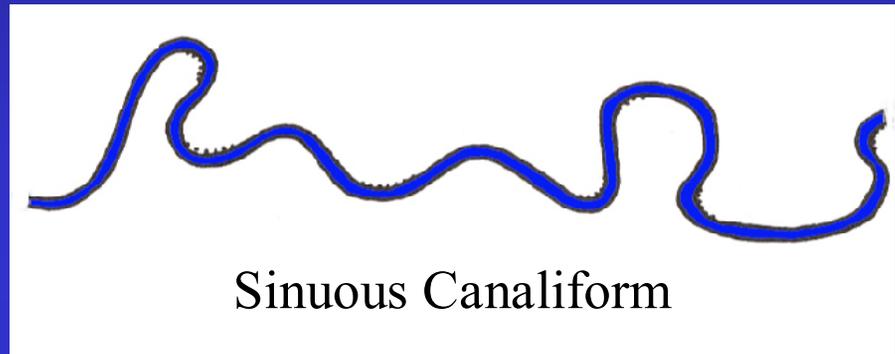
1938

- Due to the increased widening, decrease in sinuosity and reduction of the channels ability to transport sediment the channel is transforming

Sinuious Canaliform

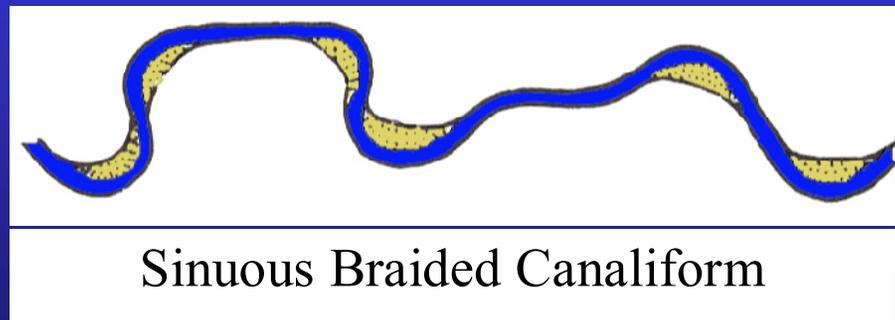
1998

Sinuious Braided Canaliform

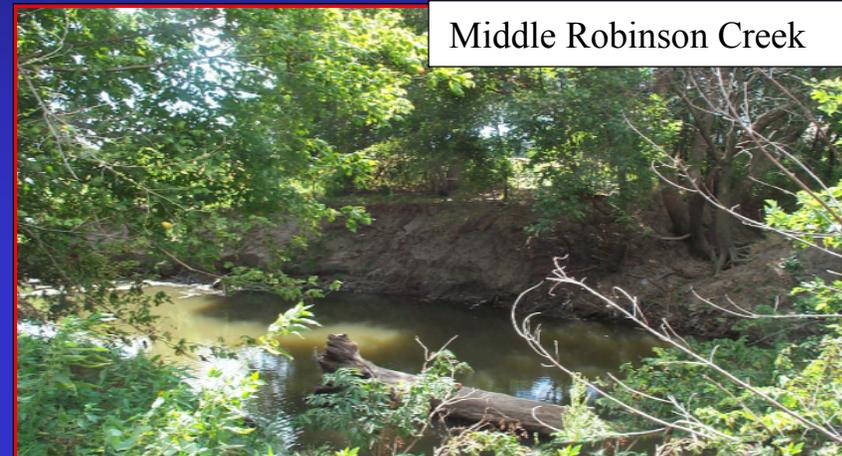
Middle Robinson Creek

- **Most of the tributaries have been channelized in the basin**
- **Headcutting has occurred along most of these channels, with widespread deposition of fine material**
- **The middle reaches of the tributaries have experienced moderate to sustainable bank erosion**

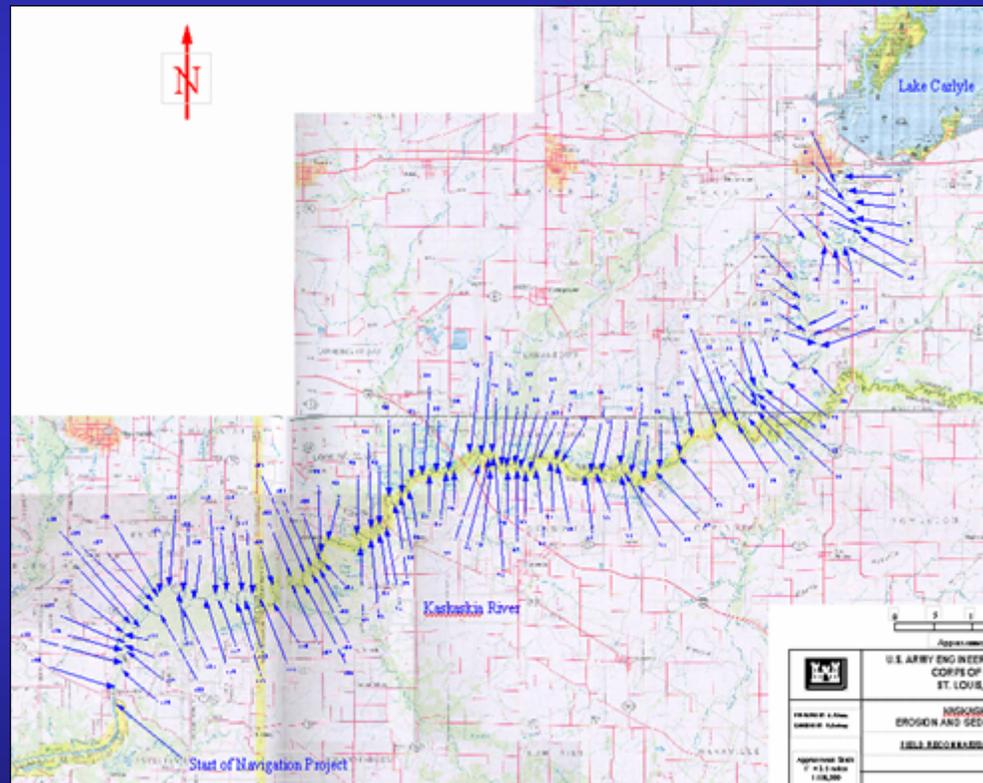
Carlyle Dam to Confluence of Mississippi

- Divided into three river regimes
- Drainage area of over 3,800 mi²
- Peak flow at Kasky Lock 50,300 cfs
- Analyzed over 130 bends

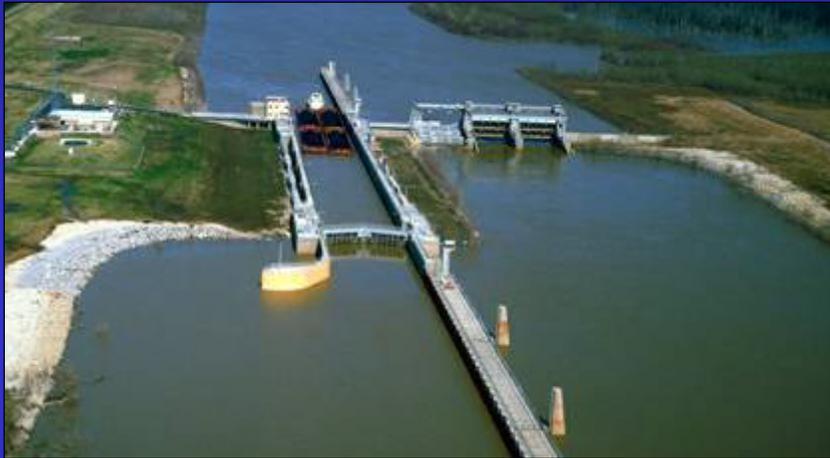
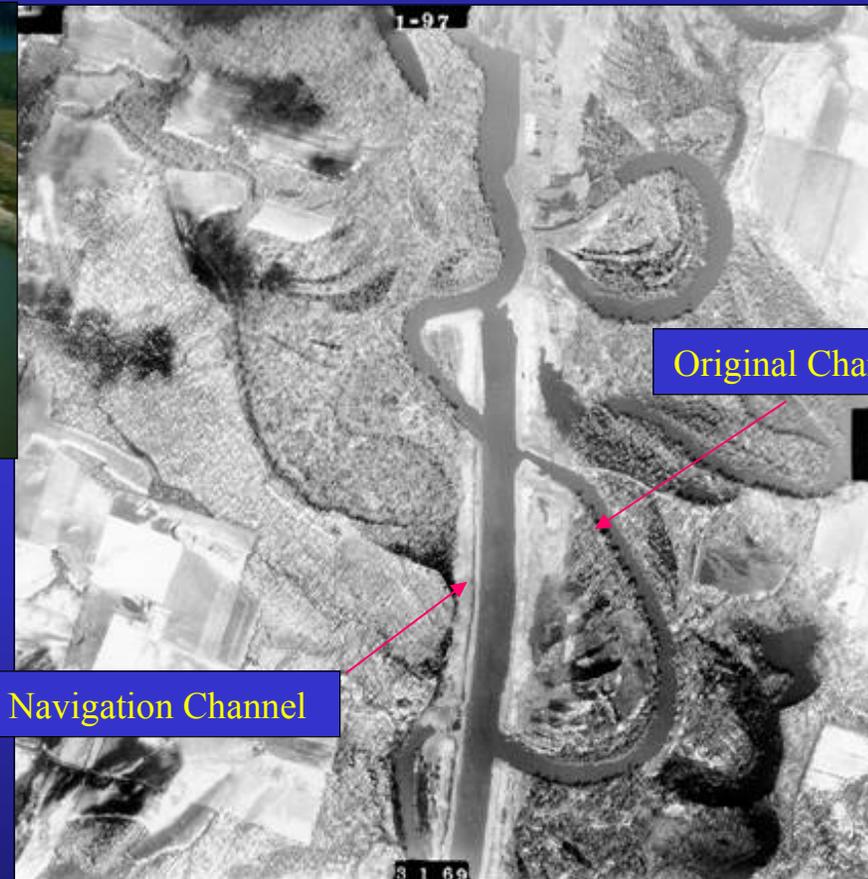
- The final excavation of the navigation channel was completed in 1972
- The lock and dam was completed in 1974

Original Channel

Navigation Channel

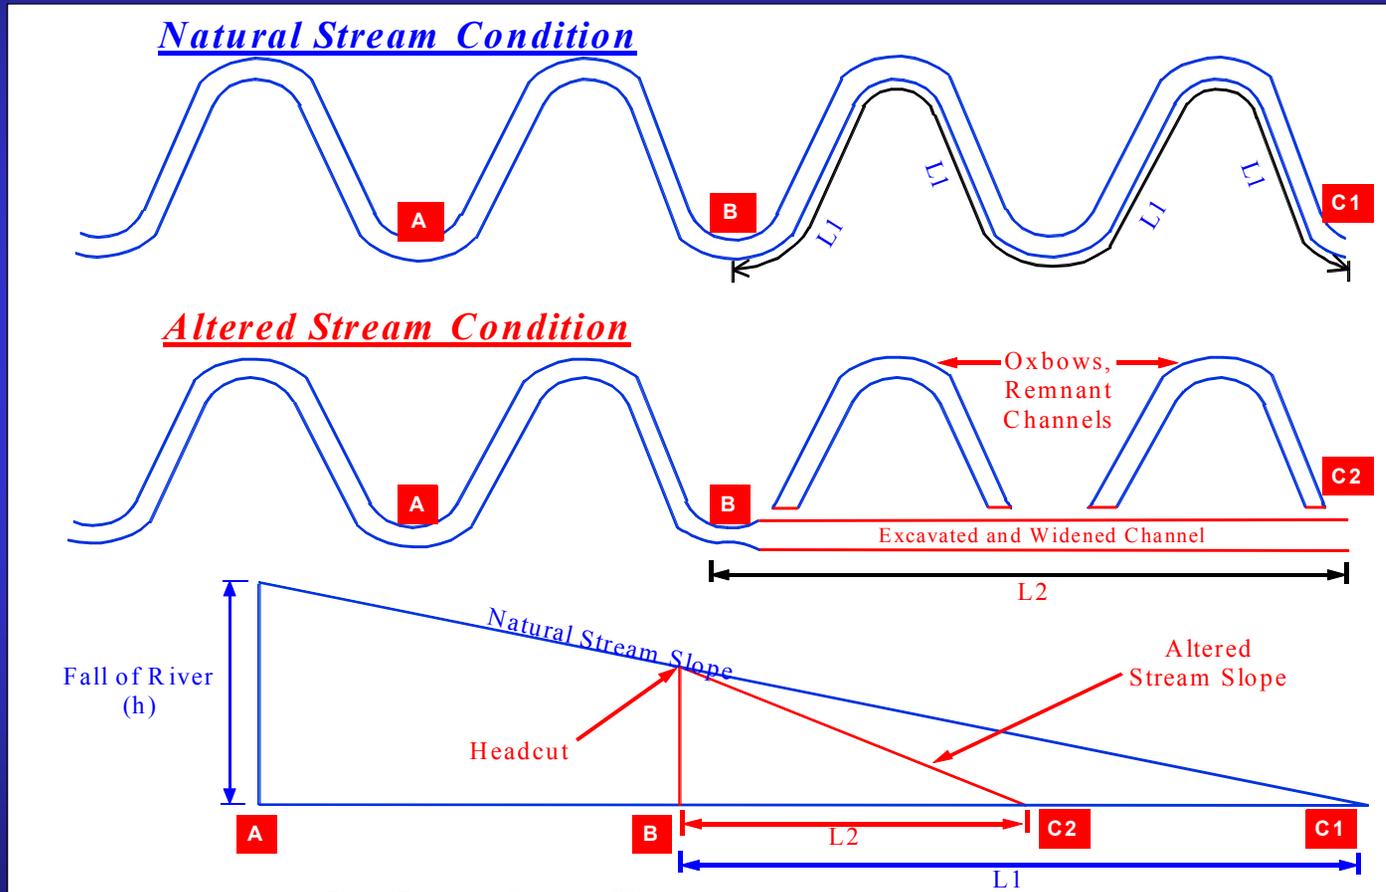
Common Effects of Channel Straightening

- Channelization of 36 miles, forming a 9 ft deep and 300 ft wide navigation channel (1972), overall reduction of 16 miles of channel length
- Channel straightening induced a destructive headcut near Fayetteville and moved upstream causing loss of private property and damage to the bottomland forest and aquatic habitat.
- The slope increased on average of 80% from 0.25 ft/mile to 0.45 ft/mile and width increased on average of 80% from 125 ft to 225 ft
- From 1972 to 1982 an estimated 2,500,000 yd³ deposited within 6 miles of the upper navigation reach between Fayetteville and New Athens
- In 1982 a grade control structure was built in Fayetteville at the upstream end of the navigation channel to eliminate the headcutting but the structure was unable to arrest the headcuts that had already moved upstream of the project reach.

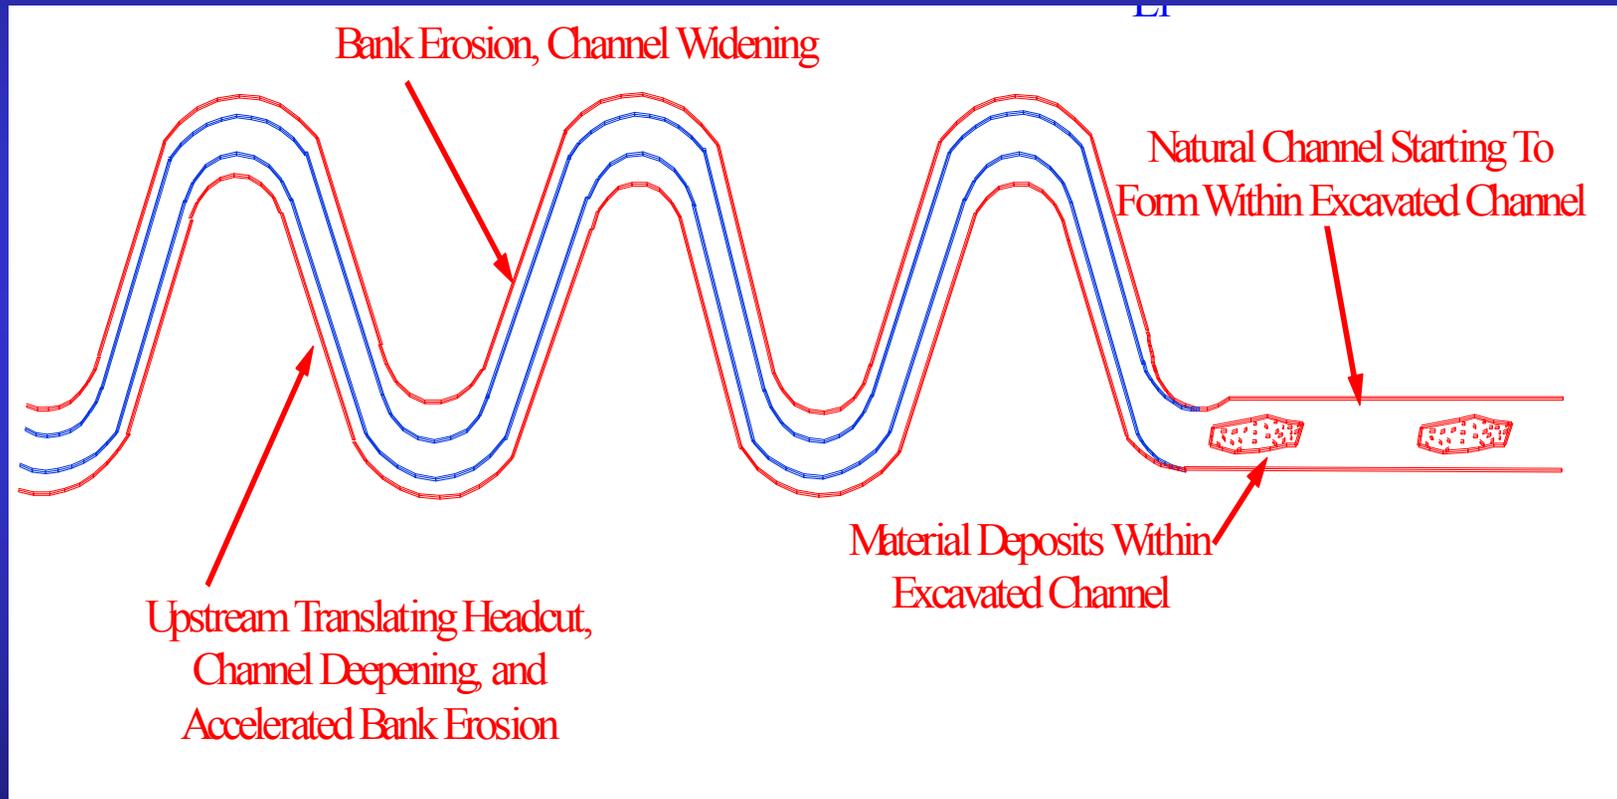
Results of Headcutting

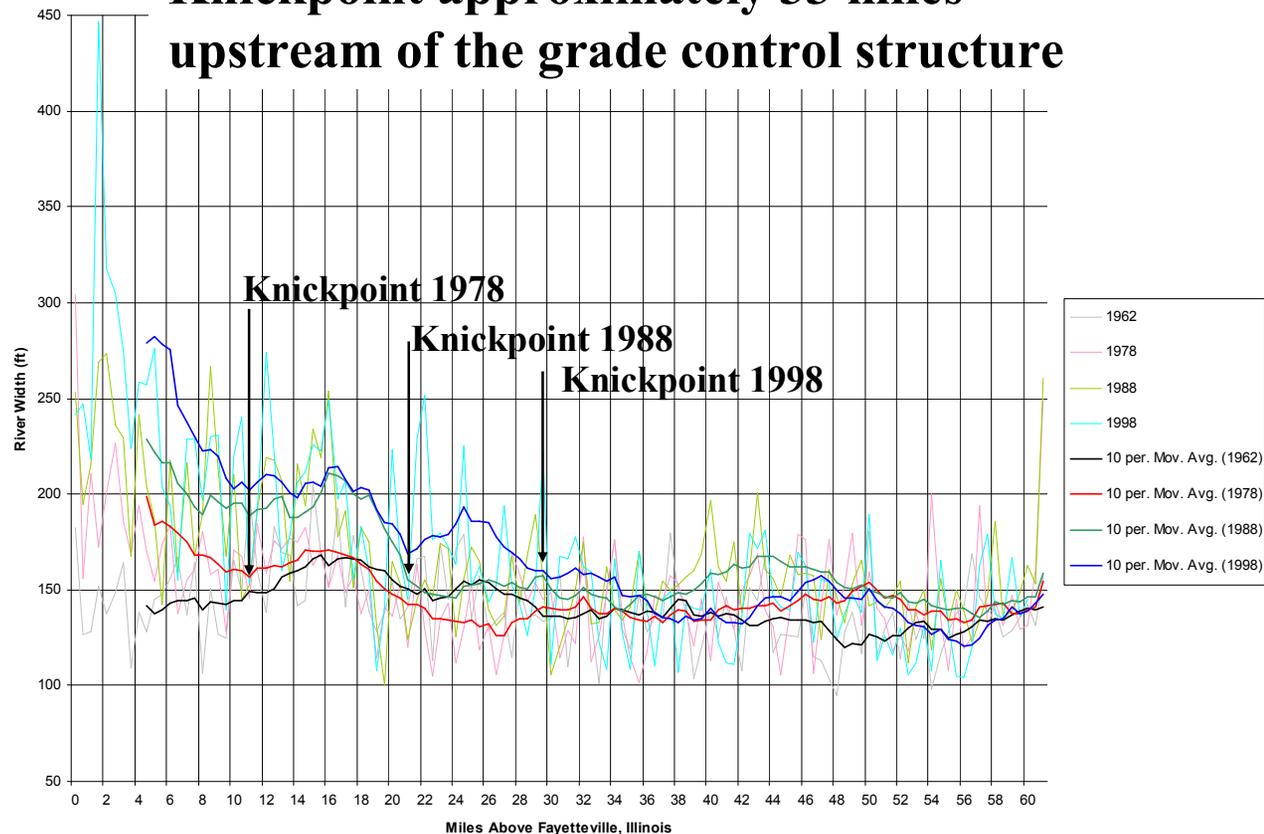
Knickpoint Location

**Knickpoint approximately 33 miles
upstream of the grade control structure**

- **Pattern – 1.44 to 2.10 sinuosity**
- **Dimension – 1962, 1978, 1988 and 1998 aeriels were analyzed and the widening rate ranged from 0.14ft/yr to 5ft/yr**
- **Profile – Degradation is occurring on the lower part of the study reach due to the headcut. The knickpoint is located approximately 33 miles above Fayetteville, upstream of this point there is no major degradation of the channel.**
- **The Carlyle Dam has no apparent effect on the stability of the channel. Bends were measured immediately downstream of the dam and no significant increase in bank erosion was evident. (Lane's Equation – discharge and load are on opposite sides of scale so they cancel each other out)**

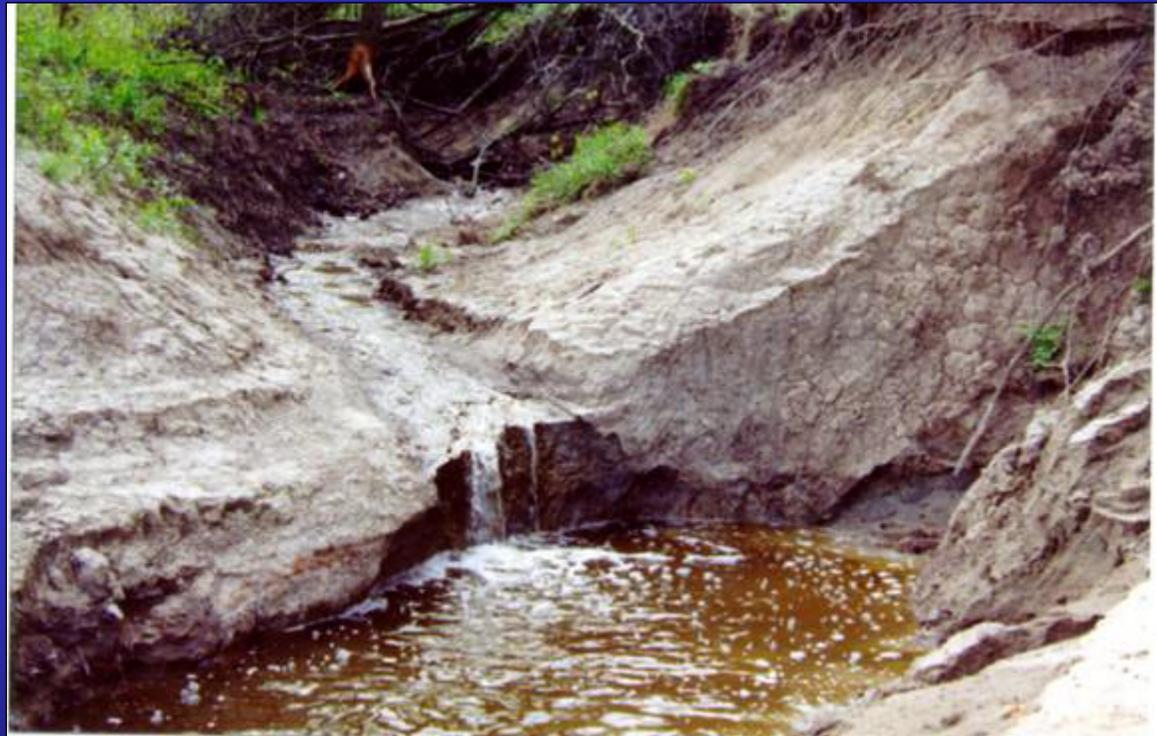
- **Headcuts are not isolated to the main channel, they adversely effect the entire system**

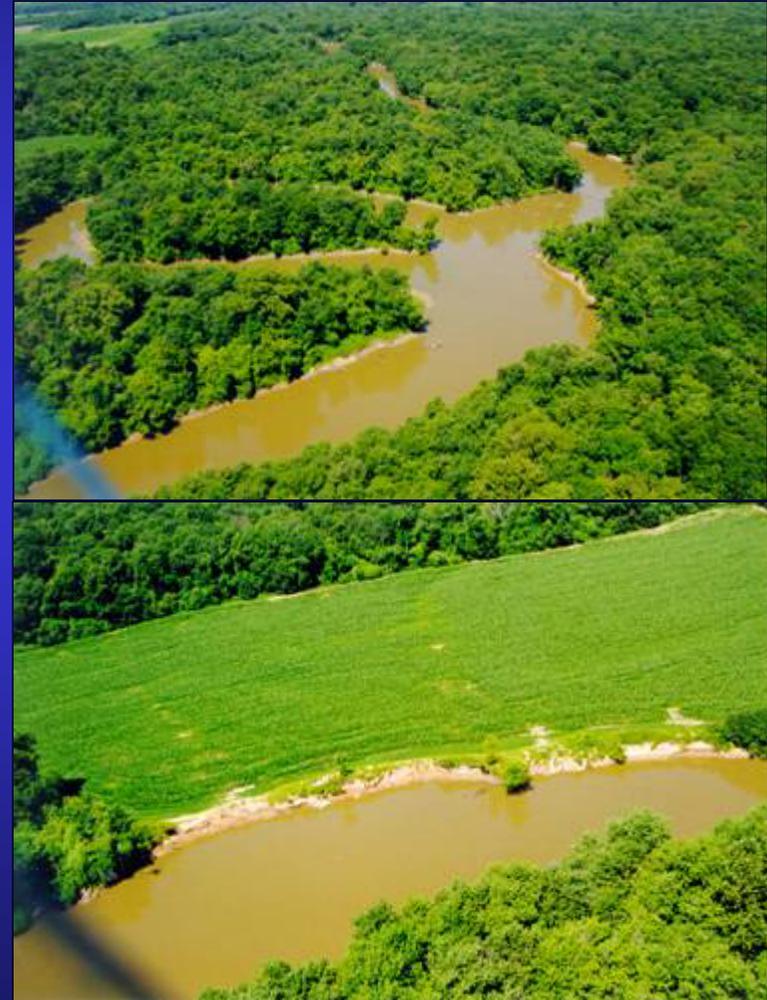
Regime One

- **Lake Carlyle to 7 miles downstream of Highway 160 (14 Miles Upstream of Fayetteville)**
- **Low to Moderate Traditional Bank Erosion**

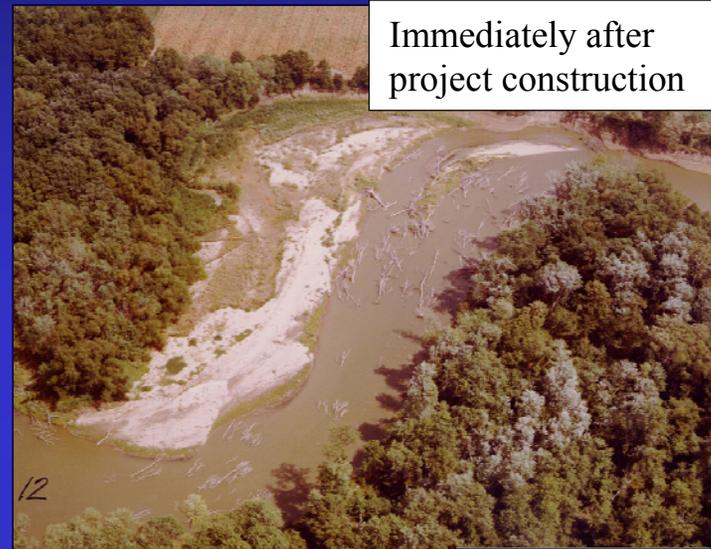
- 7 miles downstream of Highway 160 (14 Miles Upstream of Fayetteville) to approximately 2 miles below High Banks
- High Erosion, Channel Widening, Channel Downcutting, Loss of Bottomland Trees

Immediately after
project construction

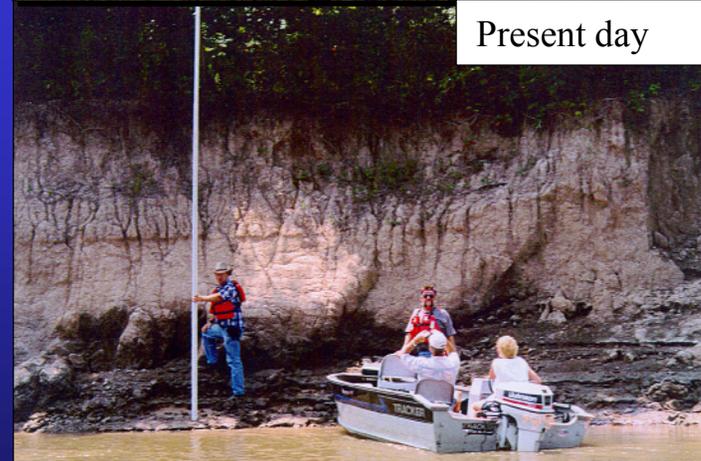
Present day

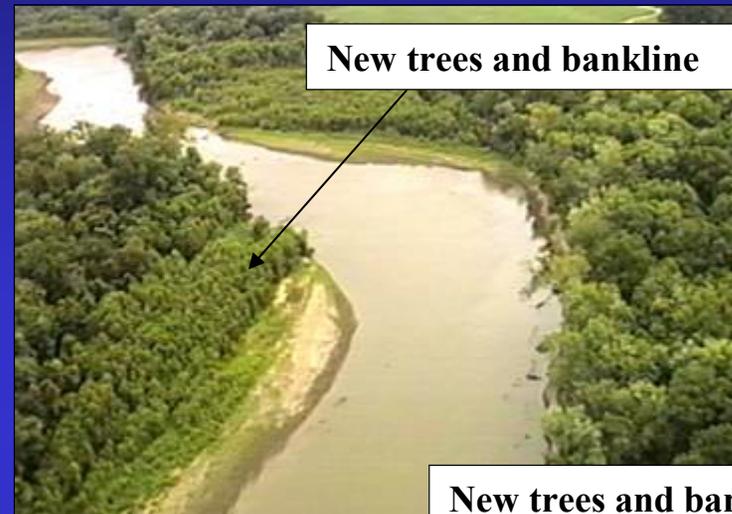
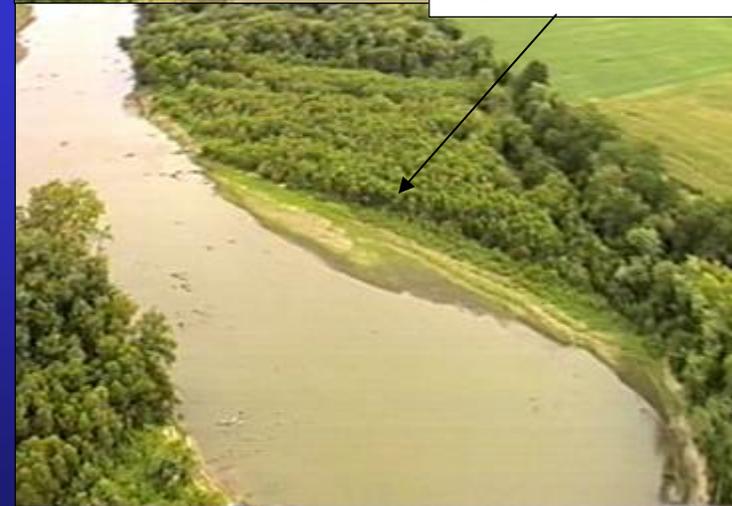
Regime Three

- 2 Miles Below High Banks to Fayetteville
- Dominant Sand Bar Formations, Development of Willows (Natural Healing)

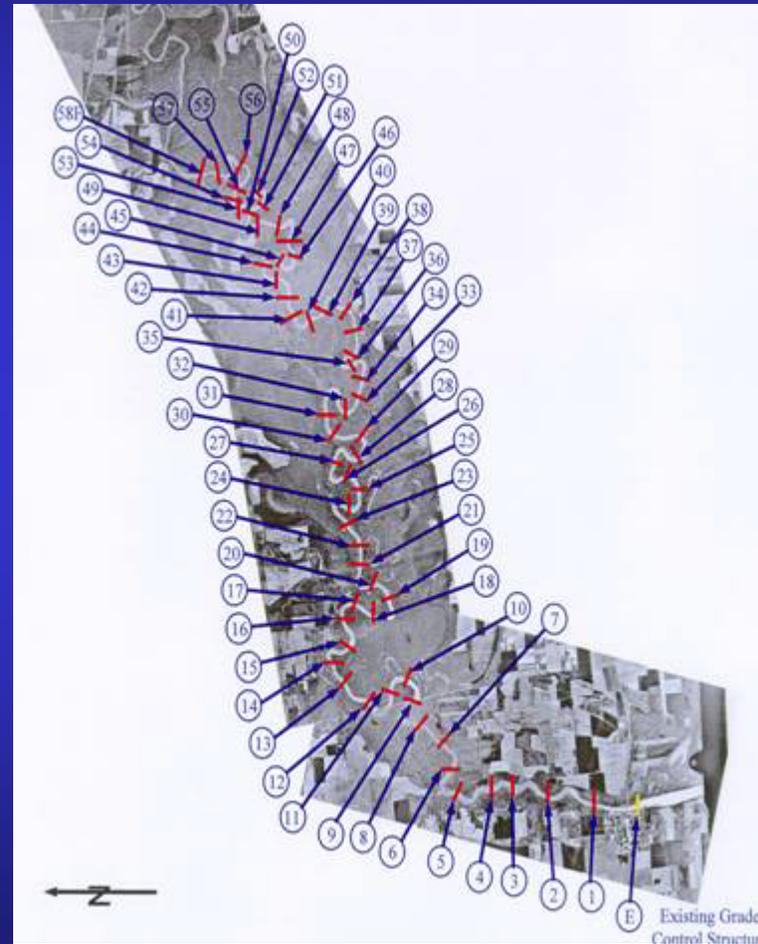
Grade Control Structures
