An Evaluation of Performance Measures for Prefabricated Submerged Concrete Breakwaters: Section 227 Cape May Point, New Jersey Demonstration Project

2.5 Year Results

Donald K Stauble - Engineer Research & Development Center,
Coastal and Hydraulics Laboratory

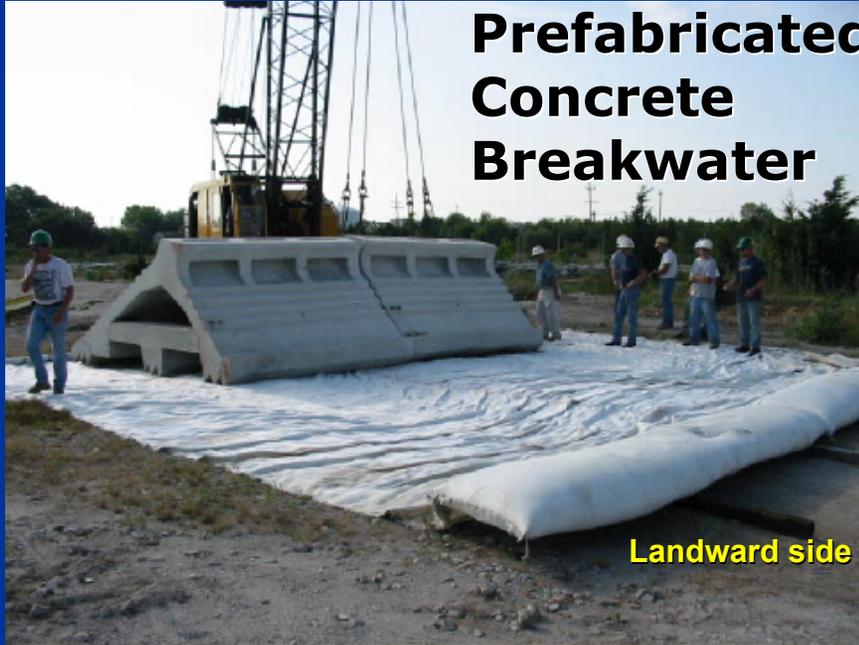
BEACHSAVER REEF

Prefabricated Concrete Breakwater

Landward side

Placed in ~ -9 ft NAVD of water
 ~ -2.7 m NAVD

Top of reef just below water line at Low water

Three reef units placed over each filter fabric scour prevention layer

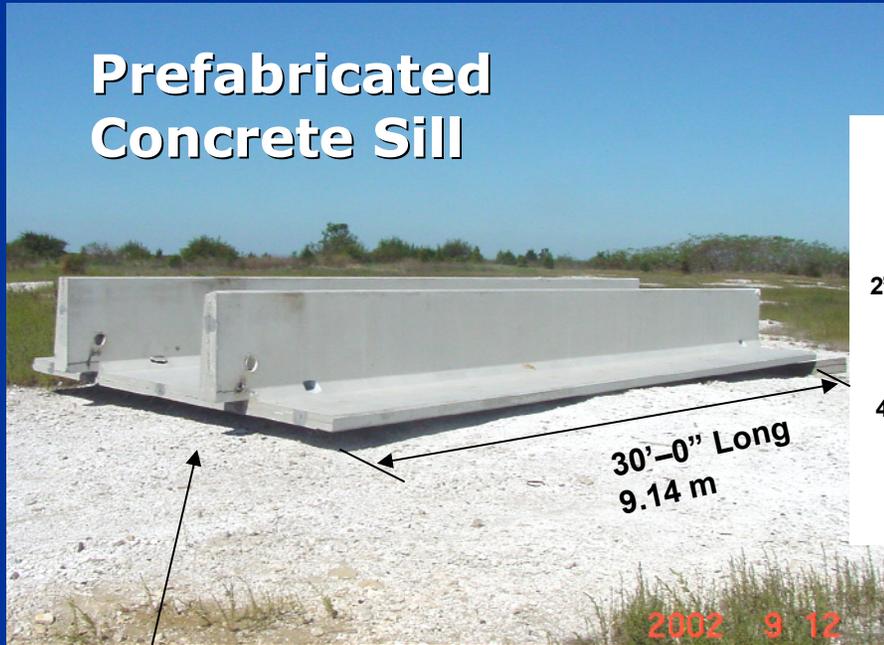
DOUBLE - T SILL

Prefabricated Concrete Sill

Units placed on sand (no filter cloth)
At ~ -9 ft NAVD w/ crest at -6 ft at low water
At ~ -2.7 m NAVD w/crest at -1.8 m at low water

Interlocking End

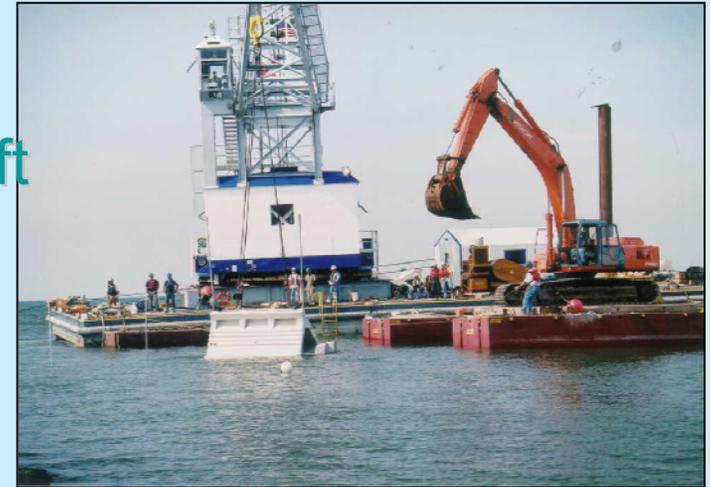
Beachsaver Reef – 16 Aug to 25 Sep 02

➤ 5 weeks @ cost of \$1,440/lf

72 10-ft-long units covering 720 ft

- Filter cloth installation
- Excavation and fill required
- Placement of units w/ diver

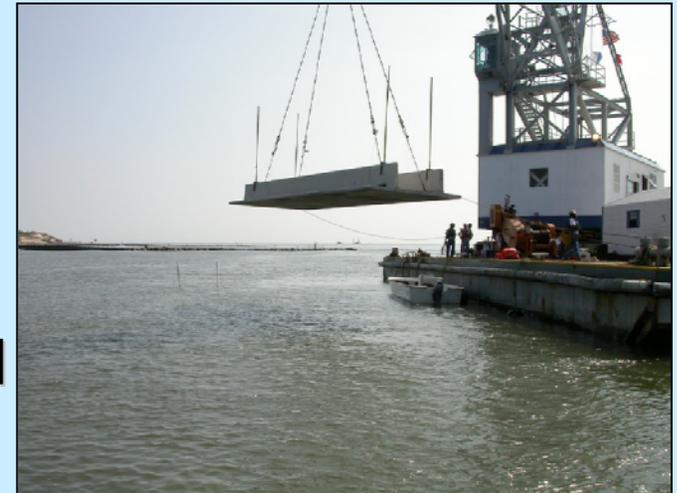
Double-T Sill – 26 Sep to 2 Oct 02

➤ 4 days @ cost of \$345/lf

22 30-ft-long units covering 660 ft

- NO Filter cloth installation
- Excavation and fill NOT required
- Placement of units w/ diver

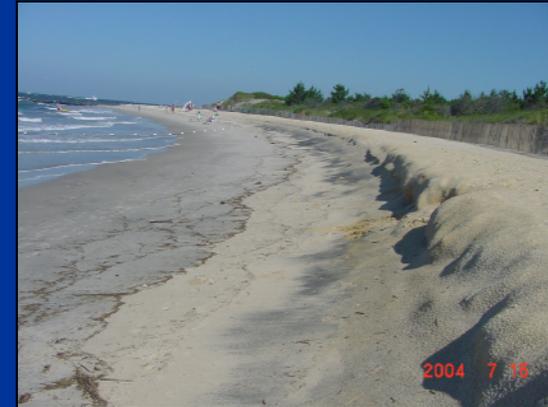
4 months later

Post-fill: -16 ft shoreline retreat
48% volume remaining

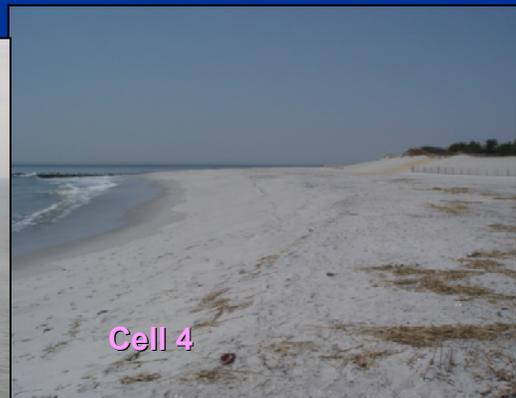
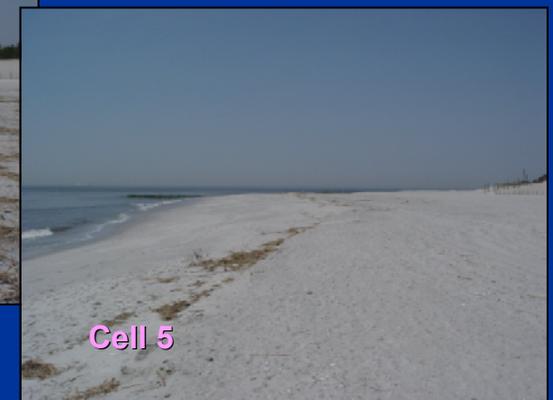
4 months later

Post-fill: +7 ft to -42 ft shoreline gain/retreat
100% to 79% volume remaining

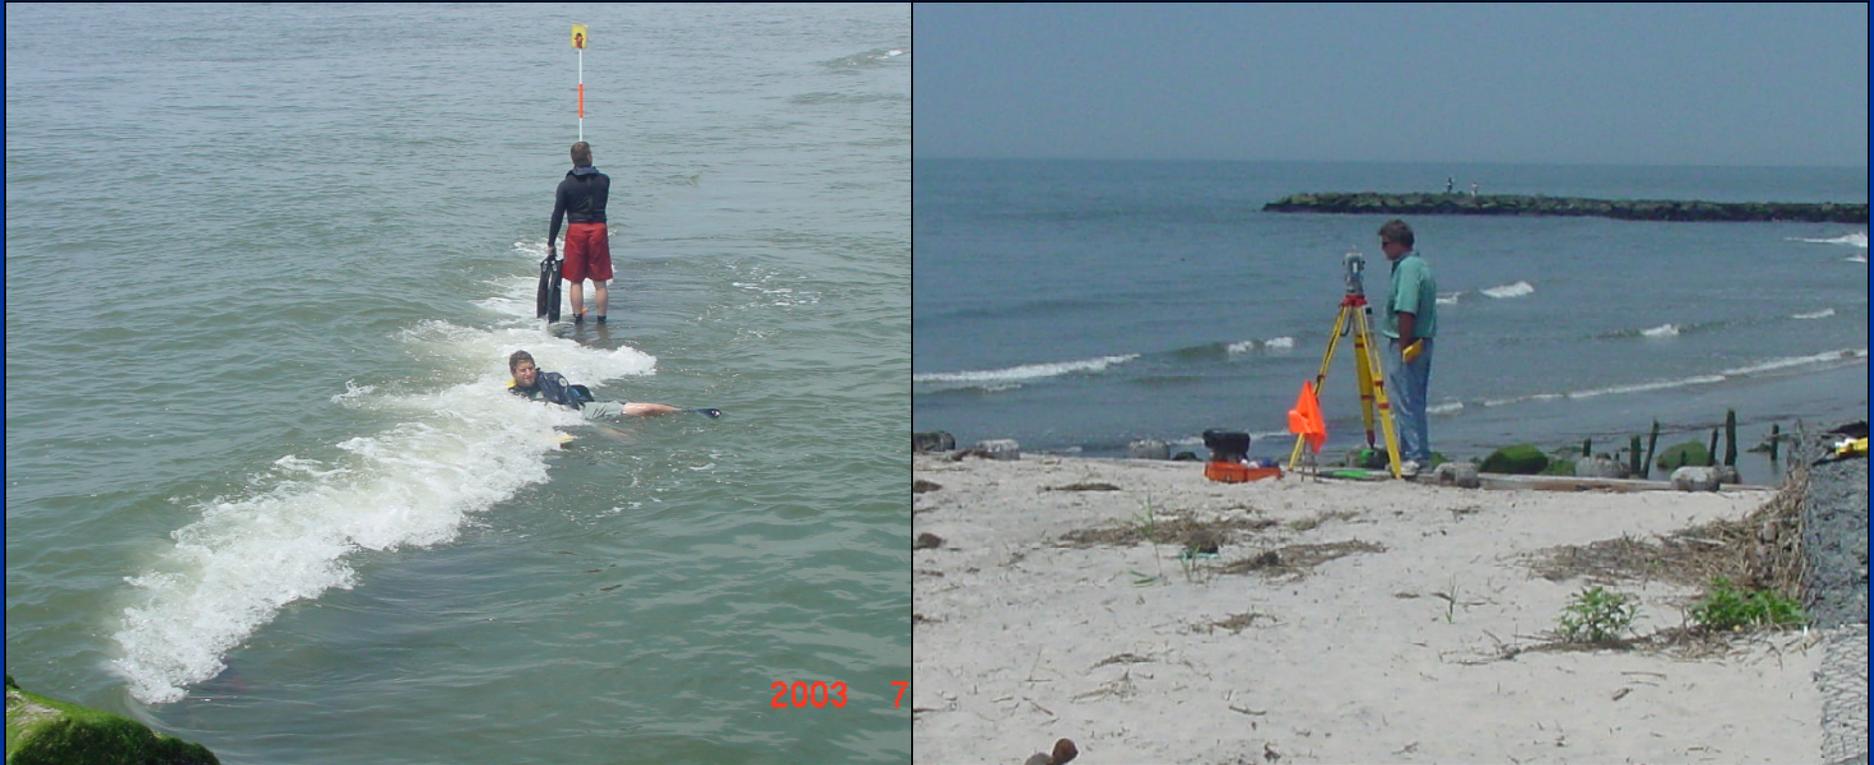
STRUCTURAL PERFORMANCE – Structural Stability

Measure Crest Elevations of Both Structures w/ Total Station to determine:

- Change in Structure Crest Elevation
- Alongshore Integrity
- Depth of Scour
