# **Design, Construction and Seepage at Prado Dam**

**Douglas E. Chitwood, P.E., G.E.  
Embankment Engineer, Prado Dam**

# Prado Dam

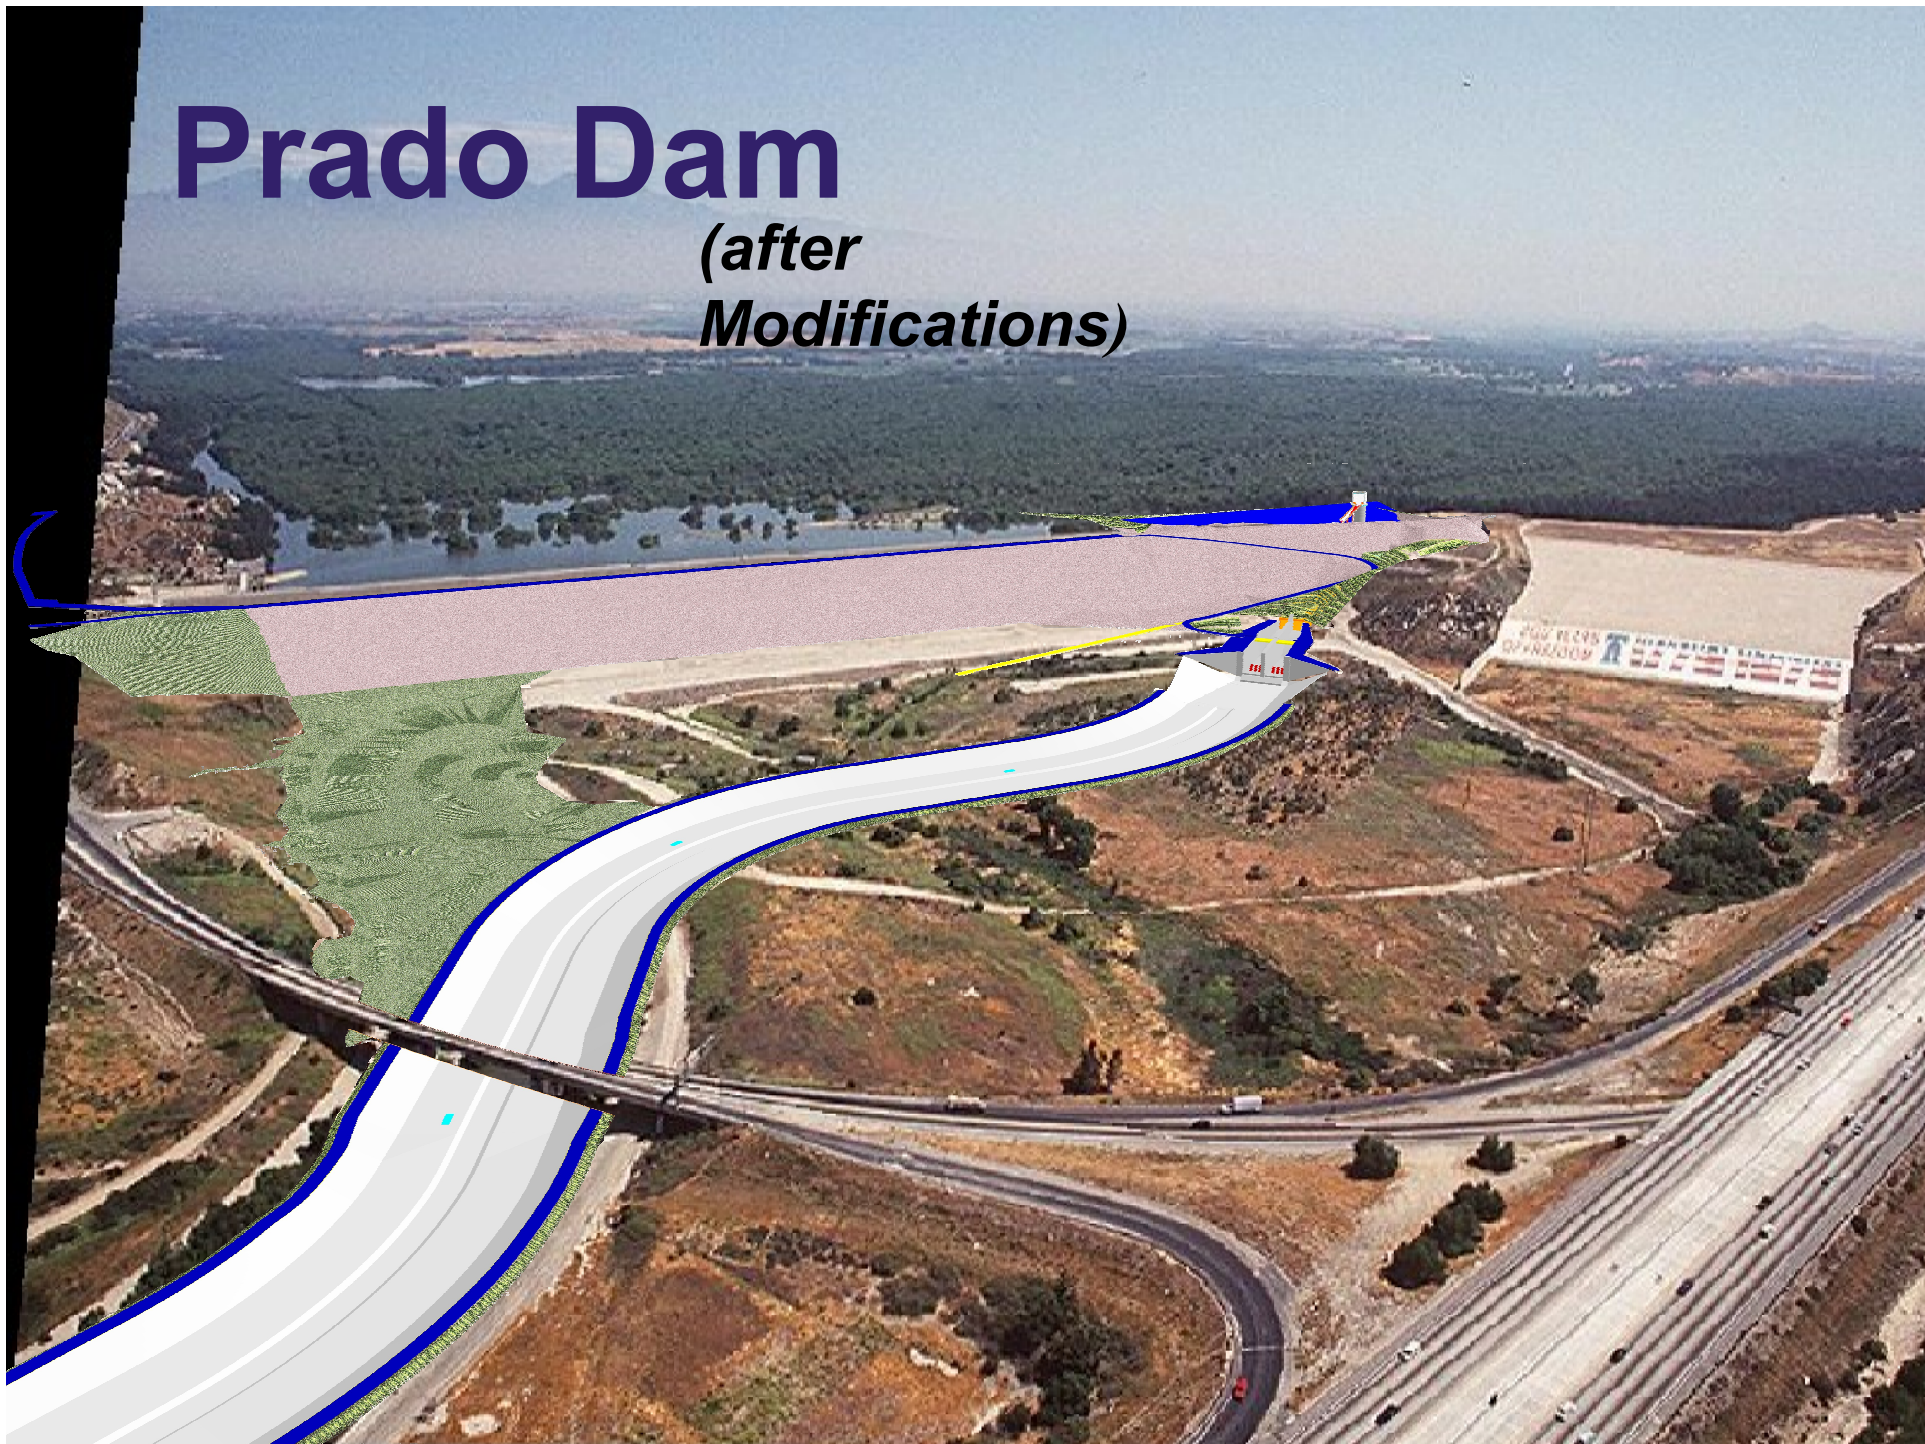
*(after  
Modifications)*

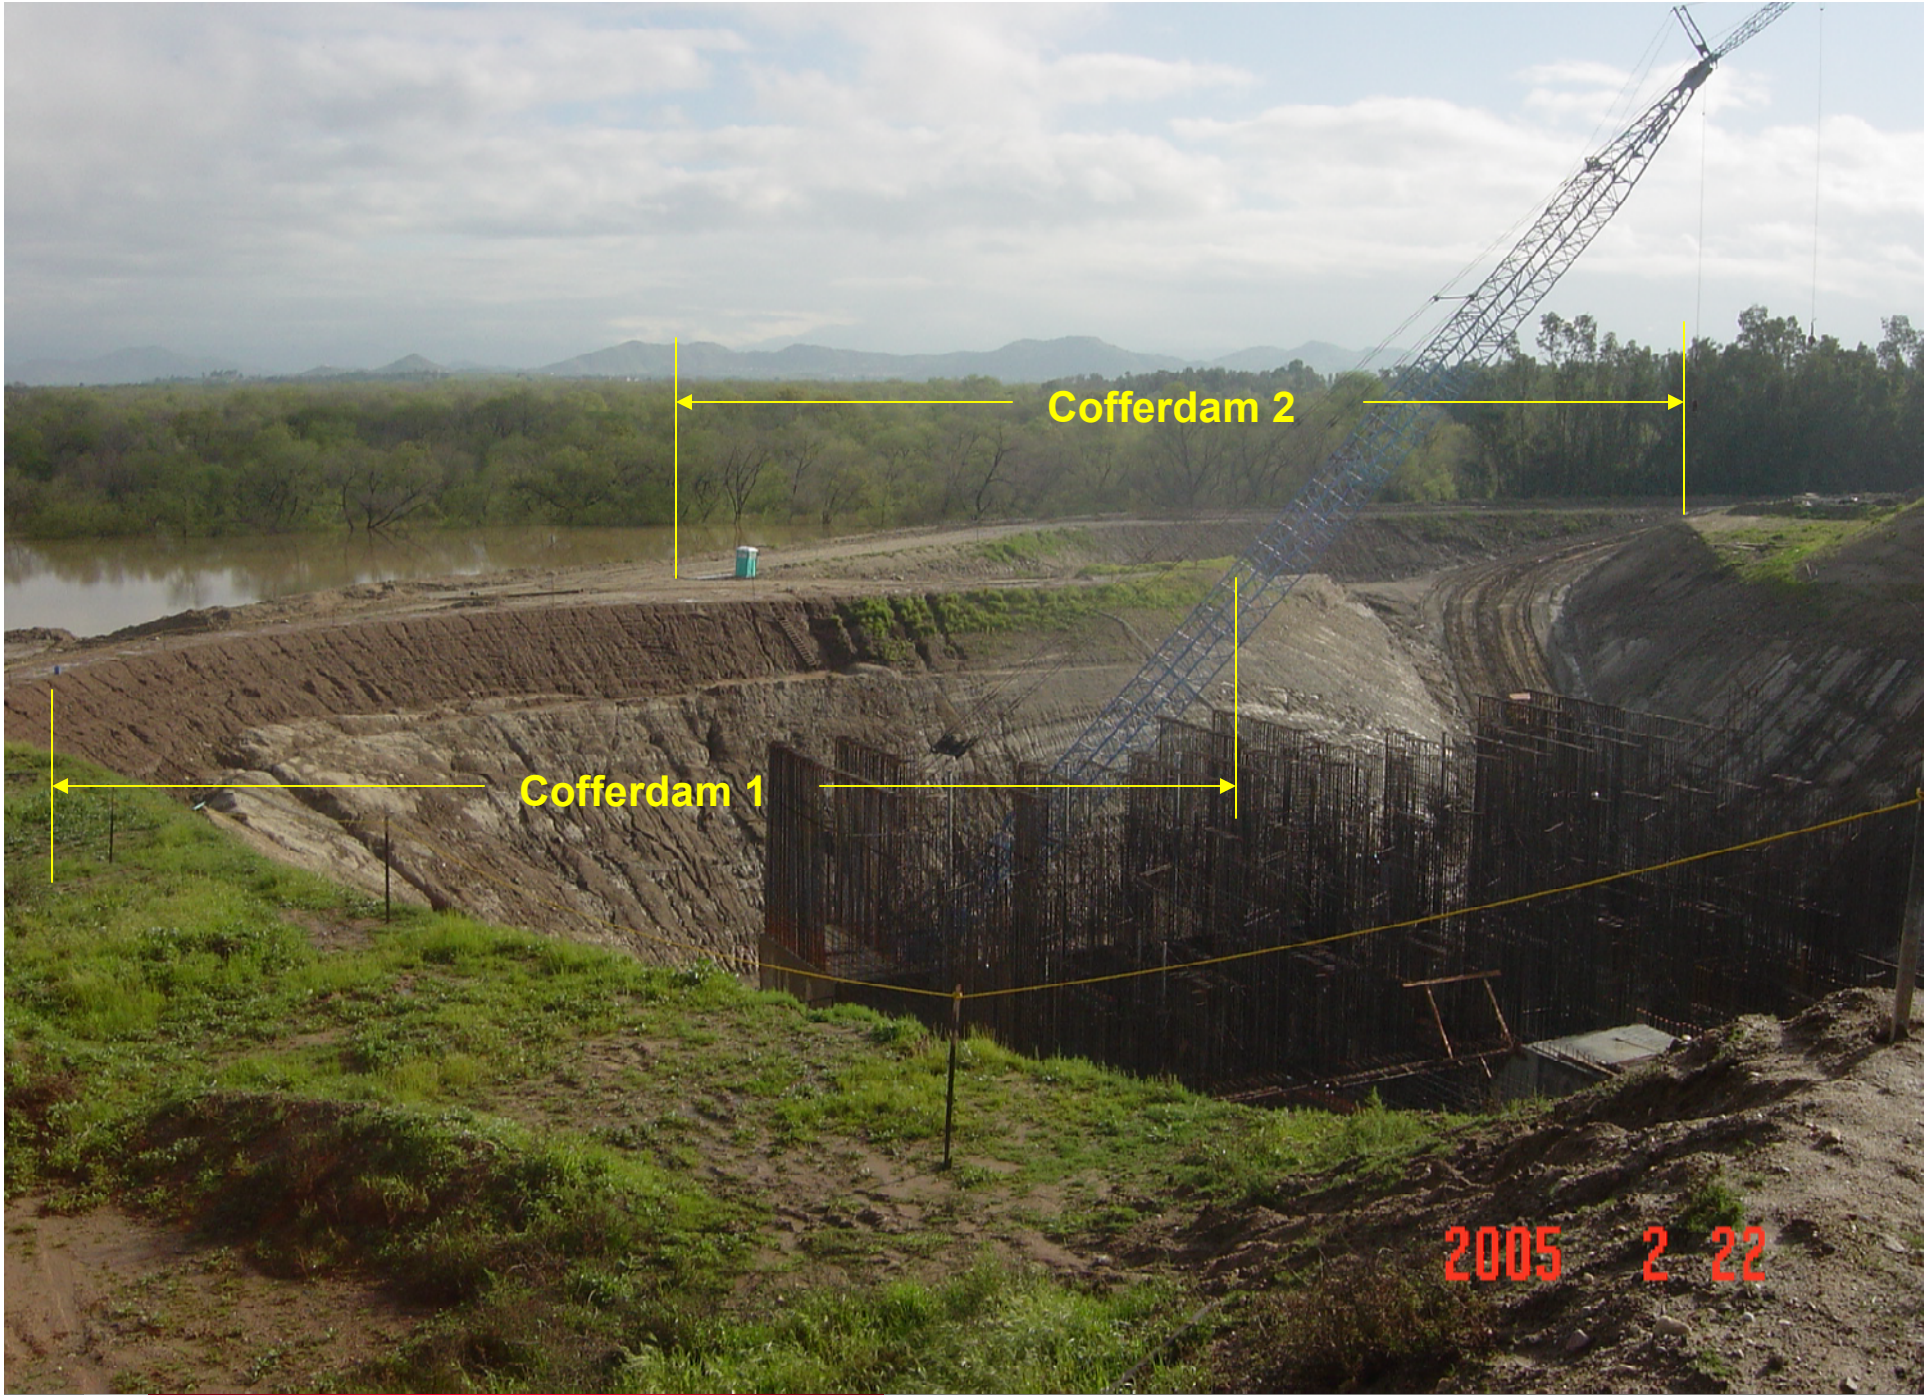
Cofferdam 2

Cofferdam 1

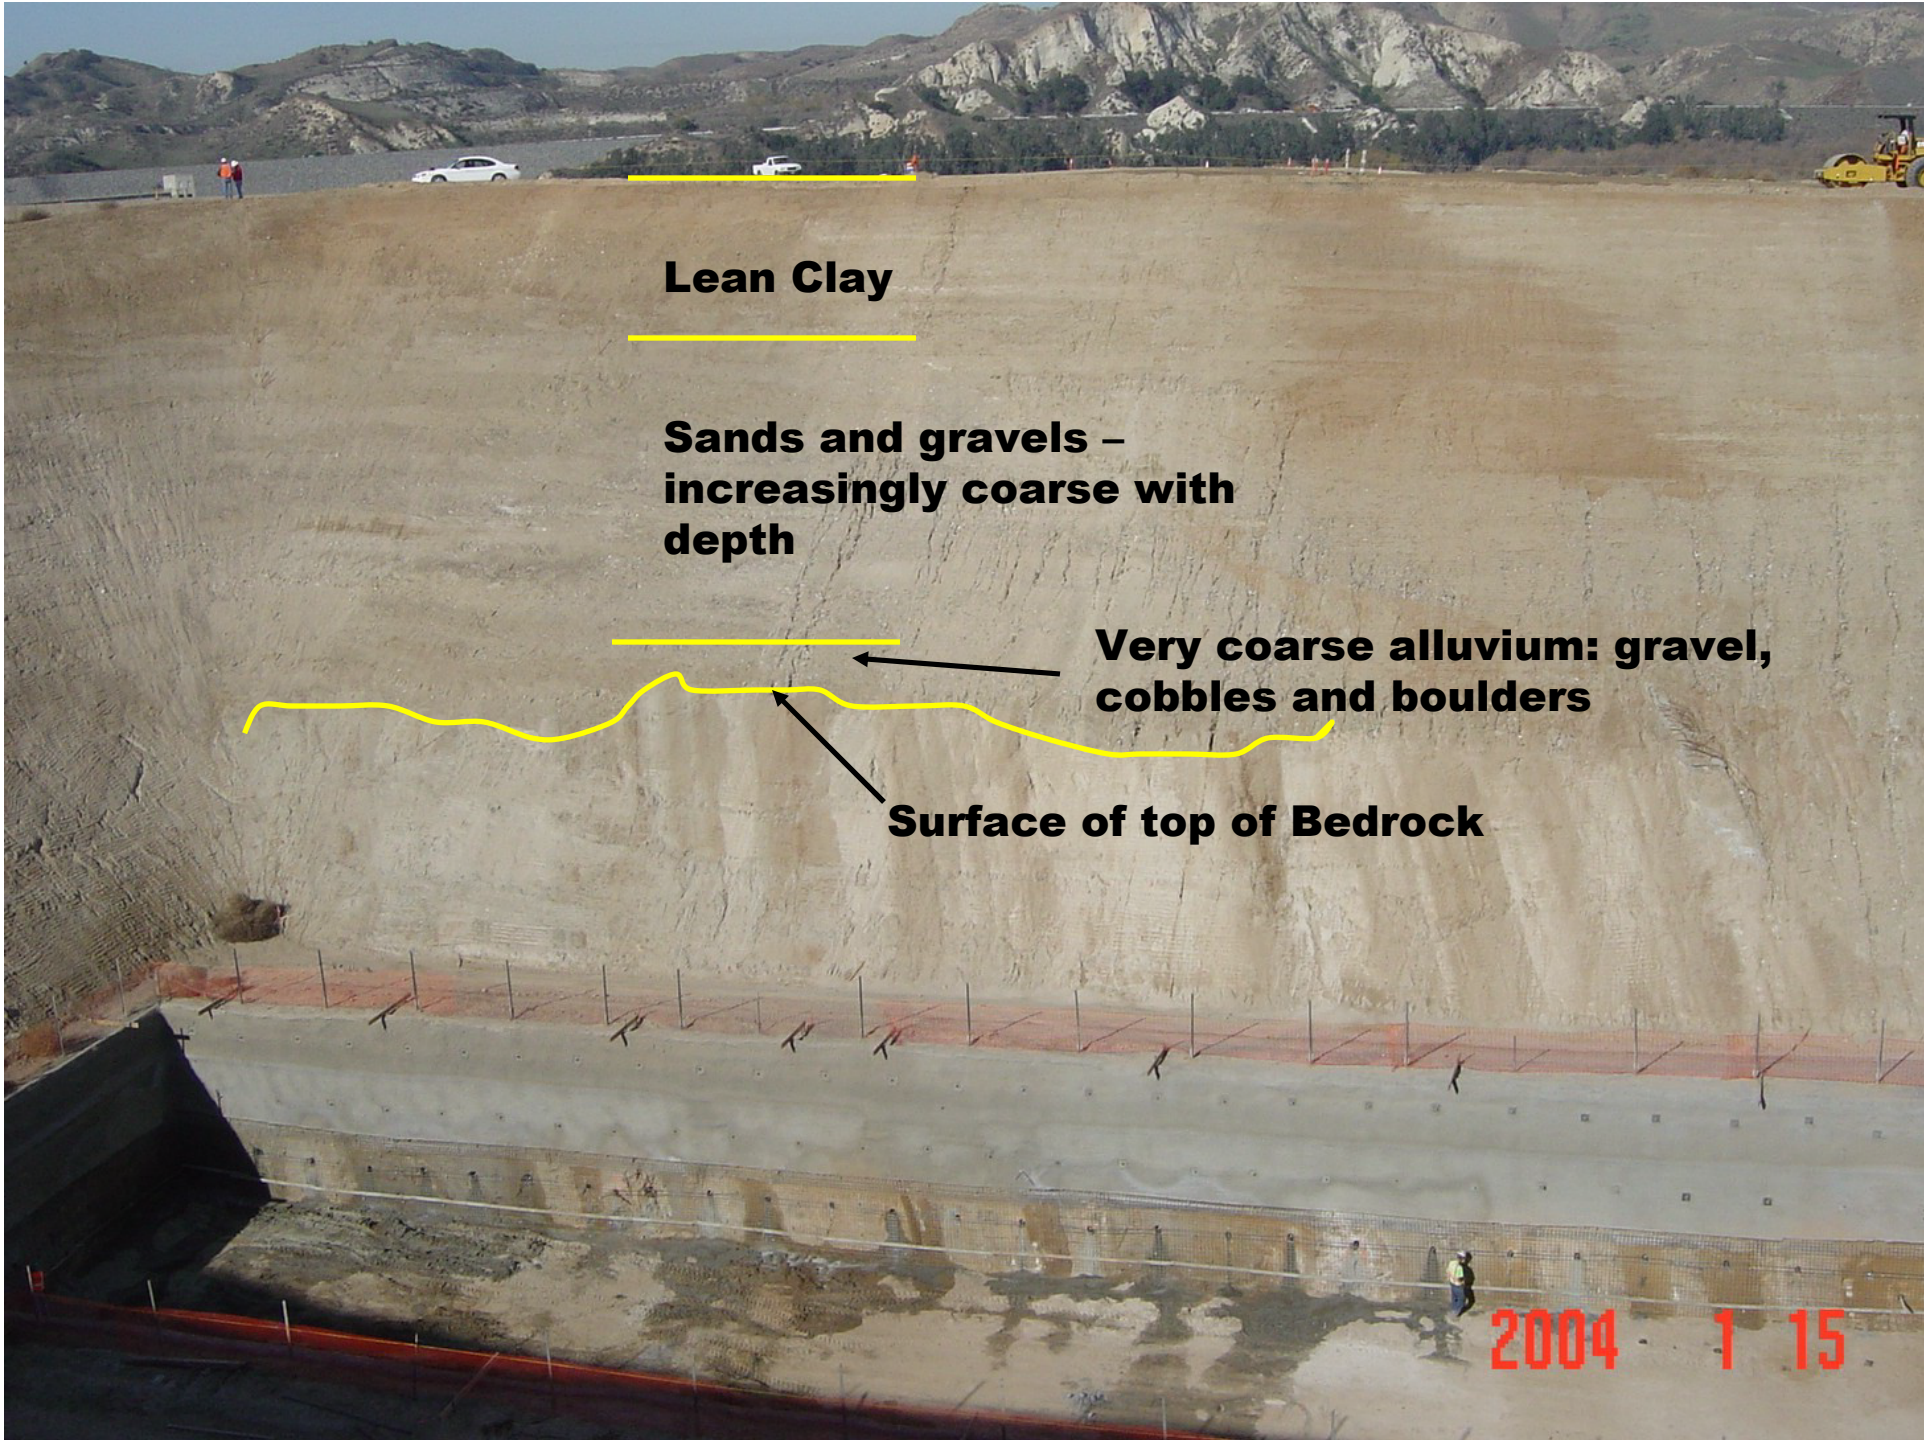
**Lean Clay**

**Sands and gravels –  
increasingly coarse with  
depth**

**Very coarse alluvium: gravel,  
cobbles and boulders**

**Surface of top of Bedrock**

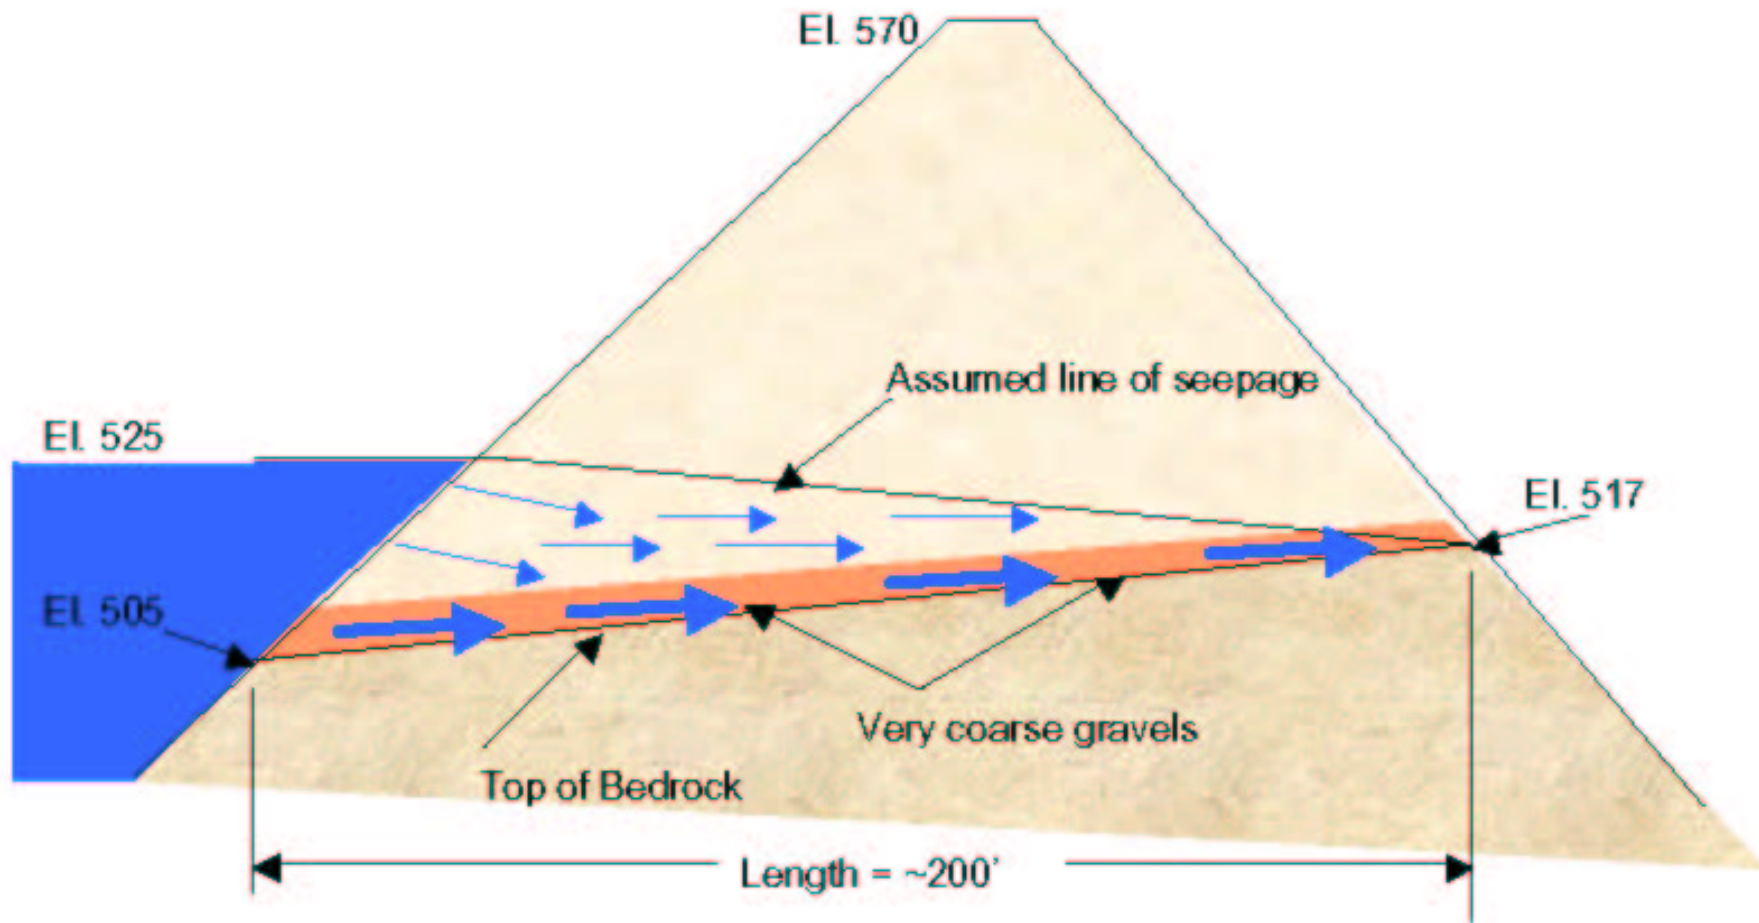
# Cross-Section through Thinnest Section of Left Abutment

**A stability analysis was conducted by the Los Angeles District Geotechnical Group on the “Thin Section” in December 2003. Among other things, the reported concluded:**

**“Catastrophic failure due to seepage will not occur as gradient would be much less than critical”**

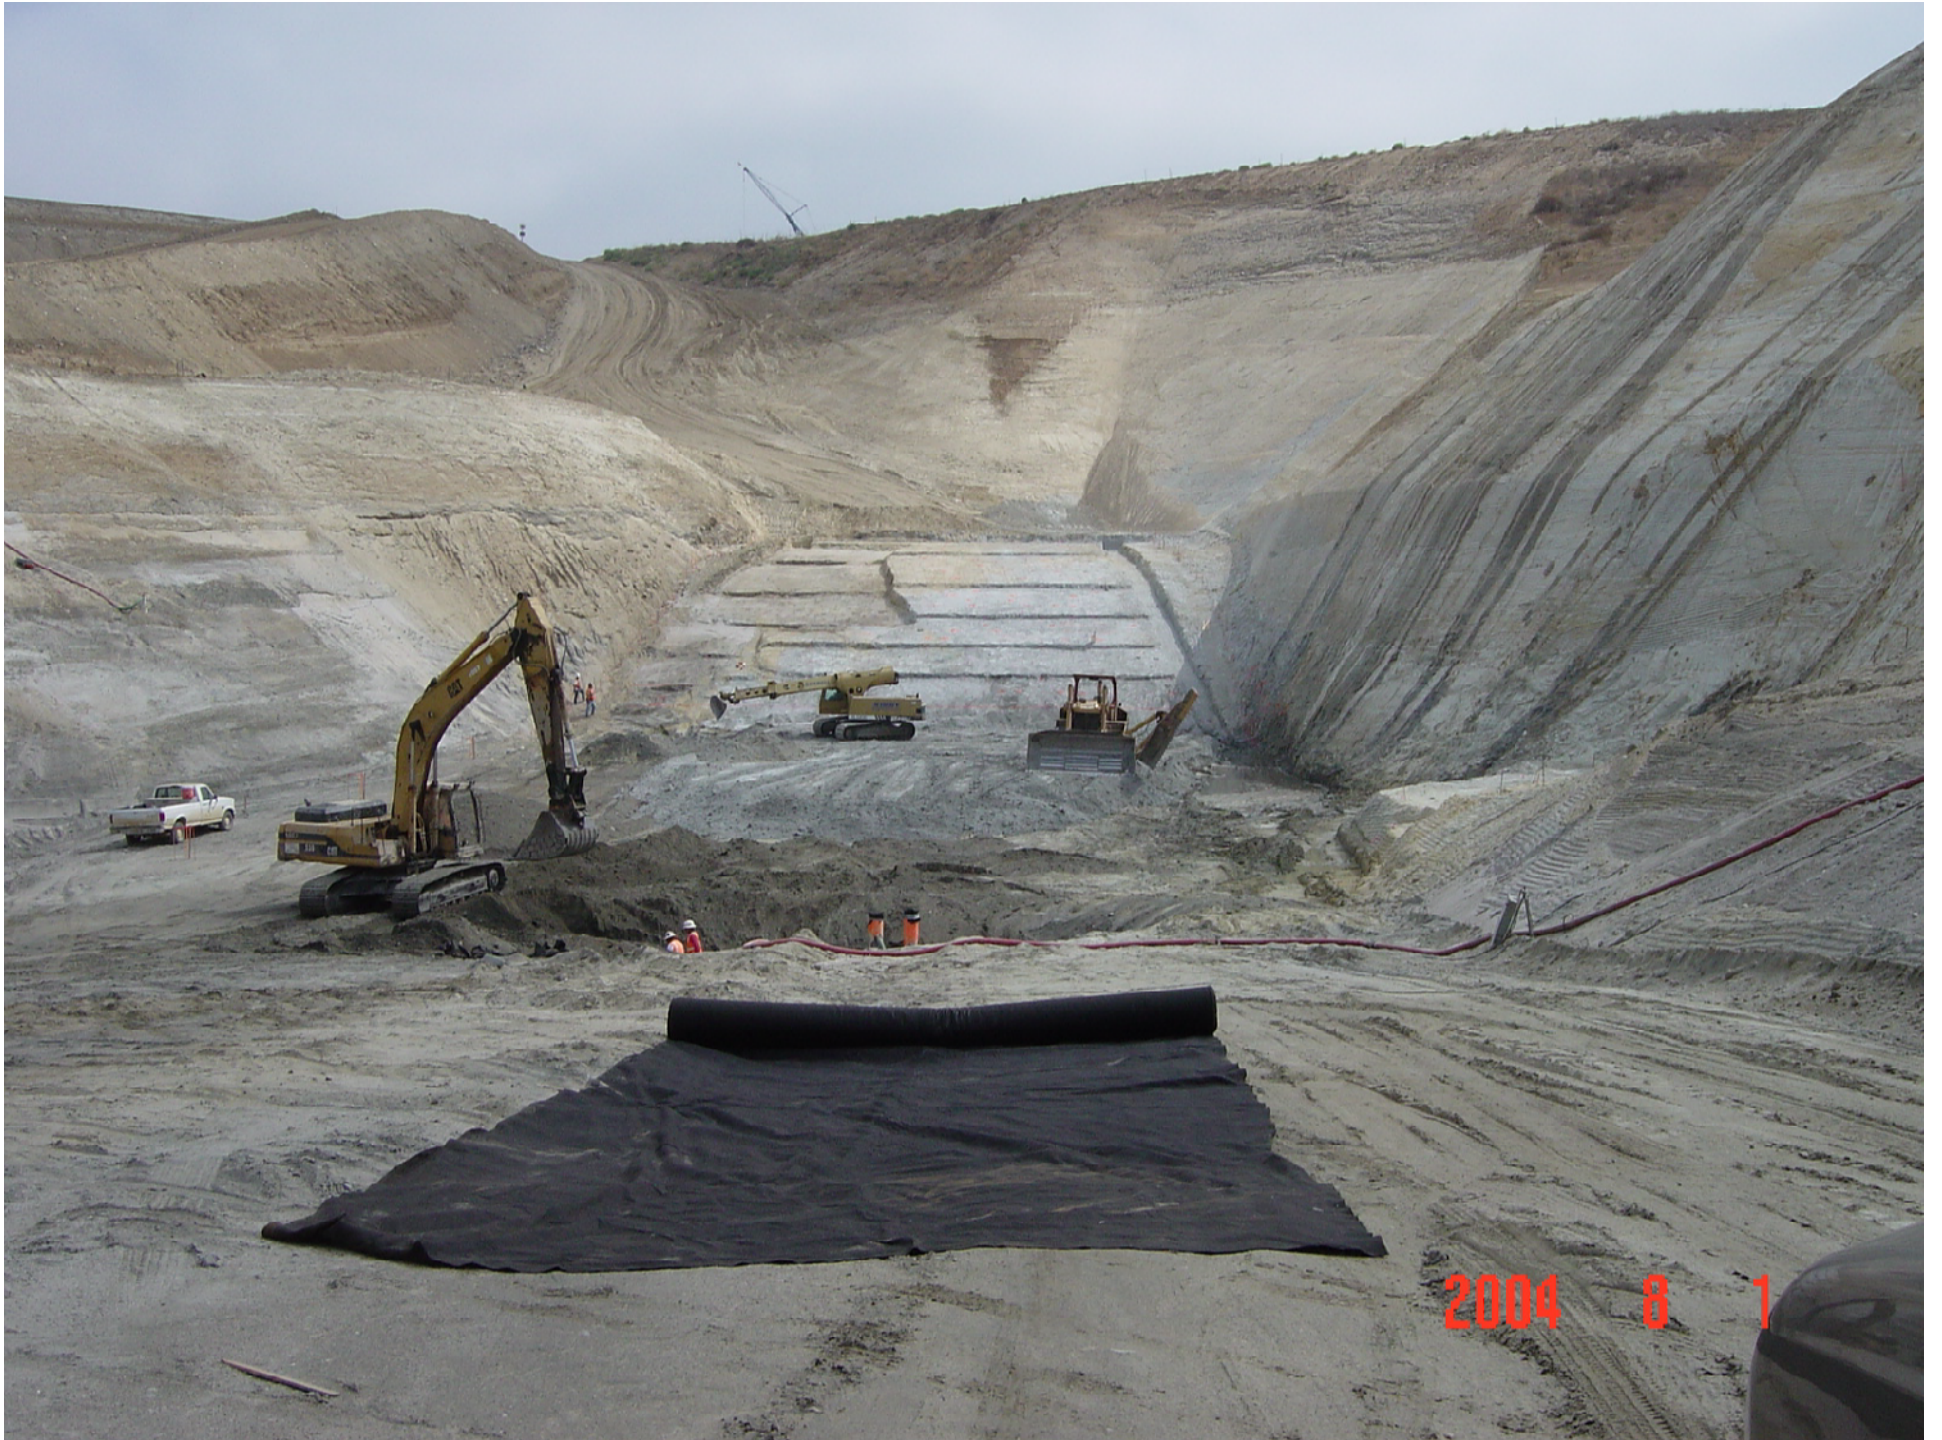
2004 8 1

- 2 gpm of seepage
- Water cloudy, but not muddy
- Flow rate, clarity constant

- Predictable, given the site geology
- Quantity of seepage increased as the saturation front developed
- Low head, low exit gradient
- No cause for concern, but “V-Trench” must be monitored

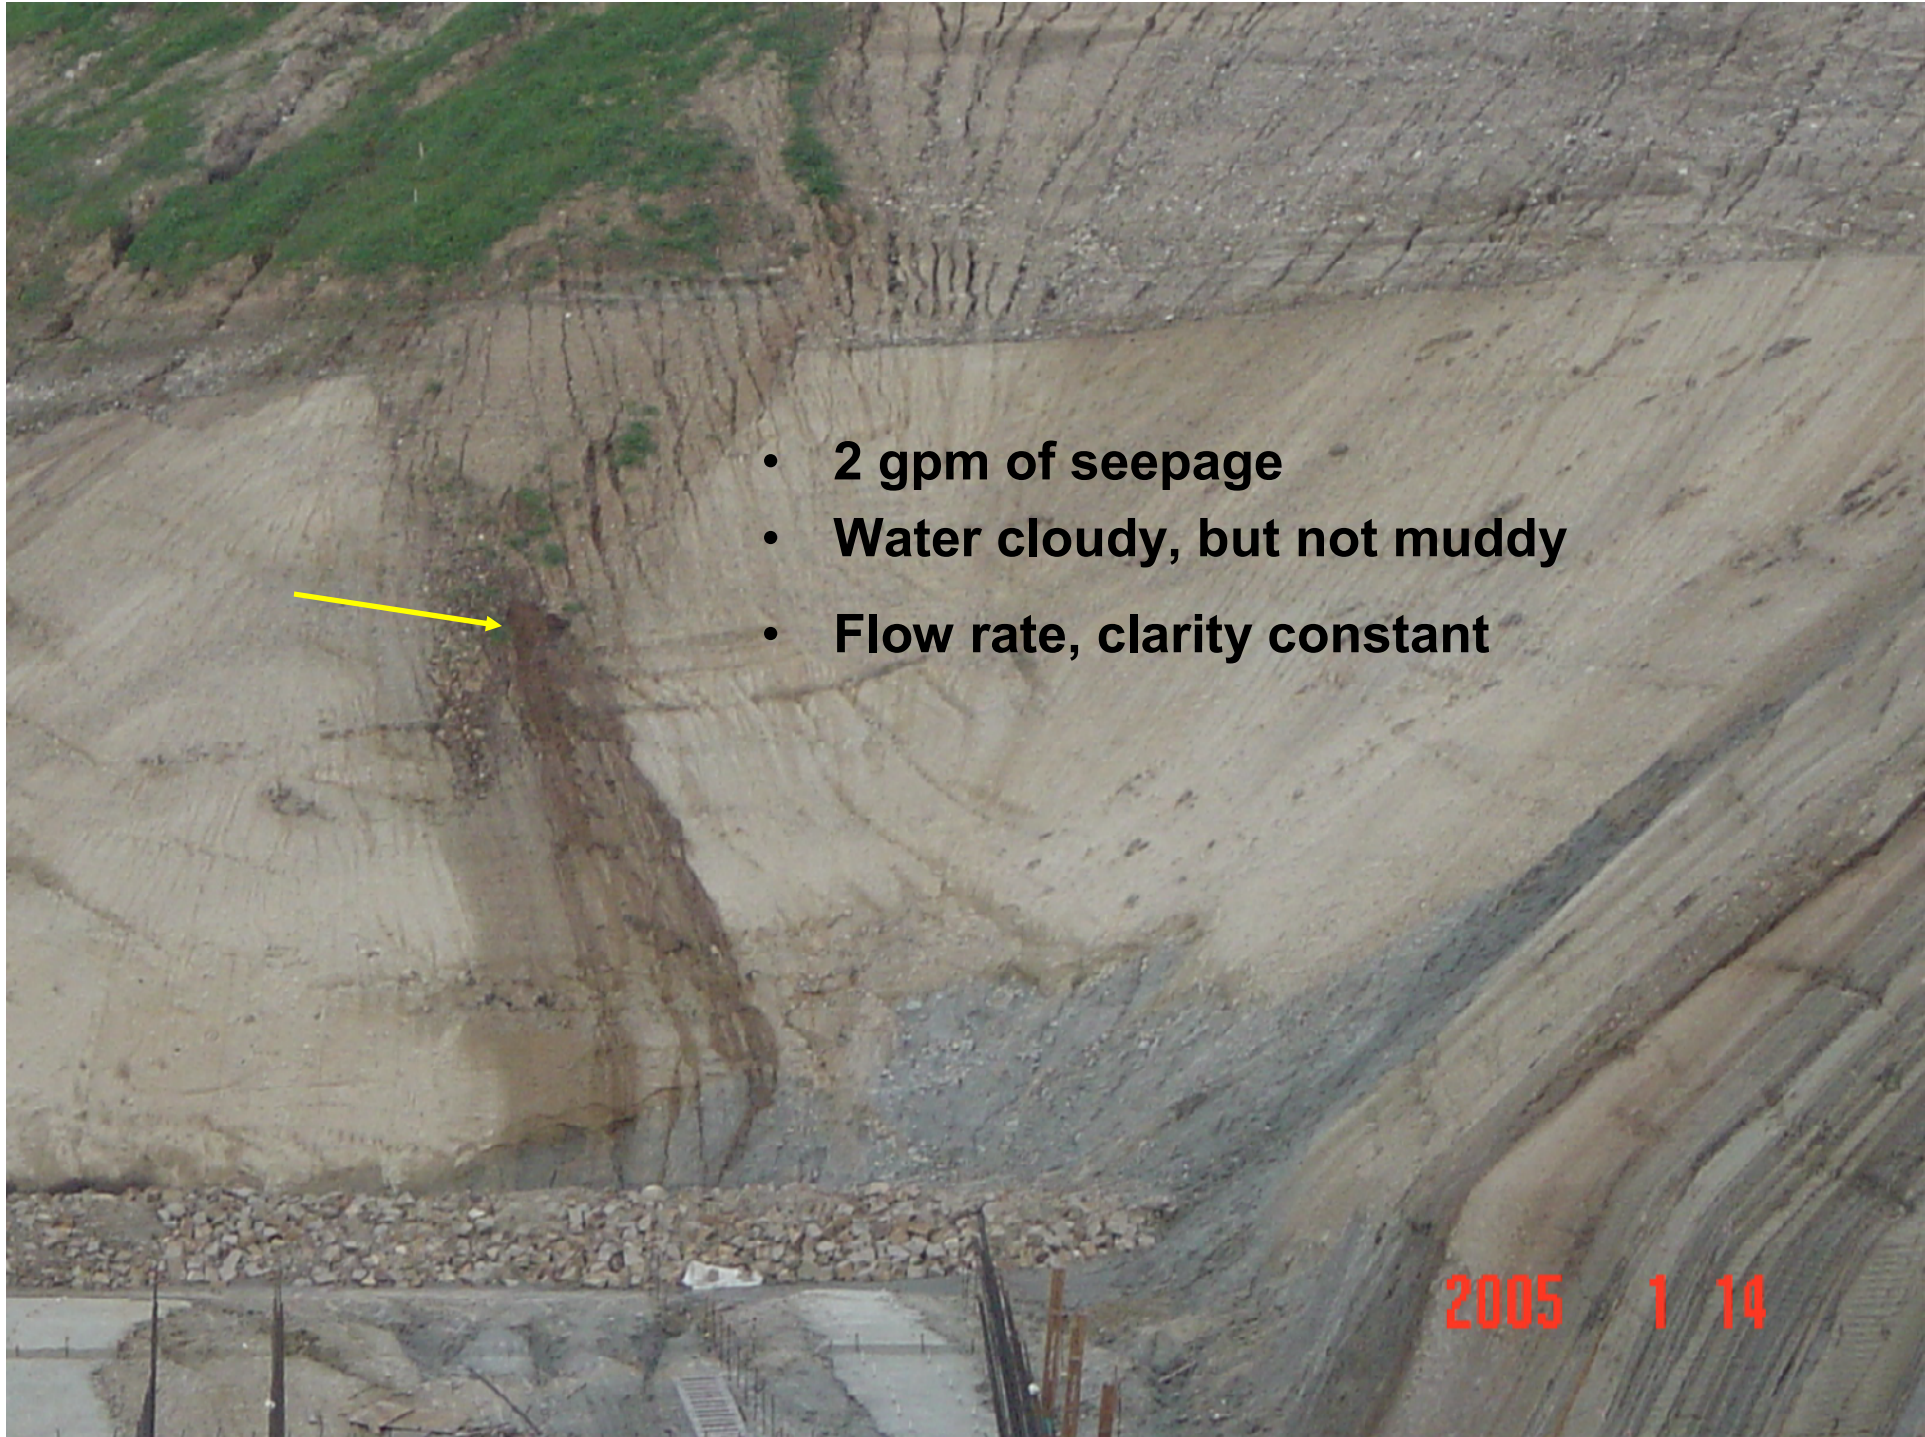
2005 1 14
