Slope Stability Evaluation of the Baldhill Dam Right Abutment

***Presentation
for the***

***2005 Tri-Service Infrastructure
Systems Conference***

***Neil T. Schwanz,
RTS Geotechnical Engineer***

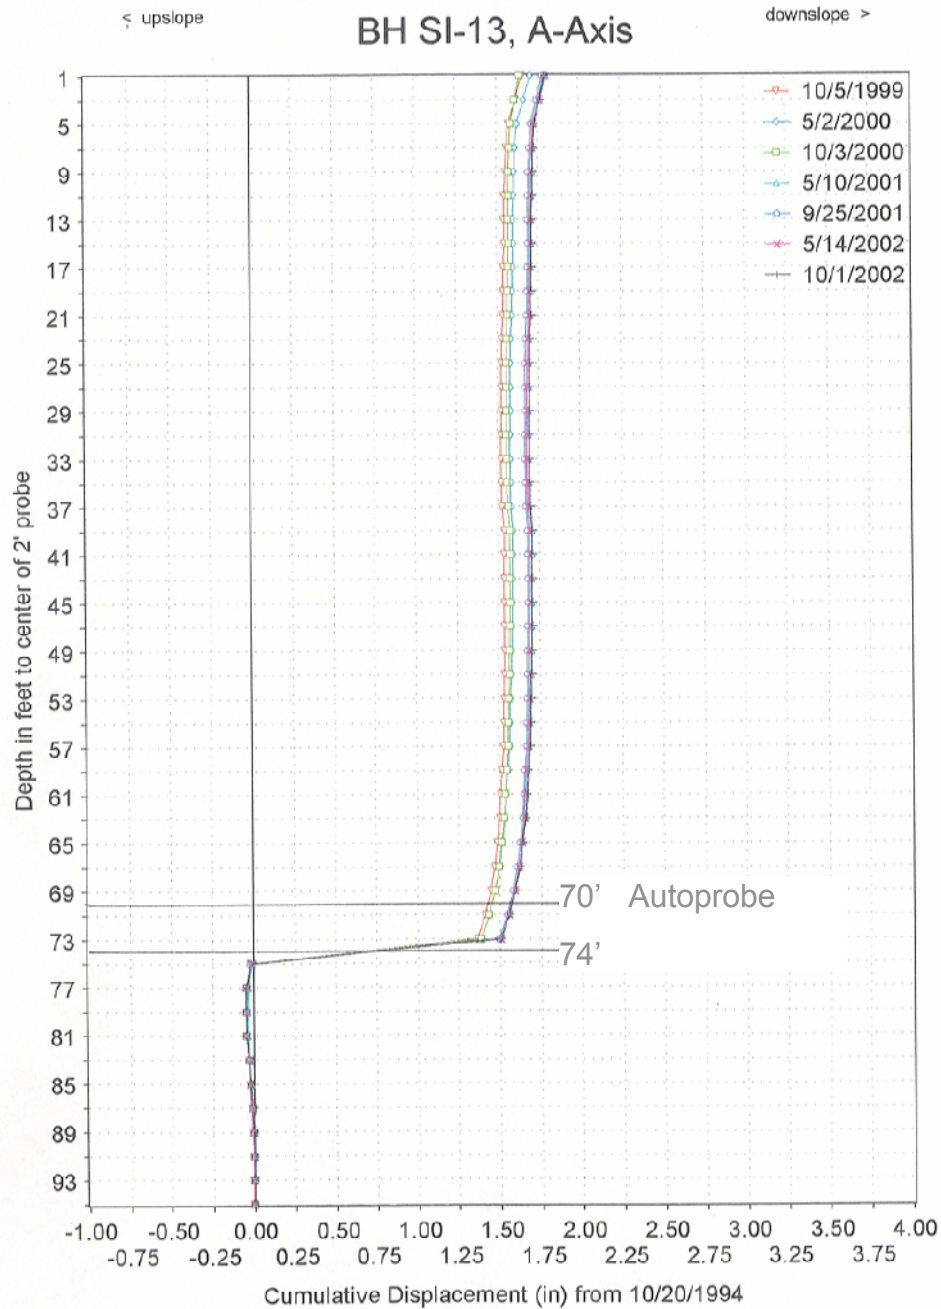
BALDHILL DAM, LAKE ASHTABULA INCLINOMETER DATA

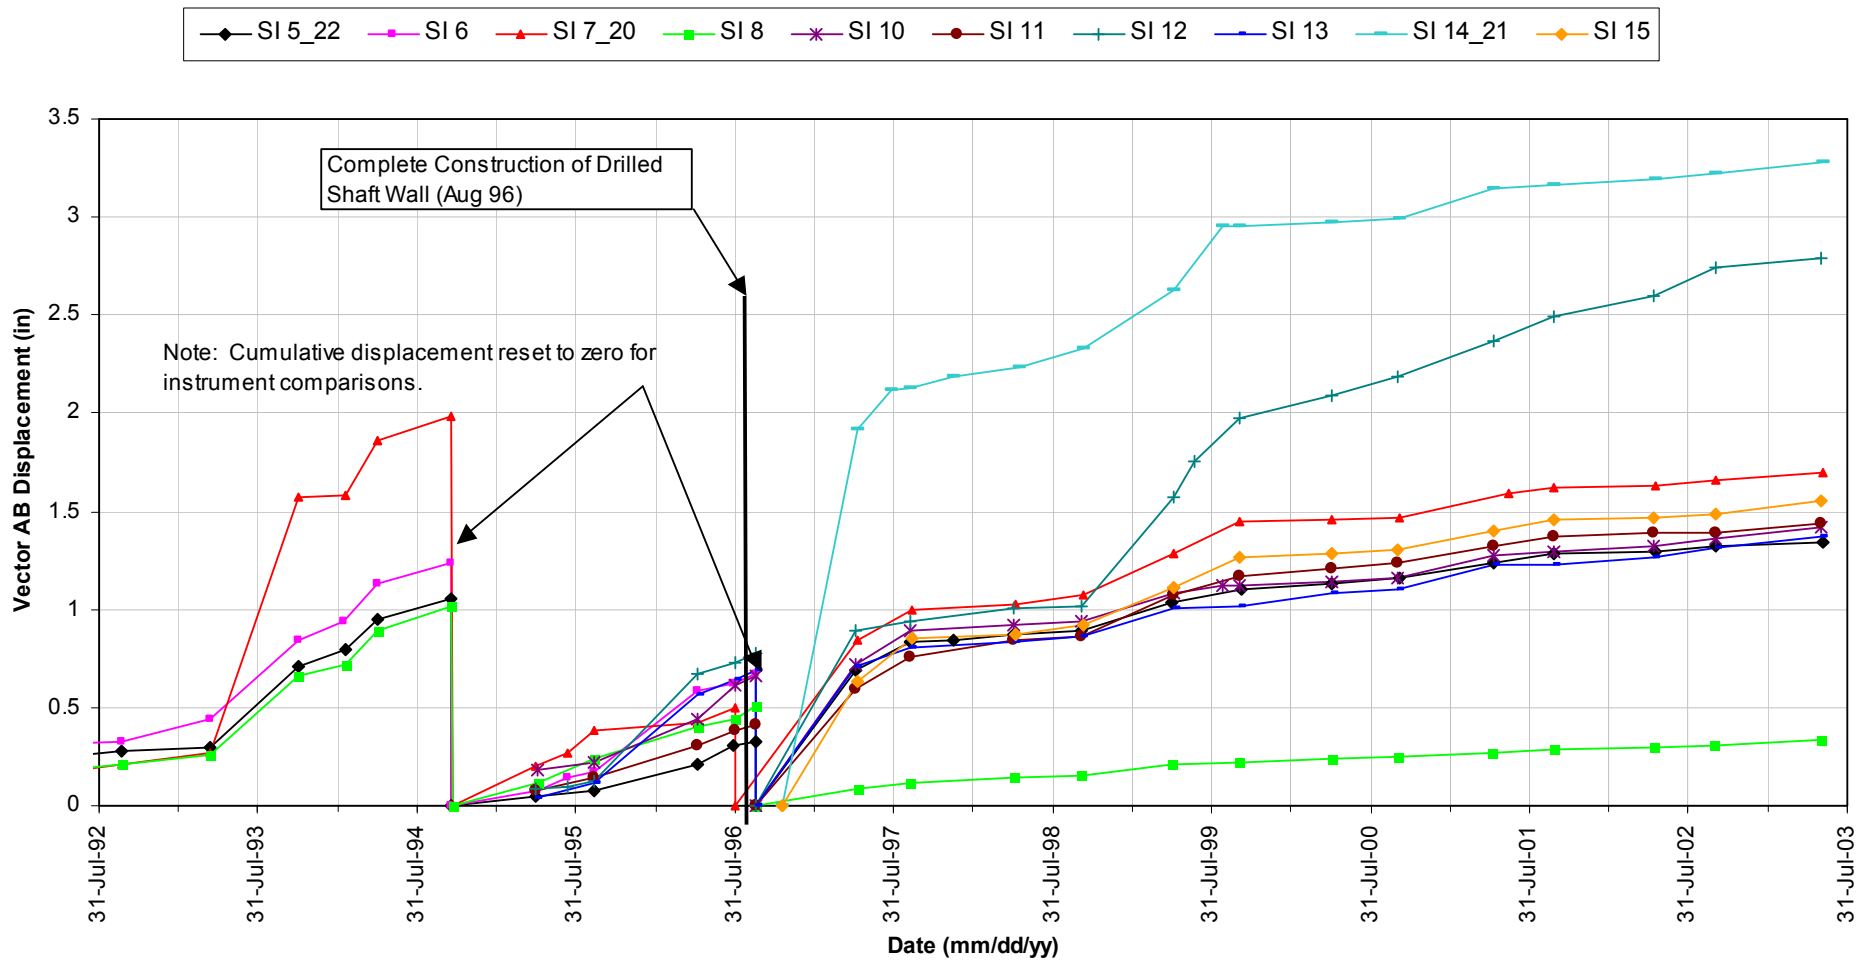
Inclinometer Displacement

Fig. 2.8. Inclinometer Displacement Rate Comparison

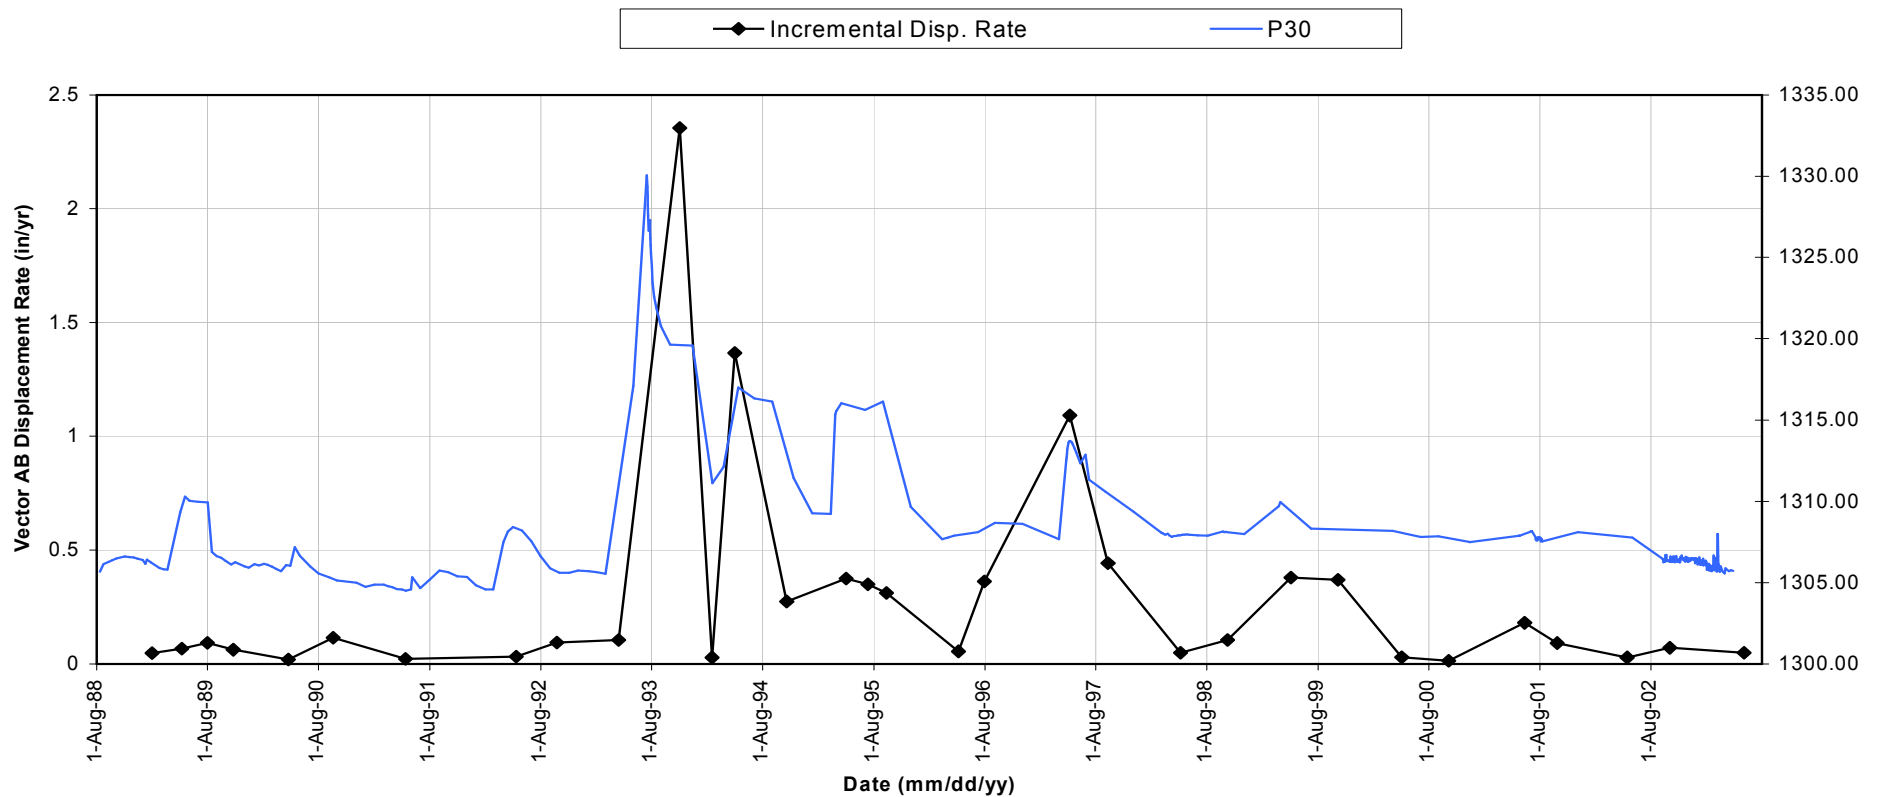
Displacement vs Pore Water Cond.

SI-7 and SI-20 (43' depth)

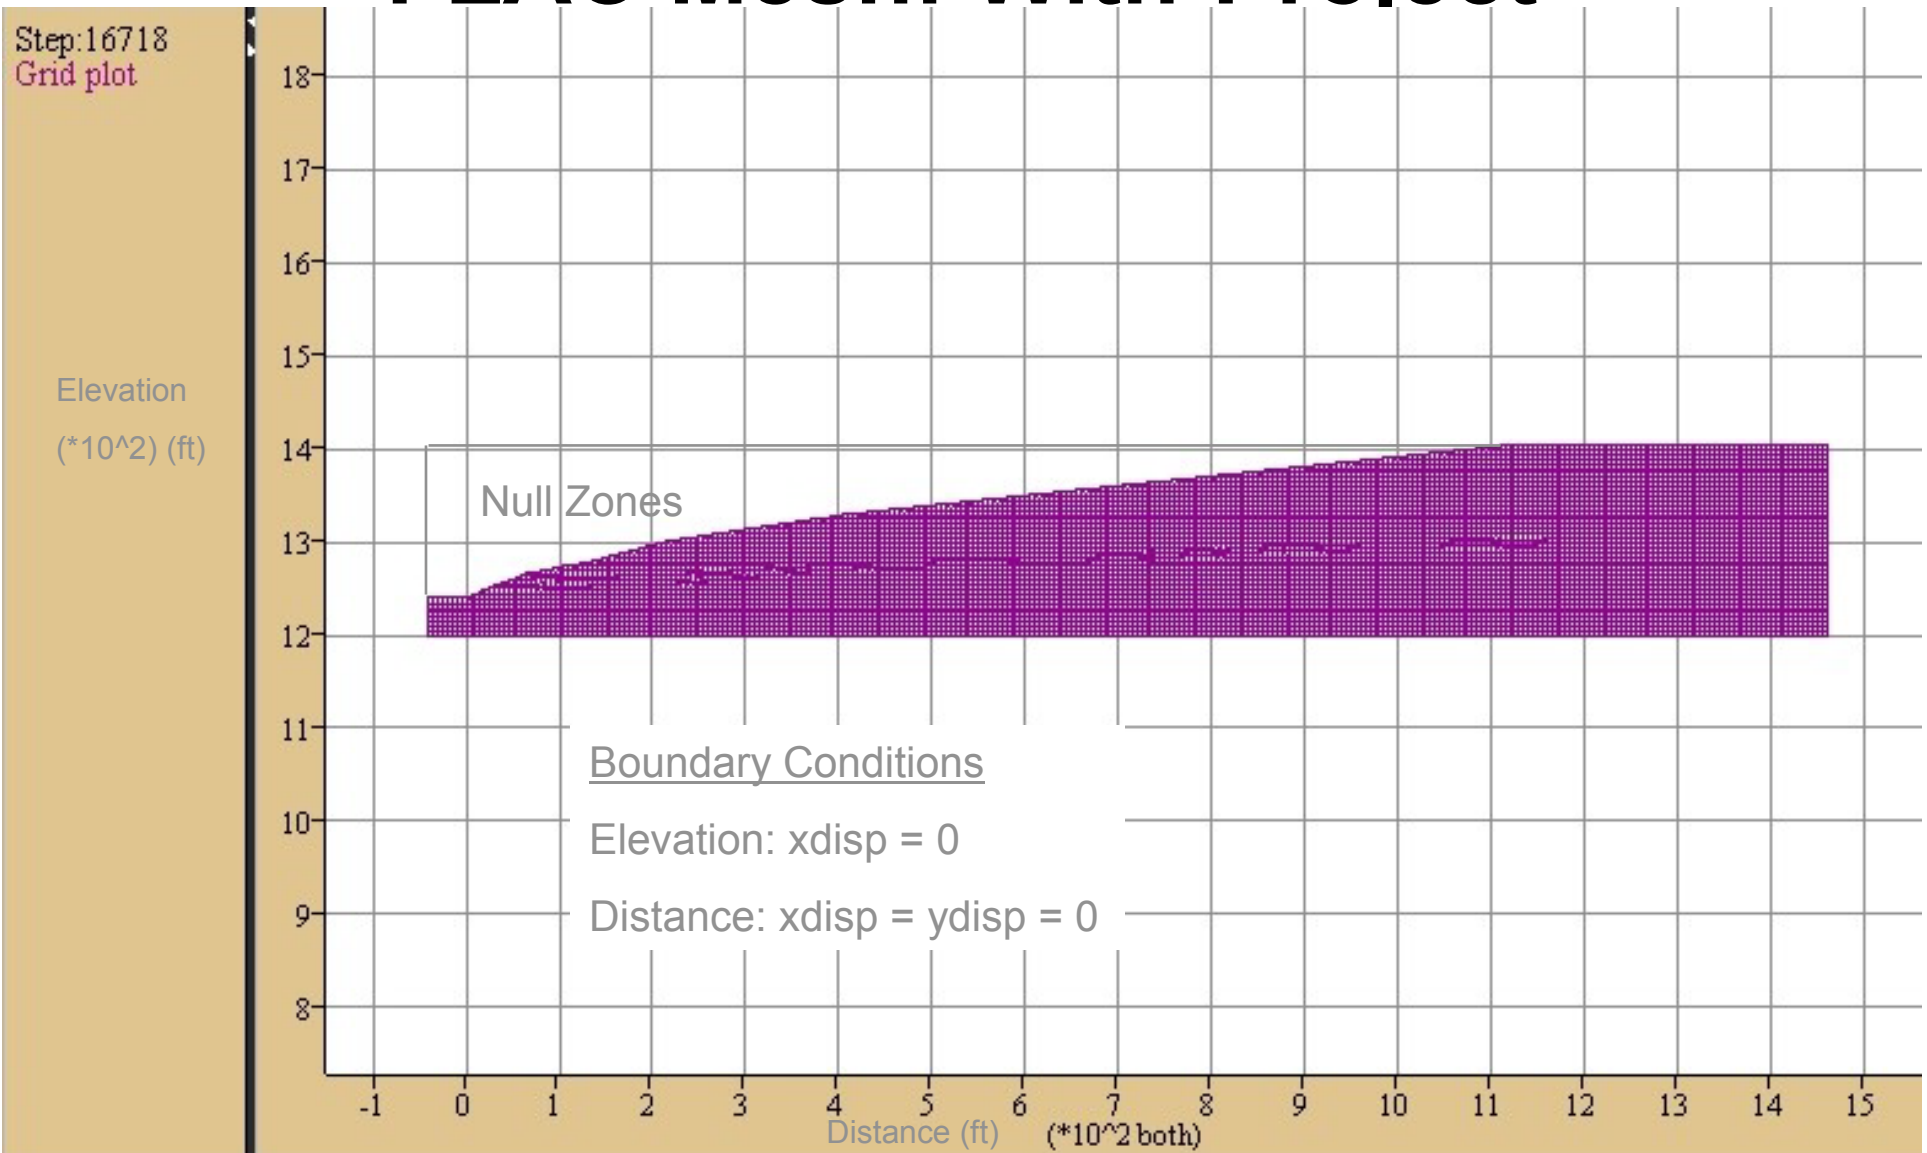
FLAC Mesh: With-Project

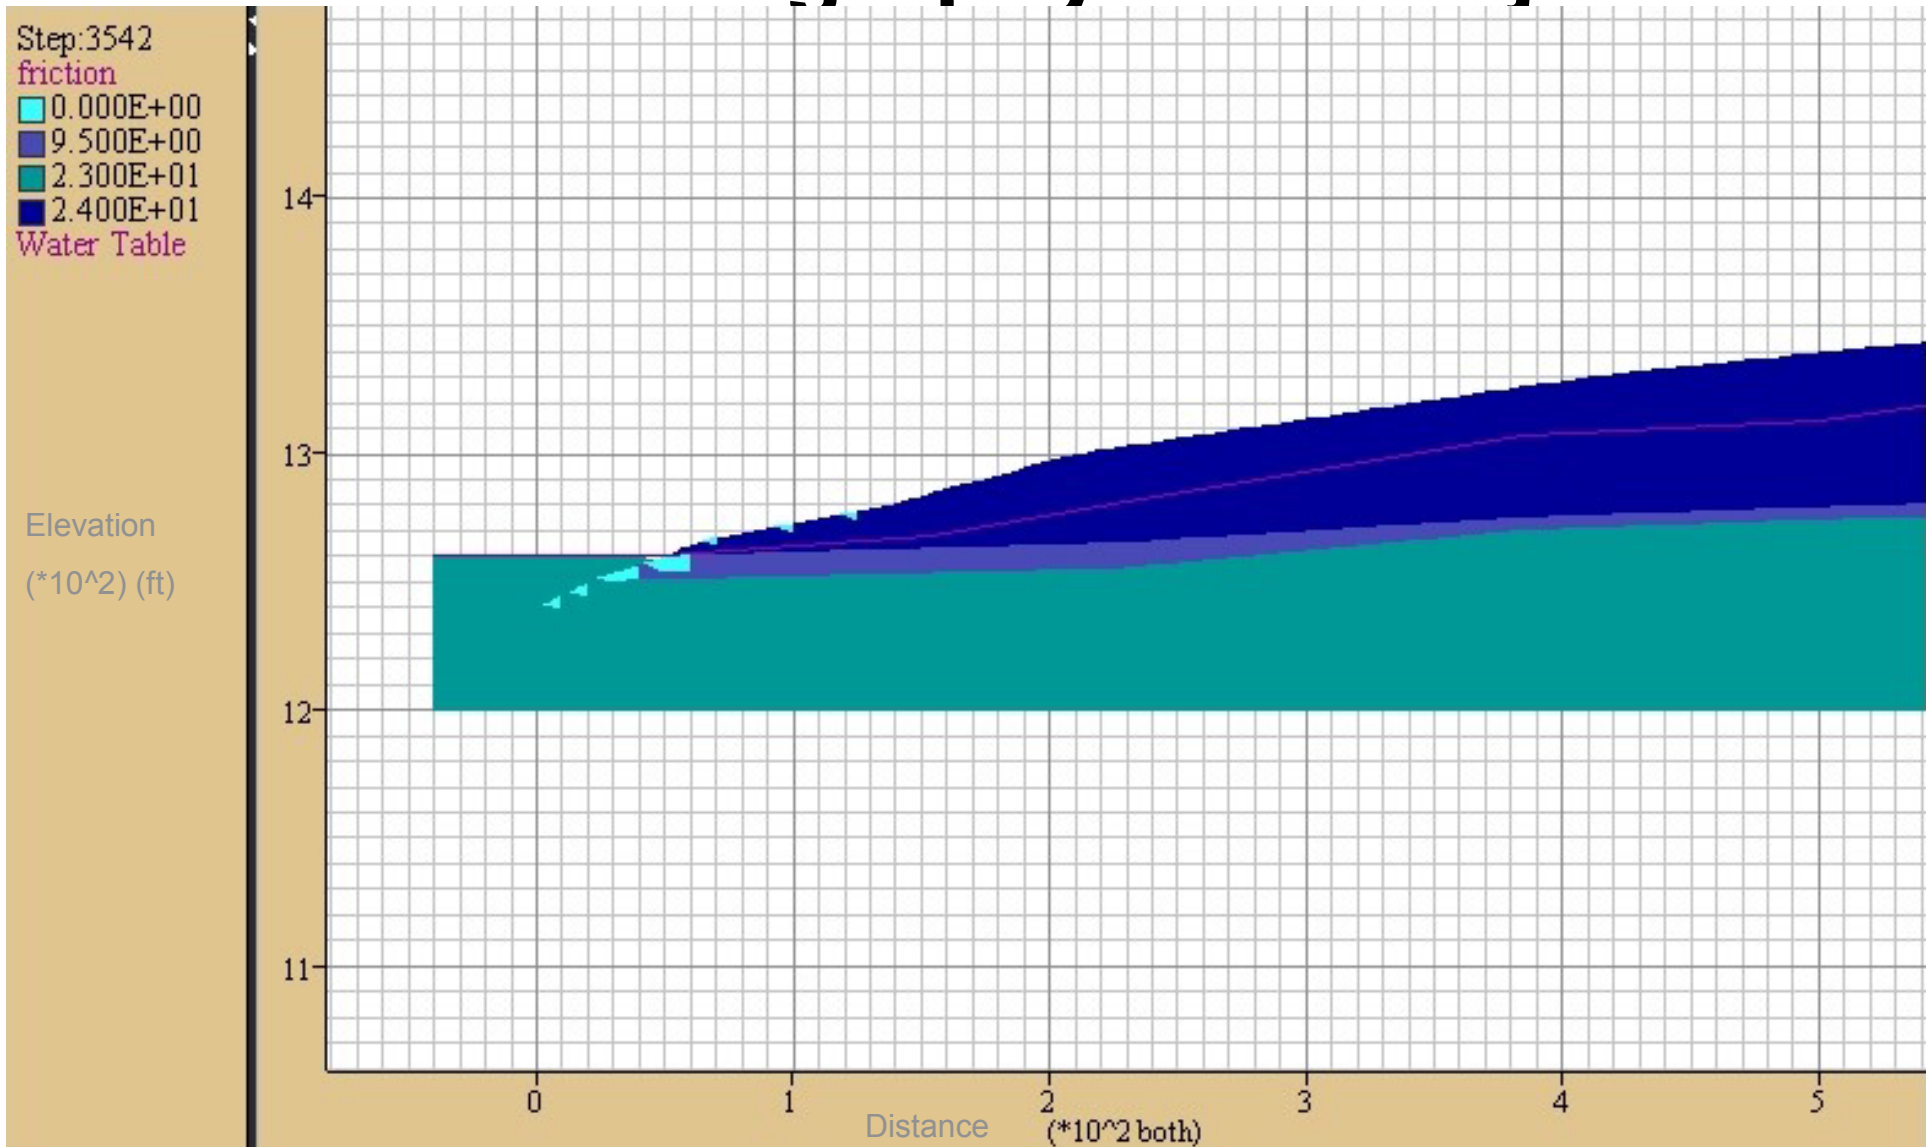
FLAC Stratigraphy: Pre-Project

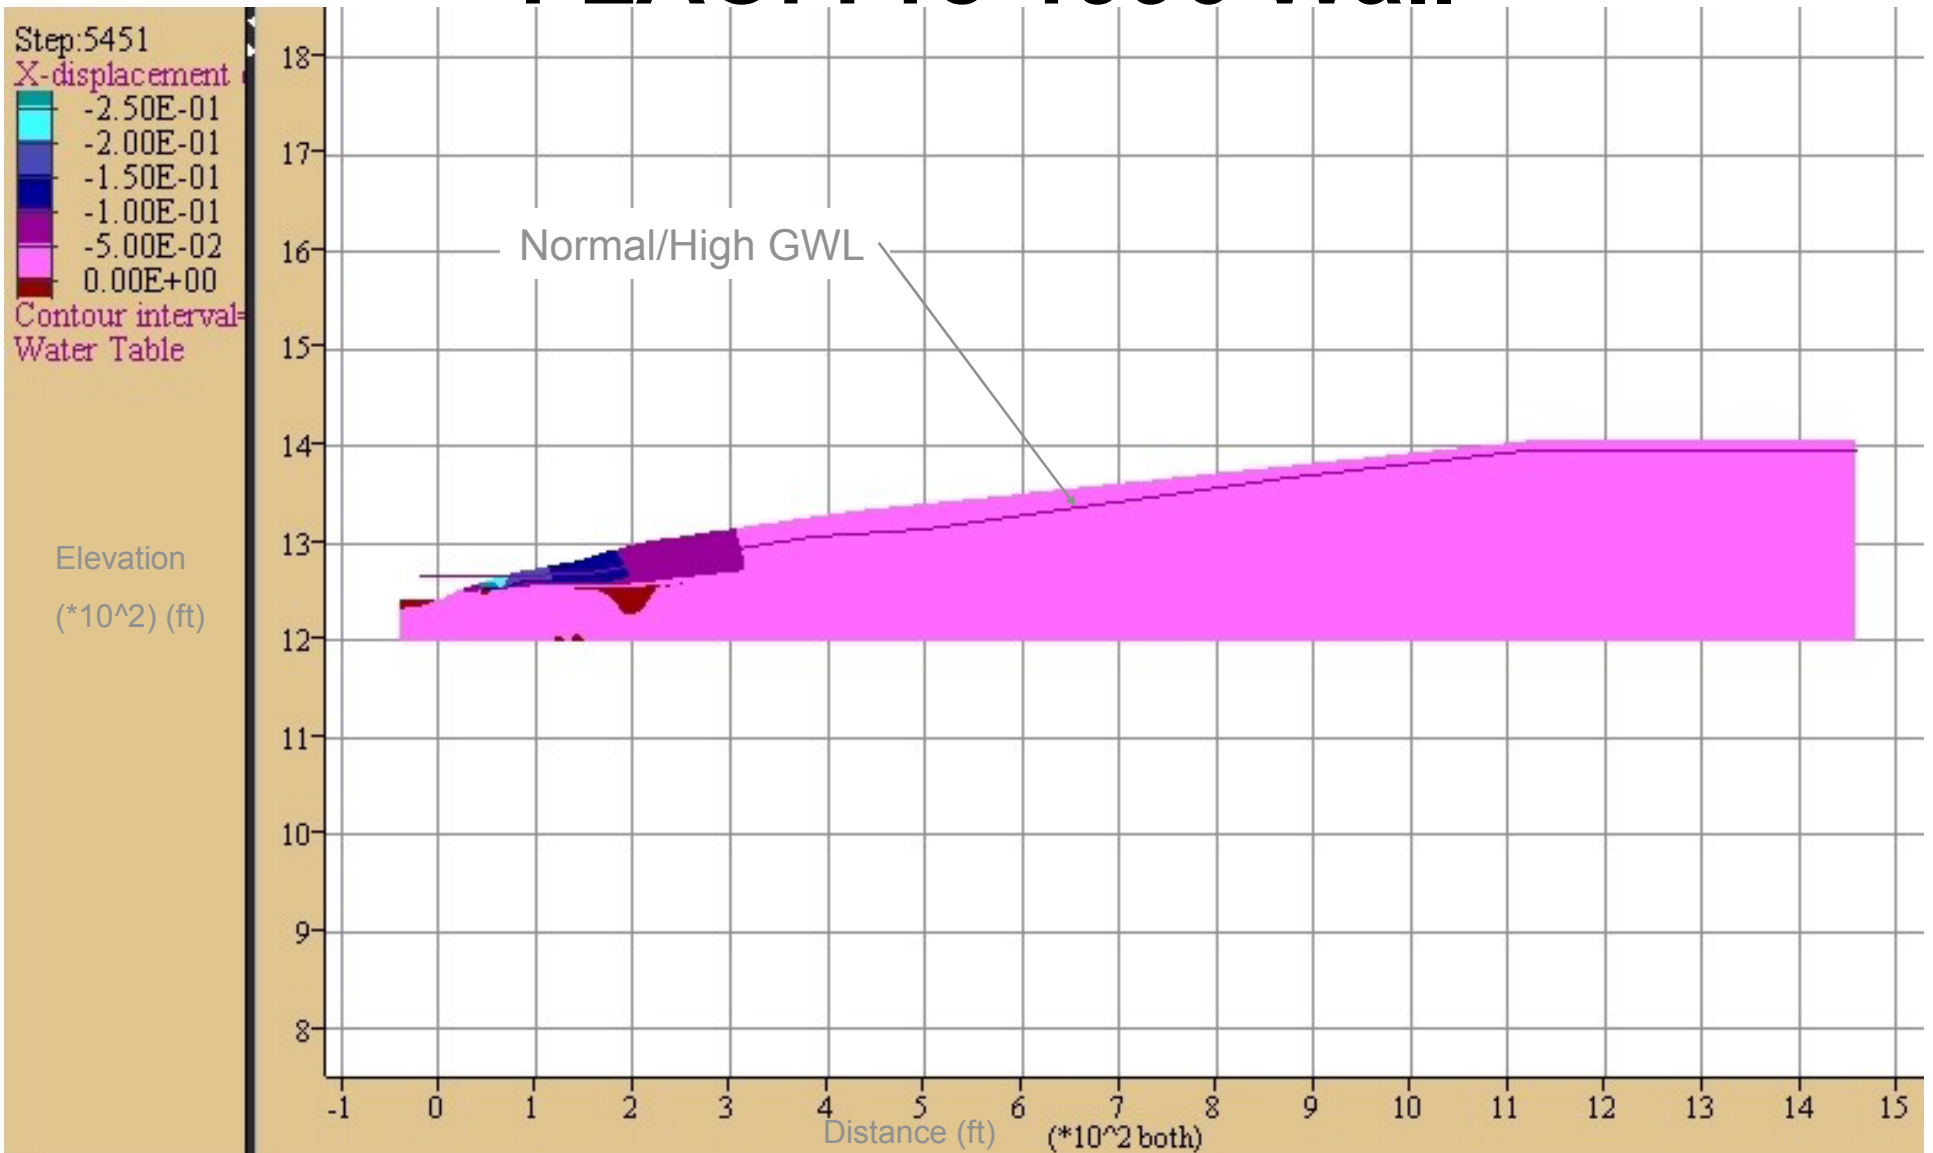
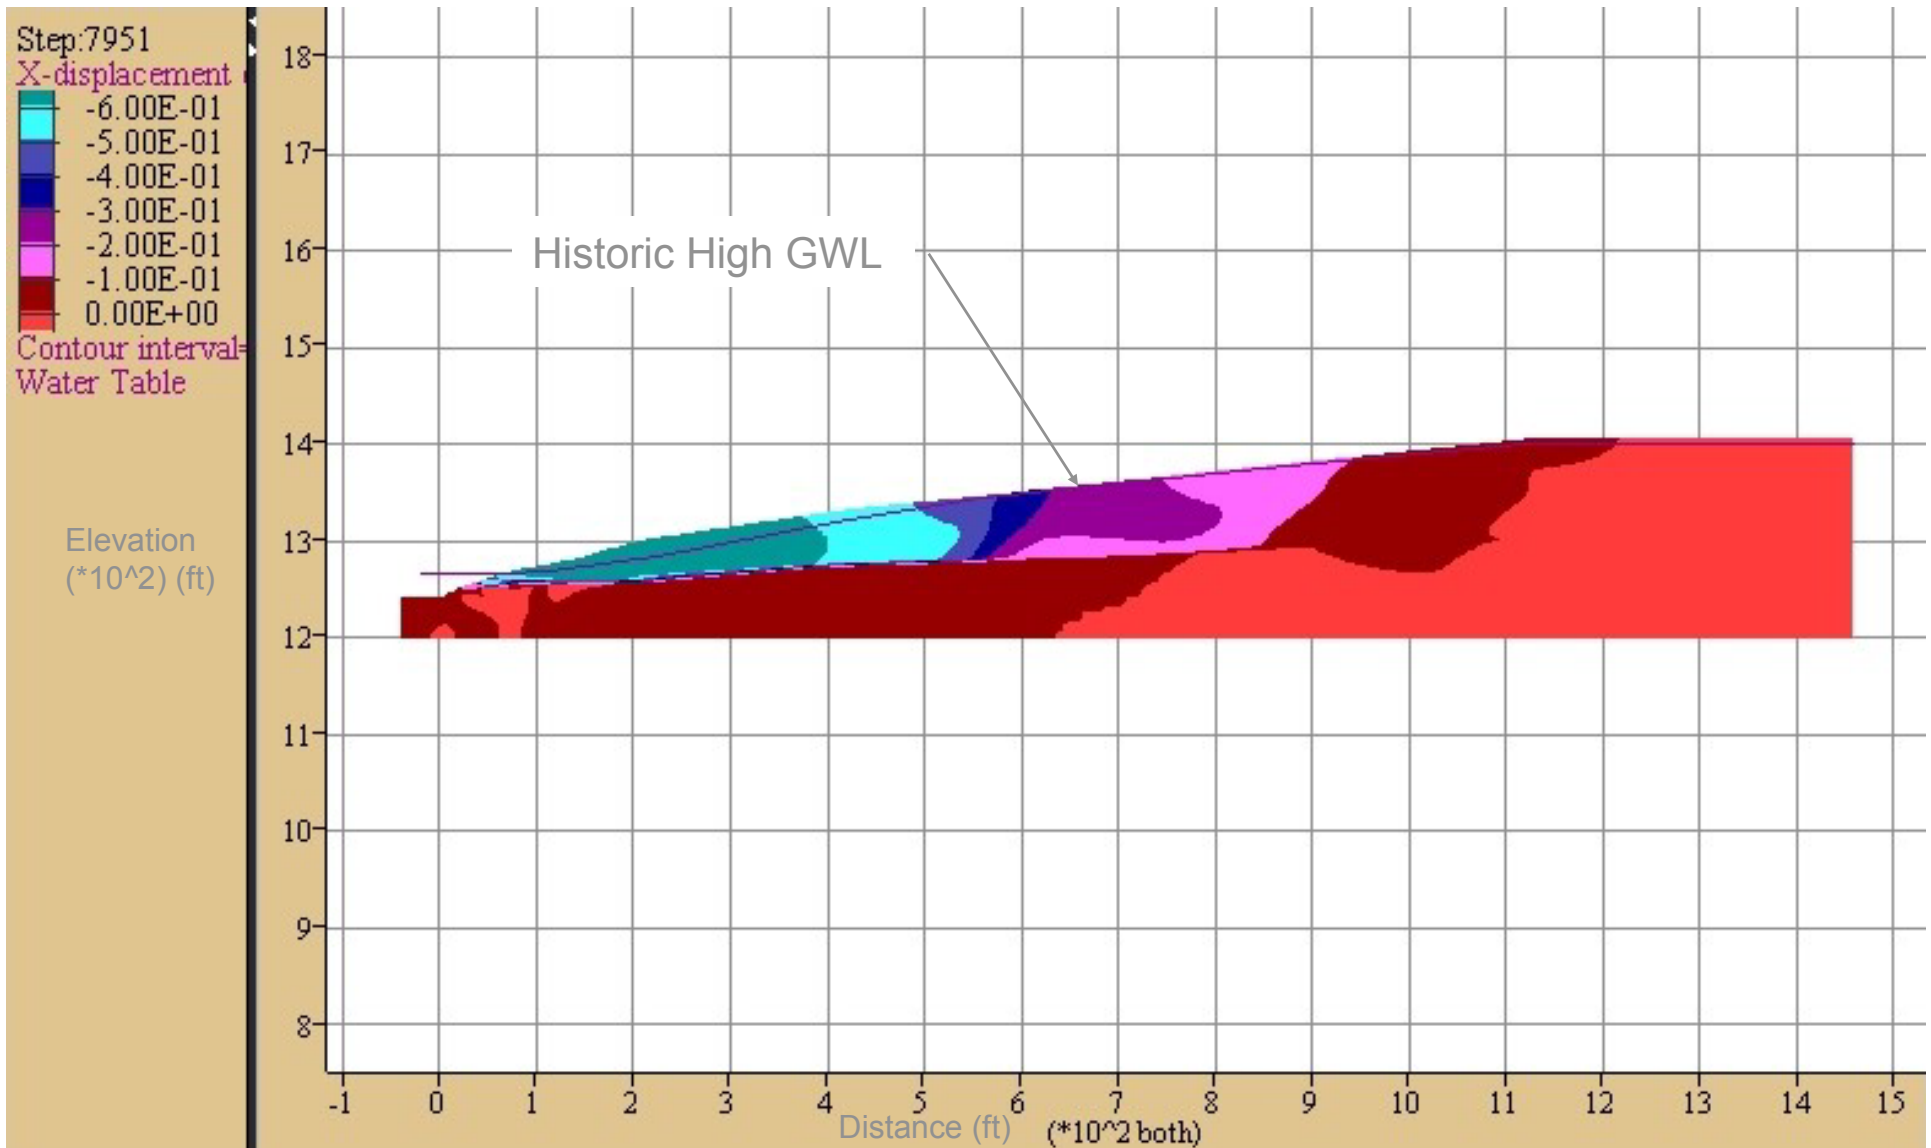
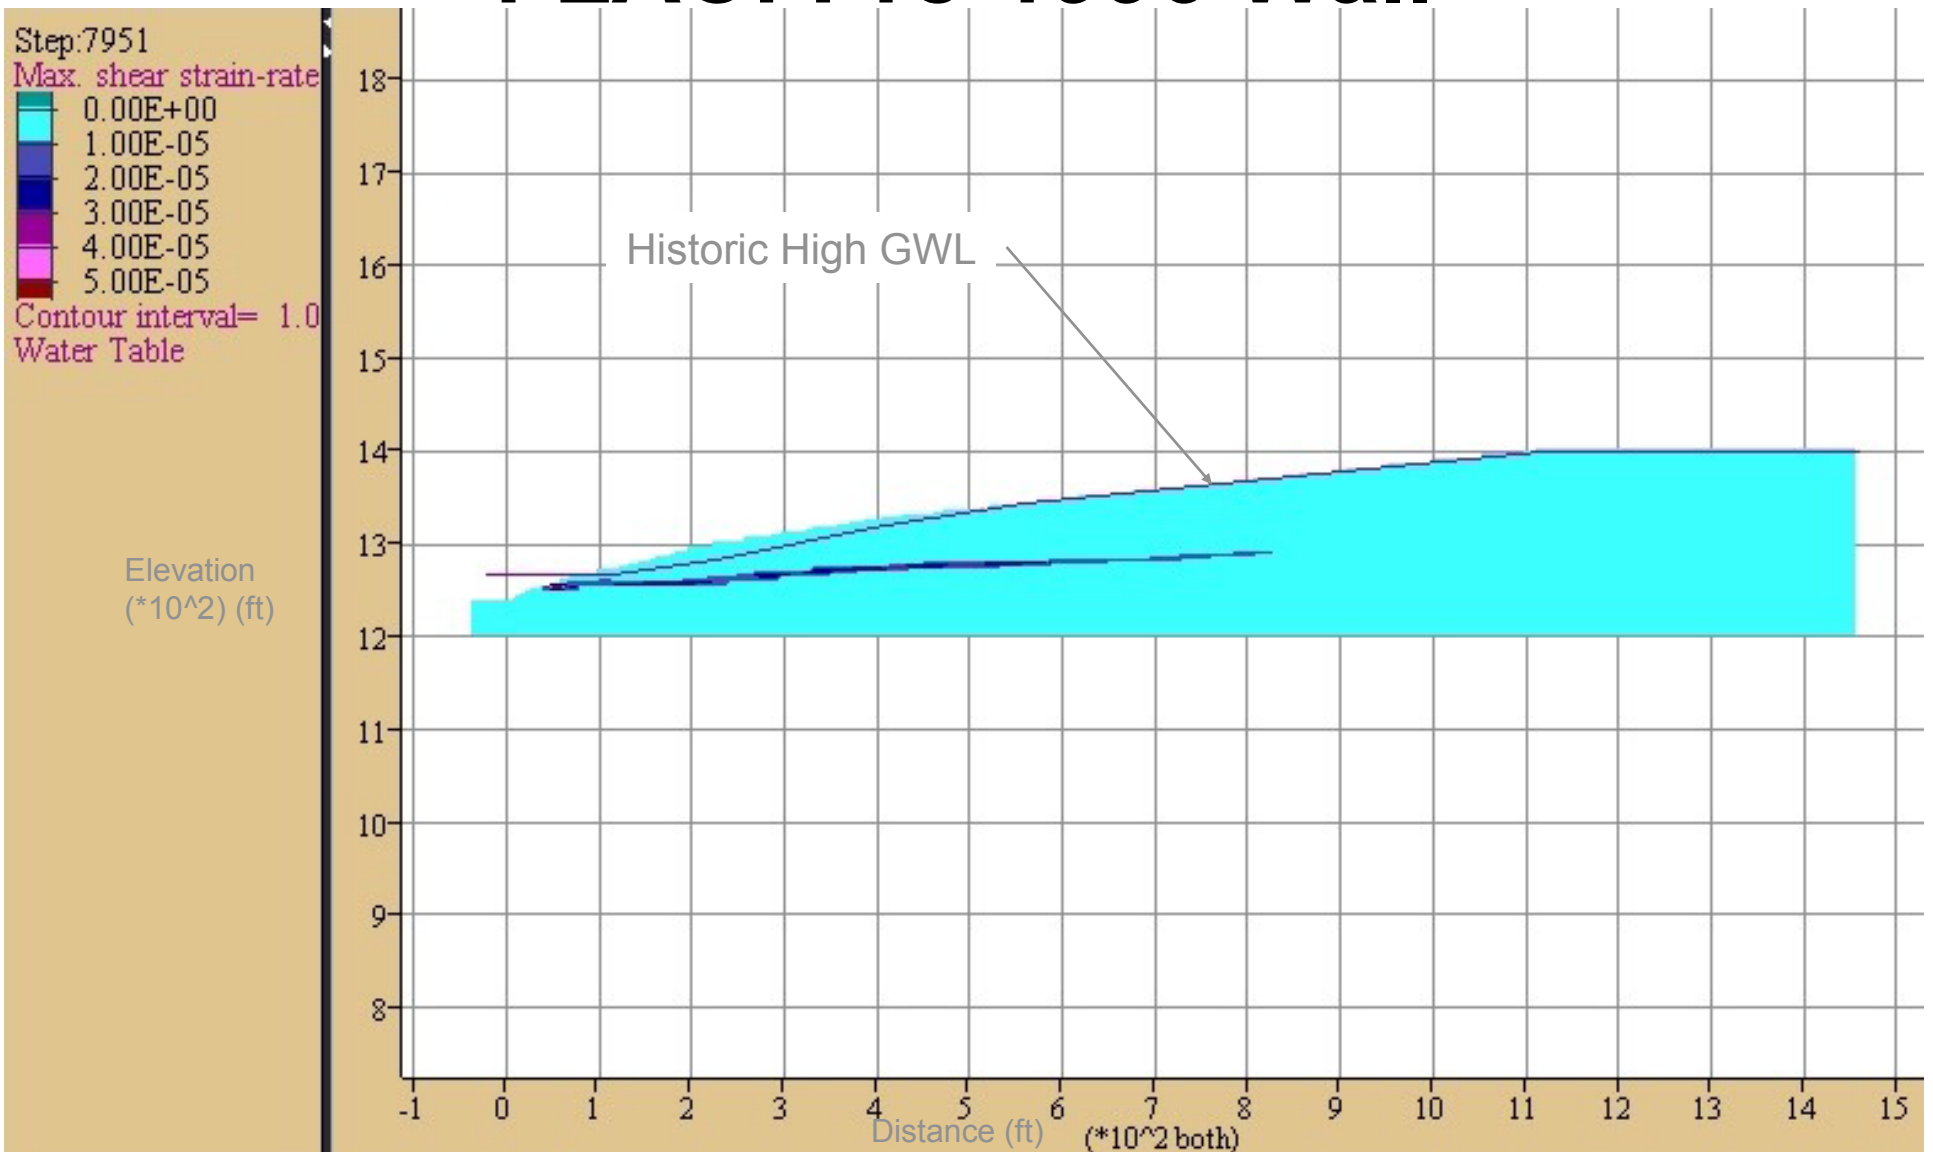
FLAC: Pre-1996 Wall

FLAC results

- ✓ No searching for the critical failure surface
- ✓ Compute displacements with visual representation
- ✓ Helps in understanding problem
- ✓ General agreement with limit equilibrium results
- ✓ Abutment is stable to past historic high GWL's
- ✓ Abutment is at risk of failure to extreme GWL's
- ✓ At an intermediate GWL, abutment may be stable, but with much more deflection of the 1996 drilled shaft wall
