Slope Stability Evaluation of the Baldhill Dam Right Abutment

***Presentation
for the***

***2005 Tri-Service Infrastructure
Systems Conference***

***Neil T. Schwanz,
RTS Geotechnical Engineer***

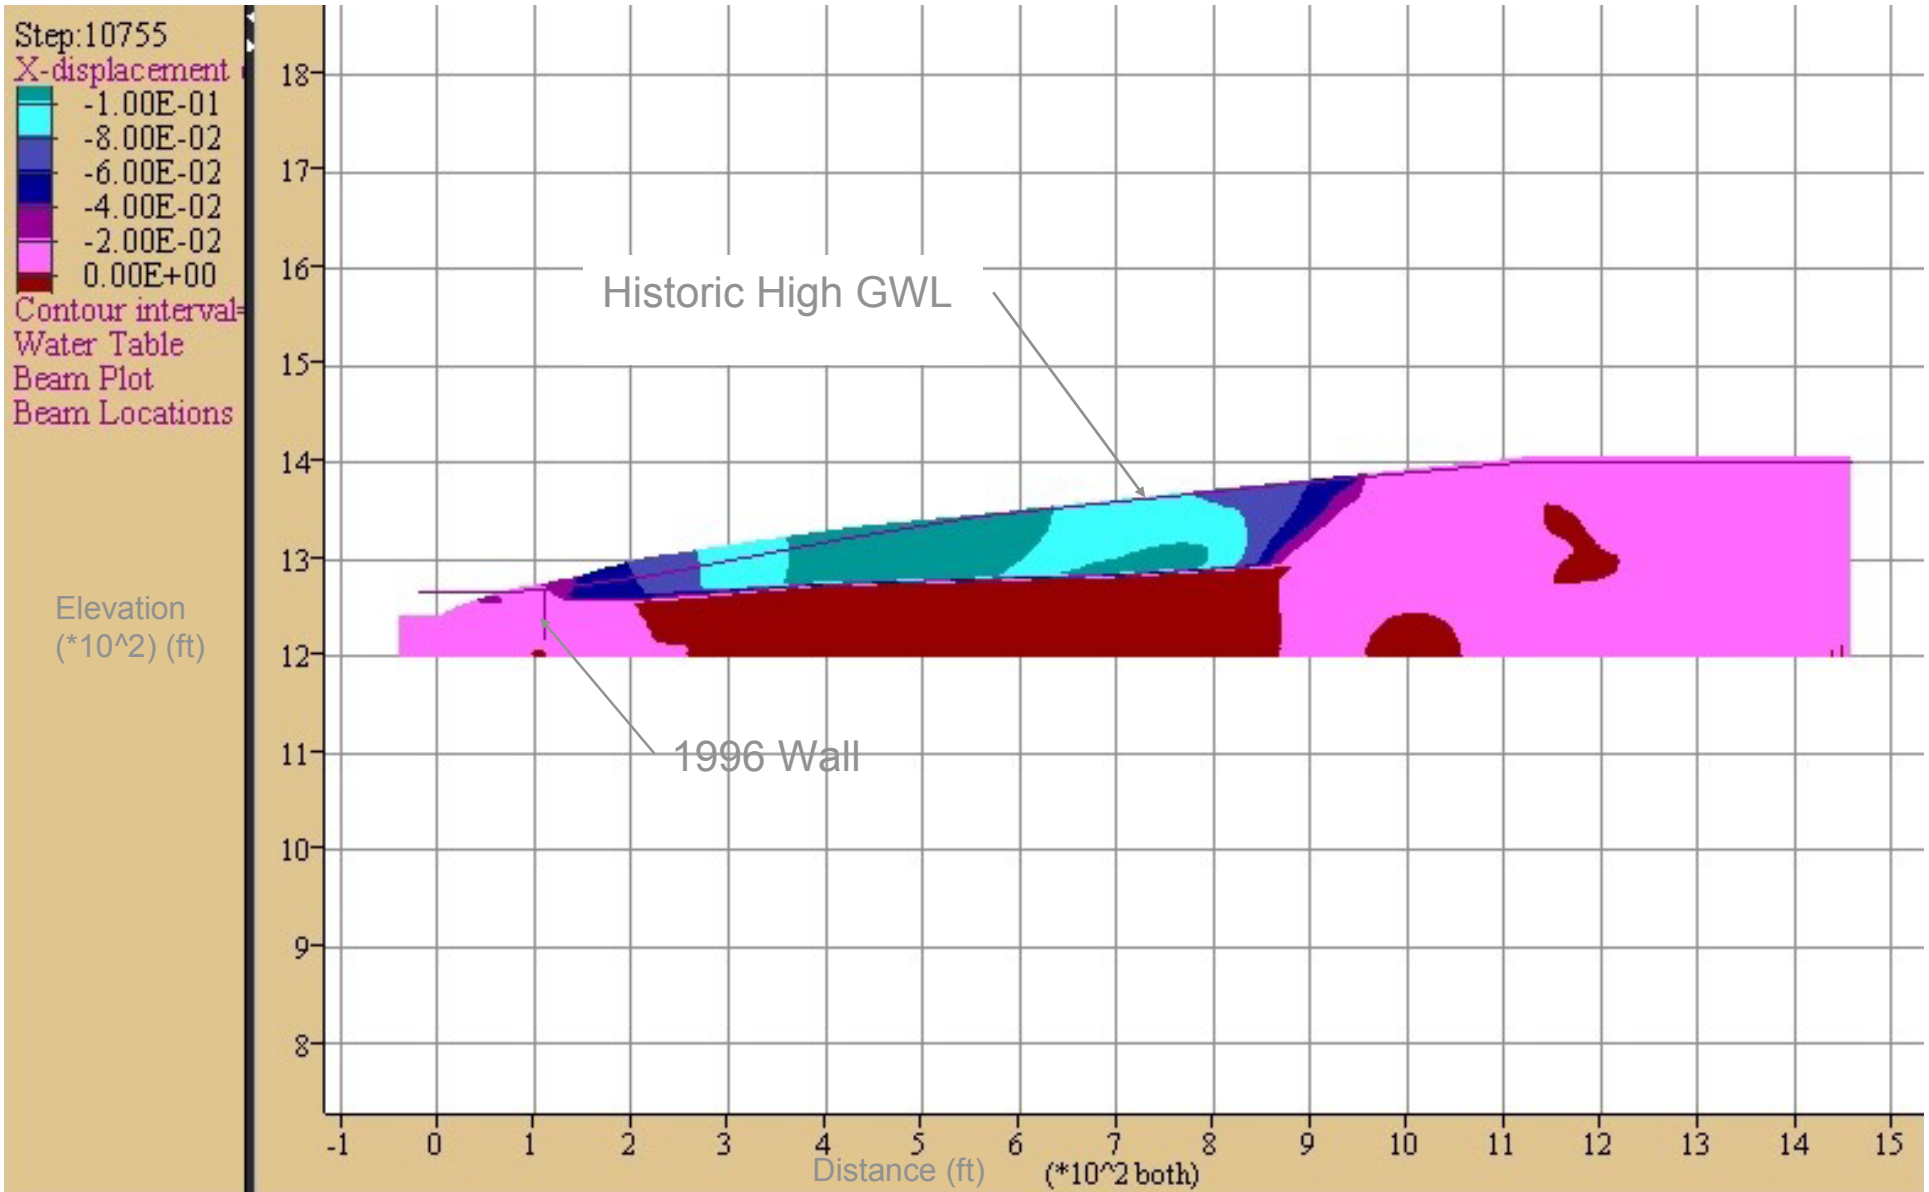
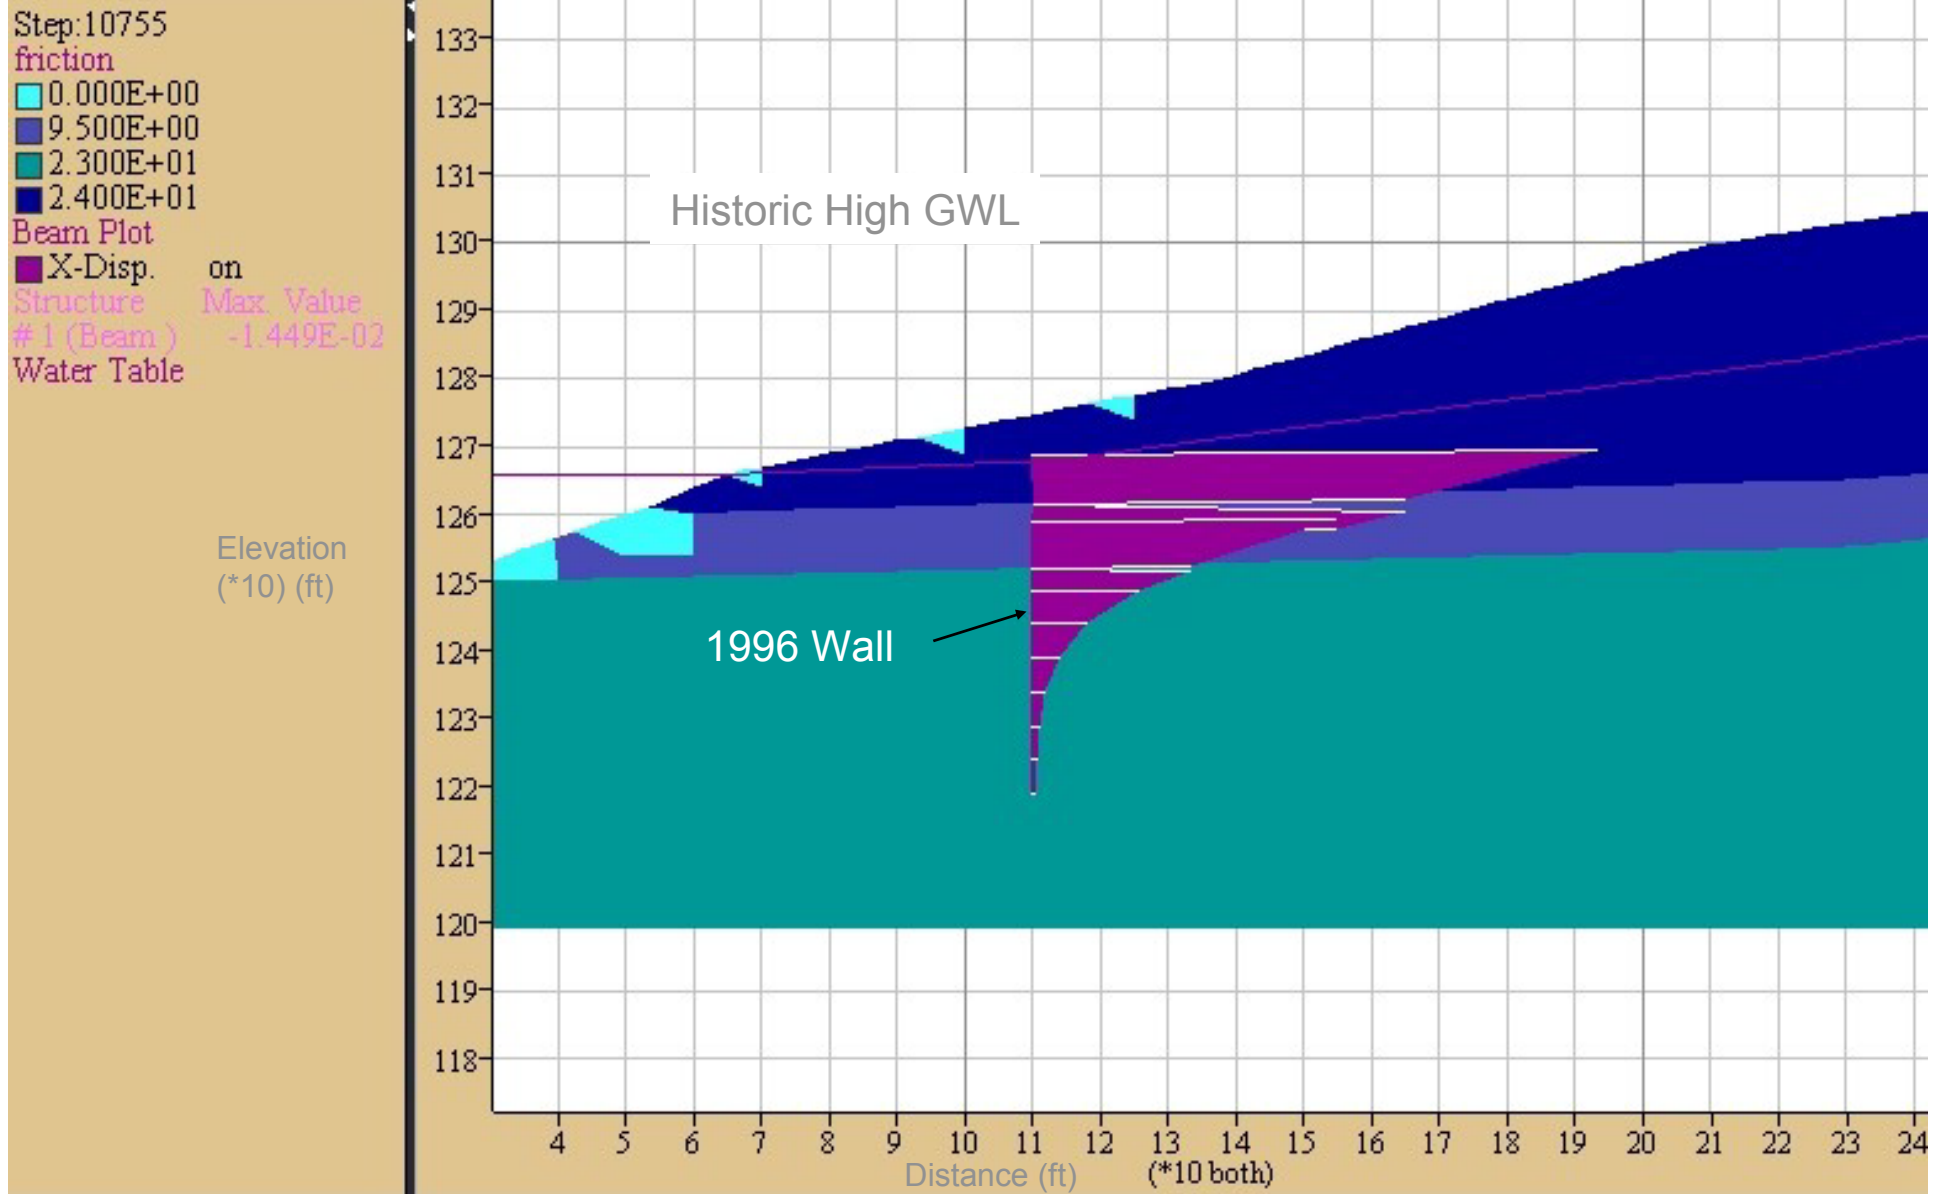
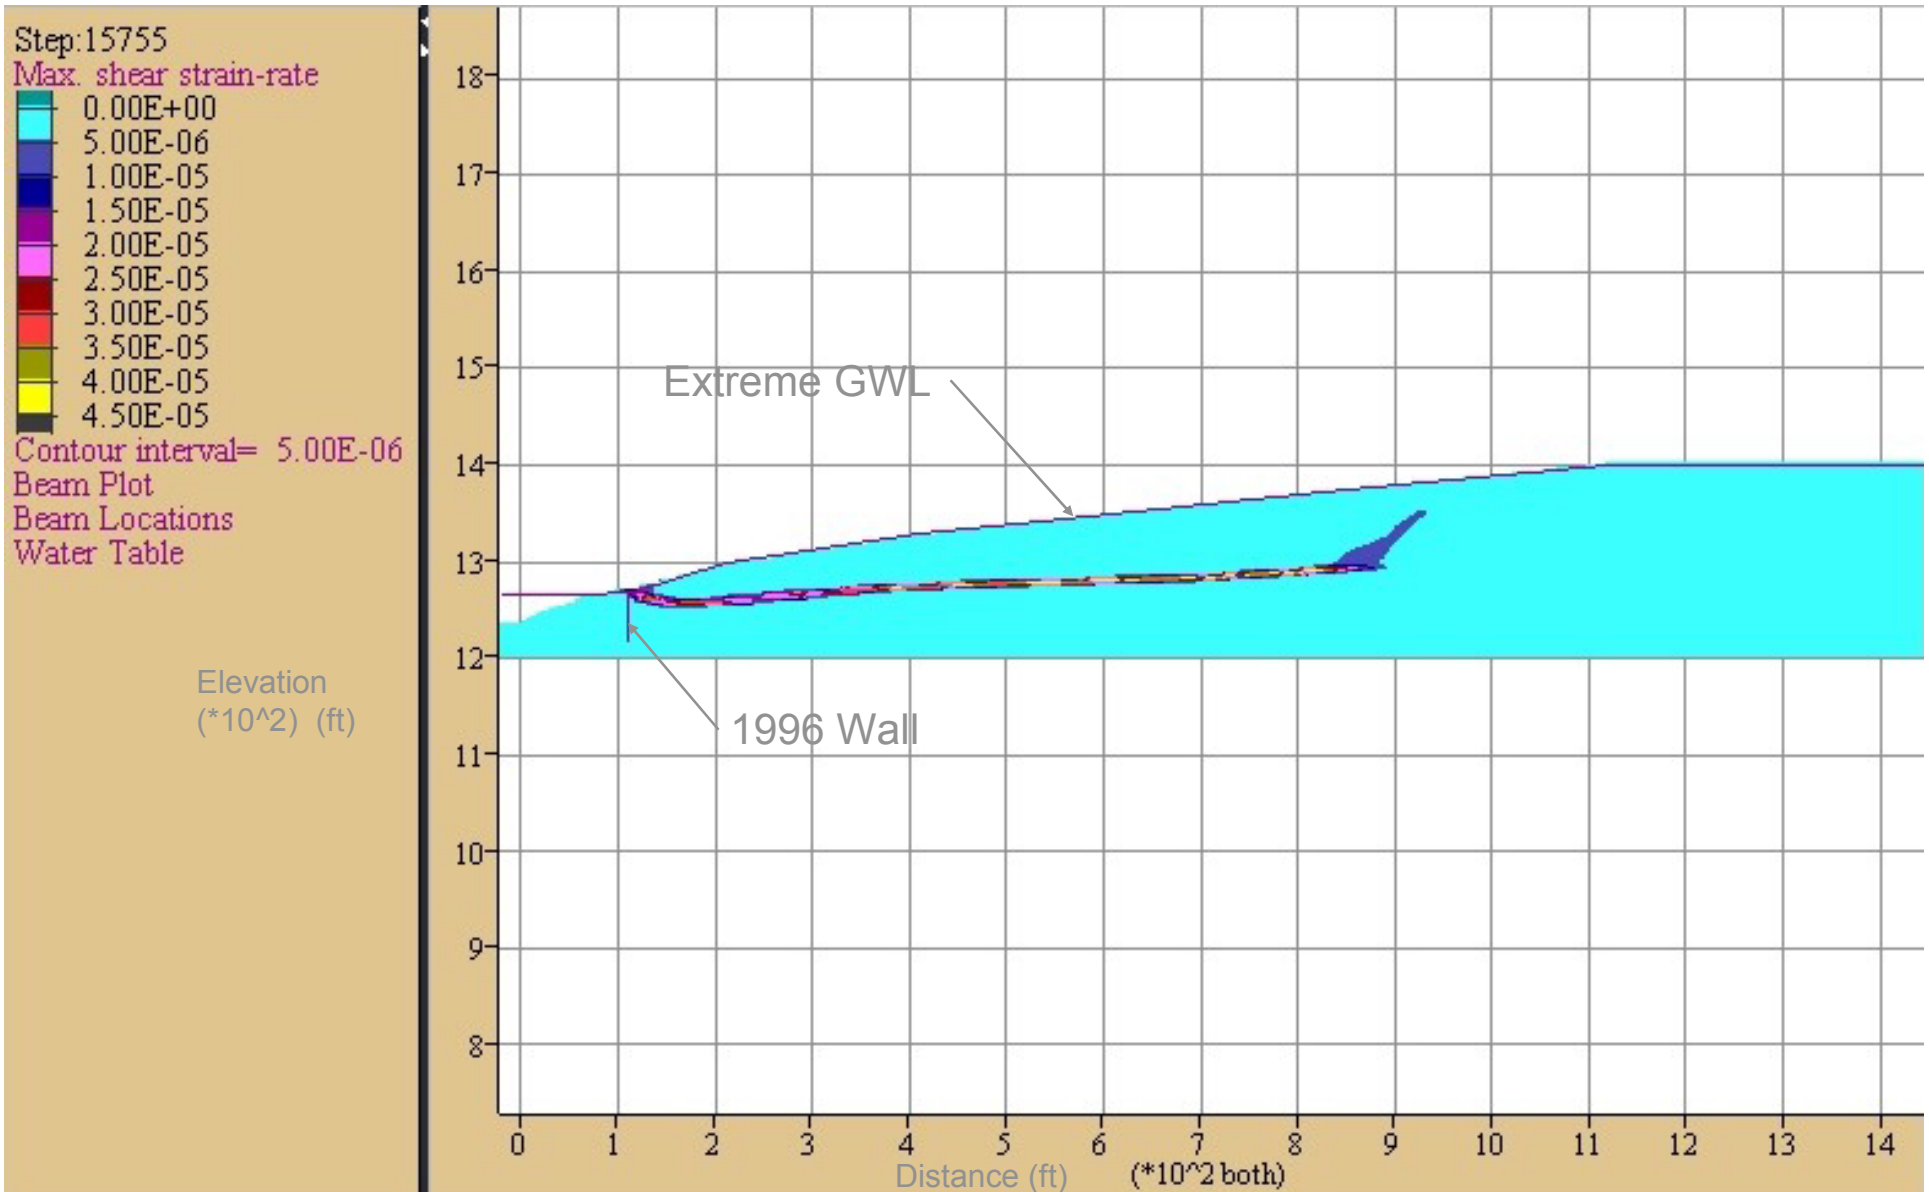
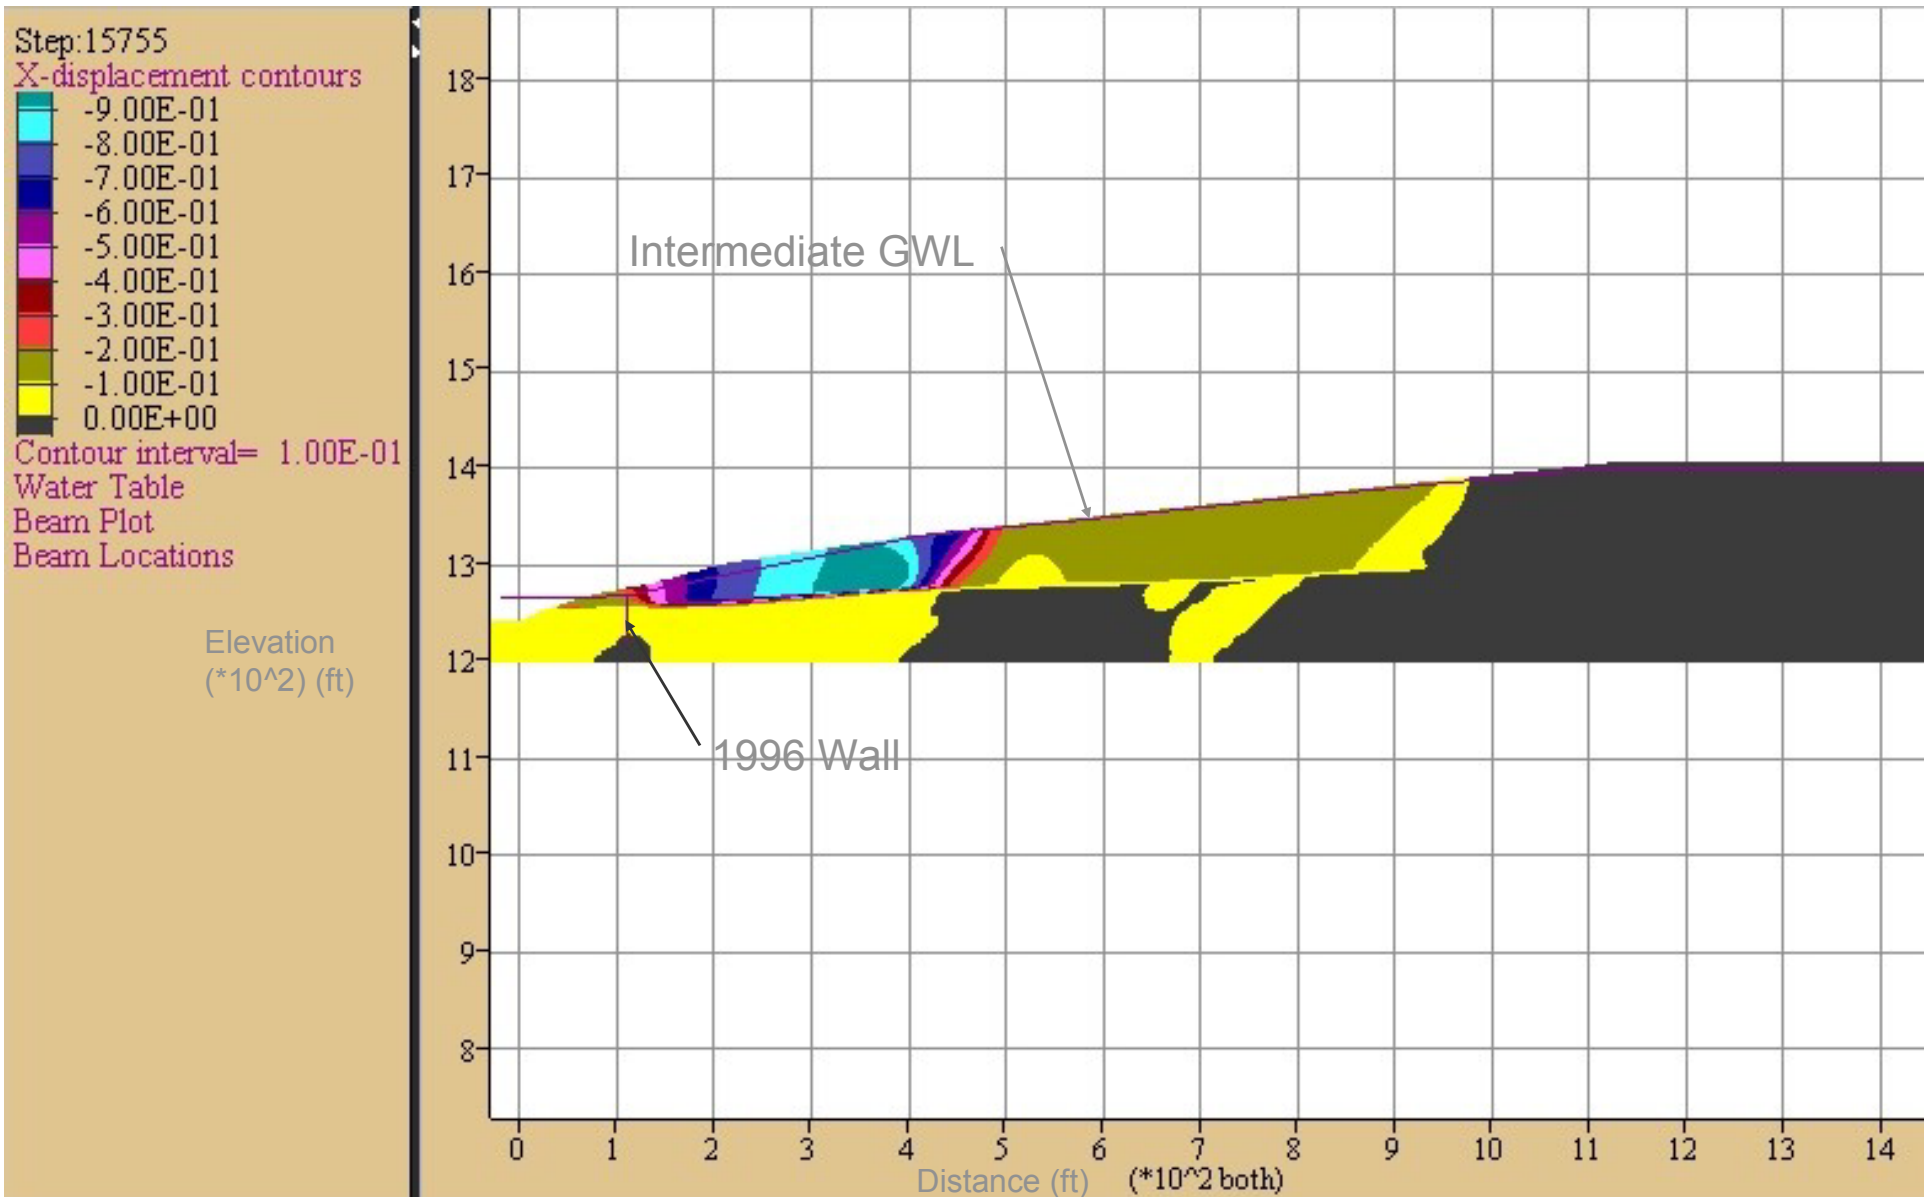
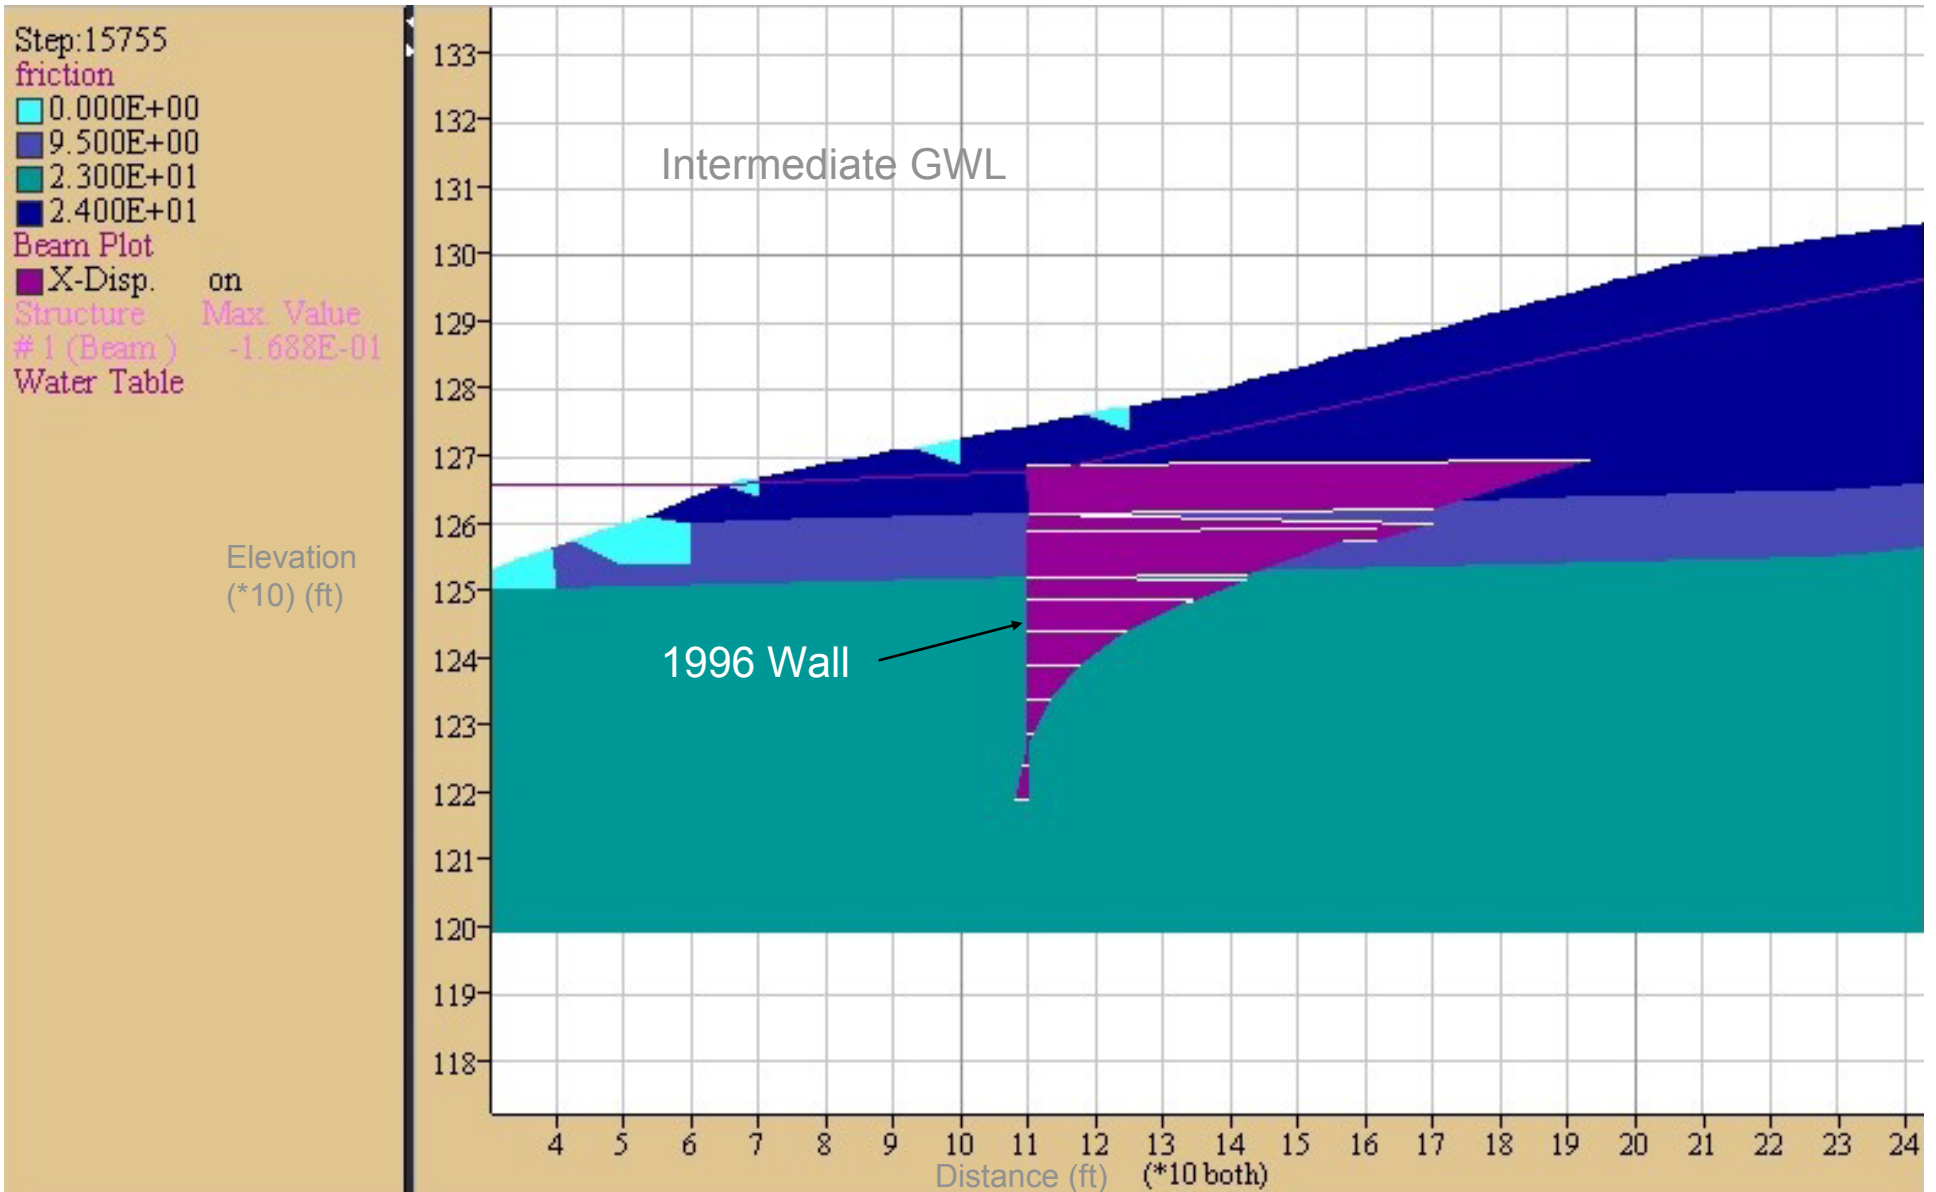
FLAC: 1996 Wall

FLAC results

- ✓ No searching for the critical failure surface
- ✓ Compute displacements with visual representation
- ✓ Helps in understanding problem
- ✓ General agreement with limit equilibrium results
- ✓ Abutment is stable to past historic high GWL's
- ✓ Abutment is at risk of failure to extreme GWL's
- ✓ At an intermediate GWL, abutment may be stable, but with much more deflection of the 1996 drilled shaft wall
