Fernando Belaunde Terry Campanilla-Pto Pizana W91278-04-C-0011

Peru Road Upgrade Project

**U.S. Army Corps of Engineers
Mobile District
Latin America Area Office**

**U.S. Army Corps of Engineers – Andrade Gutierrez
Sections II & III**

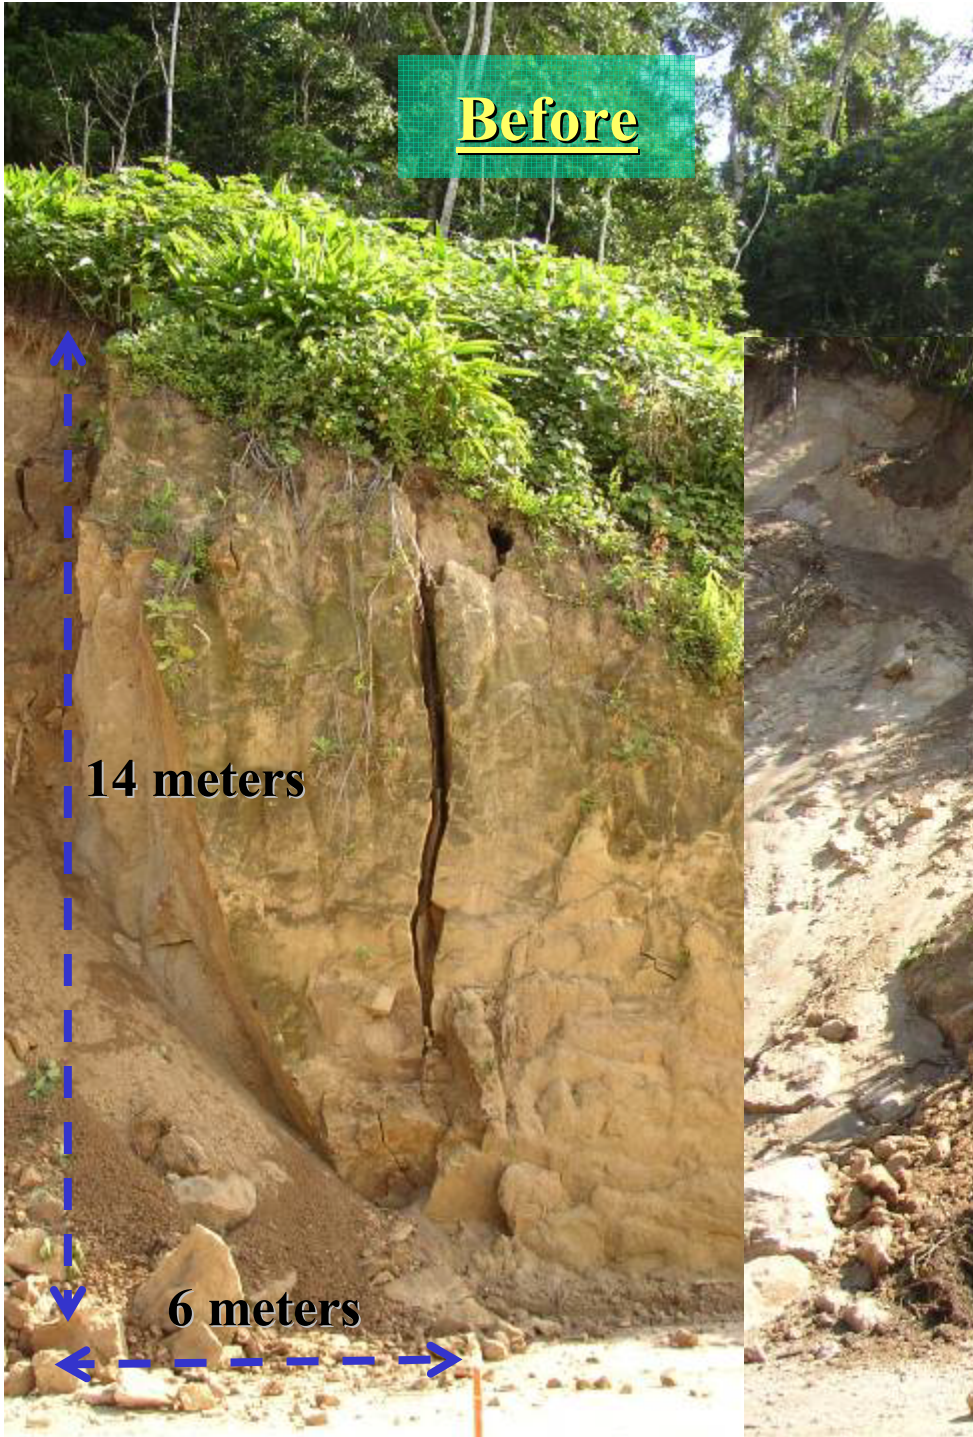
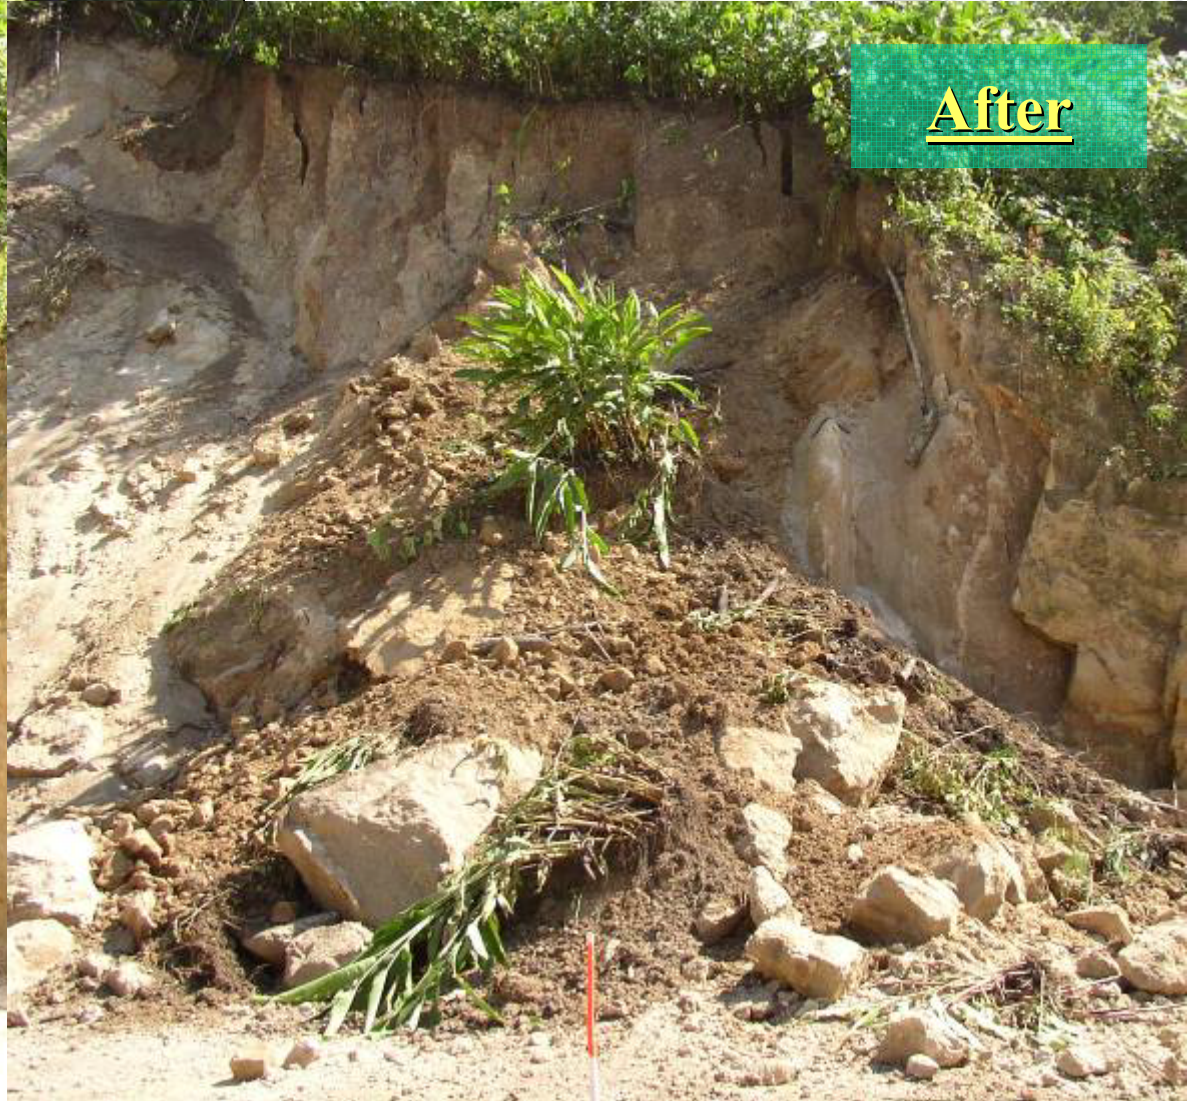
Landslides

Before

After

14 meters

6 meters

- **Delete unnecessary bridges, add box culverts where applicable**
- **Extending/reusing satisfactory culverts**
- **Use of nearby select granular borrow for platform stabilizing, backfill, and subbase course**
- **Eliminate some cuts & fills, follow the “lay of the land” where practical**
- **Road re-alignment away from slides**
- **Adjusting pavement design layers**
