# Laboratory Testing of Flood Fighting Structures

Johannes L. Wibowo, GSL

*Engineer Research and Development Center*

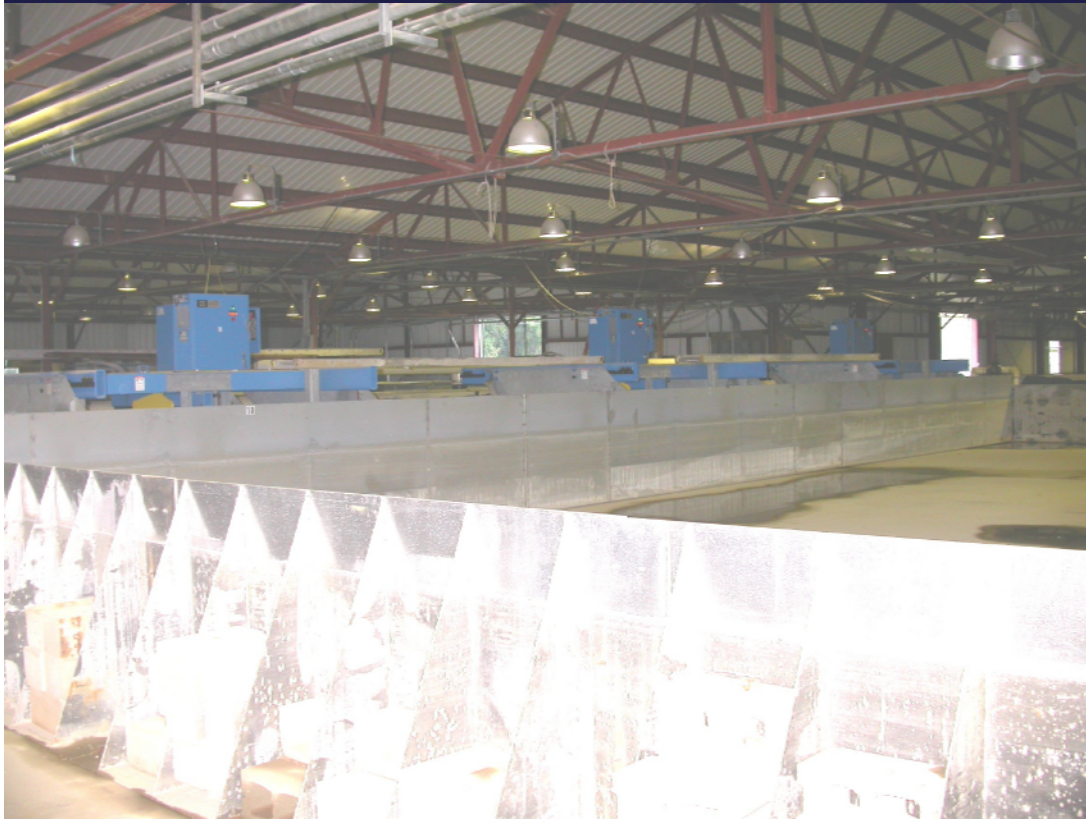
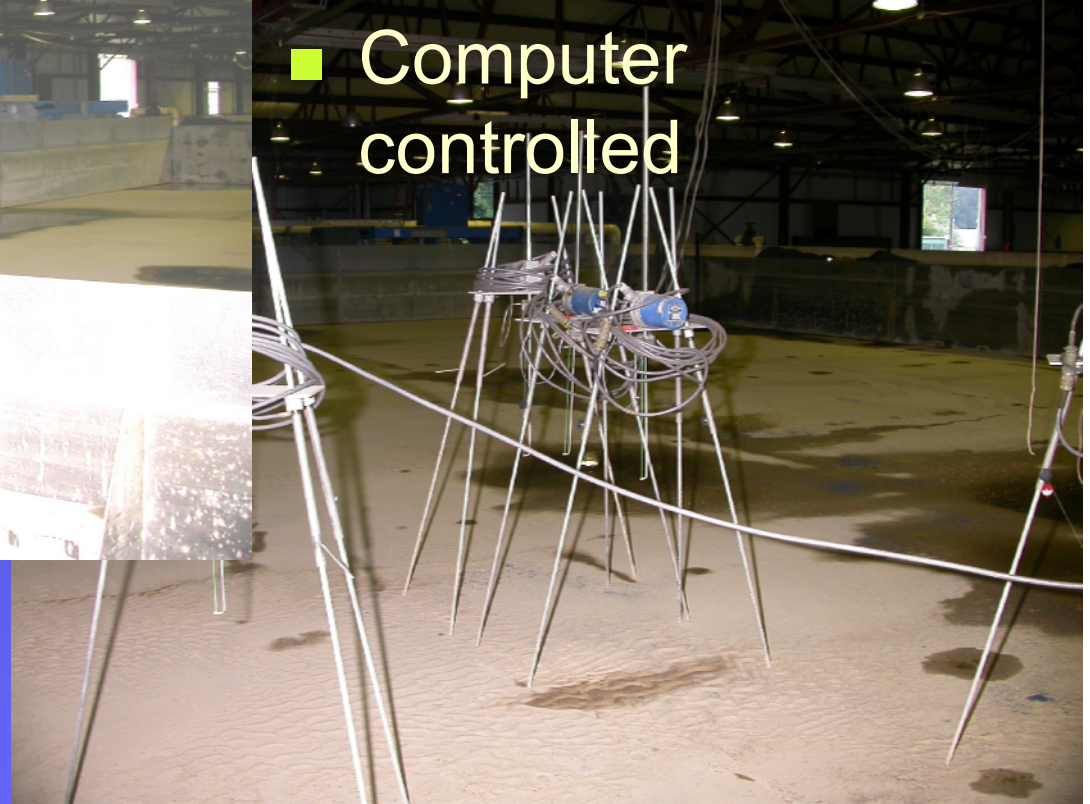
# Three 25-ft-wide wave generators

- Synchronized
- Spectral or monochromatic
- Computer controlled

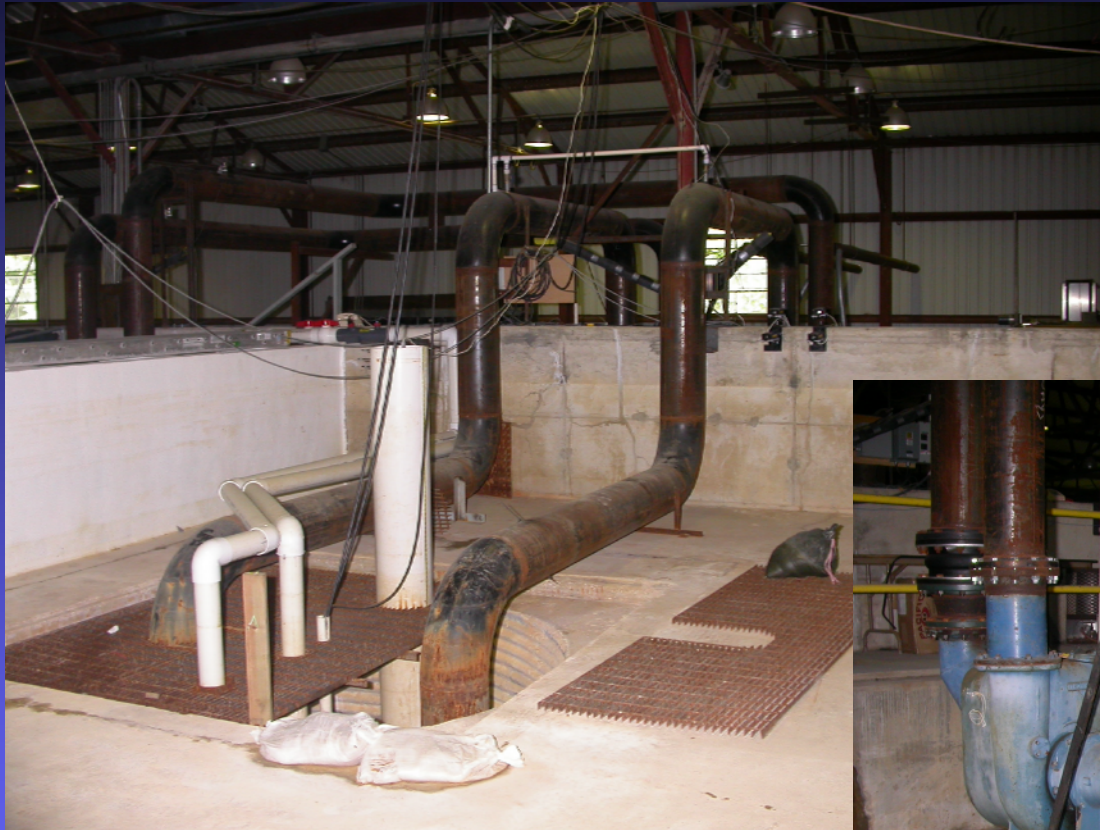
# 8-ft-diameter sump

- Two 4-in pumps
- Two diesel pumps

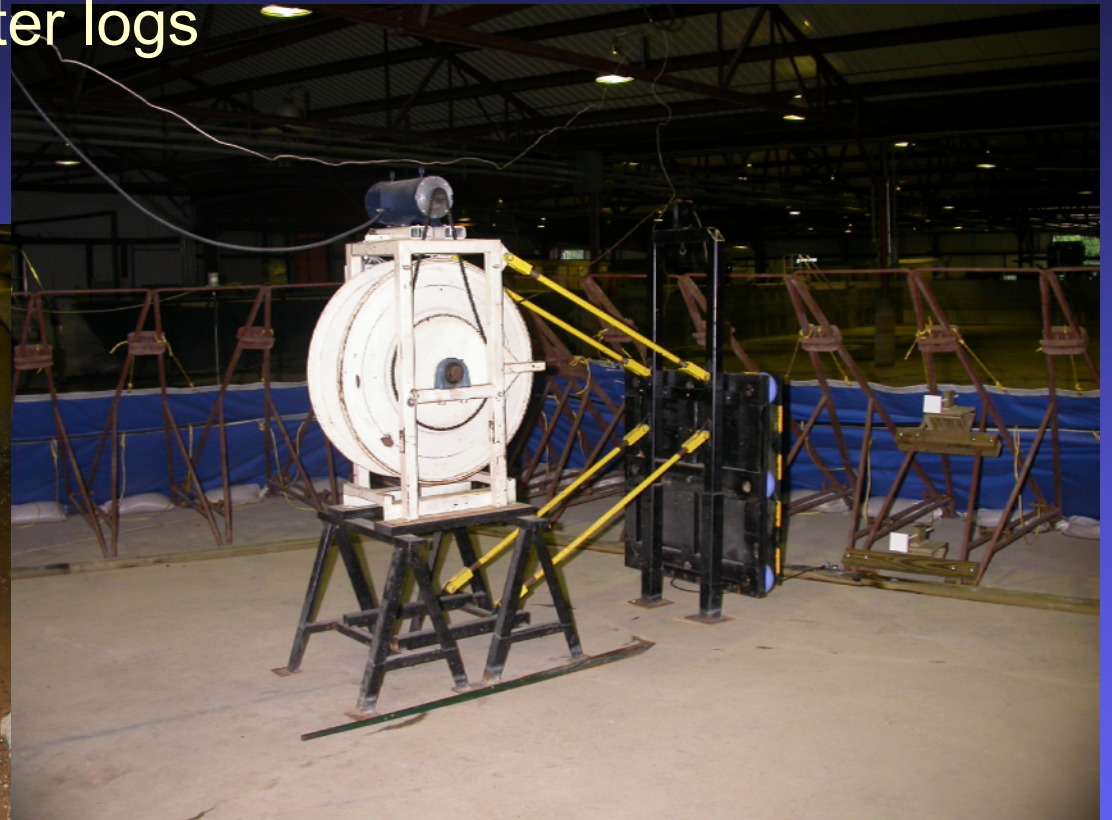
# Impact Tests

- 12-in and 16-in-diameter logs
- 5 mph

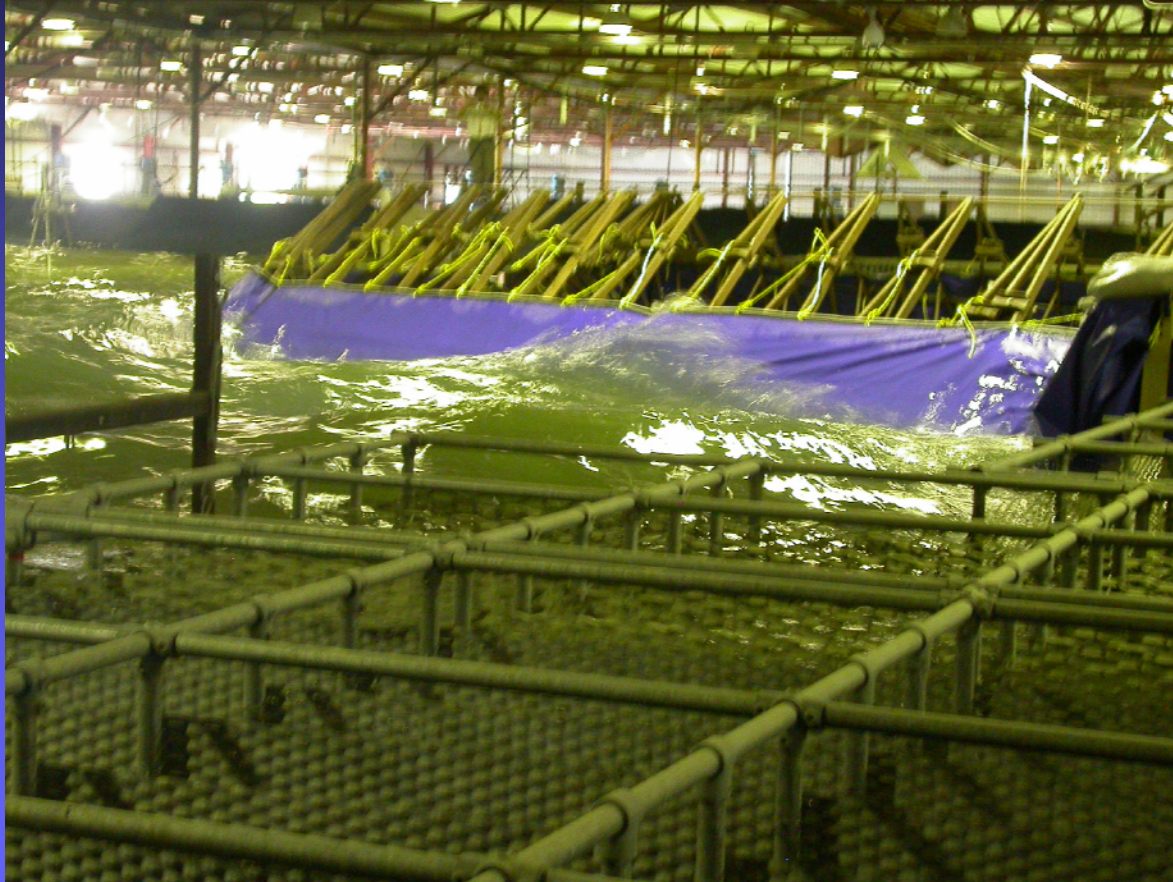
# Dynamic Wave Tests

- 2 inch Waves for 7 hours
- 6-8 inch Waves for 30 min
- 10-12 inch Waves for 10 min

- All waves at 67%H and 80%H

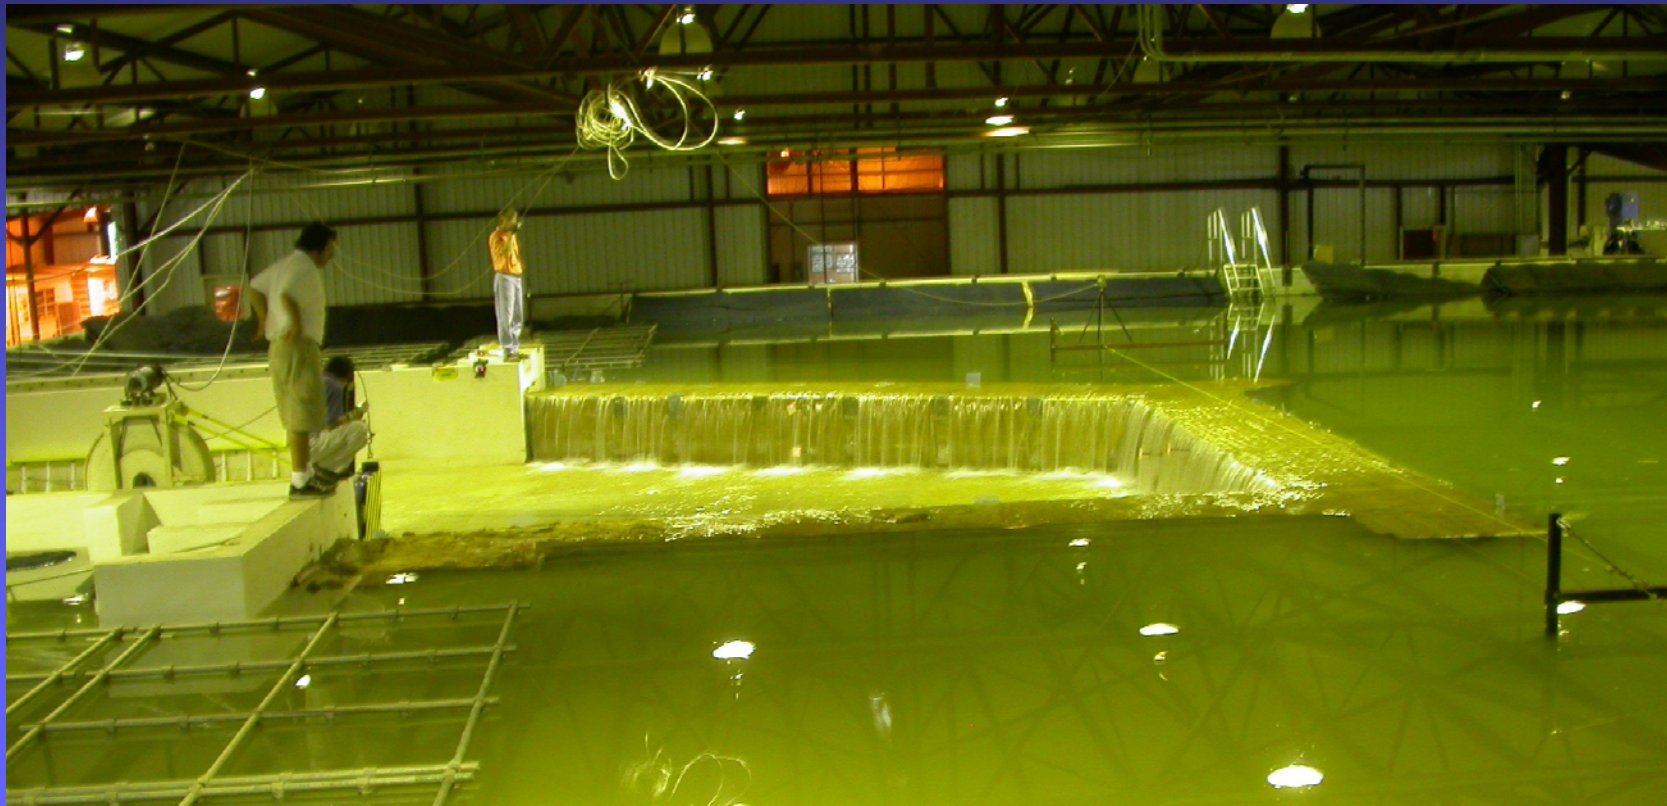
# Overtopping Test

- 1 inch Head for 1 hour
- Damage and Survivability Test

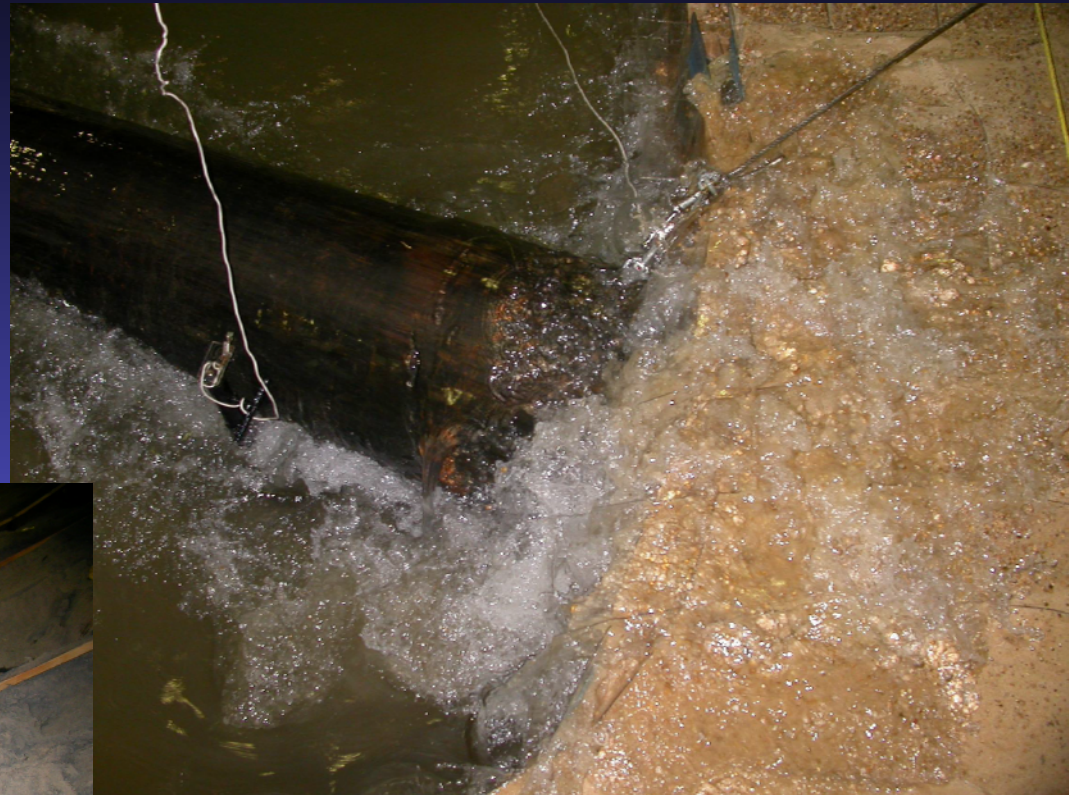
# Debris Impact Test

- 12-in-diameter log, 5 mph
- 16-in-diameter log, 5 mph

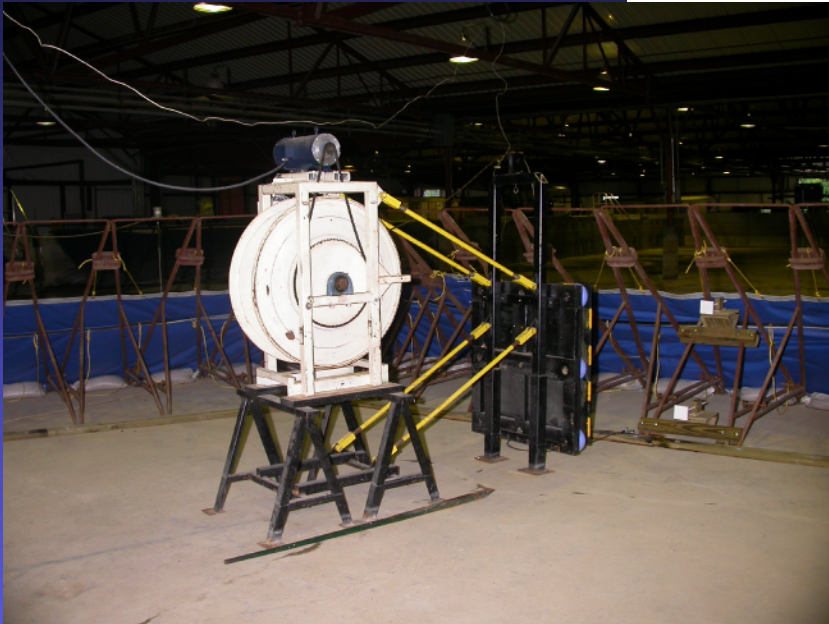
# Impact Tests

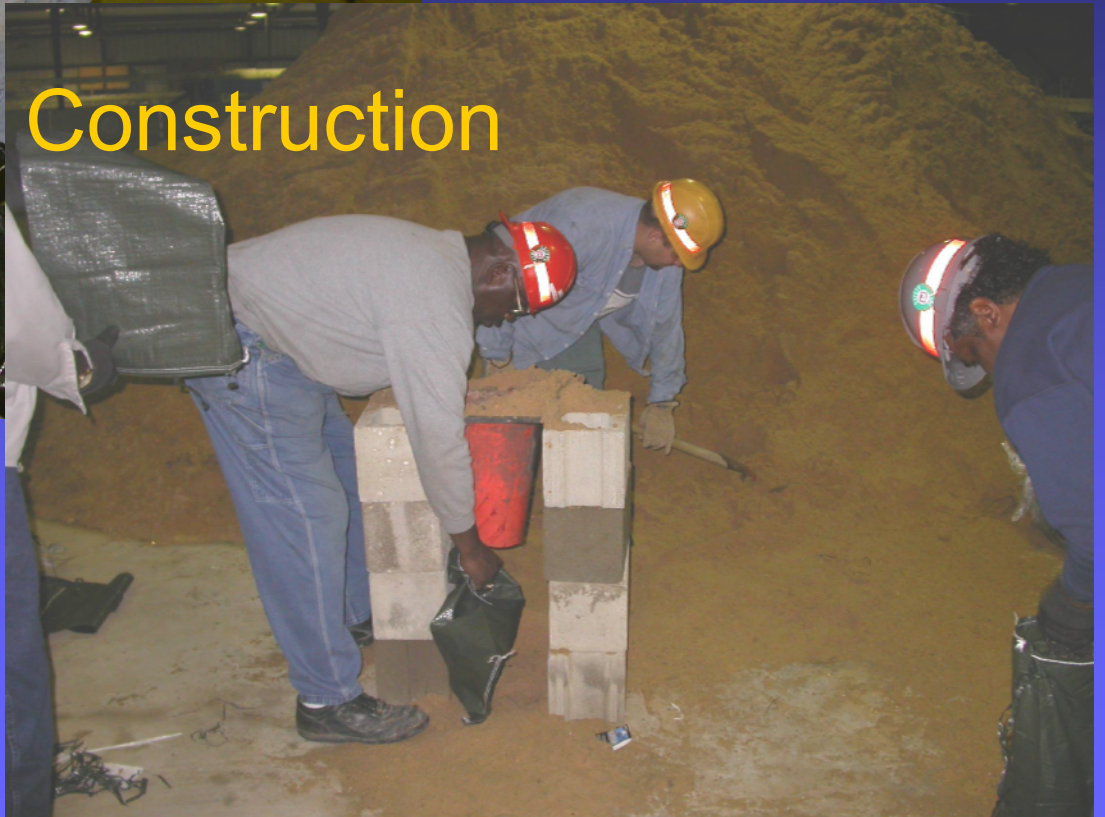
# Sandbag Levee - Construction

- 205.1 Man-hours
- Equipments:
  - Front-end loader
  - Manual sandbagger
  - Cones
- Materials
  - Sandbags
  - Sand

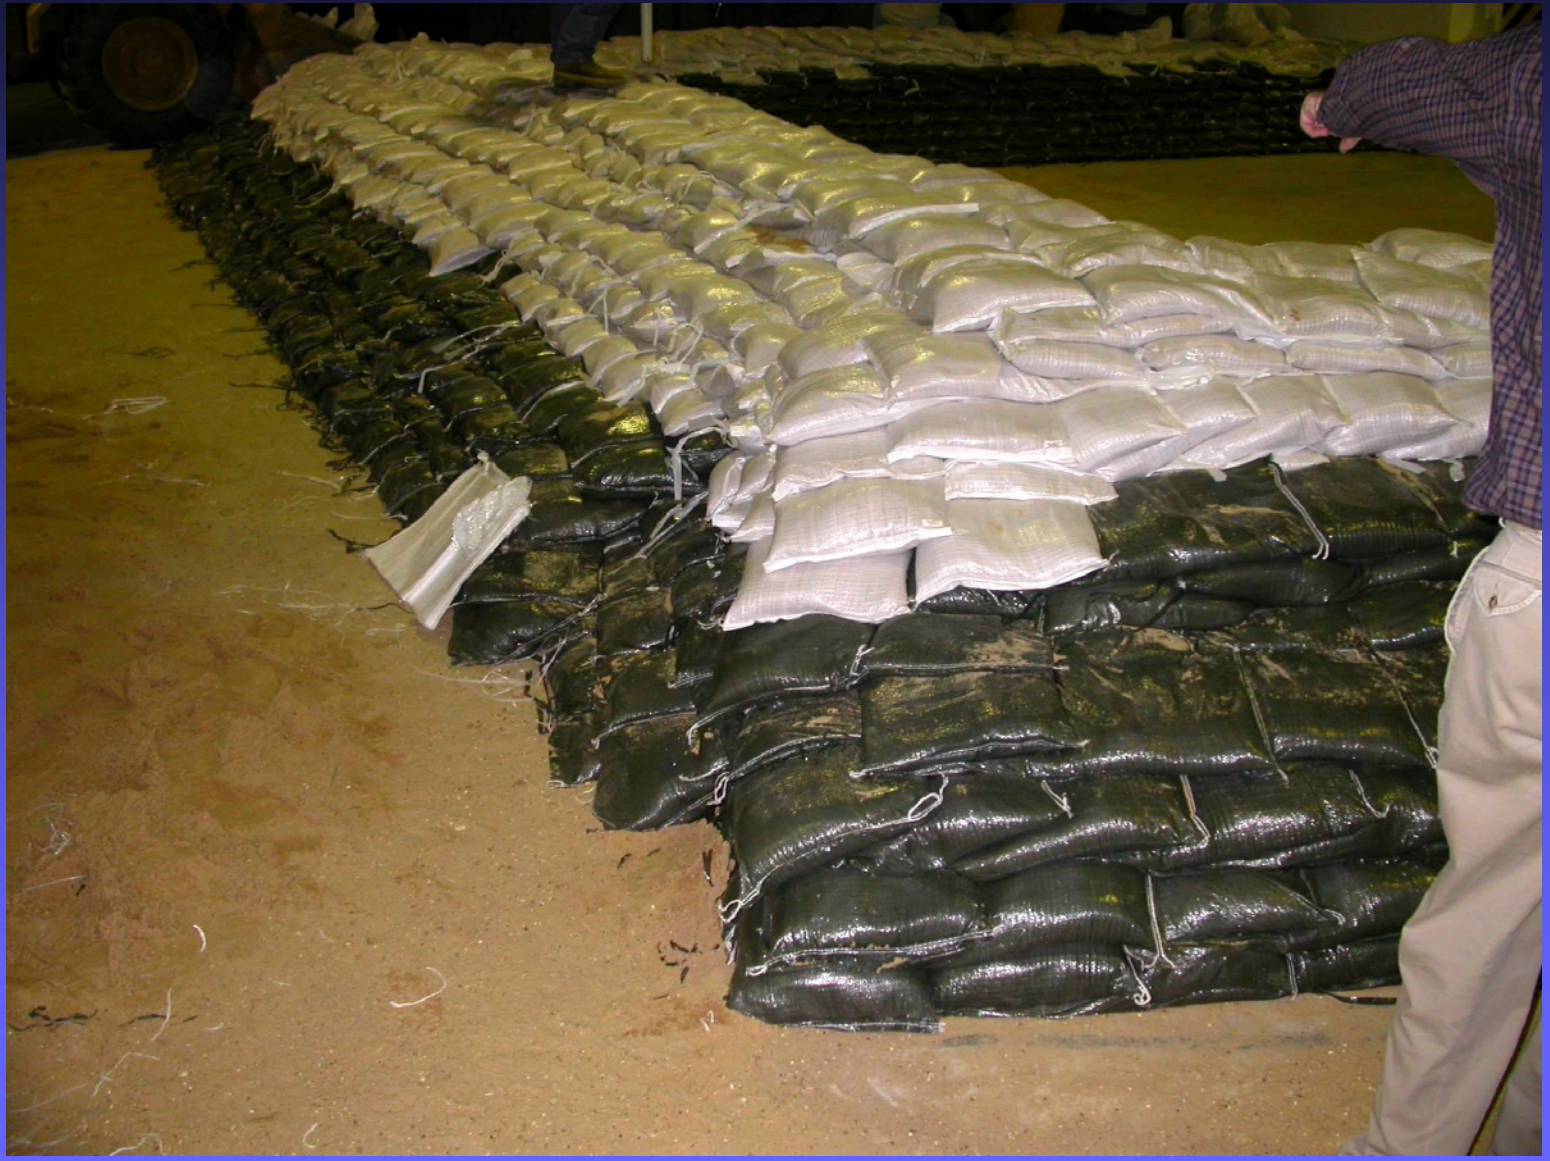
# Sandbag Levee - Construction

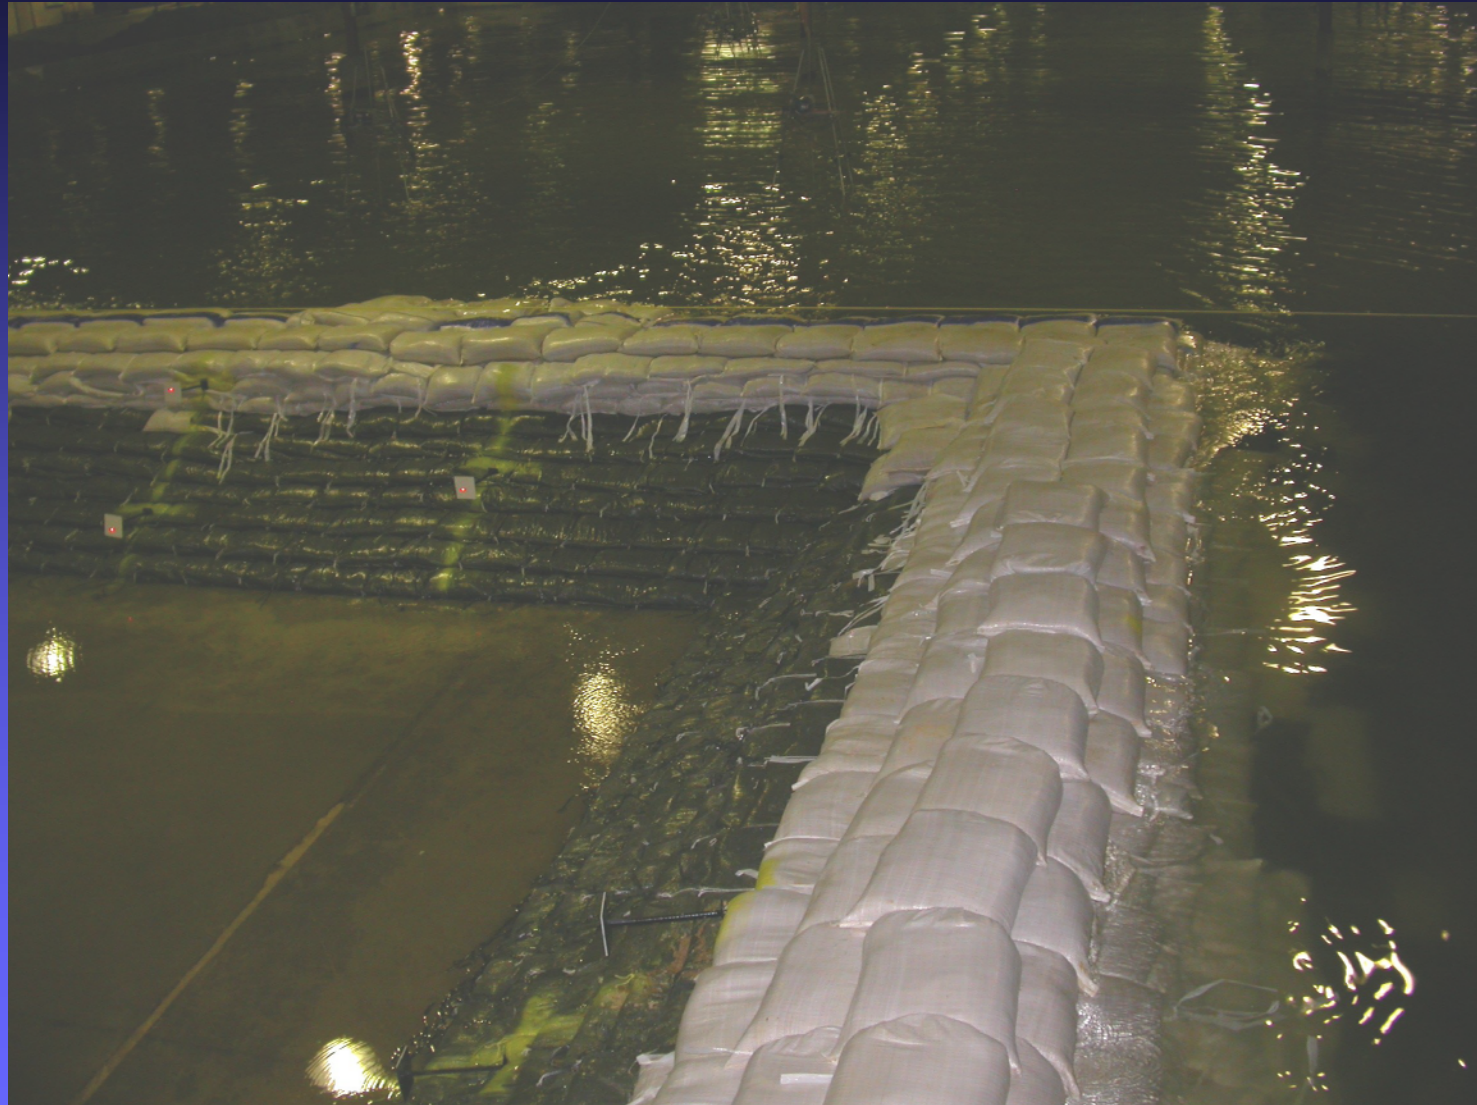
# Sandbag Levee - Static

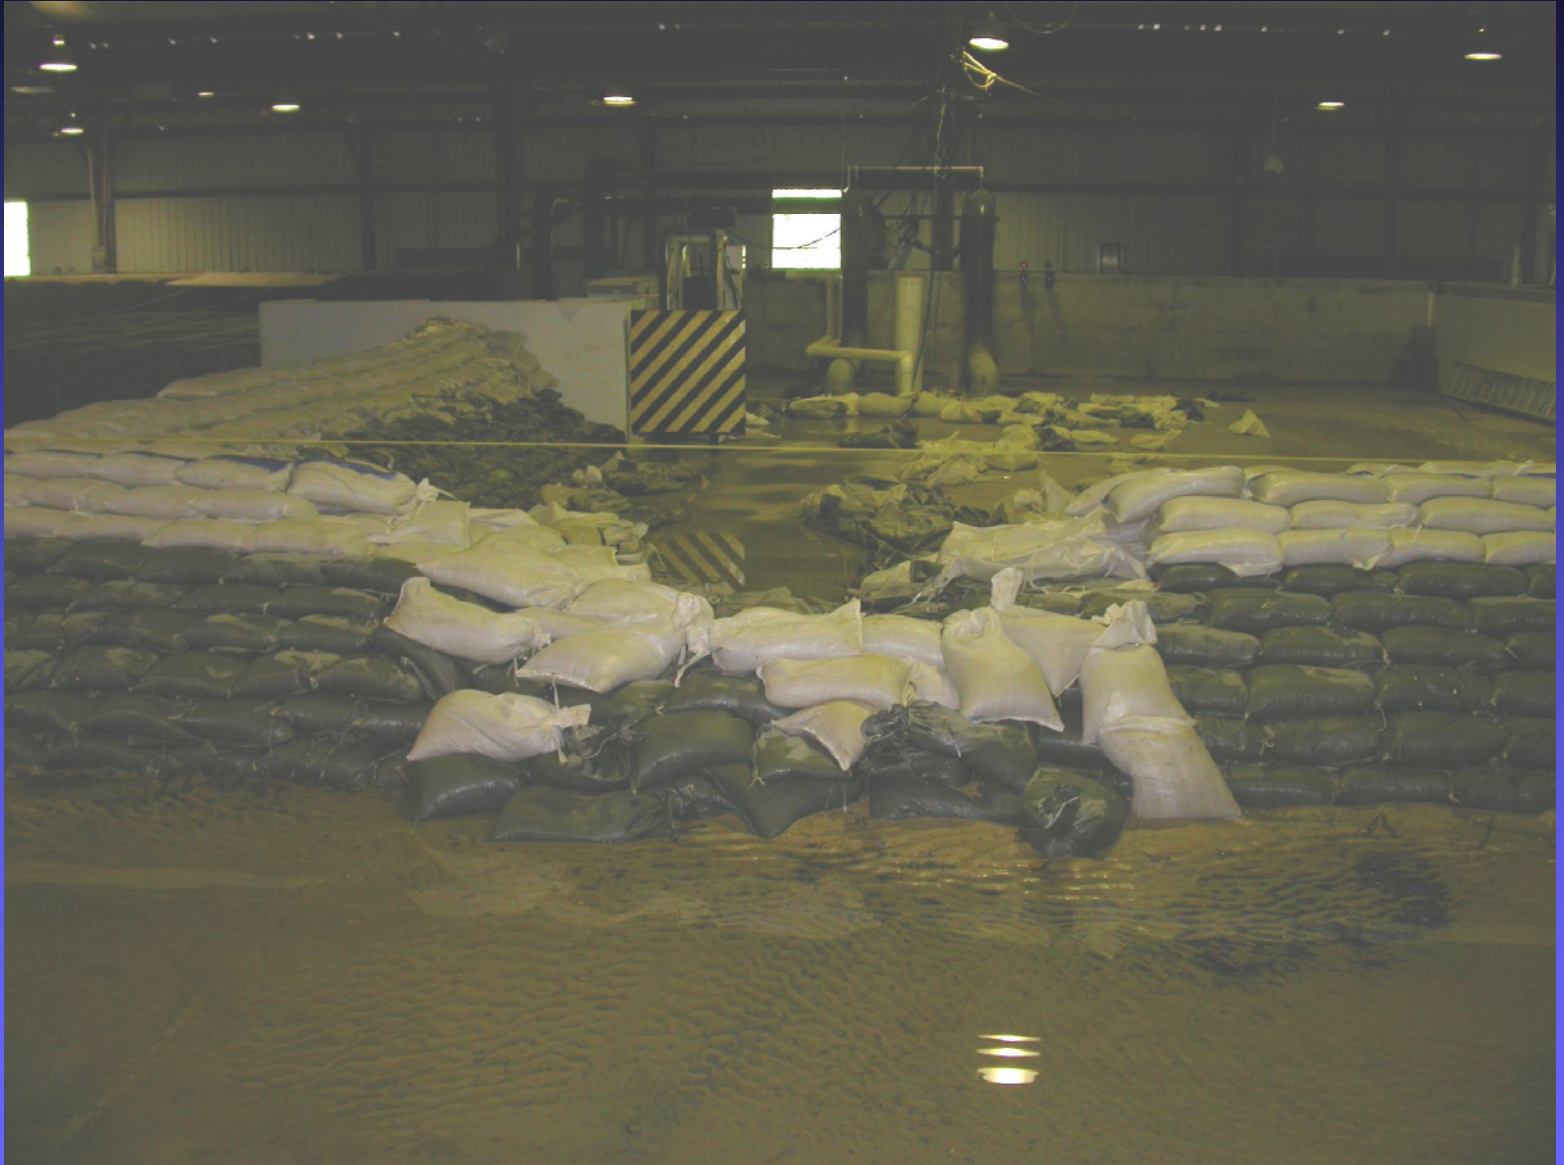
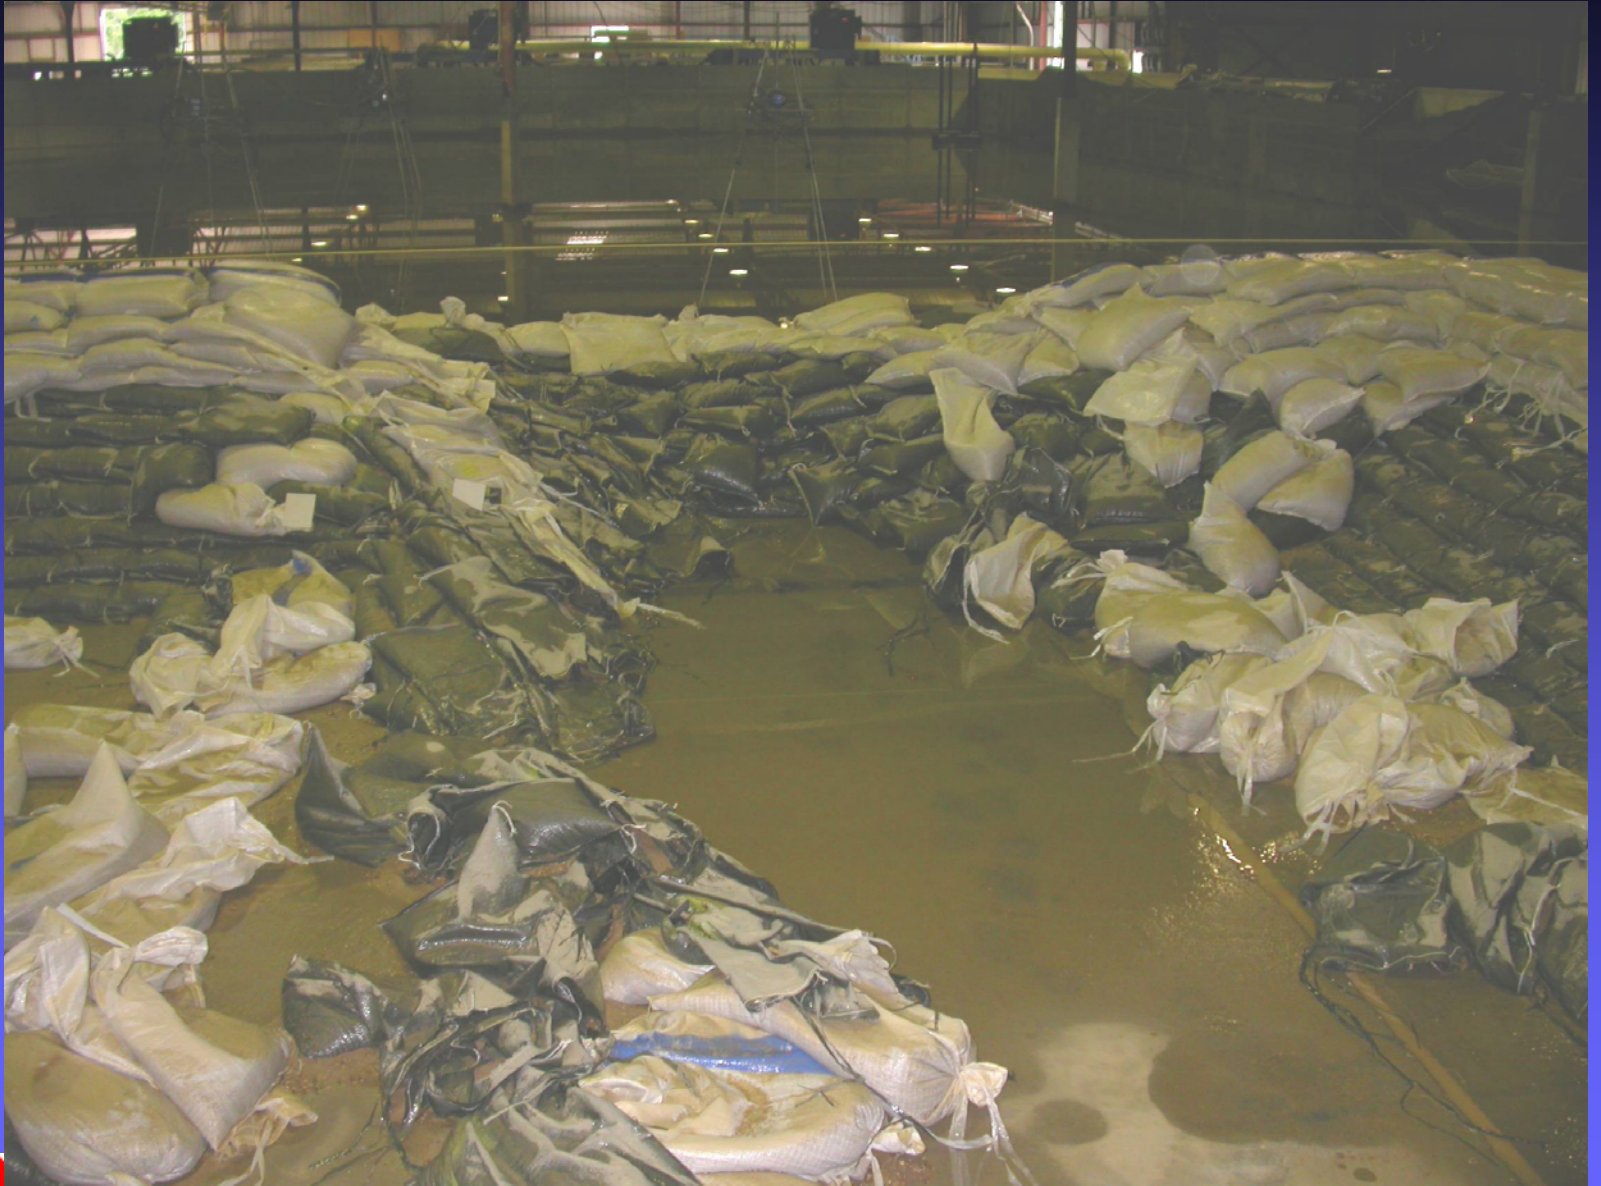
# Sandbag Levee – Overtopping

- Sandbags
  - Repeatedly damaged by waves
  - Failed during overtopping
- Hesco-Bastion Concertainer
  - Some sand settling and washout (minor)
  - Wire bent by log impact

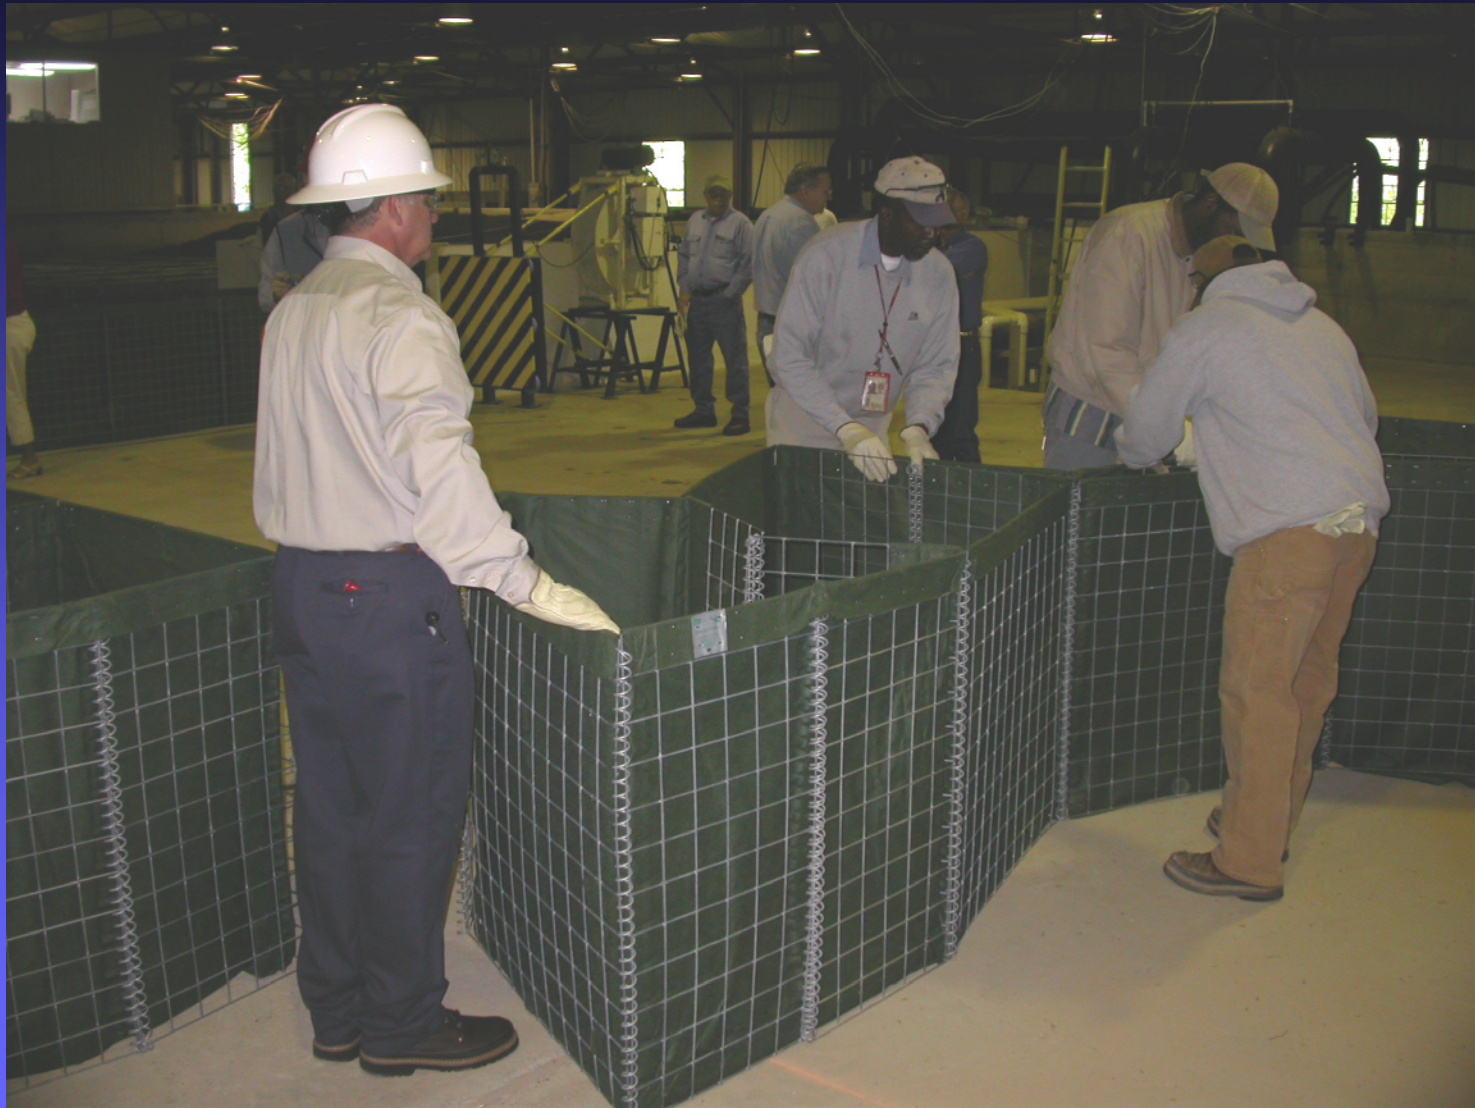
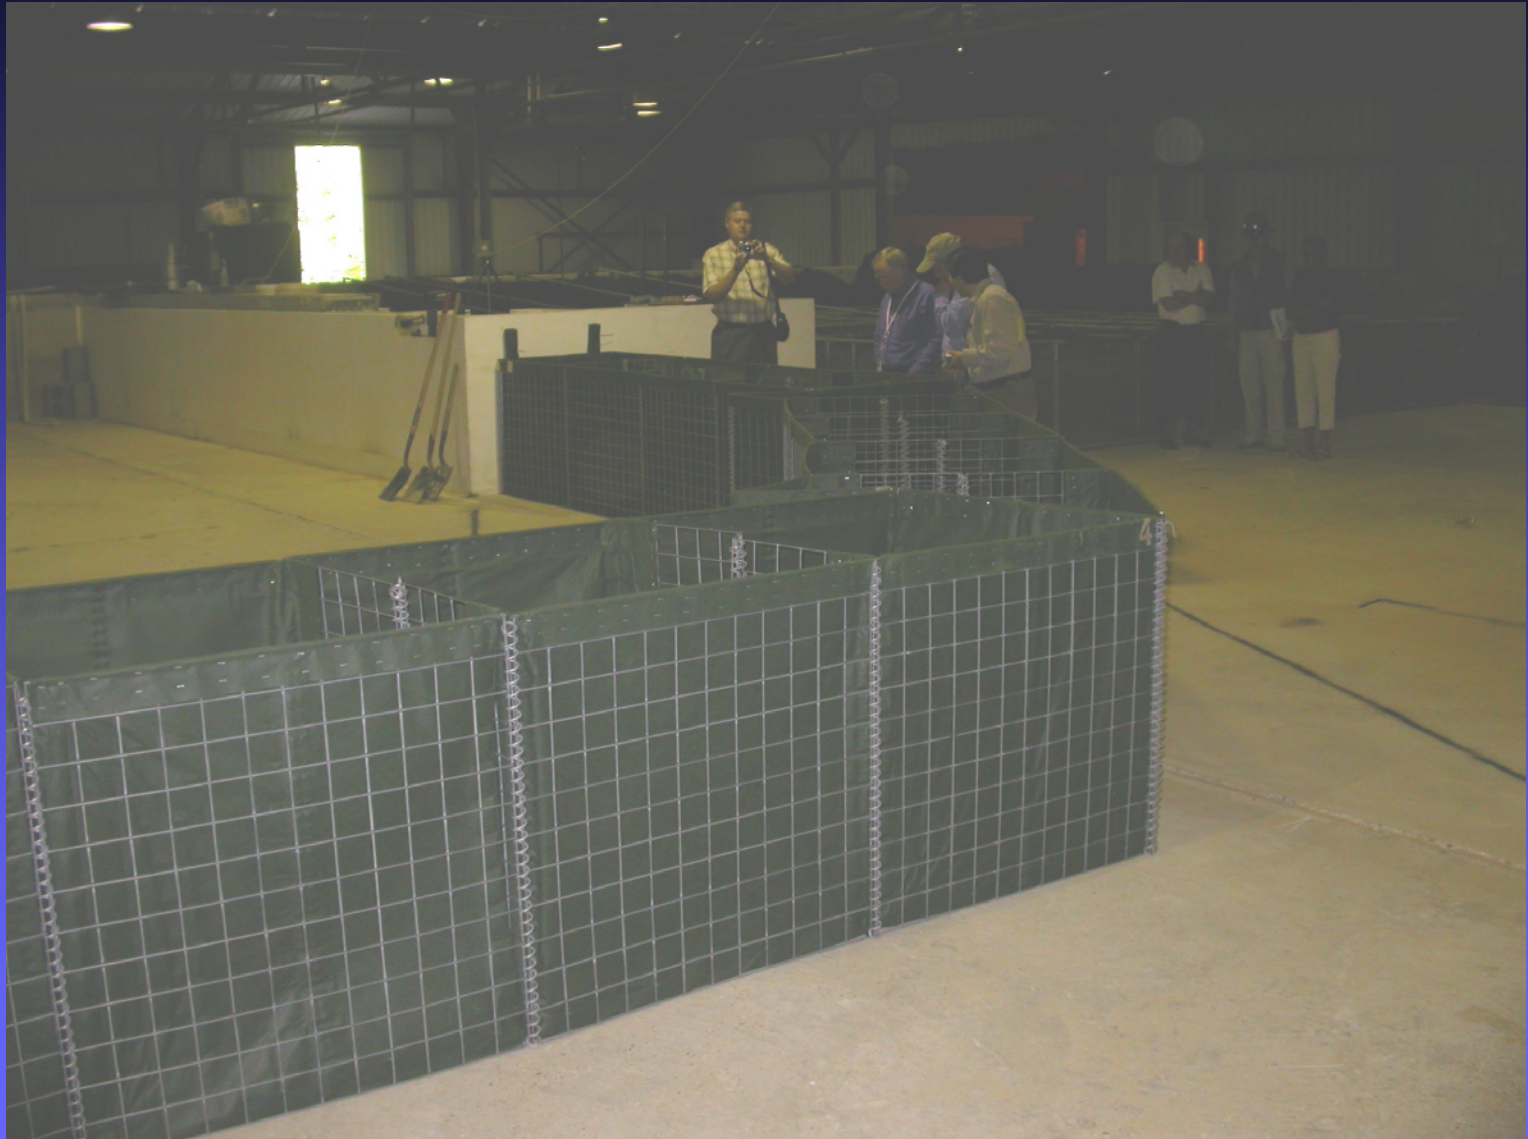
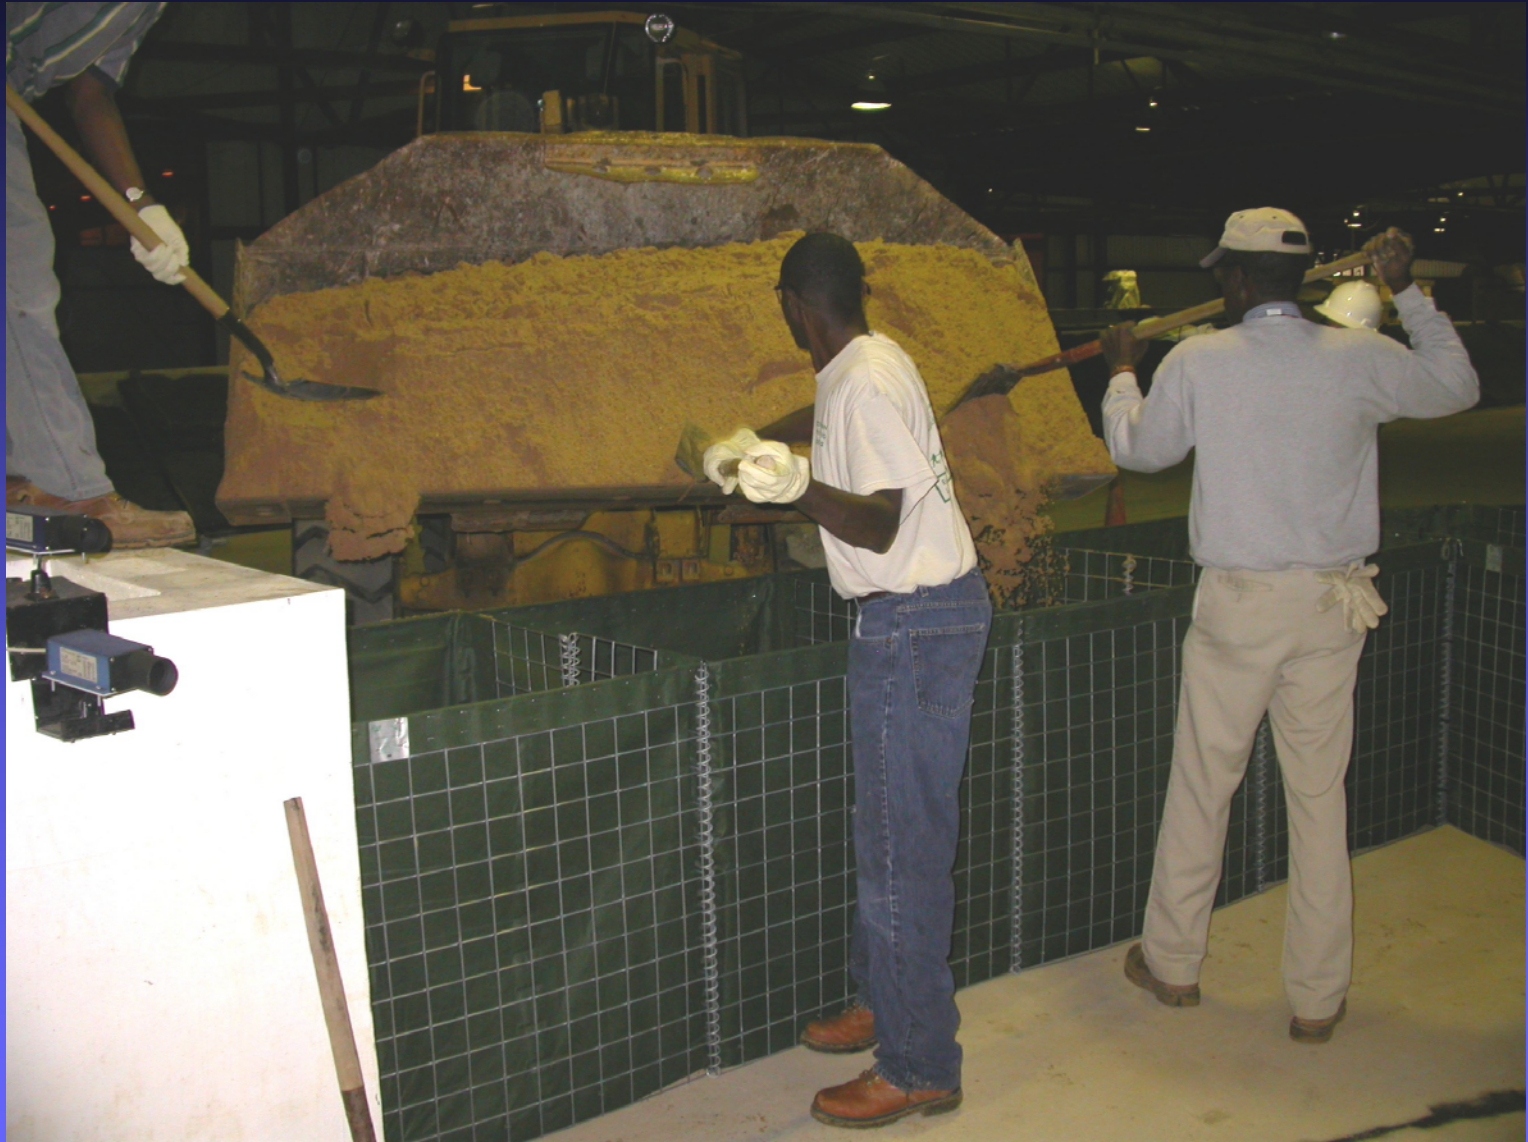
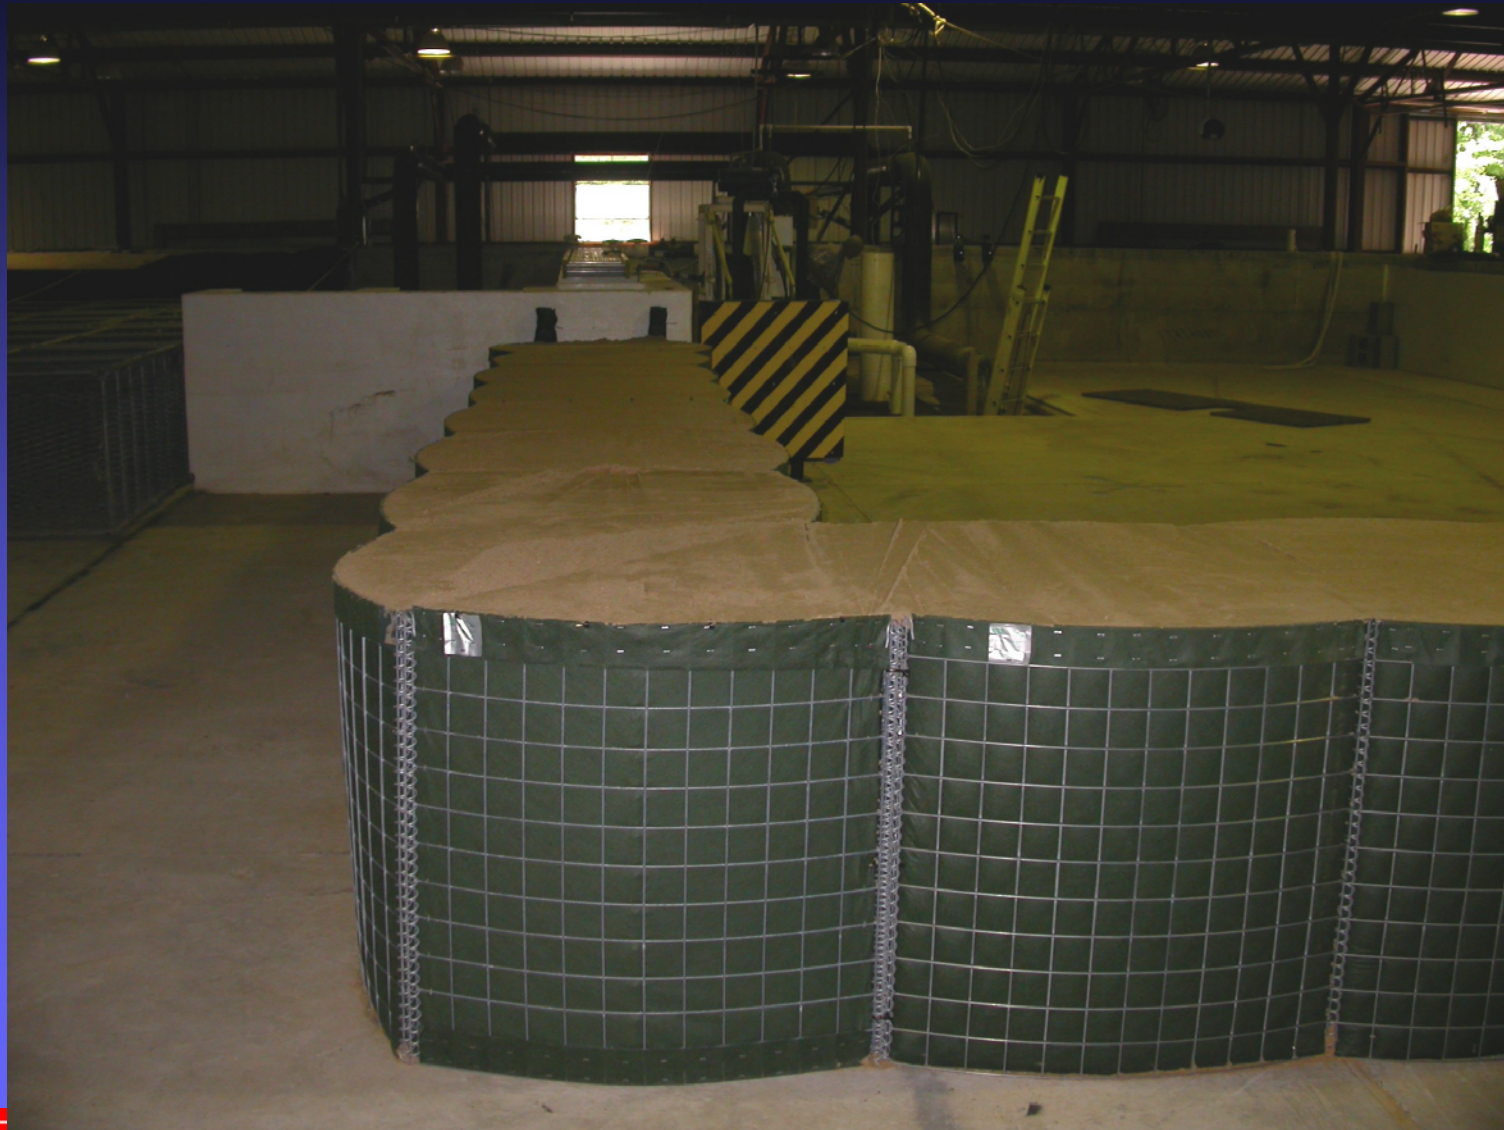
# Hesco-Bastion Concertainer Construction

- 20.8 Man-hours
- Equipments:
  - Front-end loader
- Materials
  - Concertainers
  - Sand, 5 Sandbags
  - Insulating Foam
- Comments
  - 6-man crew took 3 hr 28 min
