# Laboratory Testing of Flood Fighting Structures

Johannes L. Wibowo, GSL

*Engineer Research and Development Center*

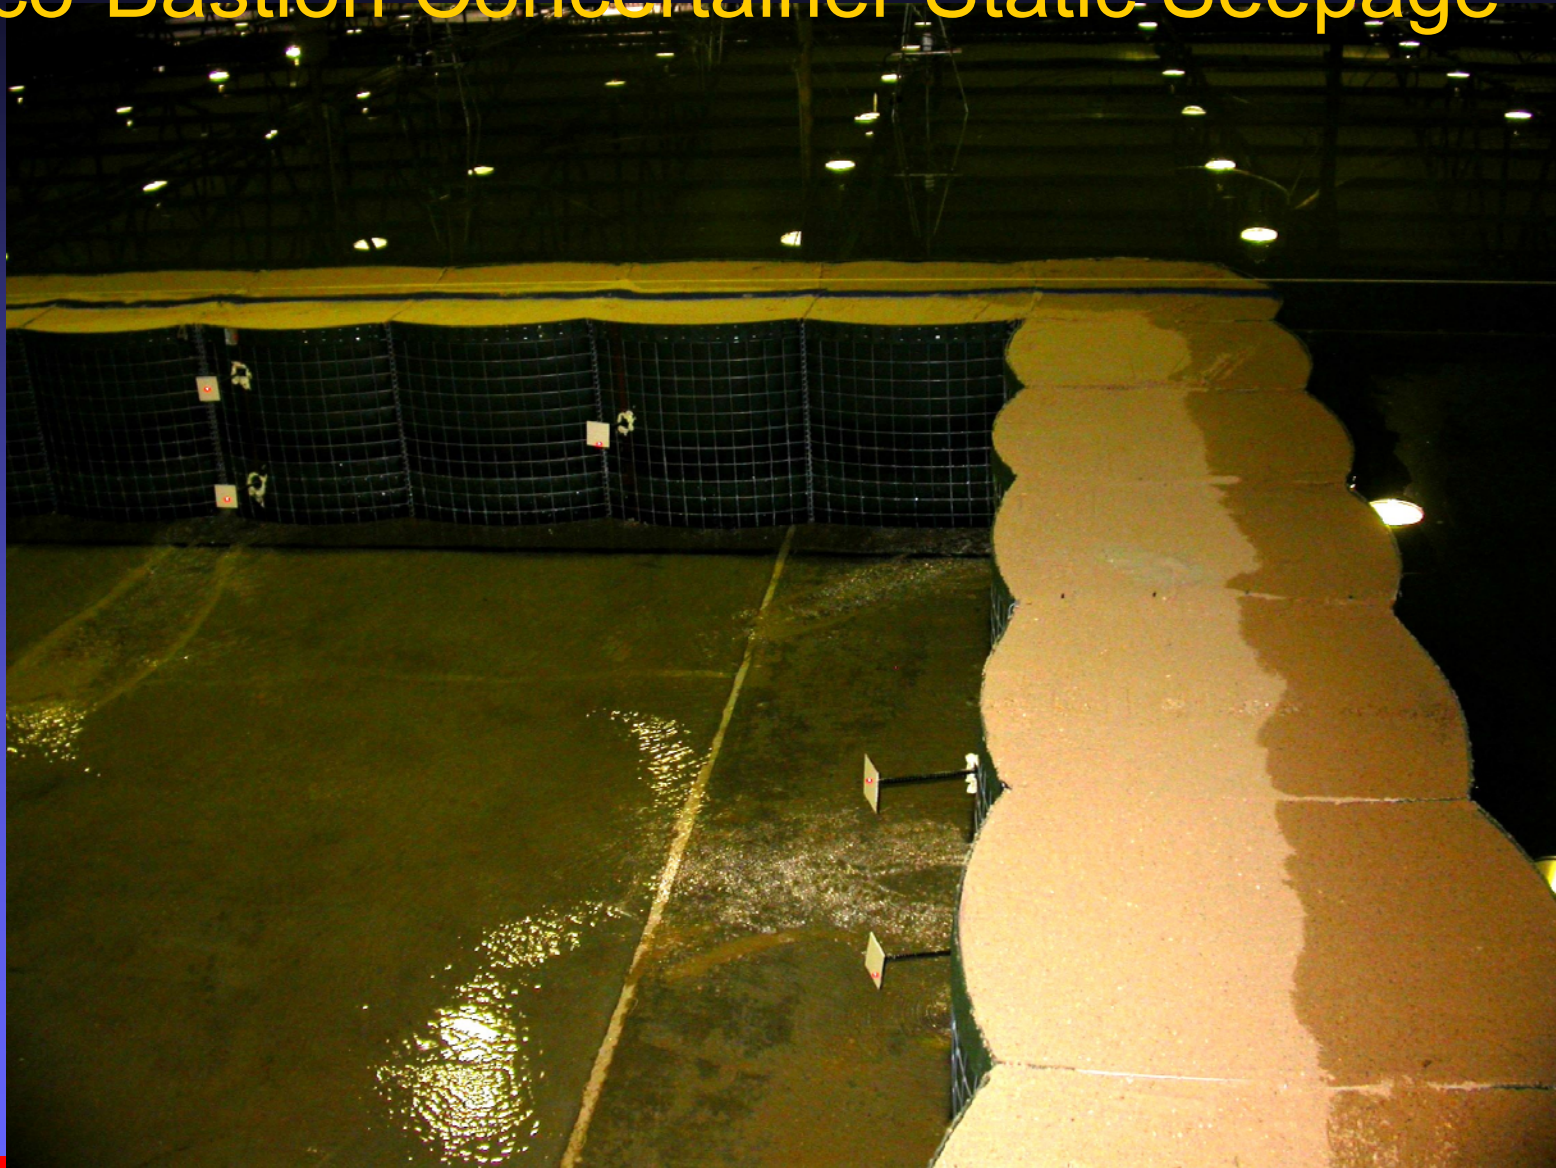
# Hesco-Bastion Concertainer Static Seepage

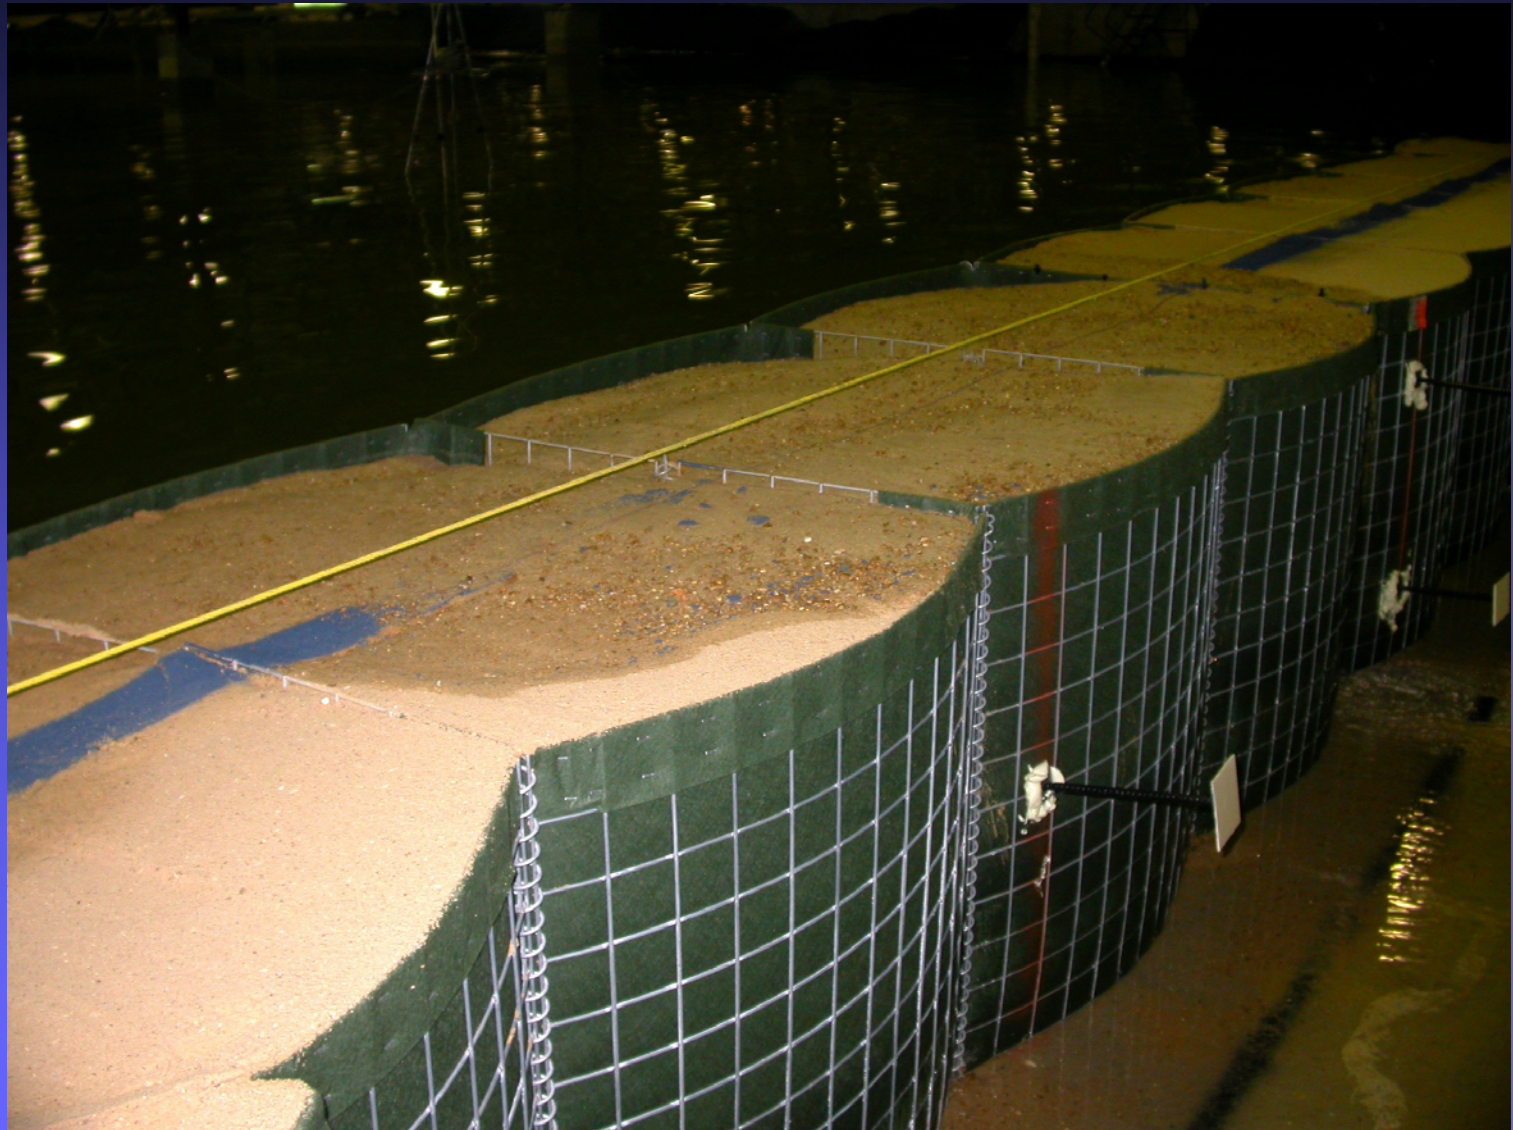
# Hesco-Bastion Concertainer – Wave Damage

- Repair 1: 1.6 Man-hours
  - Added membrane over surface
- Repair 2: 0.2 Man-hours
  - Placed sandbags along toe
- Repair 3: N/A

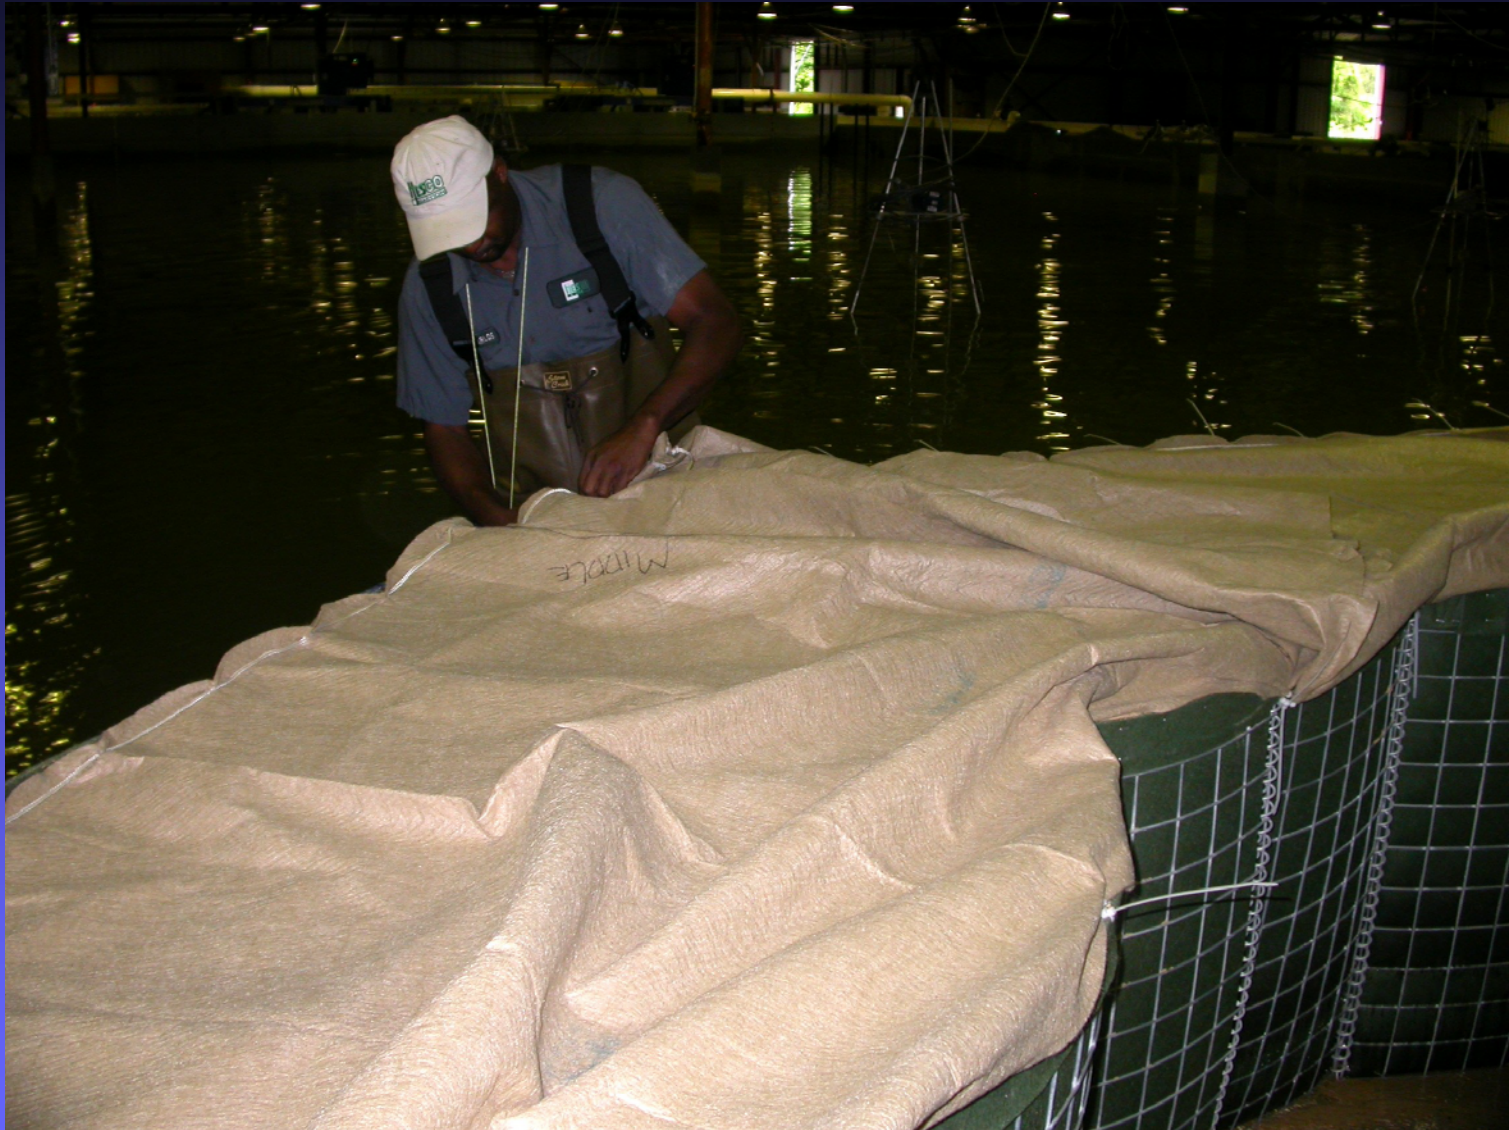
# Hesco-Bastion Concertainer – Cover Installation

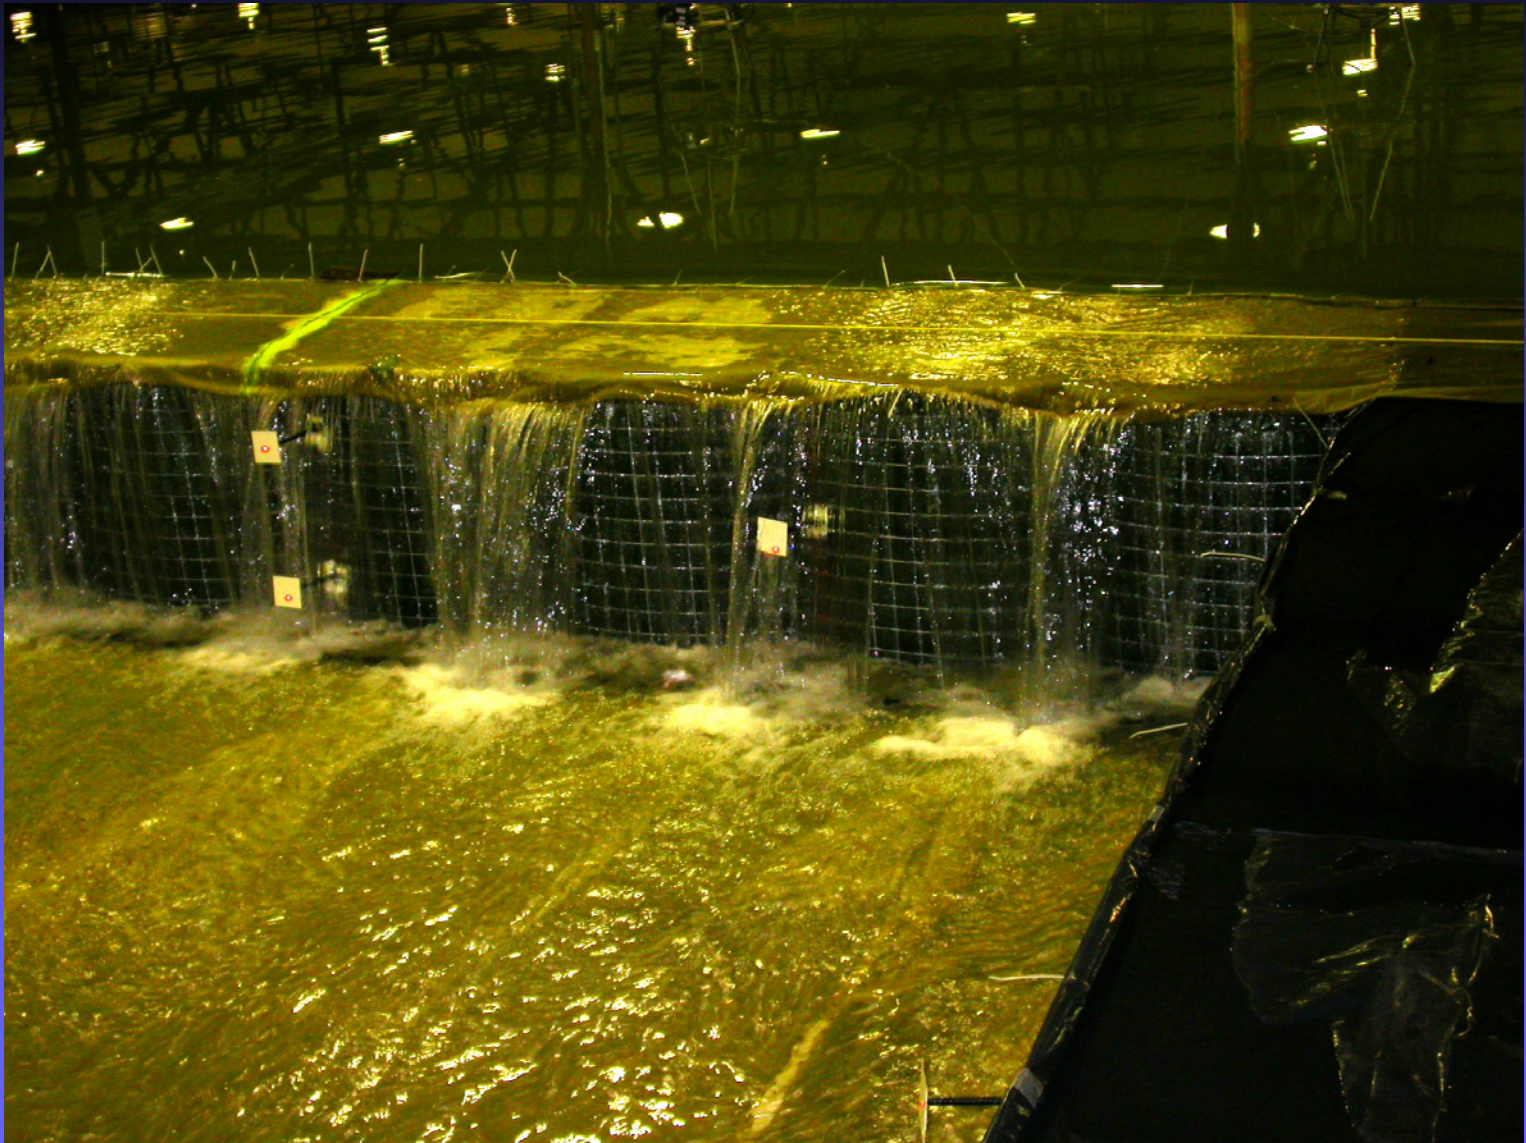
# Hesco-Bastion Concertainer – Overtopping

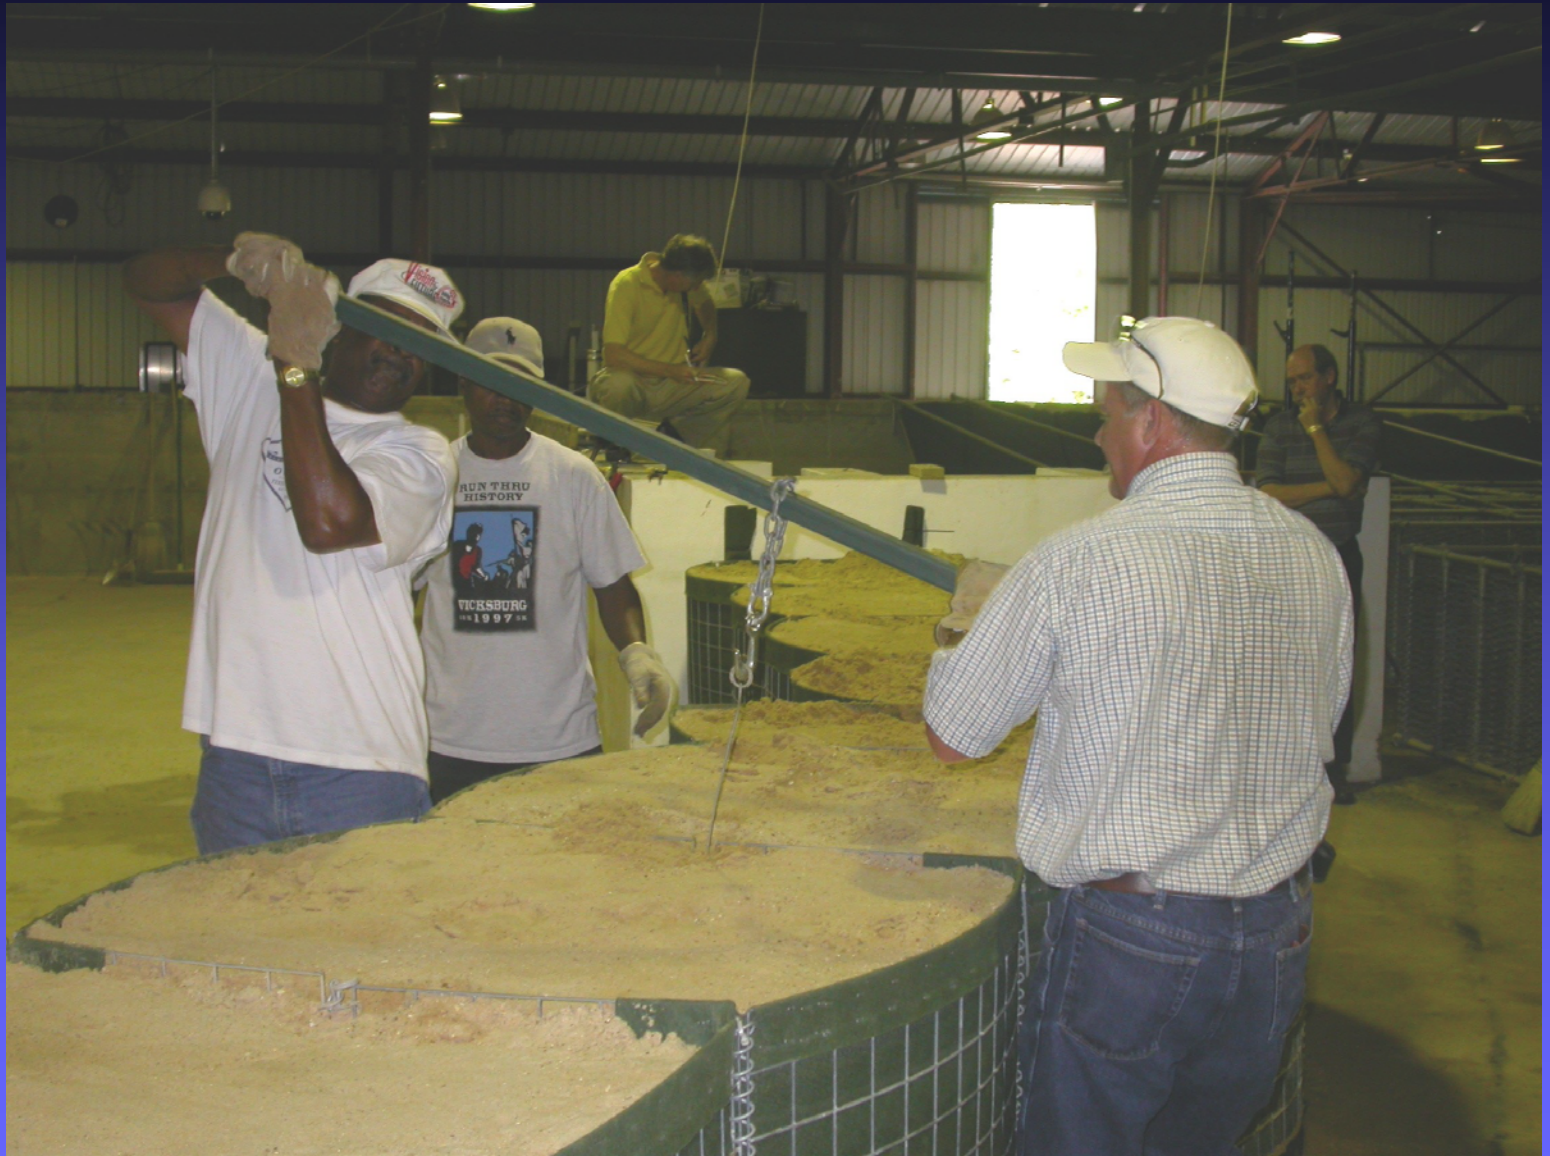
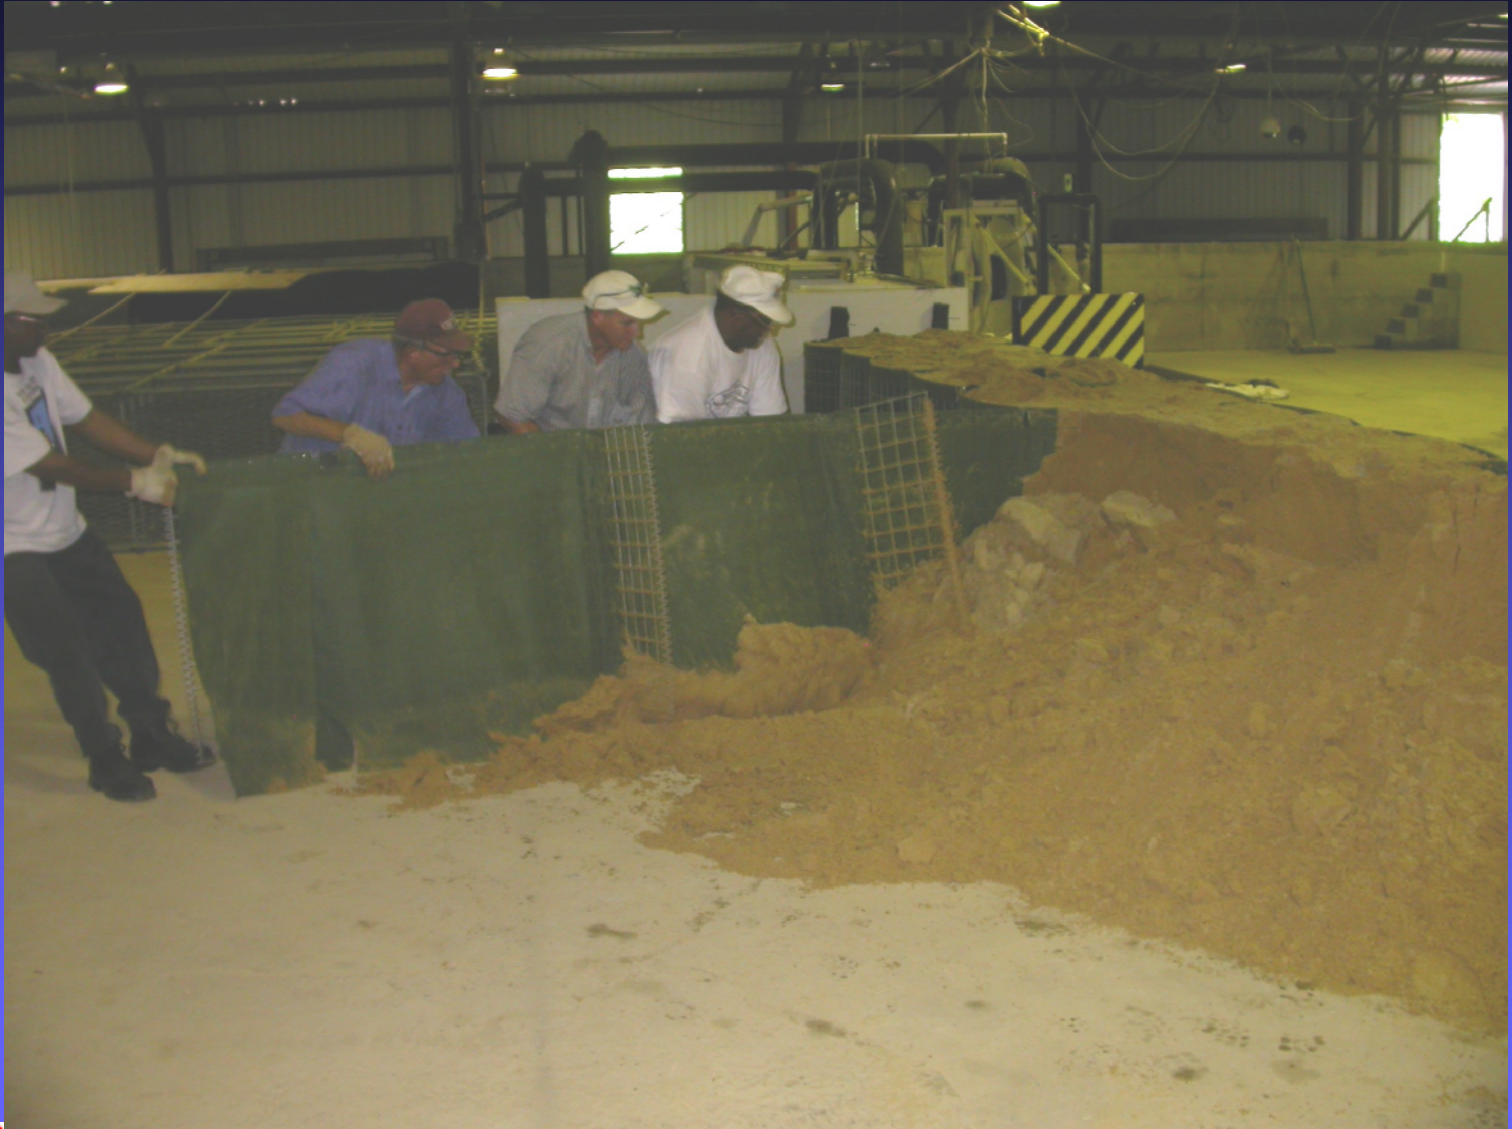
# Hesco-Bastion Concertainer – Removal

- 13.4 Man-hours
- Front-end loader

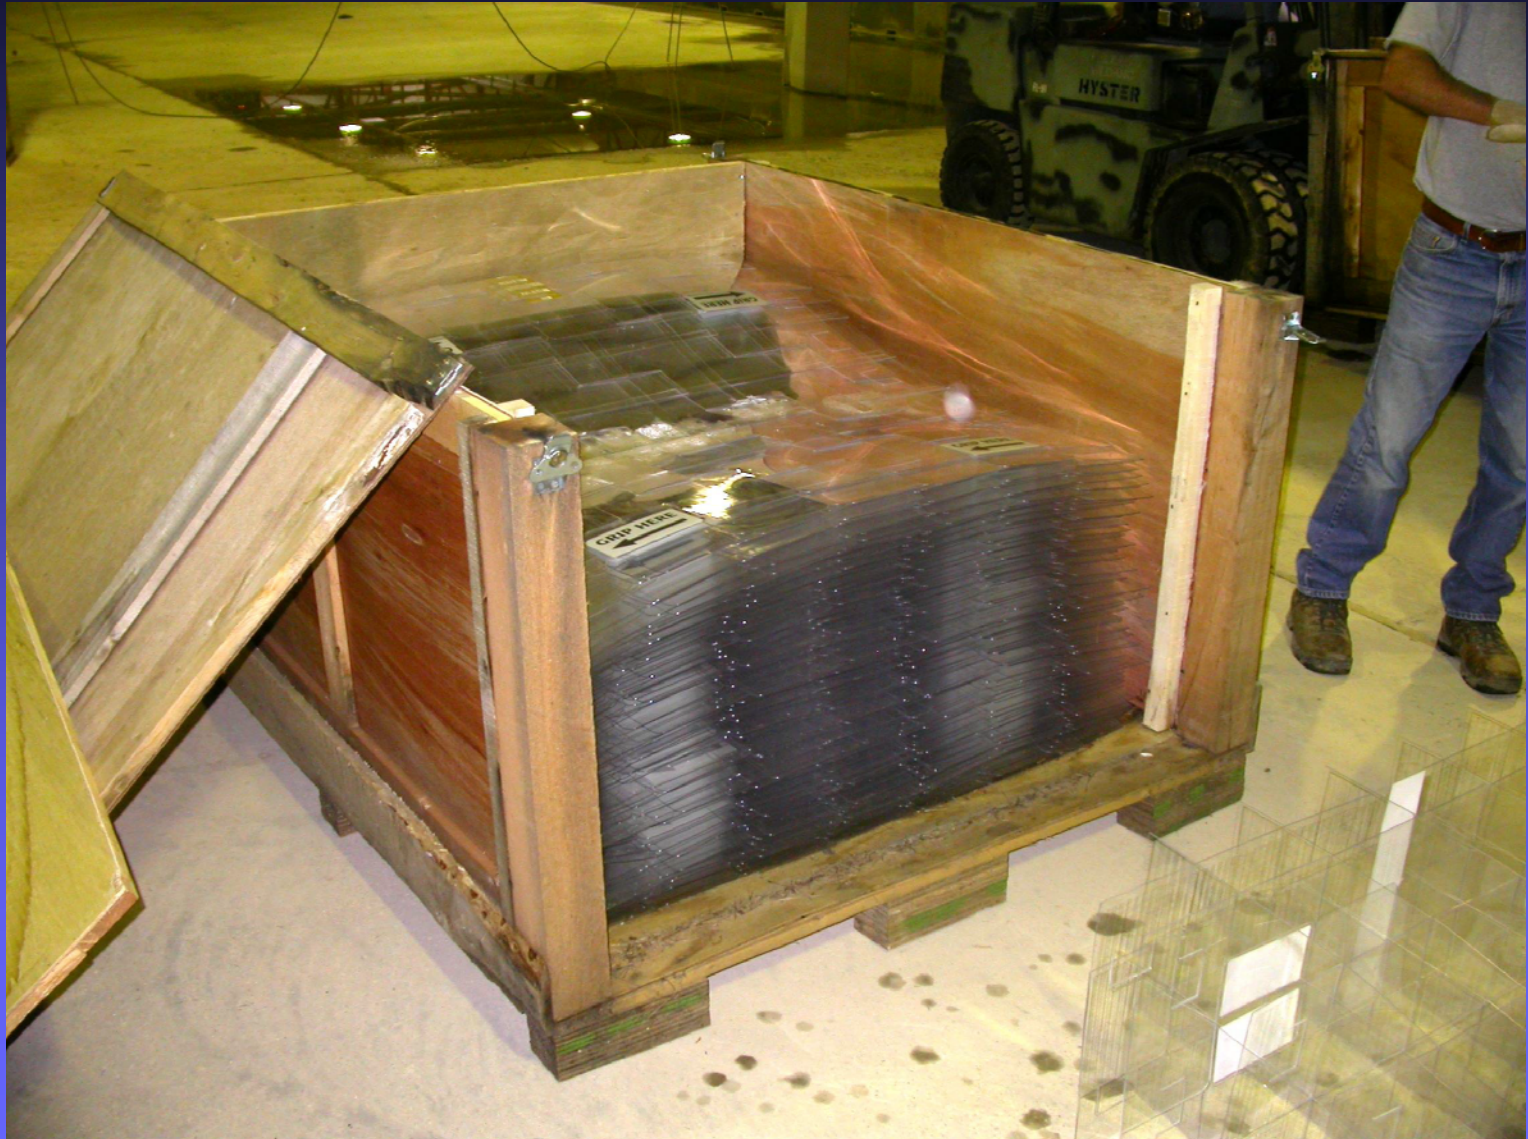
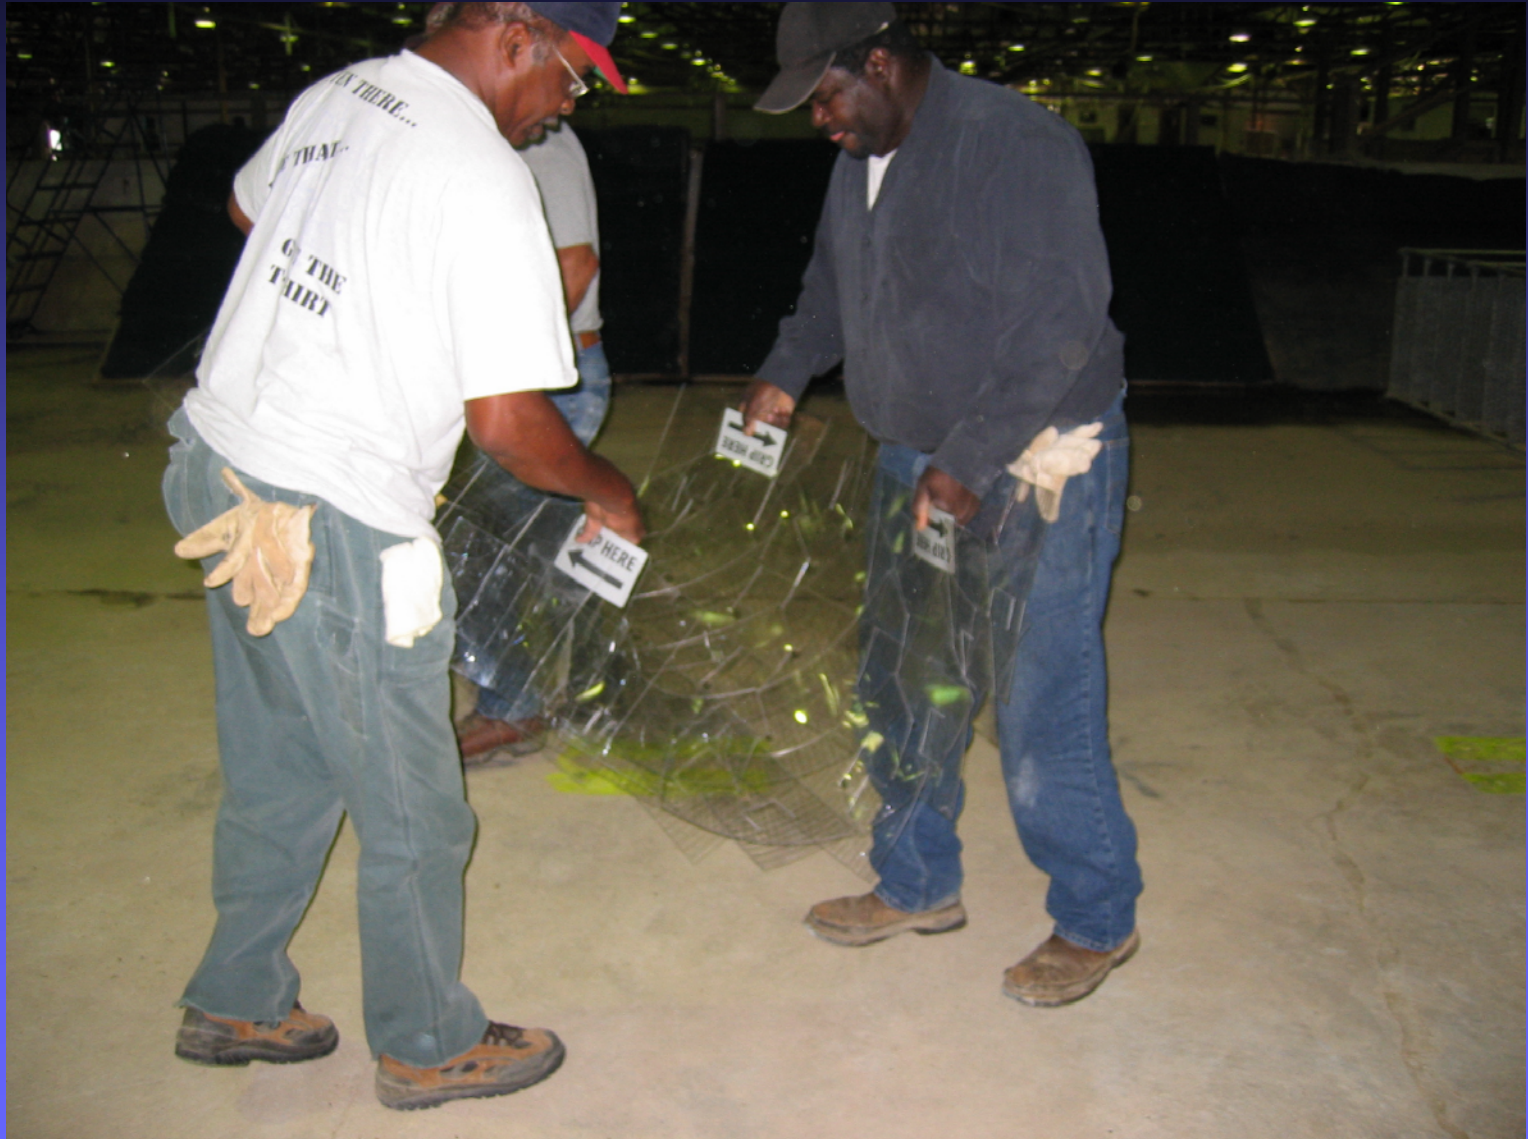
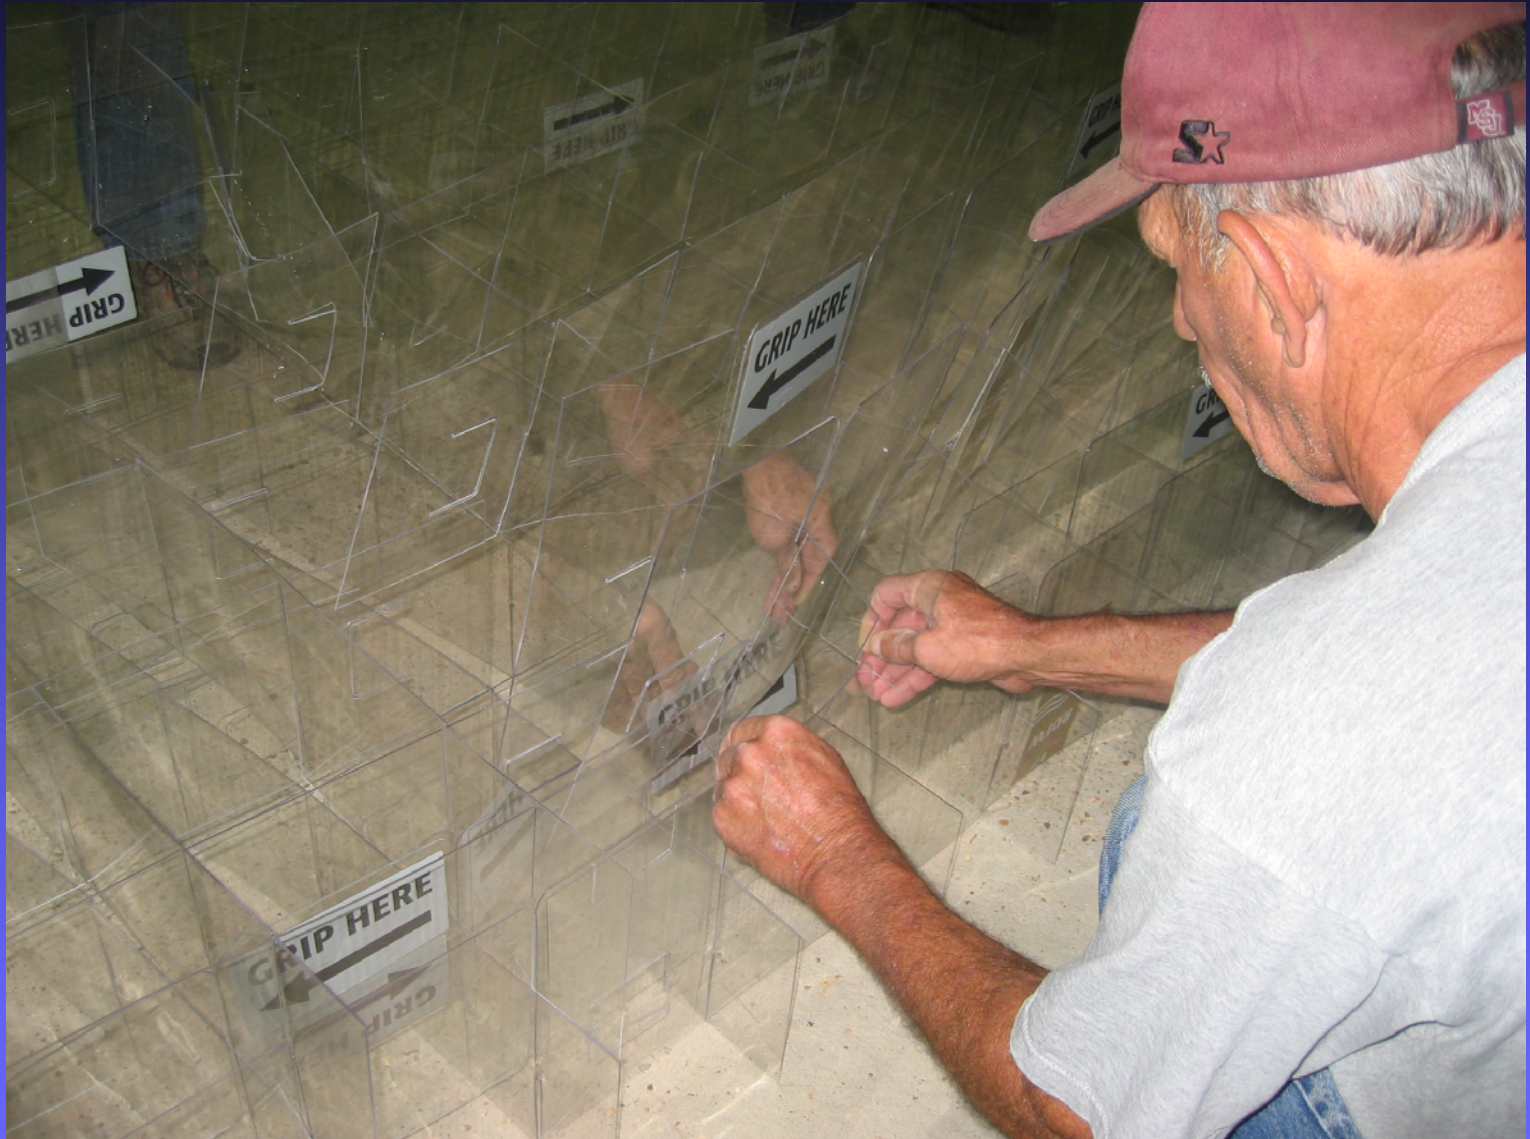
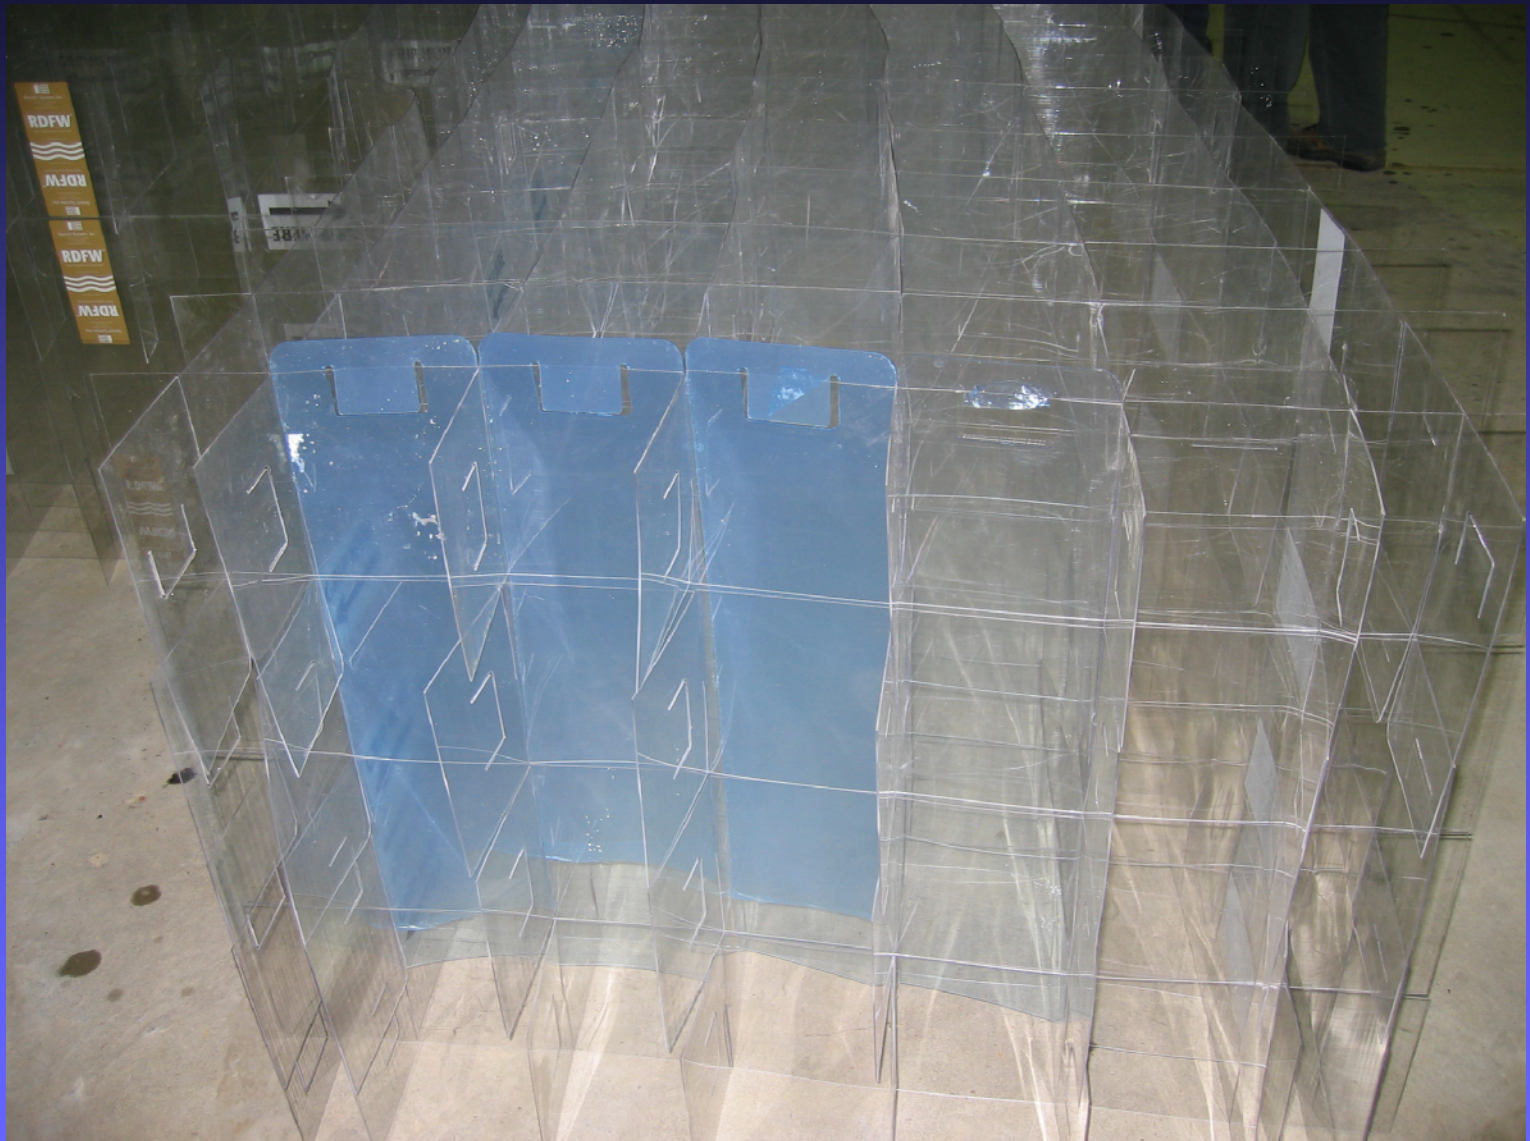
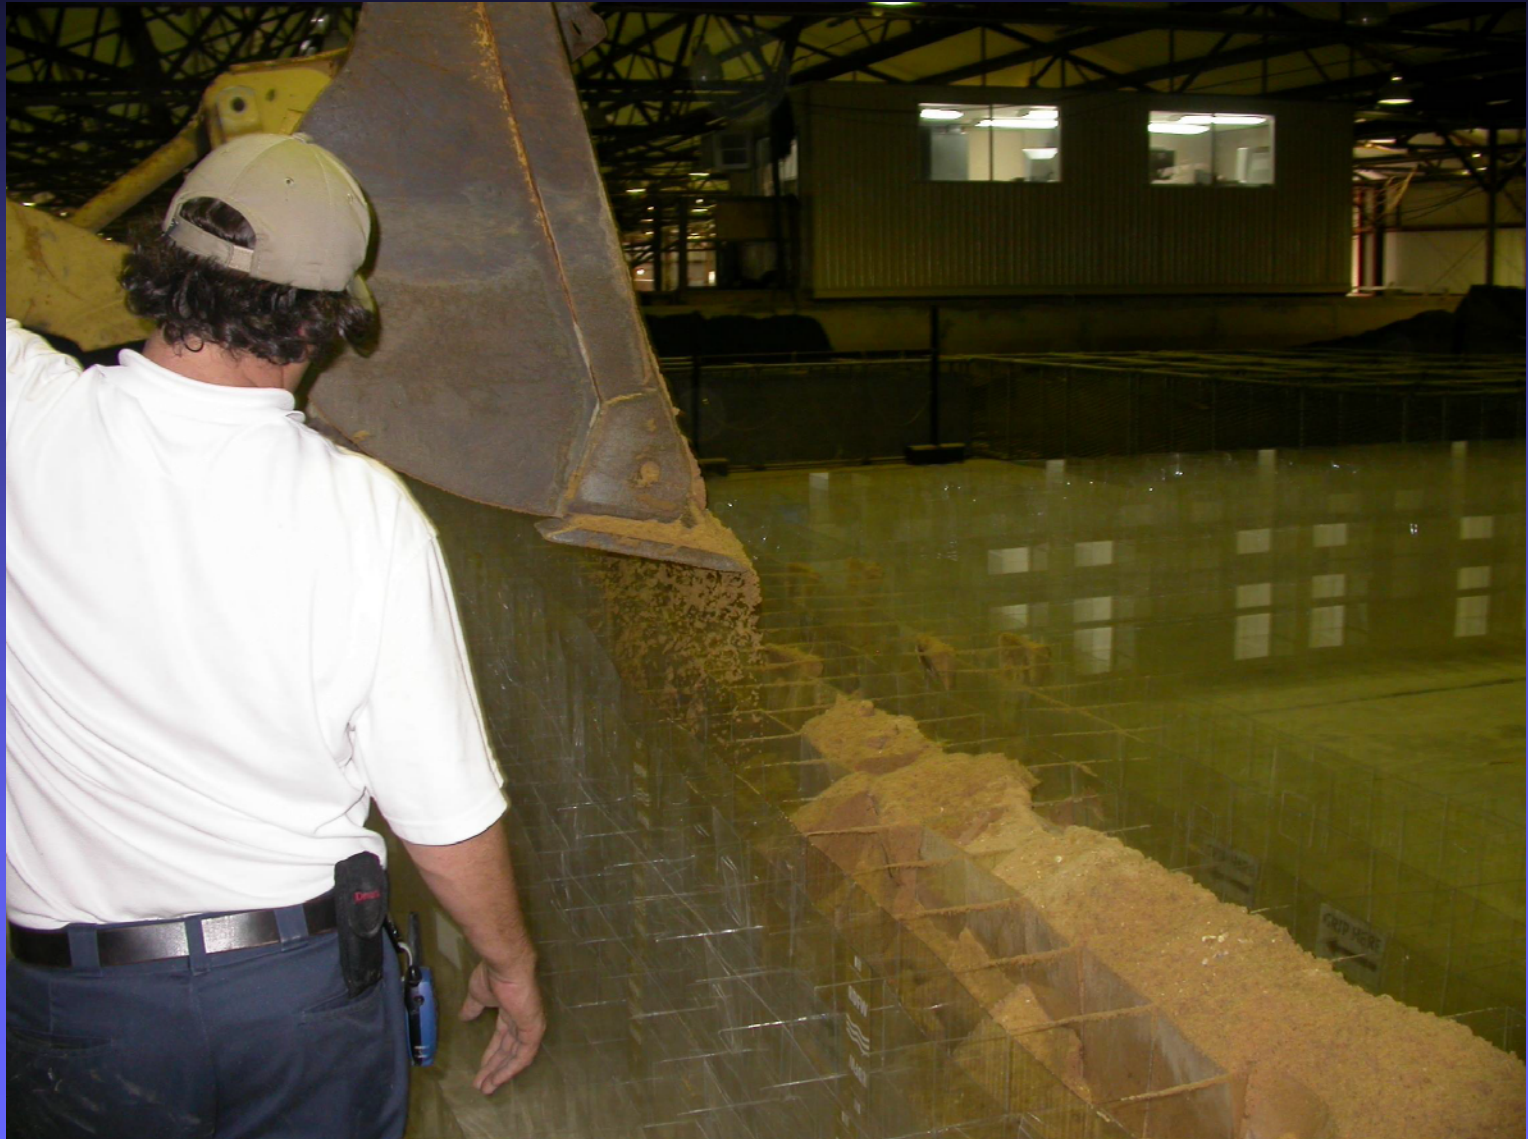
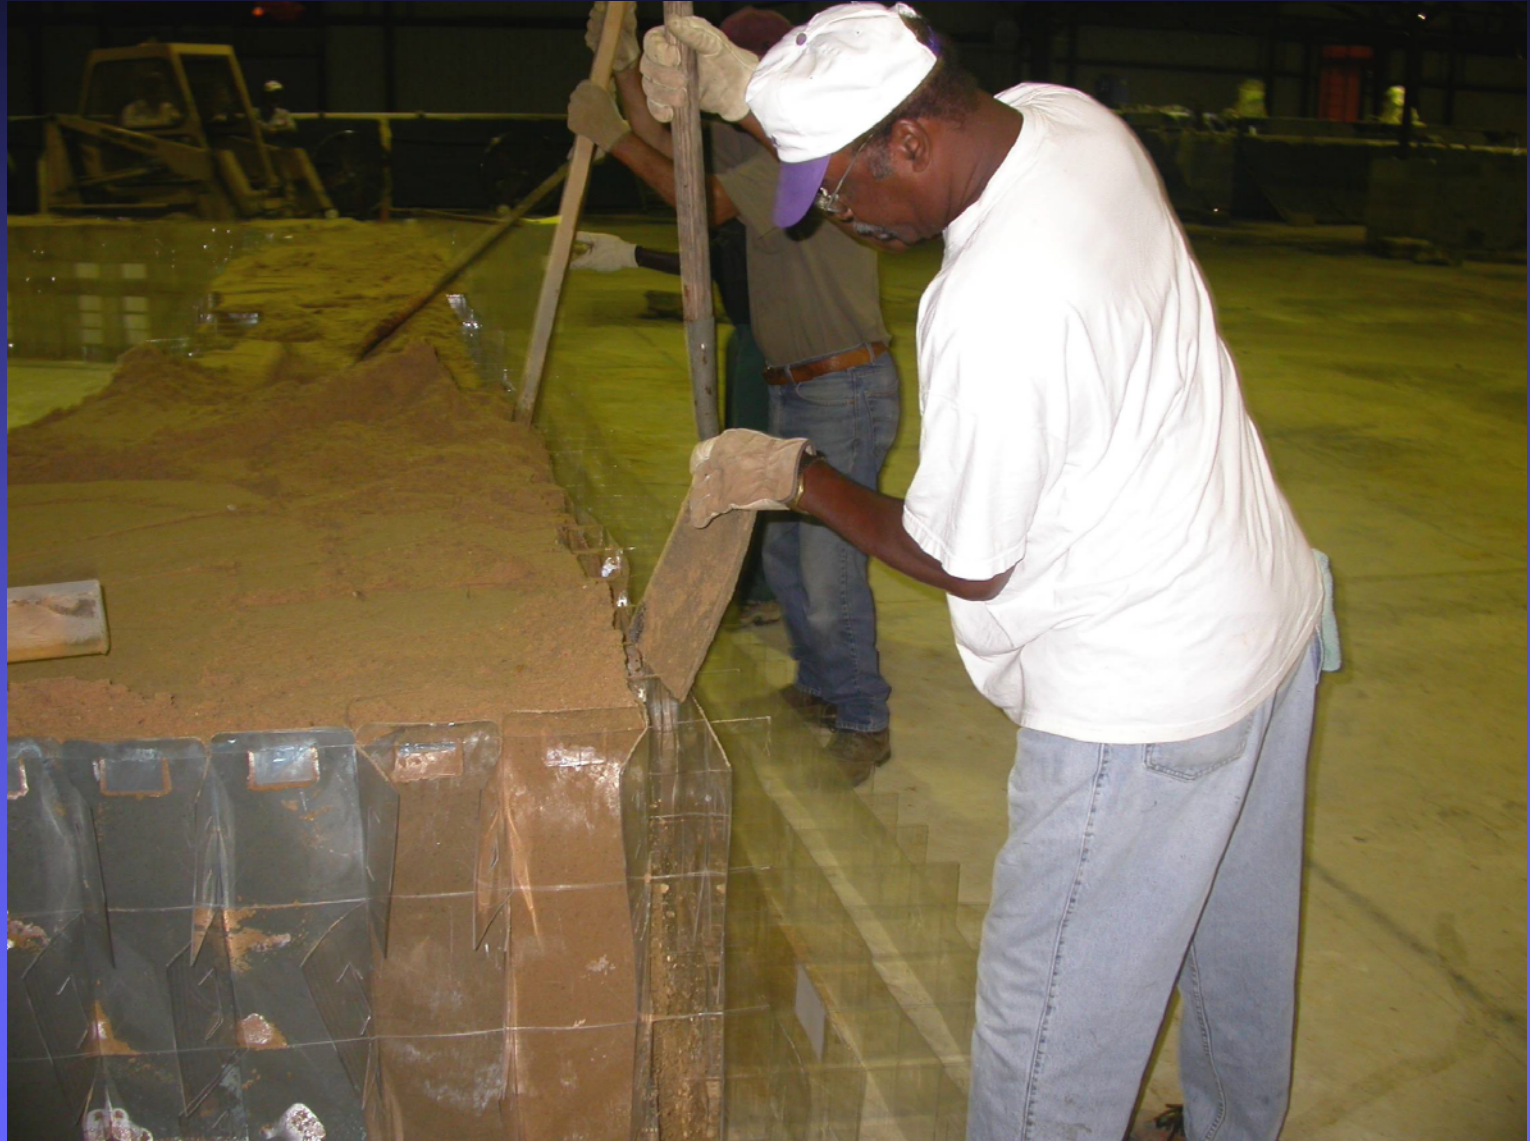
# Geocell RDFW – Construction

- Construction:
  - 32.8 Man-hours
  - Equipments:
    - Front-end loader
    - Bobcat
    - Forklift
  - Materials
    - RDFW Units
    - Sand
    - Cement
  - Comment
    - 6 man-crew, took 5 hr 28 min
- Removal:
  - 
  - 42 Man-hours
    - Bobcat
    - Forklift
    - Shop vacuums

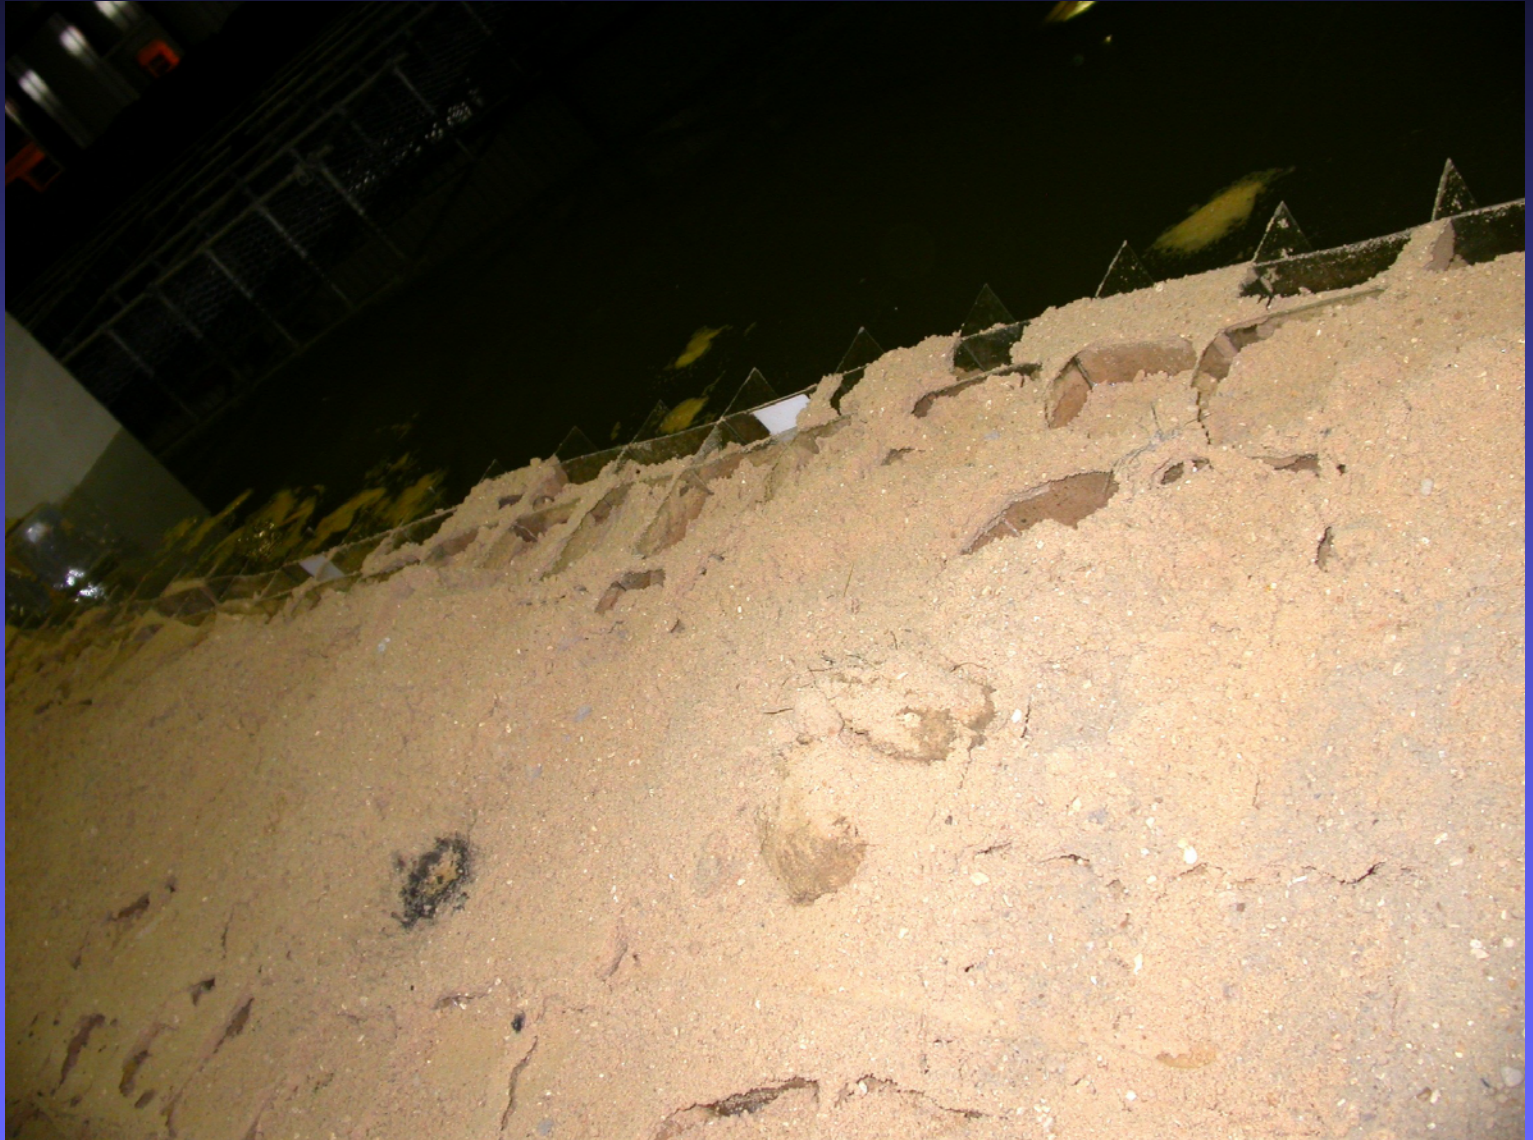
# Geocell RDFW – Static Damage

- Geocell Systems RDFW
  - Minor sand settling
  - Significant washout along edges and toe
  - Toe damaged during large waves or overtopping
  - 10% of structure broken
- Portadam
  - Fabric torn during impact tests
