# Laboratory Testing of Flood Fighting Structures

Johannes L. Wibowo, GSL

*Engineer Research and Development Center*

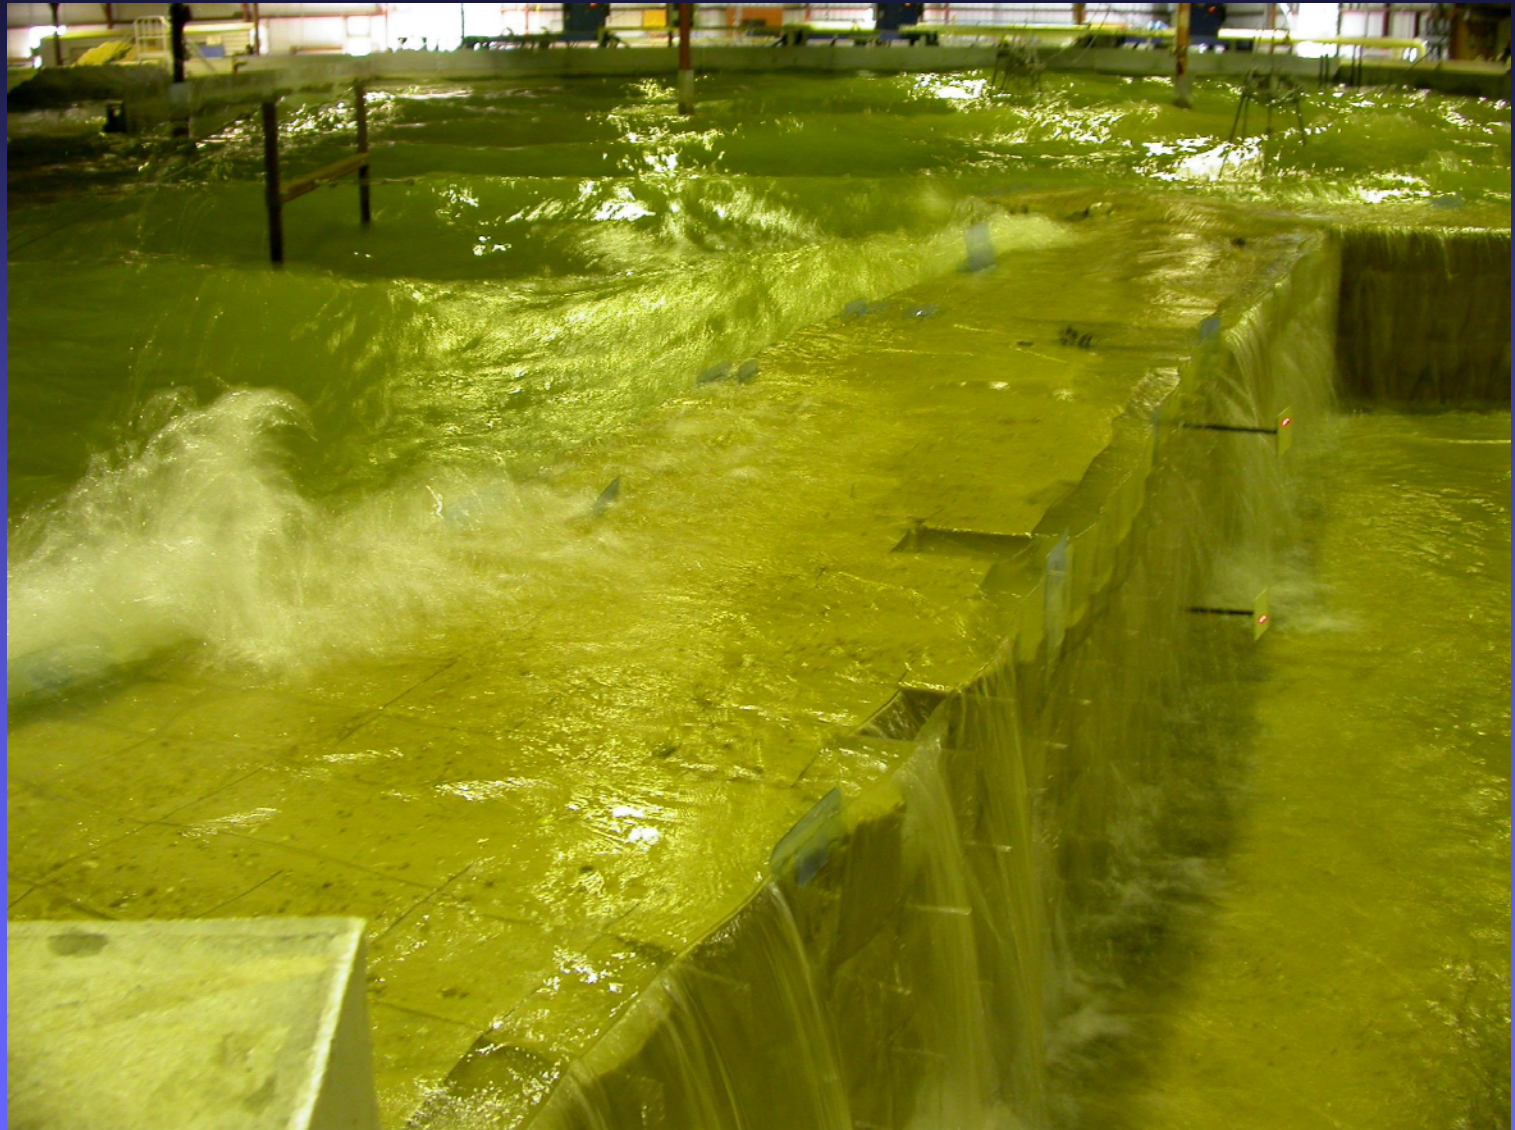
# Geocell RDFW – Wave Action

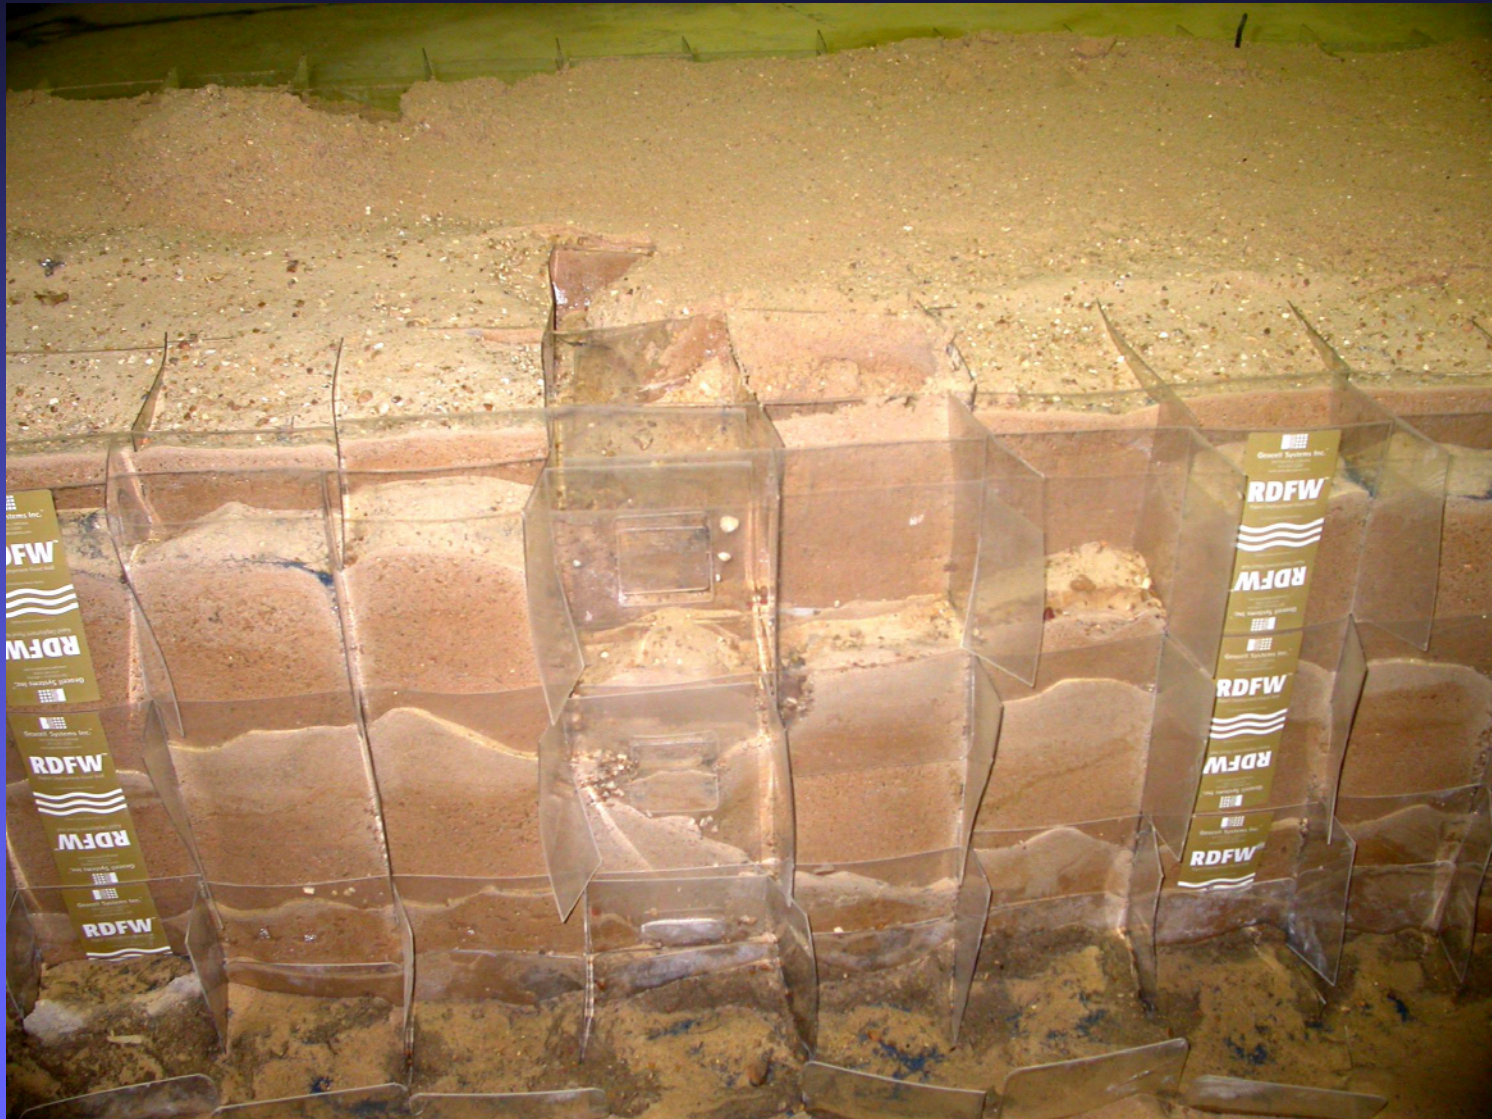
# Geocell RDFW – Wave Damage

- Geocell Systems RDFW
  - Minor sand settling
  - Significant washout along edges and toe
  - Toe damaged during large waves or overtopping
  - 10% of structure broken
- Portadam
  - Fabric torn during impact tests

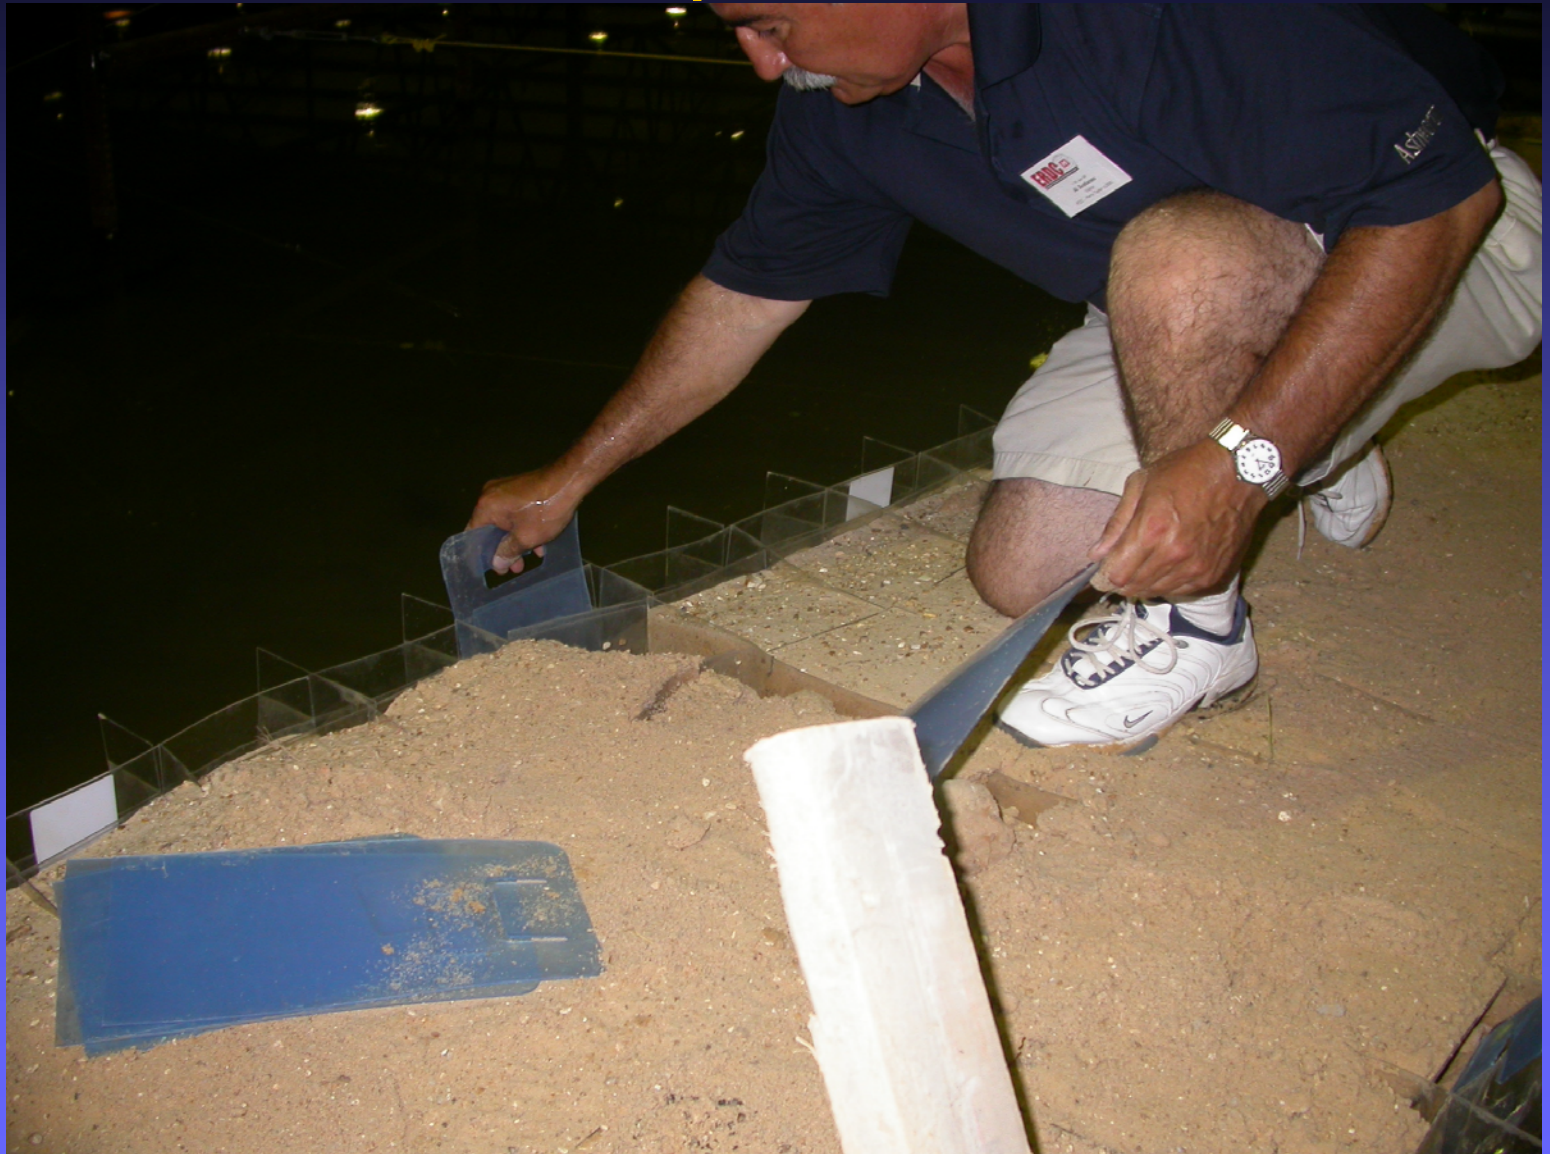
# Geocell RDFW – Repair

- Repair 1: 1.9 Man-hours
  - Added sand along top surface
- Repair 2: 0.7 Man-hours
  - Added reinforcing strips
- Repair 3: 1.9 Man-hours
  - Added additional sand

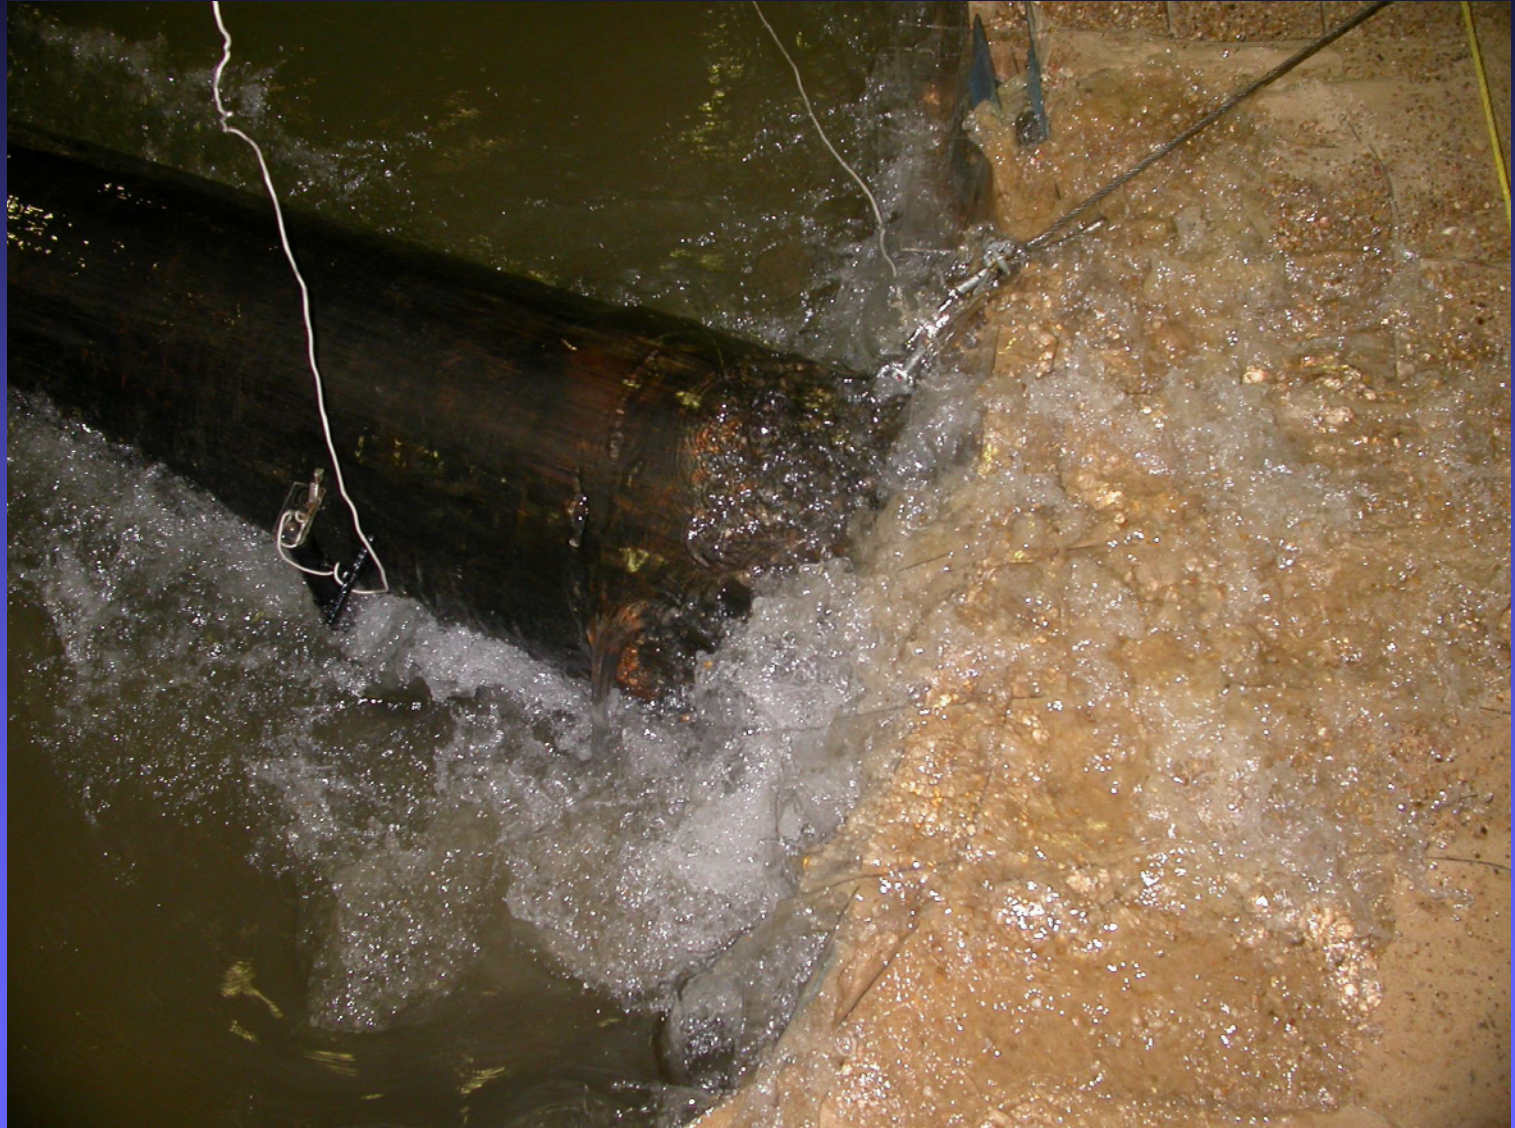
# Geocell RDFW – Log Impact

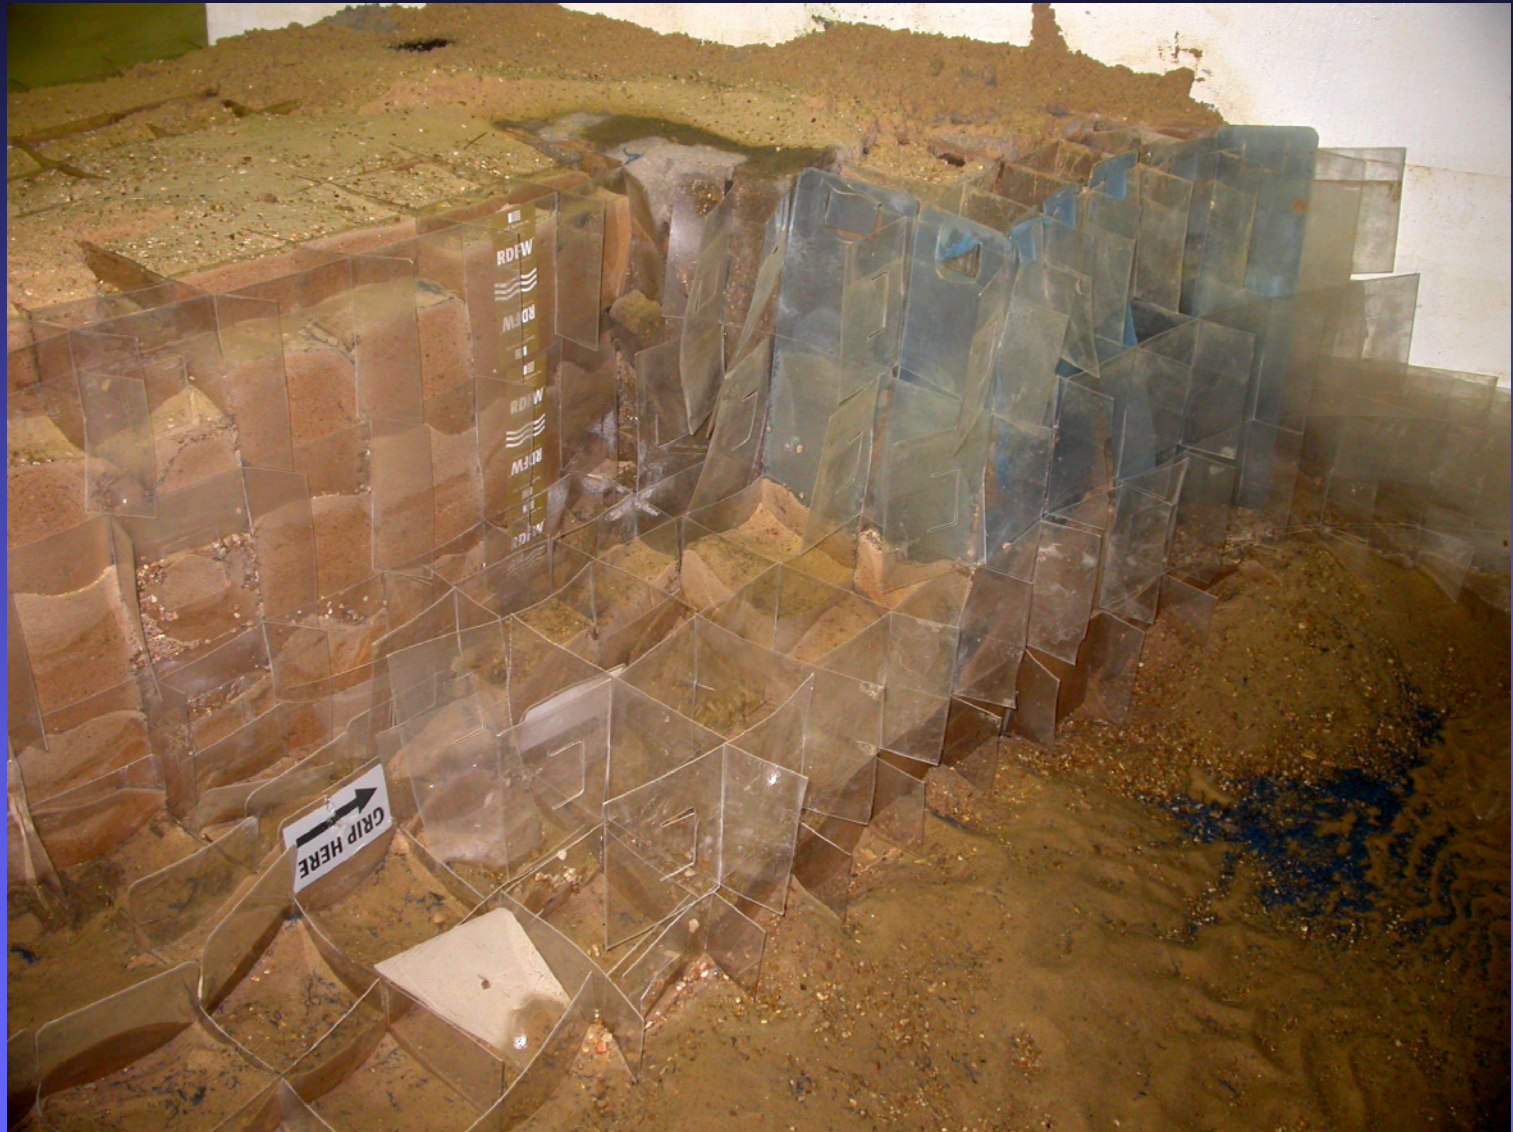
# Geocell RDFW – Damage

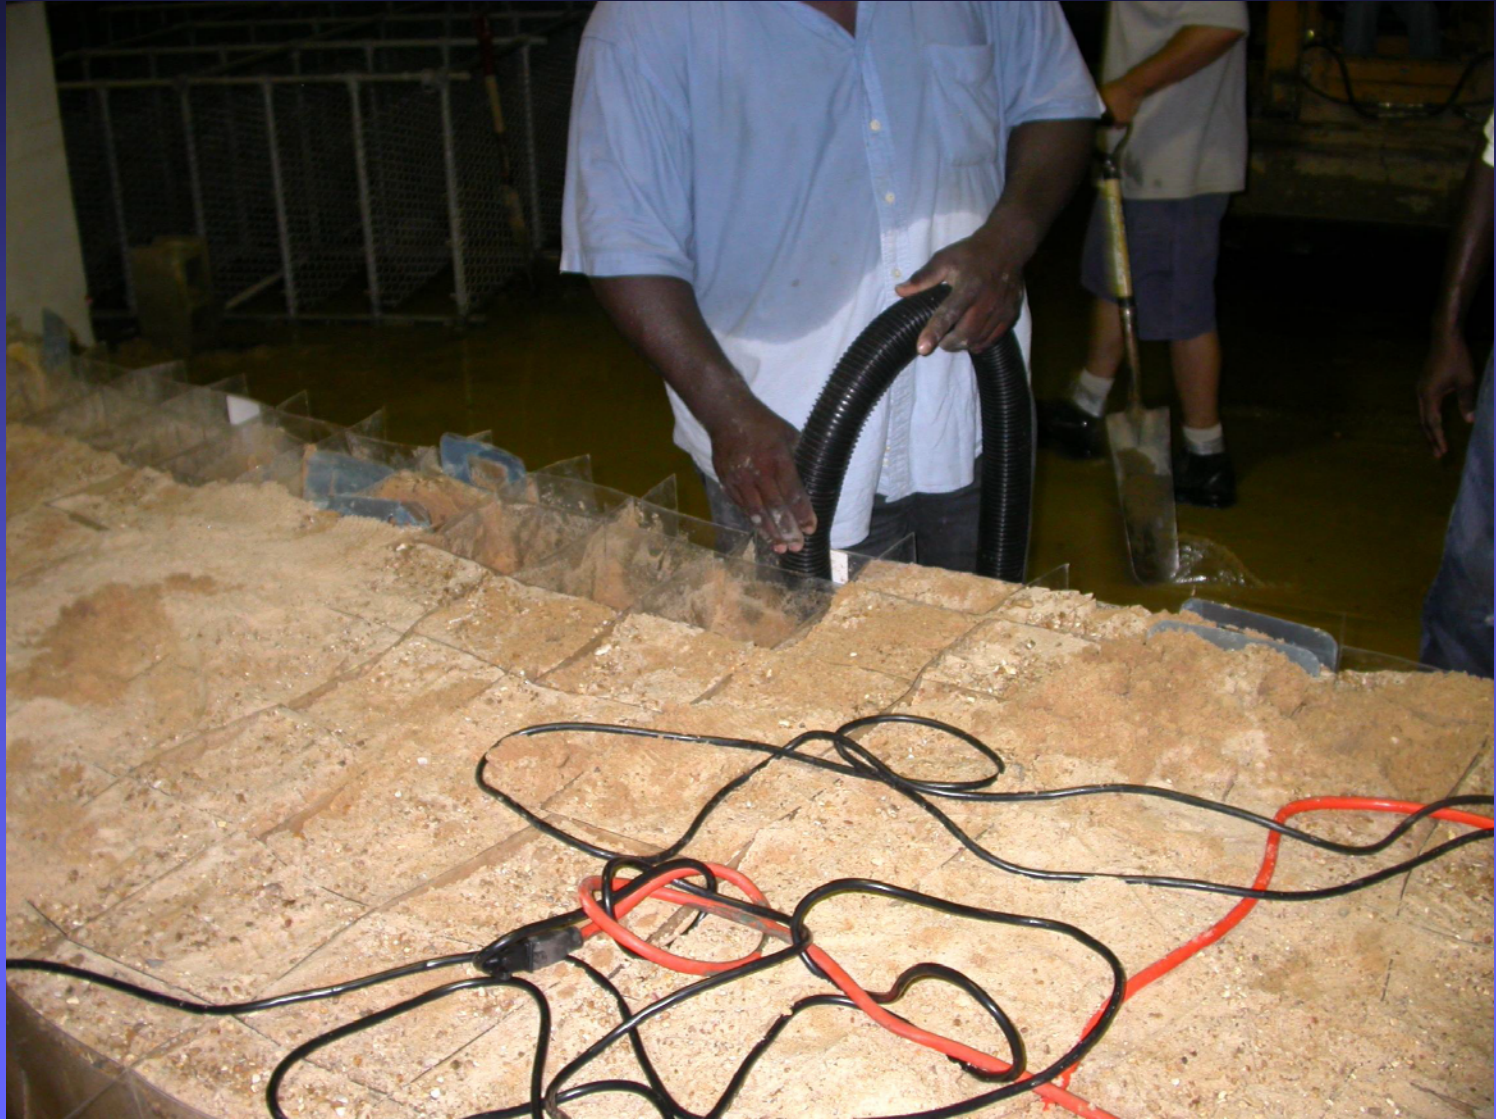
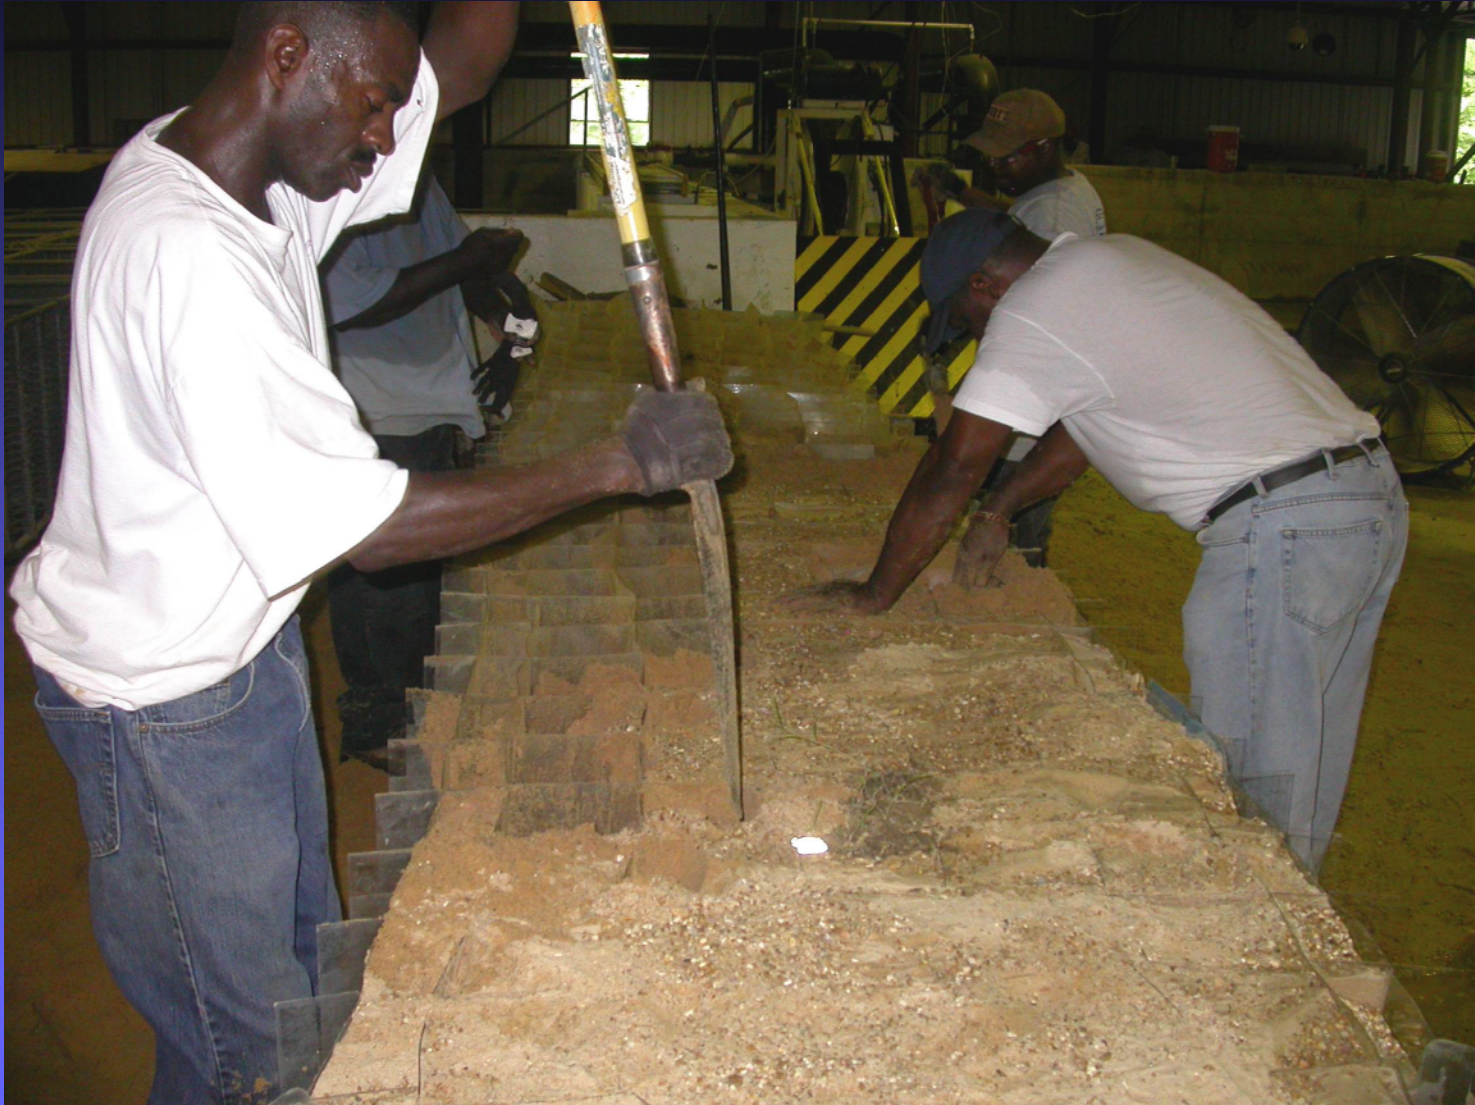
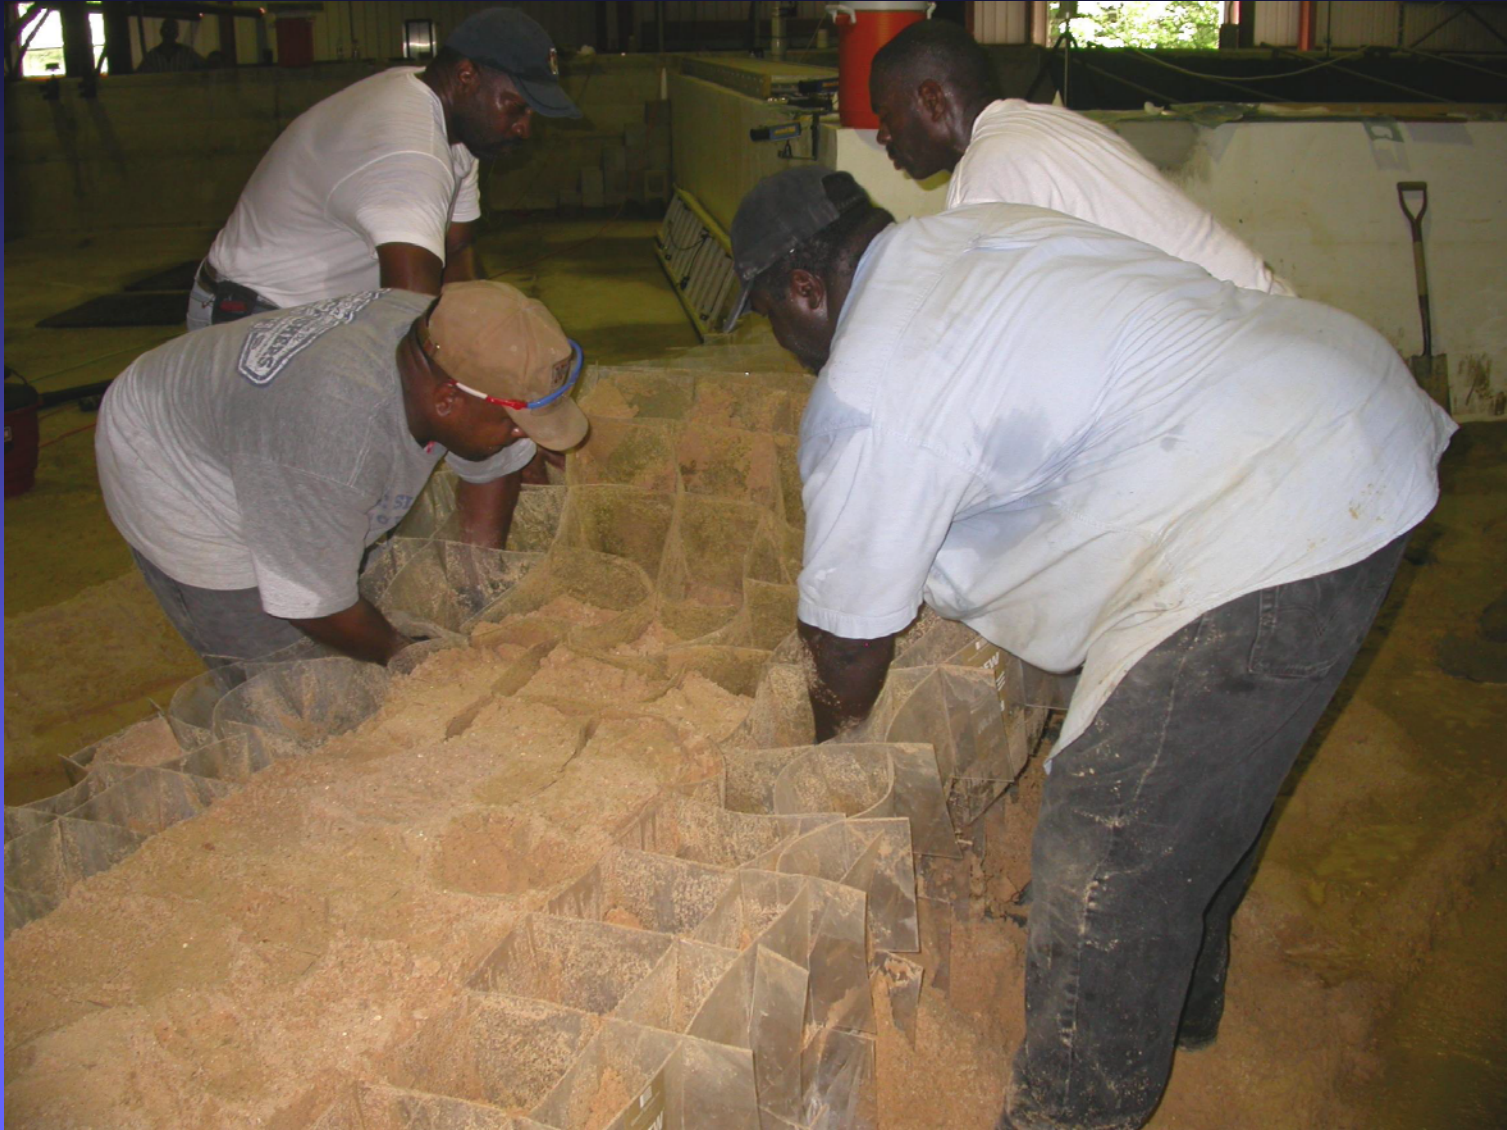
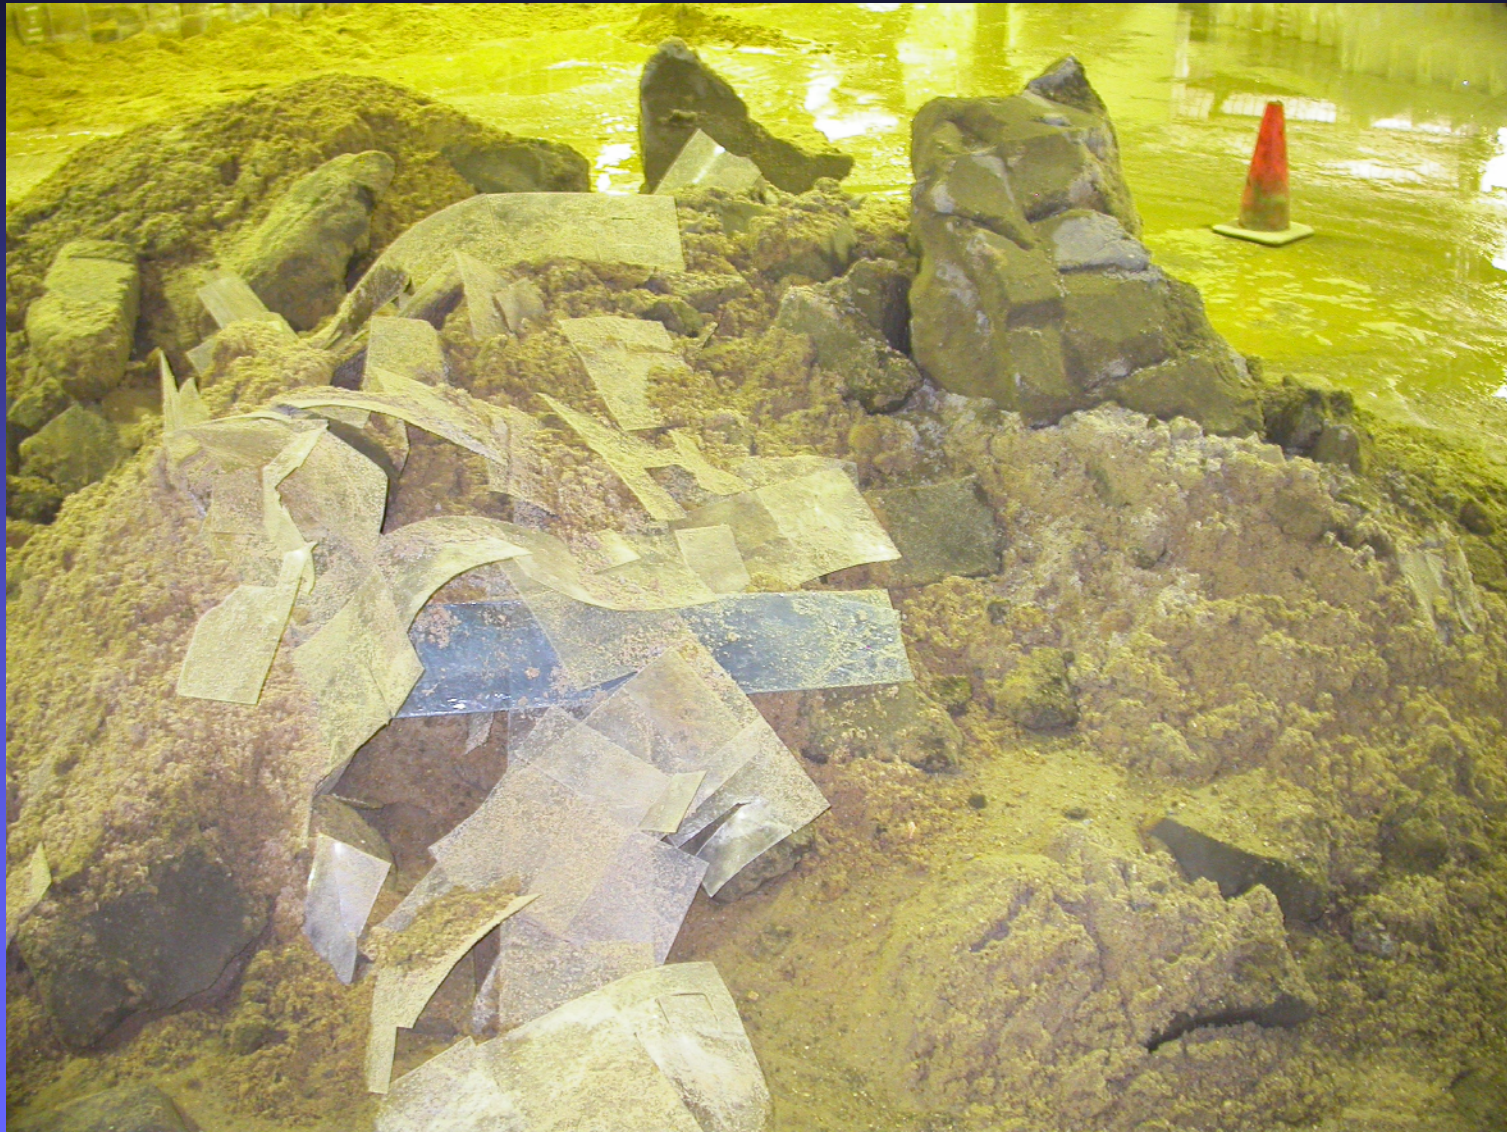
# Geocell RDFW – Removal

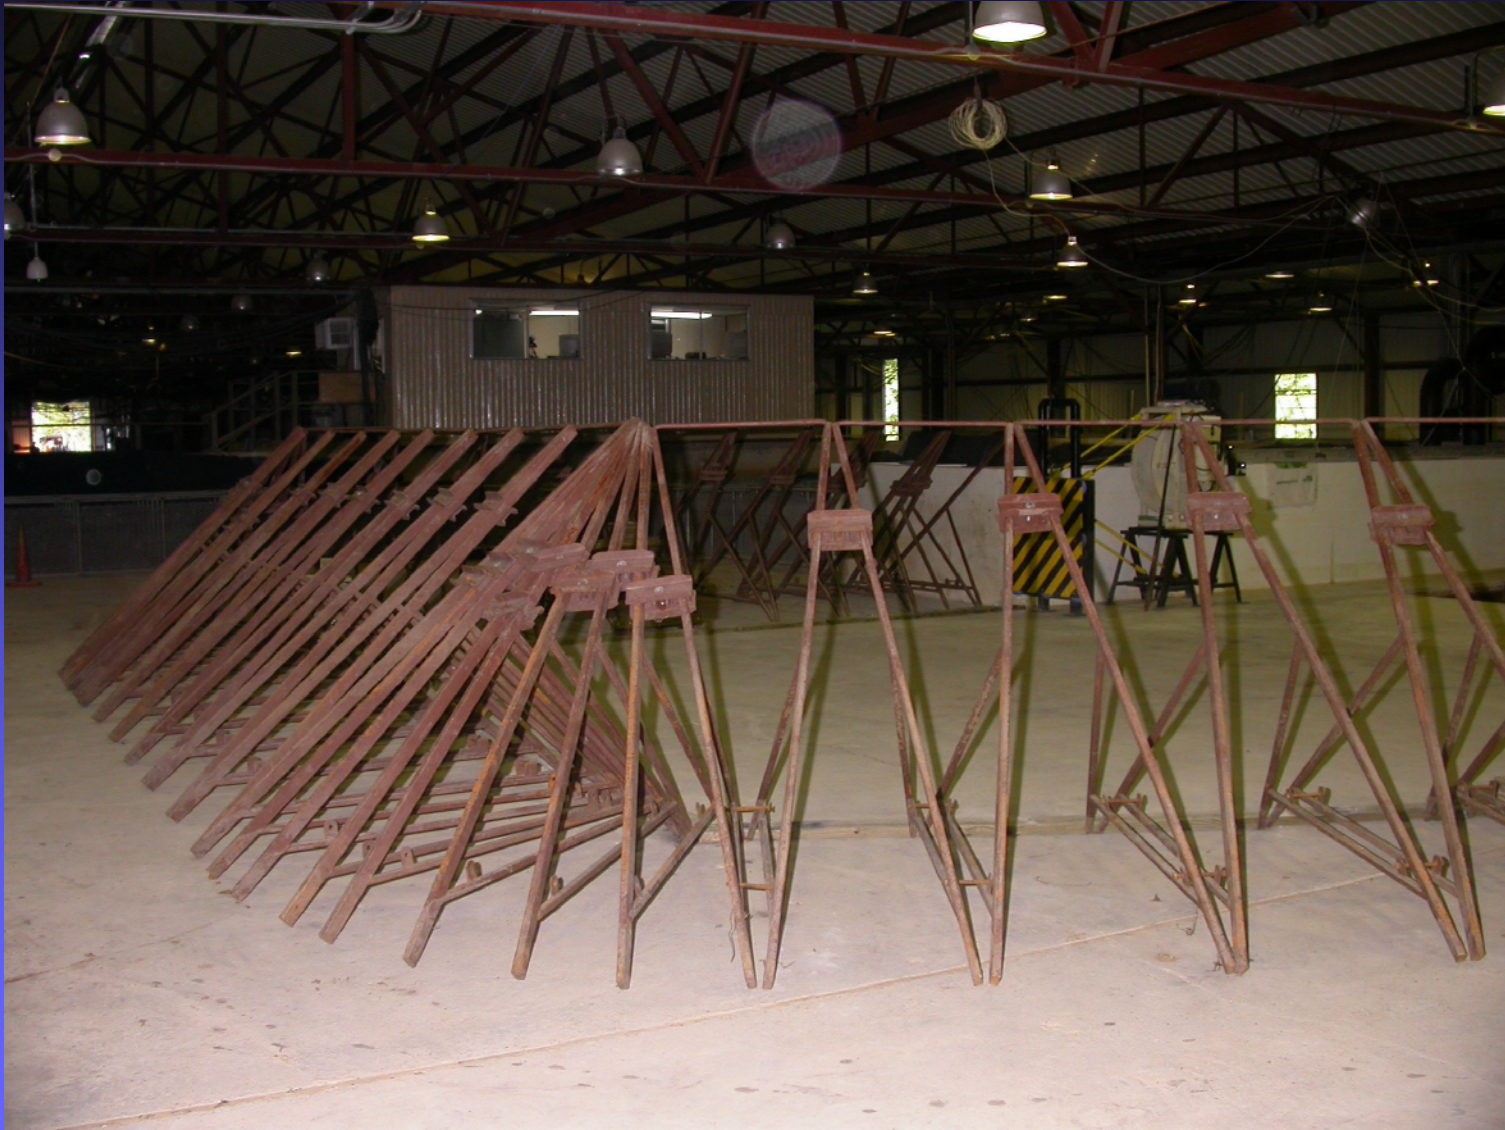
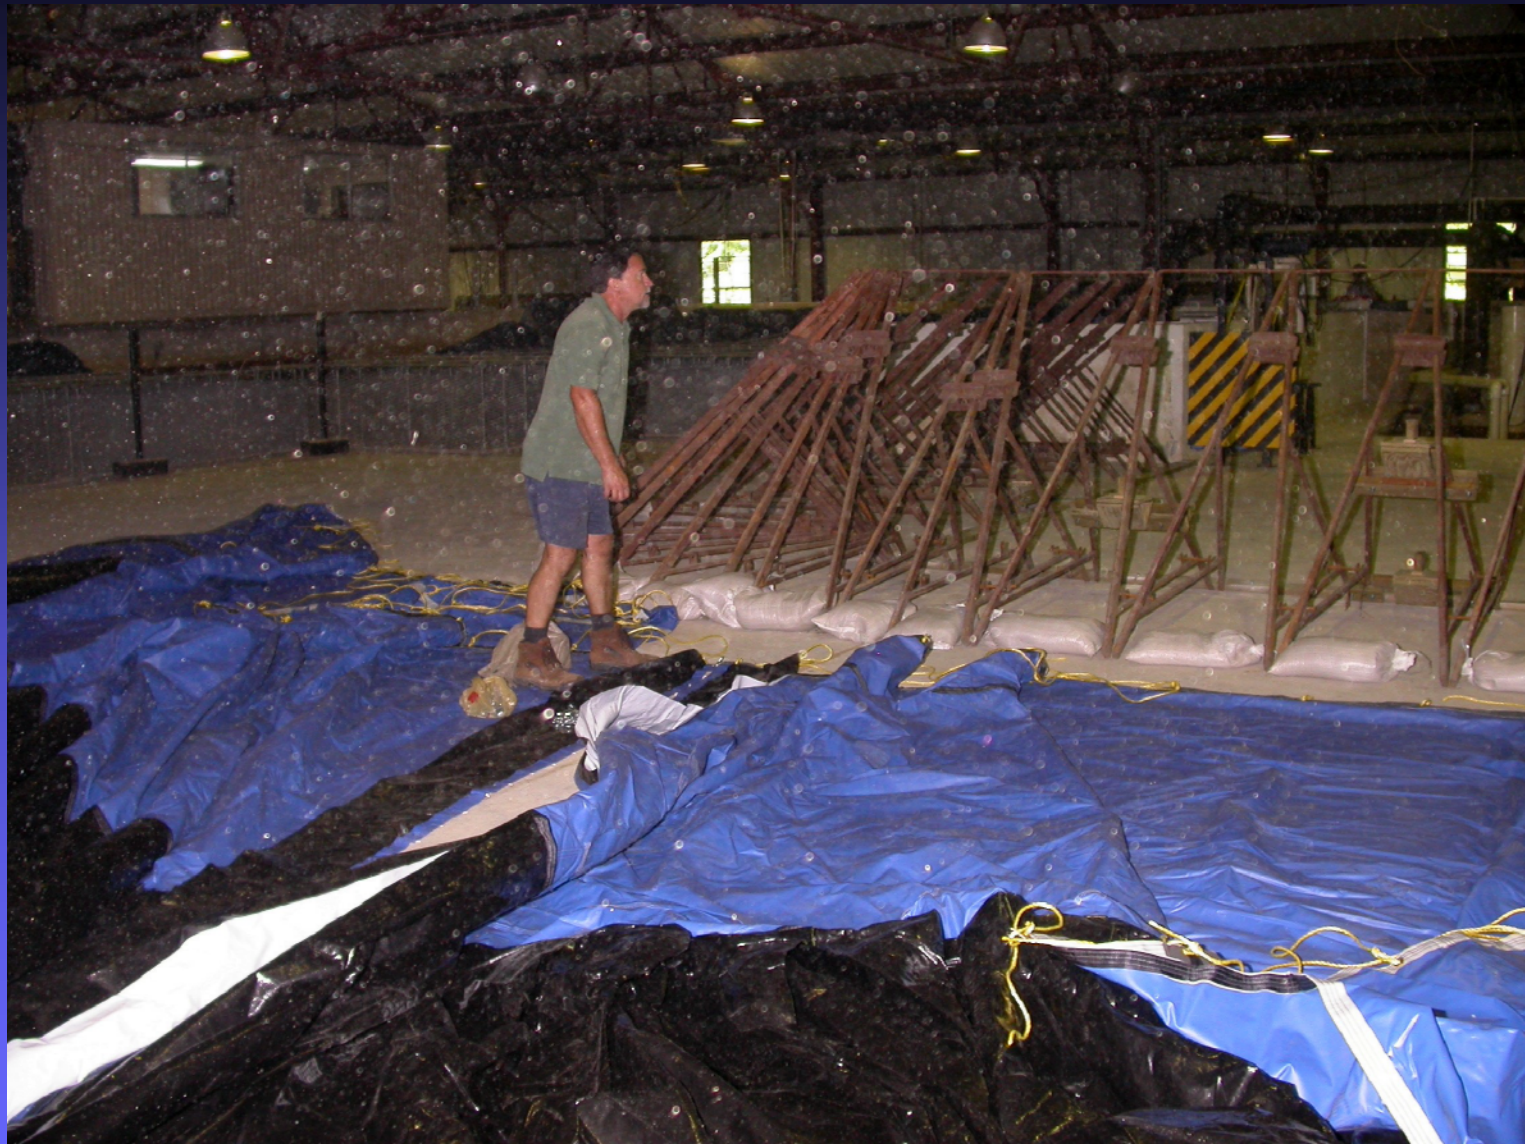
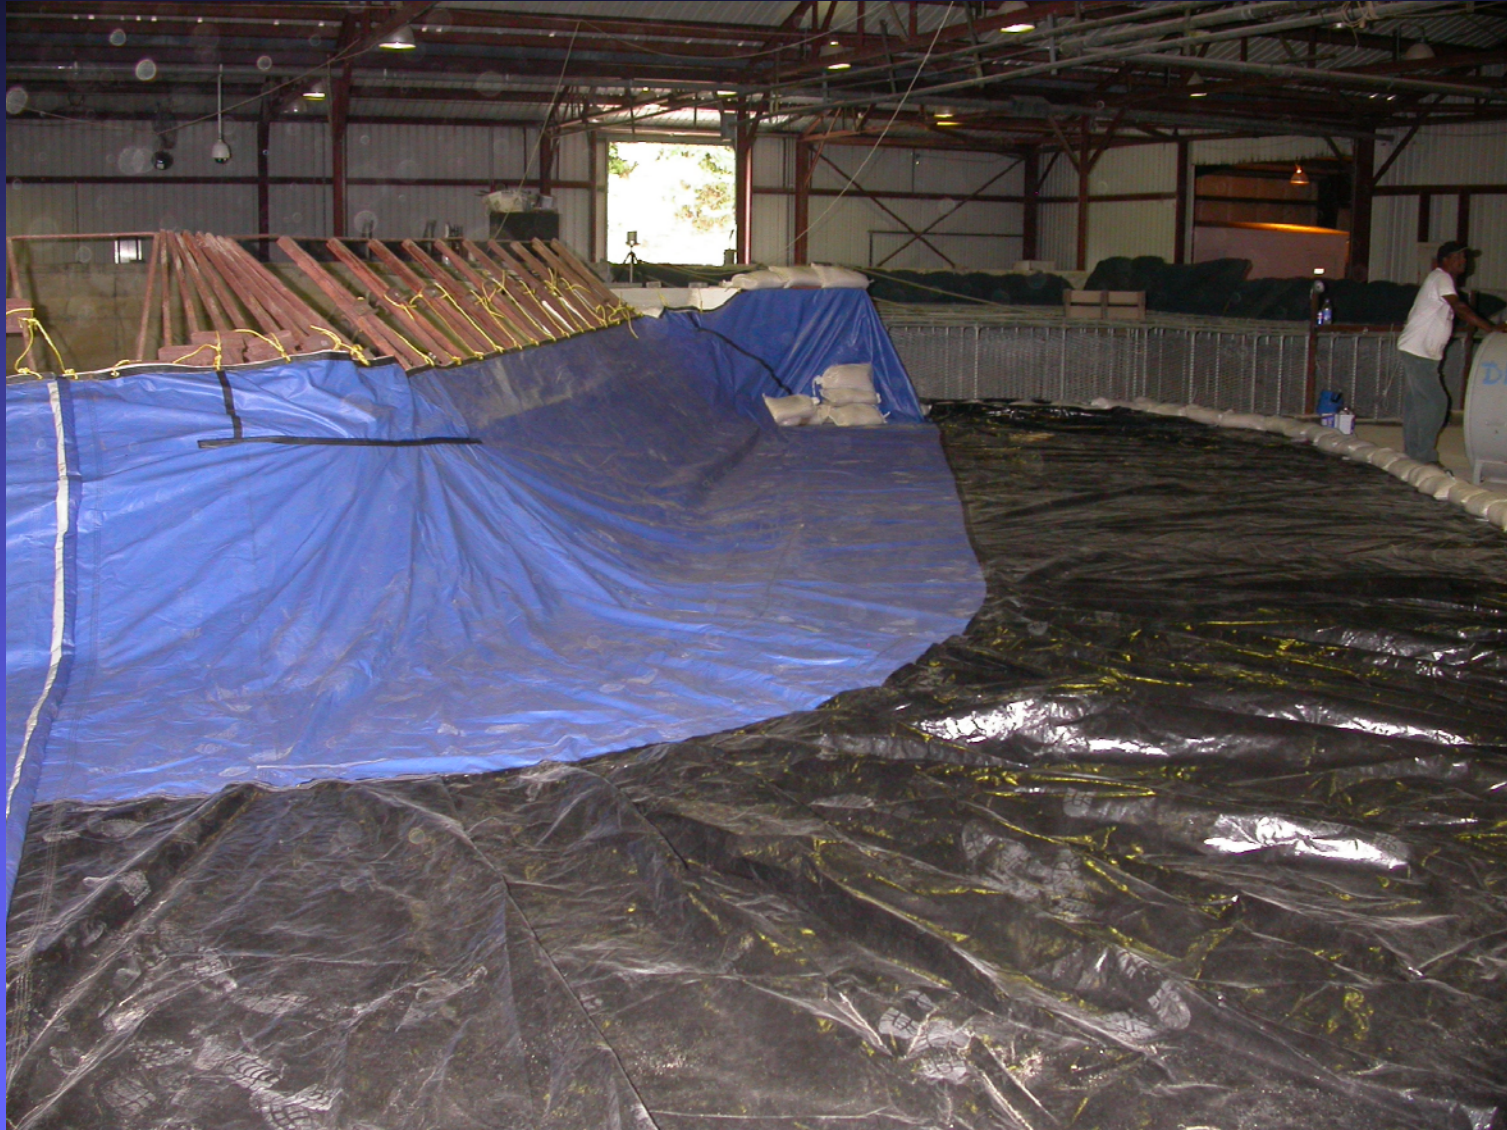
# Portadam - Construction

- Construction:
  - 24.4 Man-hours
  - Equipment:
    - Hyster Forklift
  - Materials
    - Portadam frames and cover
    - Sand bags and sand
    - Insulating foam
    - Tape, Rope
  - Comments
    - 6-man crew, 2 only filled sandbags

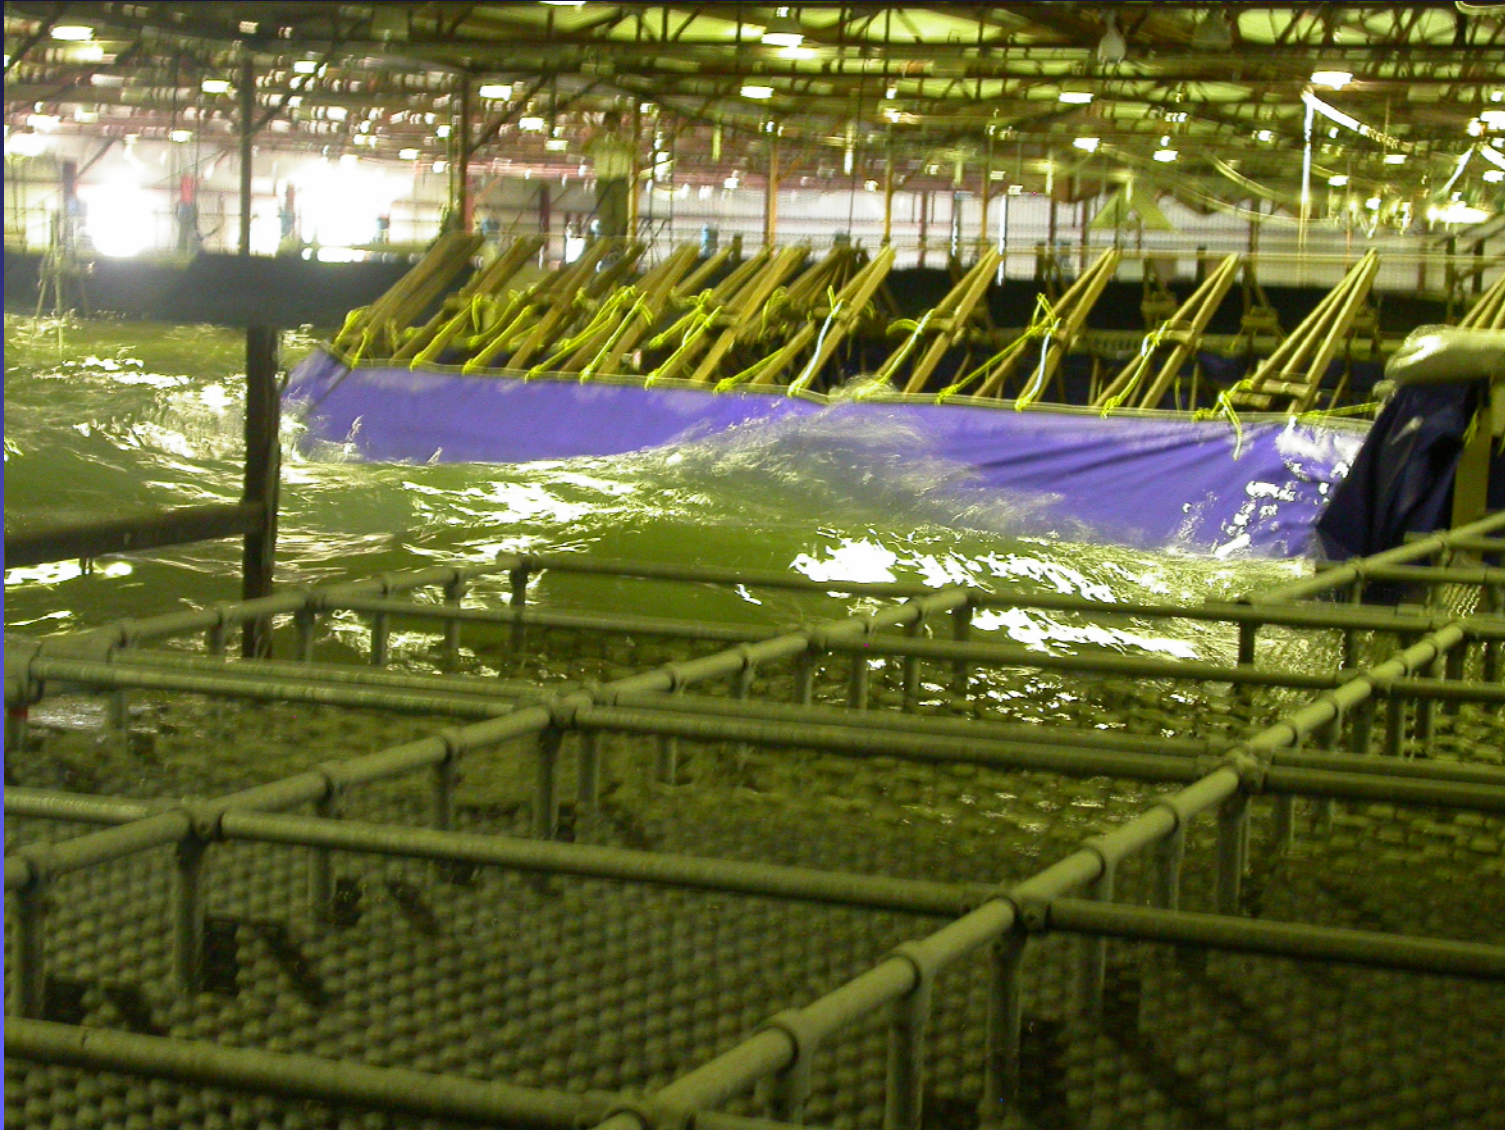
# Portadam - Waves
