# Laboratory Testing of Flood Fighting Structures

Johannes L. Wibowo, GSL

*Engineer Research and Development Center*

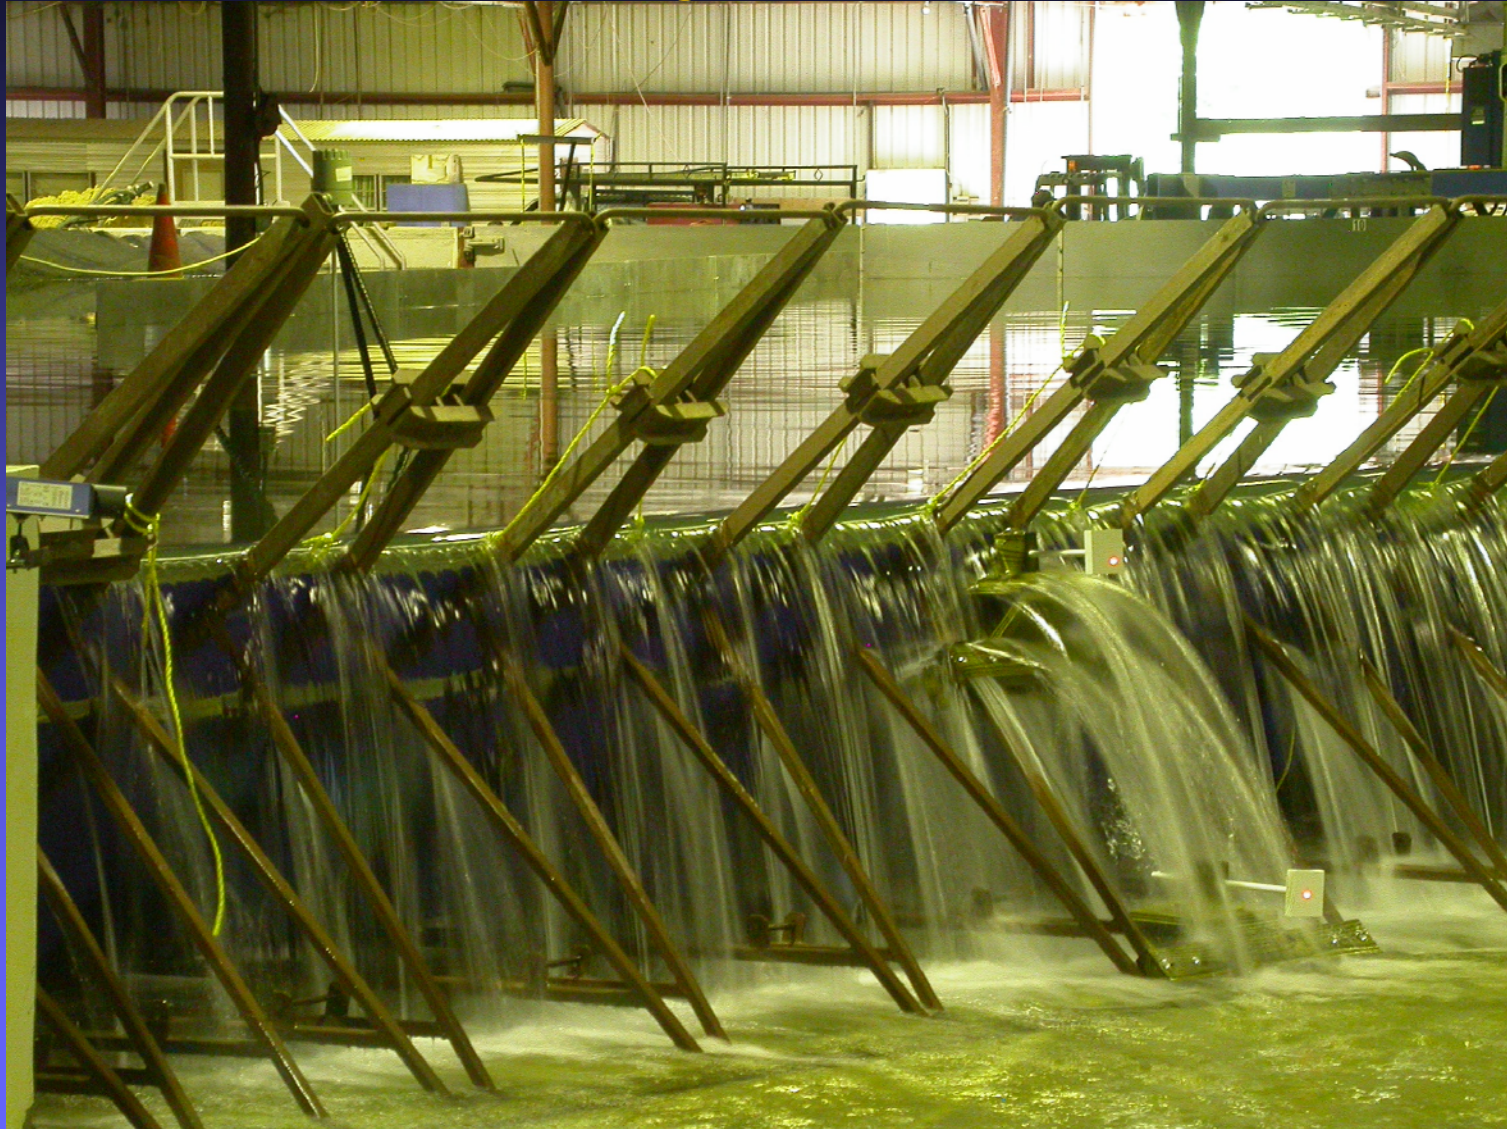
# Portadam - Overtopping

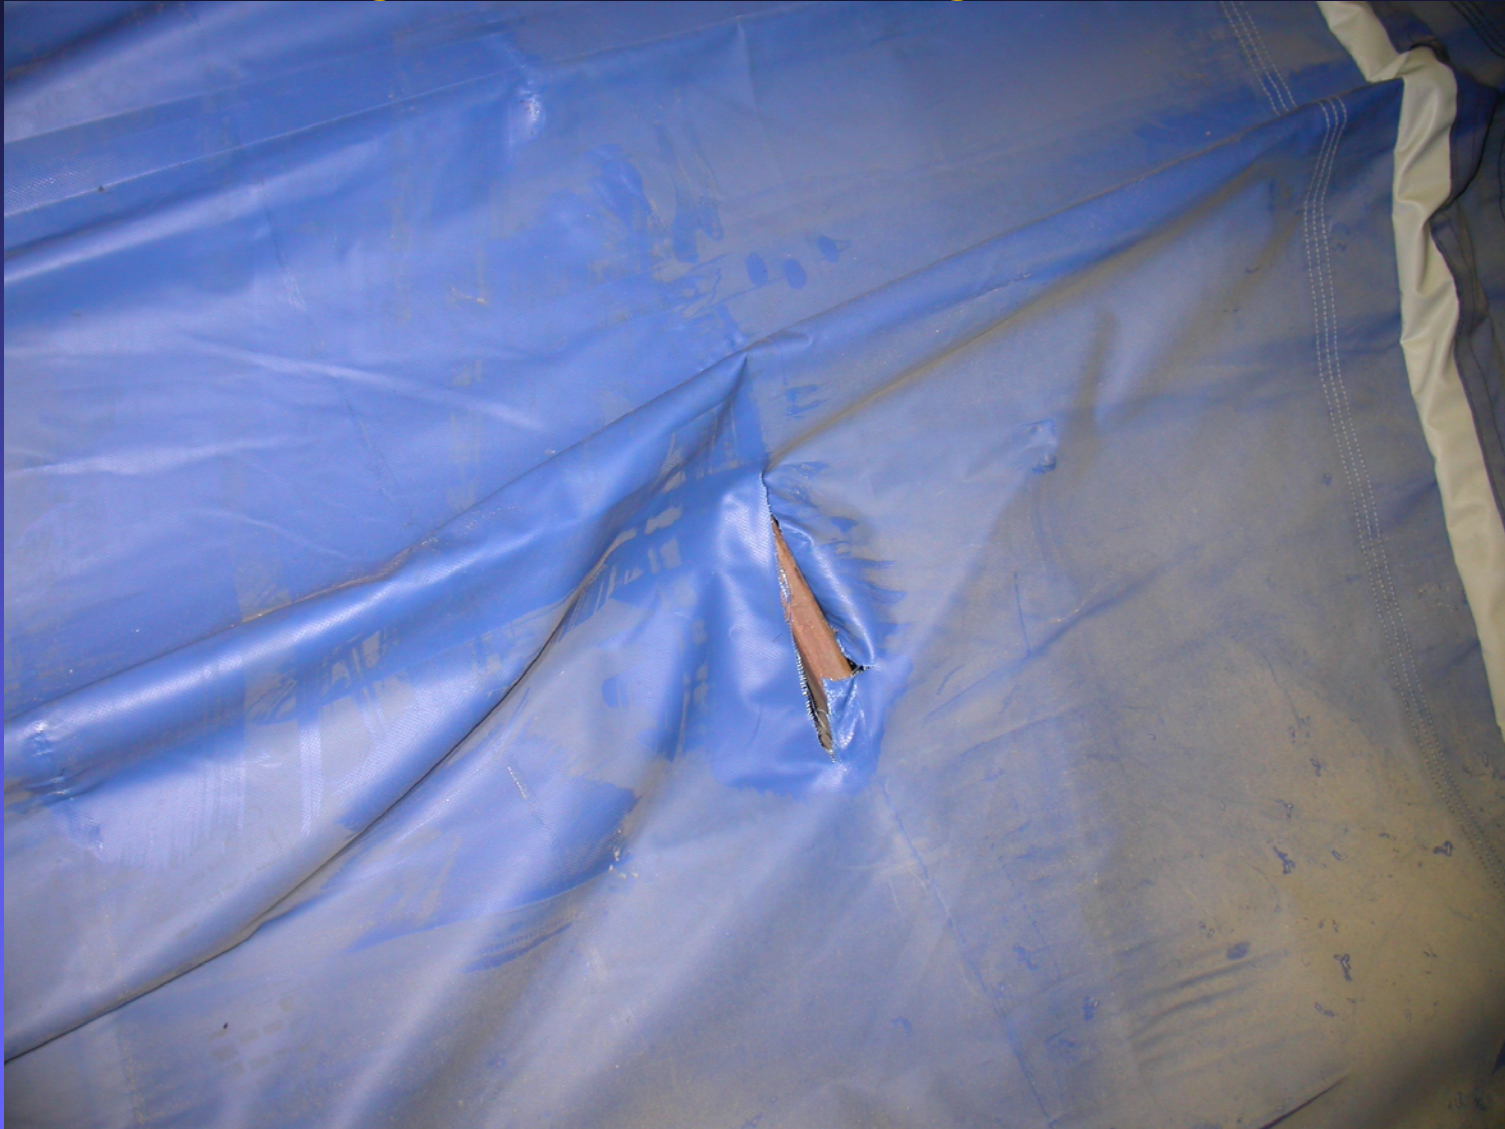
# Portadam – Log Impact Damage

- Geocell Systems RDFW
  - Minor sand settling
  - Significant washout along edges and toe
  - Toe damaged during large waves or overtopping
  - 10% of structure broken
- Portadam
  - Fabric torn during impact tests

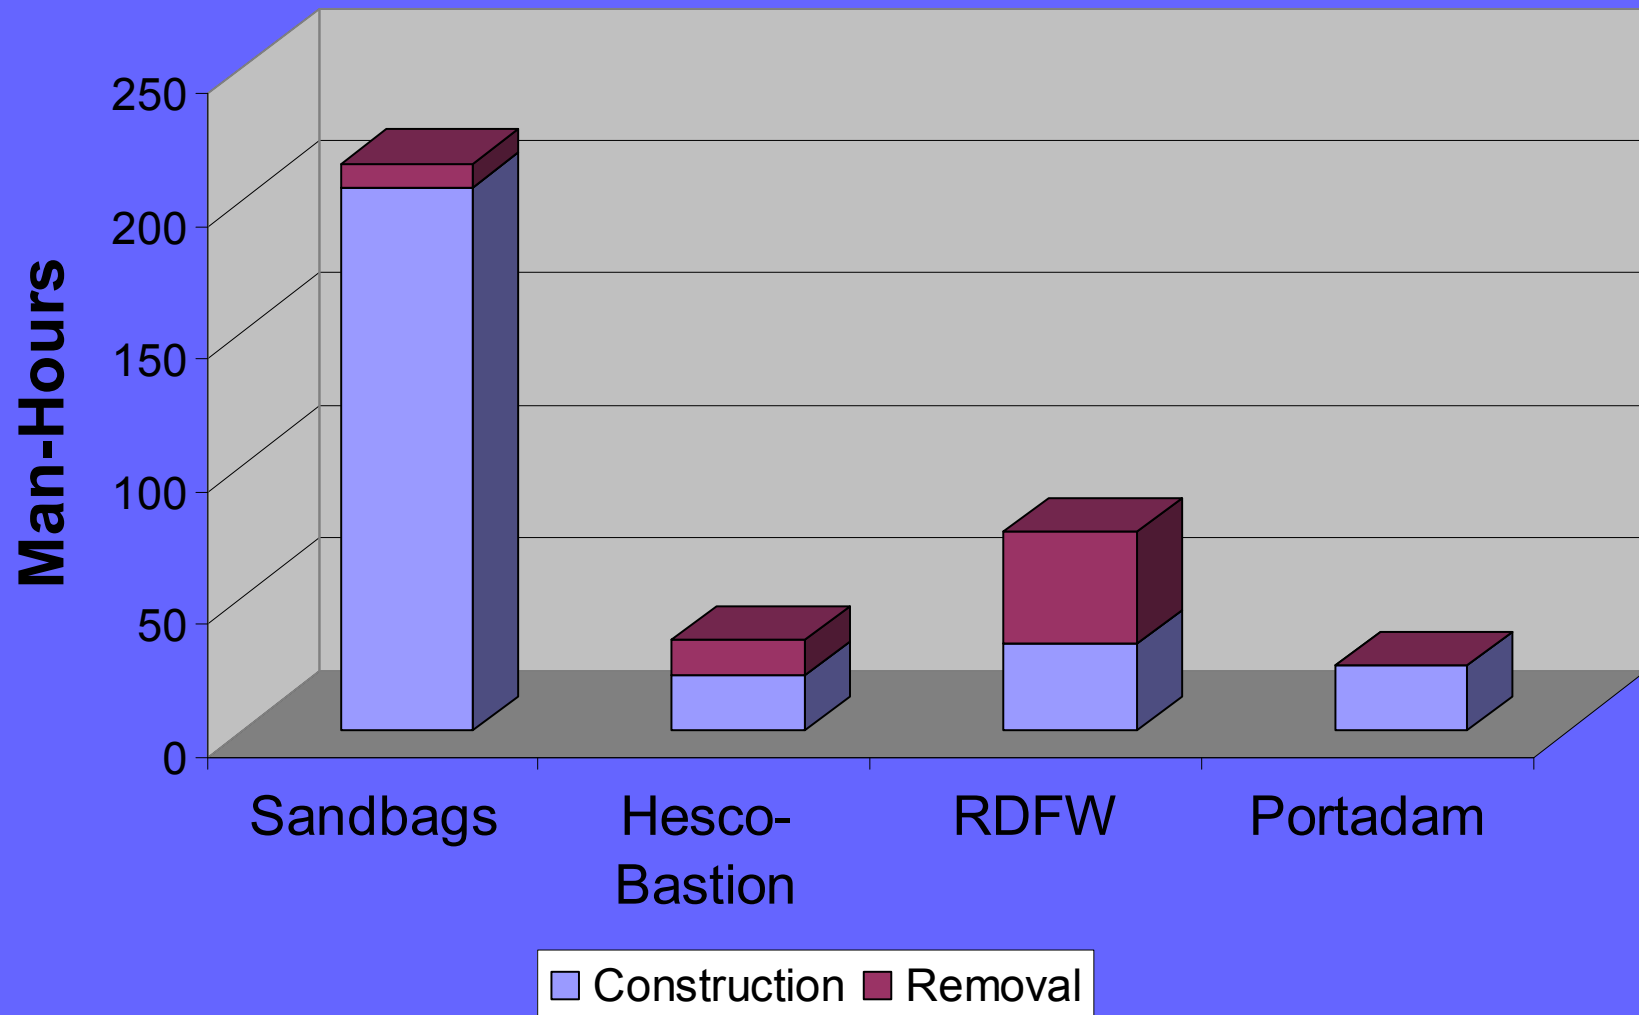
# Construction and Removal Summary

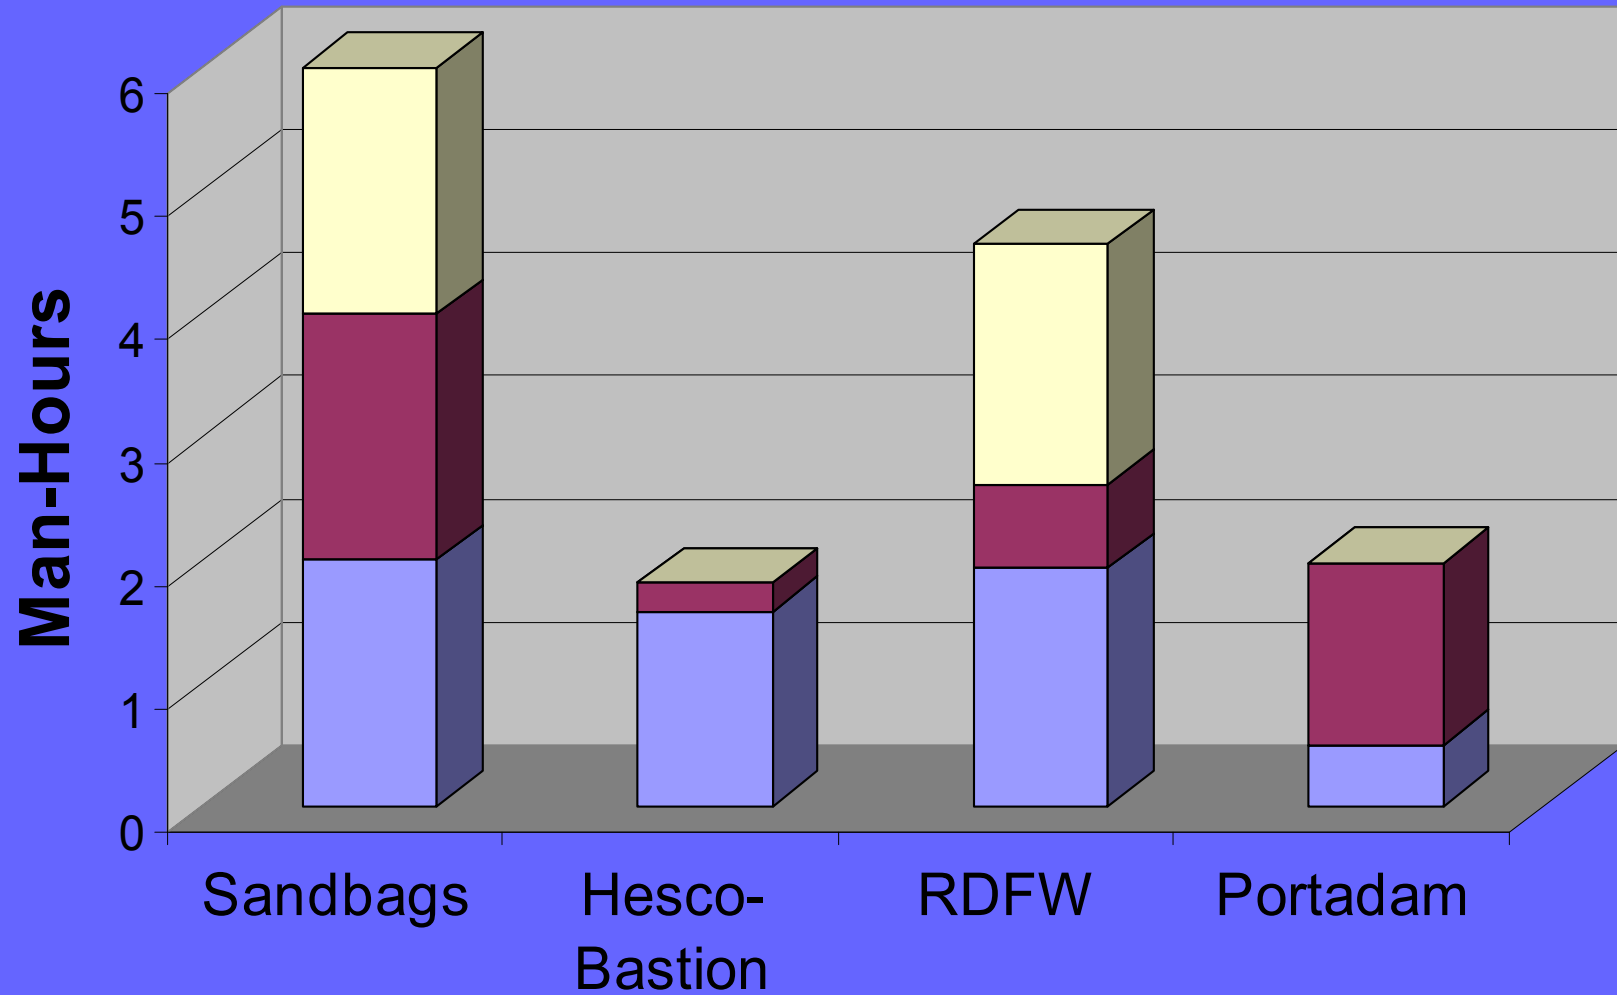
# Repair Summary

Repair 1 Repair 2 Repair 3

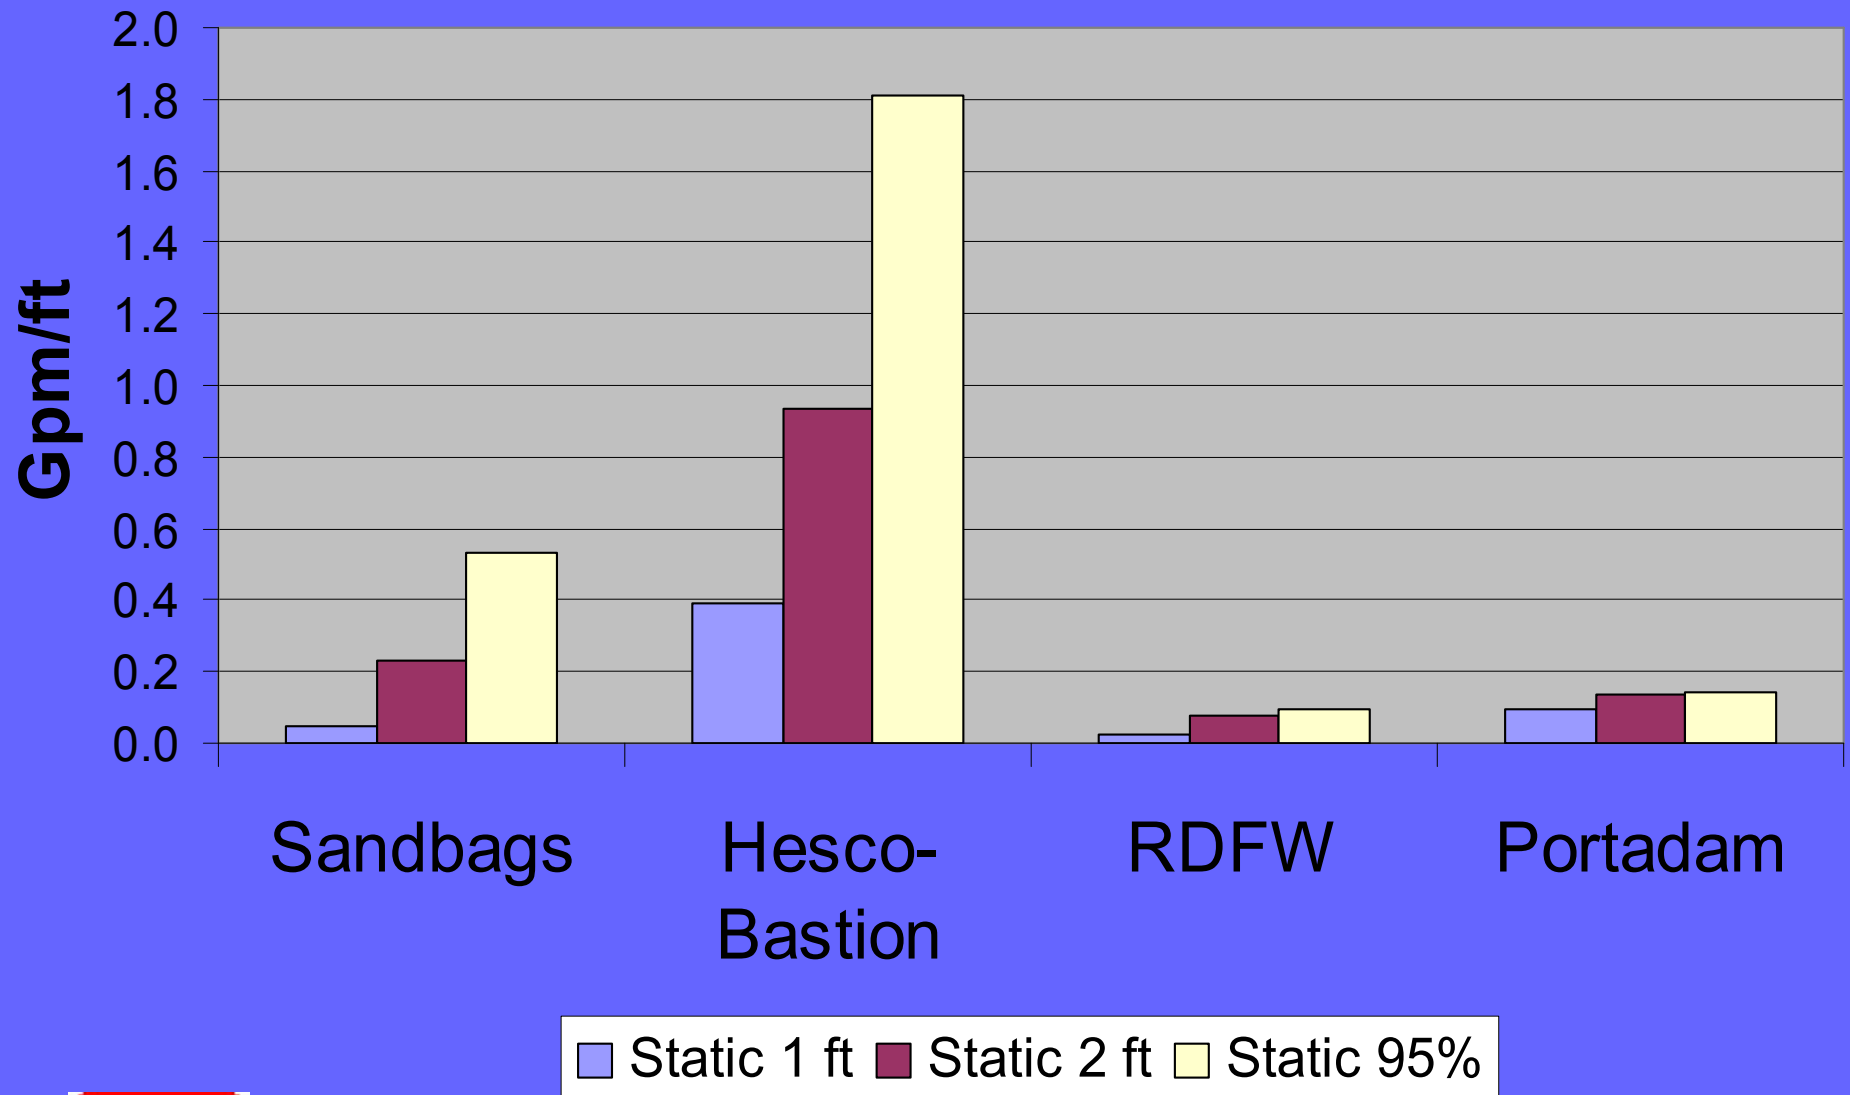
# Static Head Seepage Rates Summary

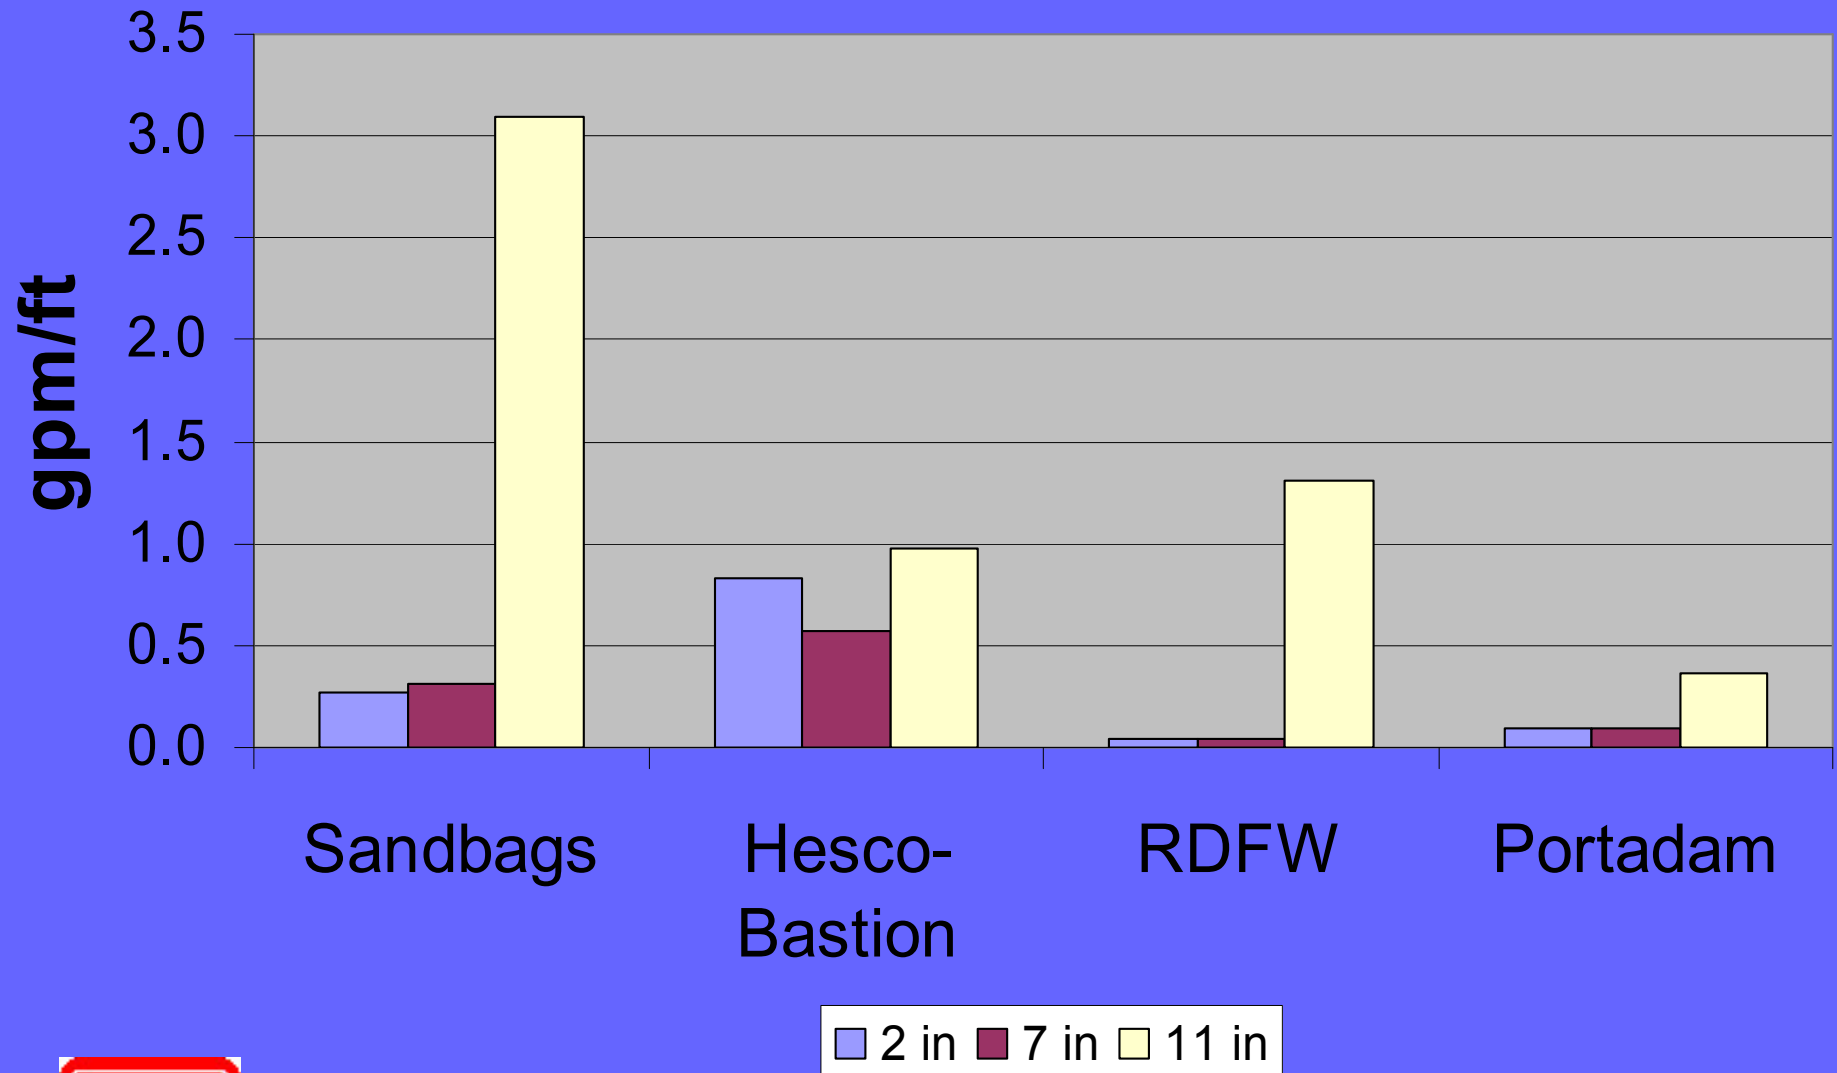
# Dynamic Wave Loading at 67%H Seepage

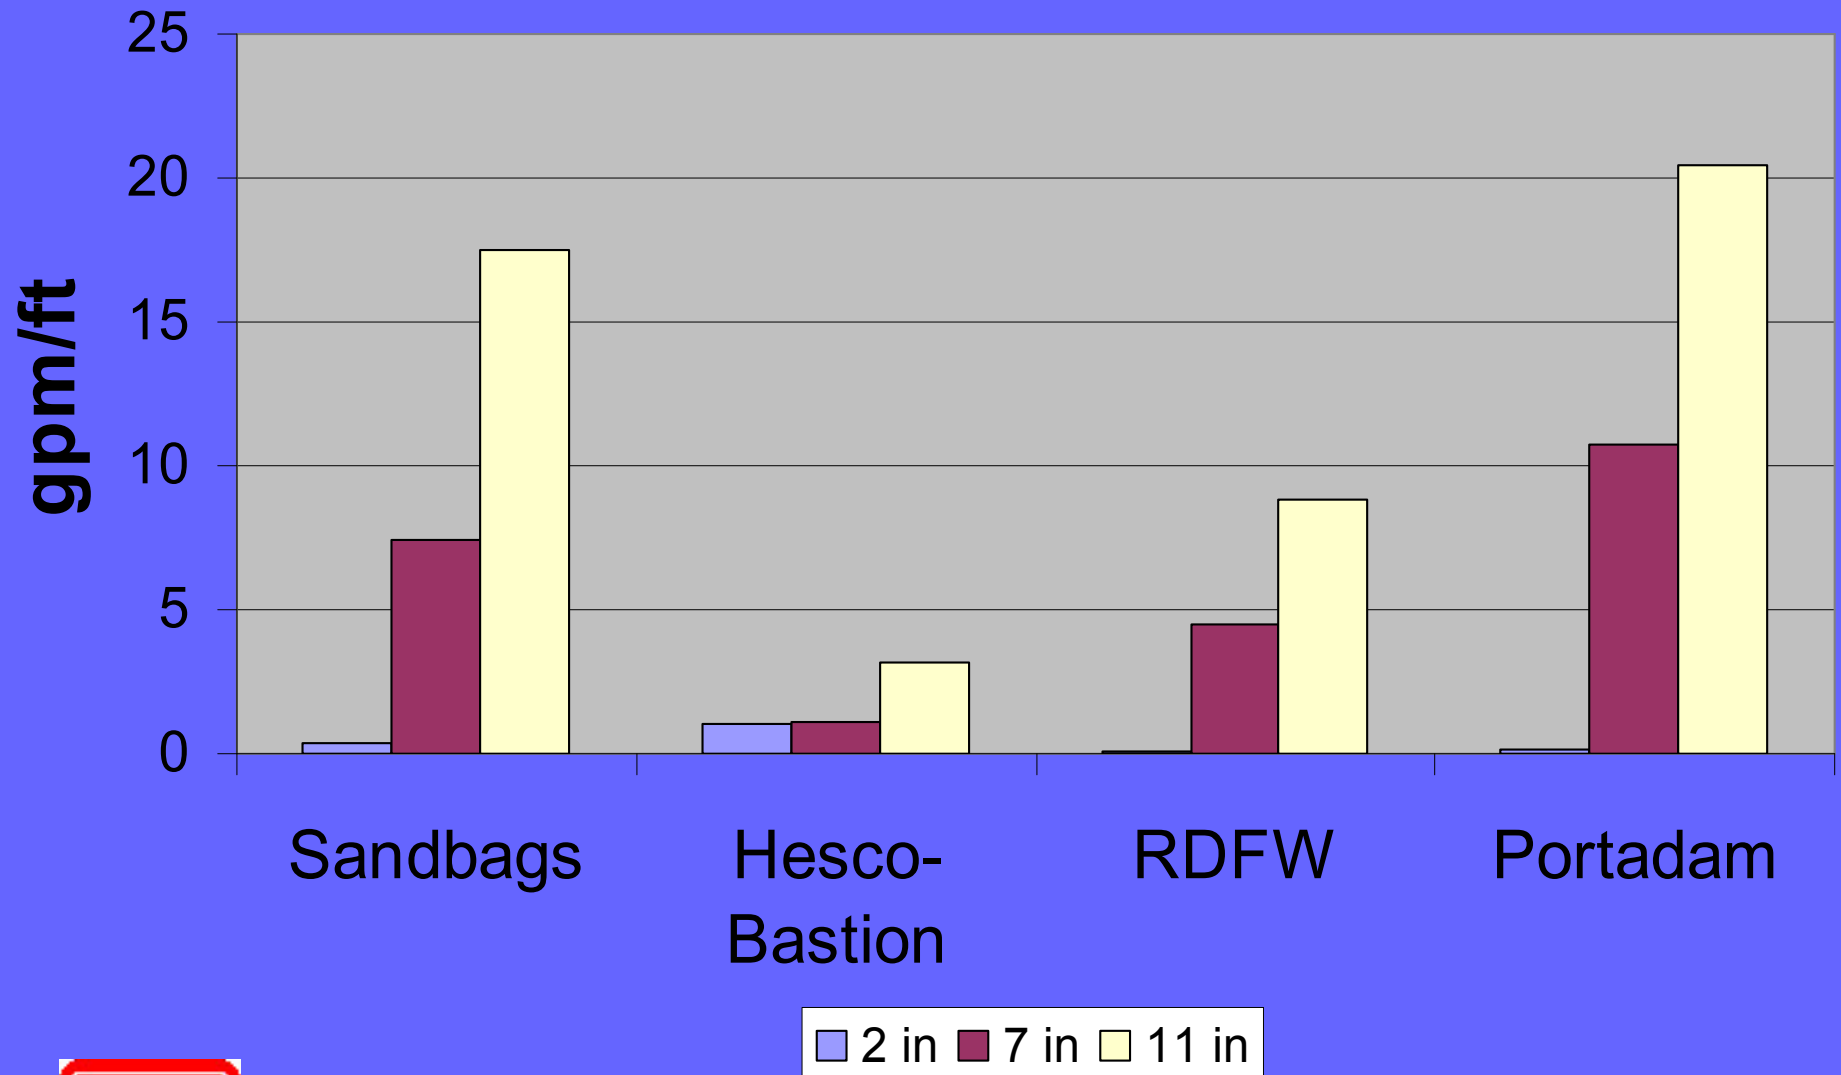
# Dynamic Wave Loading at 80%H Seepage
