Engineering Geology Challenges During Design and Construction of the Marmet Lock Project

2005 Tri-Service Infrastructure Systems Conference August 2-5, 5005

Ron Adams & Mike Nield

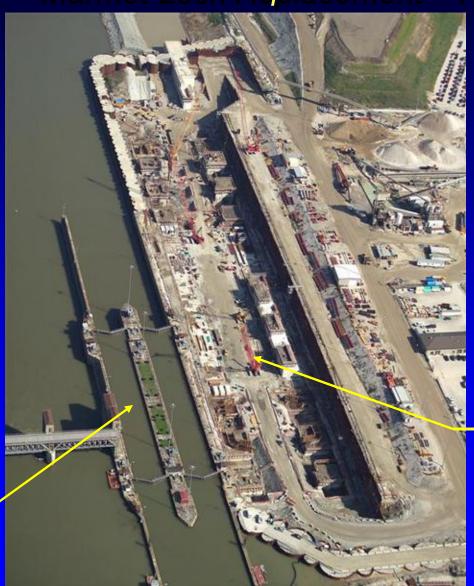
New Lock Chamber Under Construction

Existing Lock Chambers

New Lock Construction - Ariel View - May 2005

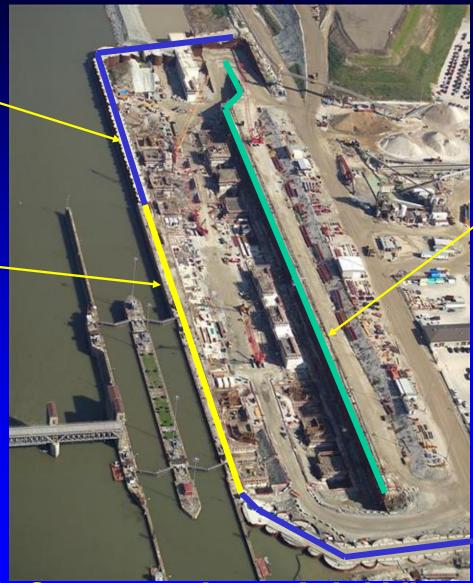
Sheet Pile Cell Cofferdam

Existing - Landwall Portion of Cofferdam

Contractor
Designed
Anchored
Retaining Wall

New Lock Construction - Ariel View - May 2005

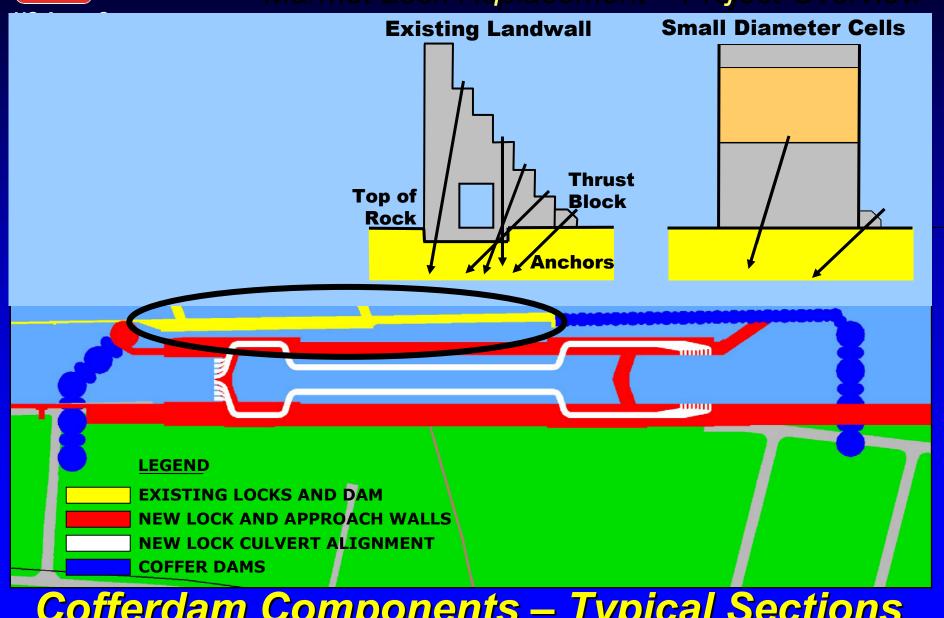
Cofferdam Components - Typical Sections

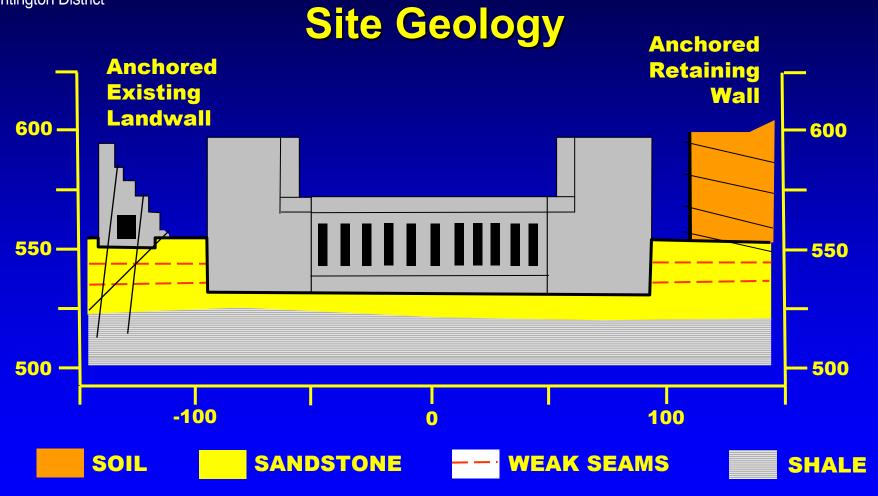
Geologic Cross Section - Upper Miter Gate

- Relatively flat top of rock surface
- Sedimentary rock of the Pennsylvanian-aged Kanawha Formation
- Nearly horizontal bedding. Discovered low angled (5 - 10°) dip to the Northwest during construction with localized stratigraphic dip
- Rock Units:
 - Sandstone member (23 to 43 feet thick)
 Shale member (19 to 33 feet thick)
- Sandstone member is competent but interbedded with many thin seams and stringers of coal and shale. Discovered to be continuous in excavated sidewalls during construction.

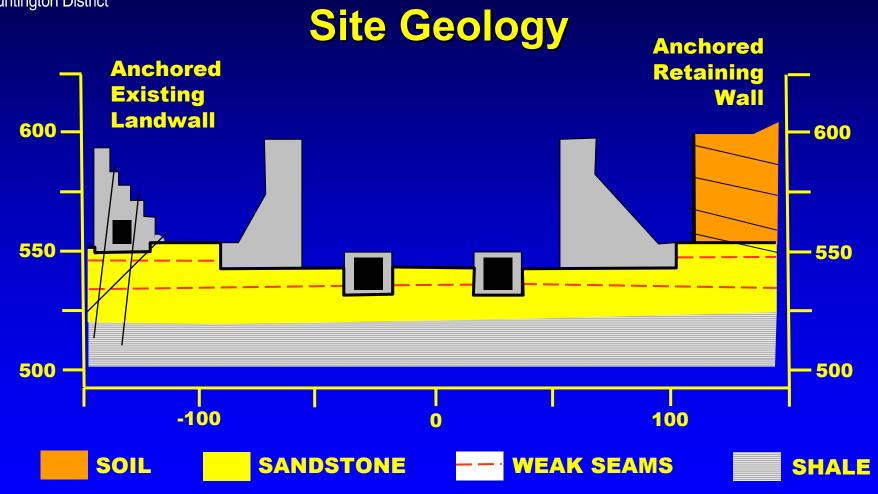
Geologic Cross Section – Chamber Monoliths

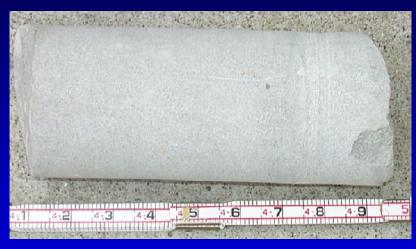
- Light gray
- Moderately hard to hard
- Medium to fine grained
- Average unconfined compressive strength8,442 psi

Sandstone Member

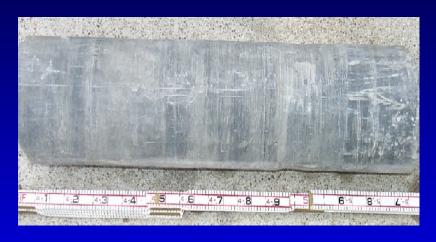
- Gray to dark gray
- Moderately hard to soft
- ♦Silty
- Average unconfined compressive strength6,678 psi

Shale Member

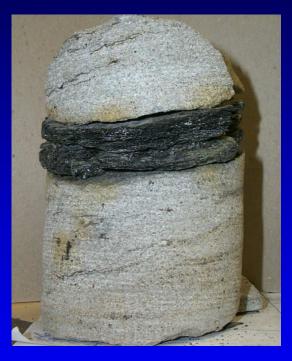
Design Sliding Friction Strength: phi angle = 23°, cohesion = 0psi

Thin Shale and Coal Seams within Sandstone

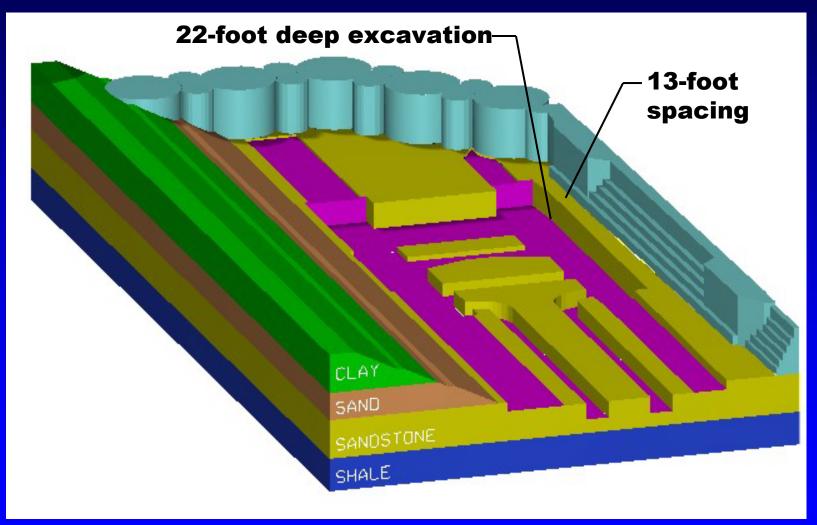
Excavation Adjacent to Structures – 3D view

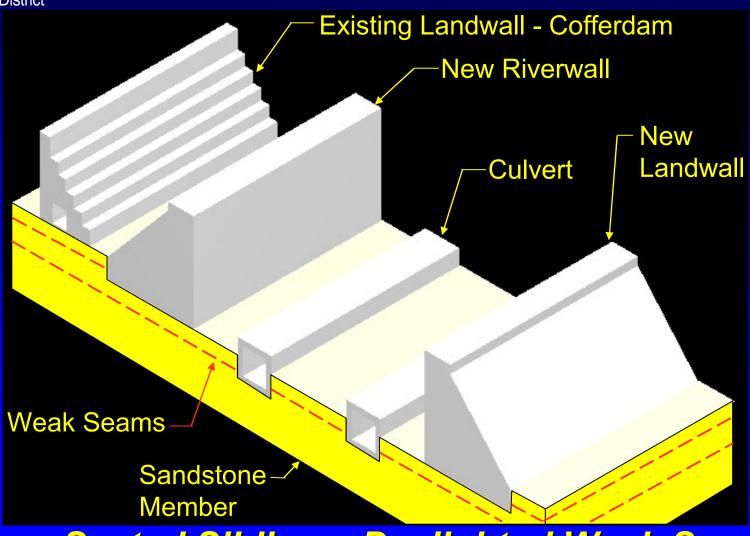
Deep Seated Sliding - Daylighted Weak Seams

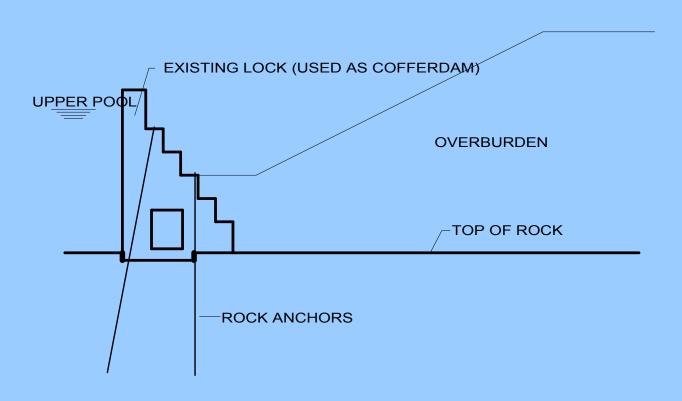
STAGED ANCHORING DURING OVERBURDEN EXCAVATION Analyzed for coal/shale seam at foundation (phi=23°, c=0psi)

INSTALL INSTRUMENTATION

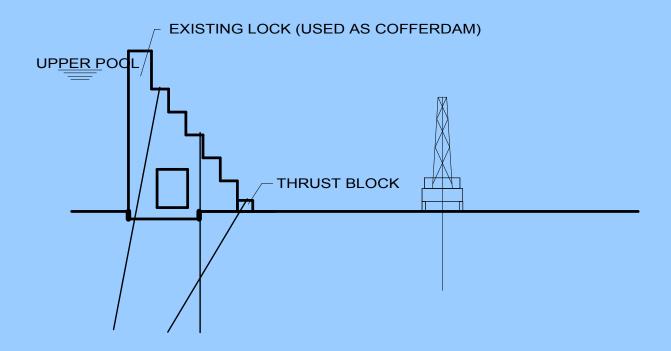
THRUST BLOCK ANCHORED PRIOR TO ROCK EXCAVATION Analyzed for daylighted horizontal fault gouge (phi=13°, c=0psi)

SUBSURFACE EXPLORATION PERFORMED

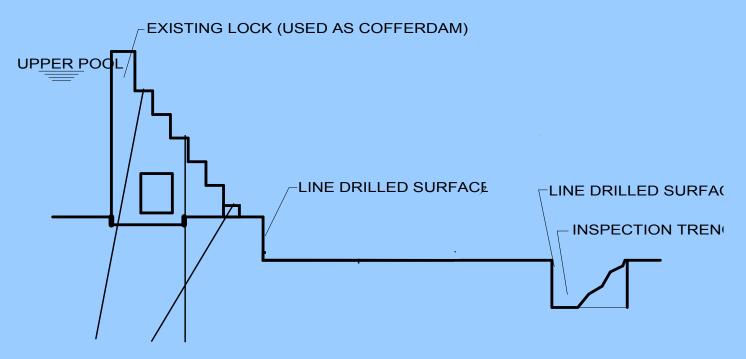
COMPLETE EXCAVATION FOR CULVER/INSPECTION TRENCH
ESTABLISH PRESENCE AND EXTENT OF WEAK SEAMS – NEW LOCK
DETERMINE CORRECIVE FOUNDATION TREATMENT – NEW LOCK

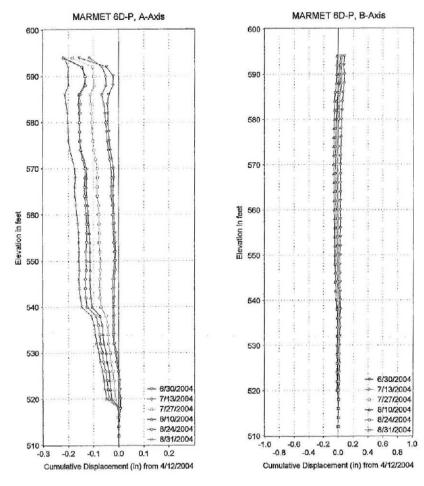
- ◆ Initial Downstream Movement
 - August 2004 Movement Occurred Along Two Weak Planes
 - El 540 +/- Where There Is A Series Of Thin Seams Of Carbonaceous Shale And Coal Within An Otherwise Generally Competent Sandstone Formation
 - El 520 +/- Where There Is A Discontinuous Thin Seam Of Clayey Material Near The Bottom Of The Sandstone Unit And An Underlying Shale Formation. This Seam Is Slightly Lower Than Any Required Excavation

Initial Movement – Cell 6D August 2004

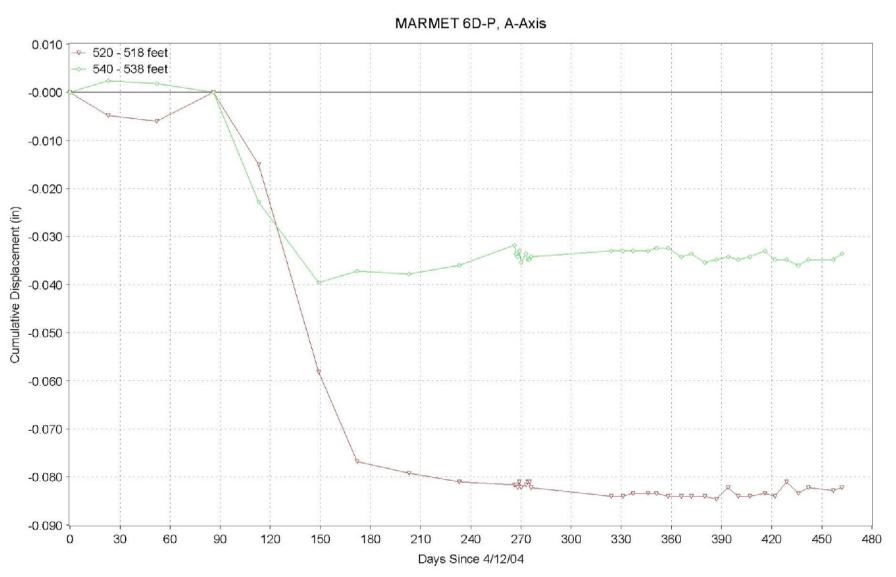
Portable Inclinometer Displacement

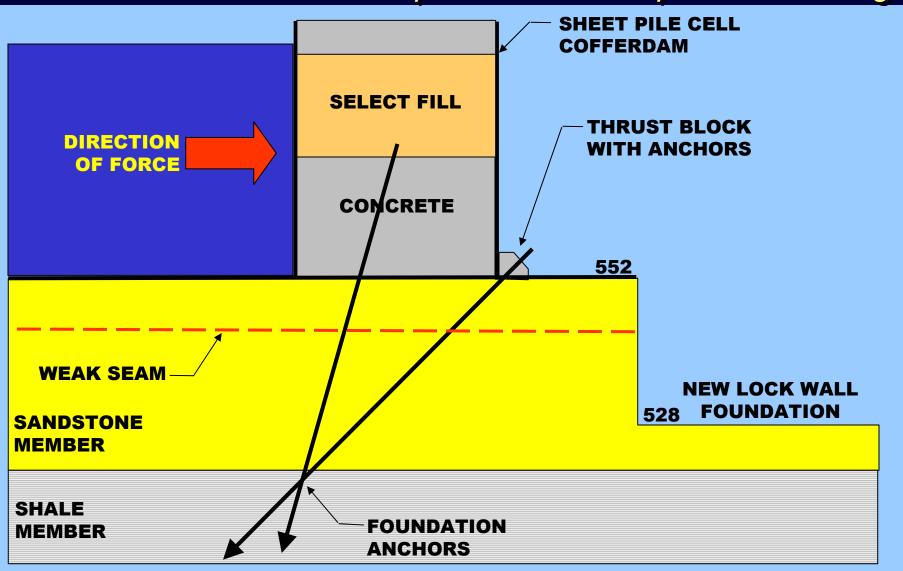
Cofferdam Foundation Movement - Section

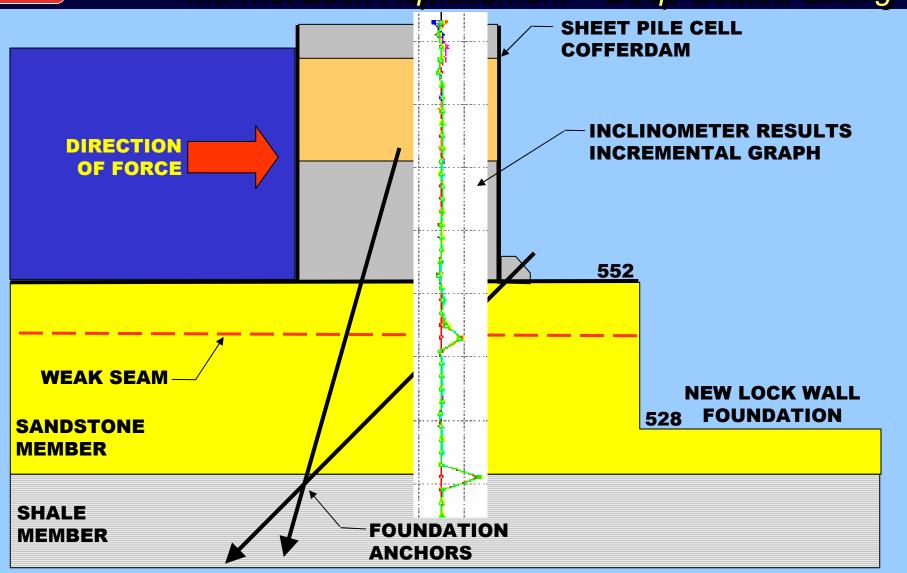
Cofferdam Foundation Movement - Section

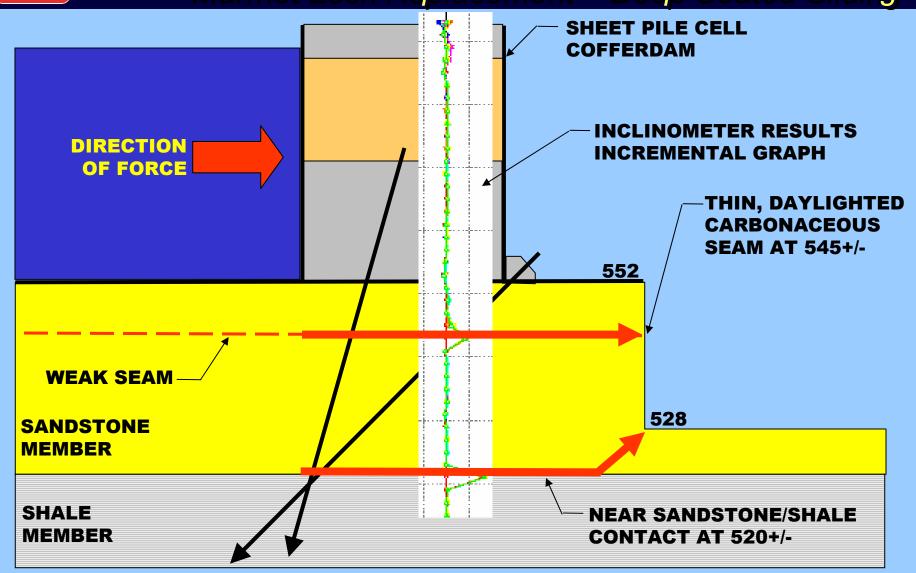
Cofferdam Foundation Movement - Section

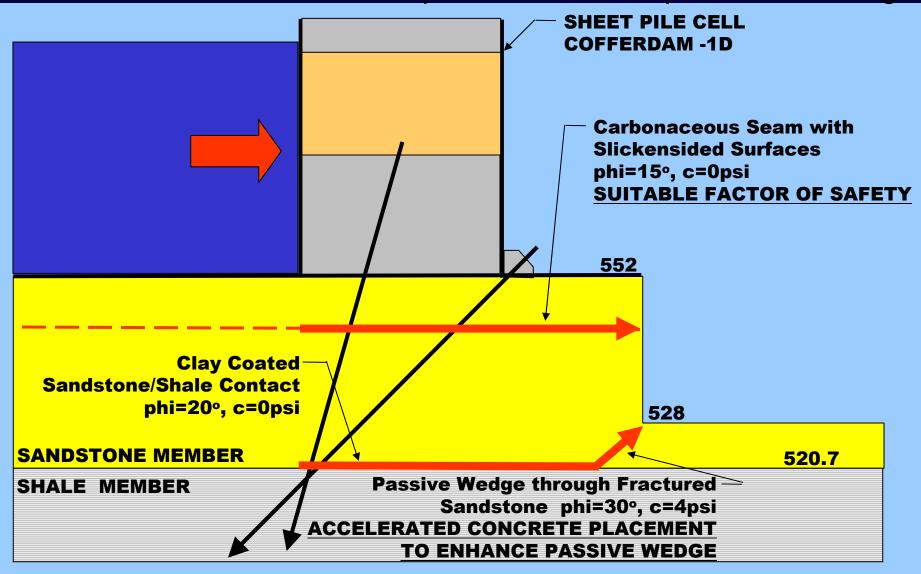
Cofferdam Foundation Movement — Cell 1D

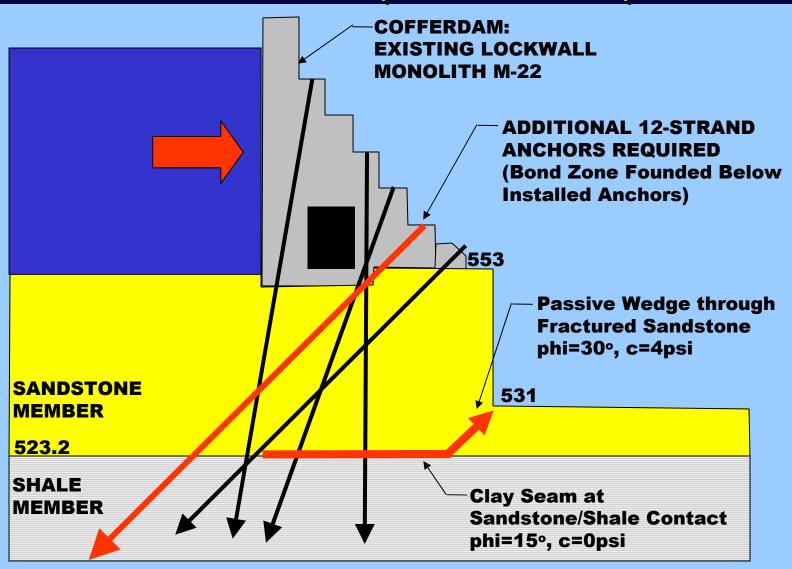
Cofferdam Foundation Movement — M-22

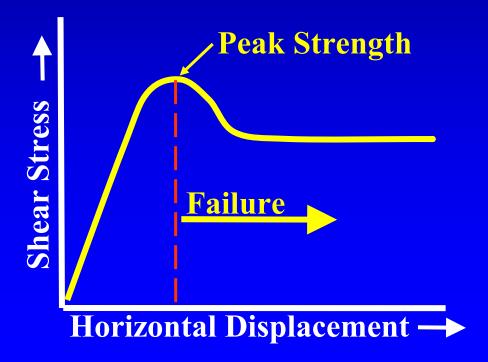
- Some displacement is required to engage rock mass shear strength
- Establish how much movement is acceptable

SCALE EFFECT OR LENGTH OF SHEARED BLOCK WAS TAKEN INTO CONSIDERATION

0.35 INCHES
ESTABLISHED AS
APPROACHING
FAILURE

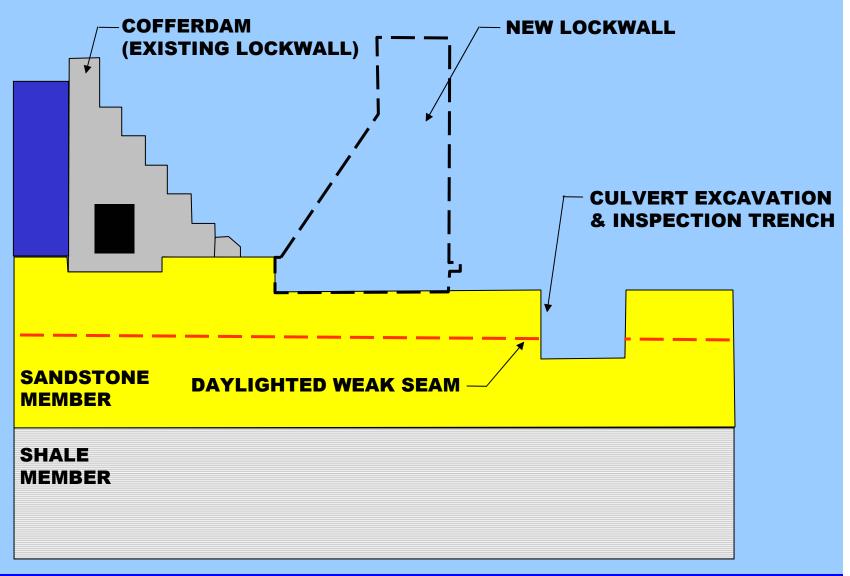
MONOLITH R-15A

Inspection Trench Sidewall - Photo

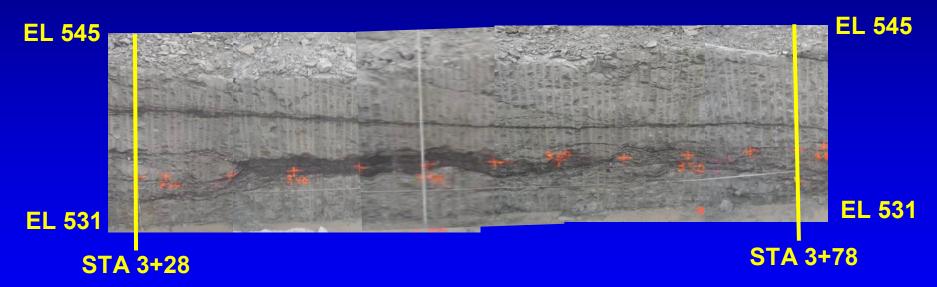
MONOLITH R-15A

Inspection Trench Sidewall - Photo

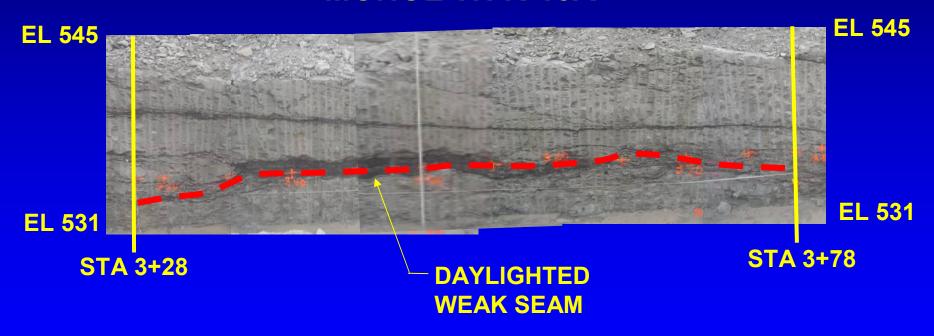
Inspection Trench Sidewall - Map

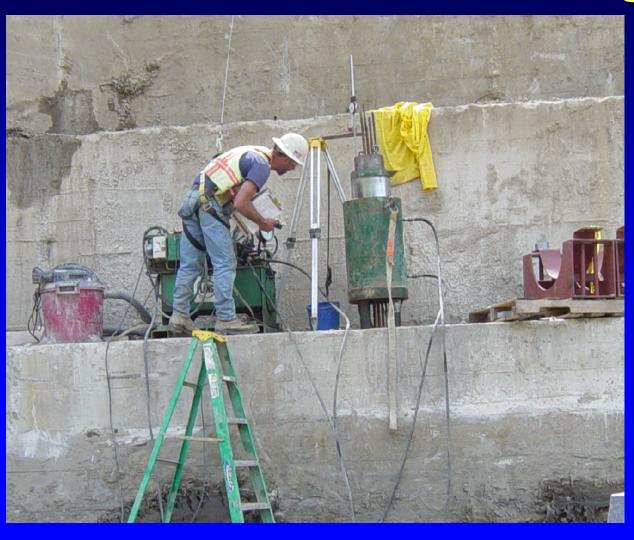
Anchor Tensioning

Anchor Tensioning Loads

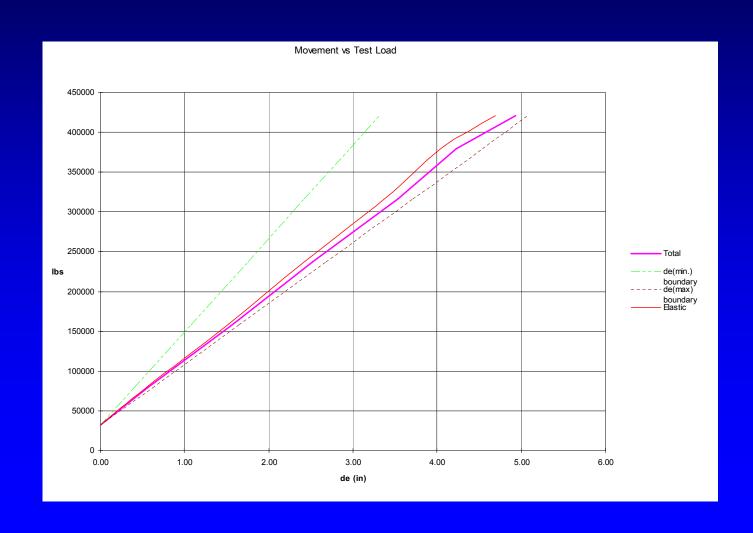
Performance Test Results

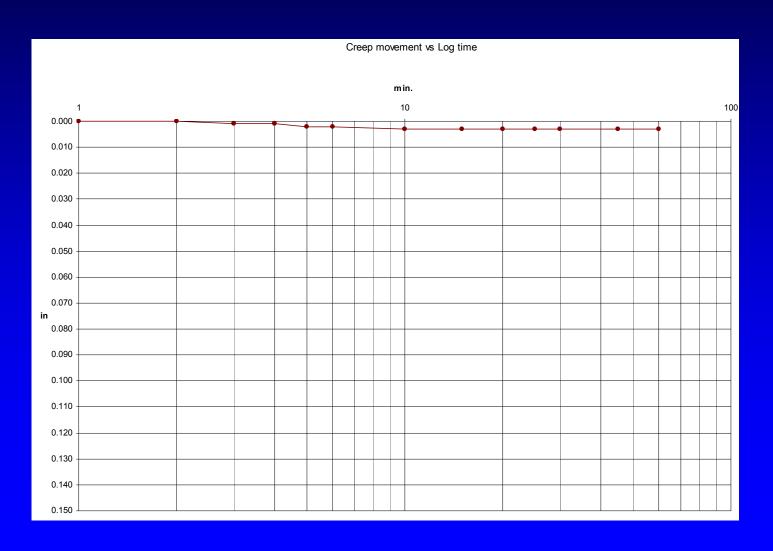
Creep Test Results

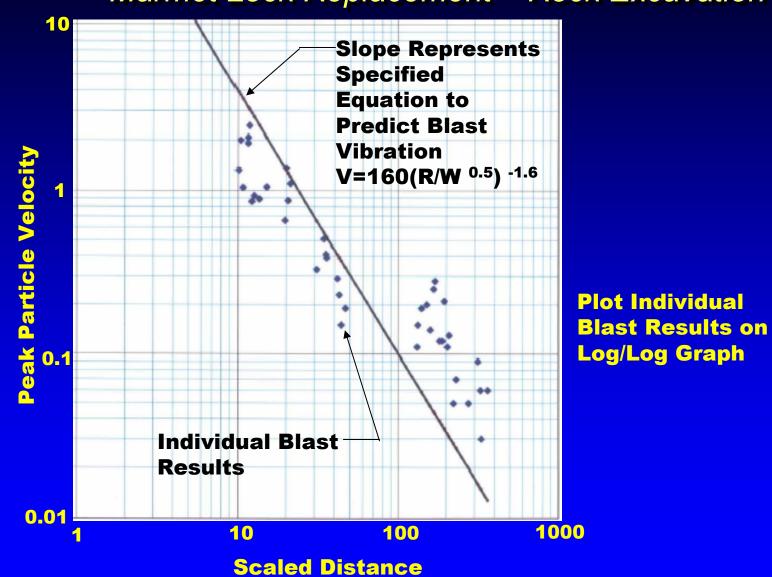
Evaluating Specified Vibration Equation

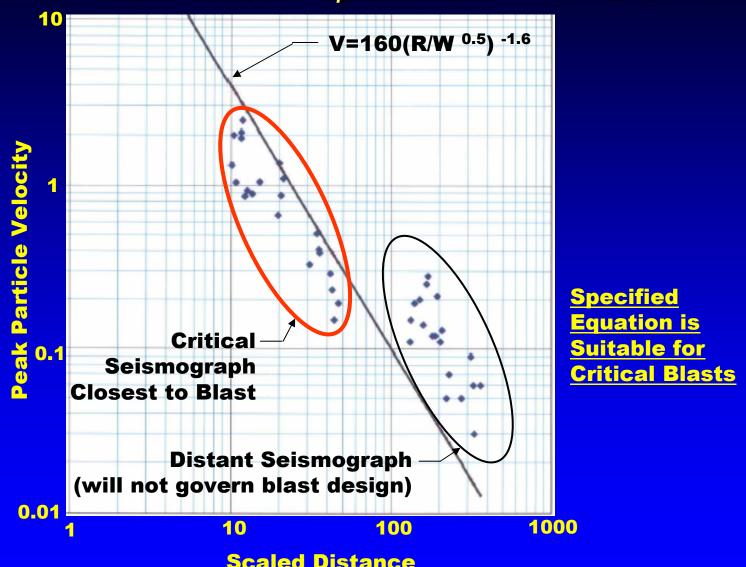
Scaled Distance

Evaluating Specified Vibration Equation

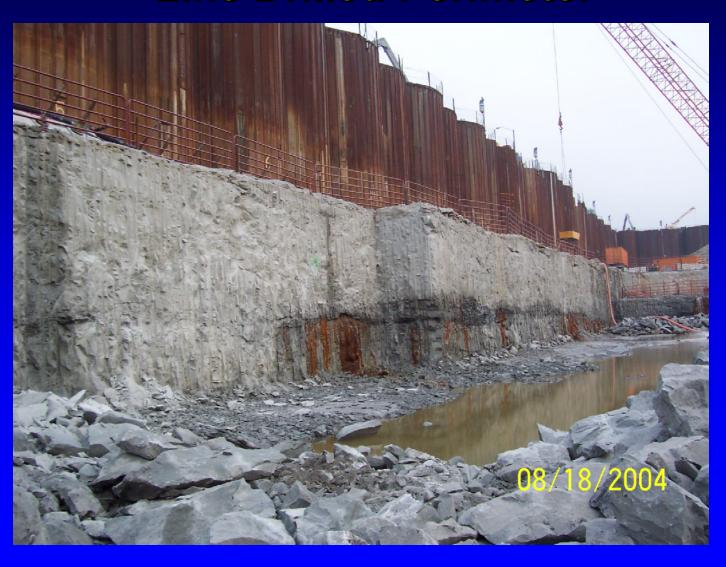
Line Drilled Perimeter

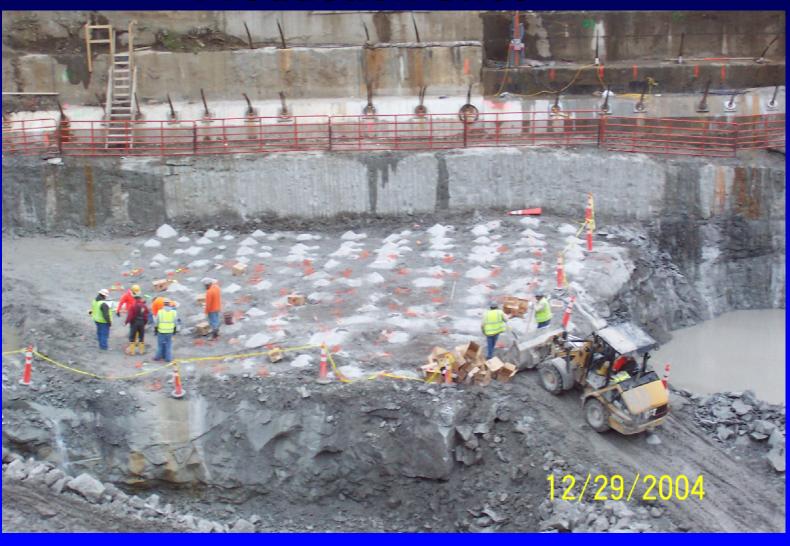
Production Shot

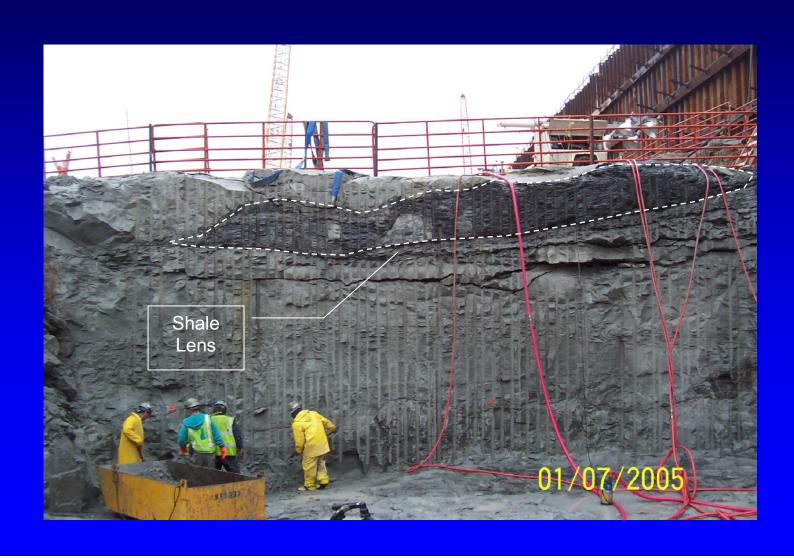
Lenticluar Beds

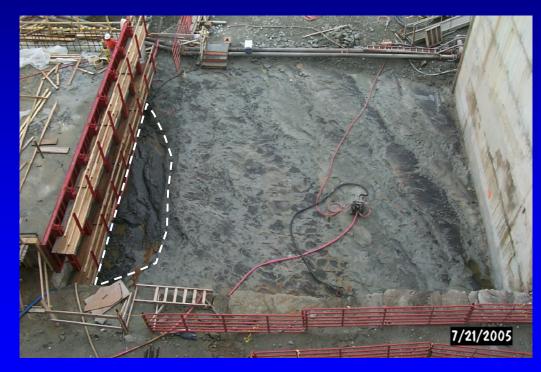
Lenticular Shale Bed Plan View

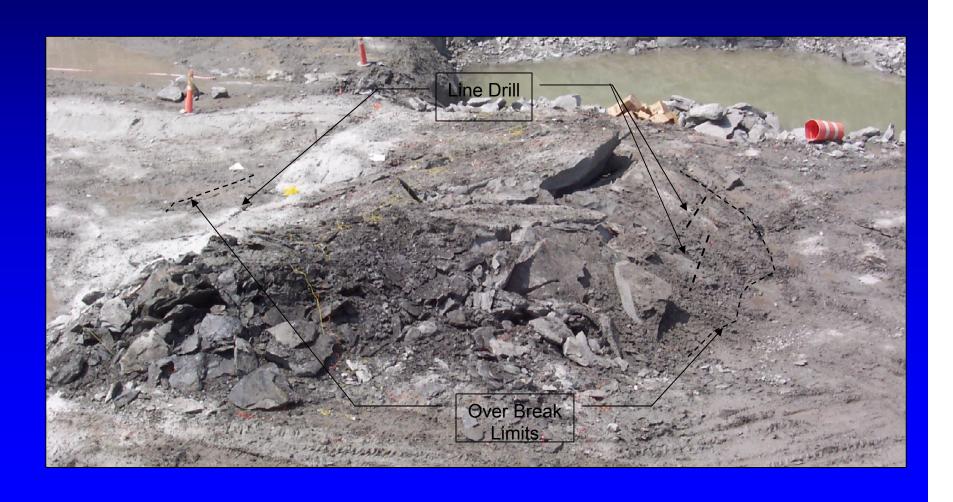
Over Break Behind Line Drilled Face

- Over Break Behind Line Drilled Faces
- Sub Drilling

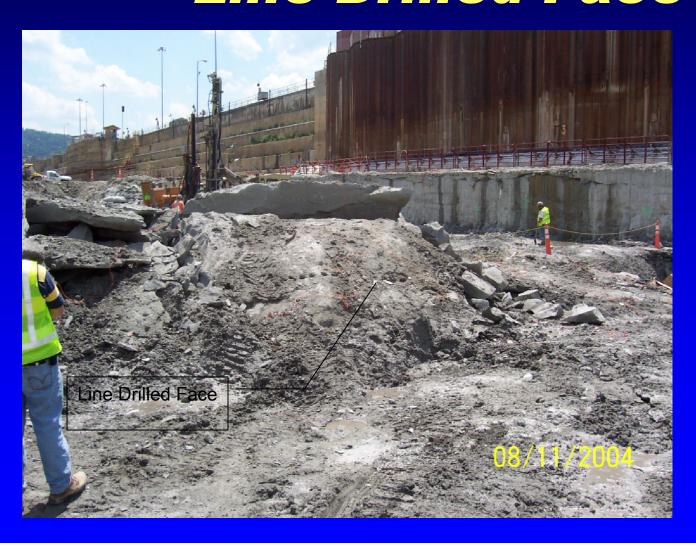
Over Break Behind Line Drilled Face

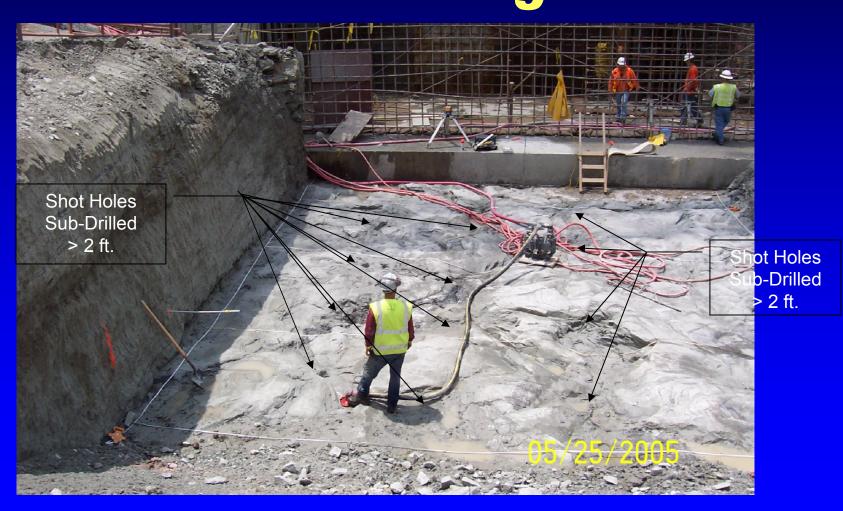
Sub Drilled Shot Hole Damage

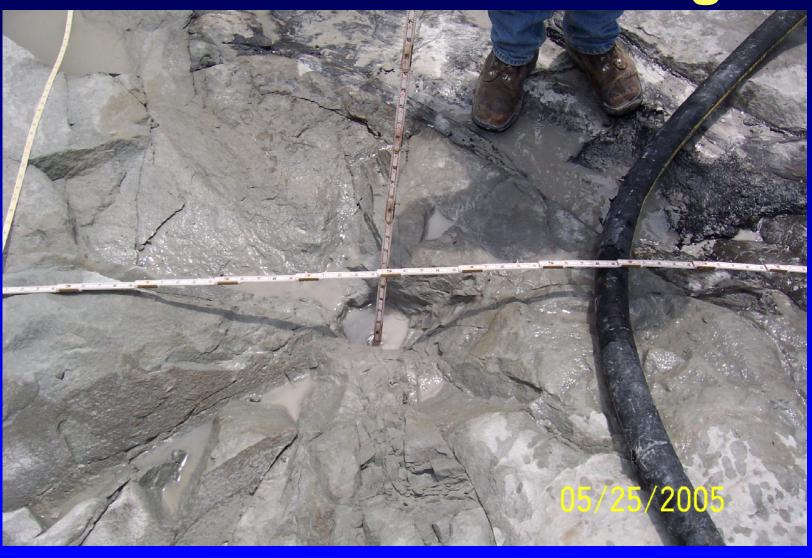
Shot Hole Damage

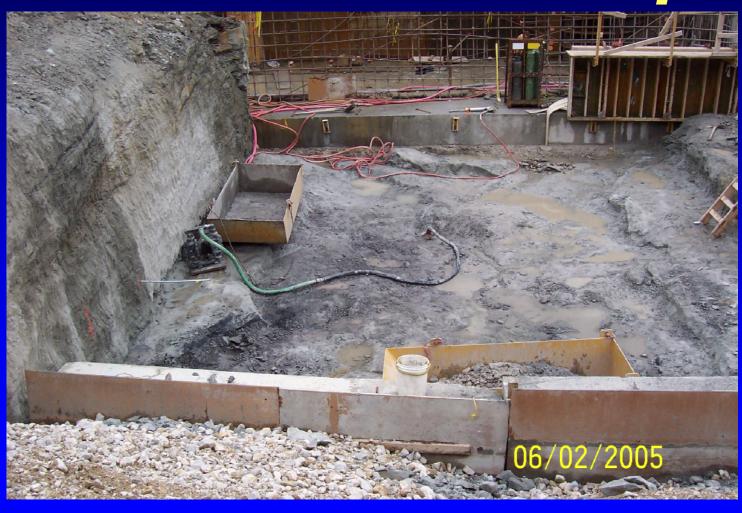
Shot Damage Post Foundation Prep.

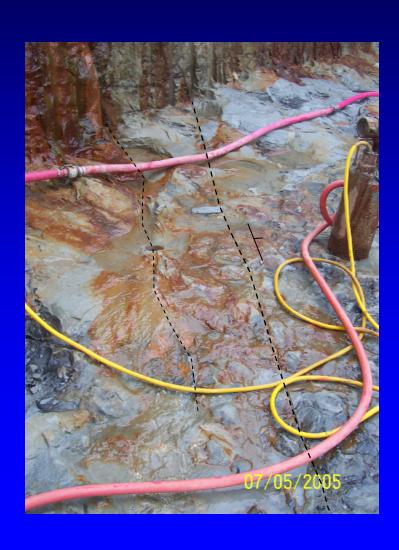
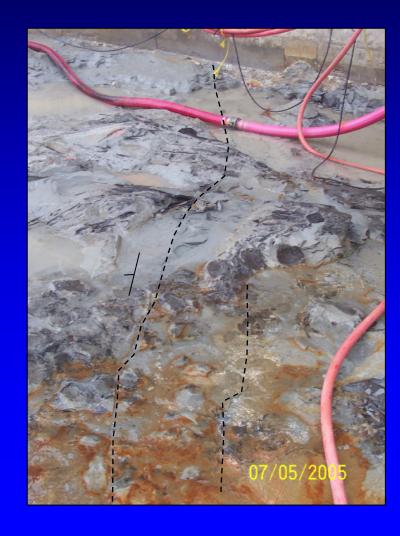
Artesian Joints

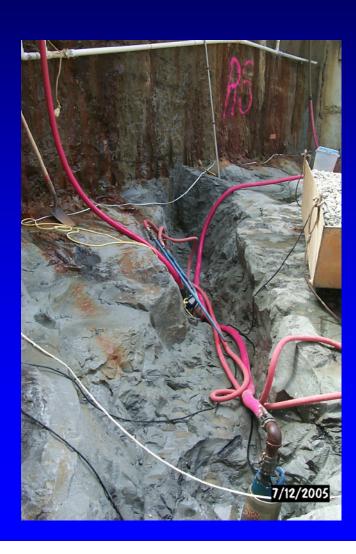
Joints Excavated

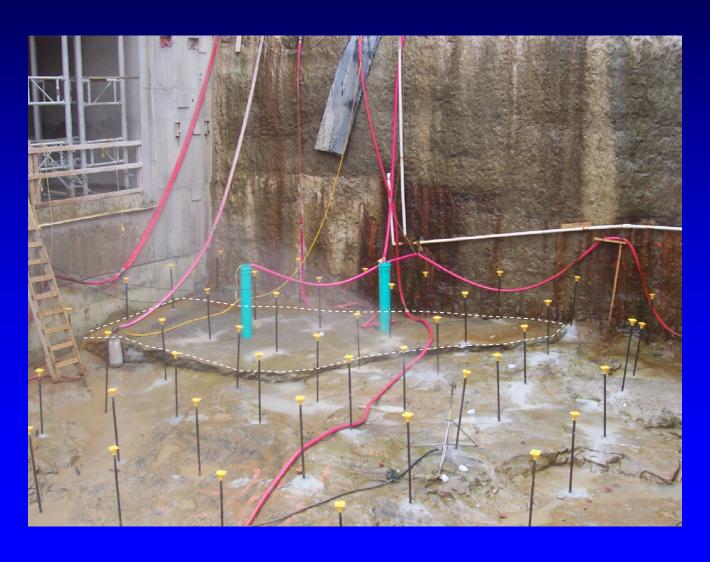
Concrete Placed

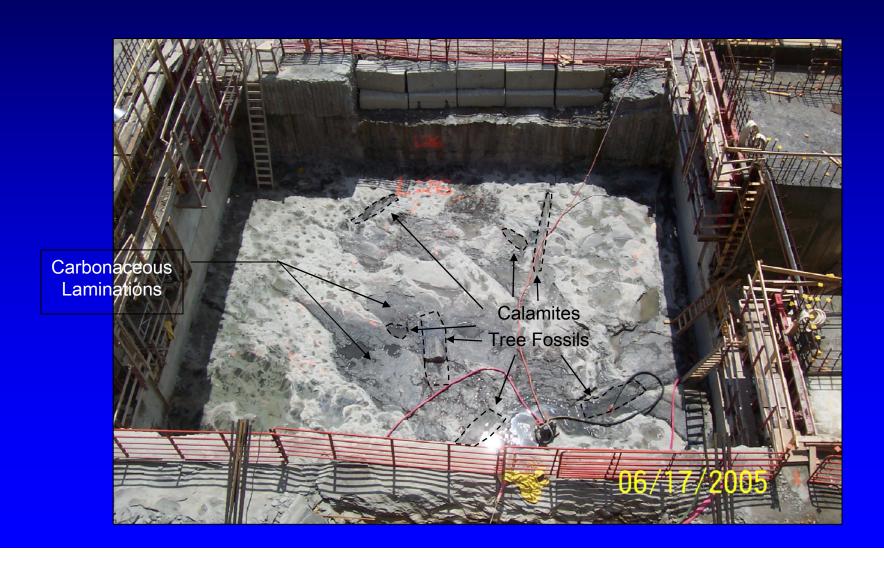
Carbonaceous Laminations and Tree Fossils

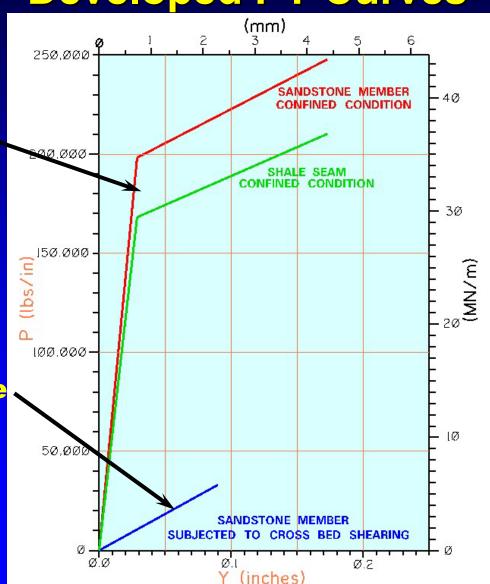
Developed PY Curves

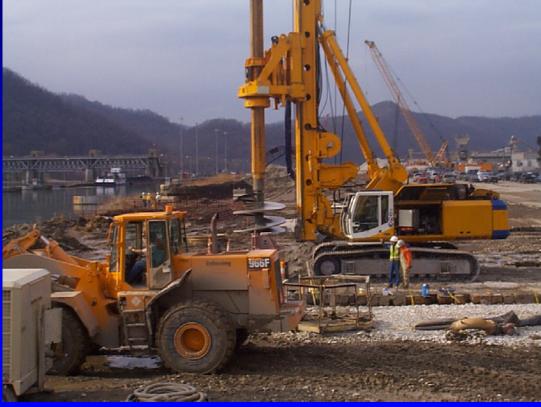
Drilled Shaft Drill Rig

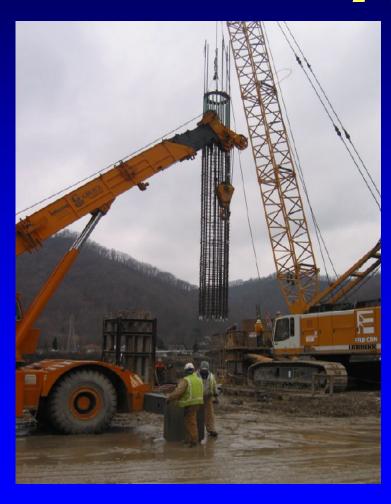
Rebar and Concrete Placement

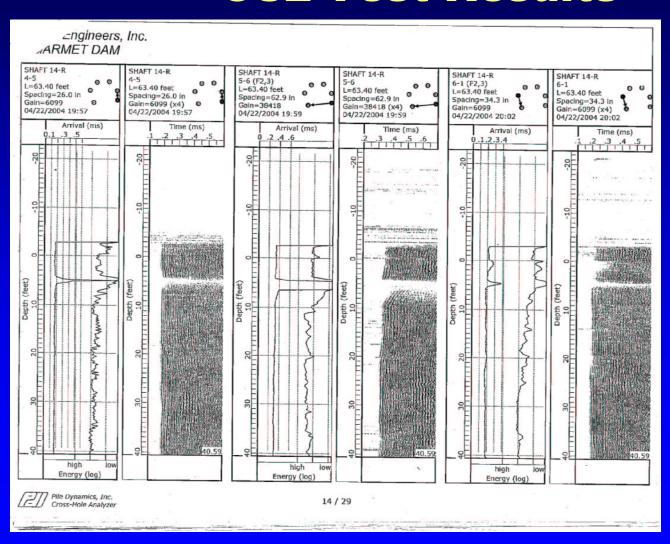
Drilled Shaft CSL Test Results

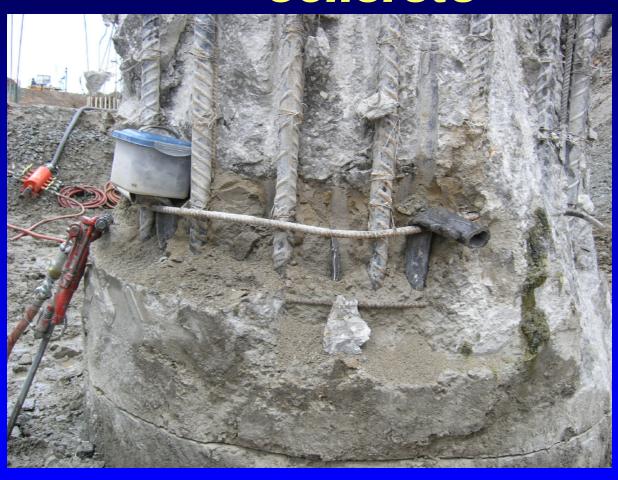
Drilled Shaft Low Density Concrete

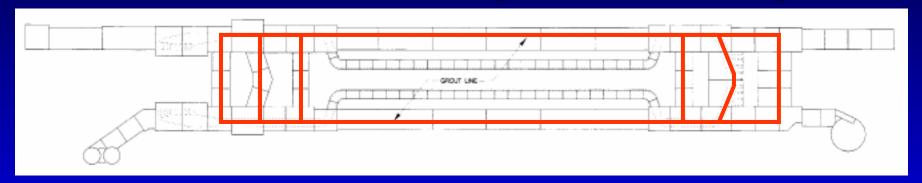
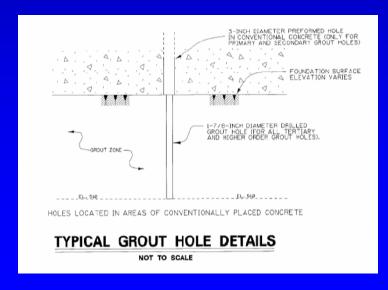
Foundation Drilling and Grouting

- Grout Curtain Extends to Elevation 510
- 10' Spacing Between Primary and Secondary Holes
- Optional Tertiary and Higher Order Holes
- All Holes Pressure Testing
- Neat Cement Grout
