Concrete Damage at Carters Dam

January 2005

Engineer Research and Development Center

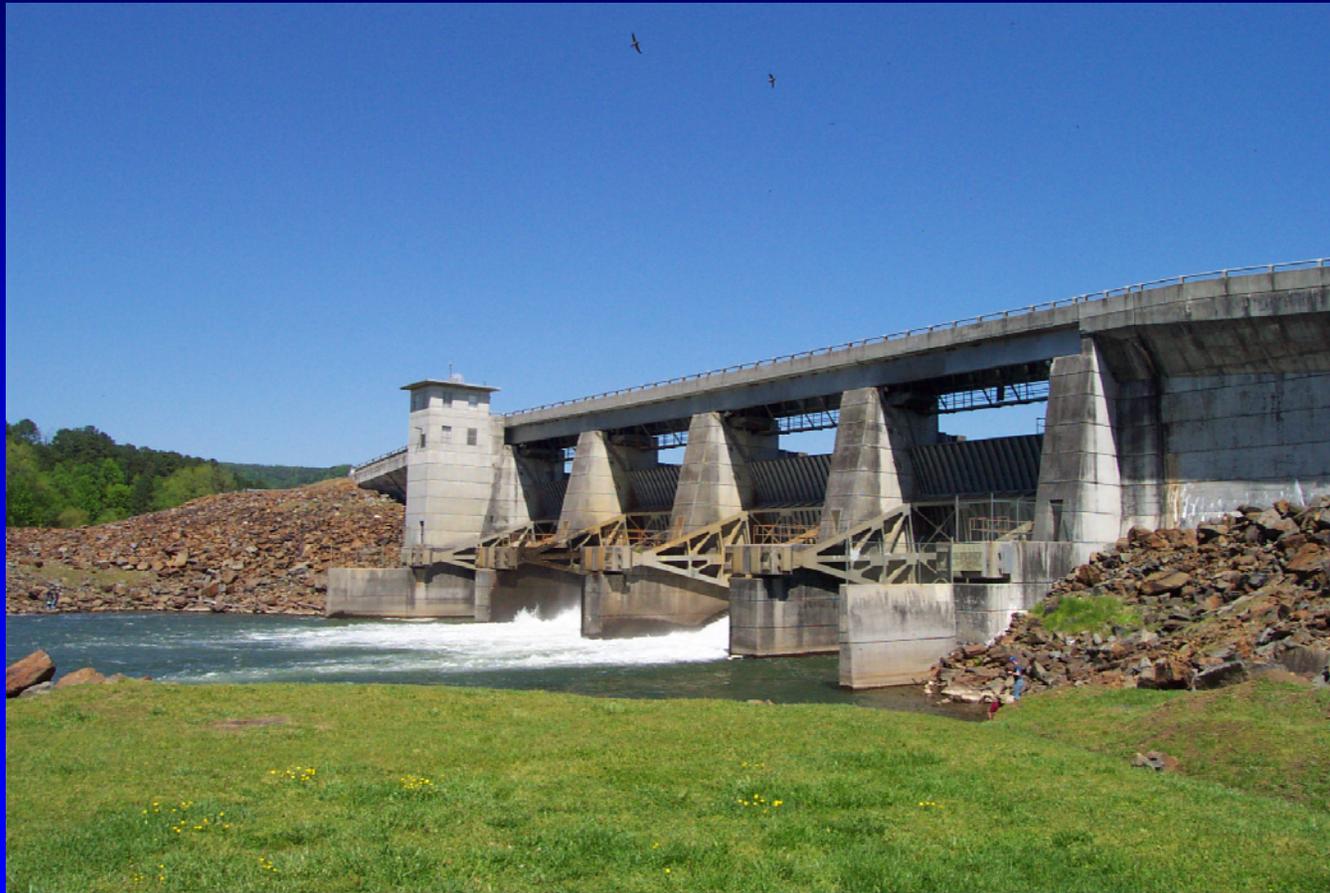
Reregulation Dam – Downstream View

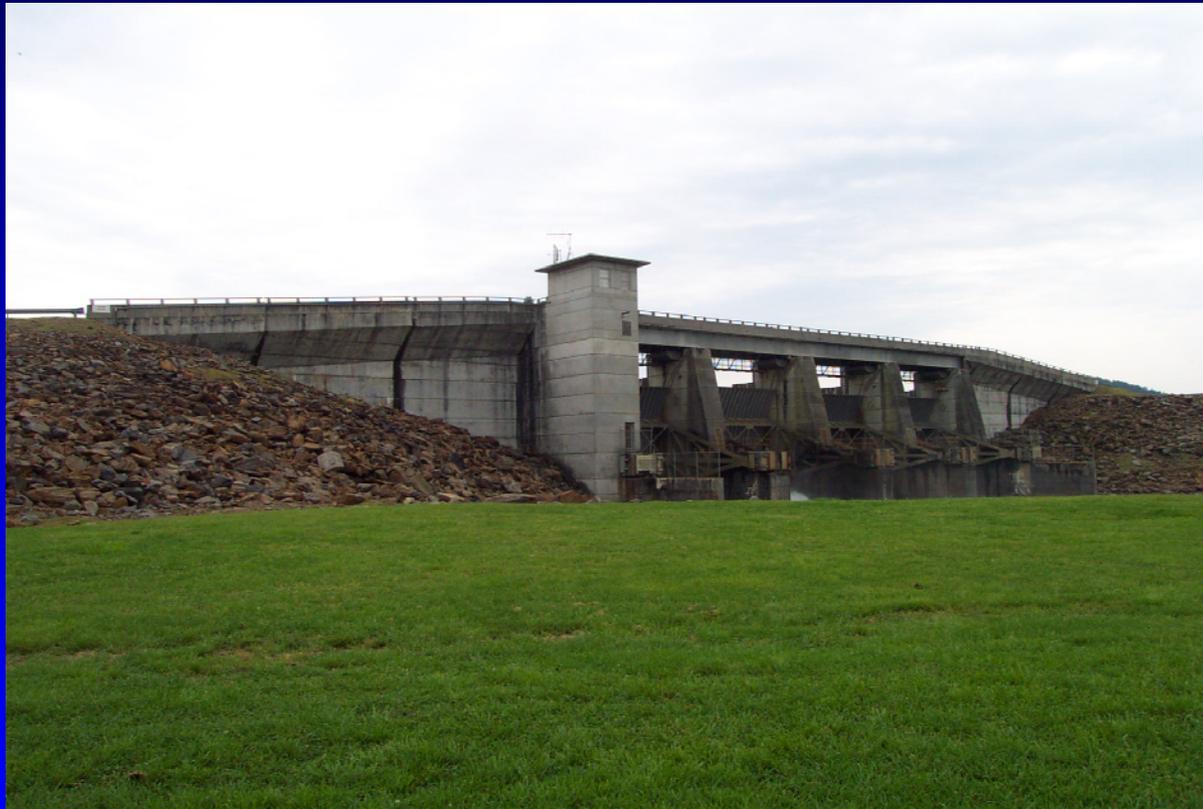
Reregulation Dam – Downstream View

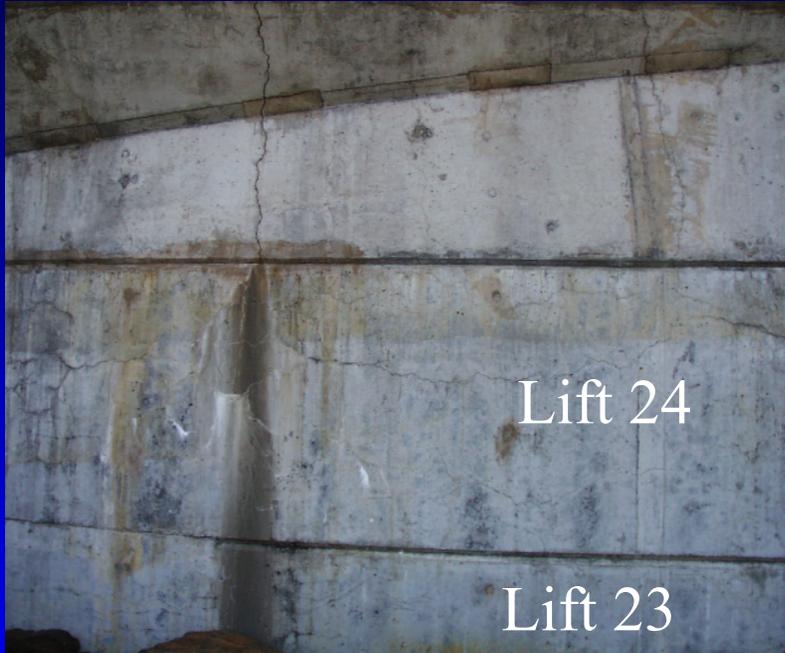
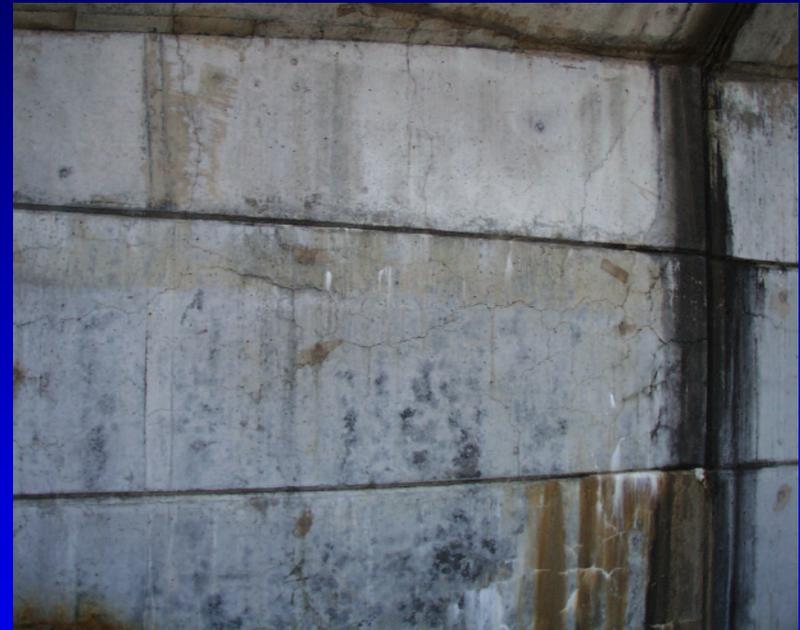
Downstream D-2, Lifts 23, 24?

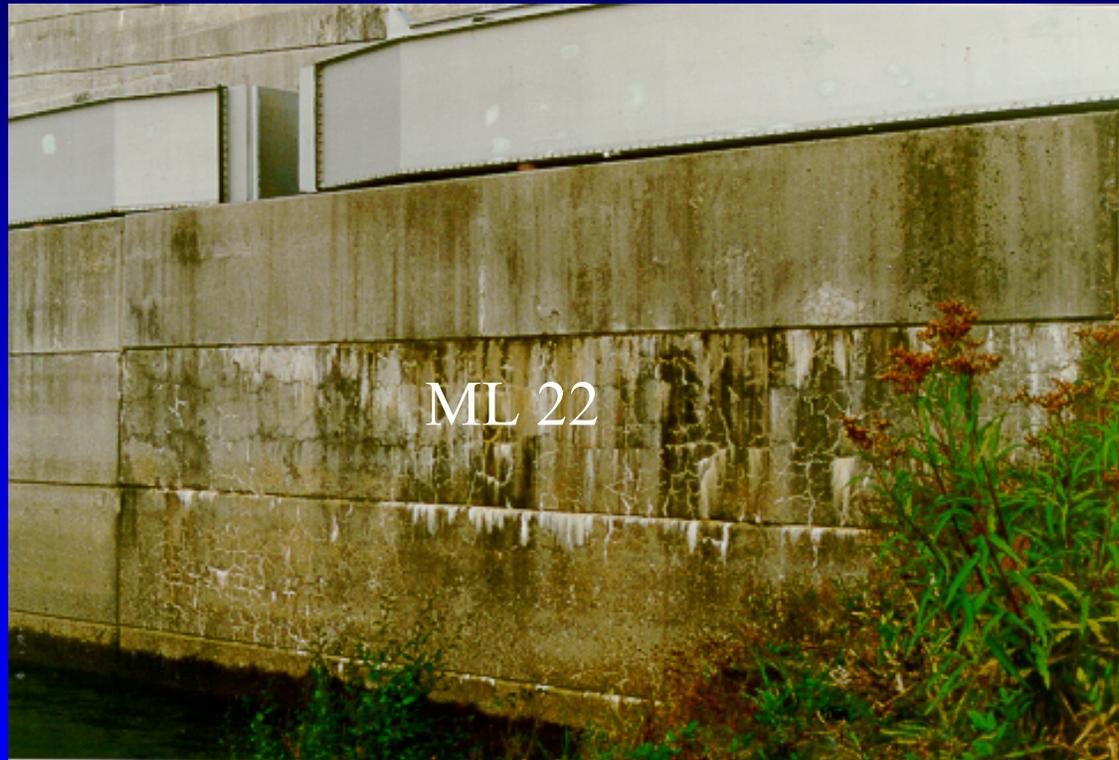
Upstream D-2

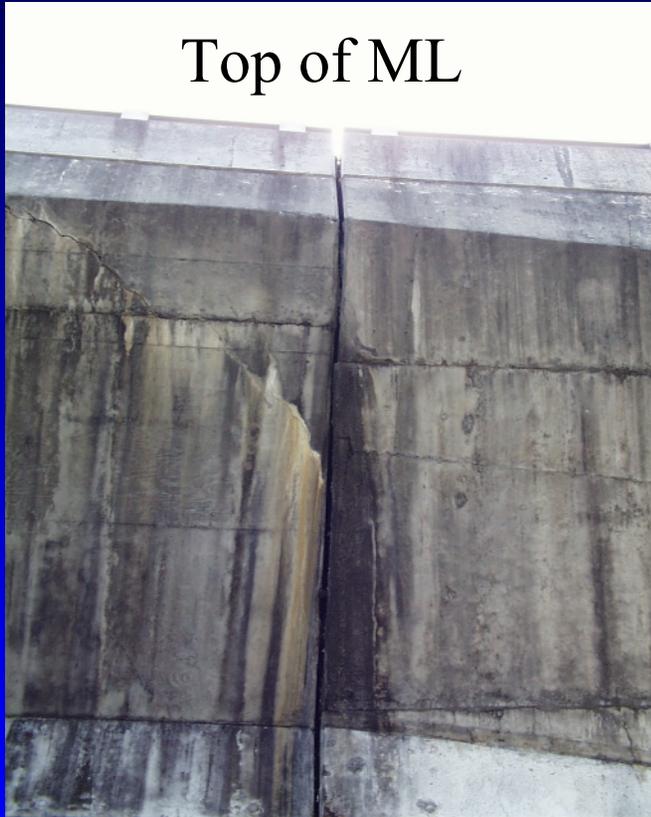
Downstream Joint - D-8 and D-9

Top of ML

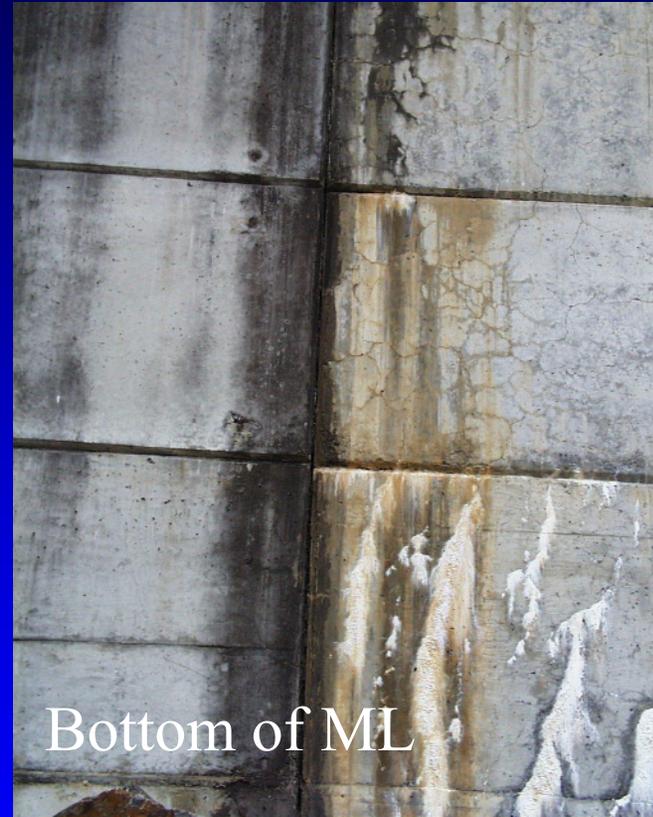
Bottom of ML

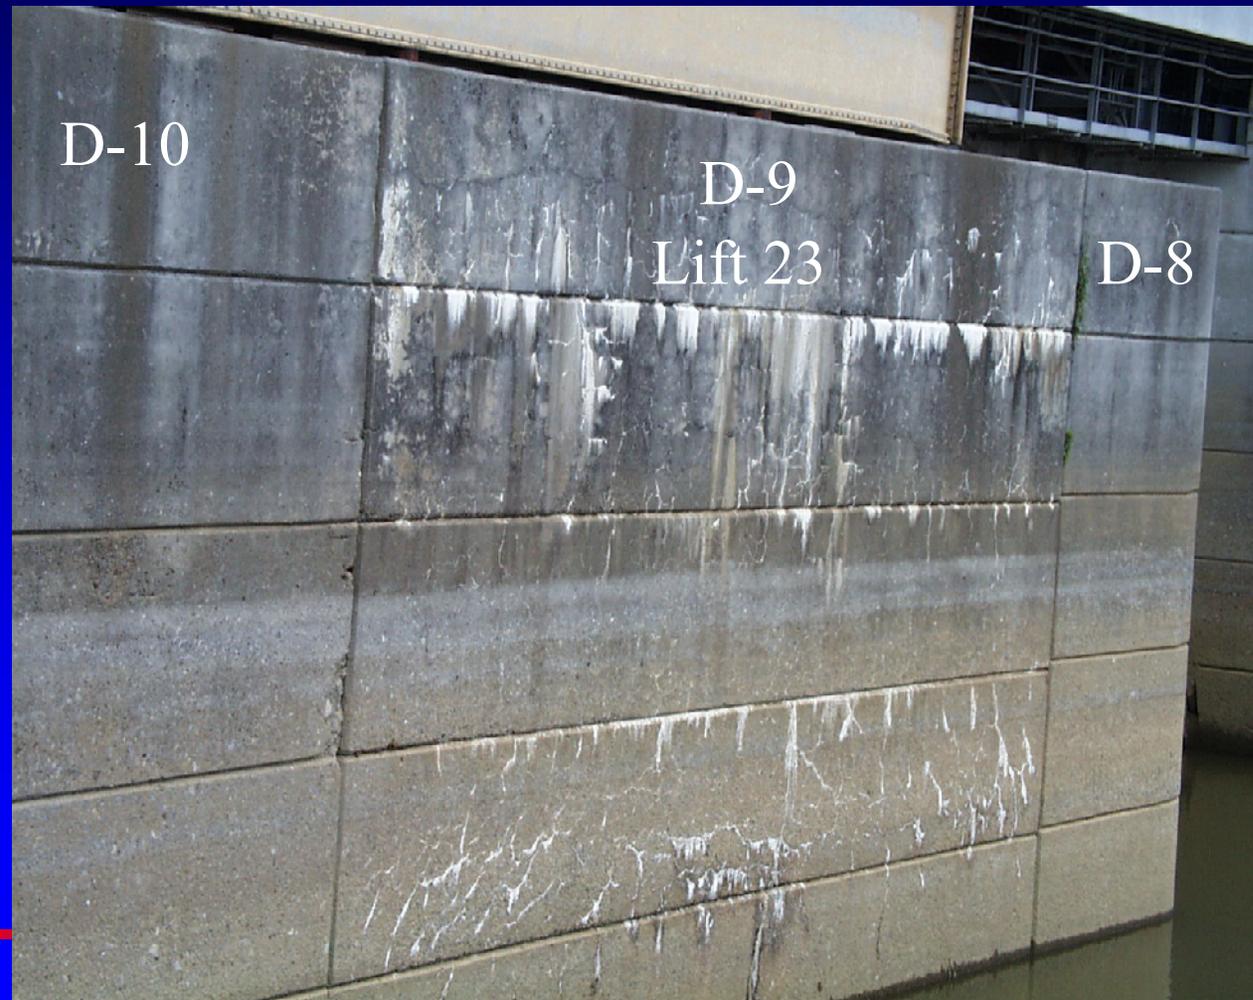
Upstream D-9

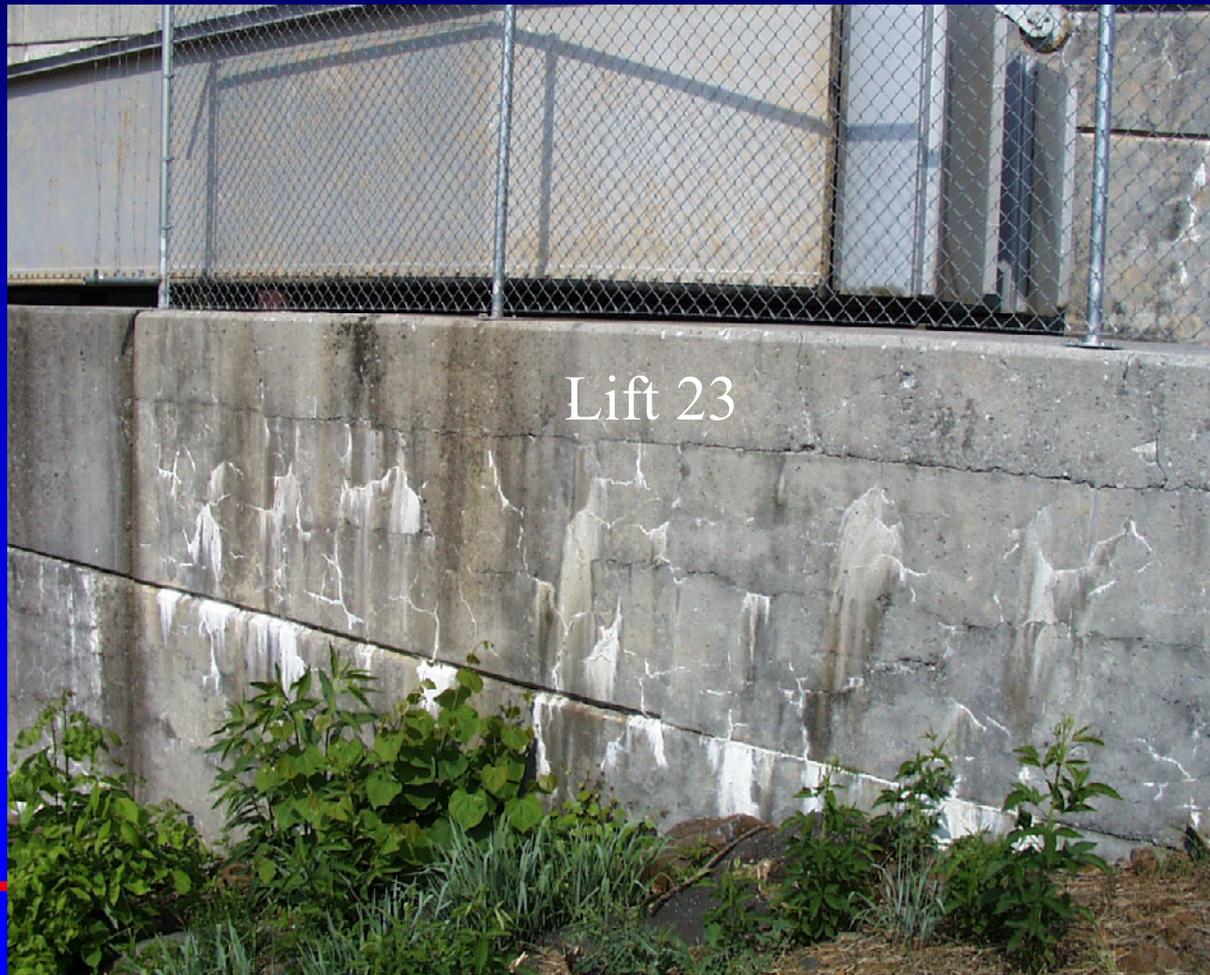
Upstream D-1

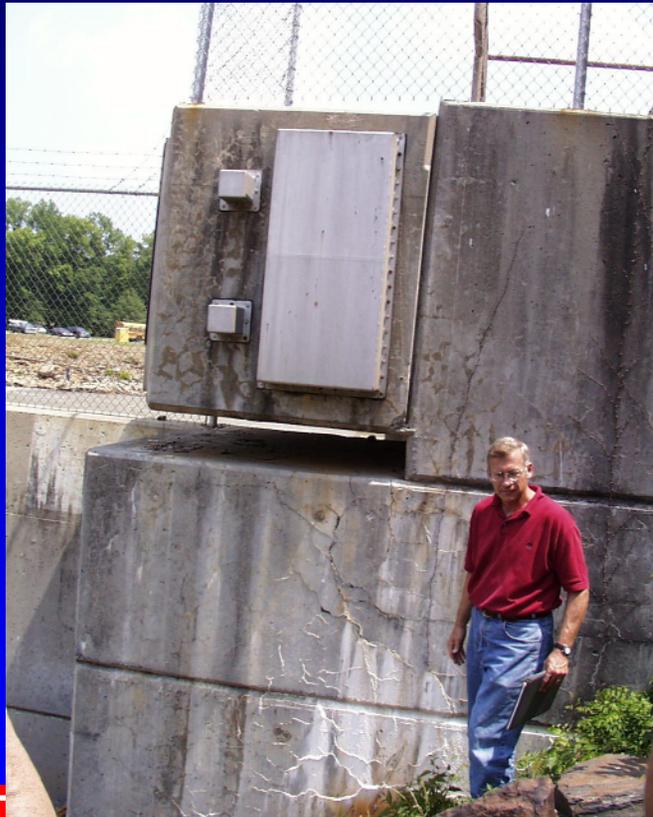
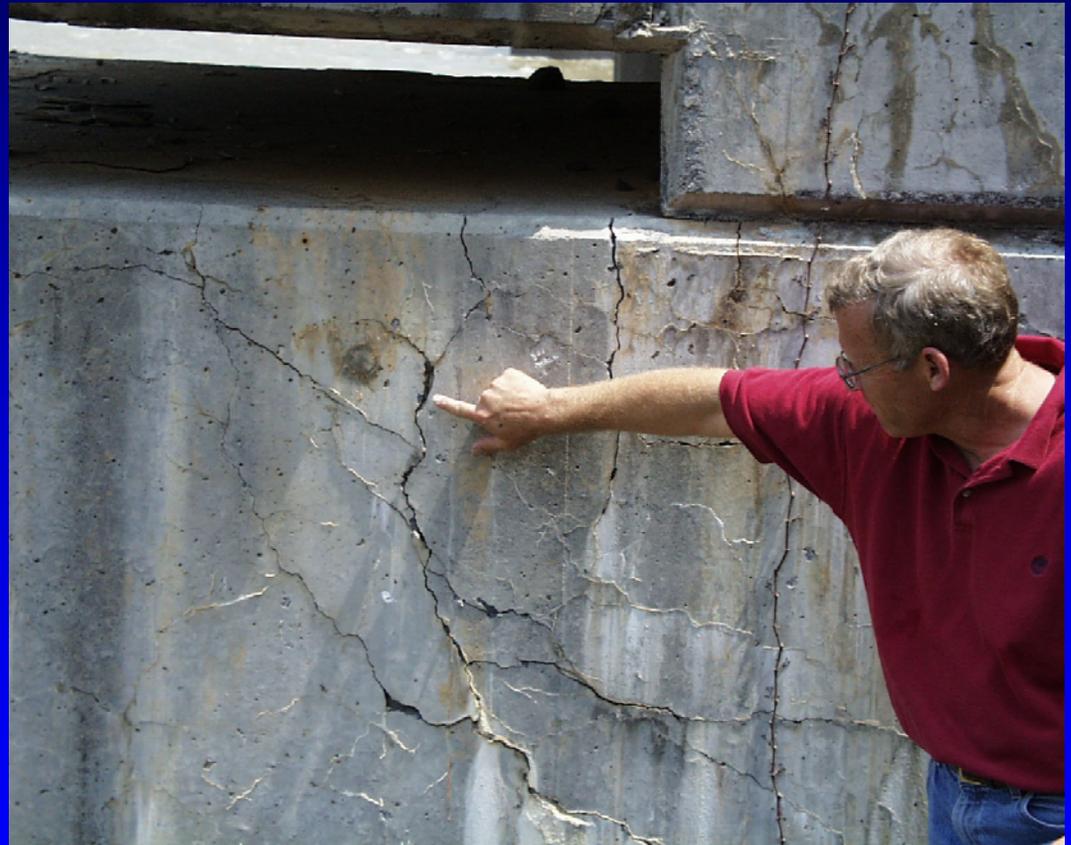
Trunnion Block, ML D-8

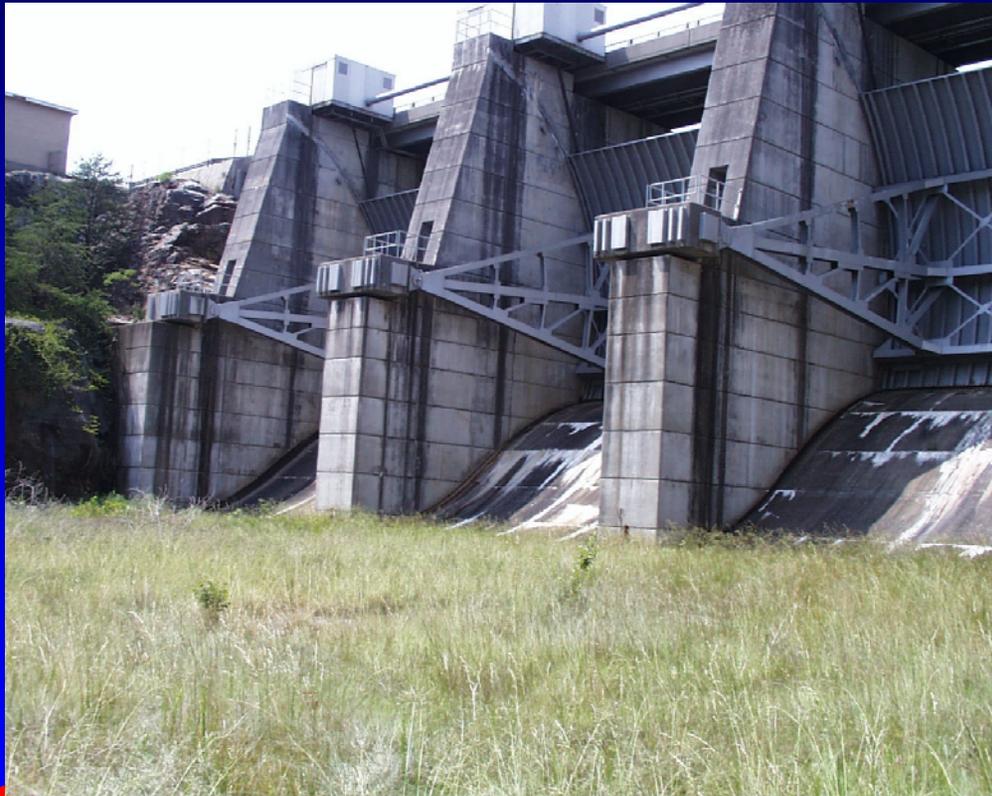
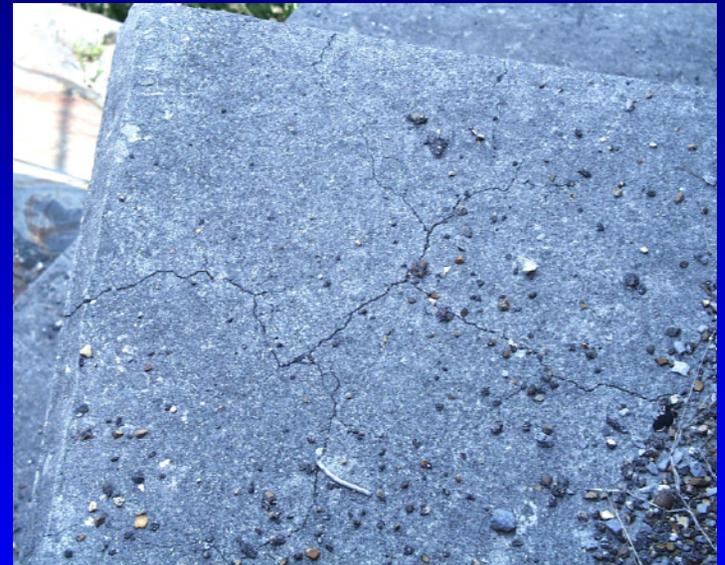
Emergency Spillway

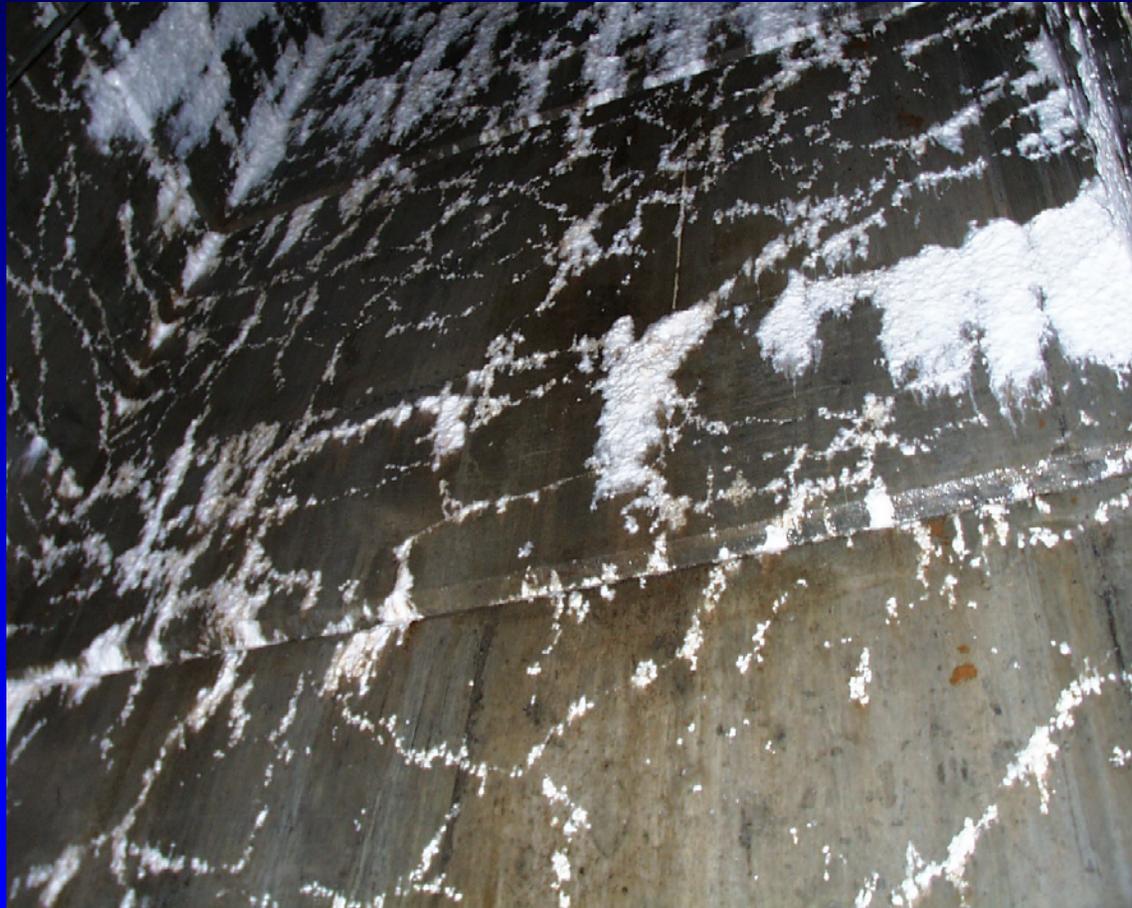
Shaft in ML 11

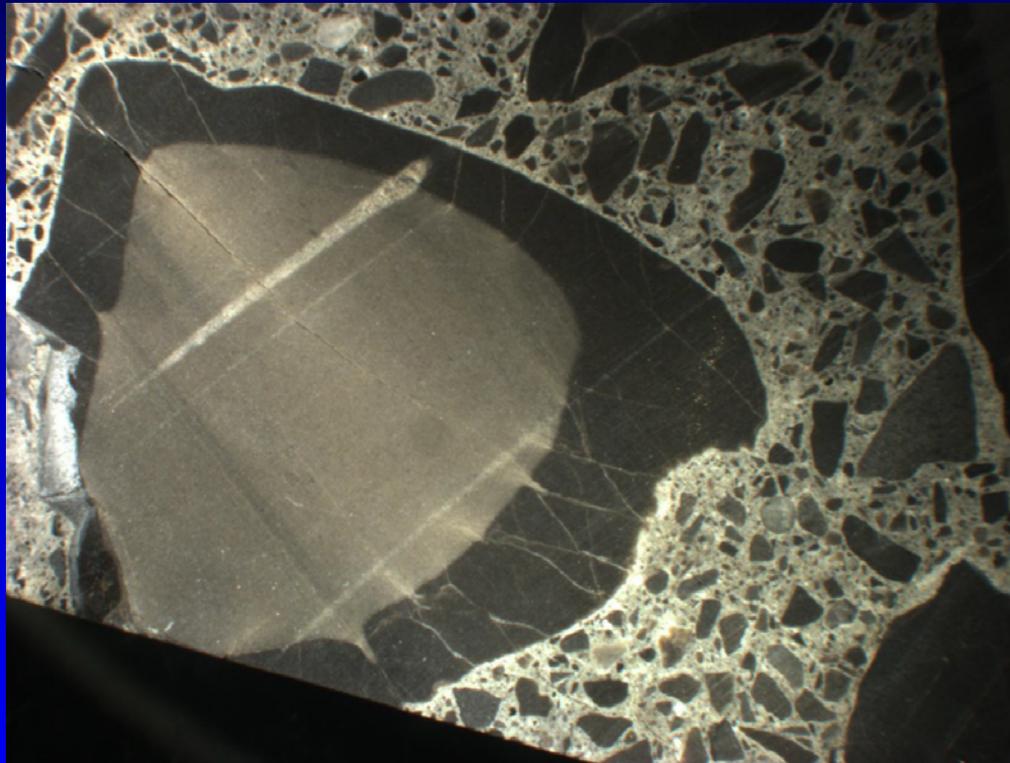
- Single source – Dalton Quarry
- At least 3 distinct types in the 1.5 and 3 inch sizes
 - One suspected of ACR
 - Problems with ACR rock: Sep – Nov 71

Reactive Pieces

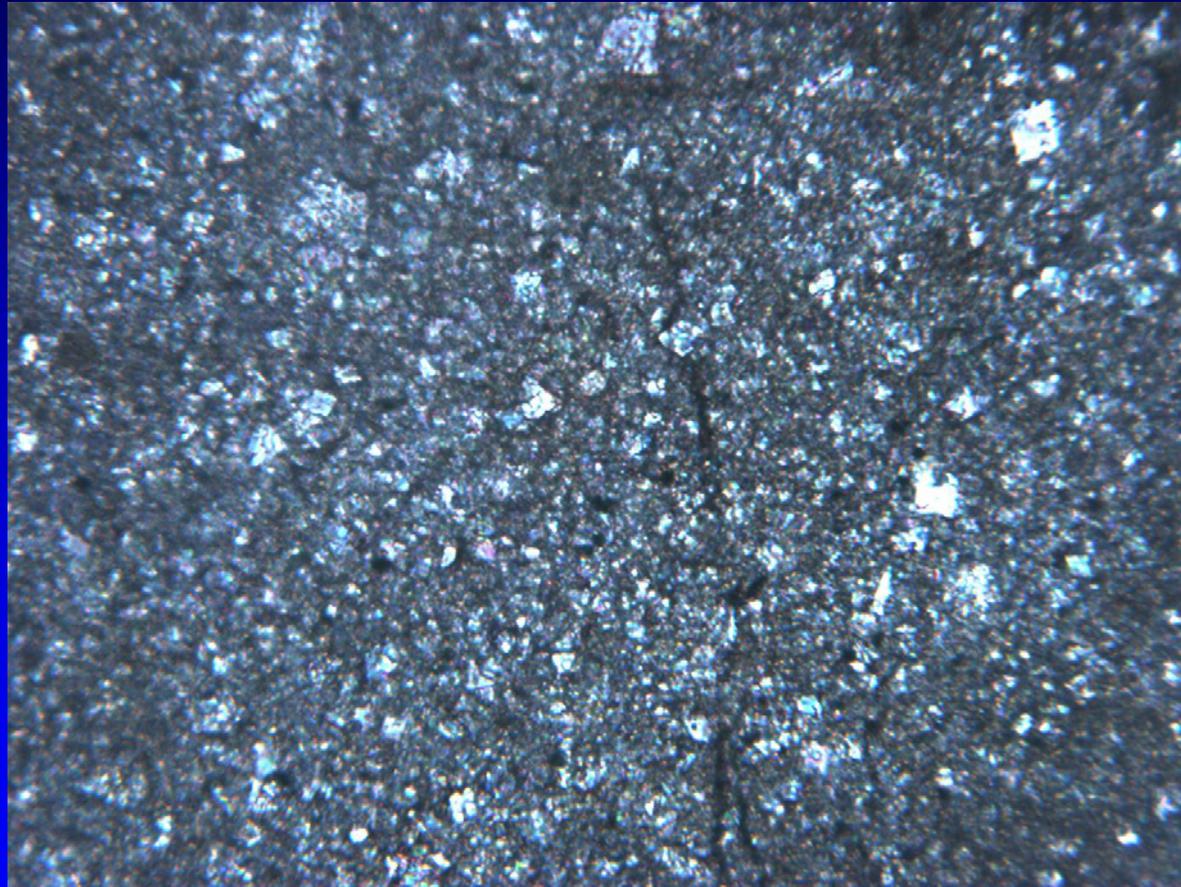
Rhombs

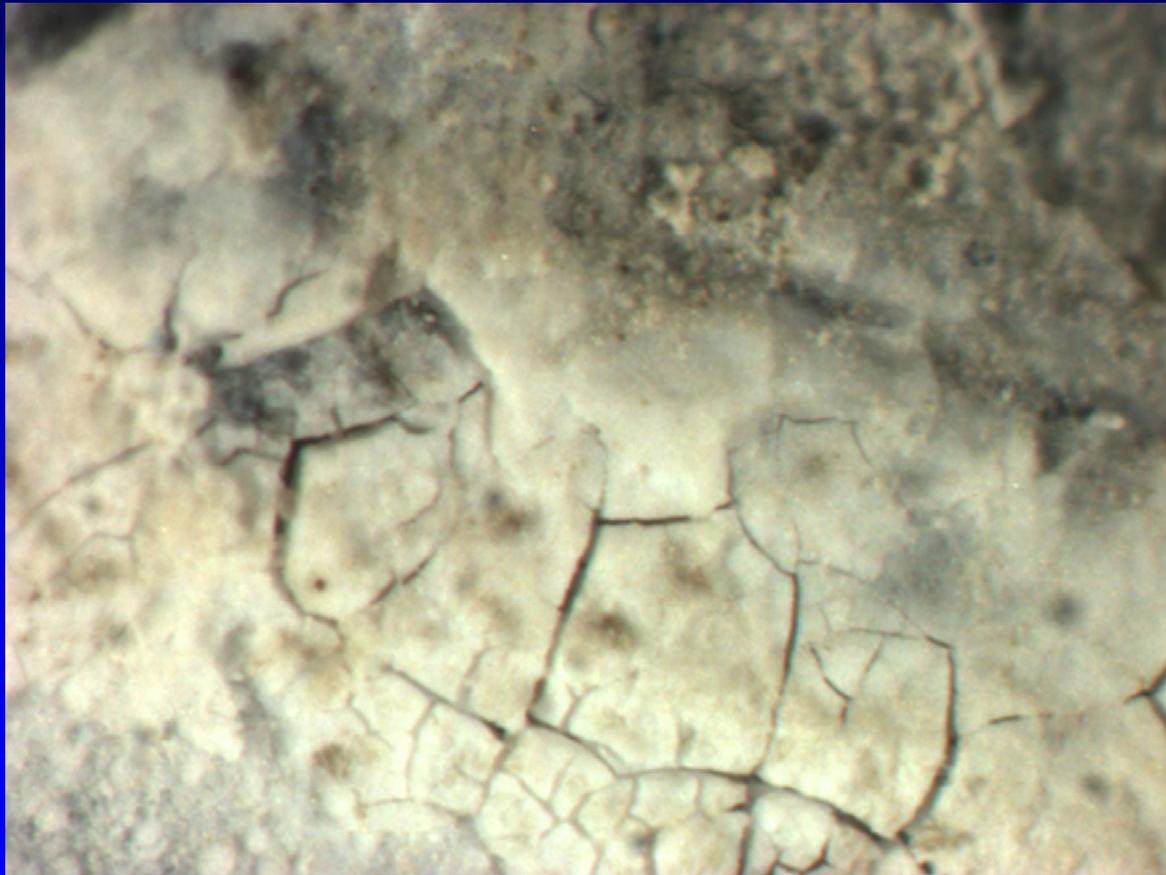
Reaction Products

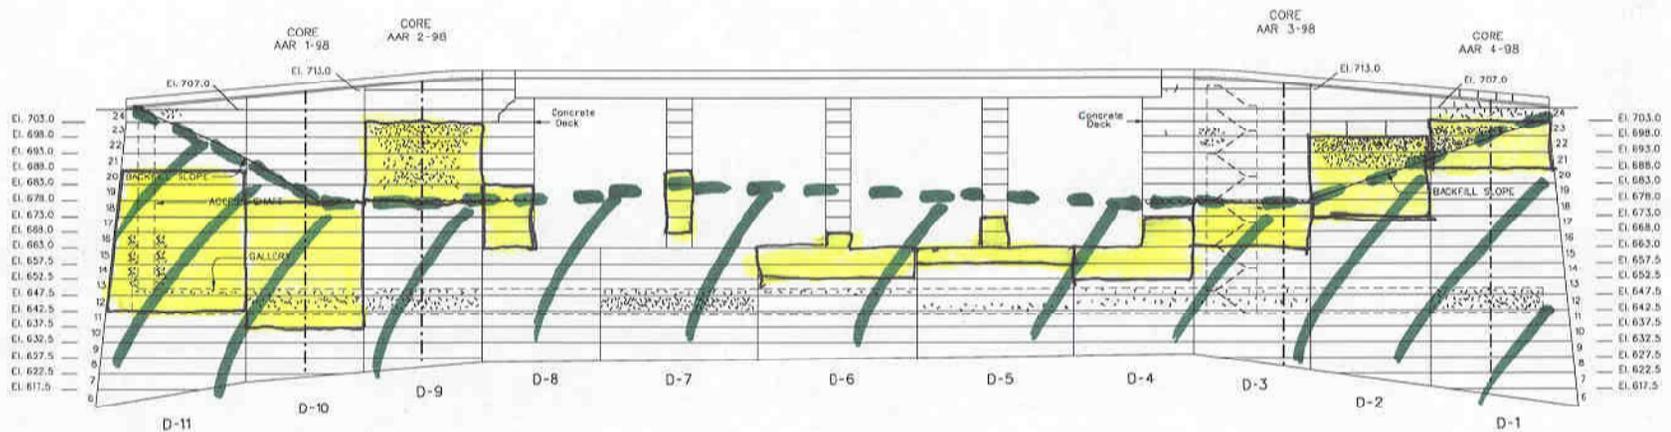
Expected Damage – Upstream Face

CARTERS REREGULATION DAM - UPSTREAM ELEVATION

- Expected Damage based on placing date

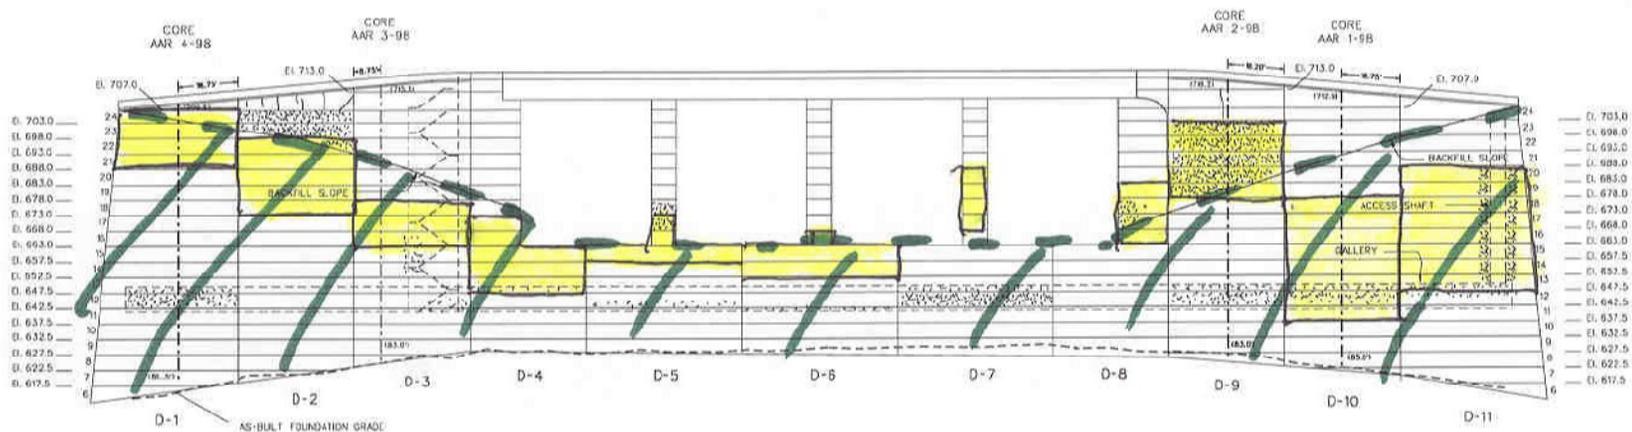
Expected Damage - Downstream Face

CARTERS REREGULATION DAM - DOWNSTREAM ELEVATION

/// Not visible (back-filled)
[Yellow box] Expected damage based on placing date

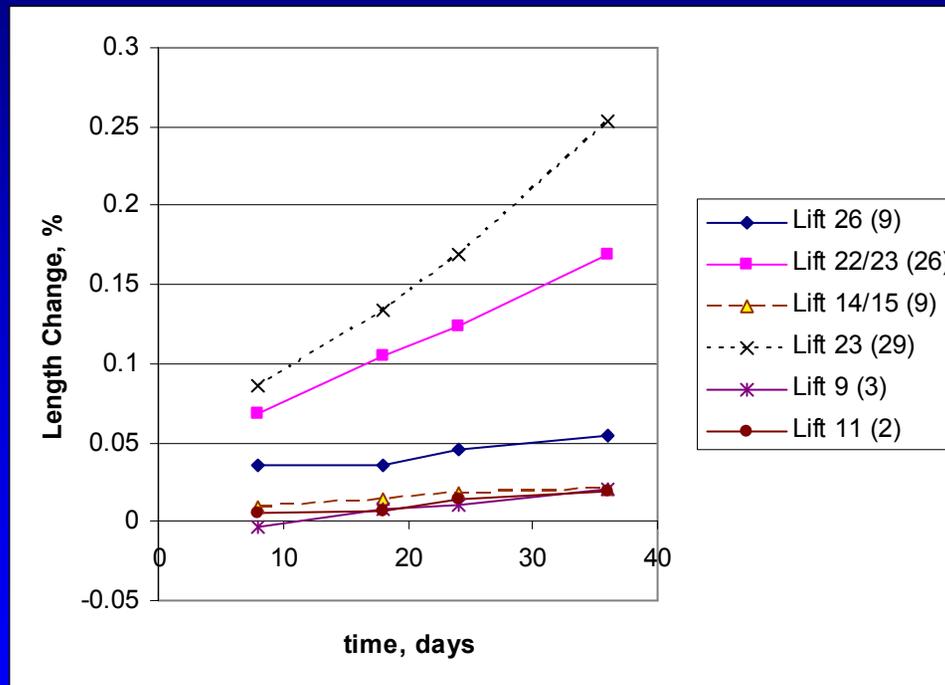
Residual Expansion

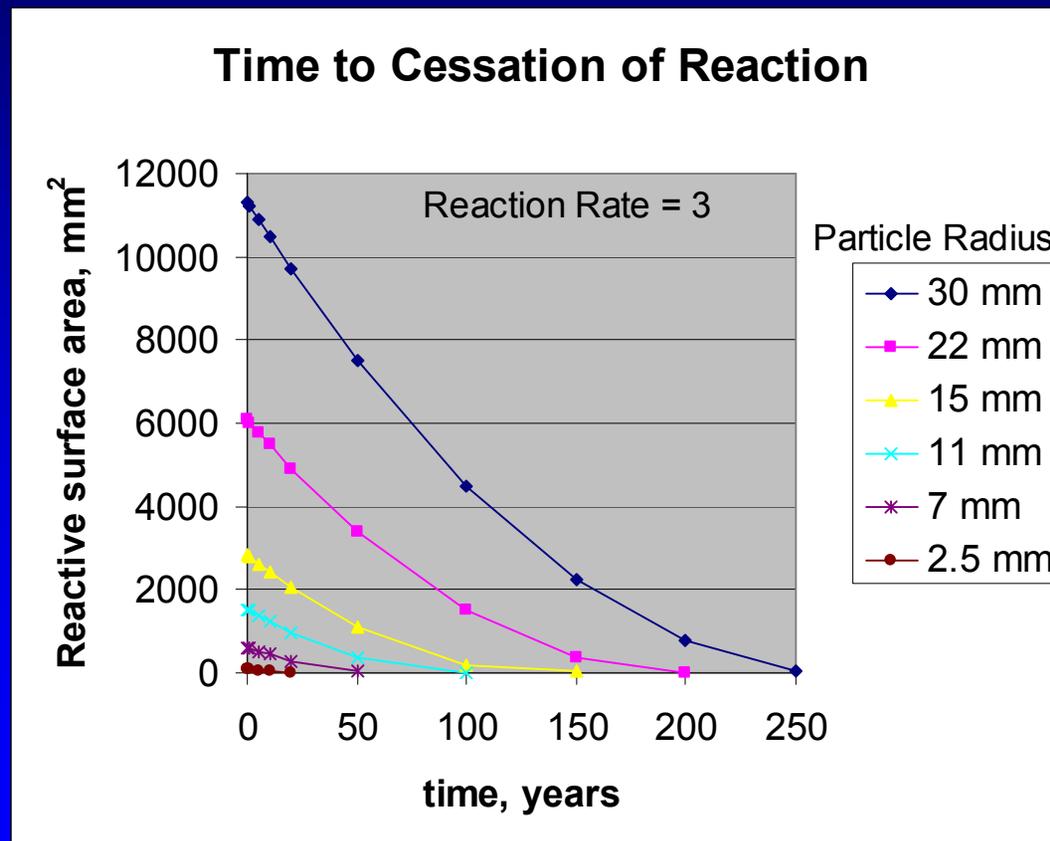
Remaining Reaction
