M107 .50 Caliber COTS/NDI Sound Suppressor Evaluation

Joshua Semick, US Army ARDEC

Objectives

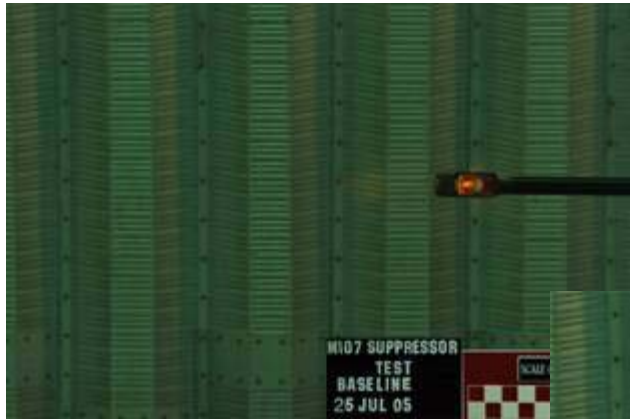
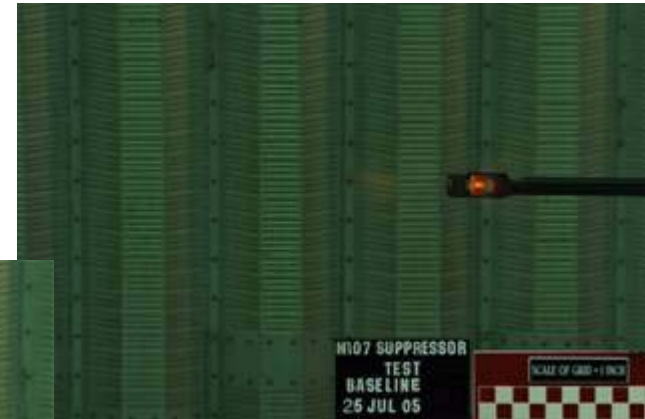
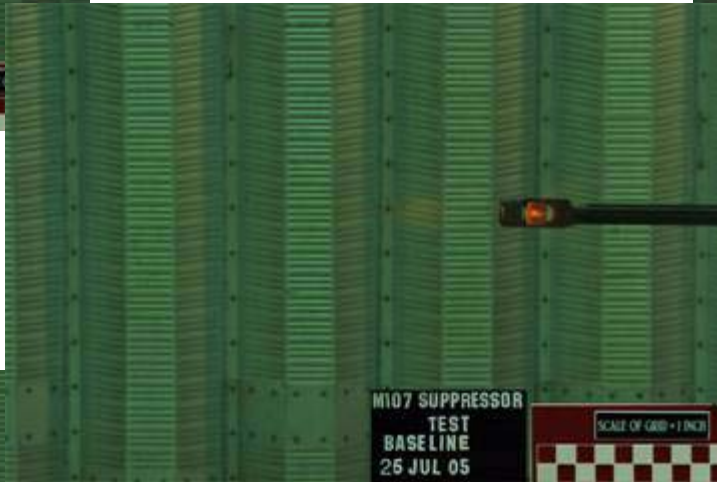
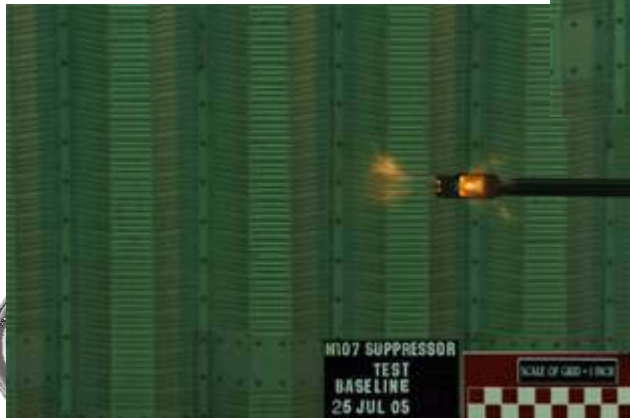
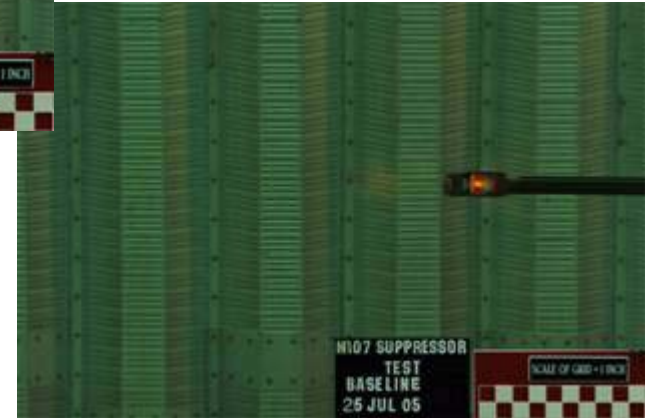
Flash (baseline)

- **Flash** – cross sectional area measured using high speed photography
- **Sound** – peak SPL recorded using digital oscilloscope at five (5) positions
- **Muzzle Blast** – ground disturbance area below suppressor
- **Recoil** – recoil energy (ft-lbs)
- **Accuracy/Dispersion** – five 10 round targets at 500 meters and 1000 meters.
- **Reliability** – 1,000 rounds per candidate, stoppages and failures were recorded
- **Limited User Evaluation** – Army and Marine Snipers

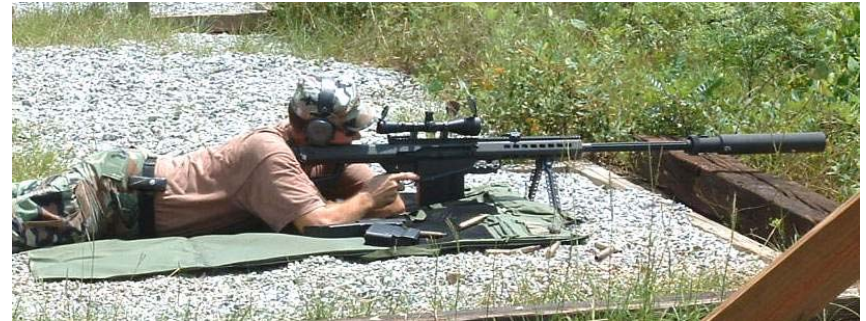
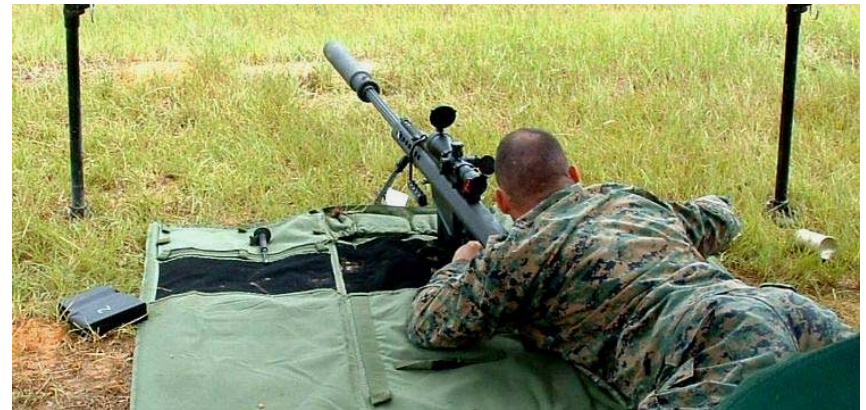
Recoil Energy

- Recoil level in excess of 45 ft-lbs reflected negatively
- Blowback
- Muzzle heavy situations reported above 5 lbs
- Quick attach/detach a must

- Drastic increases in recoil energy produced an overpowering situation resulting in stoppages and premature component failures.
- Expansion tank designs generally produced more blowback than designs that shifted sound frequency outside of the audible frequency range.
- Designs that shifted sound frequency produced excessive recoil energy levels.
