A-10 Thunderbolt II (Warthog) SYSTEMS ENGINEERING CASE STUDY

Air Force Center for Systems Engineering (AFIT/SY)
Air Force Institute of Technology
2950 Hobson Way, Wright-Patterson AFB OH 45433-7765

Sustaining Systems Engineering: The A-10 Example (Based on A-10 Systems Engineering Case Study)

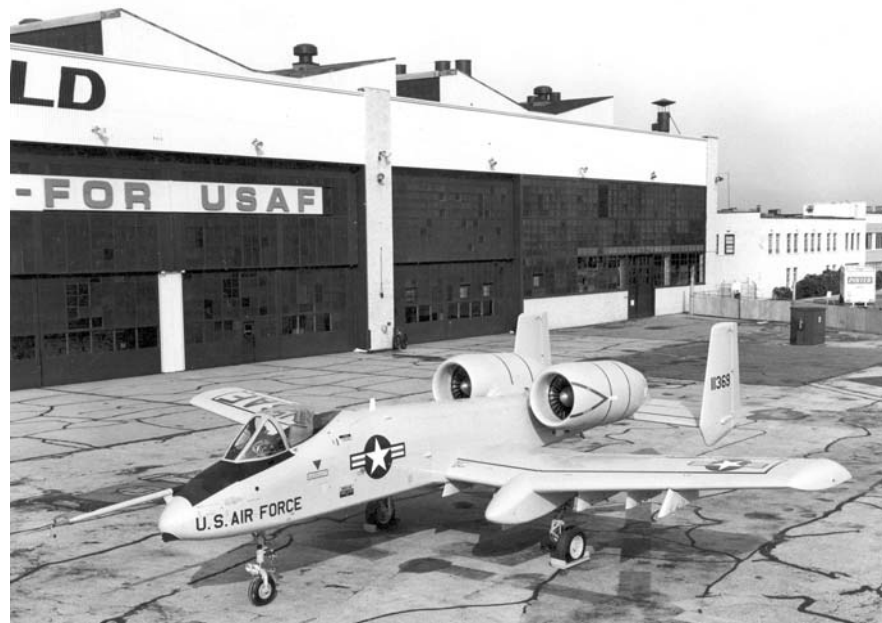
• Key sustainment features:

- Survivability – redundancy, shielded systems, engine placement
- Maintainability – interchangeable left/right side parts, simple skin panels, engine placement
- Cost Considerations – lean avionics (no night/adverse weather systems), ammunition cost reduction efforts
