175 MM M113 Cannon: Historical Perspective on the Cannon that changed our Cannon Design Process

NDIA Joint Armaments Symposium
14-17 May 2012

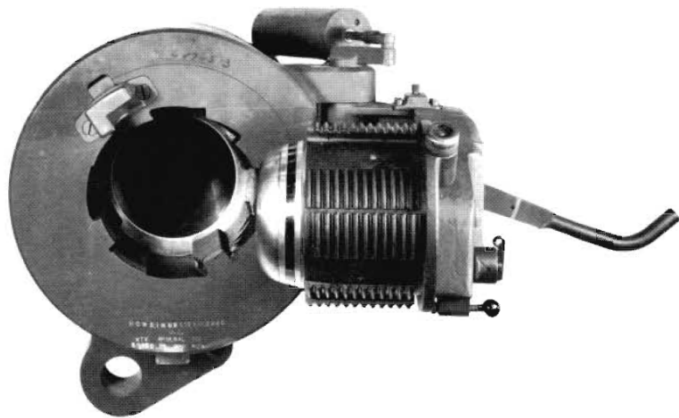
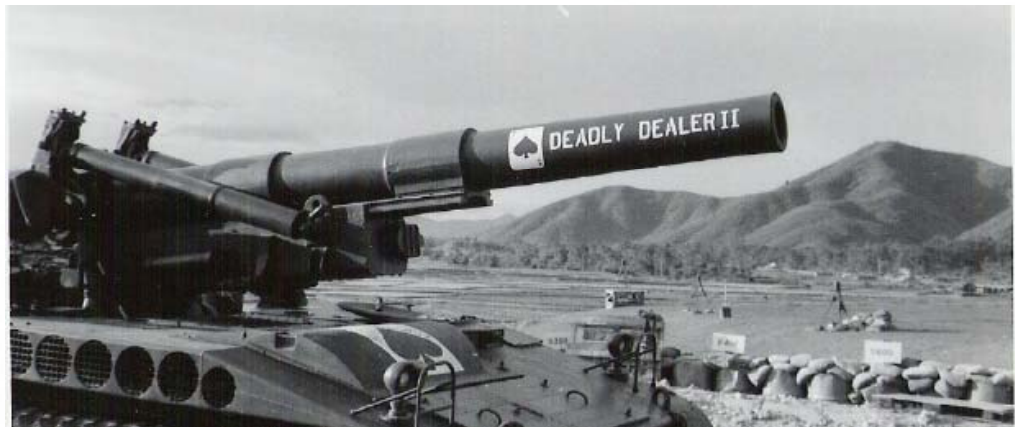
8" M110 Howitzer showing breech and tube (2) circa 1965

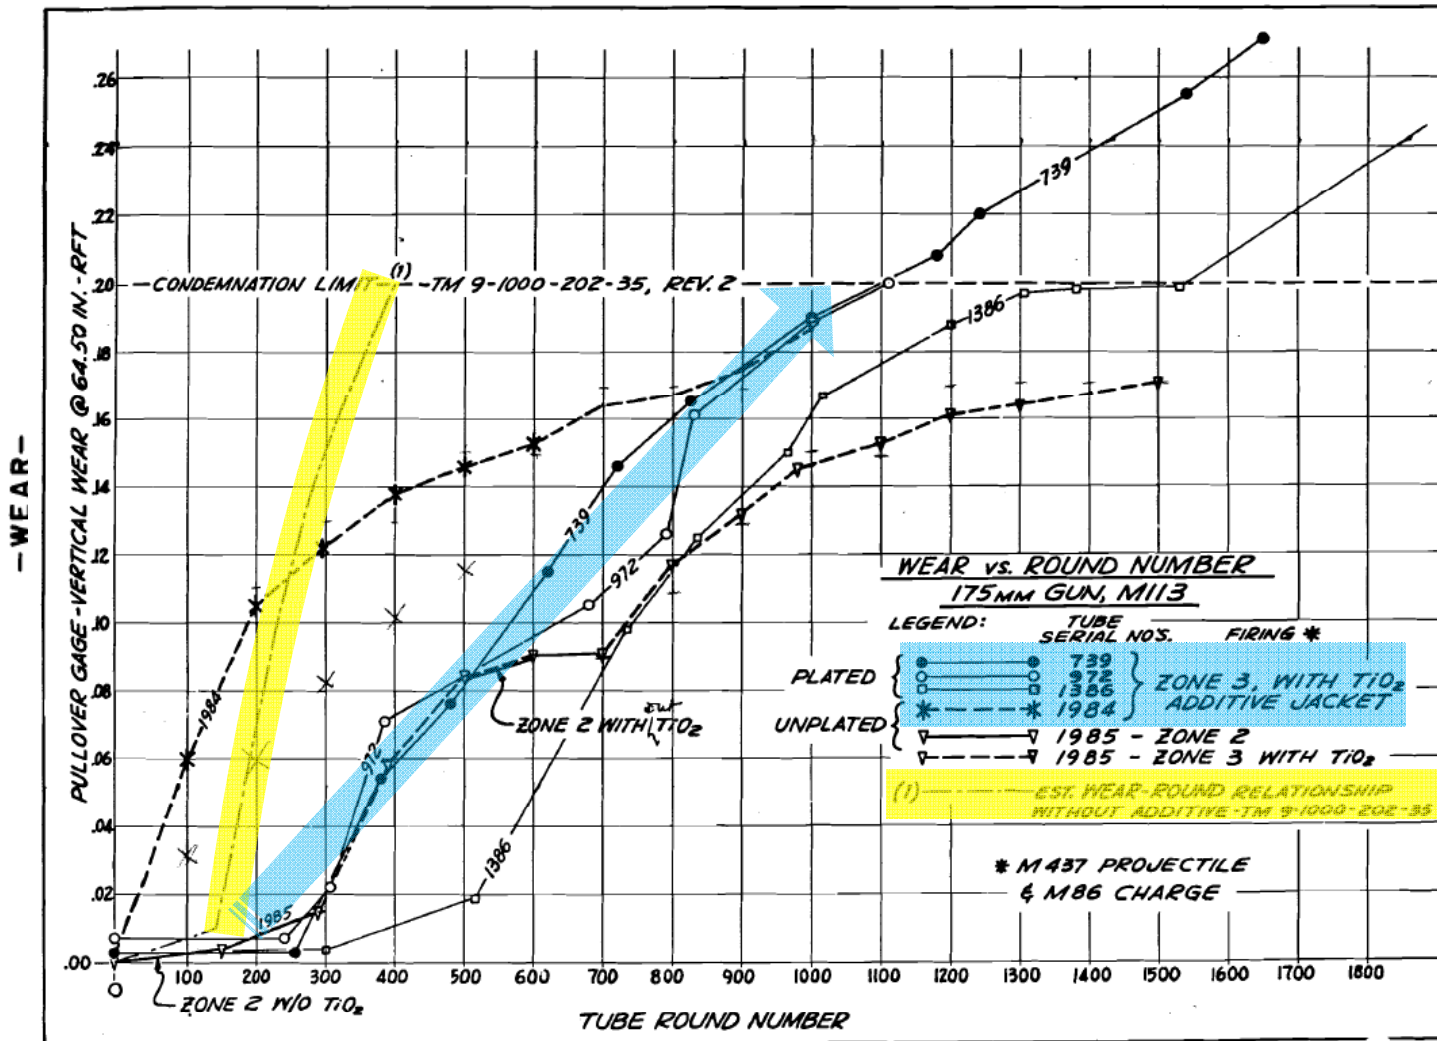
Testing of M1 Wear Additive showing drastic improvement in wear life (6)

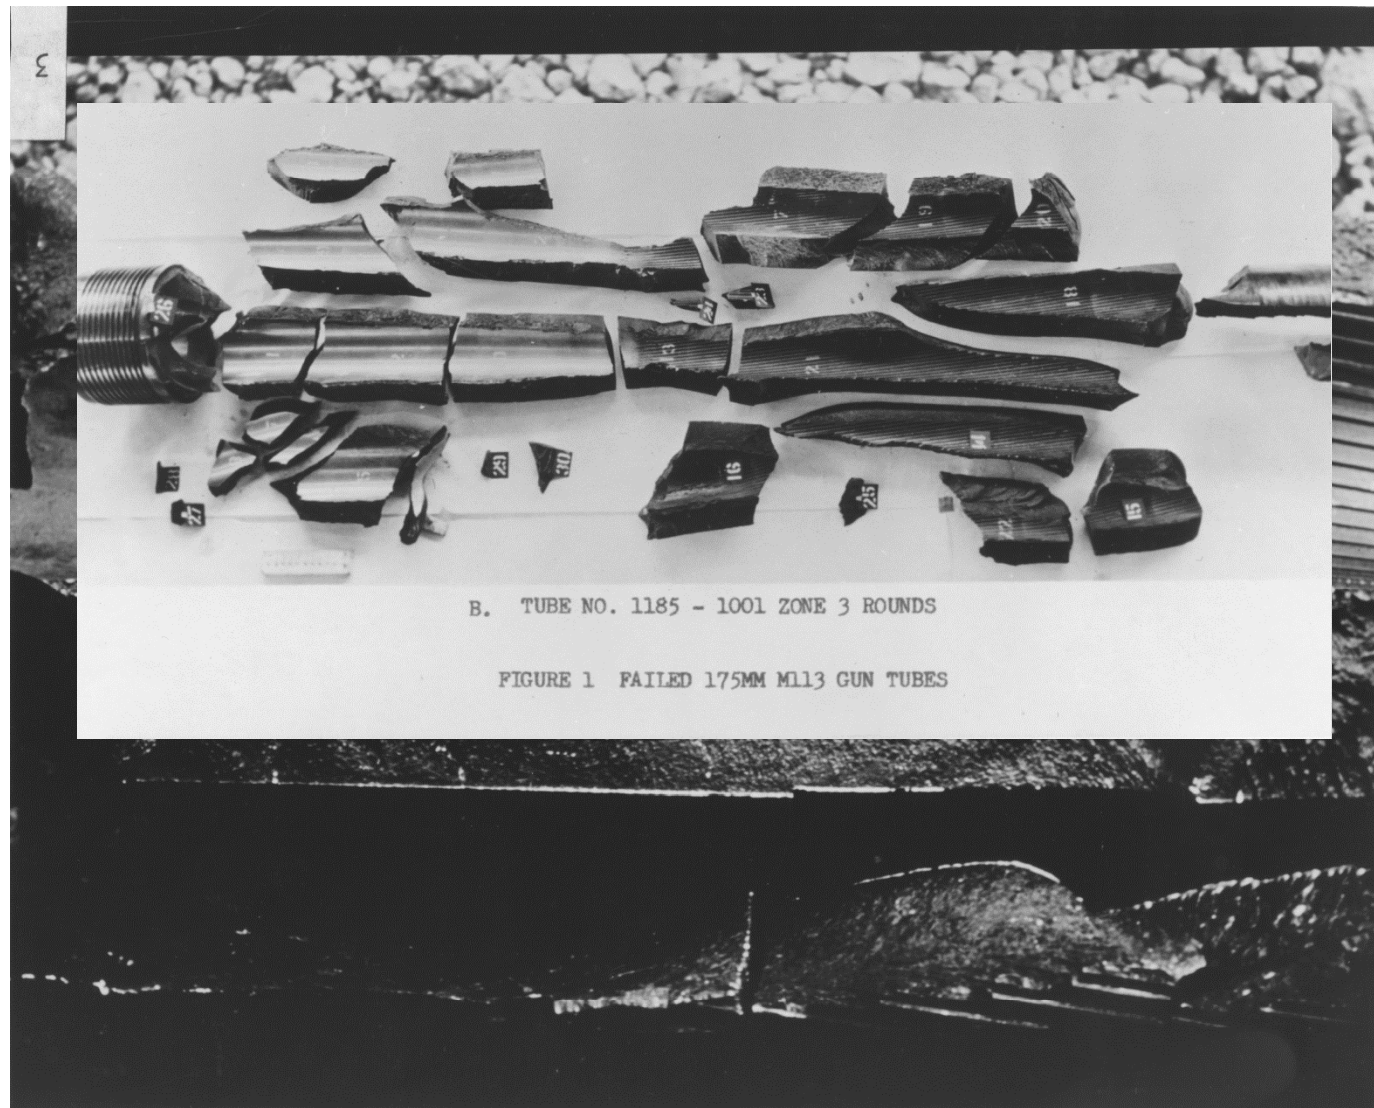
175 MM M113
Tube Serial Number 733

- April 1965, a 175 mm M113 gun tube failed during firing in Vietnam at a total of 428 Equivalent Full Charge (EFC) rounds and the failure was attributed to fatigue
- Almost immediately -
 - fatigue limit was reset to 400 EFC (300 maximum Zone 3 rounds) fatigue life on the tube
 - major investigation and analysis was launched
 - gun tubes with same properties (whole production run) were removed from service
- Now - cannons that could fire effectively (based on the new wear additive) past 1,000 rounds were now being taken out of service at 400 rounds or less.
- Given the amount of firing on-going, this was a potential crisis for field units, and the impact was heard at the Secretary of Defense level.

Soon after this, the fatigue failure was duplicated during a test. Tube (S/N 1185 failed with 1001 Zone 3 rounds.

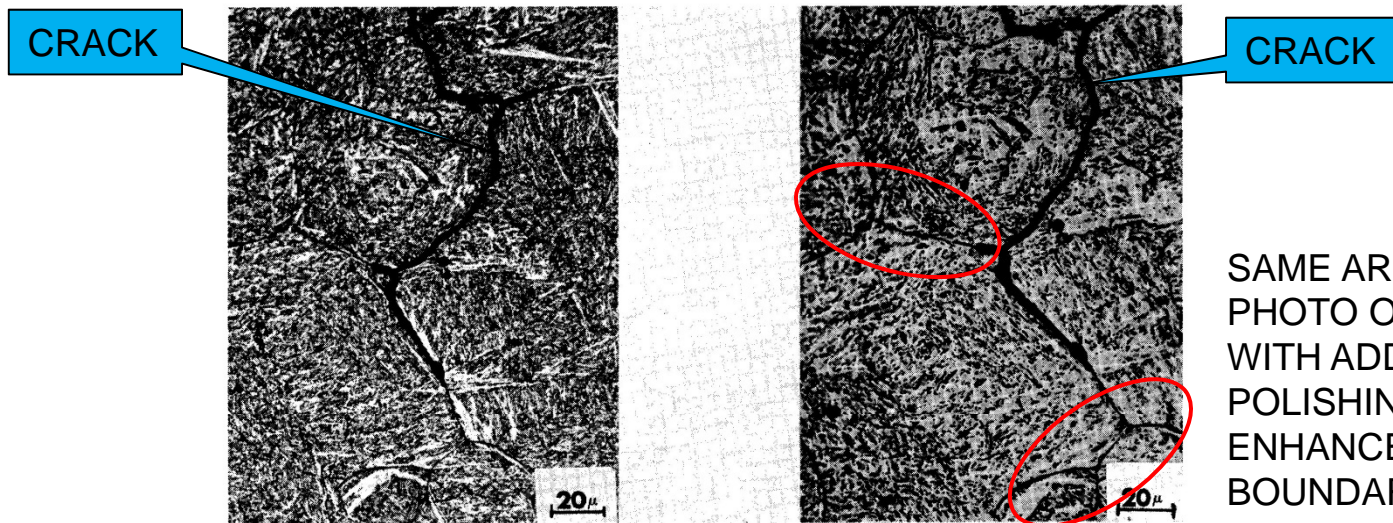
- Electron microscopic examination (a very recent tool for the period) revealed that the impurities in the lower life tubes were most prevalent in the grain boundaries, where in the longer life tubes, they appeared well distributed.
- Findings:
 - longer tempering times allowed impurities to migrate to grain boundaries
 - Weakened grain boundary zones allowed localized (fatigue) crack growth to progress quicker in an *intergranular* cracking failure mode
 - Inclusions tended to contribute to the faster crack growth - and brittle failure mode
 - Temper embrittlement also contributed to brittle failure mode

SAME AREA AS PHOTO ON LEFT WITH ADDITIONAL POLISHING TO ENHANCE GRAIN BOUNDARIES.

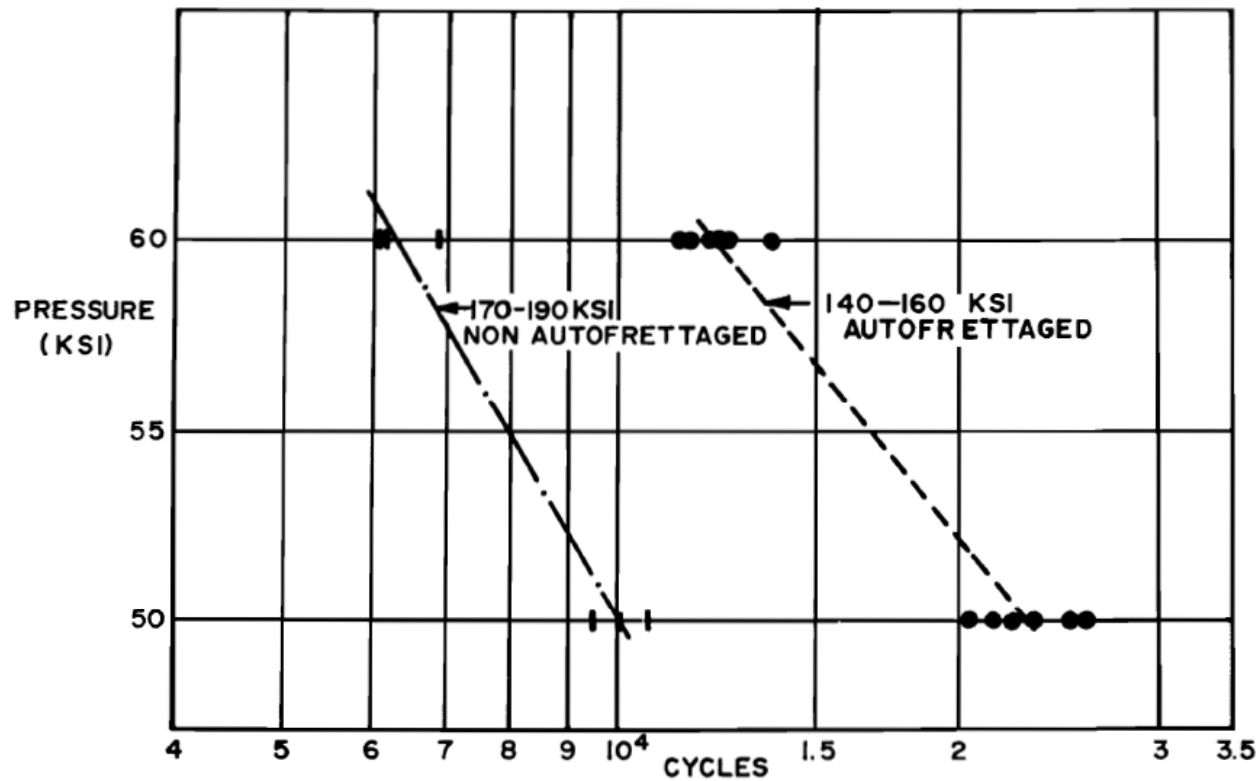
- Validation Testing of the M113A1 in 1969 revealed that the autofrettage process did improve the fatigue life.
